Report on
Preliminary Geotechnical Investigation

Cricket NSW Cricket Centre
Wilson Park, Newington Road
Sydney Olympic Park

Prepared for
Cox Architecture Pty Ltd

Project 86694.02
September 2019

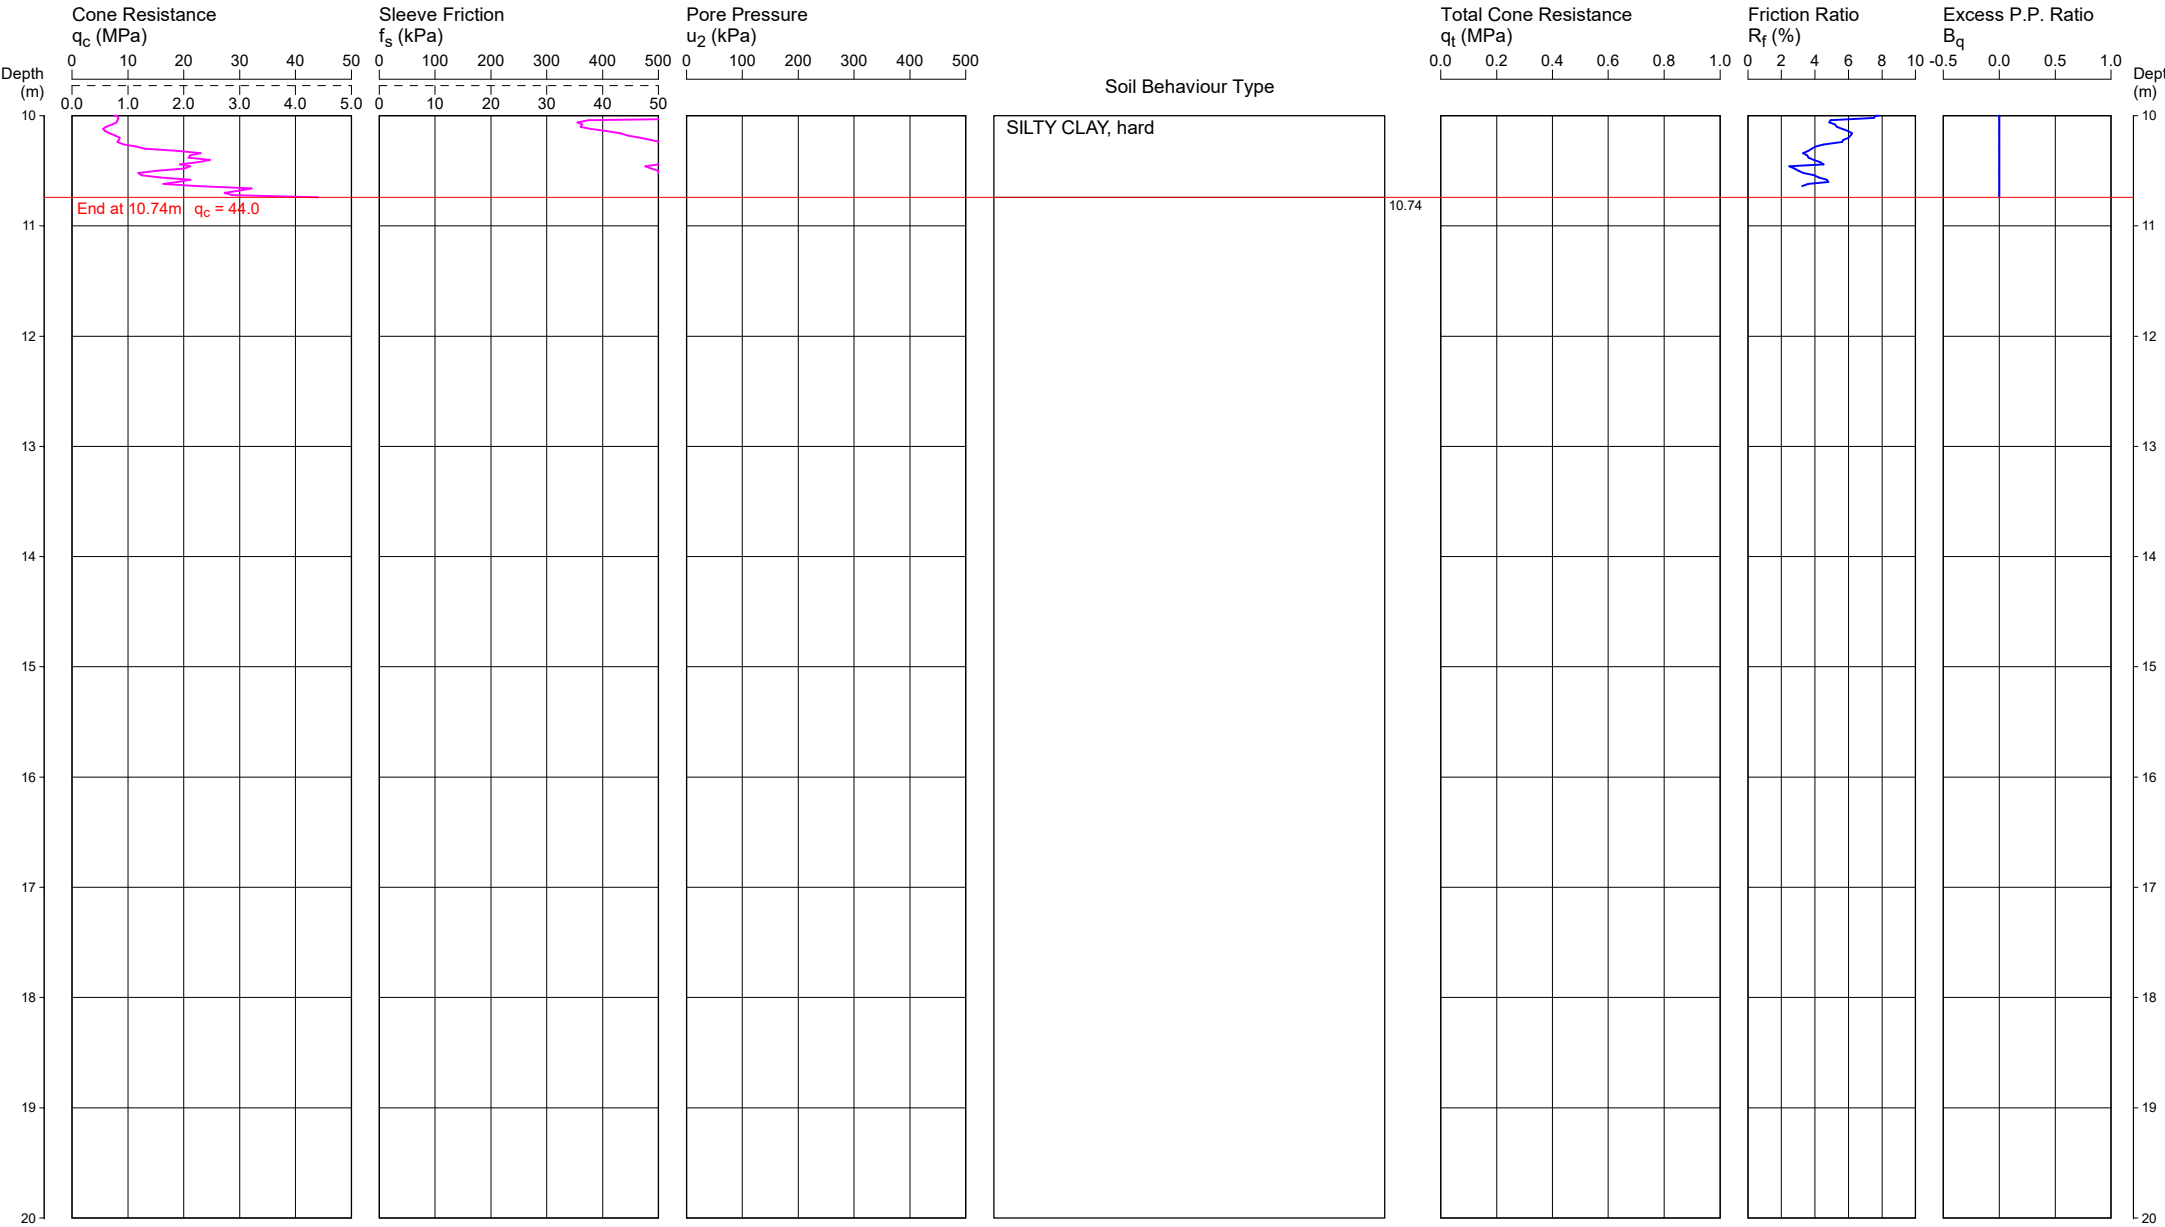
REMARKS: HAND AUGER TO 0.2 m. DUMMY CONE FROM 0.56 TO 1.2 m DEPTH TO PENETRATE FILLING. TEST DISCONTINUED DUE TO CONE TIP REFUSAL.HOLE COLLAPSE AT 0.7 m AFTER WITHDRAWAL OF RODS.

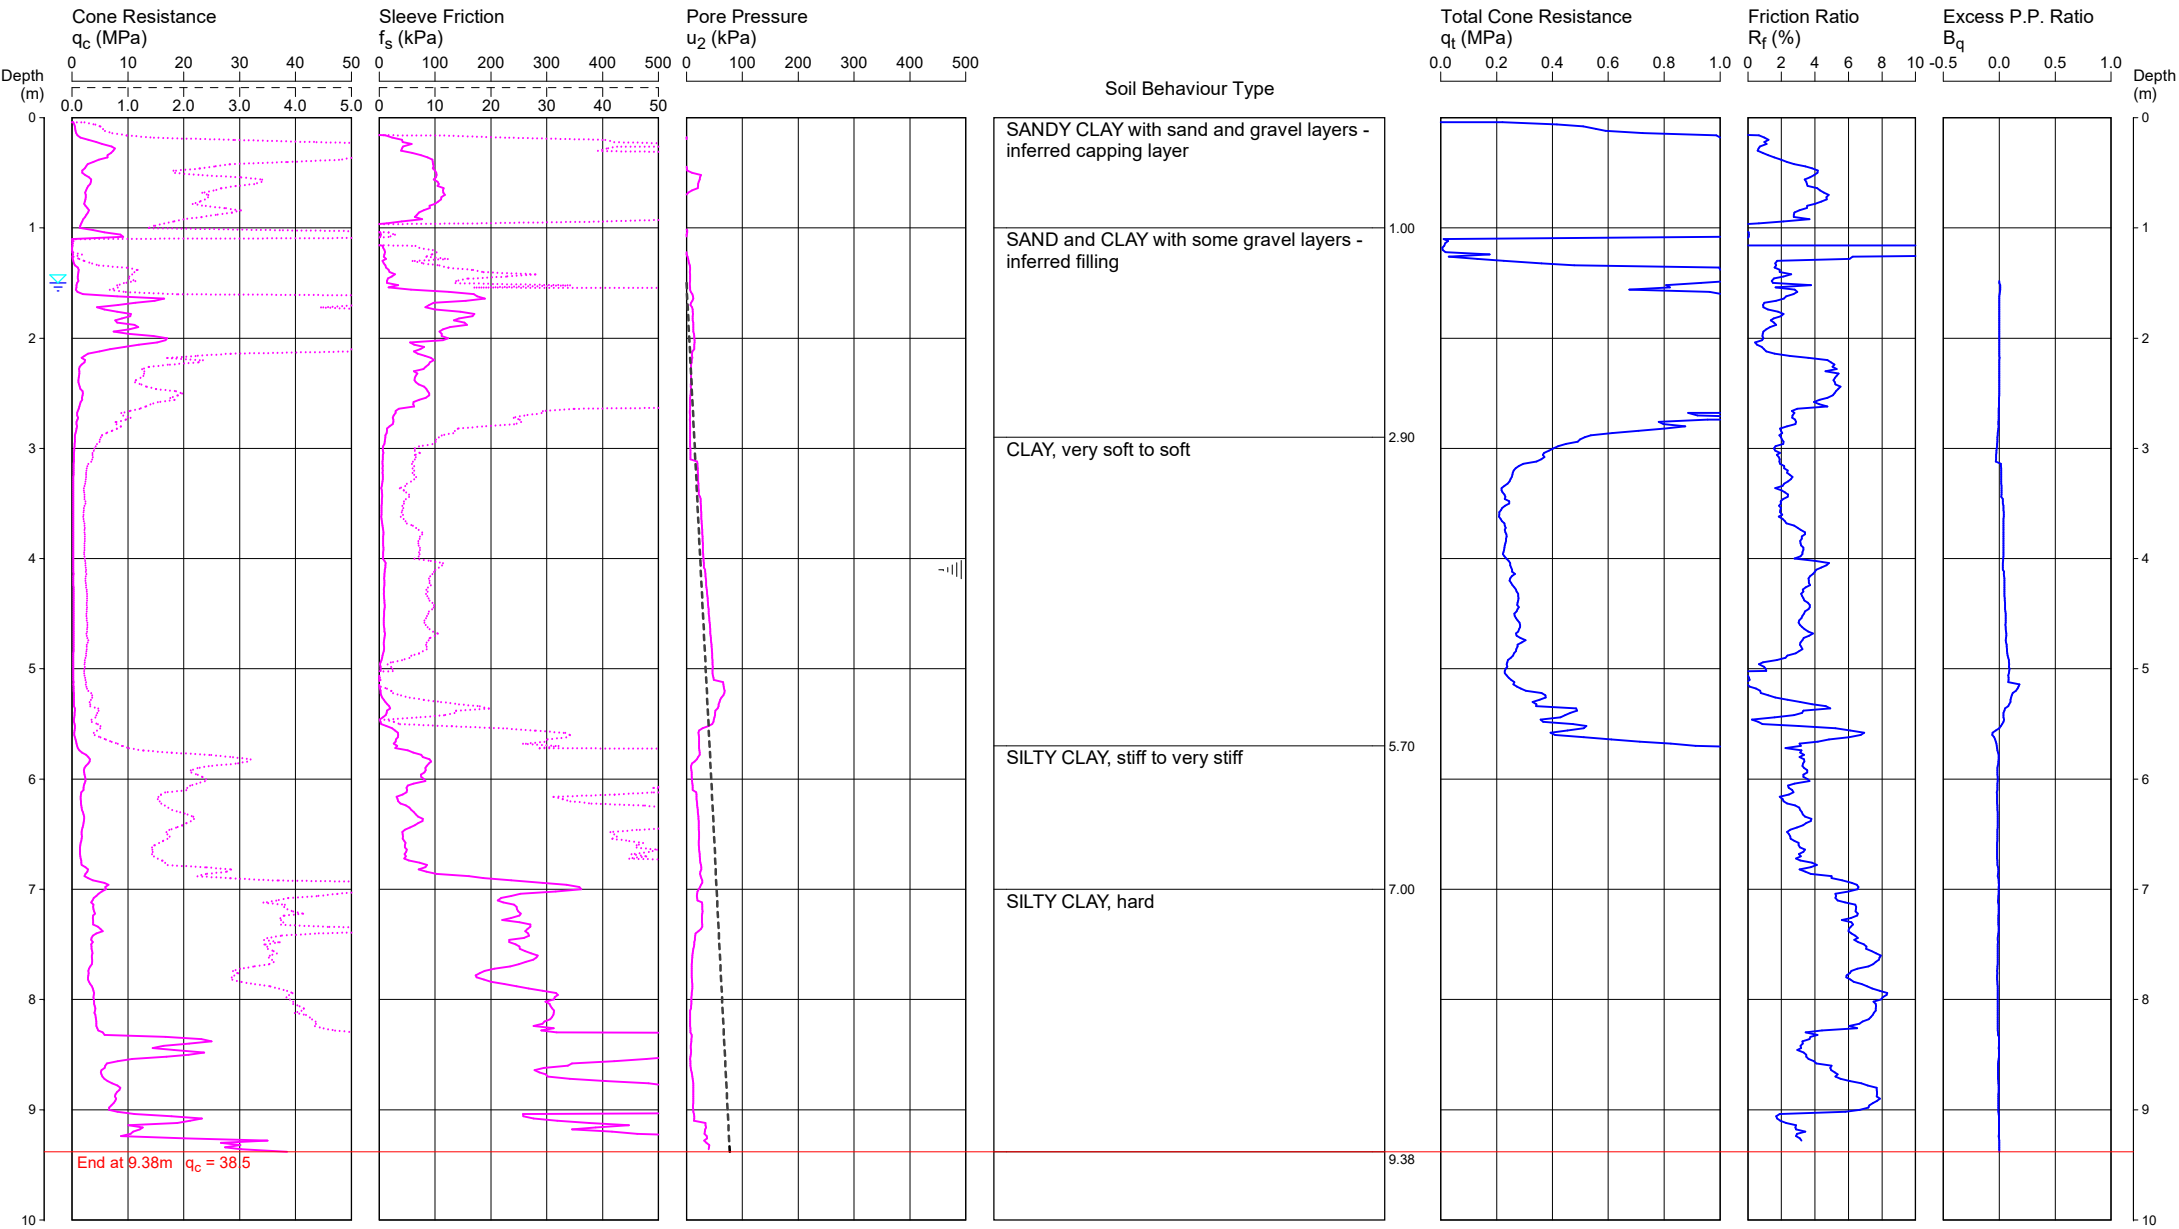
REMARKS: HAND AUGER TO 0.2 m. DUMMY CONE FROM 1.08 TO 1.4 m DEPTH TO PENETRATE FILLING.
TEST DISCONTINUED DUE TO EXCESSIVE CONE BENDING AT NEAR REFUSAL.

Water depth after test: 1.5 m

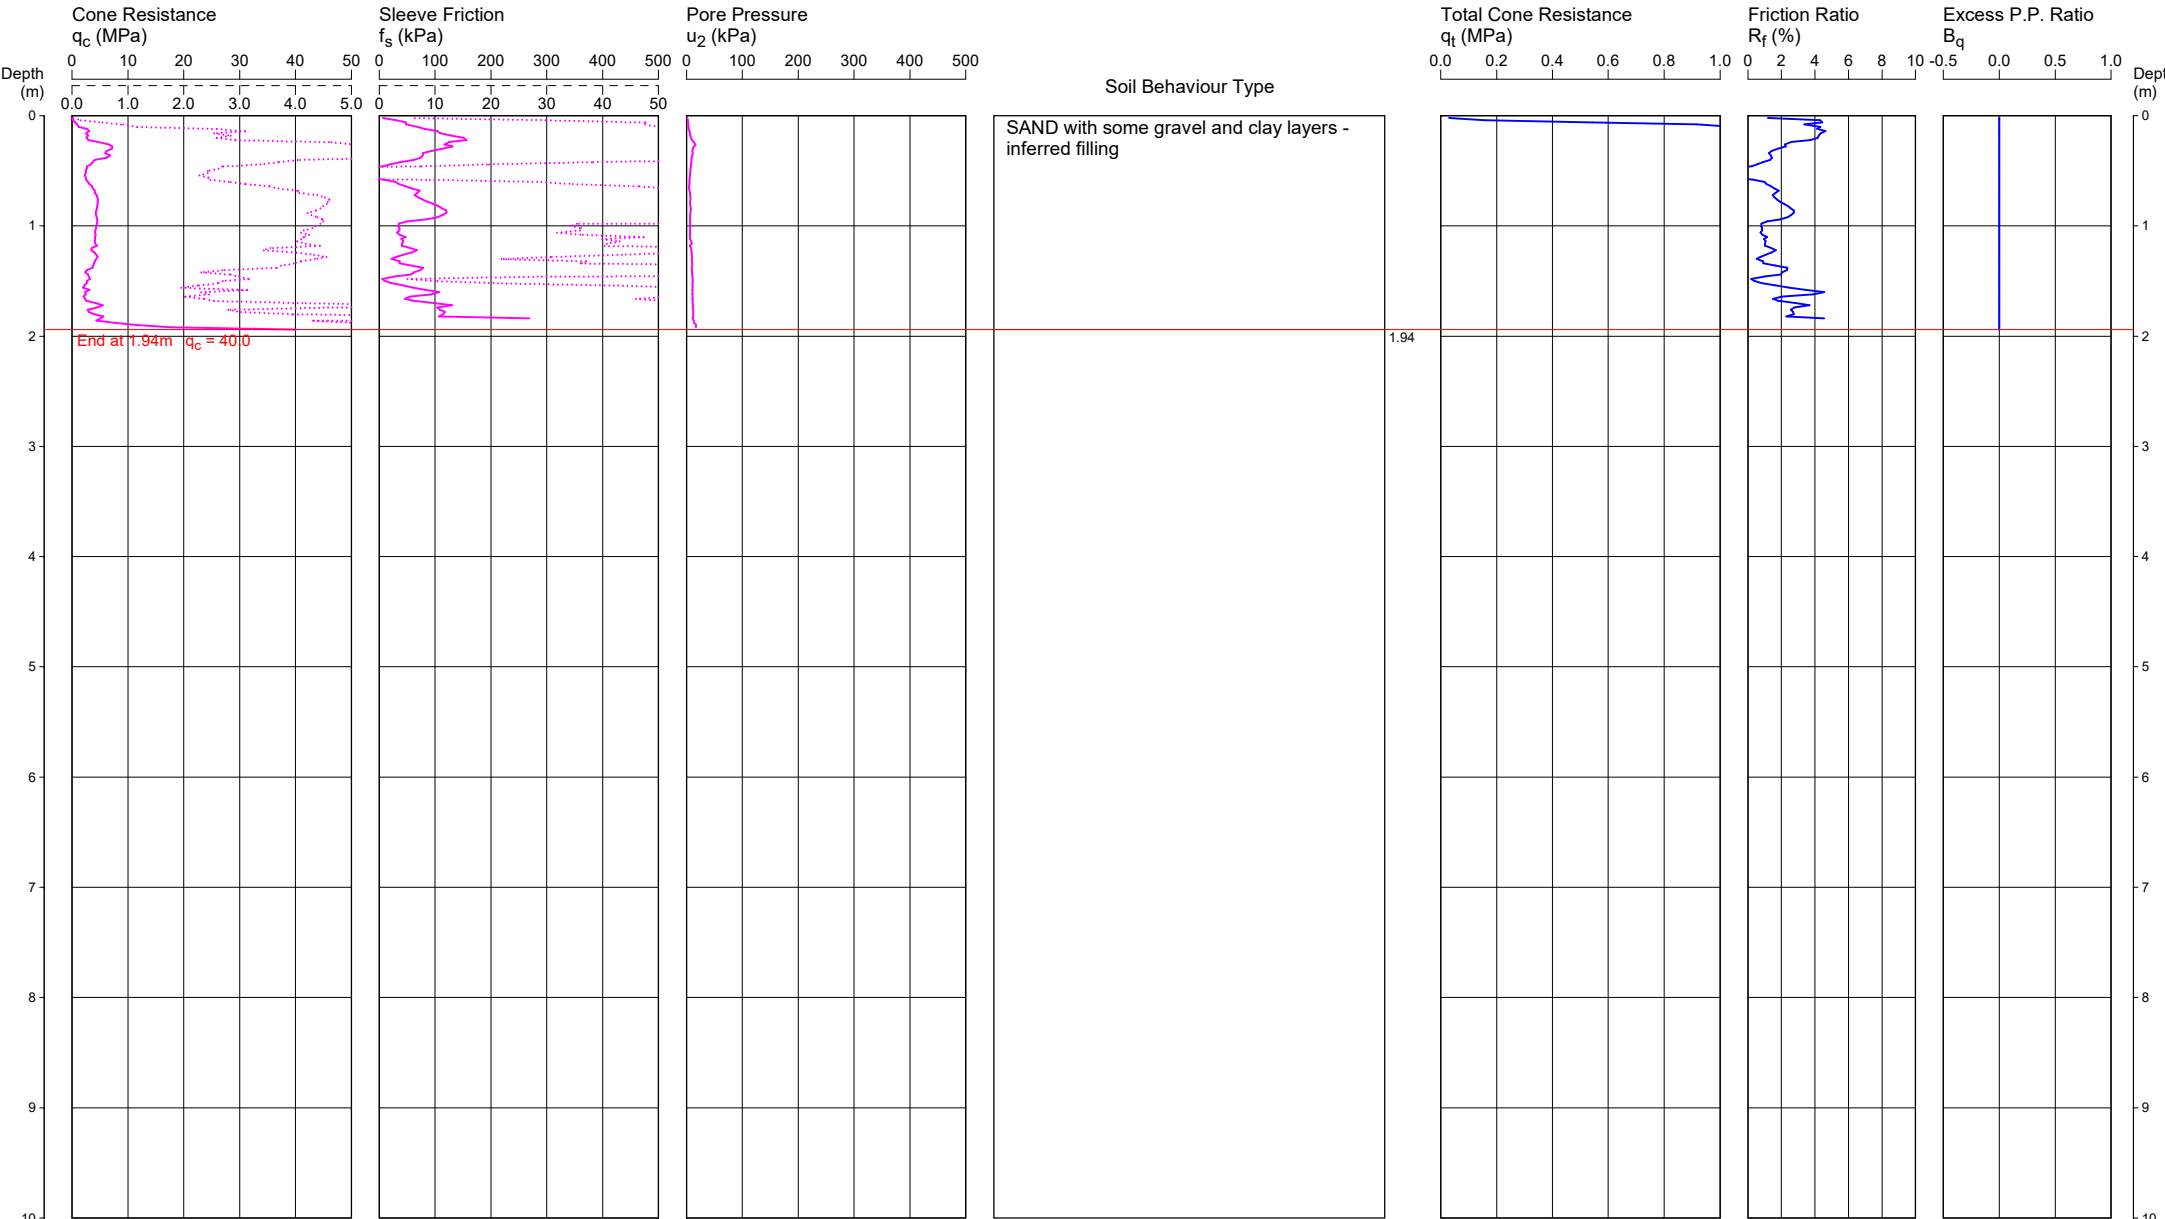
REMARKS: HAND AUGER TO 0.2 m. DUMMY CONE FROM 1.94 TO 2.44 m DEPTH TO PENETRATE FILLING. TEST DISCONTINUED DUE TO DUMMY CONE REFUSAL ON OBSTRUCTION.

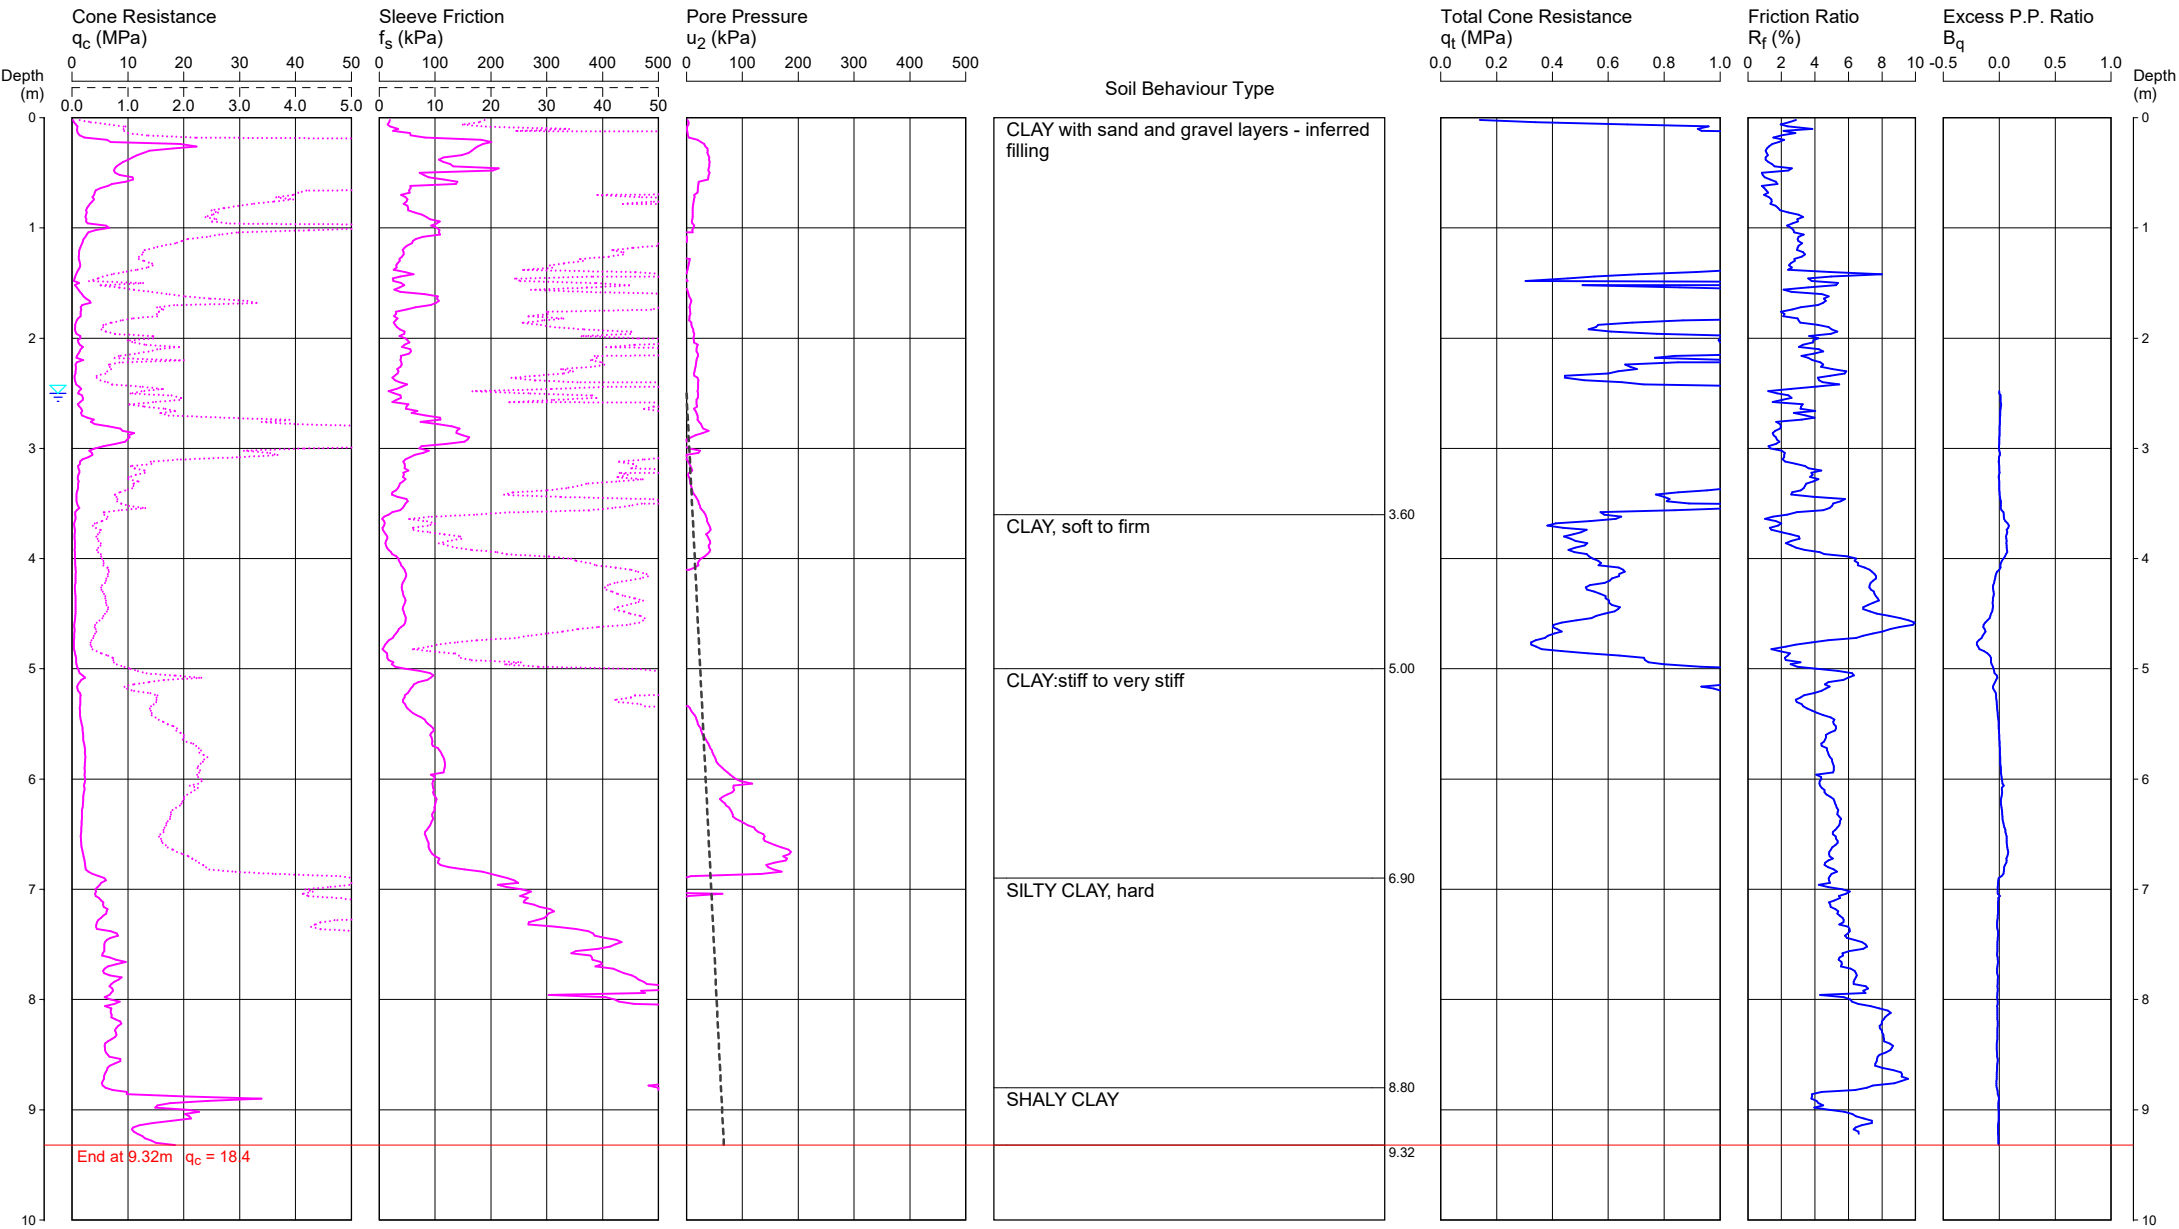
REMARKS: HAND AUGER TO 0.2 m DEPTH. TEST DISCONTINUED DUE TO EXCESSIVE CONE BENDING AT NEAR REFUSAL.

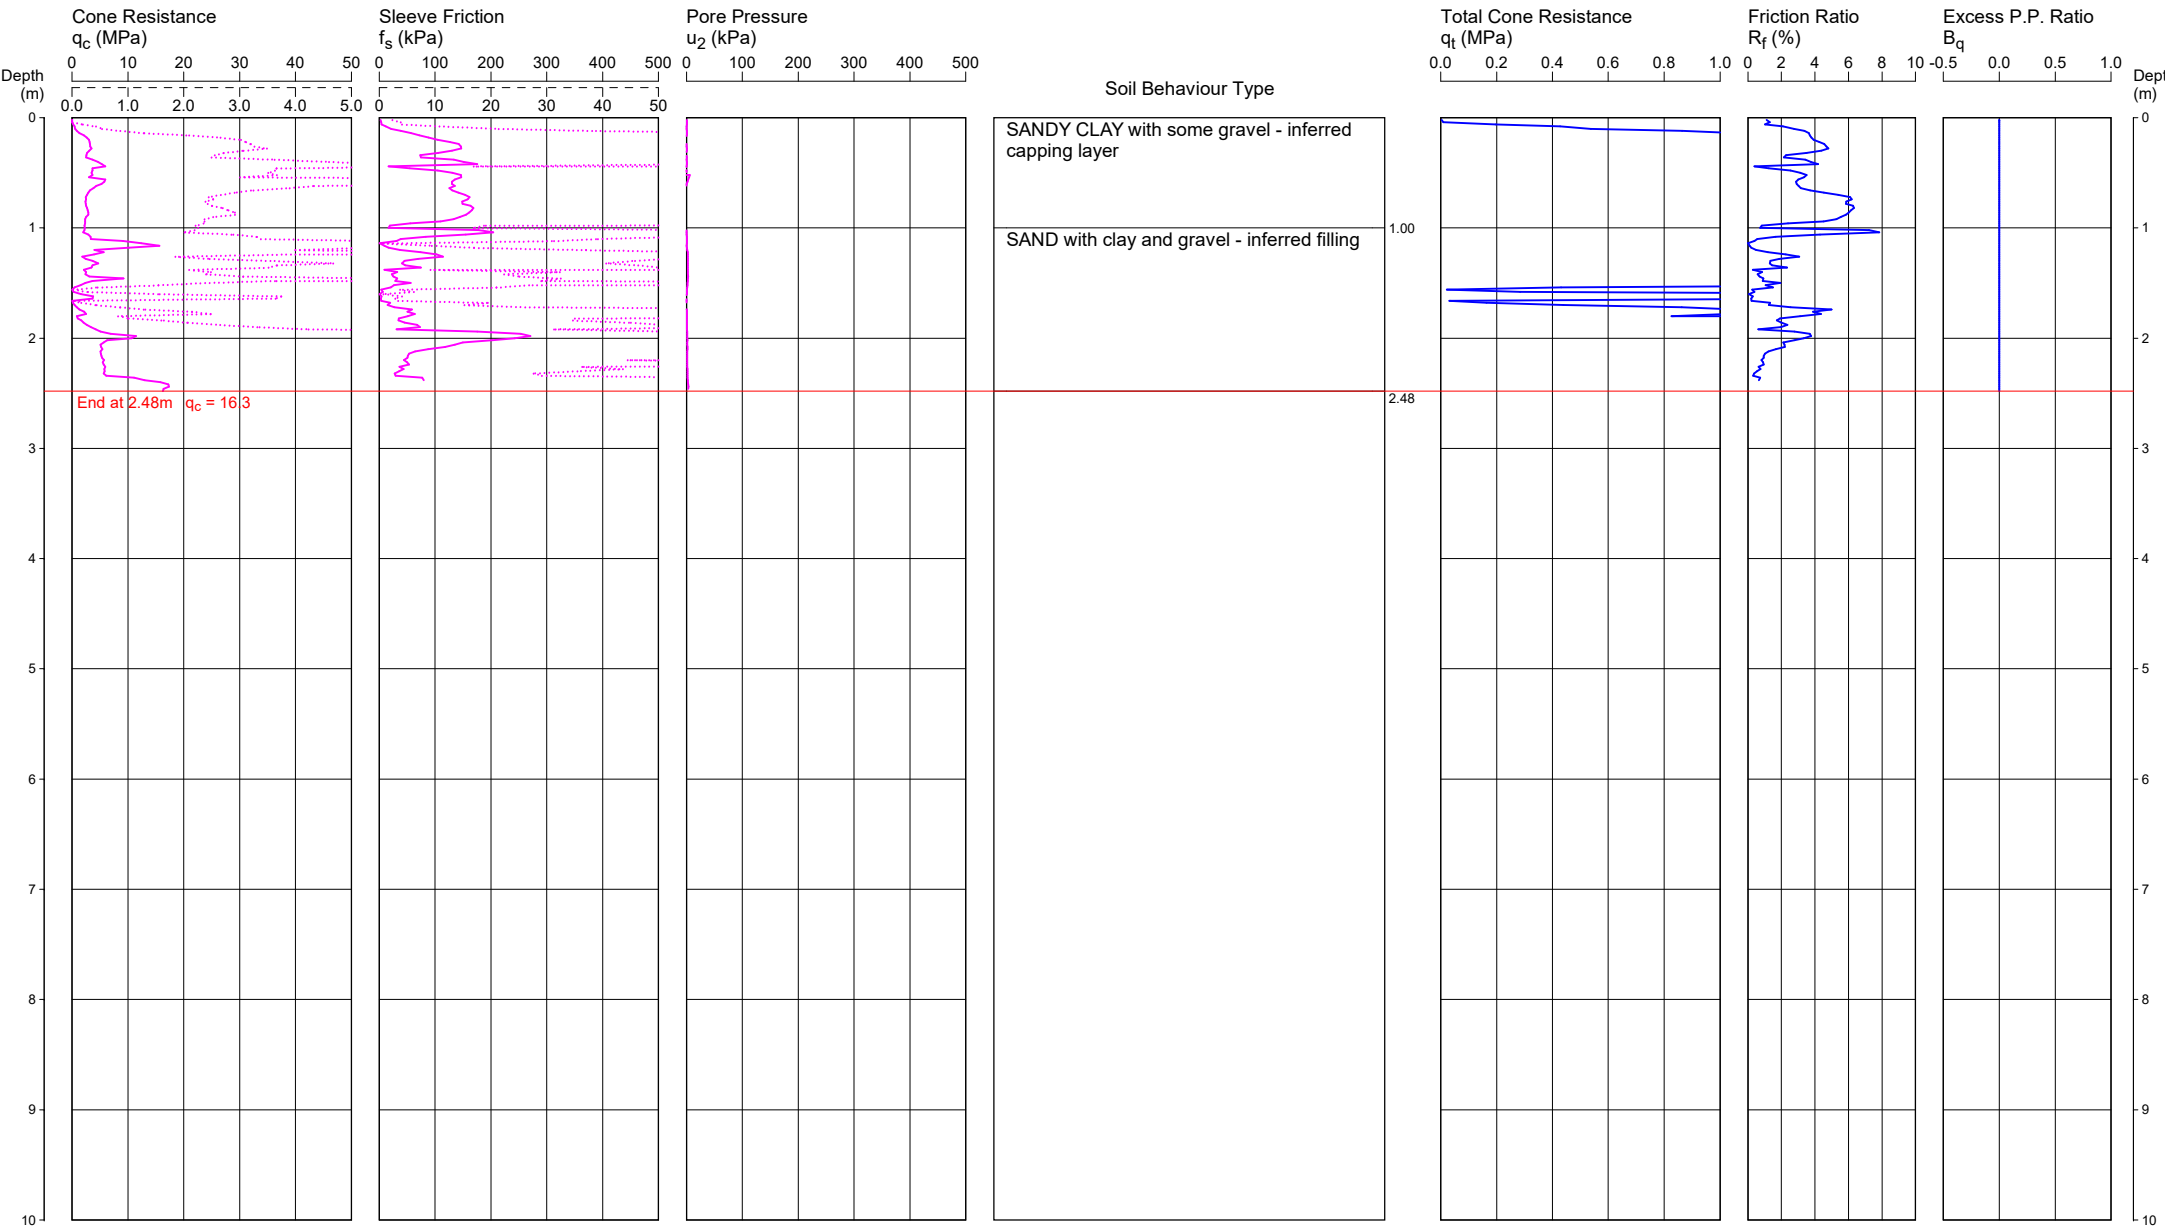
REMARKS: HAND AUGER TO 0.2 m. DUMMY CONE FROM 1.64 TO 2.0 m DEPTH TO PENETRATE FILLING. TEST DISCONTINUED DUE TO EXCESSIVE CONE BENDING ON OBSTRUCTION.

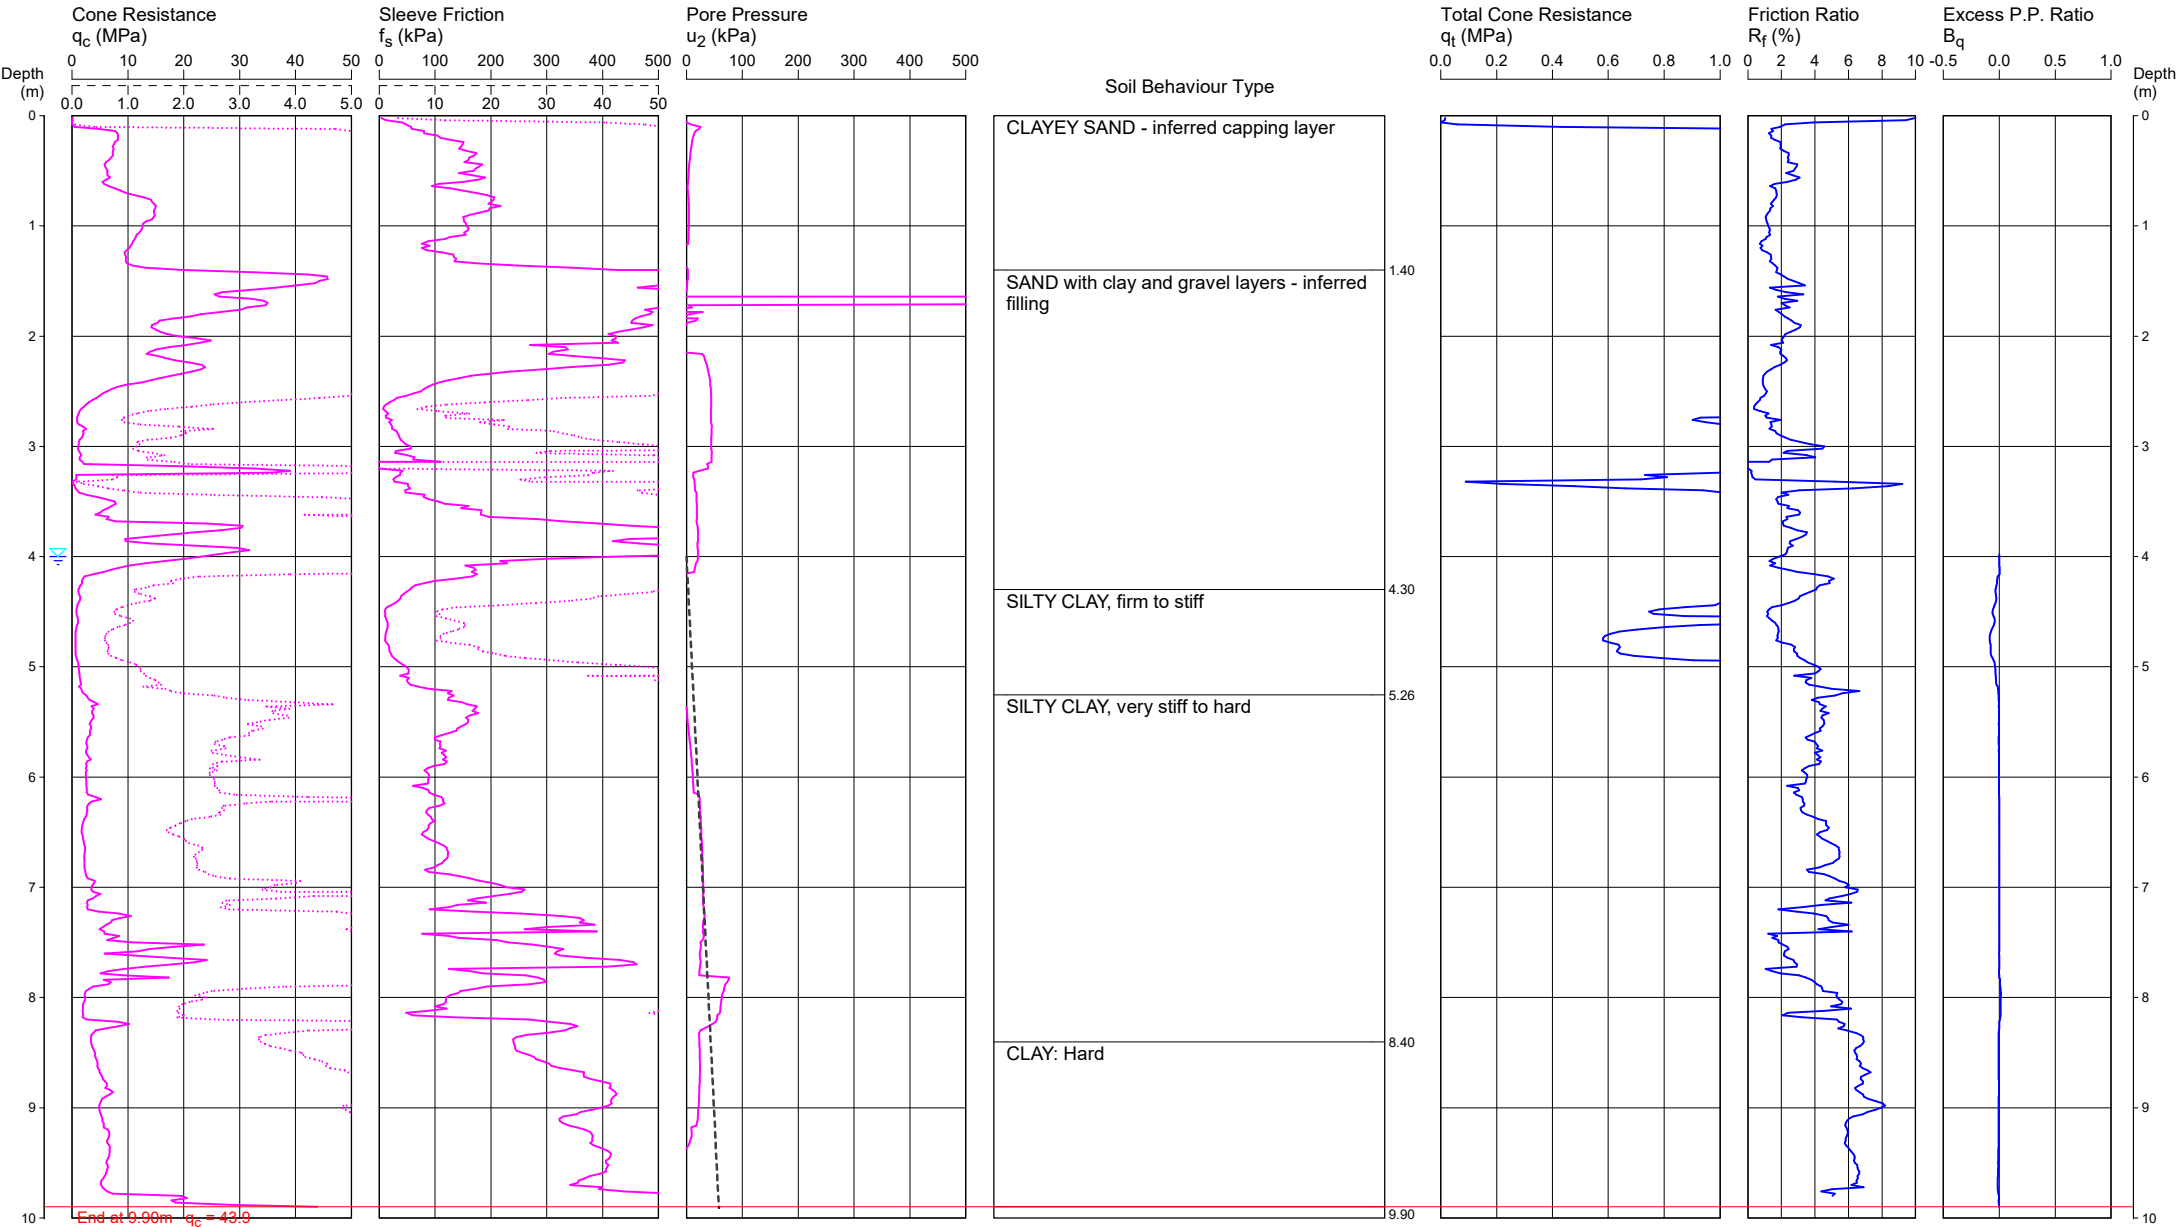
REMARKS: HAND AUGER TO 0.2 m. DUMMY CONE FROM 3.24 TO 3.6 m DEPTH TO PENETRATE FILLING.
TEST DISCONTINUED DUE TO CONE TIP REFUSAL.
GROUNDWATER OBSERVED AT 4 m AFTER WITHDRAWAL OF RODS.

Water depth after test: 4 m

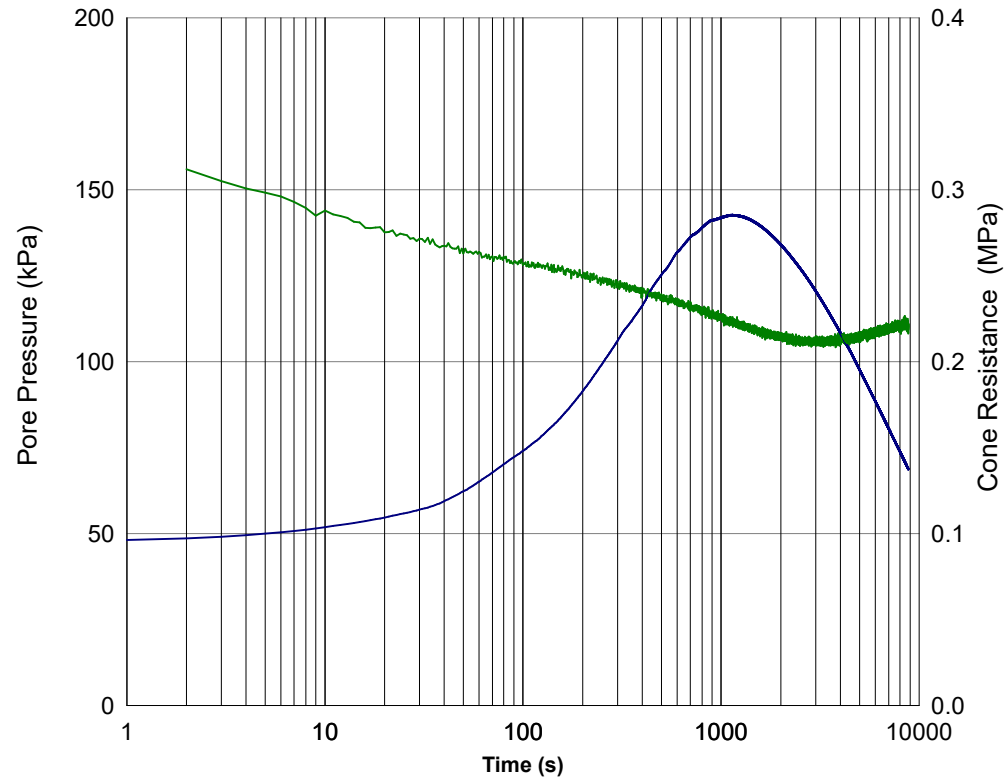
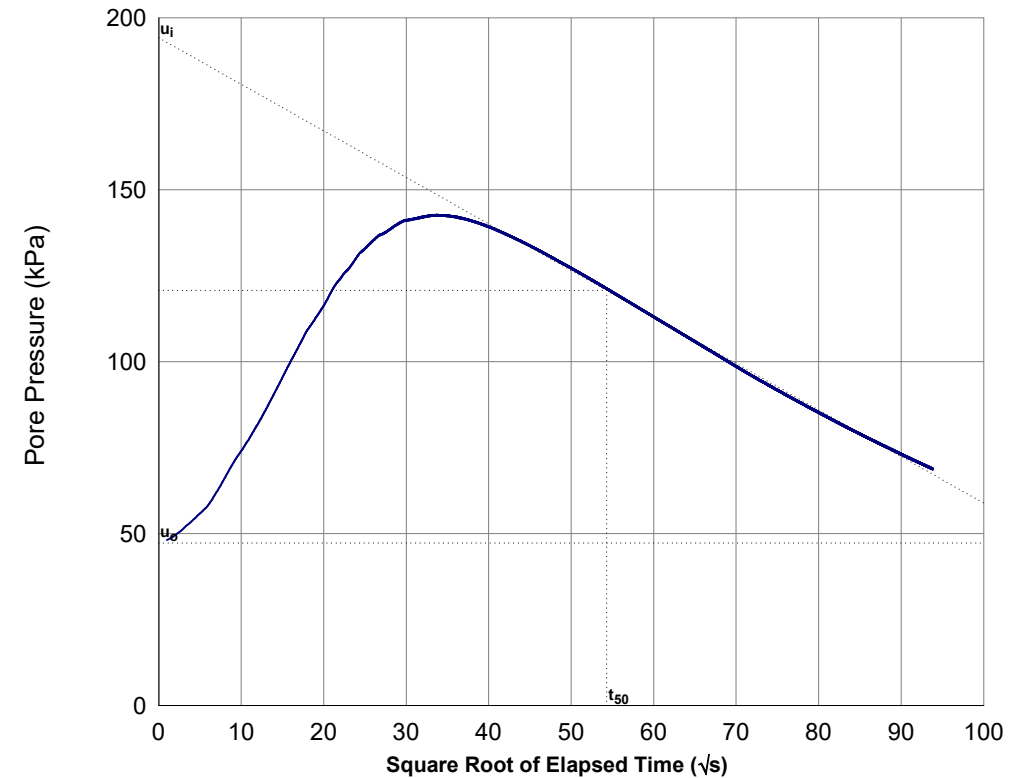
PORE PRESSURE / CONE RESISTANCE

ROOT-TIME GRAPH

Estimated hydrostatic pore pressure (u_0): 47.3 kPa
Estimated Initial Pore Pressure (u_i): 194.2 kPa
Final Measured Pore Pressure: 68.9 kPa
Time for 50% pore pressure reduction (t_{50}): 2948 seconds
49.1 minutes

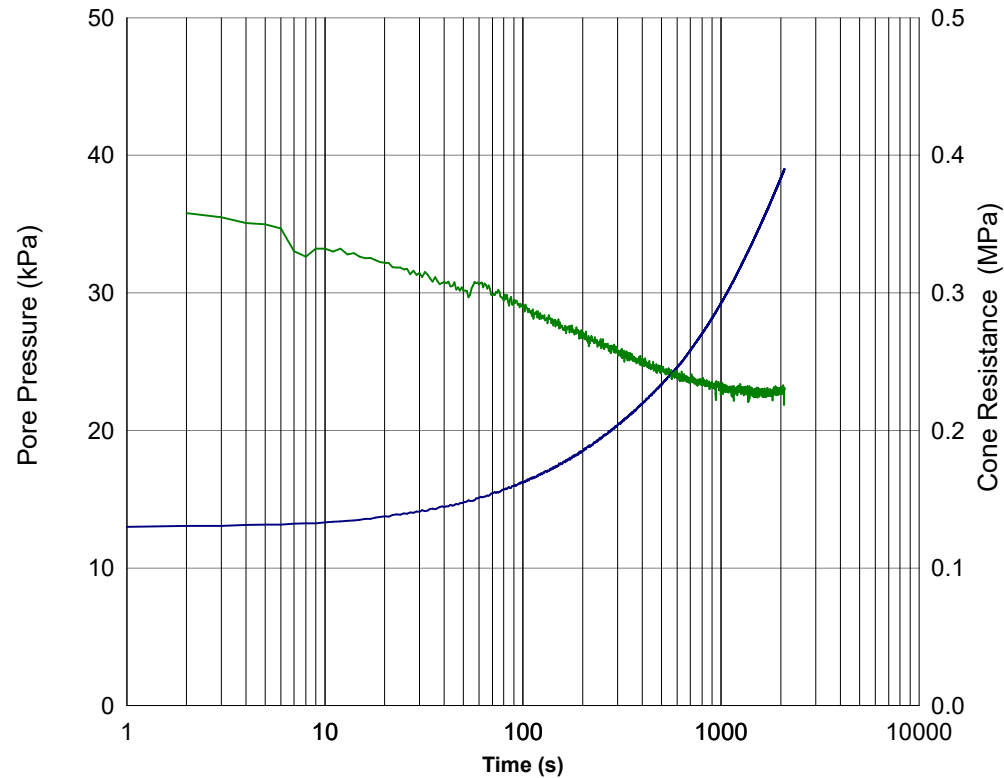
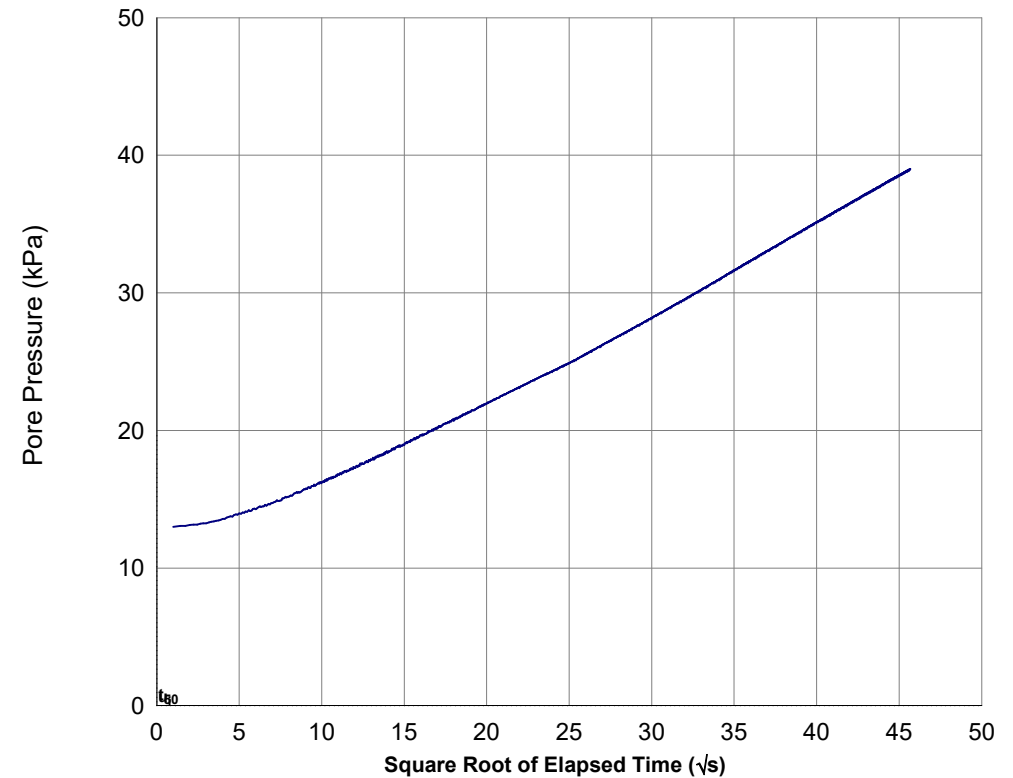
PORE PRESSURE / CONE RESISTANCE

ROOT-TIME GRAPH

Estimated hydrostatic pore pressure (u_0): 39.2 kPa
 Estimated Initial Pore Pressure (u_i): 0.0 kPa
 Final Measured Pore Pressure: 39.0 kPa
 Time for 50% pore pressure reduction (t_{50}): 0 seconds
 0.0 minutes

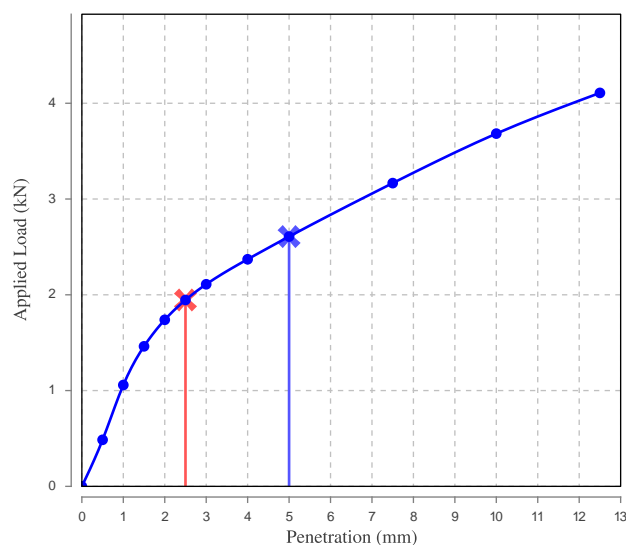
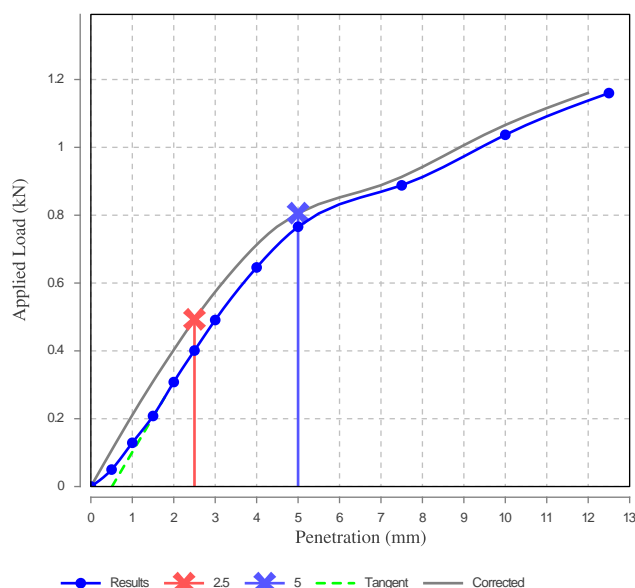
California Bearing Ratio

Report Number: 86694.02-1
Issue Number: 1
Date Issued: 16/08/2019
Client: Cox Architecture Pty Ltd
Level 6, 155 Clarence Street, Sydney NSW 2000
Contact: Anthony Crozier
Project Number: 86694.02
Project Name: Western Sydney Cricket and Community Centre
Project Location: Wilson Park, 4 Newington Road, Silverwater
Work Request: 4697
Sample Number: 19-4697A
Date Sampled: 26/07/2019
Dates Tested: 26/07/2019 - 15/08/2019
Sampling Method: Sampled by Engineering Department
Sample Location: 33 (0.4-1.0m)
Material: FILL / CLAY : grey with sand and a trace of gravel

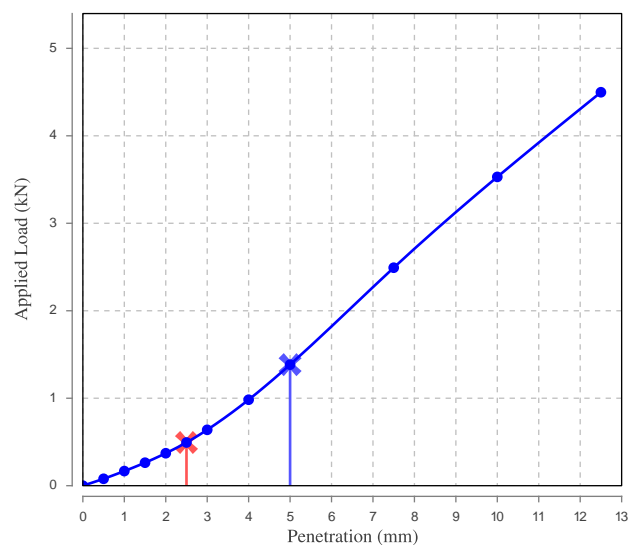
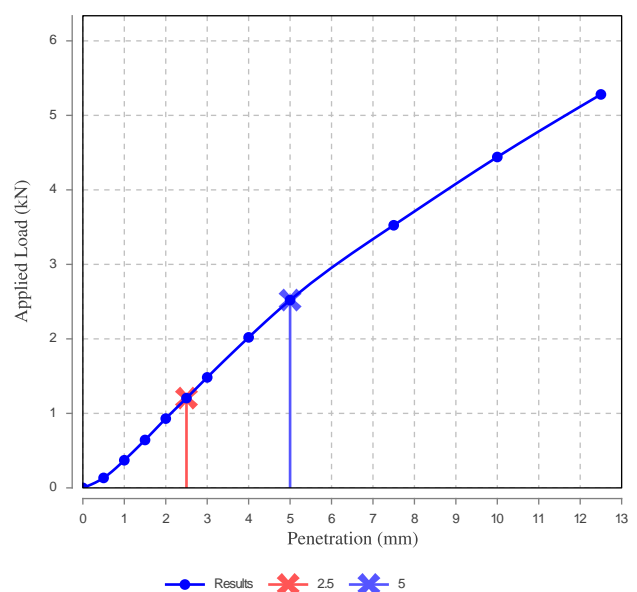
California Bearing Ratio

Report Number: 86694.02-1
Issue Number: 1
Date Issued: 16/08/2019
Client: Cox Architecture Pty Ltd
Level 6, 155 Clarence Street, Sydney NSW 2000
Contact: Anthony Crozier
Project Number: 86694.02
Project Name: Western Sydney Cricket and Community Centre
Project Location: Wilson Park, 4 Newington Road, Silverwater
Work Request: 4697
Sample Number: 19-4697B
Date Sampled: 26/07/2019
Dates Tested: 26/07/2019 - 15/08/2019
Sampling Method: Sampled by Engineering Department
Sample Location: 21 (0-0.7m)
Material: FILL / sandy GRAVEL and COBBLES : rounded light grey with silt

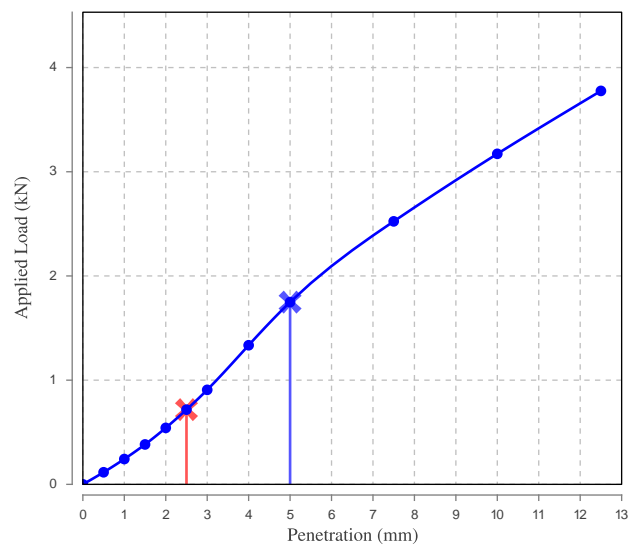
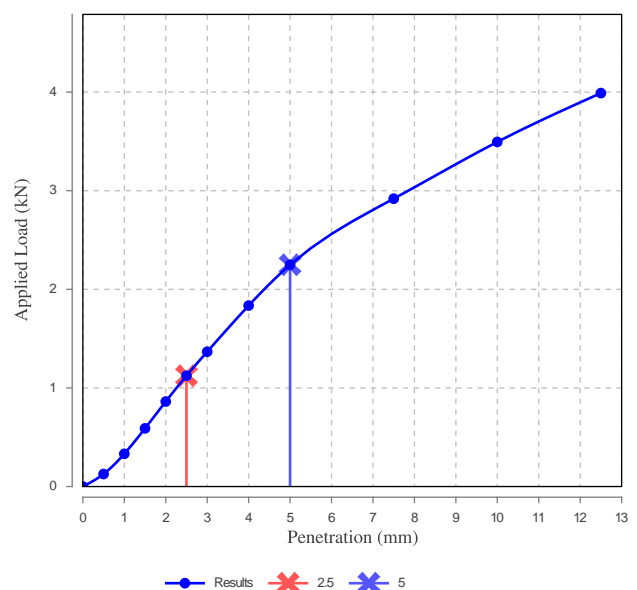
California Bearing Ratio

Report Number: 86694.02-1
Issue Number: 1
Date Issued: 16/08/2019
Client: Cox Architecture Pty Ltd
Level 6, 155 Clarence Street, Sydney NSW 2000
Contact: Anthony Crozier
Project Number: 86694.02
Project Name: Western Sydney Cricket and Community Centre
Project Location: Wilson Park, 4 Newington Road, Silverwater
Work Request: 4697
Sample Number: 19-4697C
Date Sampled: 26/07/2019
Dates Tested: 26/07/2019 - 15/08/2019
Sampling Method: Sampled by Engineering Department
Sample Location: 28 (0.2-0.8m)
Material: FILL / CLAY : orange brown with sand and a trace of gravel

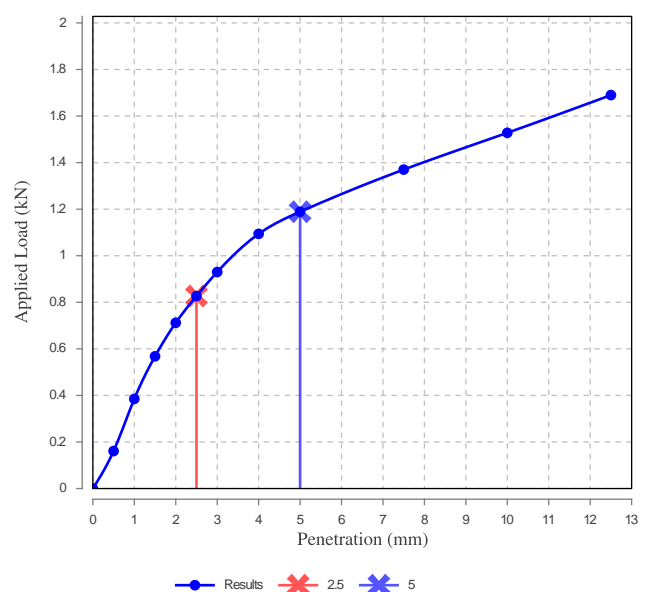
California Bearing Ratio

Report Number: 86694.02-1
Issue Number: 1
Date Issued: 16/08/2019
Client: Cox Architecture Pty Ltd
Level 6, 155 Clarence Street, Sydney NSW 2000
Contact: Anthony Crozier
Project Number: 86694.02
Project Name: Western Sydney Cricket and Community Centre
Project Location: Wilson Park, 4 Newington Road, Silverwater
Work Request: 4697
Sample Number: 19-4697D
Date Sampled: 26/07/2019
Dates Tested: 26/07/2019 - 15/08/2019
Sampling Method: Sampled by Engineering Department
Sample Location: 38 (0.2-0.7m)
Material: FILL / sandy CLAY : orange brown, with some gravel
