Report on
Preliminary Geotechnical Investigation

Cricket NSW Cricket Centre
Wilson Park, Newington Road
Sydney Olympic Park

Prepared for
Cox Architecture Pty Ltd

Project 86694.02
September 2019

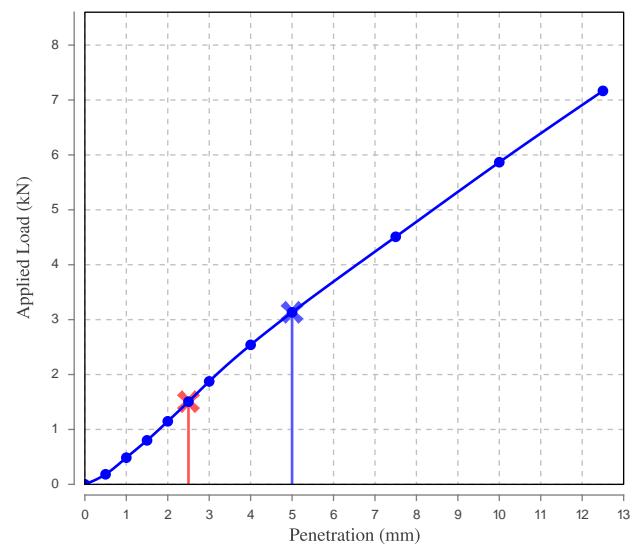
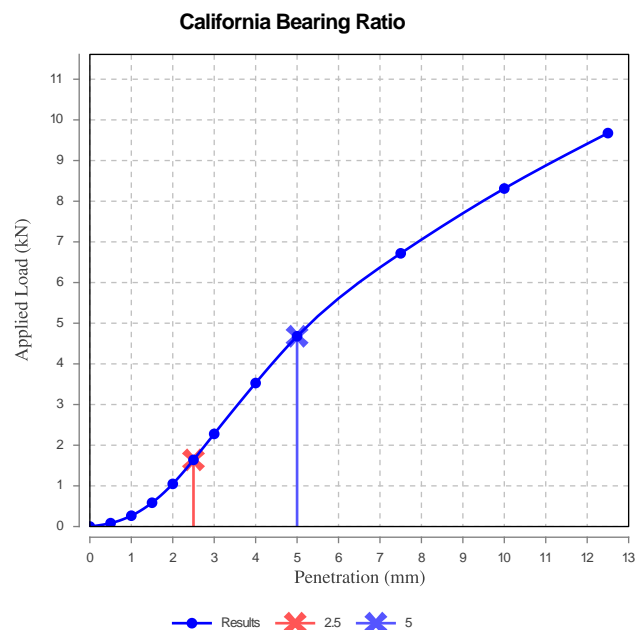
California Bearing Ratio

Report Number: 86694.02-1
Issue Number: 1
Date Issued: 16/08/2019
Client: Cox Architecture Pty Ltd
Level 6, 155 Clarence Street, Sydney NSW 2000
Contact: Anthony Crozier
Project Number: 86694.02
Project Name: Western Sydney Cricket and Community Centre
Project Location: Wilson Park, 4 Newington Road, Silverwater
Work Request: 4697
Sample Number: 19-4697E
Date Sampled: 26/07/2019
Dates Tested: 26/07/2019 - 15/08/2019
Sampling Method: Sampled by Engineering Department
Sample Location: 4 (0.2-0.7m)
Material: FILL / sandy CLAY : light brown with sandstone gravel

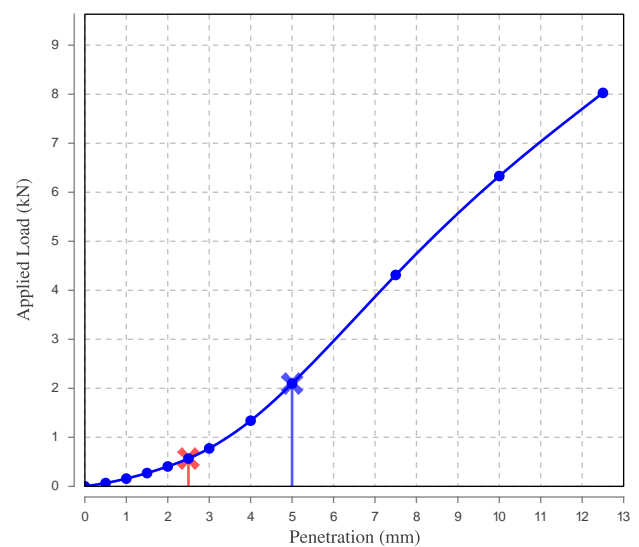
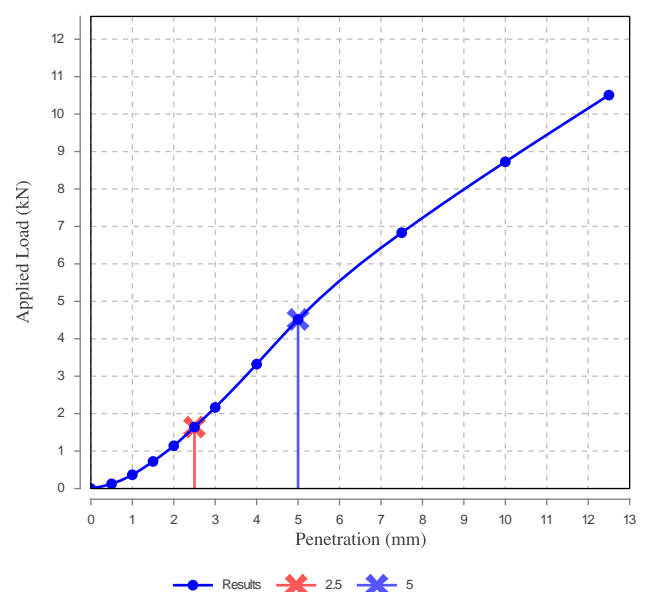
California Bearing Ratio

Report Number: 86694.02-1
Issue Number: 1
Date Issued: 16/08/2019
Client: Cox Architecture Pty Ltd
Level 6, 155 Clarence Street, Sydney NSW 2000
Contact: Anthony Crozier
Project Number: 86694.02
Project Name: Western Sydney Cricket and Community Centre
Project Location: Wilson Park, 4 Newington Road, Silverwater
Work Request: 4697
Sample Number: 19-4697F
Date Sampled: 26/07/2019
Dates Tested: 26/07/2019 - 15/08/2019
Sampling Method: Sampled by Engineering Department
Sample Location: 2 (0.2-0.7m)
Material: FILL / sandy CLAY : light brown, with sandstone gravel

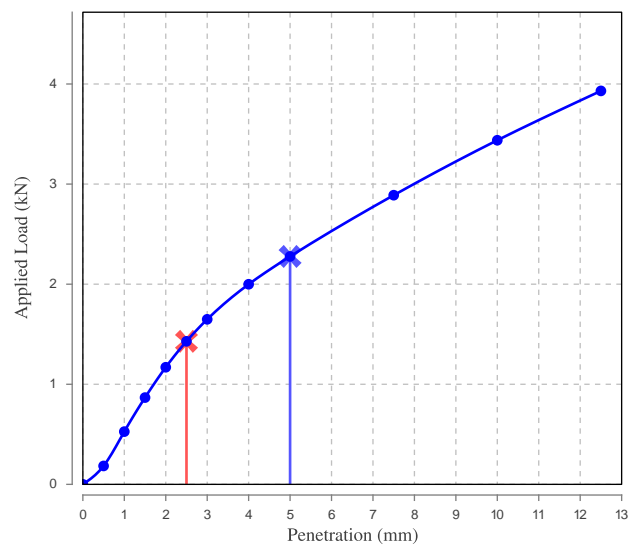
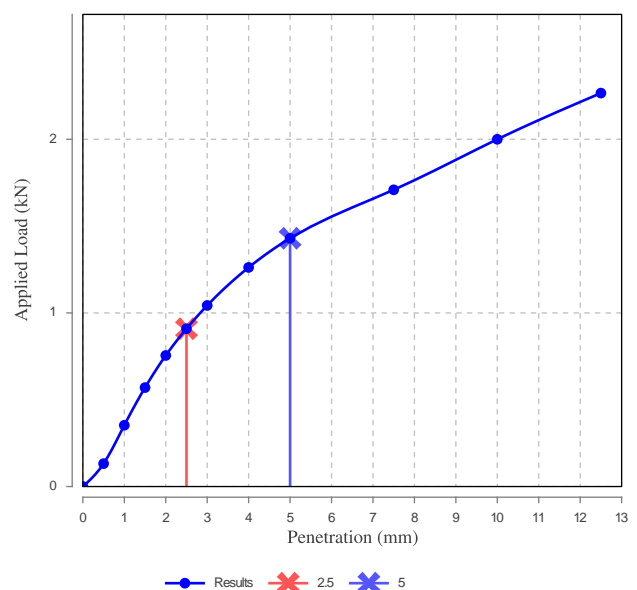
California Bearing Ratio

Report Number: 86694.02-1
Issue Number: 1
Date Issued: 16/08/2019
Client: Cox Architecture Pty Ltd
Level 6, 155 Clarence Street, Sydney NSW 2000
Contact: Anthony Crozier
Project Number: 86694.02
Project Name: Western Sydney Cricket and Community Centre
Project Location: Wilson Park, 4 Newington Road, Silverwater
Work Request: 4697
Sample Number: 19-4697G
Date Sampled: 26/07/2019
Dates Tested: 26/07/2019 - 15/08/2019
Sampling Method: Sampled by Engineering Department
Sample Location: 42 (0.1-0.8m)
Material: FILL / sandy CLAY : orange brown, with some gravel

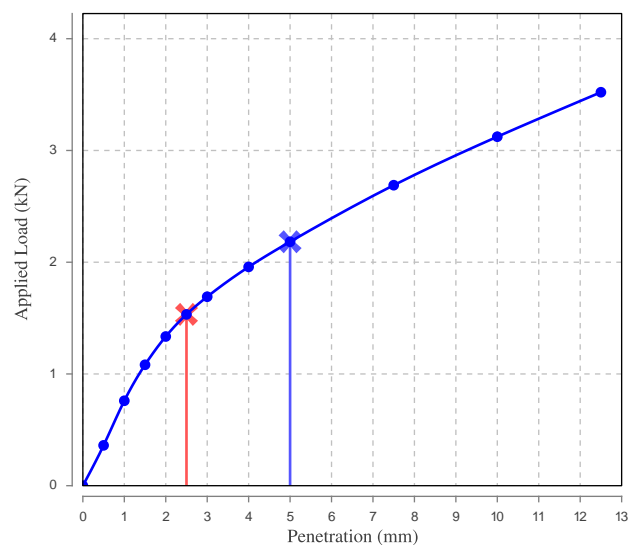
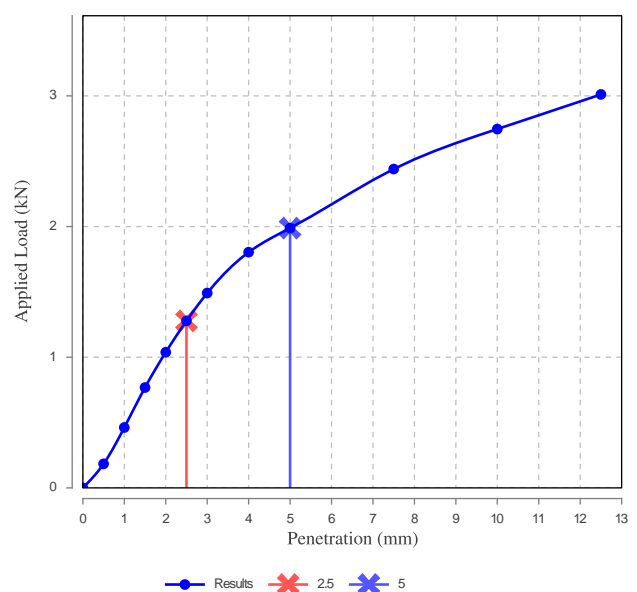
California Bearing Ratio

Report Number: 86694.02-1
Issue Number: 1
Date Issued: 16/08/2019
Client: Cox Architecture Pty Ltd
Level 6, 155 Clarence Street, Sydney NSW 2000
Contact: Anthony Crozier
Project Number: 86694.02
Project Name: Western Sydney Cricket and Community Centre
Project Location: Wilson Park, 4 Newington Road, Silverwater
Work Request: 4697
Sample Number: 19-4697H
Date Sampled: 26/07/2019
Dates Tested: 26/07/2019 - 15/08/2019
Sampling Method: Sampled by Engineering Department
Sample Location: 31 (0.2-0.7m)
Material: FILL / sandy CLAY : orange brown, with gravel and a trace of cobbles of both sedimentary and igneous origin

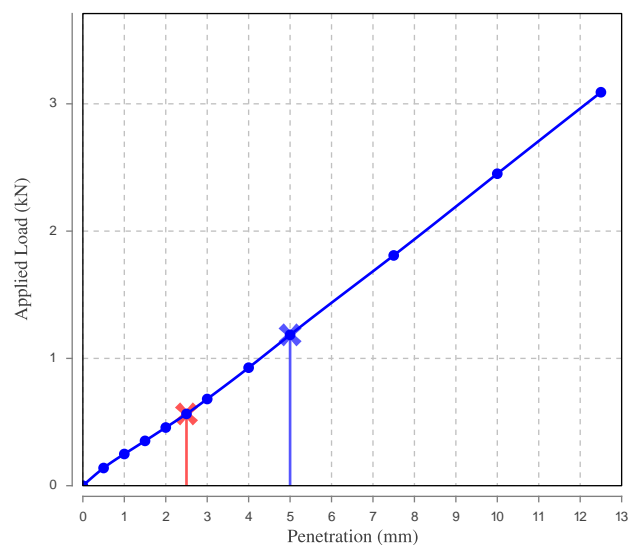
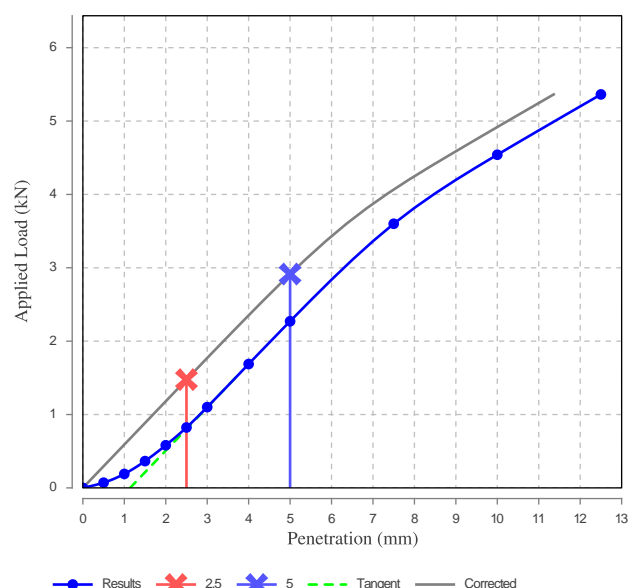
California Bearing Ratio

Report Number: 86694.02-1
Issue Number: 1
Date Issued: 16/08/2019
Client: Cox Architecture Pty Ltd
Level 6, 155 Clarence Street, Sydney NSW 2000
Contact: Anthony Crozier
Project Number: 86694.02
Project Name: Western Sydney Cricket and Community Centre
Project Location: Wilson Park, 4 Newington Road, Silverwater
Work Request: 4697
Sample Number: 19-4697I
Date Sampled: 26/07/2019
Dates Tested: 26/07/2019 - 15/08/2019
Sampling Method: Sampled by Engineering Department
Sample Location: 22 (0.2-0.9m)
Material: FILL / sandy CLAY : grey with gravel and a trace of terracotta

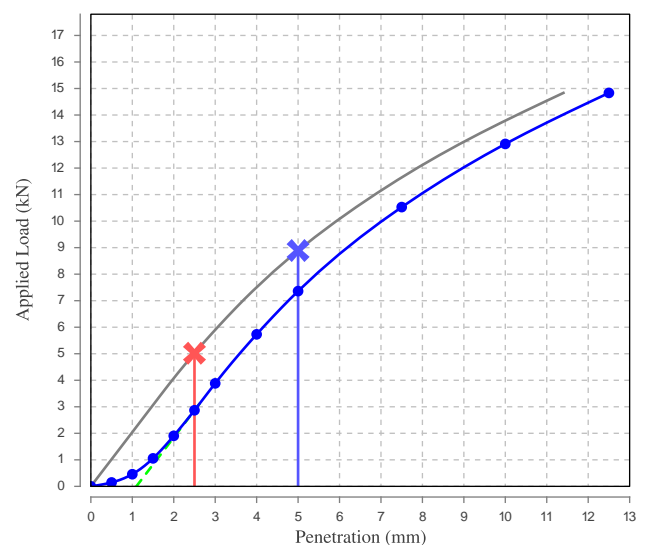
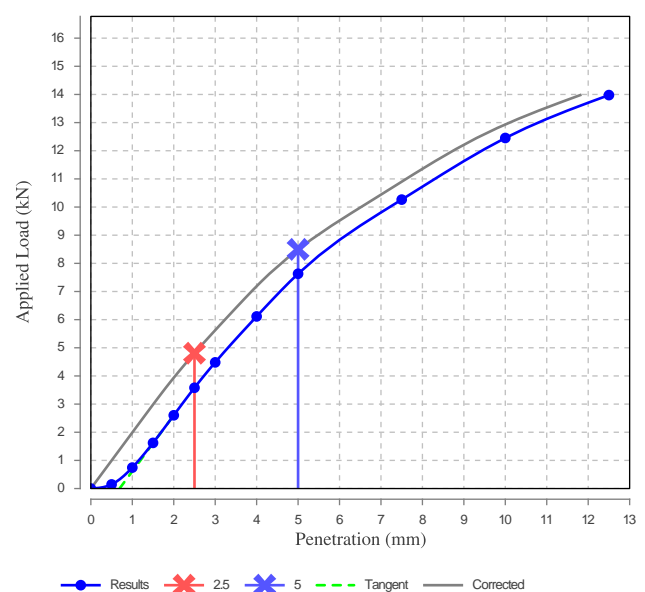
California Bearing Ratio

Report Number: 86694.02-1
Issue Number: 1
Date Issued: 16/08/2019
Client: Cox Architecture Pty Ltd
Level 6, 155 Clarence Street, Sydney NSW 2000
Contact: Anthony Crozier
Project Number: 86694.02
Project Name: Western Sydney Cricket and Community Centre
Project Location: Wilson Park, 4 Newington Road, Silverwater
Work Request: 4697
Sample Number: 19-4697J
Date Sampled: 26/07/2019
Dates Tested: 26/07/2019 - 15/08/2019
Sampling Method: Sampled by Engineering Department
Sample Location: 5 (0.2-0.7m)
Material: FILL / sandy CLAY : light brown, with sandstone gravel

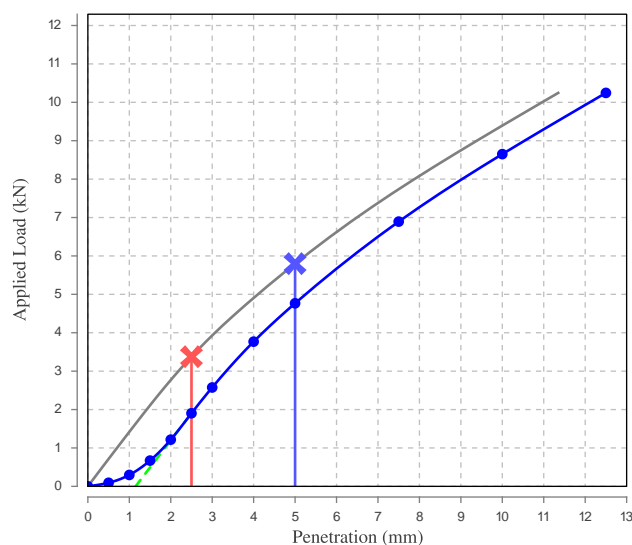
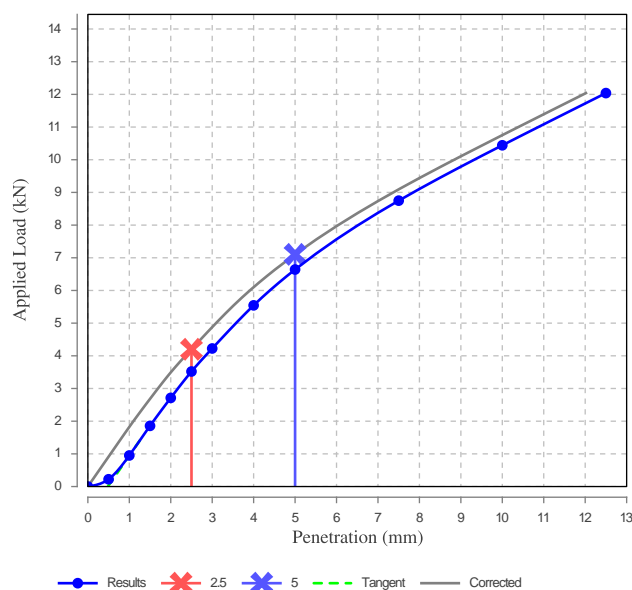
California Bearing Ratio

Report Number: 86694.02-1
Issue Number: 1
Date Issued: 16/08/2019
Client: Cox Architecture Pty Ltd
Level 6, 155 Clarence Street, Sydney NSW 2000
Contact: Anthony Crozier
Project Number: 86694.02
Project Name: Western Sydney Cricket and Community Centre
Project Location: Wilson Park, 4 Newington Road, Silverwater
Work Request: 4697
Sample Number: 19-4697K
Date Sampled: 26/07/2019
Dates Tested: 26/07/2019 - 15/08/2019
Sampling Method: Sampled by Engineering Department
Sample Location: 25 (0.2-0.8m)
Material: FILL / silty SAND : grey, with brick, tile and gravel

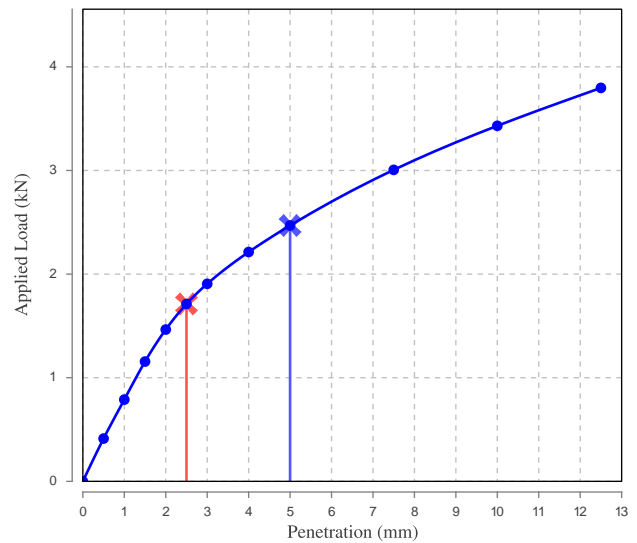
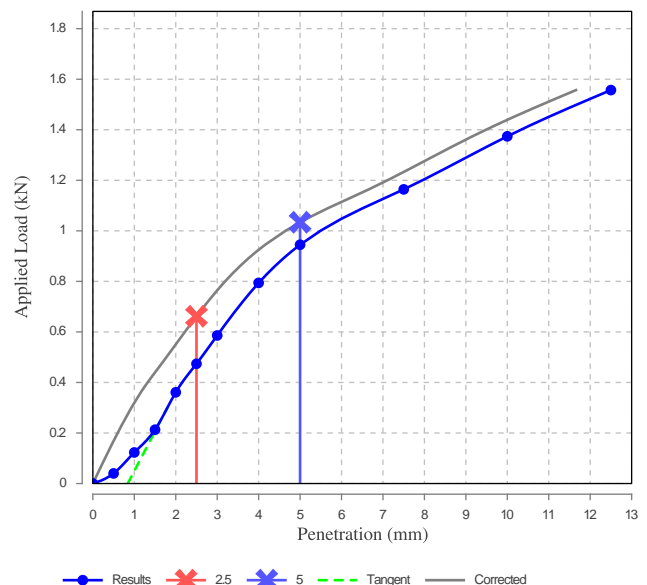
California Bearing Ratio

Report Number: 86694.02-1
Issue Number: 1
Date Issued: 16/08/2019
Client: Cox Architecture Pty Ltd
Level 6, 155 Clarence Street, Sydney NSW 2000
Contact: Anthony Crozier
Project Number: 86694.02
Project Name: Western Sydney Cricket and Community Centre
Project Location: Wilson Park, 4 Newington Road, Silverwater
Work Request: 4697
Sample Number: 19-4697L
Date Sampled: 26/07/2019
Dates Tested: 26/07/2019 - 15/08/2019
Sampling Method: Sampled by Engineering Department
Sample Location: 29 (0.4-0.6m)
