Site Audit Report

**Lot 204 in DP 1265921 (Stage 2B)
12 Johnston Crescent,
Horsley Park NSW**

Report Reference: 600105_0301-2010

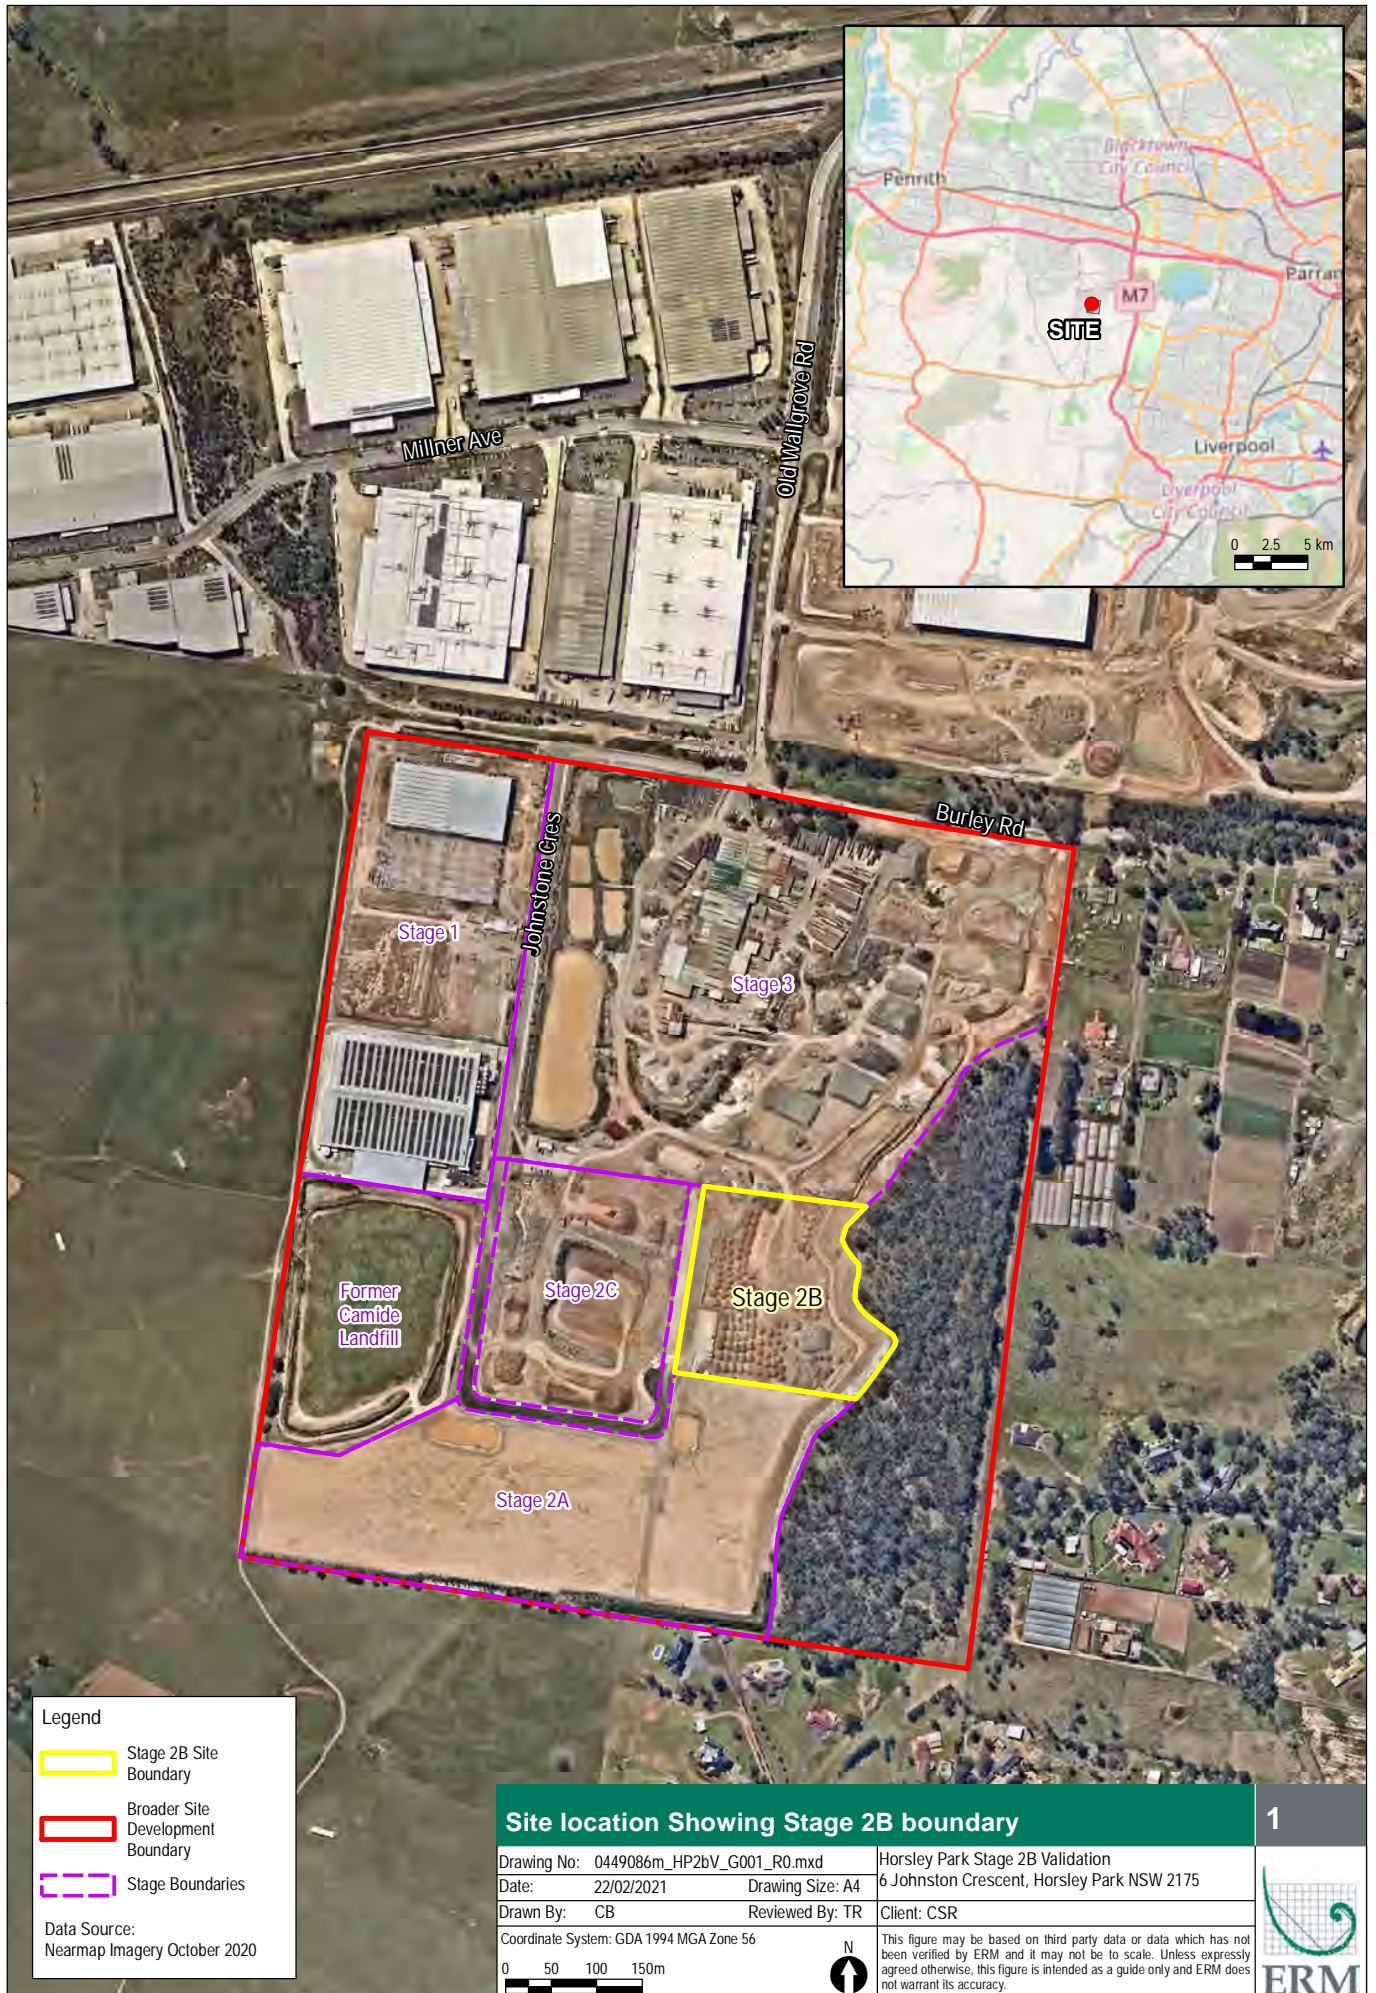
1

Site location Showing Stage 2B boundary

Located within **Appendix B** are plans that depict the site. The consultant's **Figure 1** illustrates the location of what is referred to throughout the Site Audit as the Stage 2B area within the wider site. The outline of the former Camide Landfill to the west of the Stage 2B area.

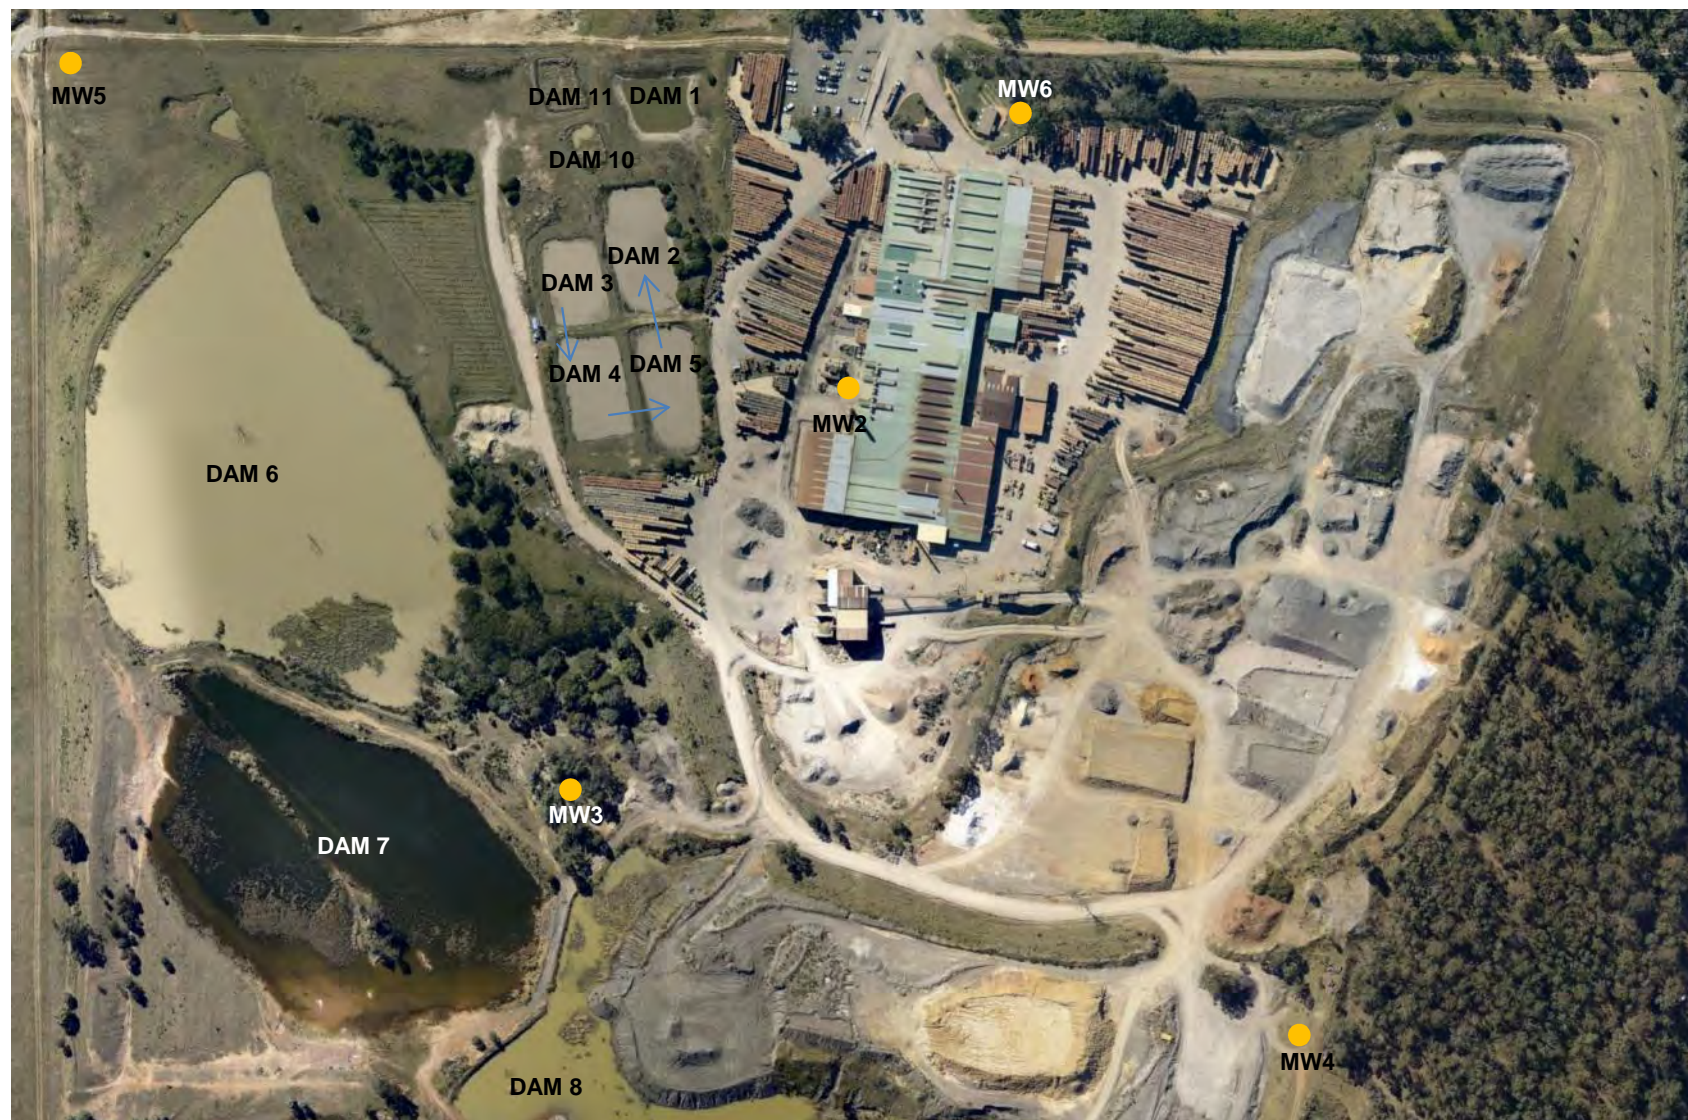
Appendix D: Phase 2 Sample Location Plan (DLA, September 2013)

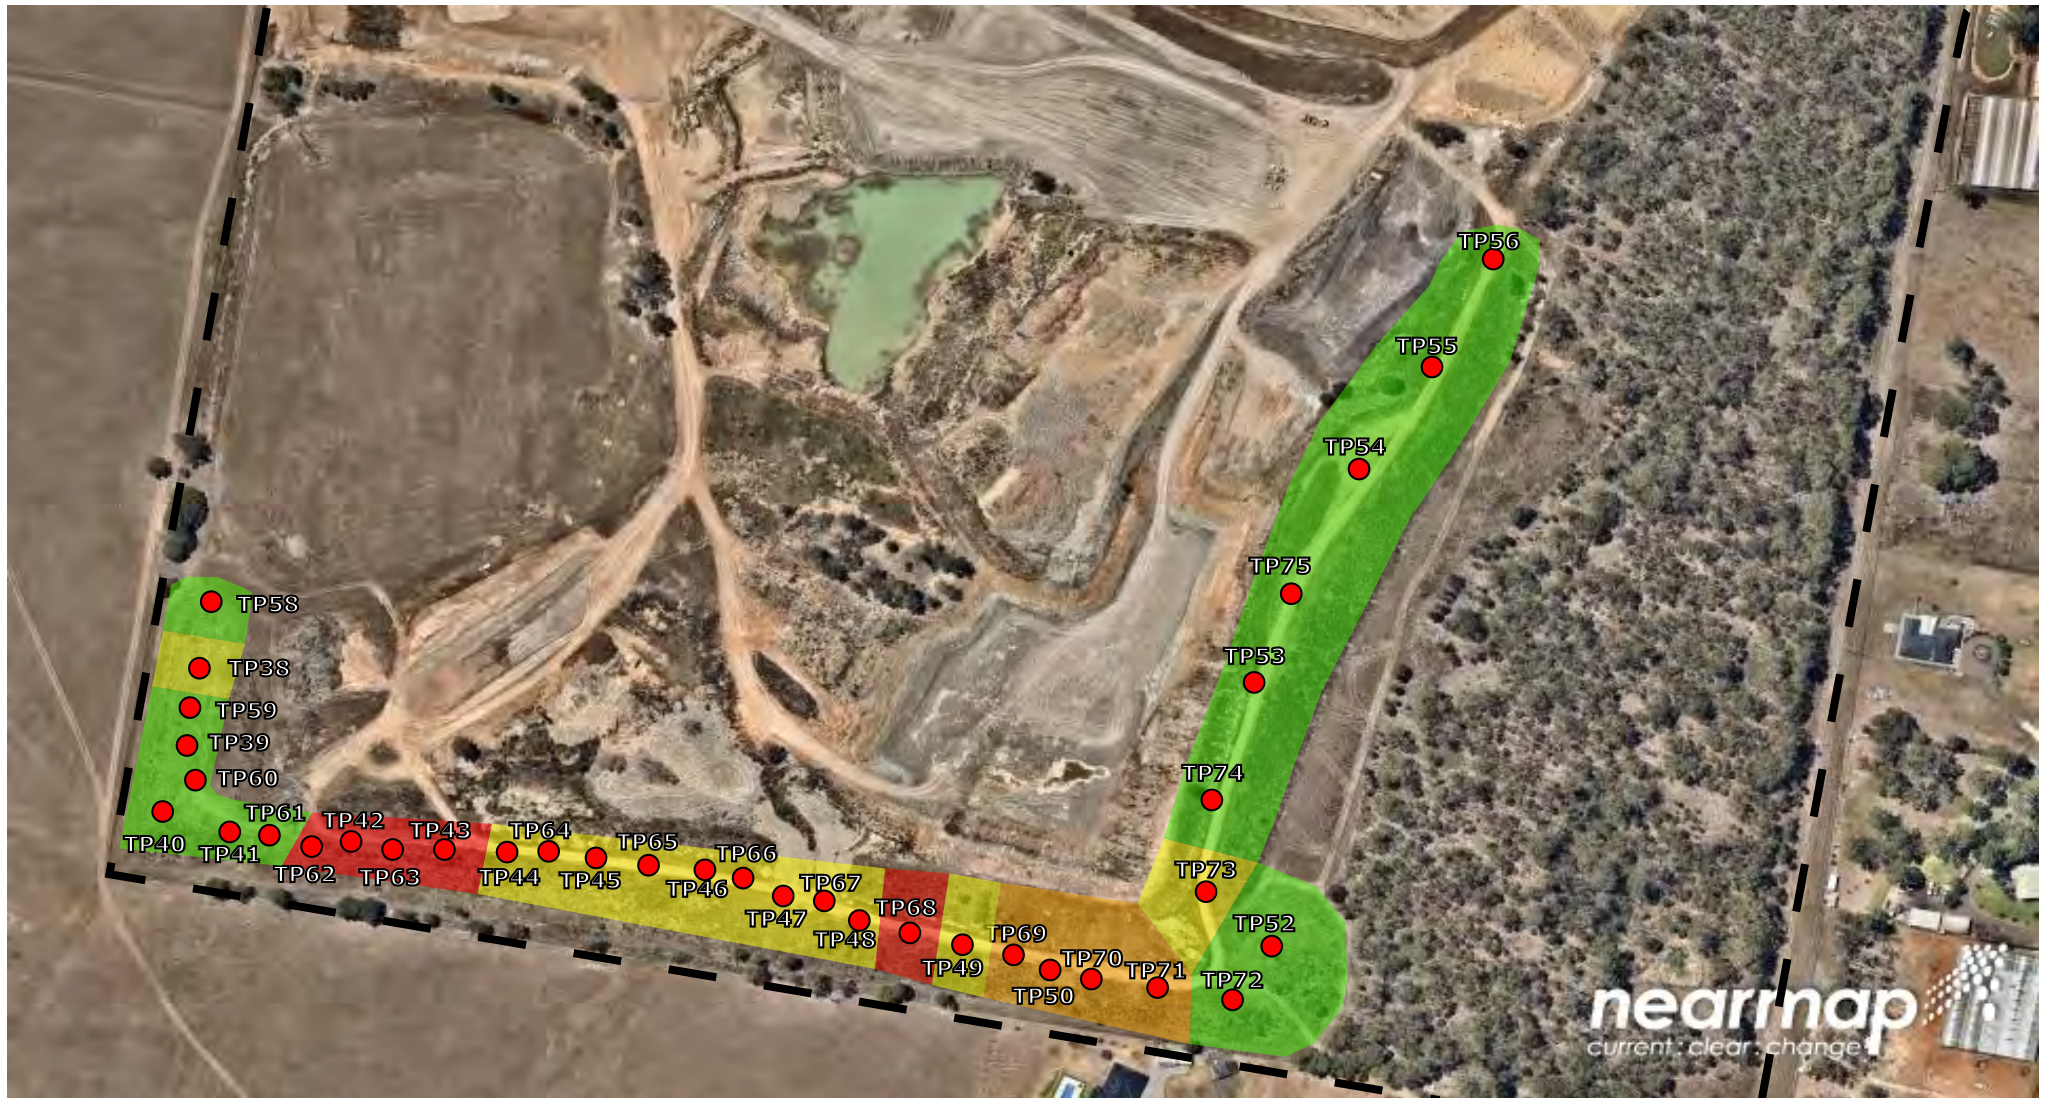
Figure No.
3

Appendix F:
Bund Wall Assessment Sample Location Plan
(DLA, June 2018)

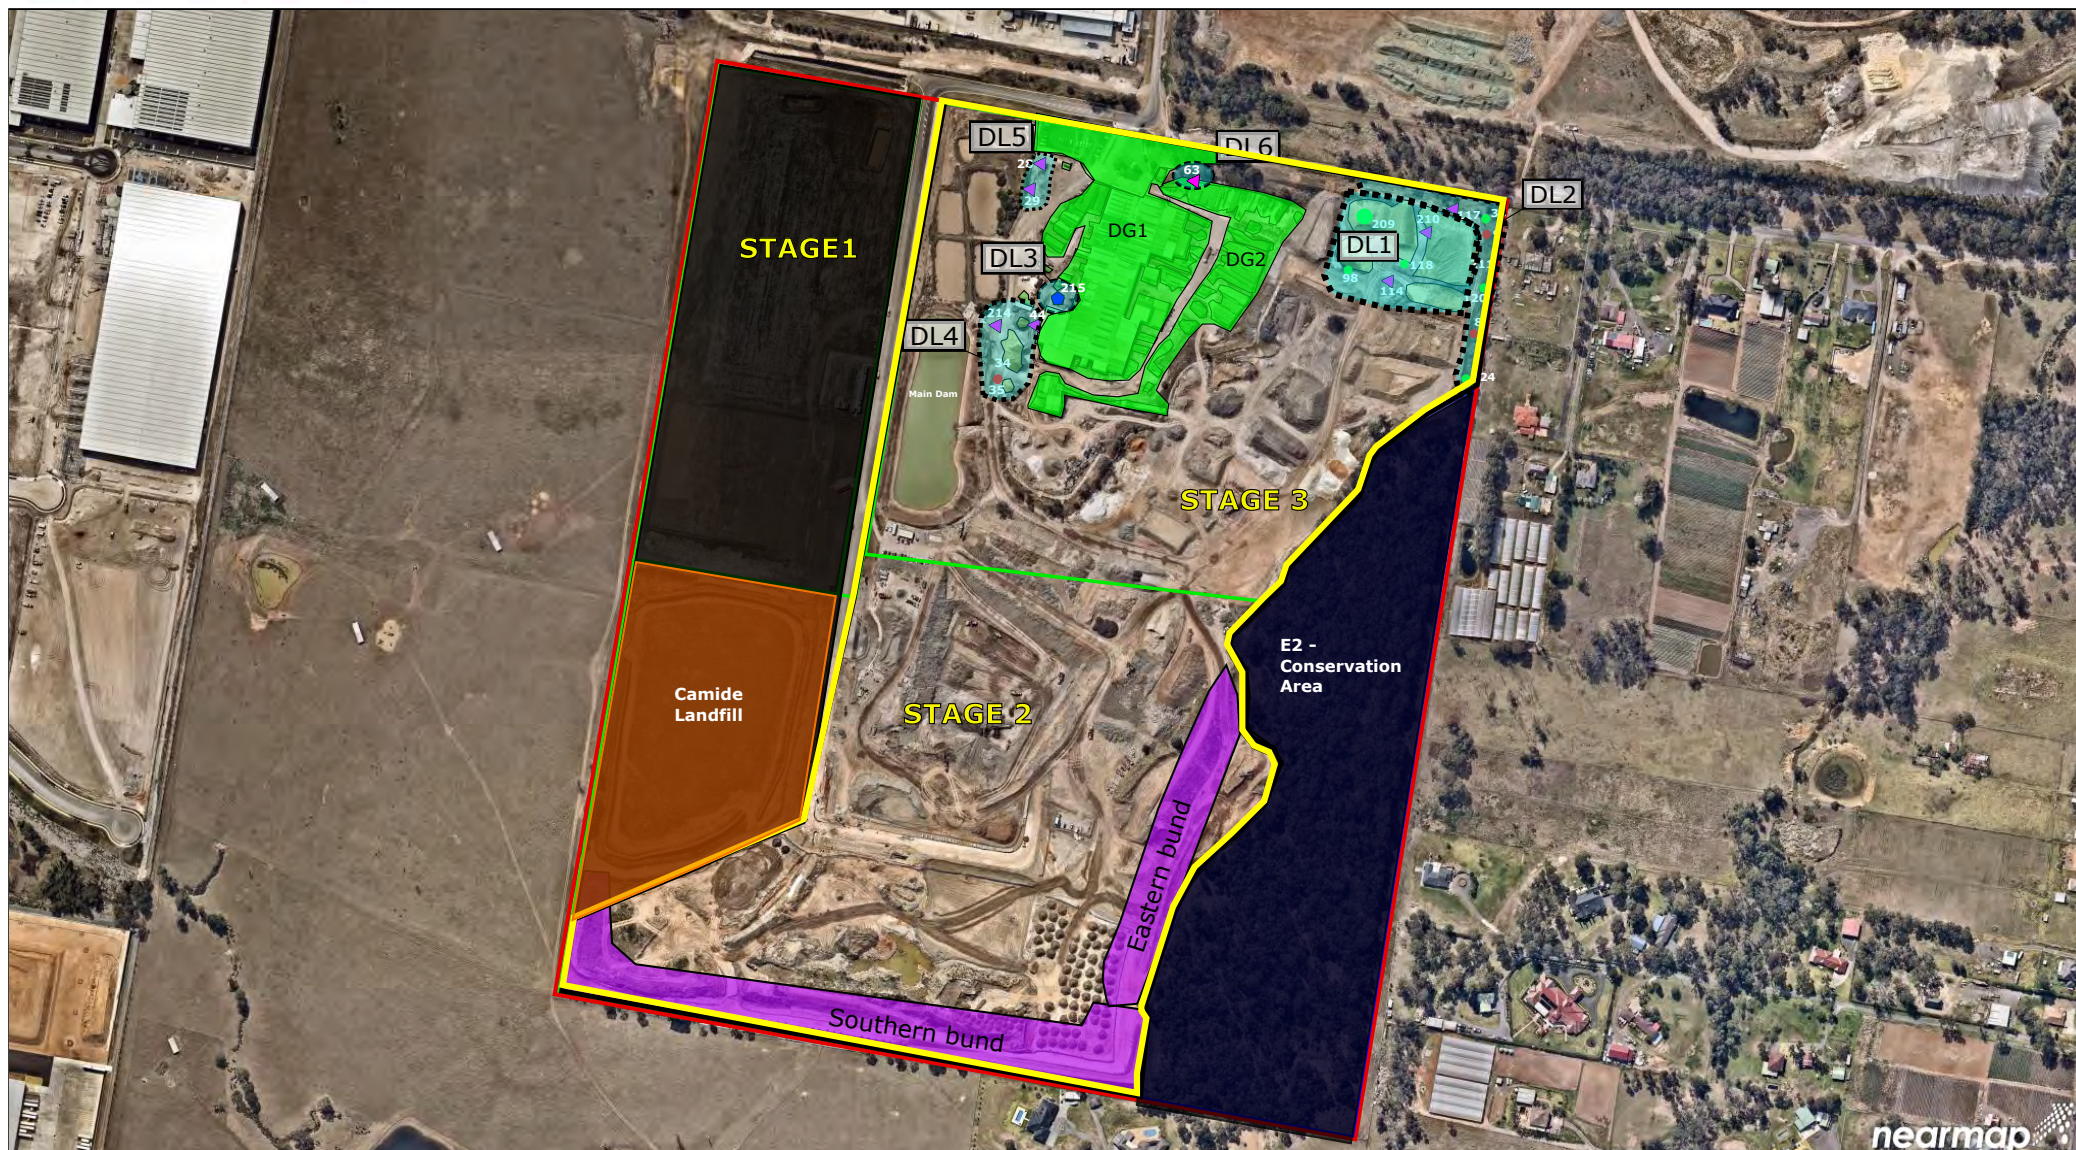
Appendix H: **Areas of Environmental Concern (ERM, December 2019)**

- Site Boundary
- Stage Boundaries
- Outside development area (E2 Conservation)
- Area applicable to revised RAP
- Camide Landfill subject to EMP
- Southern and Eastern Bund walls
- Data Gap areas
- Area covered by 2014 RAP

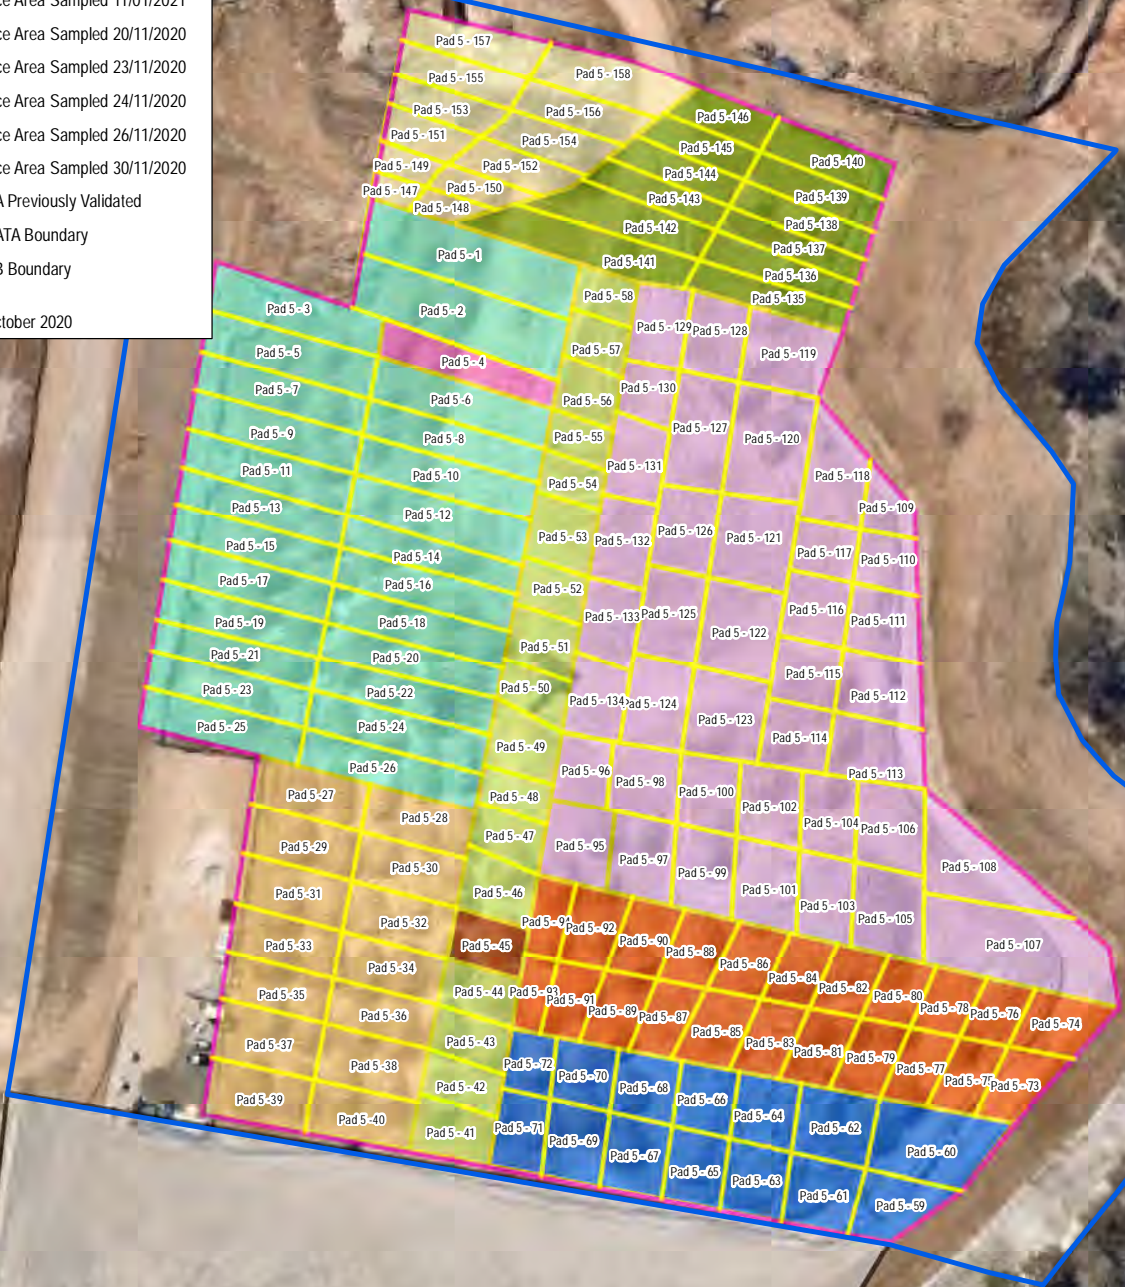
Validation Sample Locations Pad 5

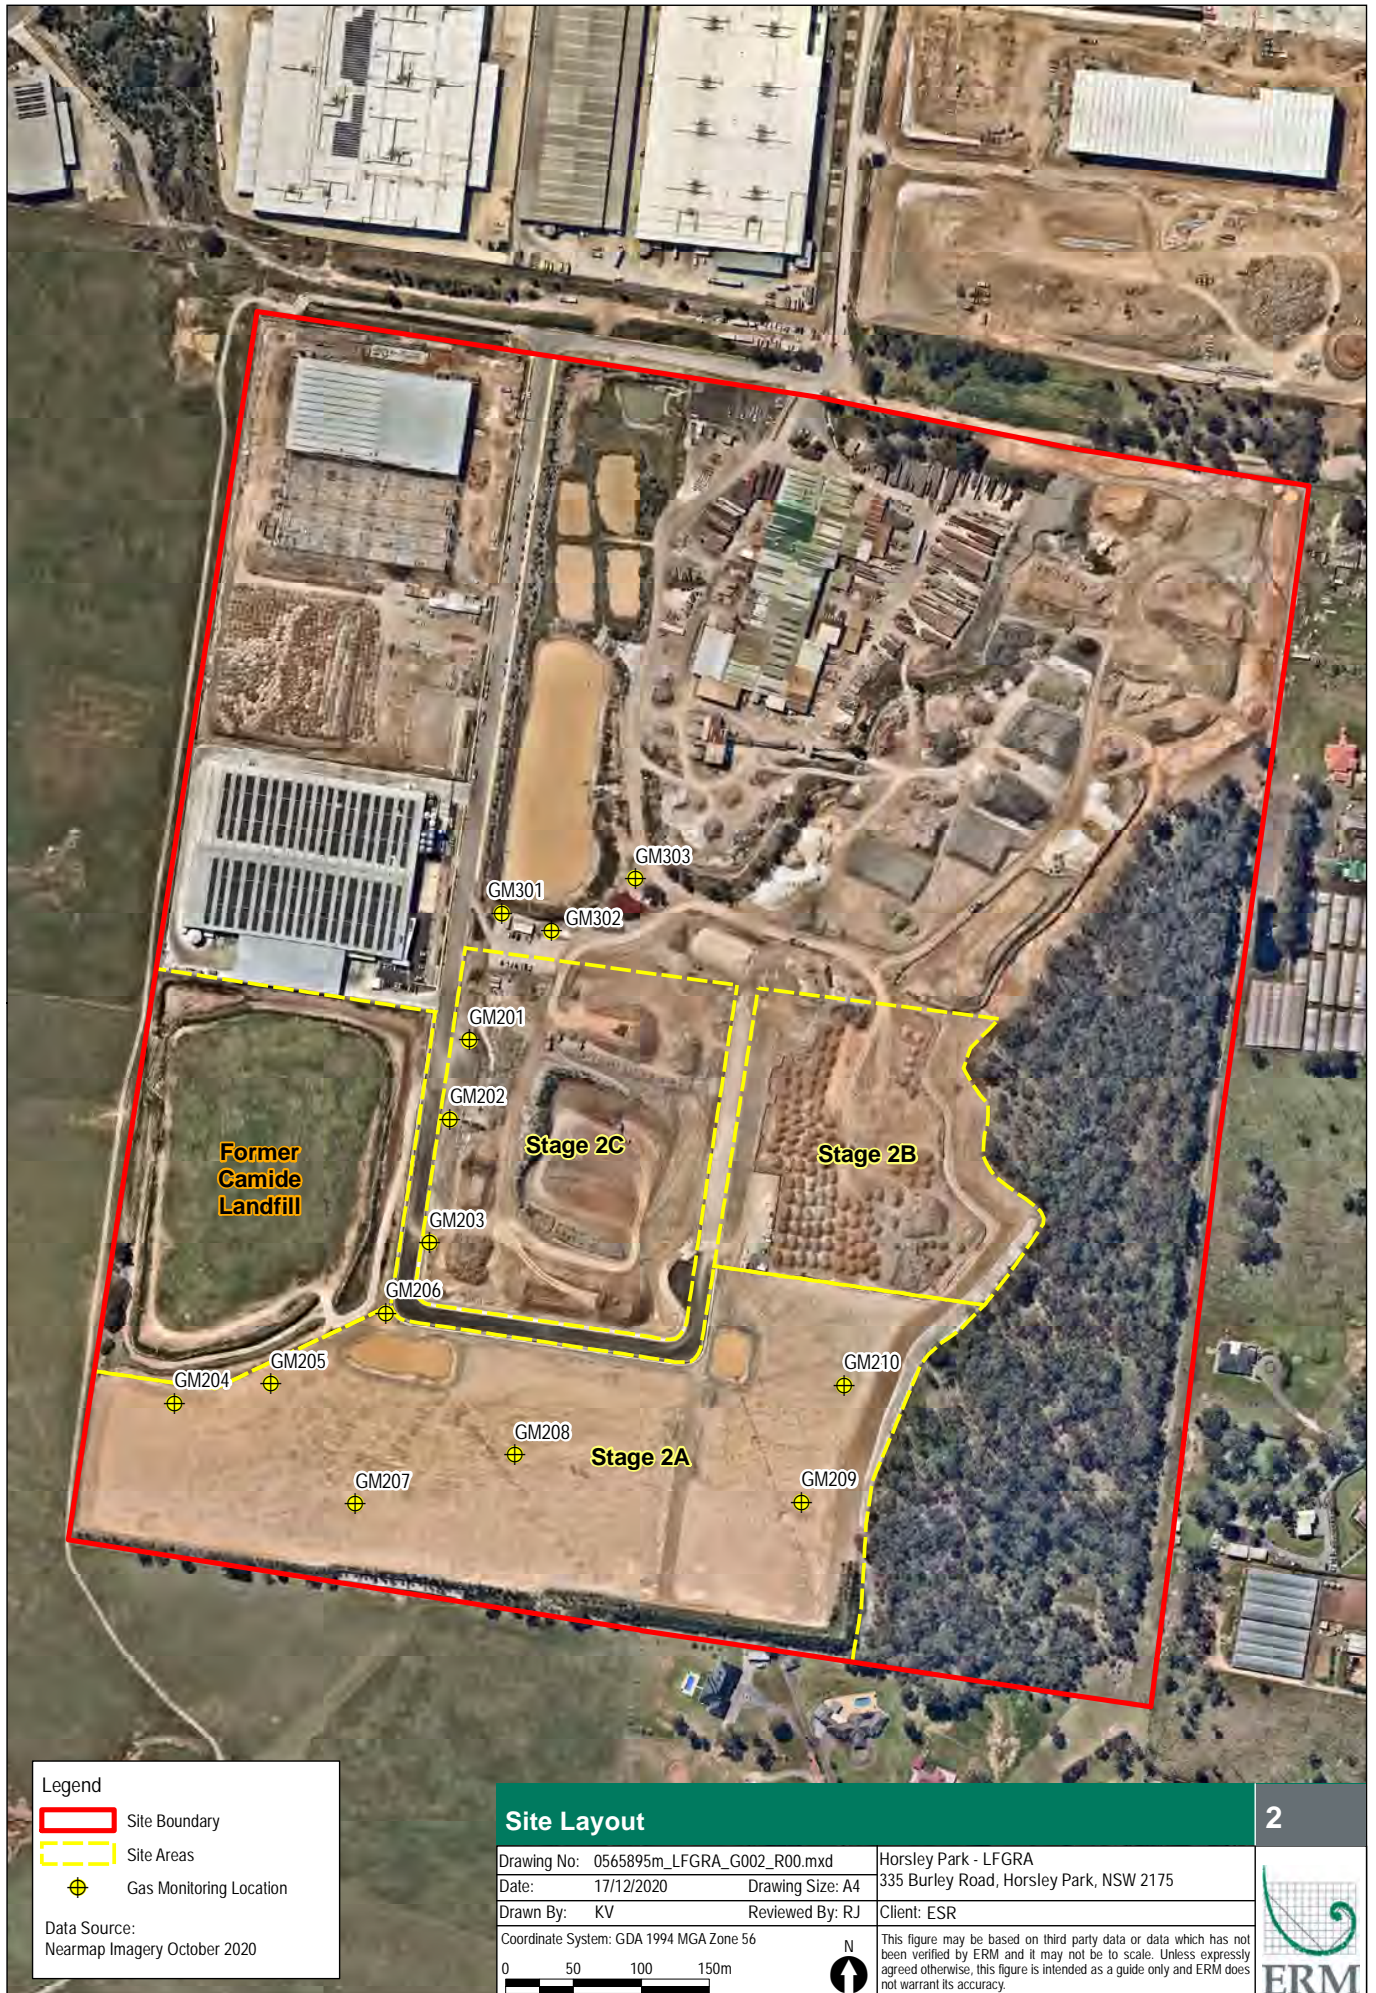
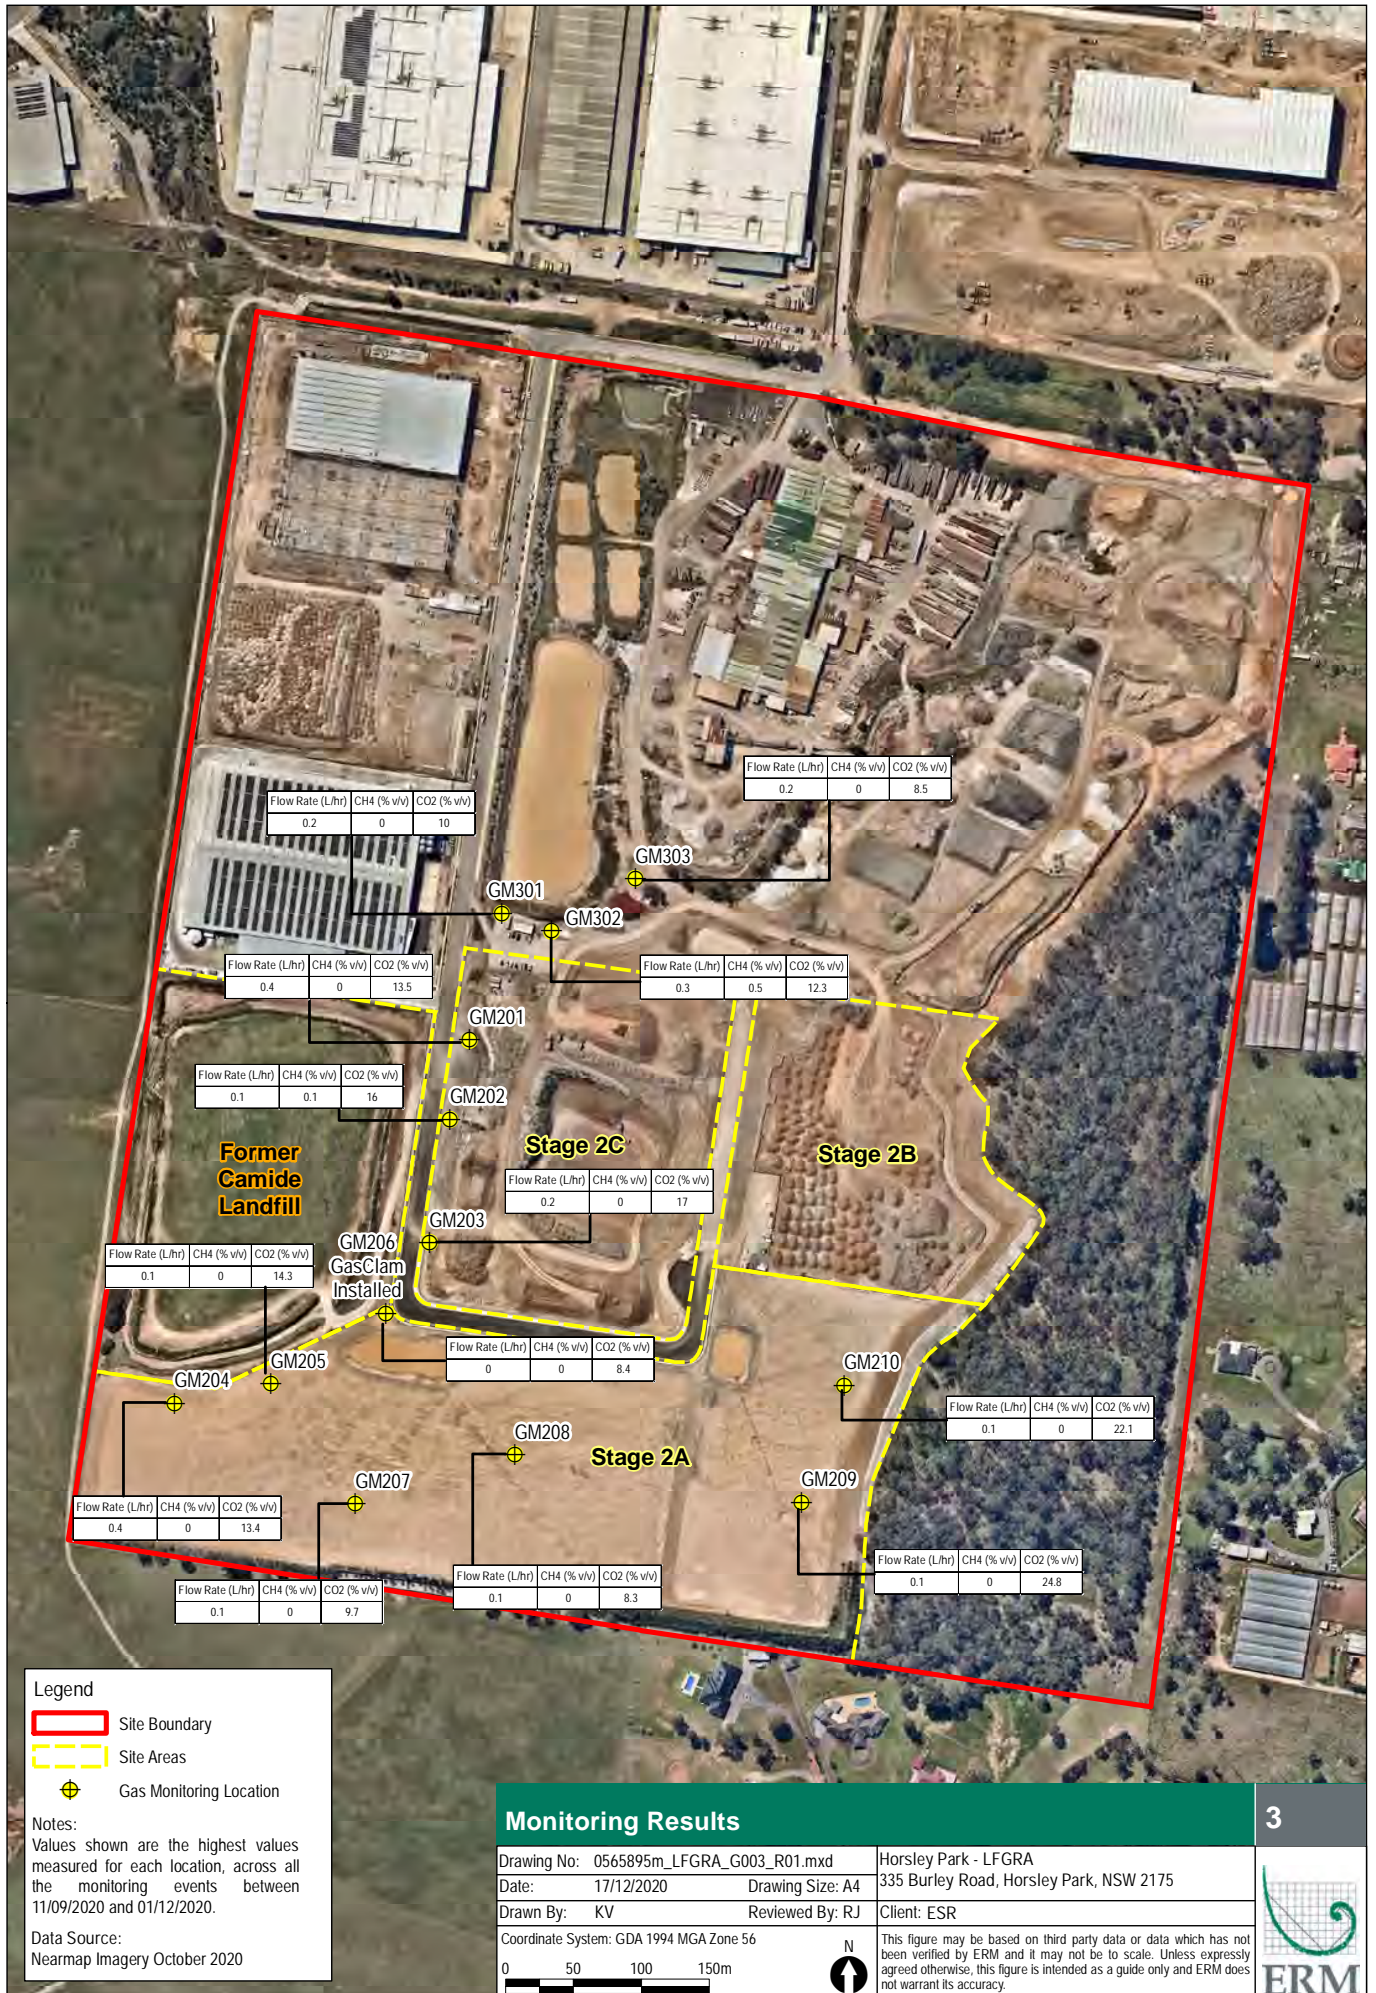
Drawing No:	0565895m_LFGRA_G003_R01.mxd
Date:	17/12/2020
Drawn By:	KV
Coordinate System:	GDA 1994 MGA Zone 56
Drawing Size:	A4
Reviewed By:	RJ
Scale:	0 50 100 150m

Appendix K:
Landfill Gas Risk Assessment Location Plan (ERM, August 2021)

Monitoring Results

The tabulated data from the spot monitoring is included in **Appendix L** and depicted on the Consultant Figure 3 in **Appendix K**.

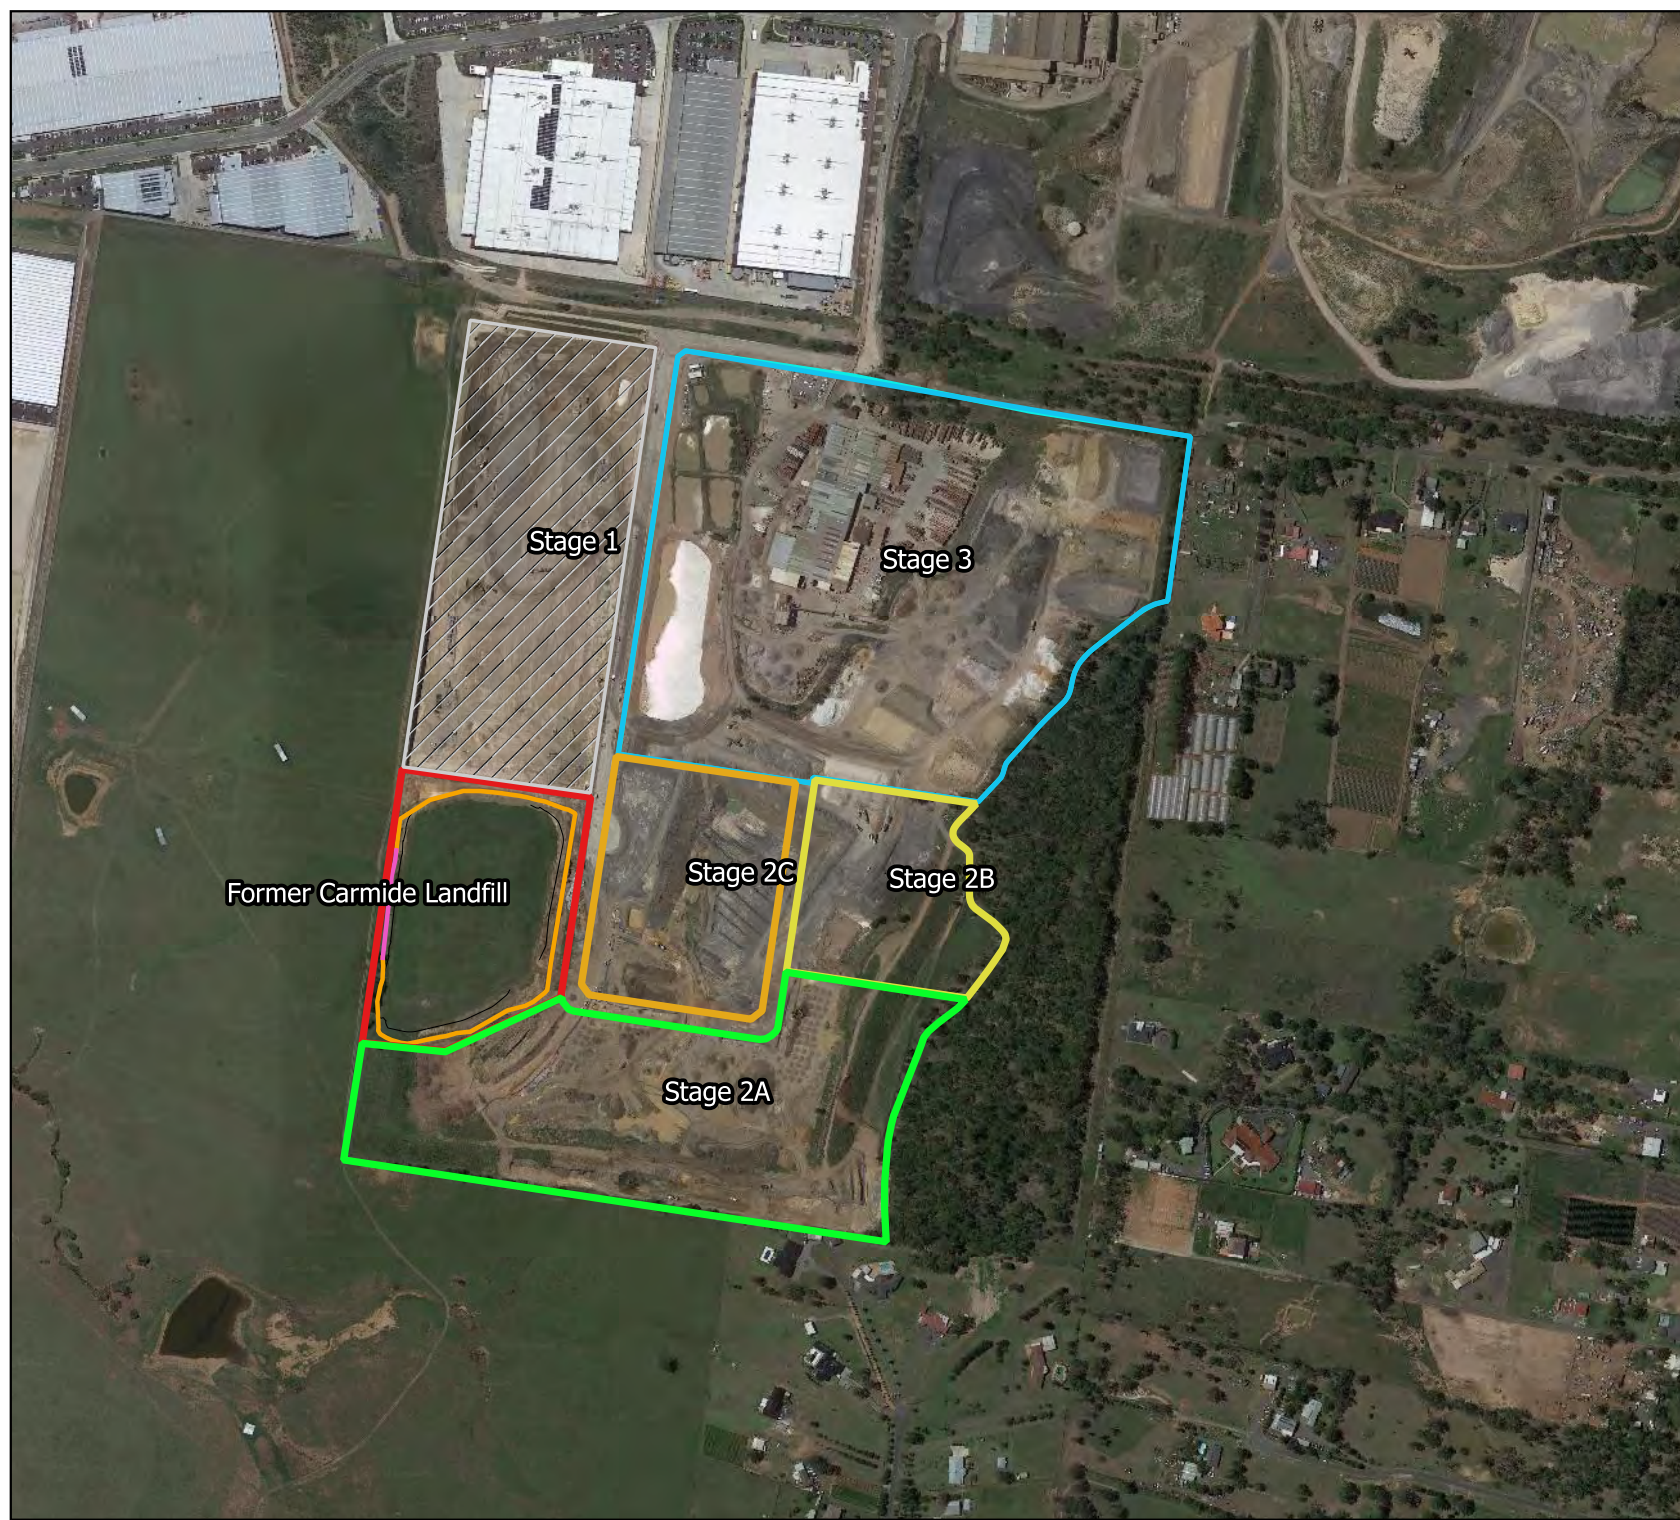
Figure 1 - Site Location Plan

-   Stage 1
-   Stage 2A
-   Stage 2B
-   Stage 2C
-   Stage 3

This Environmental Management Plan (EMP) has been prepared to document the management and monitoring requirements for the former Camide Landfill (Figure 1) to demonstrate that the landfill gas does not present a risk to surrounding off-site properties.

Camide operated a non-putrescible solid waste landfill at the Horsley Park site from 1990 to 1994. The landfilling took place in a quarry void created by clay extraction activities. It has been estimated that 950,000 m³ of waste was imported to the site in an area of 4.1ha of the site as indicated in Figure 1.

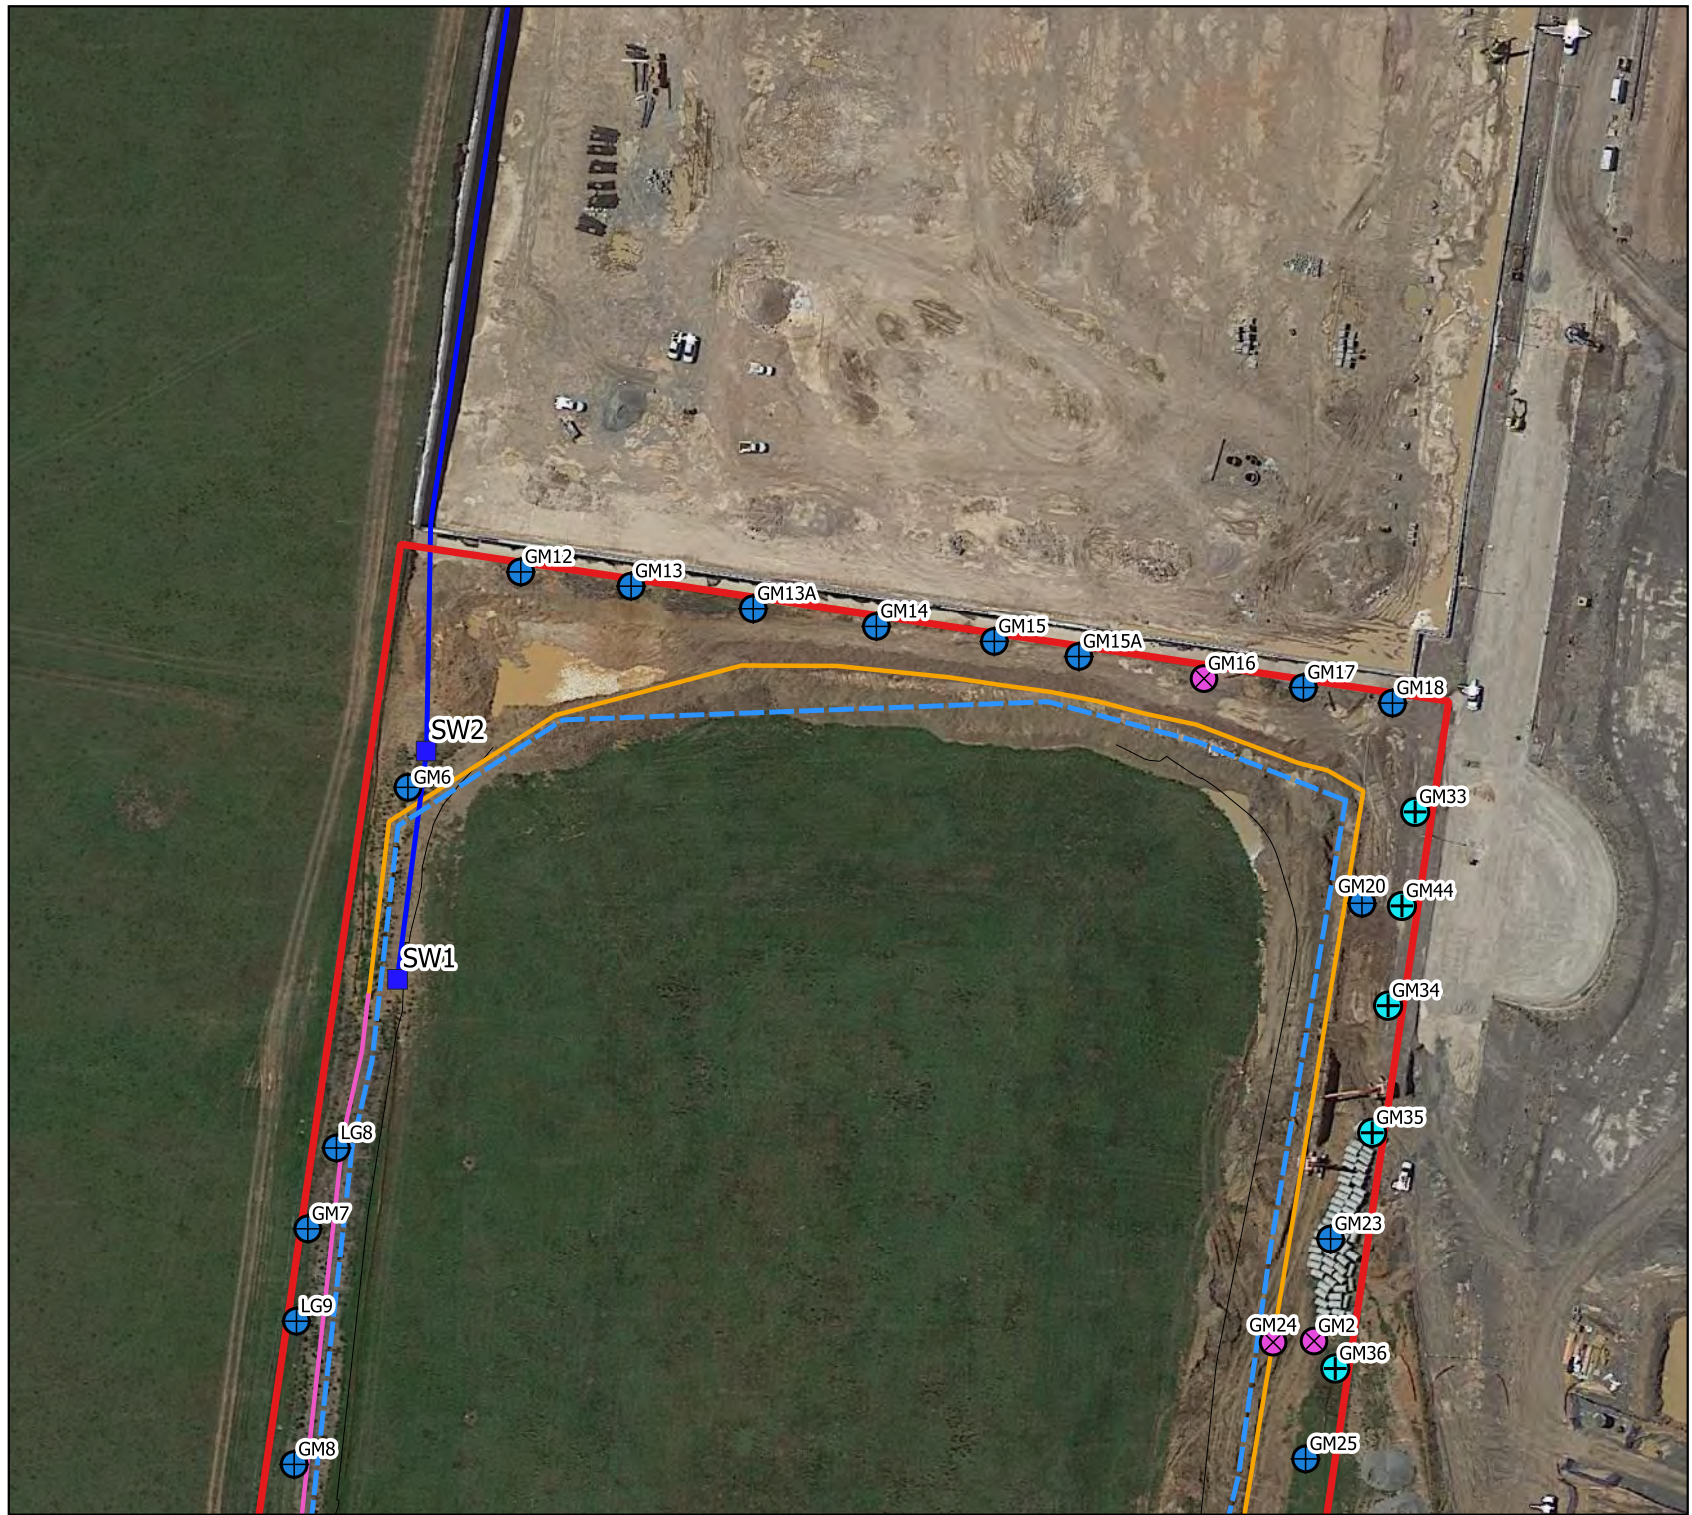
Figure 3 - Site Stormwater Pit Location

- Former Camide Landfill
- Existing Biofiltration Trench
- New Biofiltration Trench
- Extent of Waste
- SW Pits

Gas accumulation monitoring in enclosed structures monitoring should be undertaken in accordance with SWLG 2016 and the procedures outlined in Appendix D. Monitor potential gas accumulation in subsurface structures which do not have preventative measures installed. These monitoring points should include the stormwater pits which run to the north across into Stage 1 from the landfill site as shown on Figure 3 and Table 13 below. The monitoring procedure for landfill gas monitoring of enclosed structure and bump test quality control requirements are provided in Appendix D.
