PEDESTRIAN WIND ENVIRONMENT STATEMENT INTERCONTINENTAL HOTEL REFURBISHMENT, SYDNEY

WD237-03F02(REV5)- WS REPORT

AUGUST 4, 2020

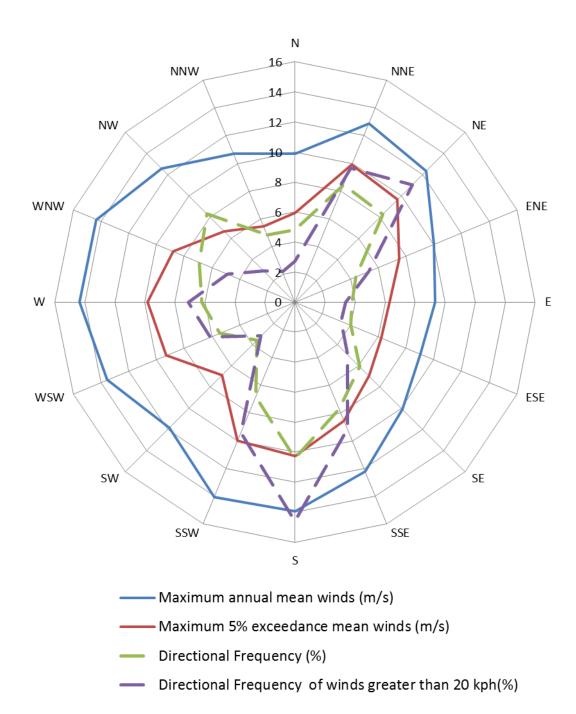
Figure 2a: Annual and Weekly Recurrence Mean Wind Speeds, and Frequencies of Occurrence, for the Region (based on observations from the Kingsford Smith Airport (Sydney Airport) meteorological station from 1995 to 2016, corrected to open terrain at 10m)

Legend

Line thickness represents the magnitude of the regional wind from that direction Line length represents the frequency that the regional wind occurs from that direction

The Sydney region is governed by three principal wind directions, and these can potentially affect the subject refurbishment. These winds prevail from the north-east, south and west. These wind directions were determined from an analysis undertaken by Windtech Consultants of recorded directional wind speeds obtained at the meteorological station located at Kingsford Smith Airport (Sydney Airport). The data has been collected from this station from 1995 to 2016 between 6am to 10pm and corrected so that it represents winds over standard open terrain at a height of 10m above ground level. Figure 2a shows a summary of this analysis in the form of a directional plot of the annual and 5% exceedance mean winds for the region. The frequency of occurrence of these winds is also shown in Figure 2a. Figure 2b shows the 5% exceedance mean wind speeds for the region relative to the building form of the proposed refurbishment.

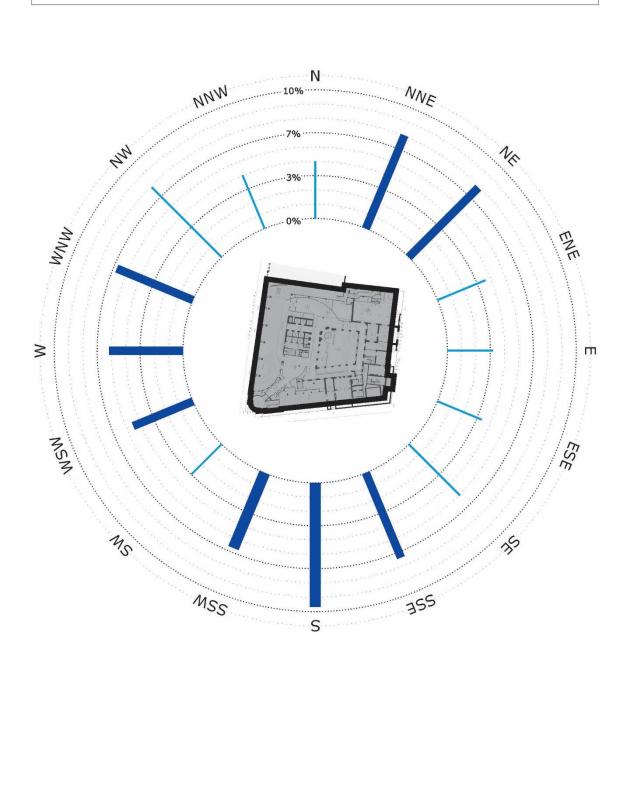
Figure 2b: Regional Wind Climate in relation to the Building Form

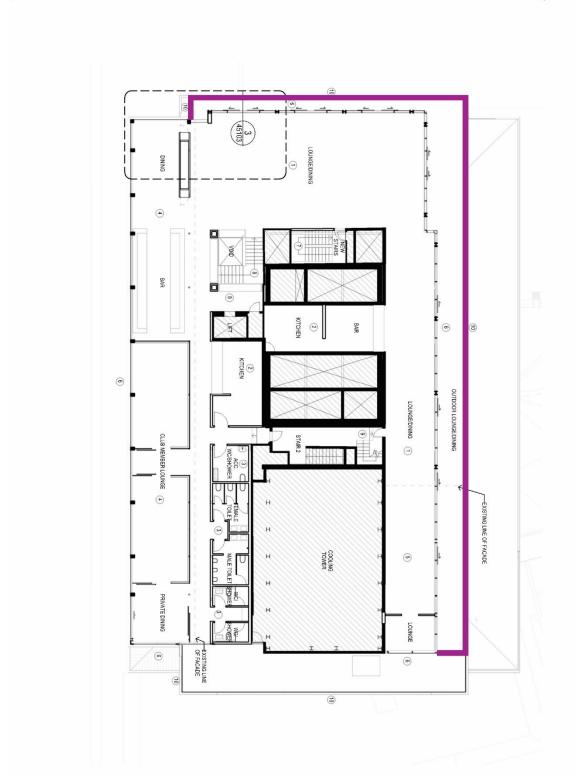
Inclusion of a 1.4m high impermeable balustrade.

Figure 3: Suggested Treatment Strategy - Level 32 Plan

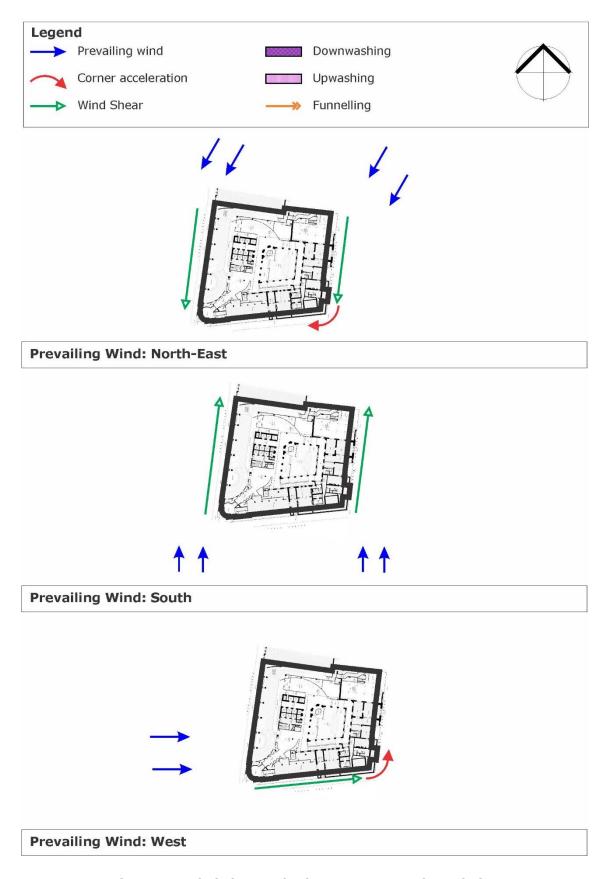
Figure 4a: Wind Flow-Path Diagrams - Ground Level Plan

Flow-path diagrams which highlight the potentially critical wind effects around the various trafficable areas of the proposed refurbishment are shown in Figures 4.

The orientation of Phillip Street with the prevailing southerly winds has the potential to generate funnelling winds and sidestreaming winds along the corresponding pedestrian footpath area. This is expected to be a pre-existing wind condition which is not expected to be worsened with the addition of the proposed refurbishment. As such, the wind conditions along Phillip Street are expected to be comparable to the existing site conditions.

Furthermore, the westerly winds are expected to funnel along Bridge Street and potentially accelerate around the south-east corner of the refurbishment. Similarly, the north-easterly winds are expected to sidestream along Macquarie Street and accelerate around the south-eastern corner of the refurbishment and potentially funnel along Bridge Street. The effect of the prevailing north-easterly winds is expected to be dampened by the existing street trees along Macquarie Street. The wind conditions along Bridge Street and Macquarie Street are also expected to be similar to the existing site conditions.

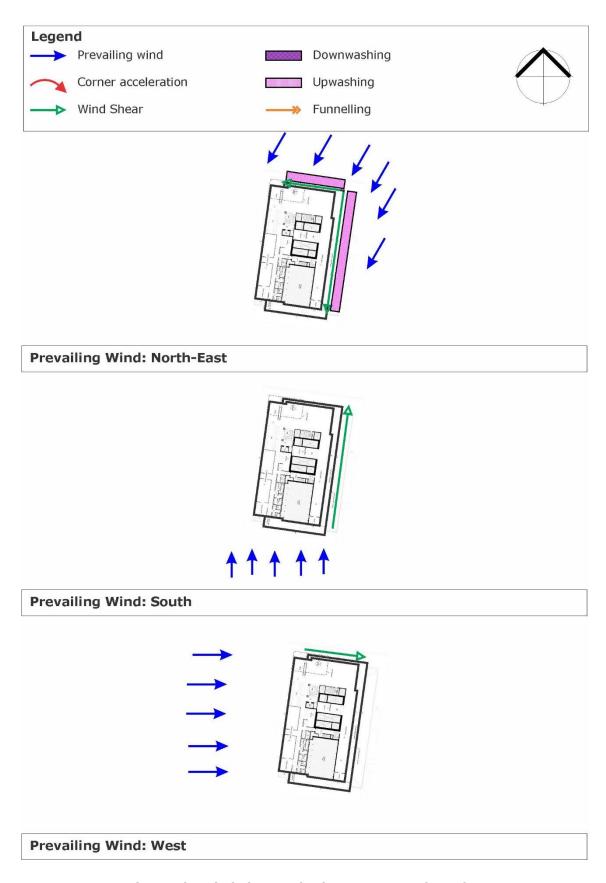
Figure 4b: Wind Flow-Path Diagrams - Level 32 Plan

The ground plane will be used primarily for circulation. However, there are potential dining areas such as the outdoor Lounge/ Dining area on Level 32. The recommended criterion for wind conditions for the circulation area is 7.5m/s with a 5% probability of exceedance, whereas the proposed dining areas will need to satisfy a more stringent comfort criterion of 3.5m/s with a 5% probability of exceedance. Although this assessment is of a qualitative nature, the abovementioned criteria are considered when assessing the wind environment impacts.
