REMEDIATION ACTION PLAN

September 2021 J169135

Department of Education (SCHOOL INFRASTRUCTURE NSW)

7-11 Burroway Road, Wentworth Point, NSW

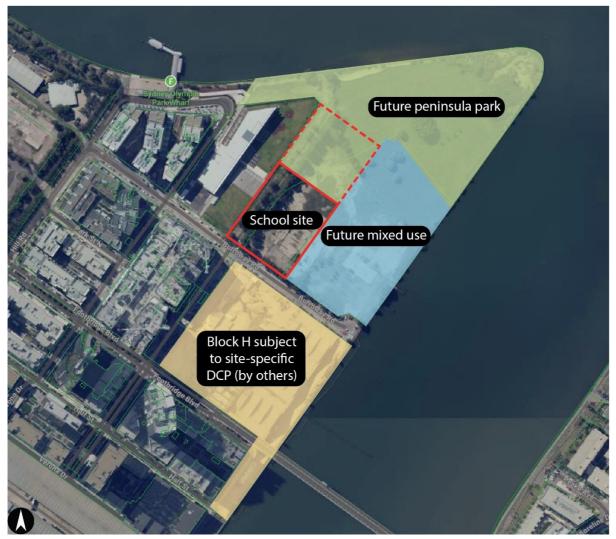
Site Aerial Map Source: Mecone

The site is approximately 9,511sqm in area, with a frontage of approximately 91m to Burroway Road. It currently contains vacant land, which is cleared of all past development, and almost entirely cleared of native vegetation.

The surrounding area is generally characterised by high rise residential and mixed-use developments. The site is directly adjacent to the Wentworth Point Peninsula Park and immediately east of Wentworth Point Public School.

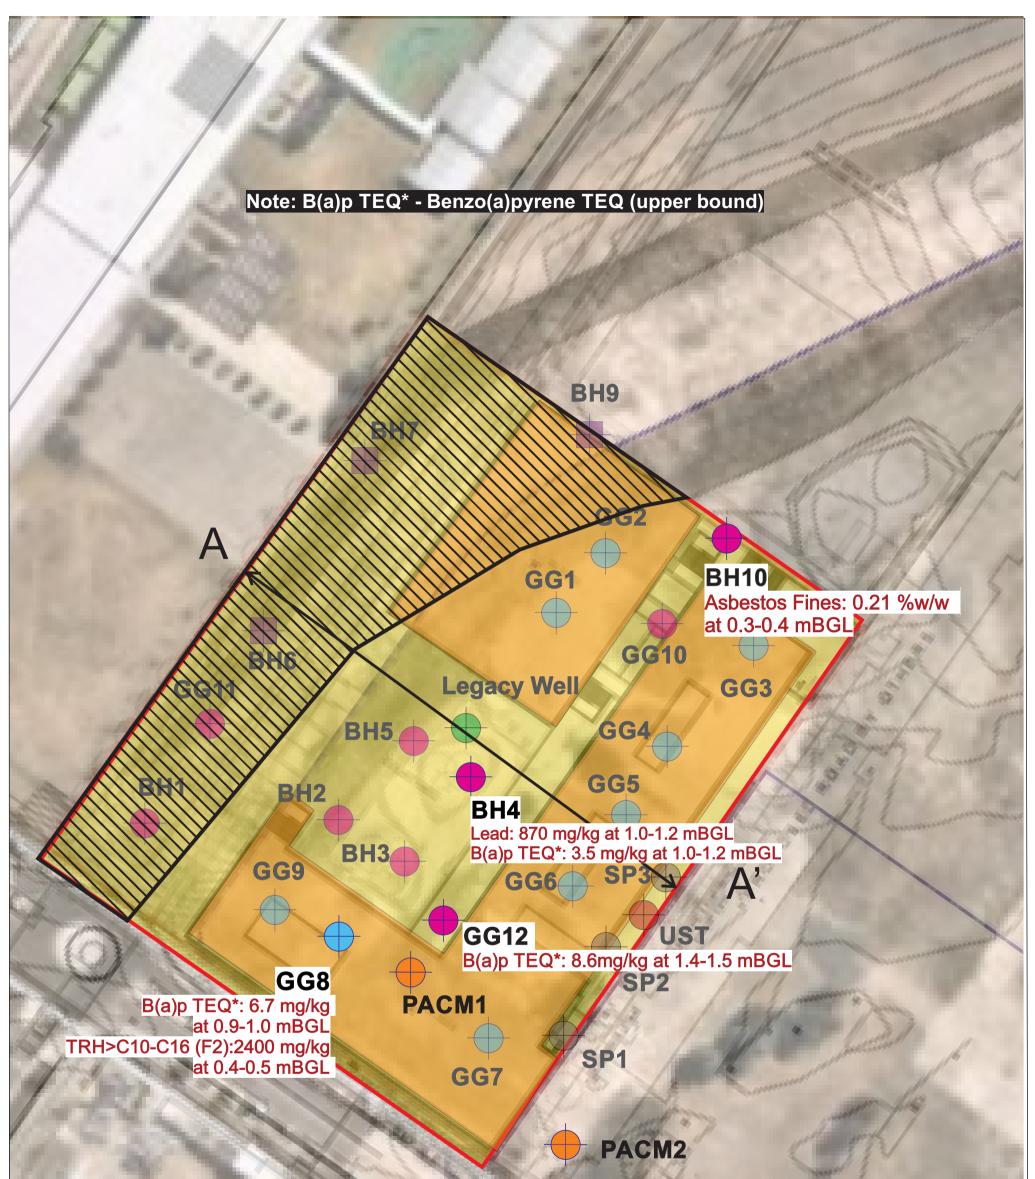
Lead HIL-C Criterion: 600 mg/kg; Benzo(a)pyrene TEQ HILC Criterion: 3mg/kg; TRH>C10-C16(F2) HSL-A&B (0 to <1m): 110 mg/kg; AF/FA HIL-C Creiterion: 0.001%w/w;

Historical use of underground petroleum storage systems was noted on site and the site contains identified and potential abandoned underground asset locations (see *Figure 2* and Section 4.4). The site is a non-regulated former NSW EPA notified contaminated site. The site was subject to partial remediation in 2019, which consisted capping at the western corridor and north western sections of the site (see *Figure 2*).

Sandstone material imported in 2019, which makes up the Soil Mound (see Figure 4) as well as the former capping layer applied to the western corridor and north and northwest sections of the site (see Figure 2), was previously verified as VENM and suitable to be re-used on-site.

A UST was identified in the scope of the DSI (2021), which may be an abandoned oil-sump. The UST was filled with water. Furthermore, review of former contamination reports indicated the site may contain additional abandoned UST's, one potential location was indicated as the southwest section of the site (see. Figure 2 and Figure 4) in the previous reports (PB 2015, GHD 2013).

Conceptual Site Model (CSM) of the site has been formed by considering the geophysical characteristics of the site, contamination sources, potential receptors and the pathways to the receptors. The CSM, as required by the NEPC (2013), is an iterative process constantly being updated during the investigation process as more information becomes available. The following CSM is presented based on the results of the DSI (2021) and review of previous contamination reports (see Section 4.4). A graphical illustration of the CSM is displayed on **Figure 4** as a cross-section drawing. The cross-section line is displayed on **Figure 2**, indicated as A-A'.

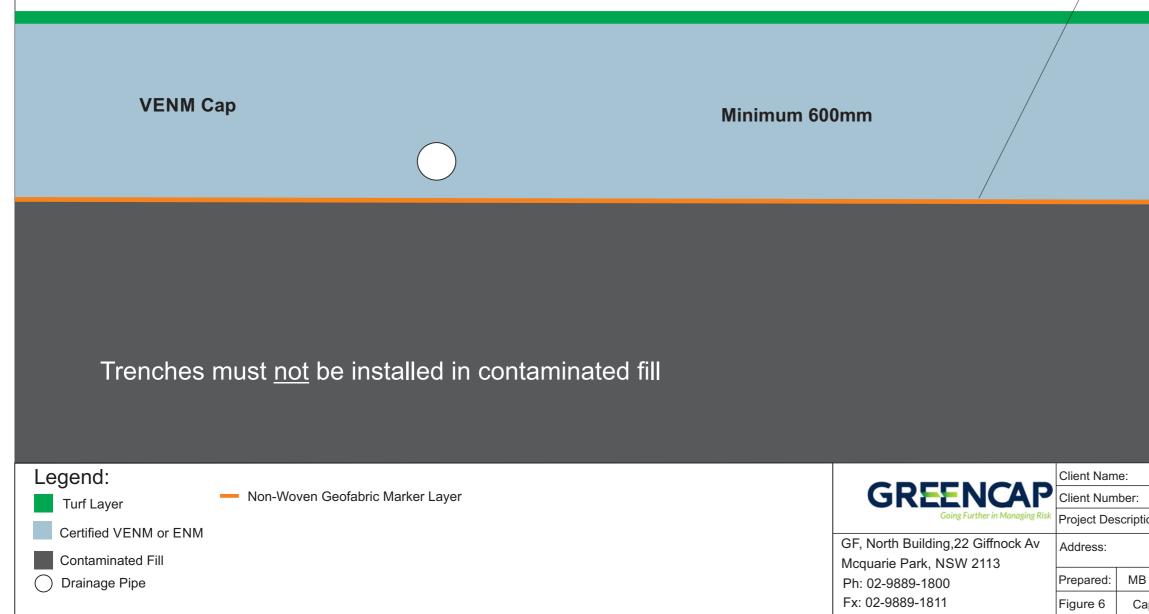
geofabric marker layer

Department of Education (School Infrastructure NSW)							
	C123934 Project Number: J169135							
tion:	Remediation Action Plan - SOPHS							
	7-11 Burroway Road, Wentworth Point, NSW							
З	Reviewed:	SW	Date:	21/06/2021				
ap C	ap Construction Details

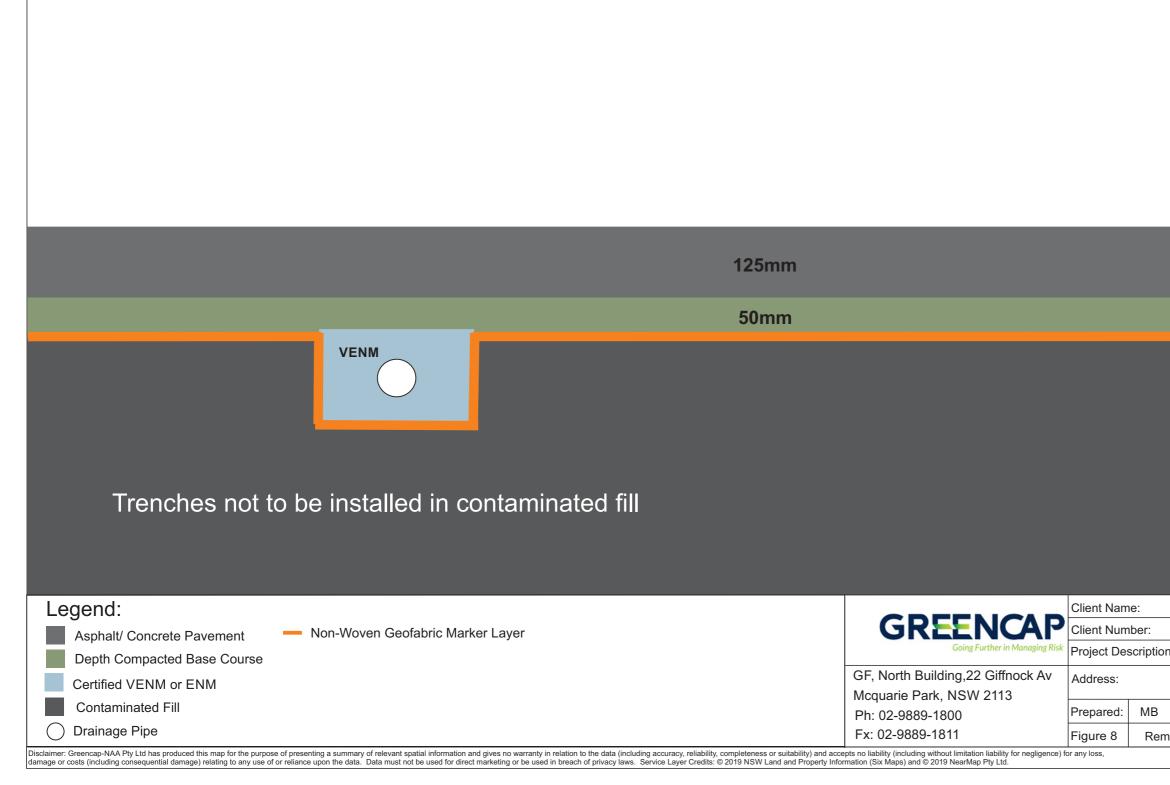
geofabric marker layer

Department of Education (School Infrastructure NSW)							
	C123934 Project Number: J169135							
tion:	Remediation Action Plan - SOPHS							
	7-11 Burroway Road, Wentworth Point, NSW							
3	Reviewed:	SW	Date:	21/06/2021				
emediation Area - Trafficable Pavement around the field
