Russell Vale Colliery Preliminary Works
Project Modification 4

Russell Vale Colliery Preliminary Works Project
Modification 4

Prepared by
Umwelt (Australia) Pty Limited
on behalf of
Wollongong Coal Limited

Bellambi Gully Diversion Pipeline Review

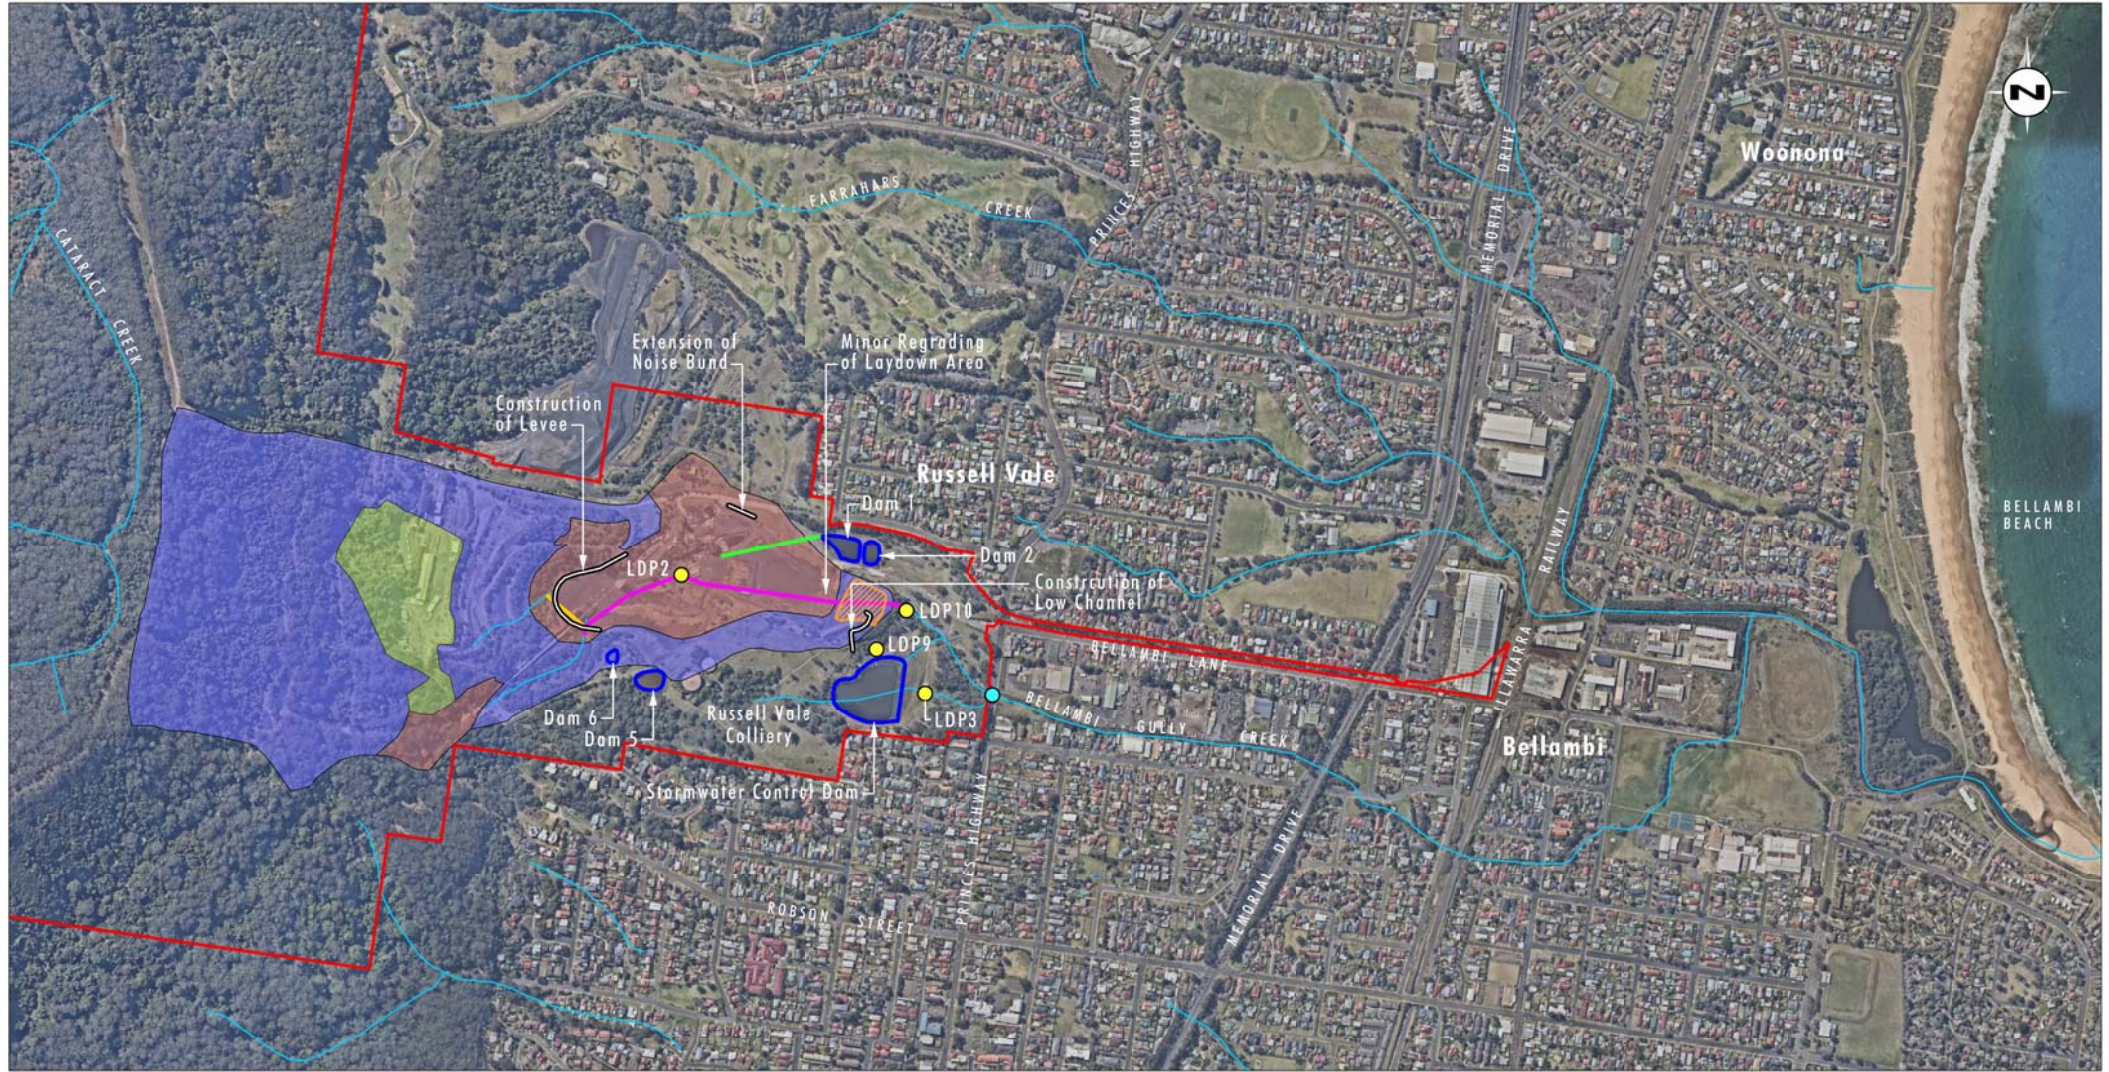
The modelling further demonstrated that refinements to the Cardno (2015) proposed mitigation strategy, by incorporating detention storage related to the construction a new upstream levee (**Figure 5.1**), will have significant benefits over the 2015 Cardno solution.

Figure 1.1	Location map	5
Figure 1.2	Bellambi Gully creek and existing stormwater management system on site	6
Figure 5.1	Updated Proposed Stormwater Management Measures (Engeny, 2018a)	18

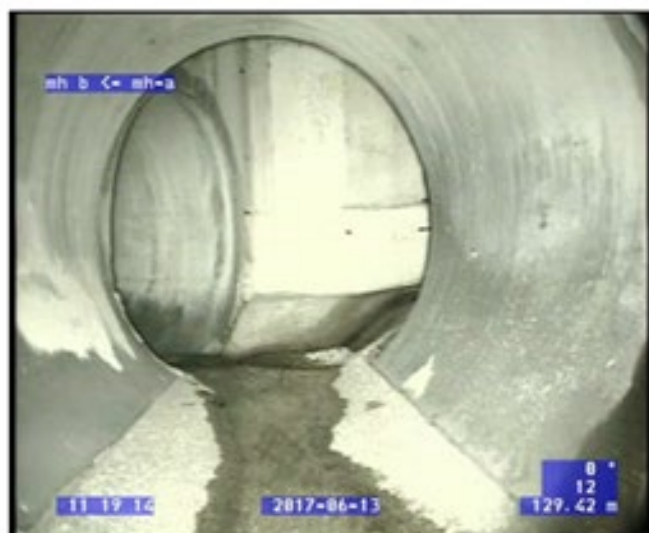
Figure 4.4 CCTV Inspection Photos for ~Chainage 60 (Interflow, June 2017)

In general, the pipe located under the coal stockpile appears to be in good structural condition (based on the visual Interflow inspection report and photographs, 2017), despite the historical stockpile height and associated dead load. It should be noted that it is unknown if any live loads were applied to the pipeline concurrent with the maximum dead load. A representative photo of the pipeline under the stockpile area are shown in Figure 4.4.

Photo: SW001 (US Part 2)_MH A_MH
B_20062017_133200_A.jpg
129.42m, New material, Concrete Pipe , General Comments
returns to original pipe material

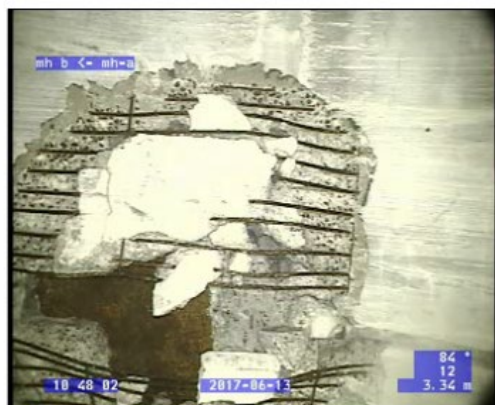
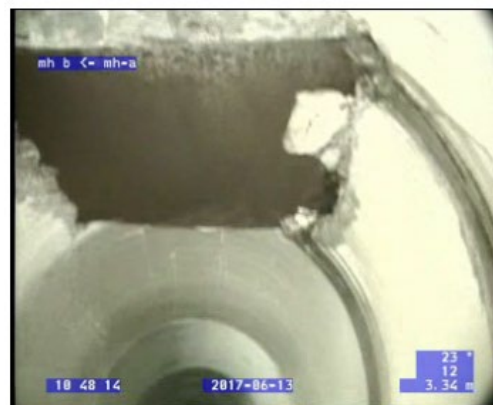
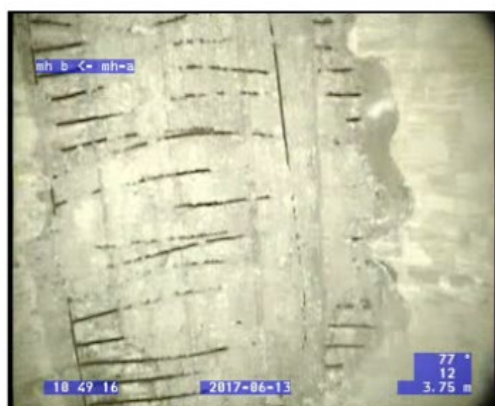
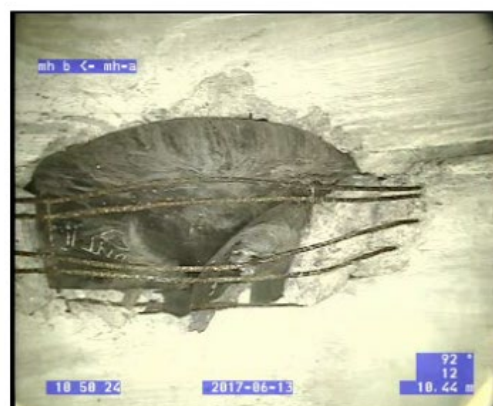
Figure 4.5 CCTV Inspection Photos for ~Chainage 200 to 220 (Interflow, June 2017)

Apparent structural damage exists to the pipeline in the low cover areas surrounding Manhole B and under the laydown area. CCTV photos of some of these damaged locations are shown in Figure 4.5 and Figure 4.6.

Photo: SW001 (US Part 1)_MH A_MH
B_20062017_123939_A.jpg
3.34m, Steel reinforcement is visible with little or no corrosion evident , from 11 to 1 o'clock

Photo: SW001 (US Part 1)_MH A_MH
B_20062017_124126_A.jpg
3.34m, Suspected Surface Damage , Obstruction: 5-20%,
General Comments Hole in pipe obvert has been repaired using a steel sheet, from 10 to 2 o'clock

Photo: SW001 (US Part 1)_MH A_MH
B_20062017_124203_A.jpg
3.75m, Steel reinforcement is visible with little or no corrosion evident , from 11 to 1 o'clock

Photo: SW001 (US Part 1)_MH A_MH
B_20062017_124258_A.jpg
10.44m, Reinforcement is exposed and corroded , General Comments possible repair of pipe hole, from 11 to 1 o'clock

Based on the CCTV inspection report and images (Interflow, 2017) there is significant evidence of structural degradation in many areas, especially in those areas with lower depths of cover. The apparent structural damage to the pipe is generally in the form of exposed reinforcement, longitudinal cracks in the pipe, holes or previous repairs to the top of the pipeline, squashed or irregular cross section and bulging/bellies in the line of the corrugated steel pipe liner.

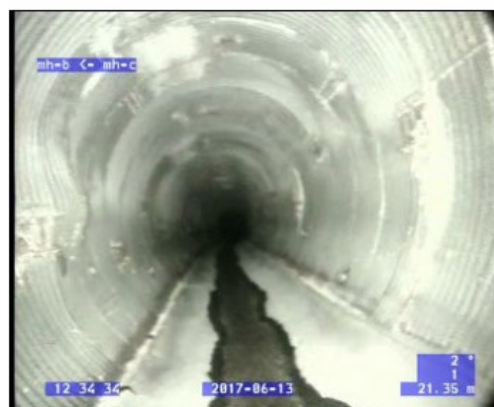
Figure 4.6 CCTV Inspection Photos for ~Chainage 485 to 495 (Interflow, June 2017)

Photo: SW001 (Section 3B)_MH B_MH
C_20062017_120205_A.jpg
11.92m, Defective repair , other defects: Bulging of corrugated iron in invert

Photo: SW001 (Section 3B)_MH B_MH
C_20062017_120355_A.jpg
21.35m, Defective repair , other defects: Bulging of corrugated iron, General Comments on left hand side of pipe wall

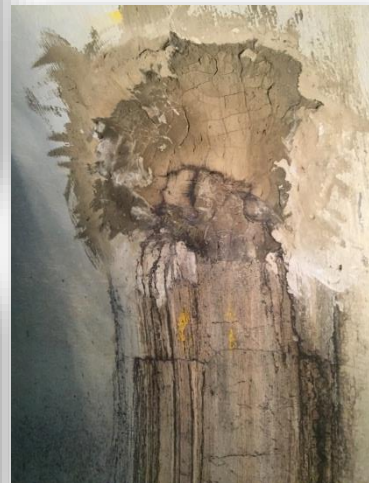
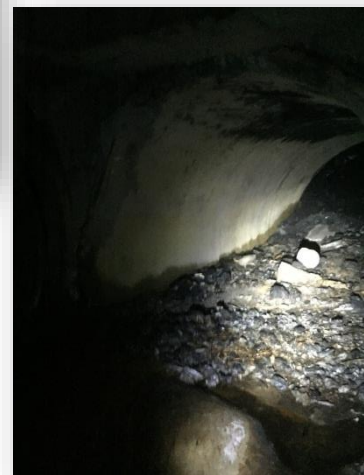
Joint between pipes

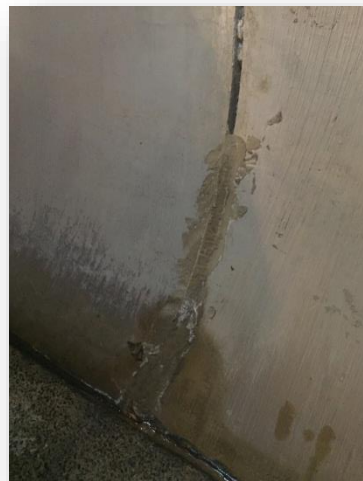
Repaired Joints

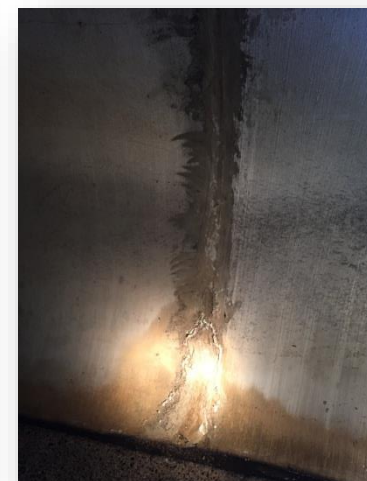
Repair and Patch of Joints

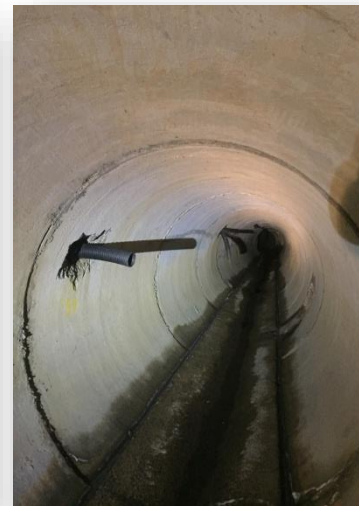
After 40m to 63m agg pipes

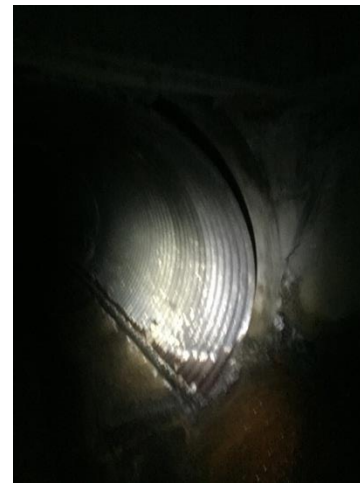
86m start of corrugation repairs

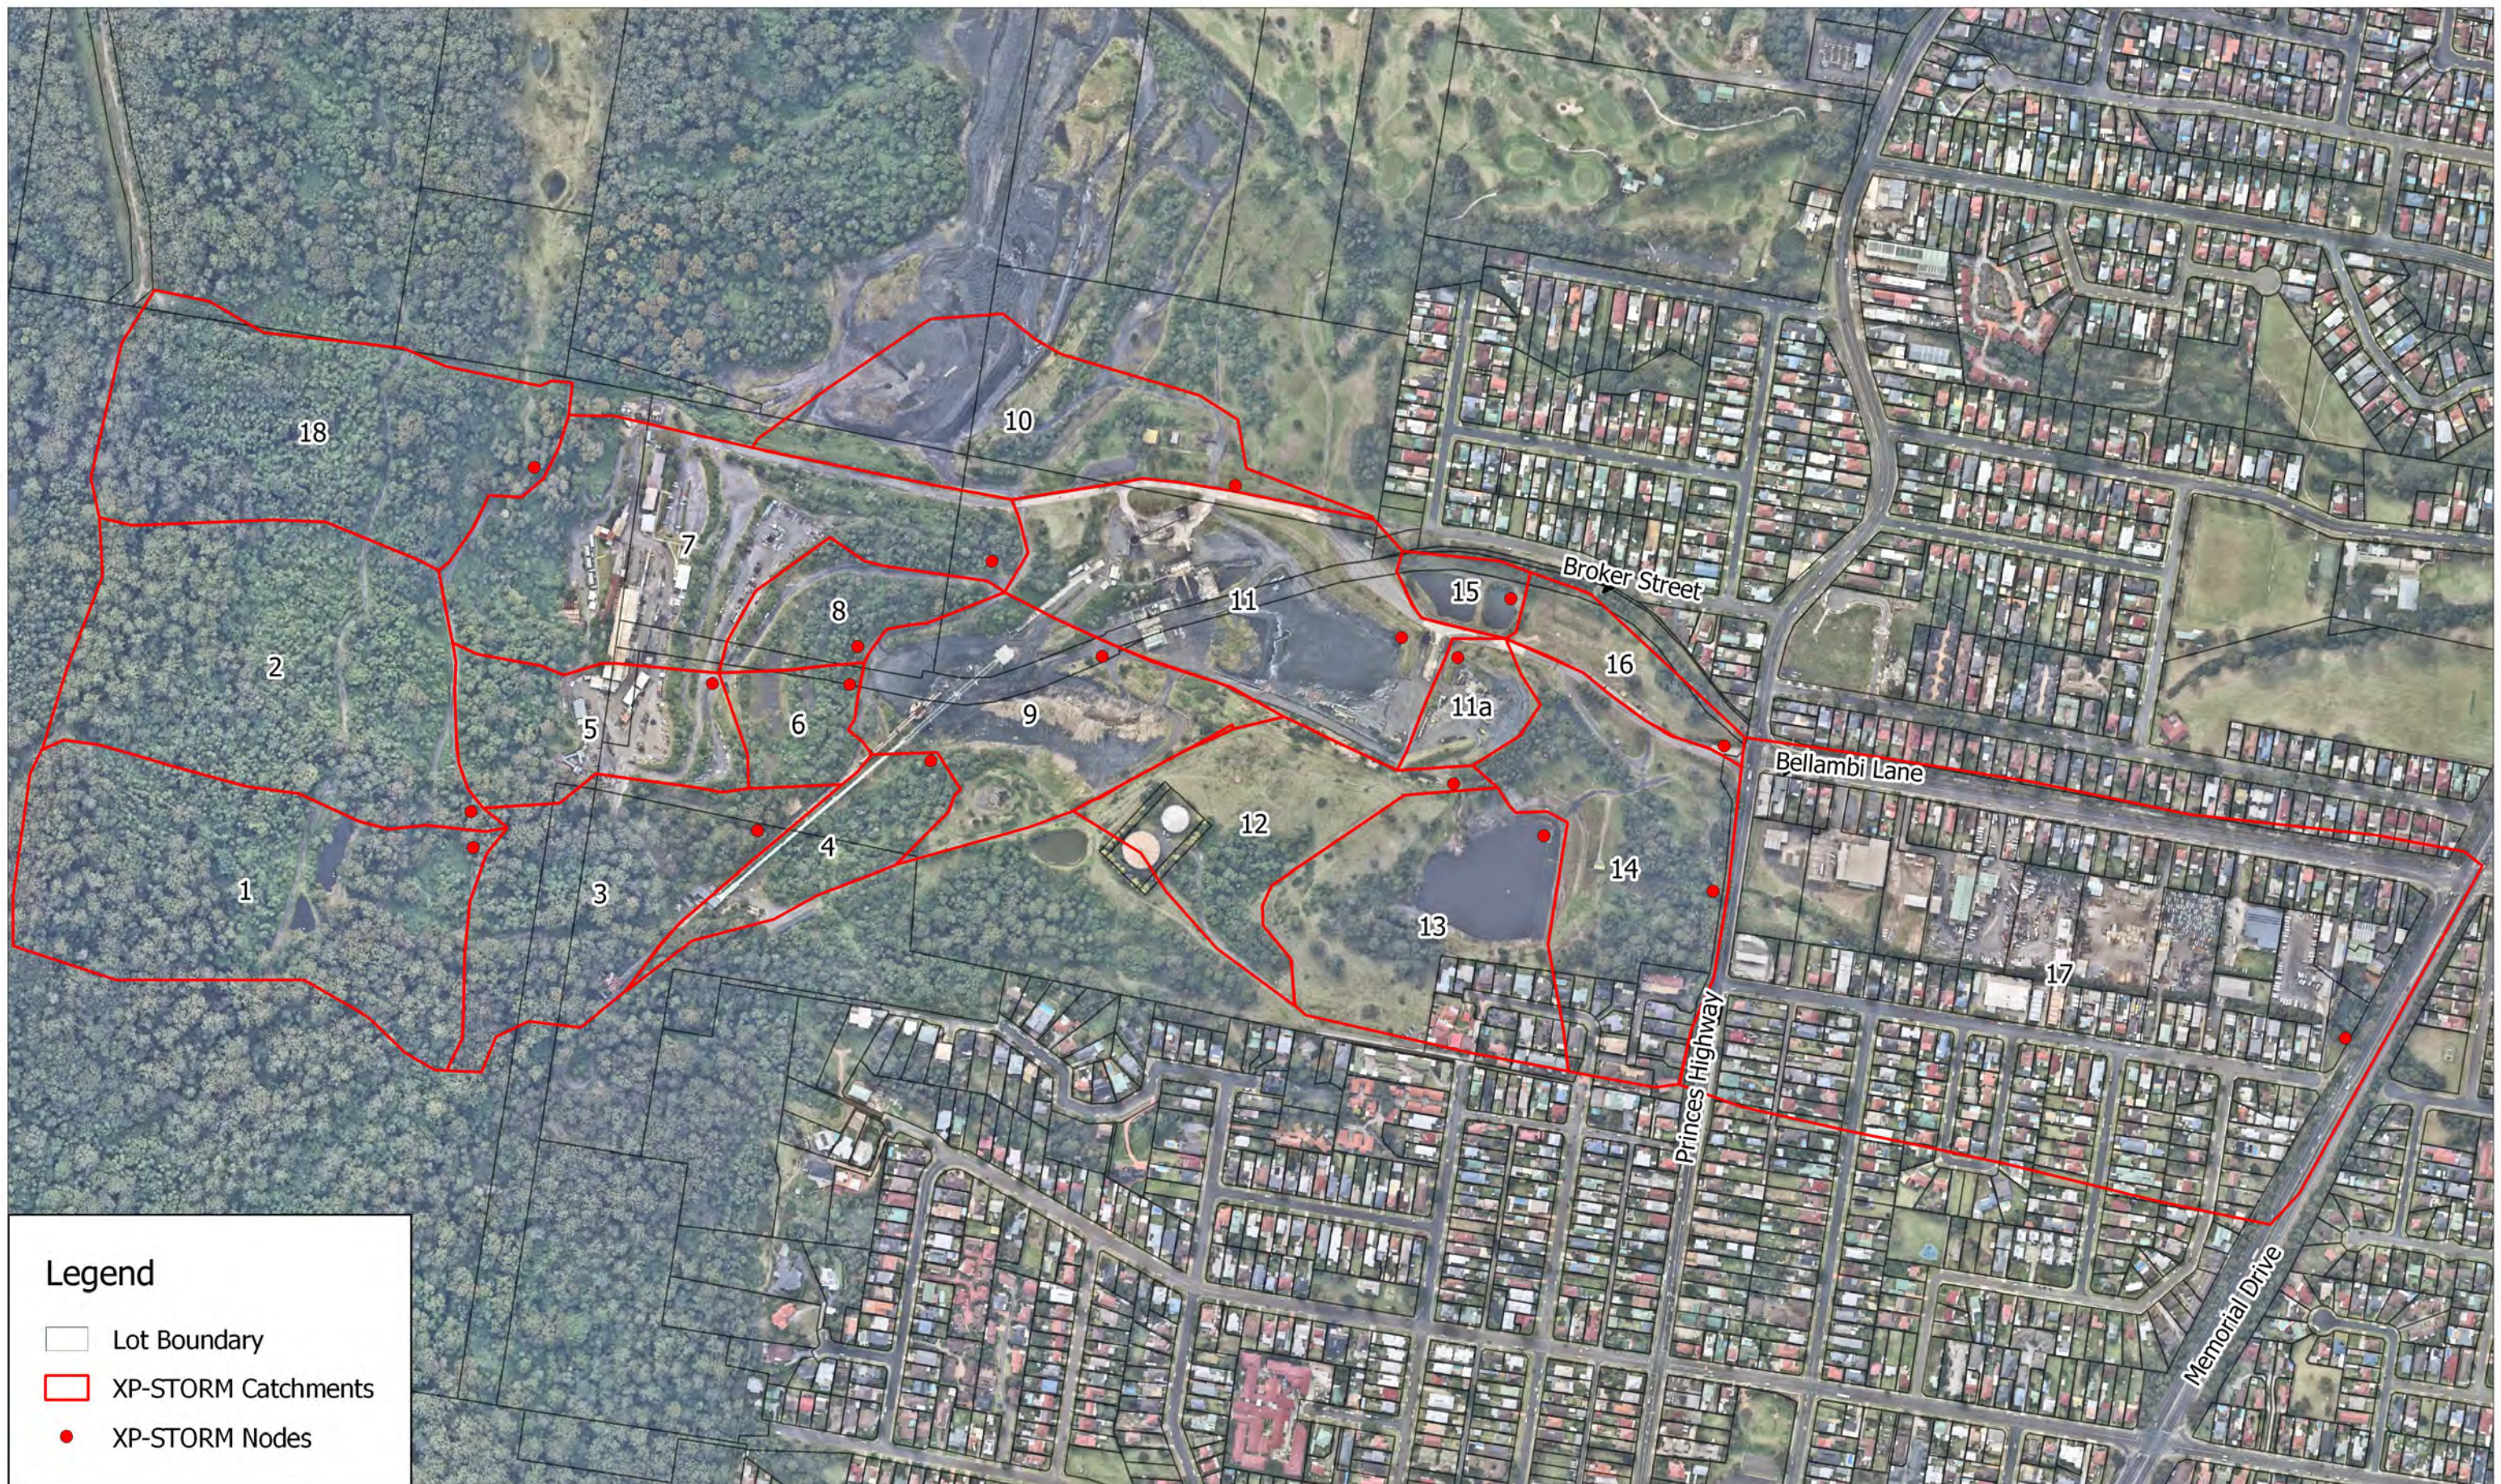
The adopted sub-catchment delineation for the study area is shown in Figure 4.1. Impervious and pervious fractions have been identified for each sub-catchment, based on aerial imagery and site inspections. Impervious areas include buildings, roads and hardstand areas. Stockpile and laydown areas consist of coal and gravel materials as well as some grassed areas. Site inspections have identified significant infiltration across stockpile areas which have therefore been classified as pervious. Catchment parameters are summarised in Table 4.1.

- Lot Boundary
- XP-STORM Catchments
- XP-STORM Nodes

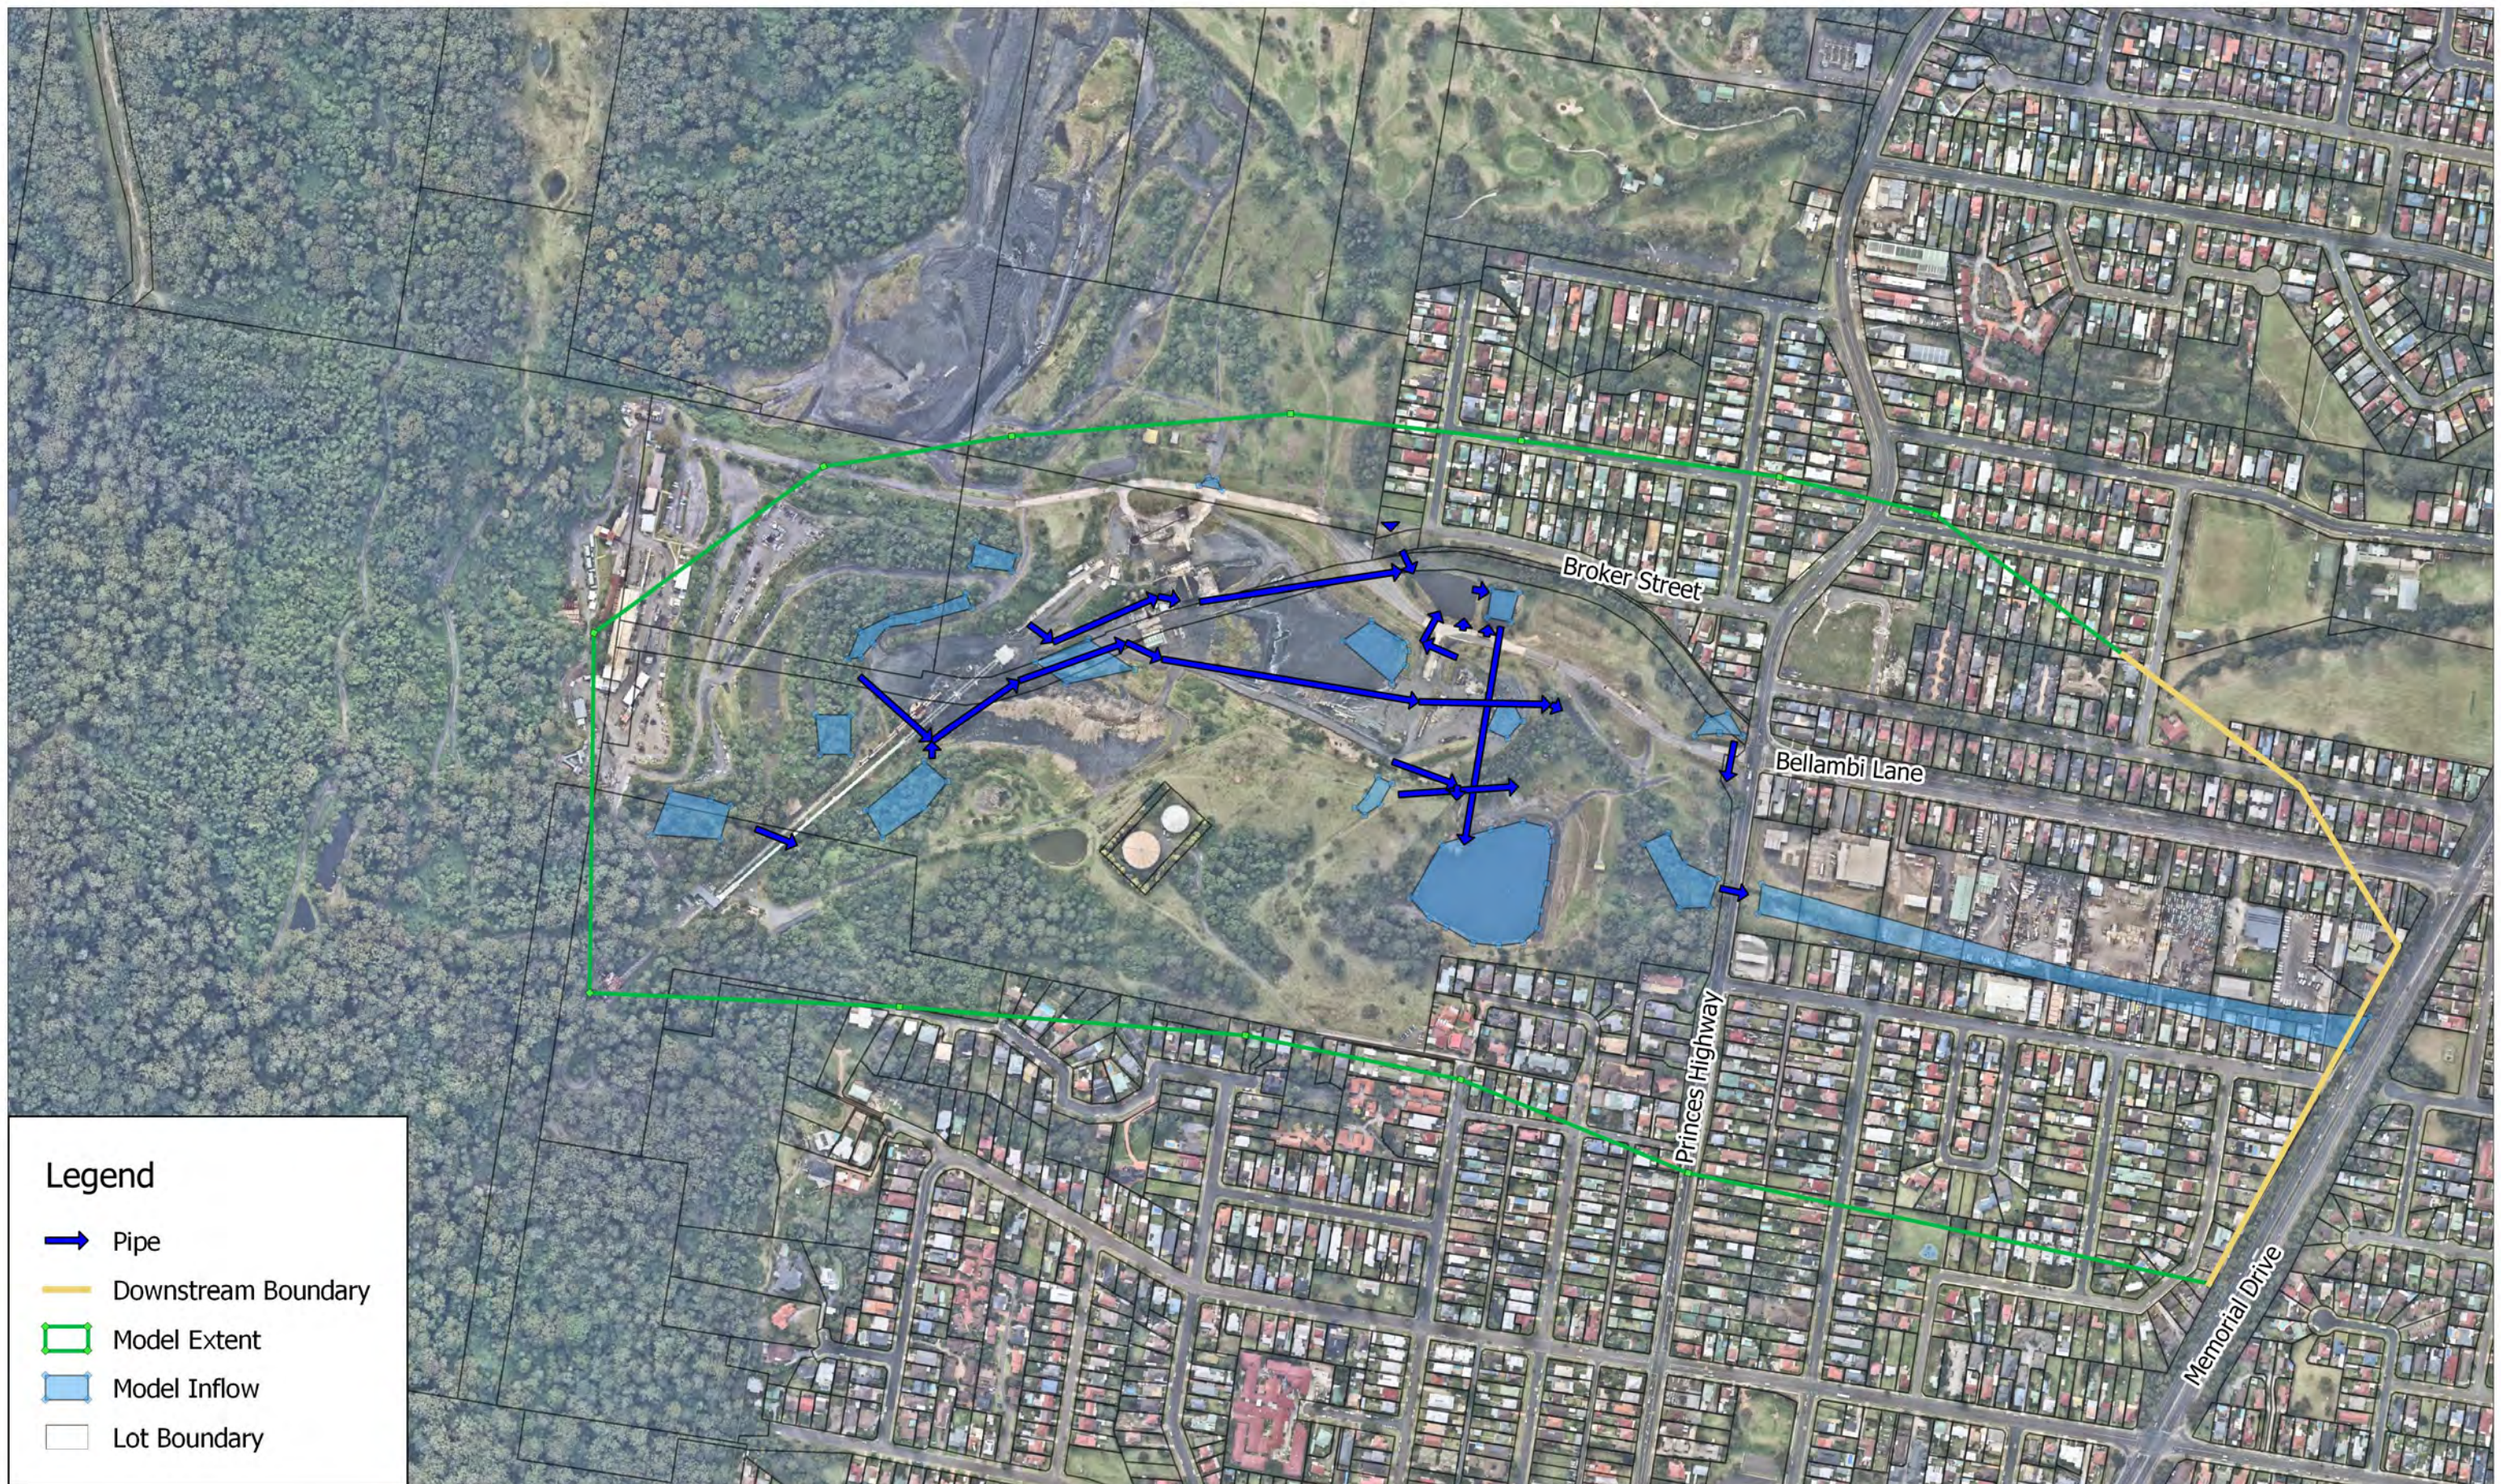
The hydraulic model extends from upstream of the waterway crossing beneath the coal conveyor to Memorial Drive, approximately 650 m downstream of the Site boundary.

Figure 5.1 provides an overview of the hydraulic model domain.

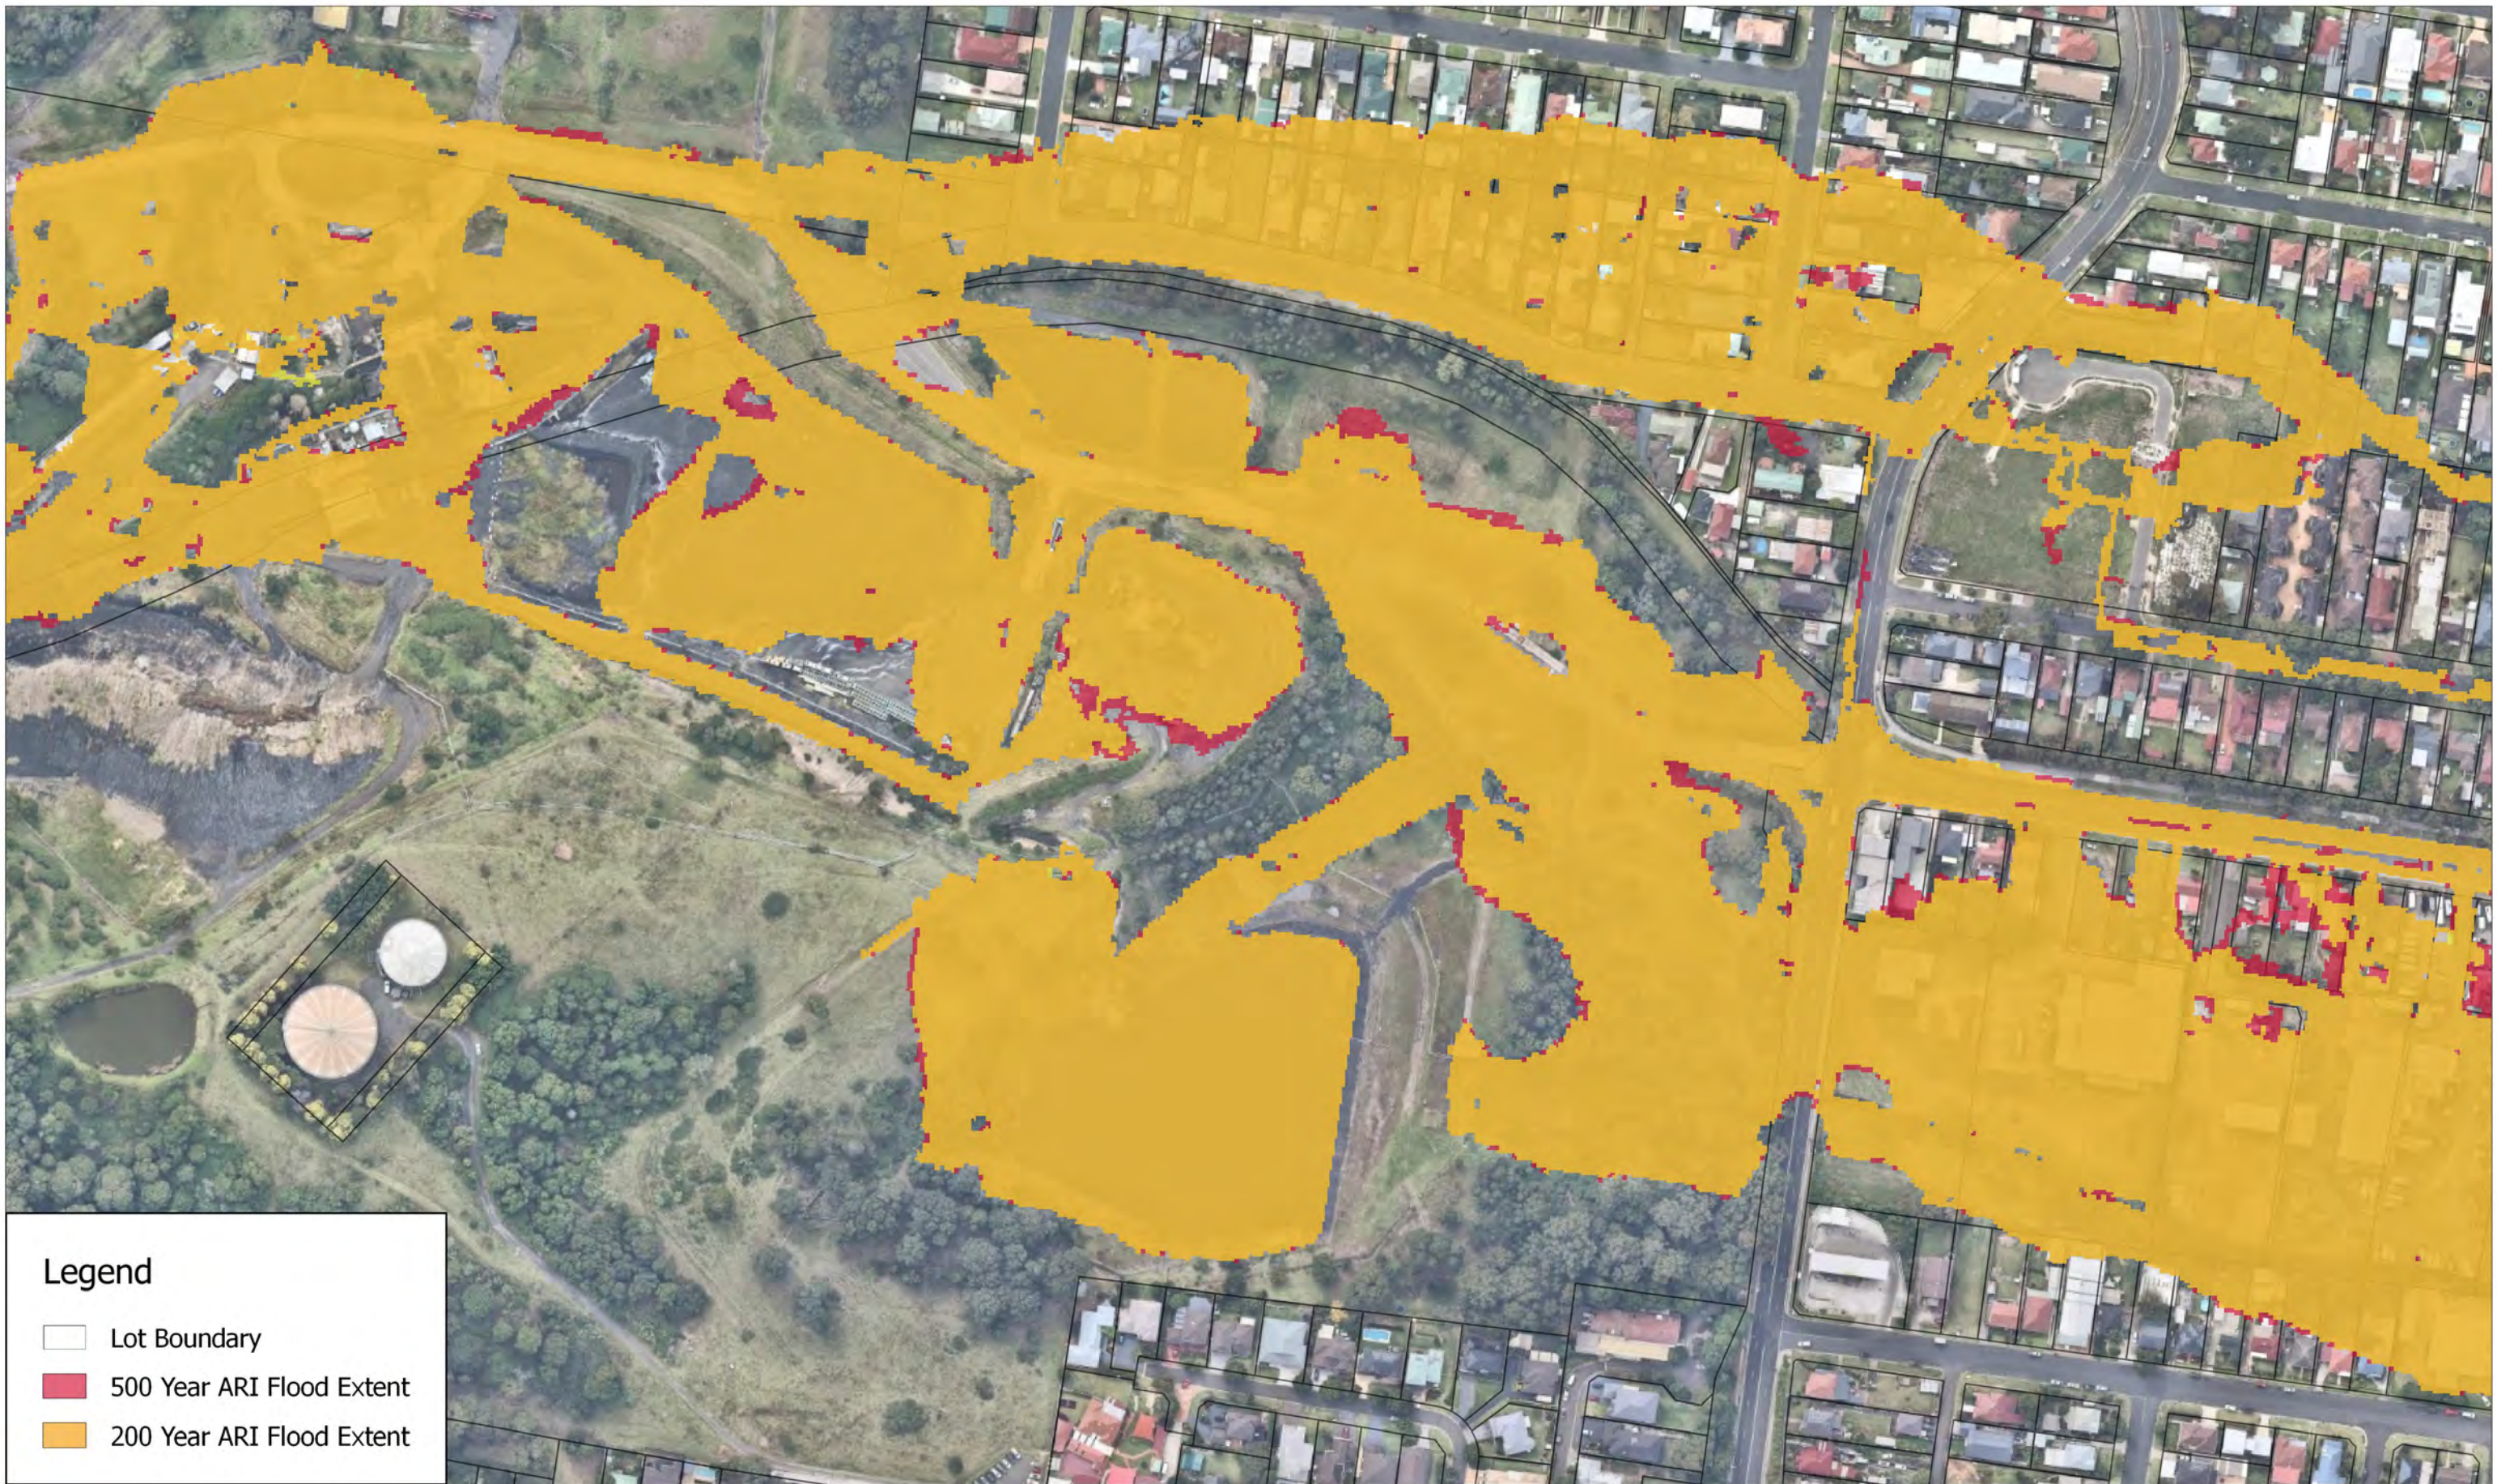
The potential impacts of climate change on flood behaviour have been assessed by modelling the 200 year and 500 year ARI events as proxies for climate change. In general, the flood behaviour remains unchanged between the 200 year and 500 year ARI events. Flood extents typically similar for the two events with minor differences (refer to Figure 6.1).

- Lot Boundary
- 500 Year ARI Flood Extent
- 200 Year ARI Flood Extent

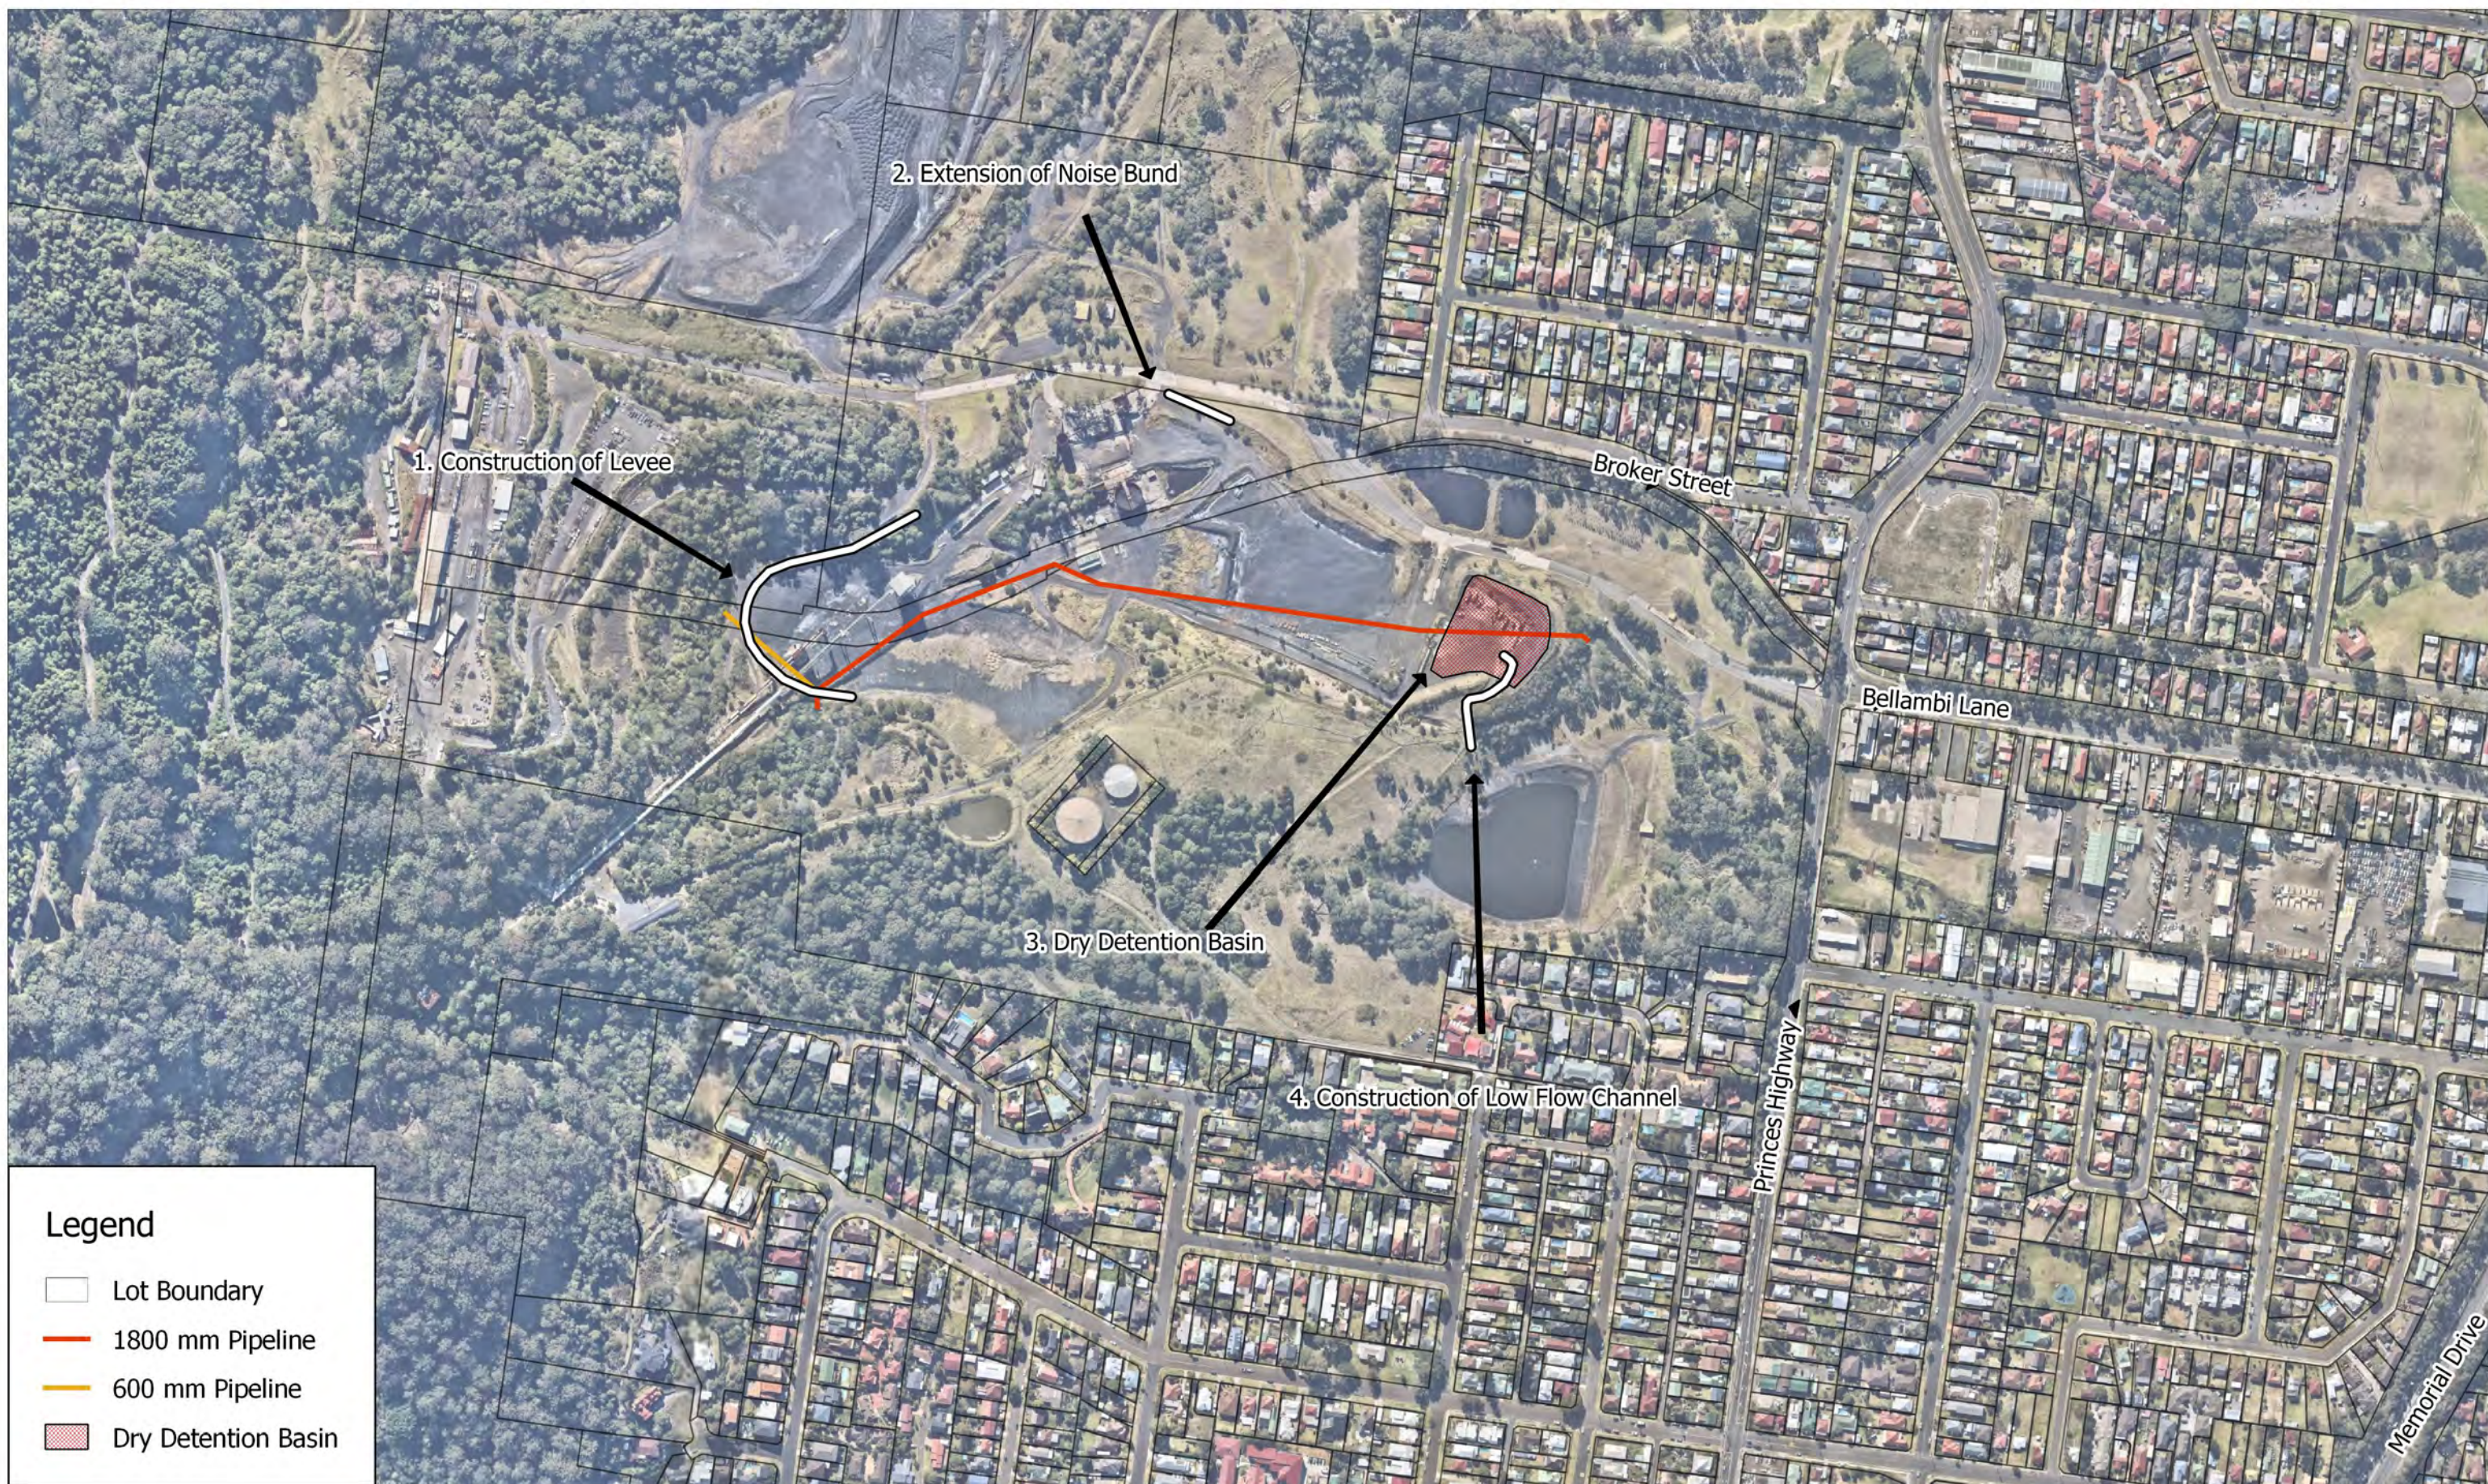
2. Extending the noise bund east of the coal loader to the access road (as per the Noise Management Plan).
3. Minor regrading of the laydown area to convey flows to the east and limit spilling to Bellambi Lane. The laydown area east of the current truck wash will be utilised as a dry detention basin with a low flow channel (point 4 below) conveying overflows to the Stormwater Control Dam. The effective capacity of this dry detention basin is 2.1 ML.

4. Construction of a flow channel from the laydown area to the Stormwater Control Dam to act as an outlet from the dry detention basin. The proposed channel would be trapezoidal in shape, follow the existing access track in this area with a base width of 4 m and grading from 39.0 mAHD to 38.0 mAHD before flowing into the Stormwater Control Dam. Batter slopes have been modelled at 1:1.5 (v:h) which is typical of the batter slopes of the existing noise/visual bunding.

- Lot Boundary
- 1800 mm Pipeline
- 600 mm Pipeline
- Dry Detention Basin
