Russell Vale Colliery Preliminary Works
Project Modification 4

Russell Vale Colliery Preliminary Works Project
Modification 4

Prepared by
Umwelt (Australia) Pty Limited
on behalf of
Wollongong Coal Limited

Bellambi Gully Diversion Pipeline Review

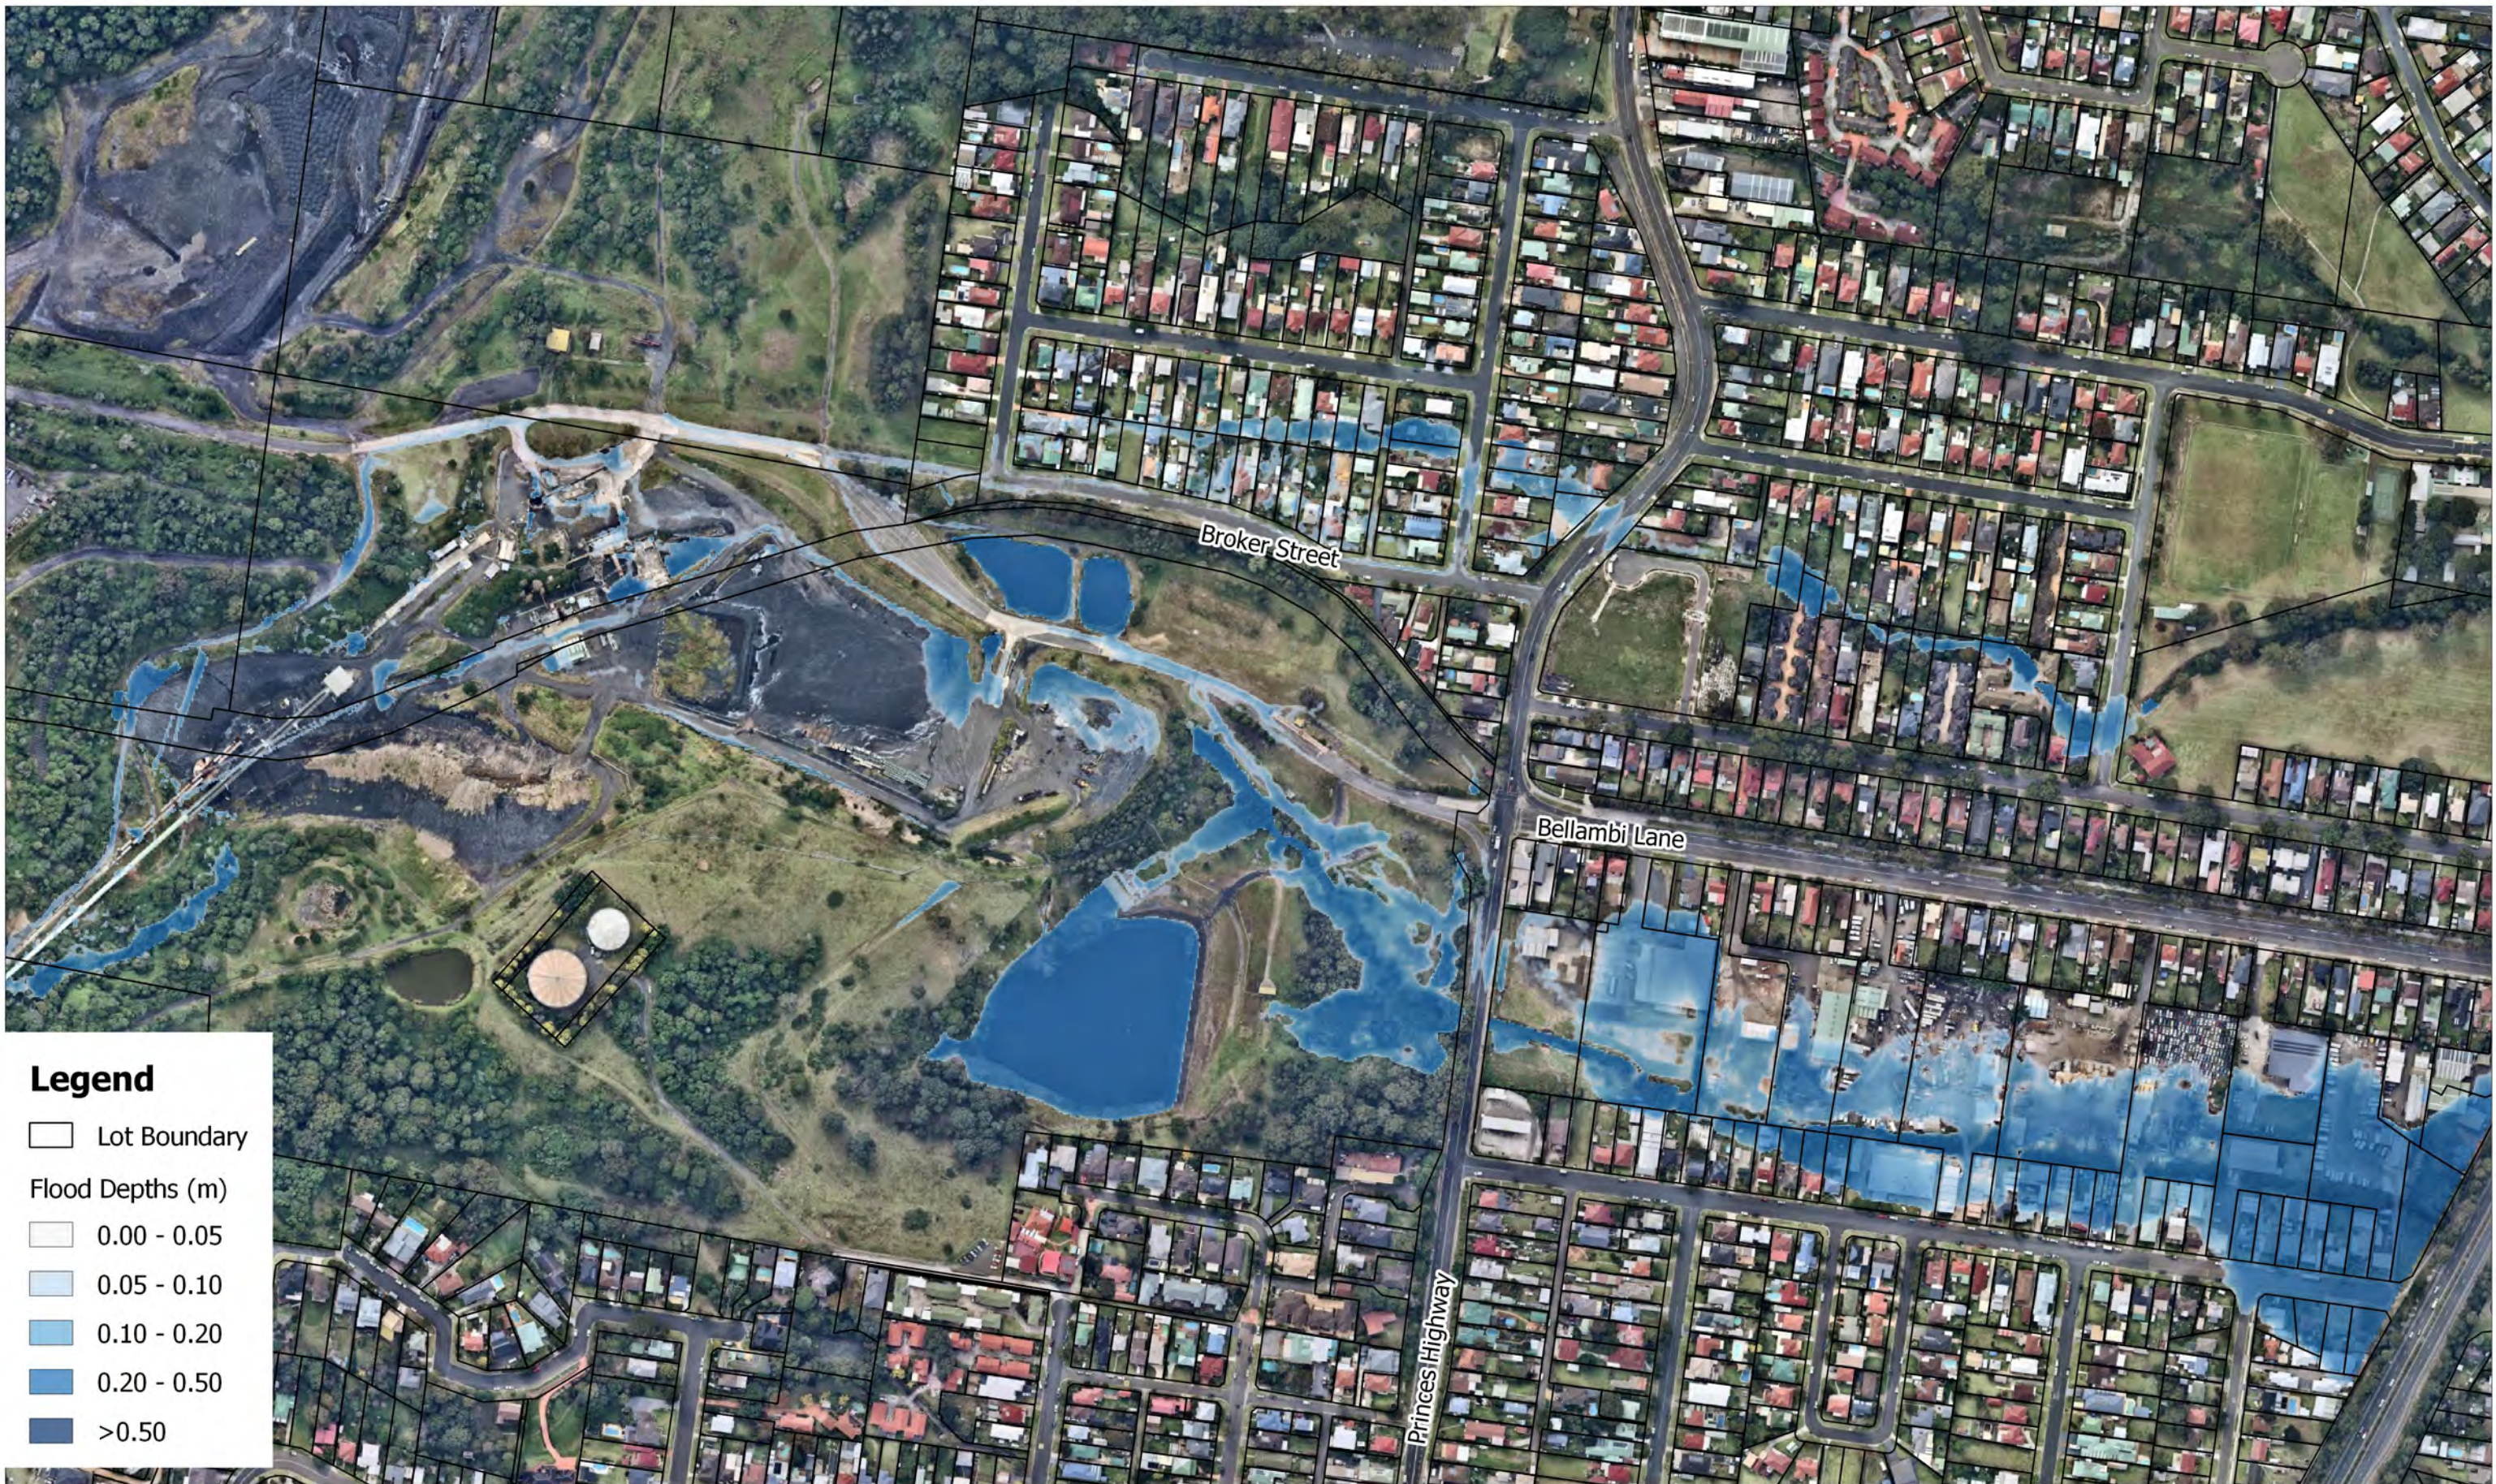
Bellambi Gully Flood Assessment
10 Year ARI Flood Event
Maximum Modelled Flood Depth
Existing Scenario

- Lot Boundary
- Flood Depths (m)
 - 0.00 - 0.05
 - 0.05 - 0.10
 - 0.10 - 0.20
 - 0.20 - 0.50
 - >0.50

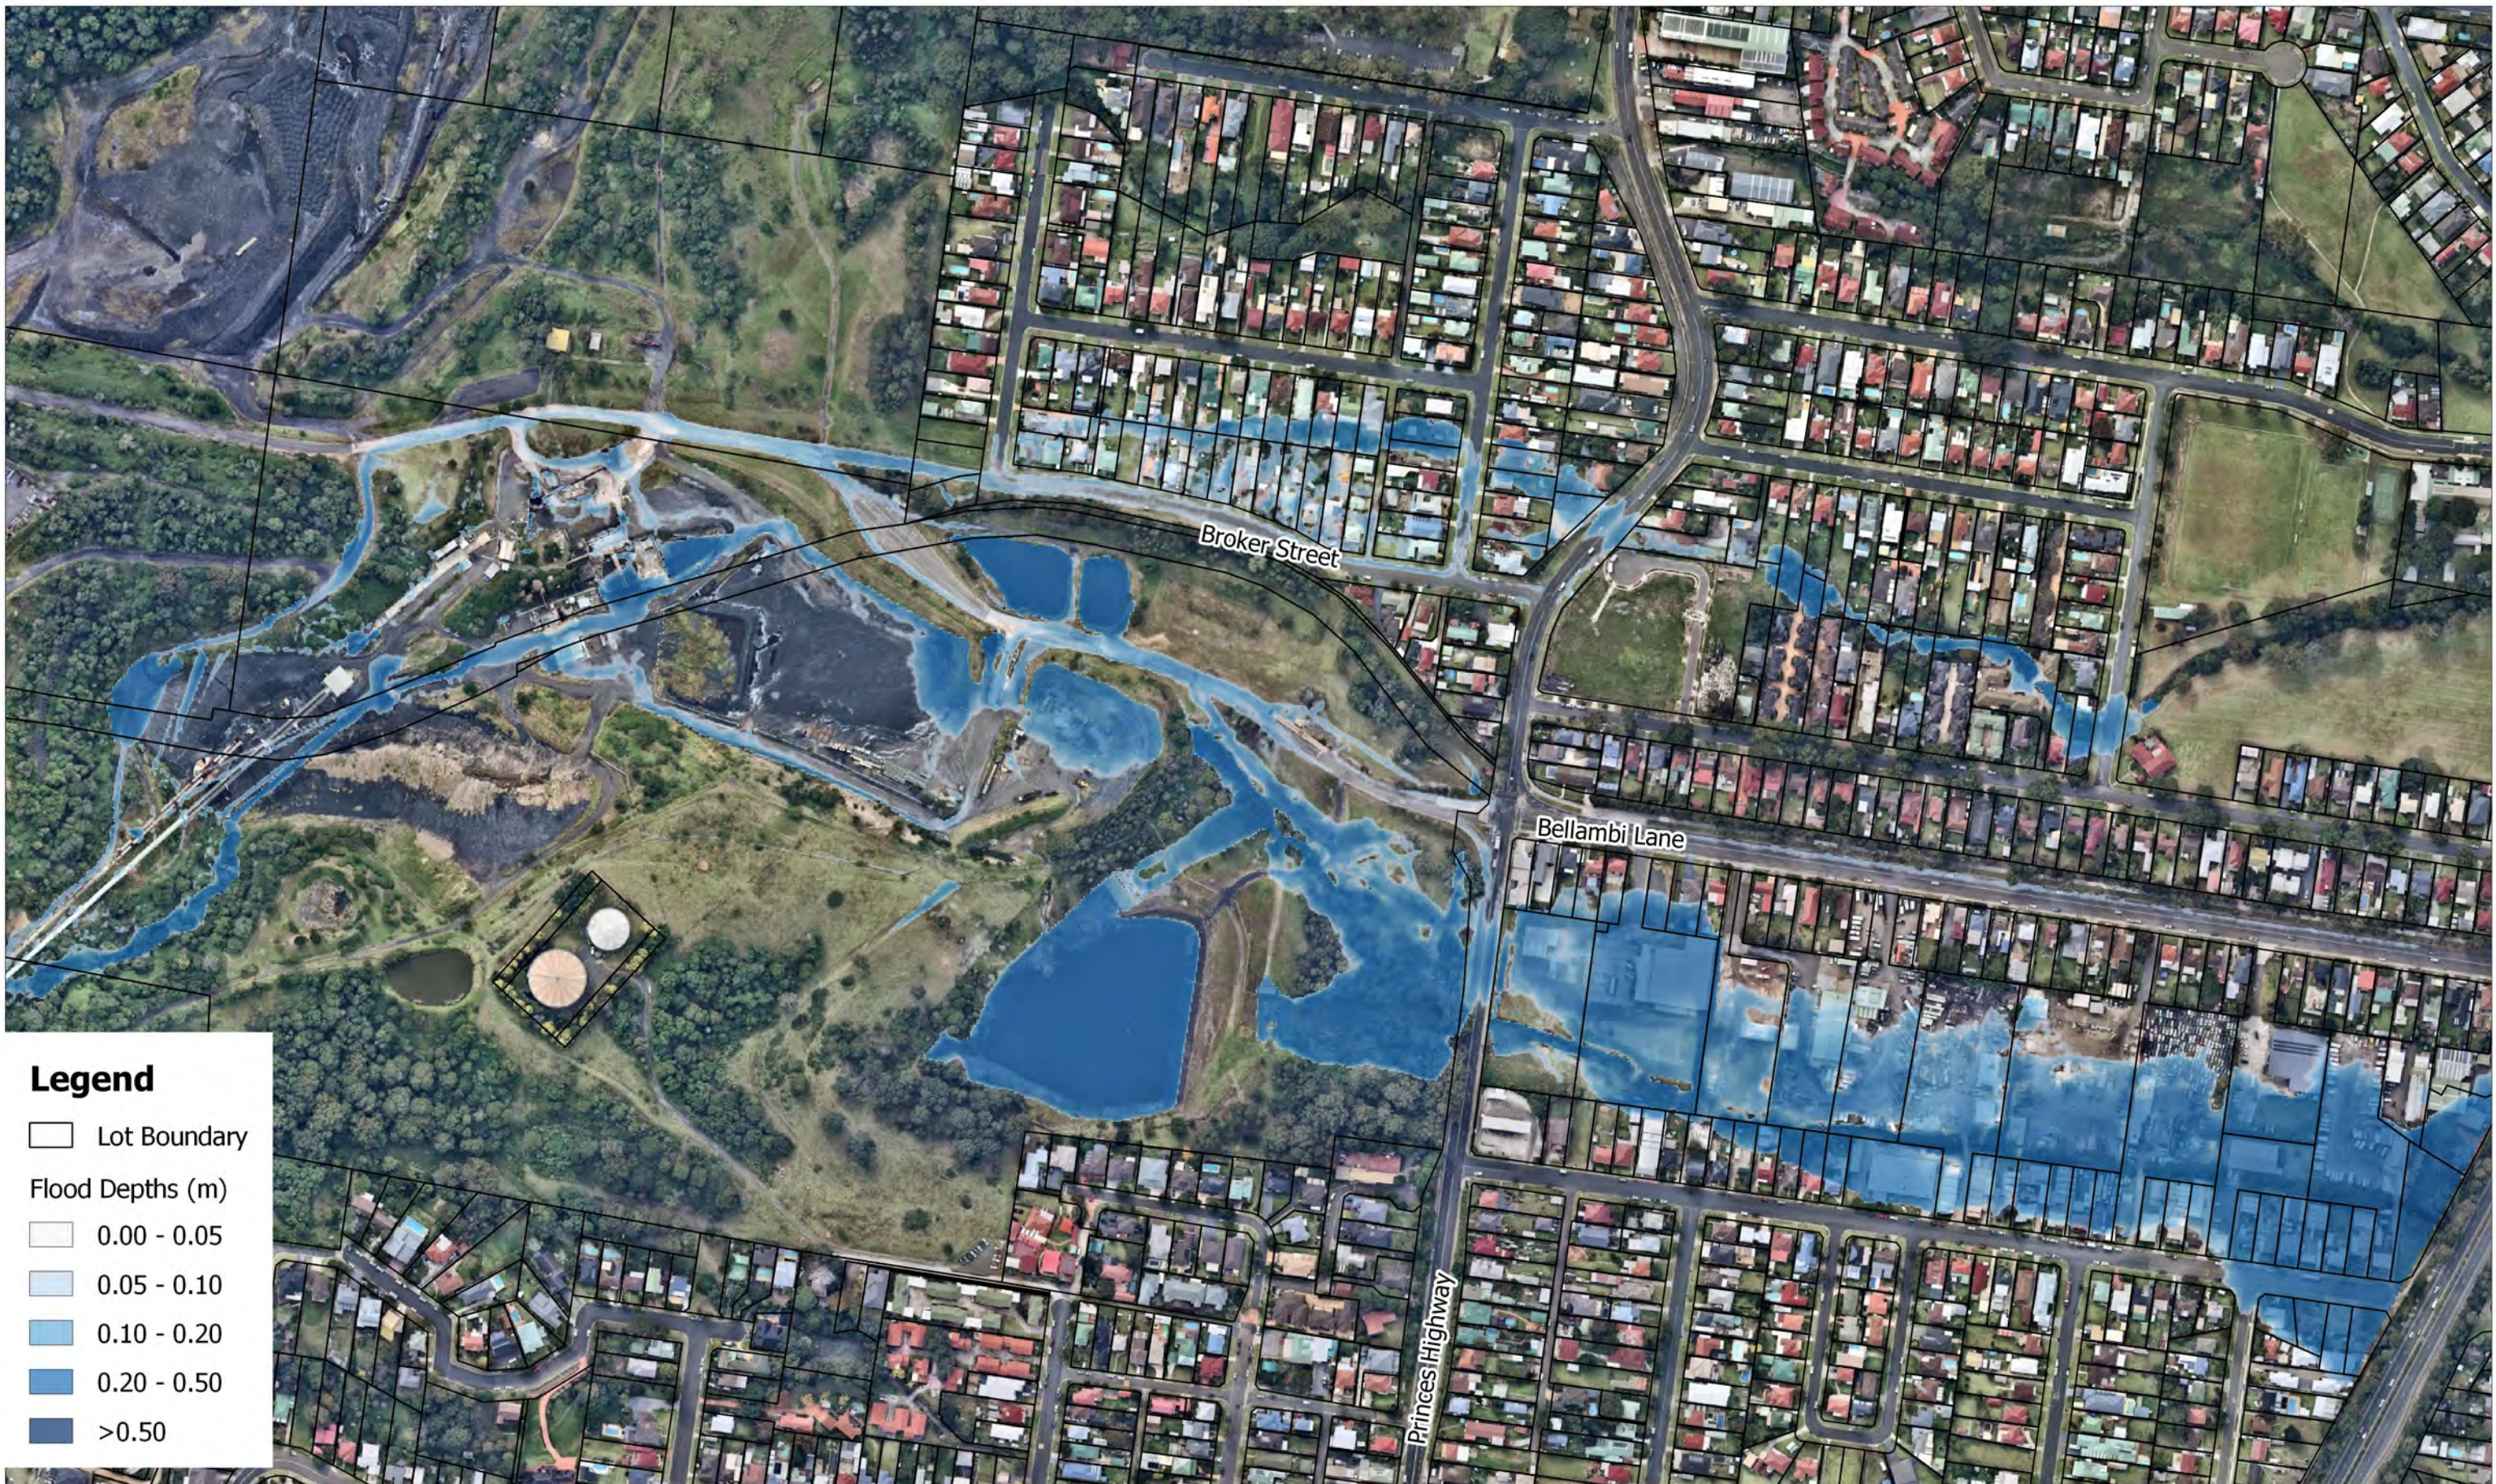
Bellambi Gully Flood Assessment
100 Year ARI Flood Event
Maximum Modelled Flood Depth
Existing Scenario

- Lot Boundary
- Flood Depths (m)
 - 0.00 - 0.05
 - 0.05 - 0.10
 - 0.10 - 0.20
 - 0.20 - 0.50
 - >0.50

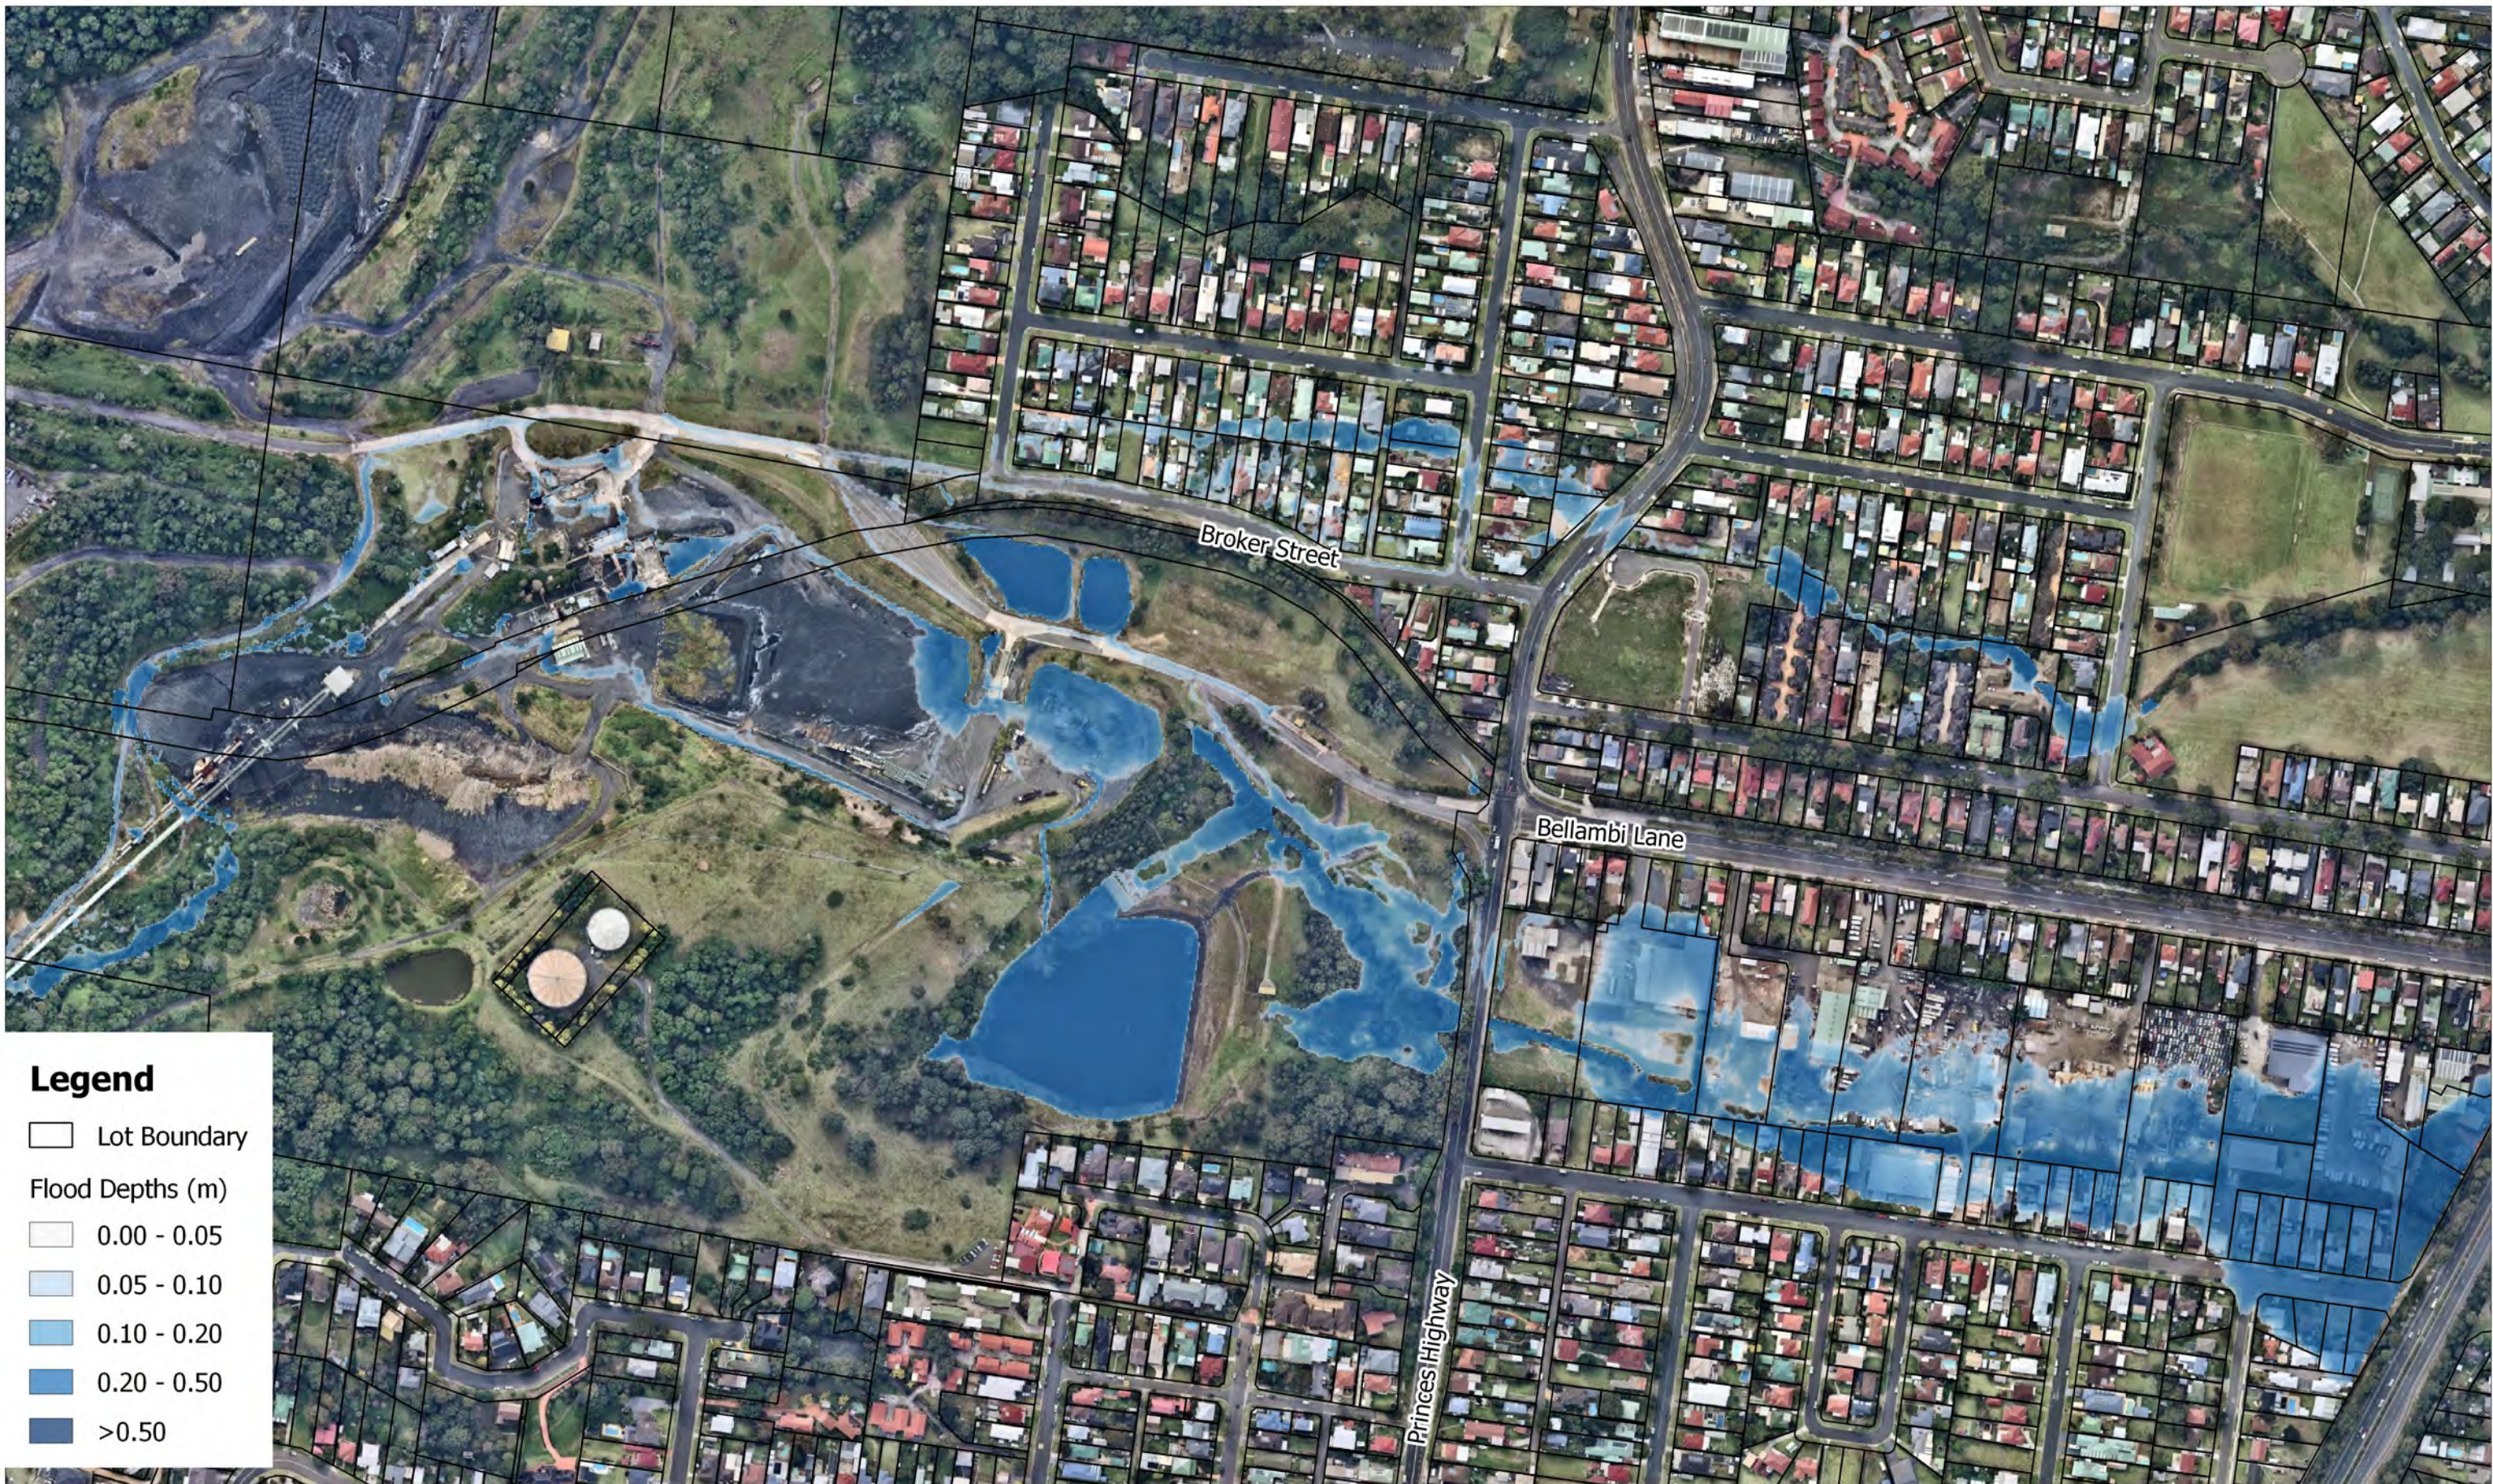
Bellambi Gully Flood Assessment
10 Year ARI Flood Event
Maximum Modelled Flood Depth
Proposed Scenario

- Lot Boundary
- Flood Depths (m)
- 0.00 - 0.05
- 0.05 - 0.10
- 0.10 - 0.20
- 0.20 - 0.50
- >0.50

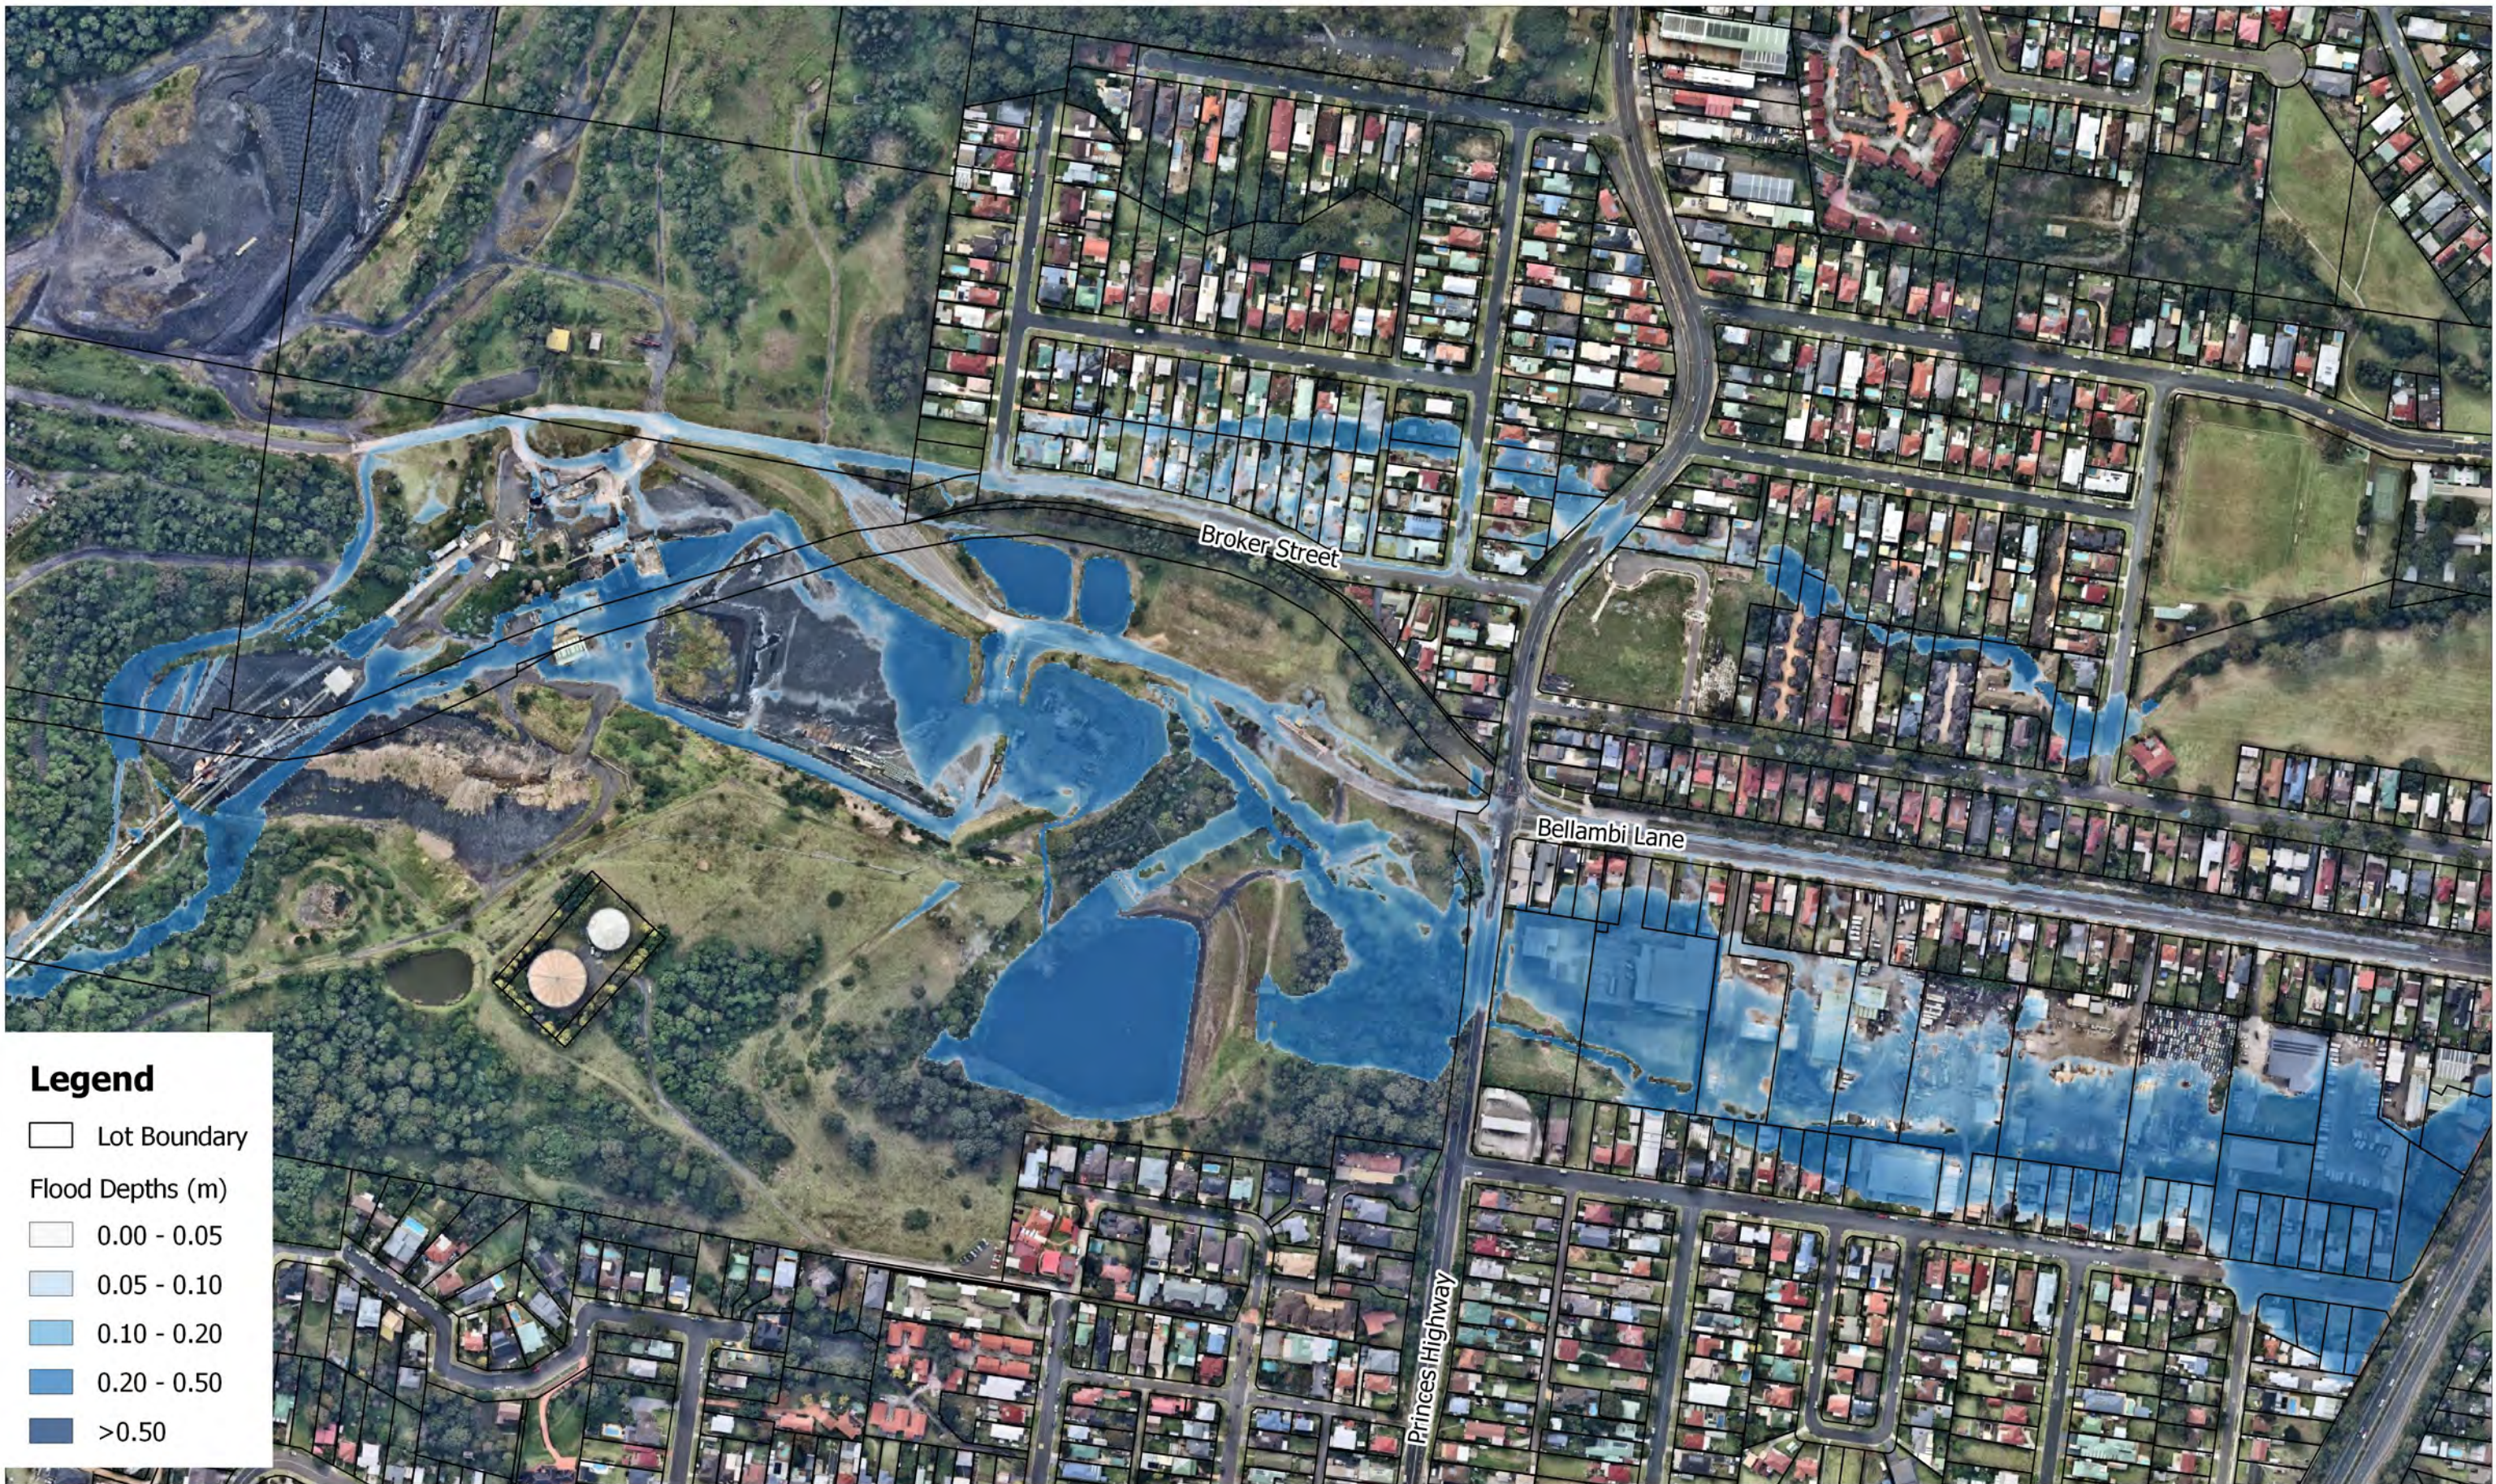
Bellambi Gully Flood Assessment
100 Year ARI Flood Event
Maximum Modelled Flood Depth
100% Blockage- Proposed Scenario

- Lot Boundary
- Flood Depths (m)
 - 0.00 - 0.05
 - 0.05 - 0.10
 - 0.10 - 0.20
 - 0.20 - 0.50
 - >0.50

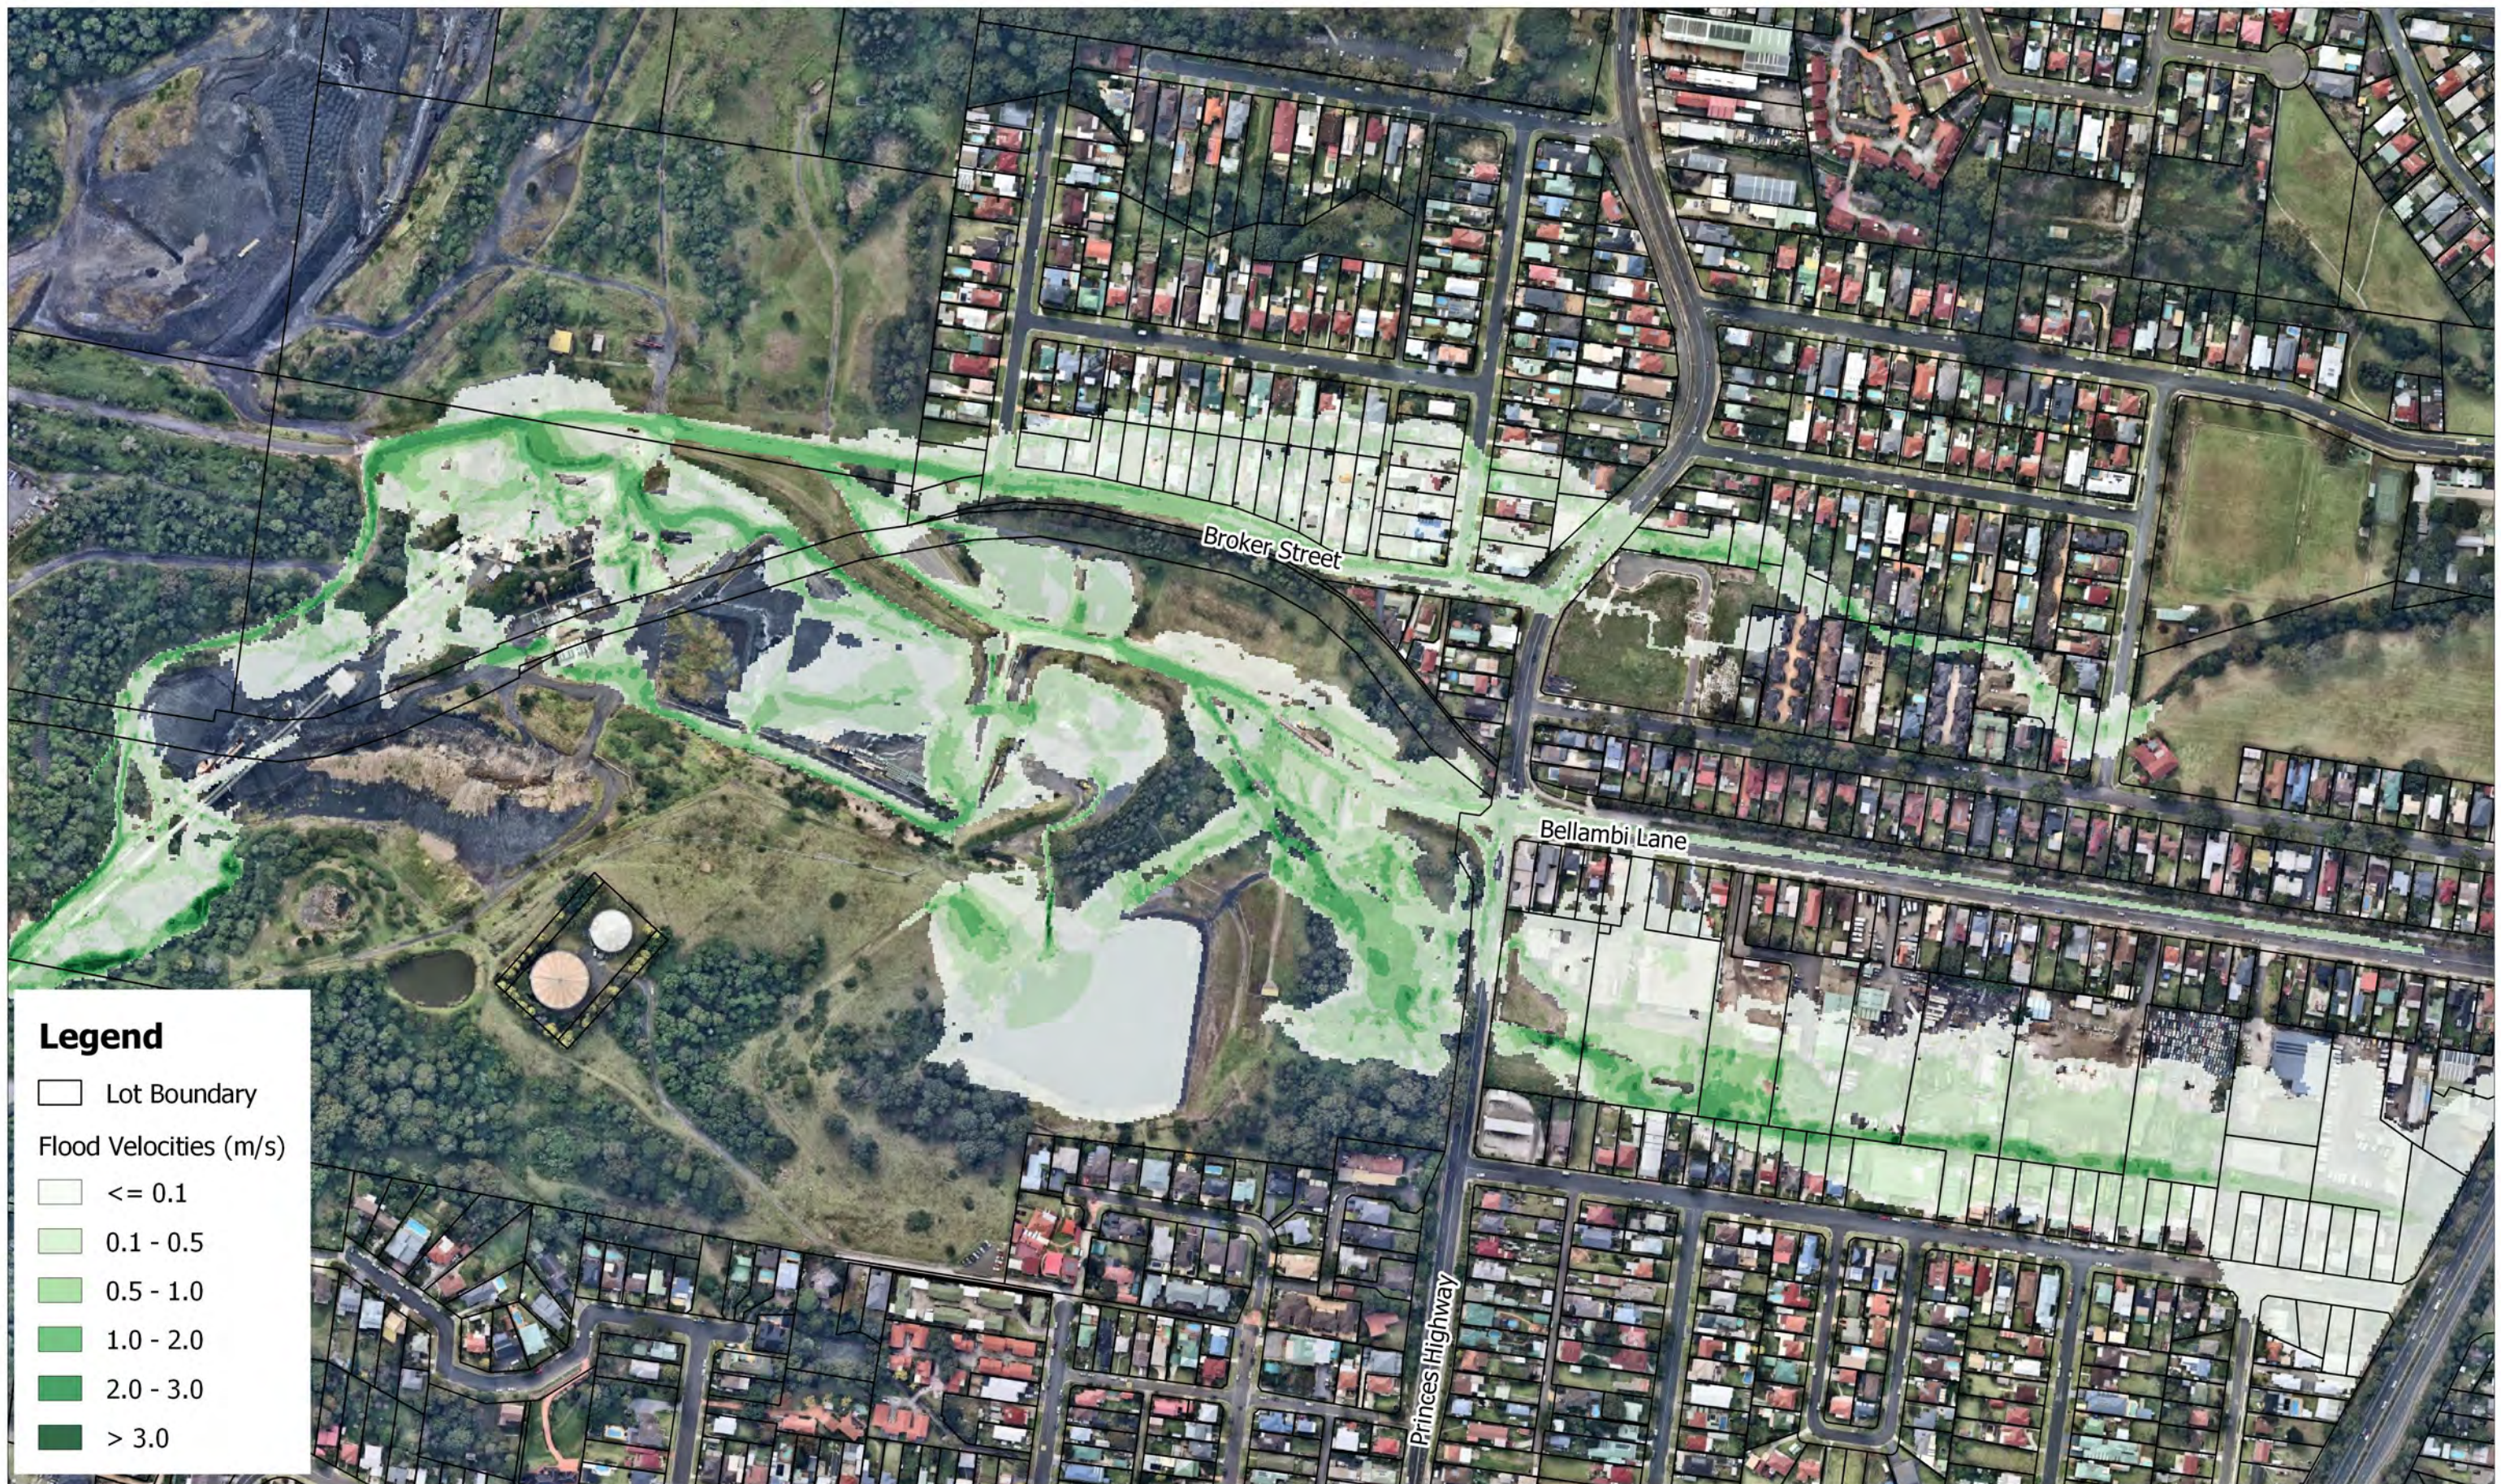
5 Year ARI Flood Event
 Maximum Modelled Flood Velocity
 Proposed Scenario

Appendix C shows the results for the flood depths and velocities with the proposed flood management measures conditions for the modelled events.

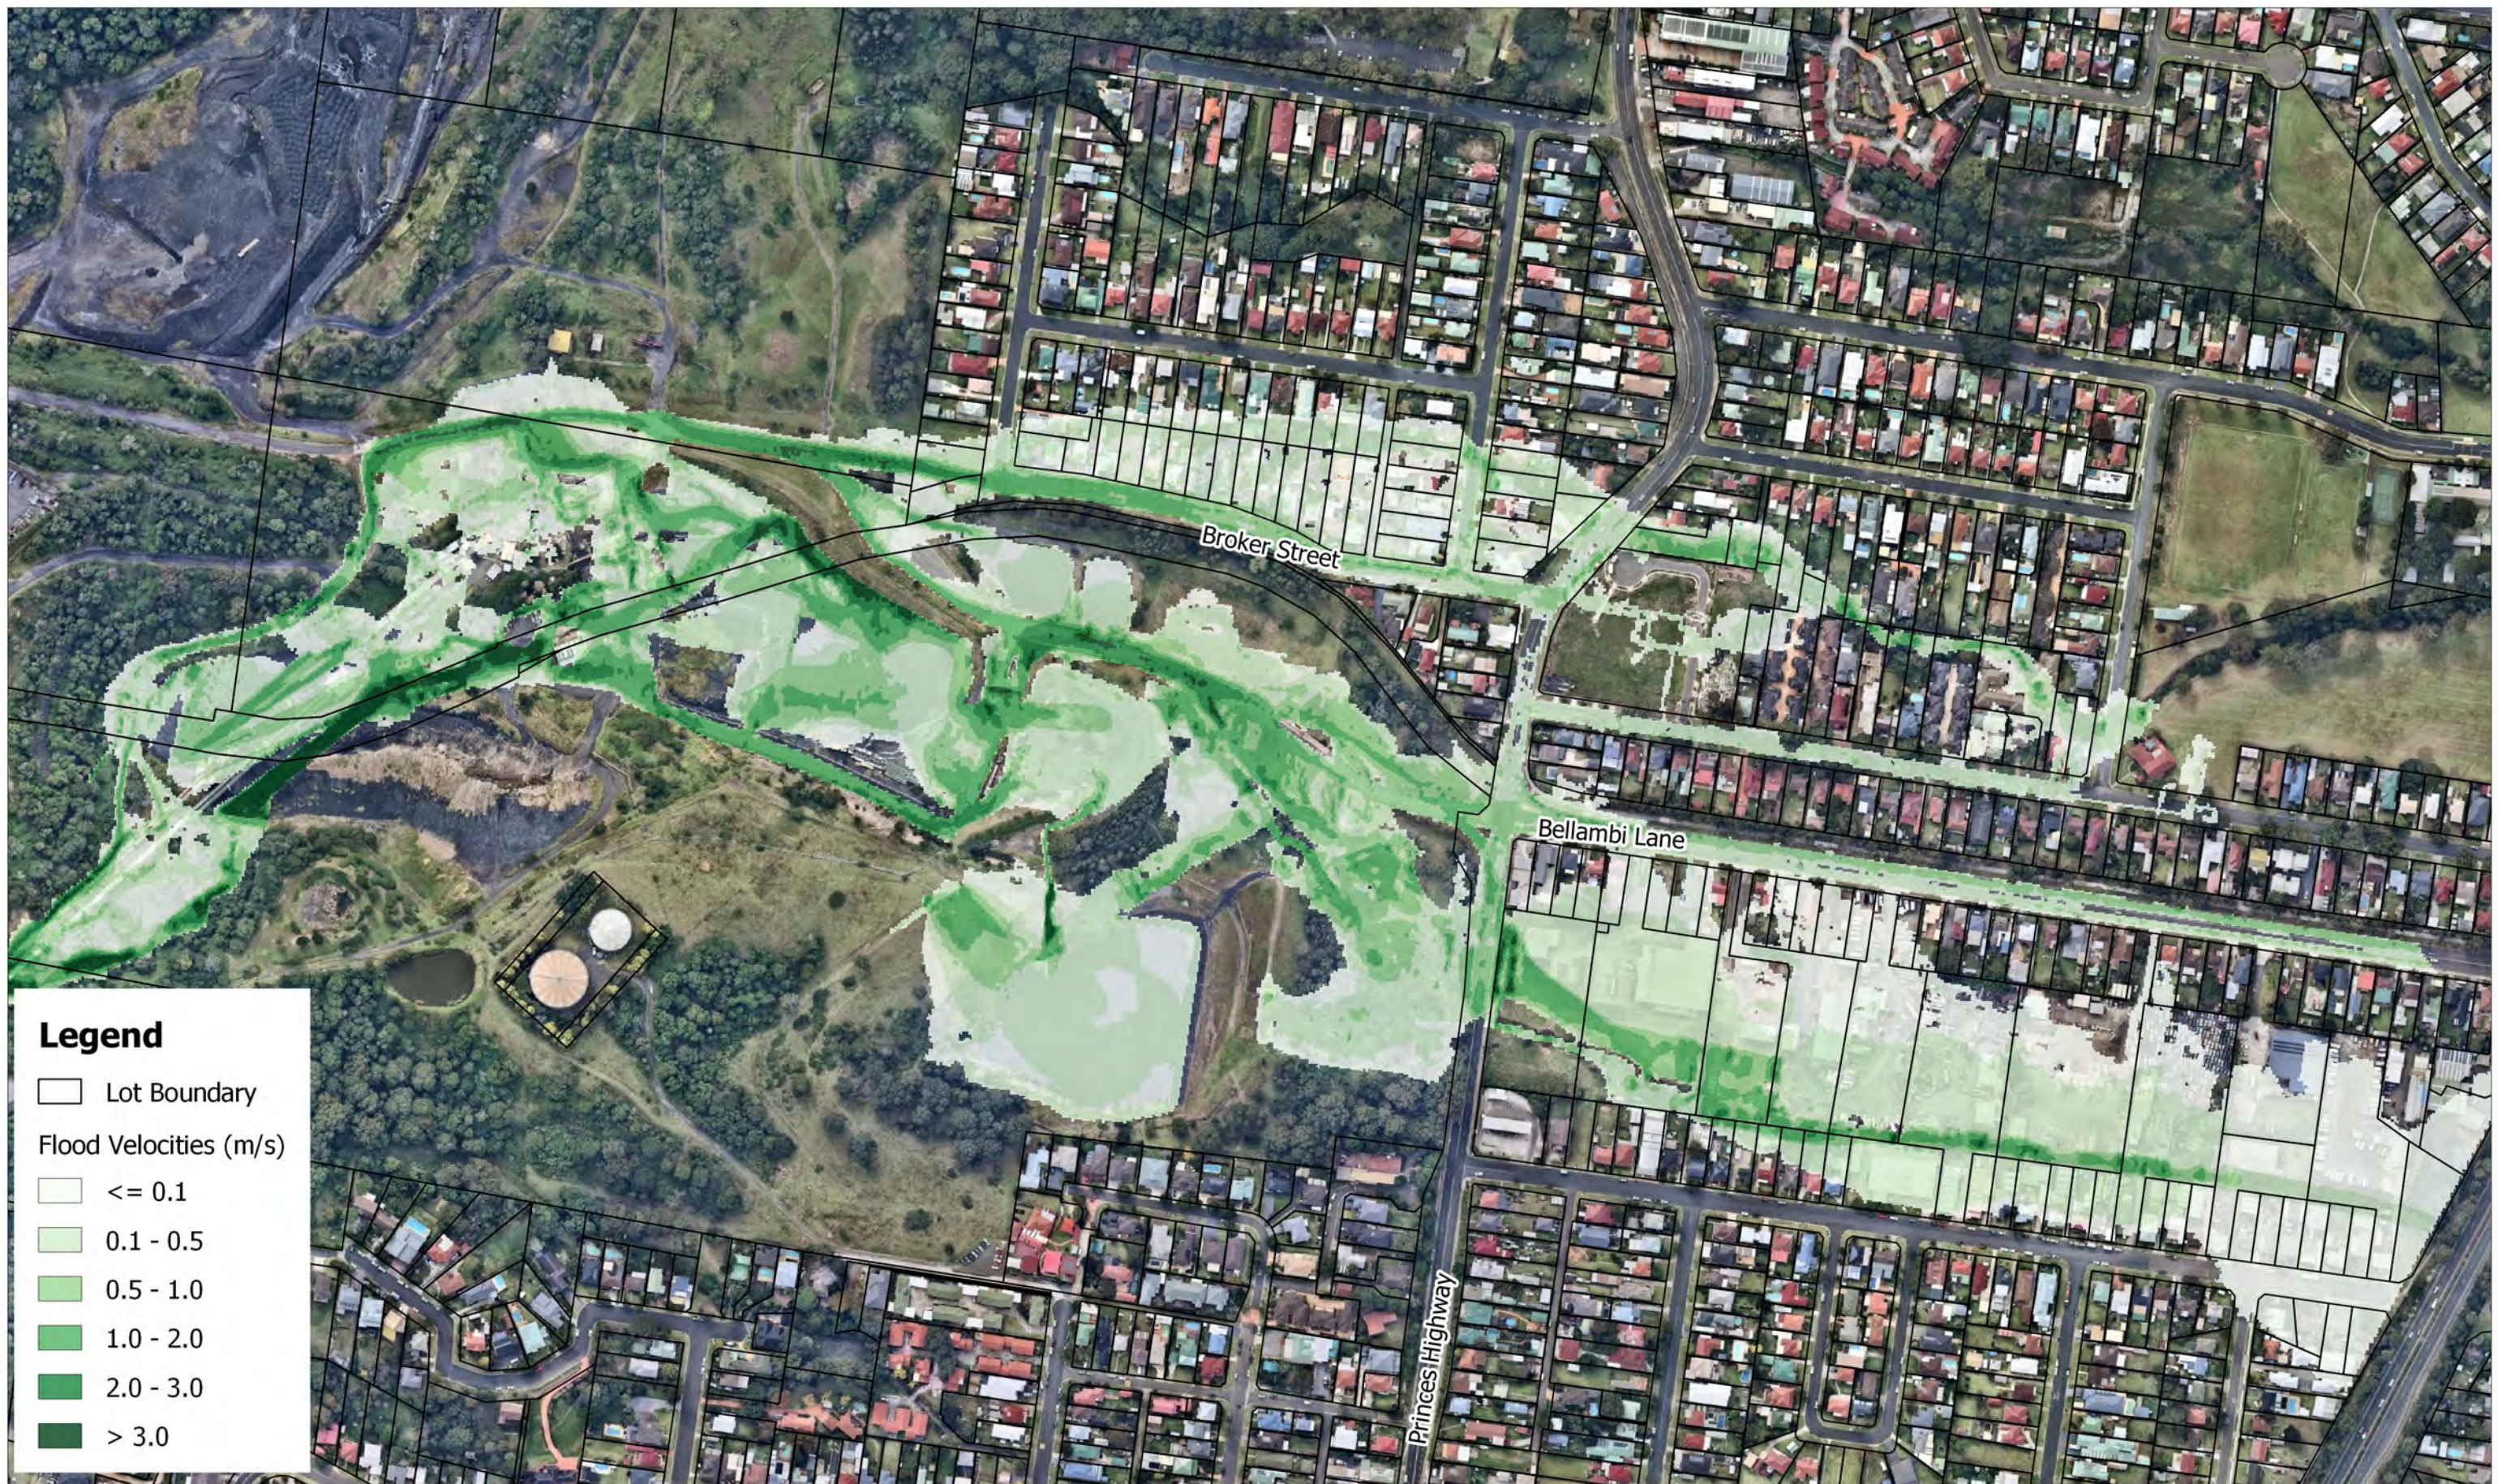
100 Year ARI Flood Event
Maximum Modelled Flood Velocity
20% Blockage- Proposed Scenario
