Russell Vale Colliery Preliminary Works
Project Modification 4

Russell Vale Colliery Preliminary Works Project
Modification 4

Prepared by
Umwelt (Australia) Pty Limited
on behalf of
Wollongong Coal Limited

Bellambi Gully Diversion Pipeline Review

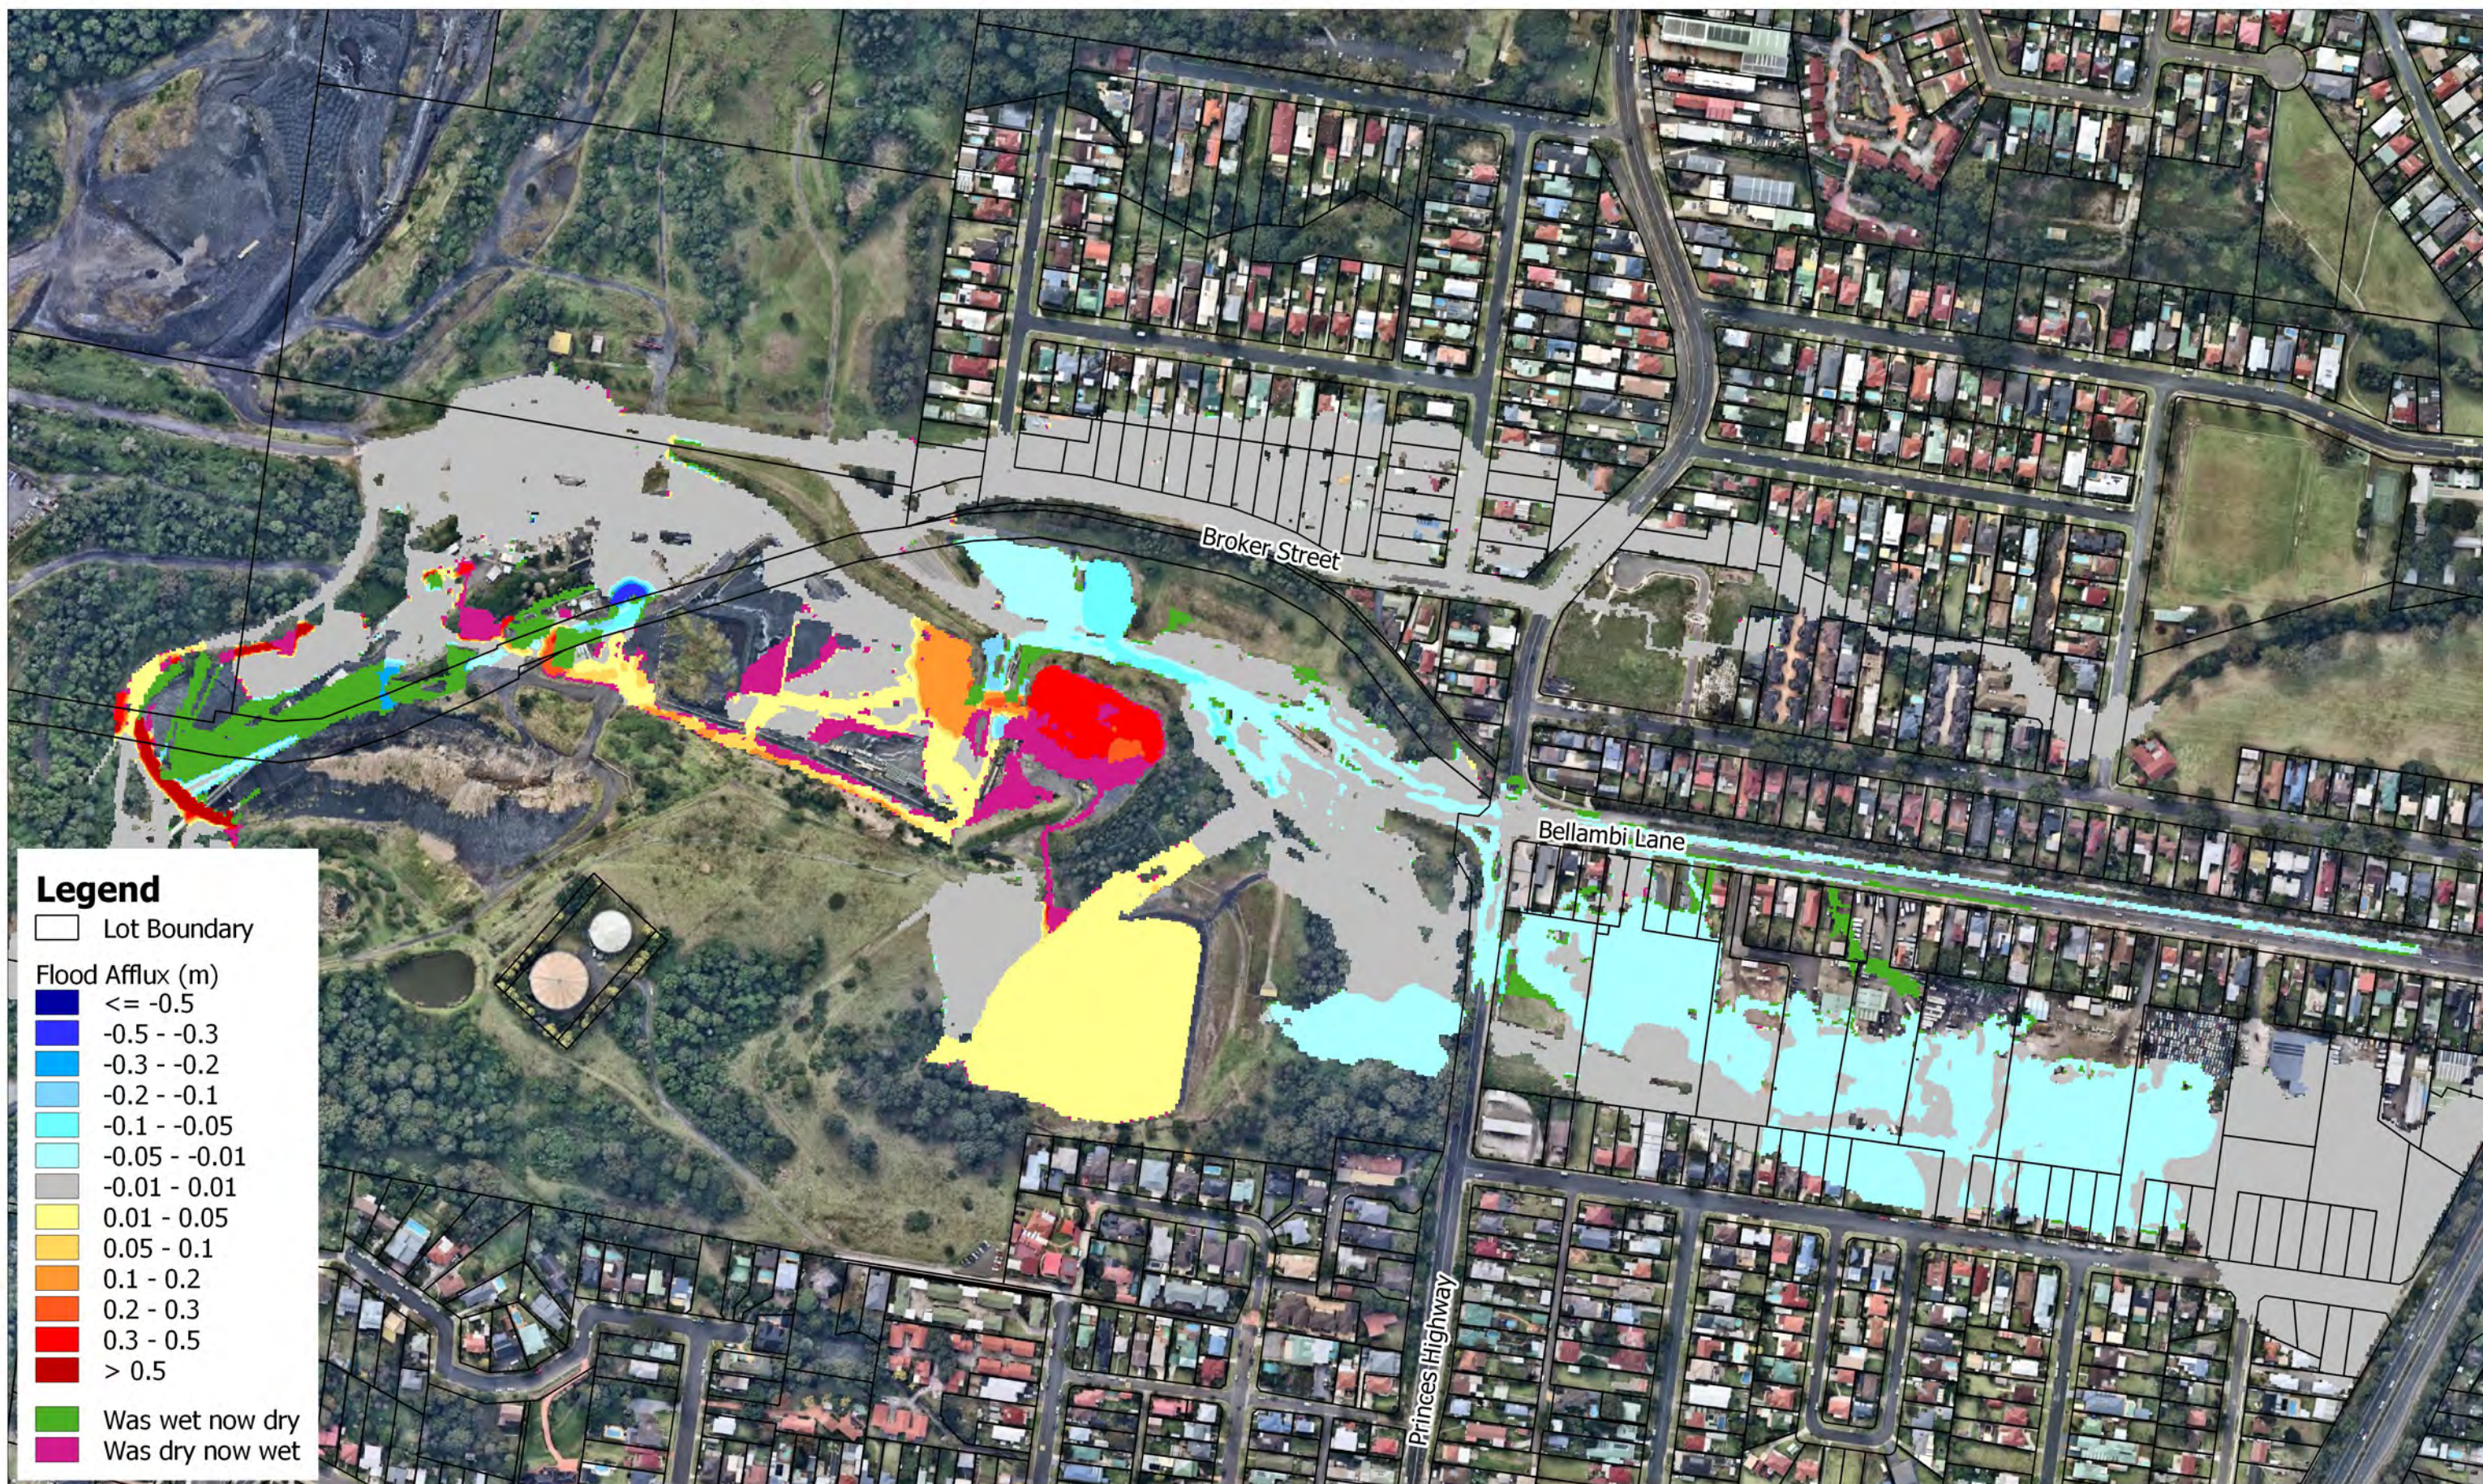
5 Year ARI Flood Event
Flood Afflux
Proposed Scenario

Appendix C contains flood afflux maps for each modelled option versus current conditions.

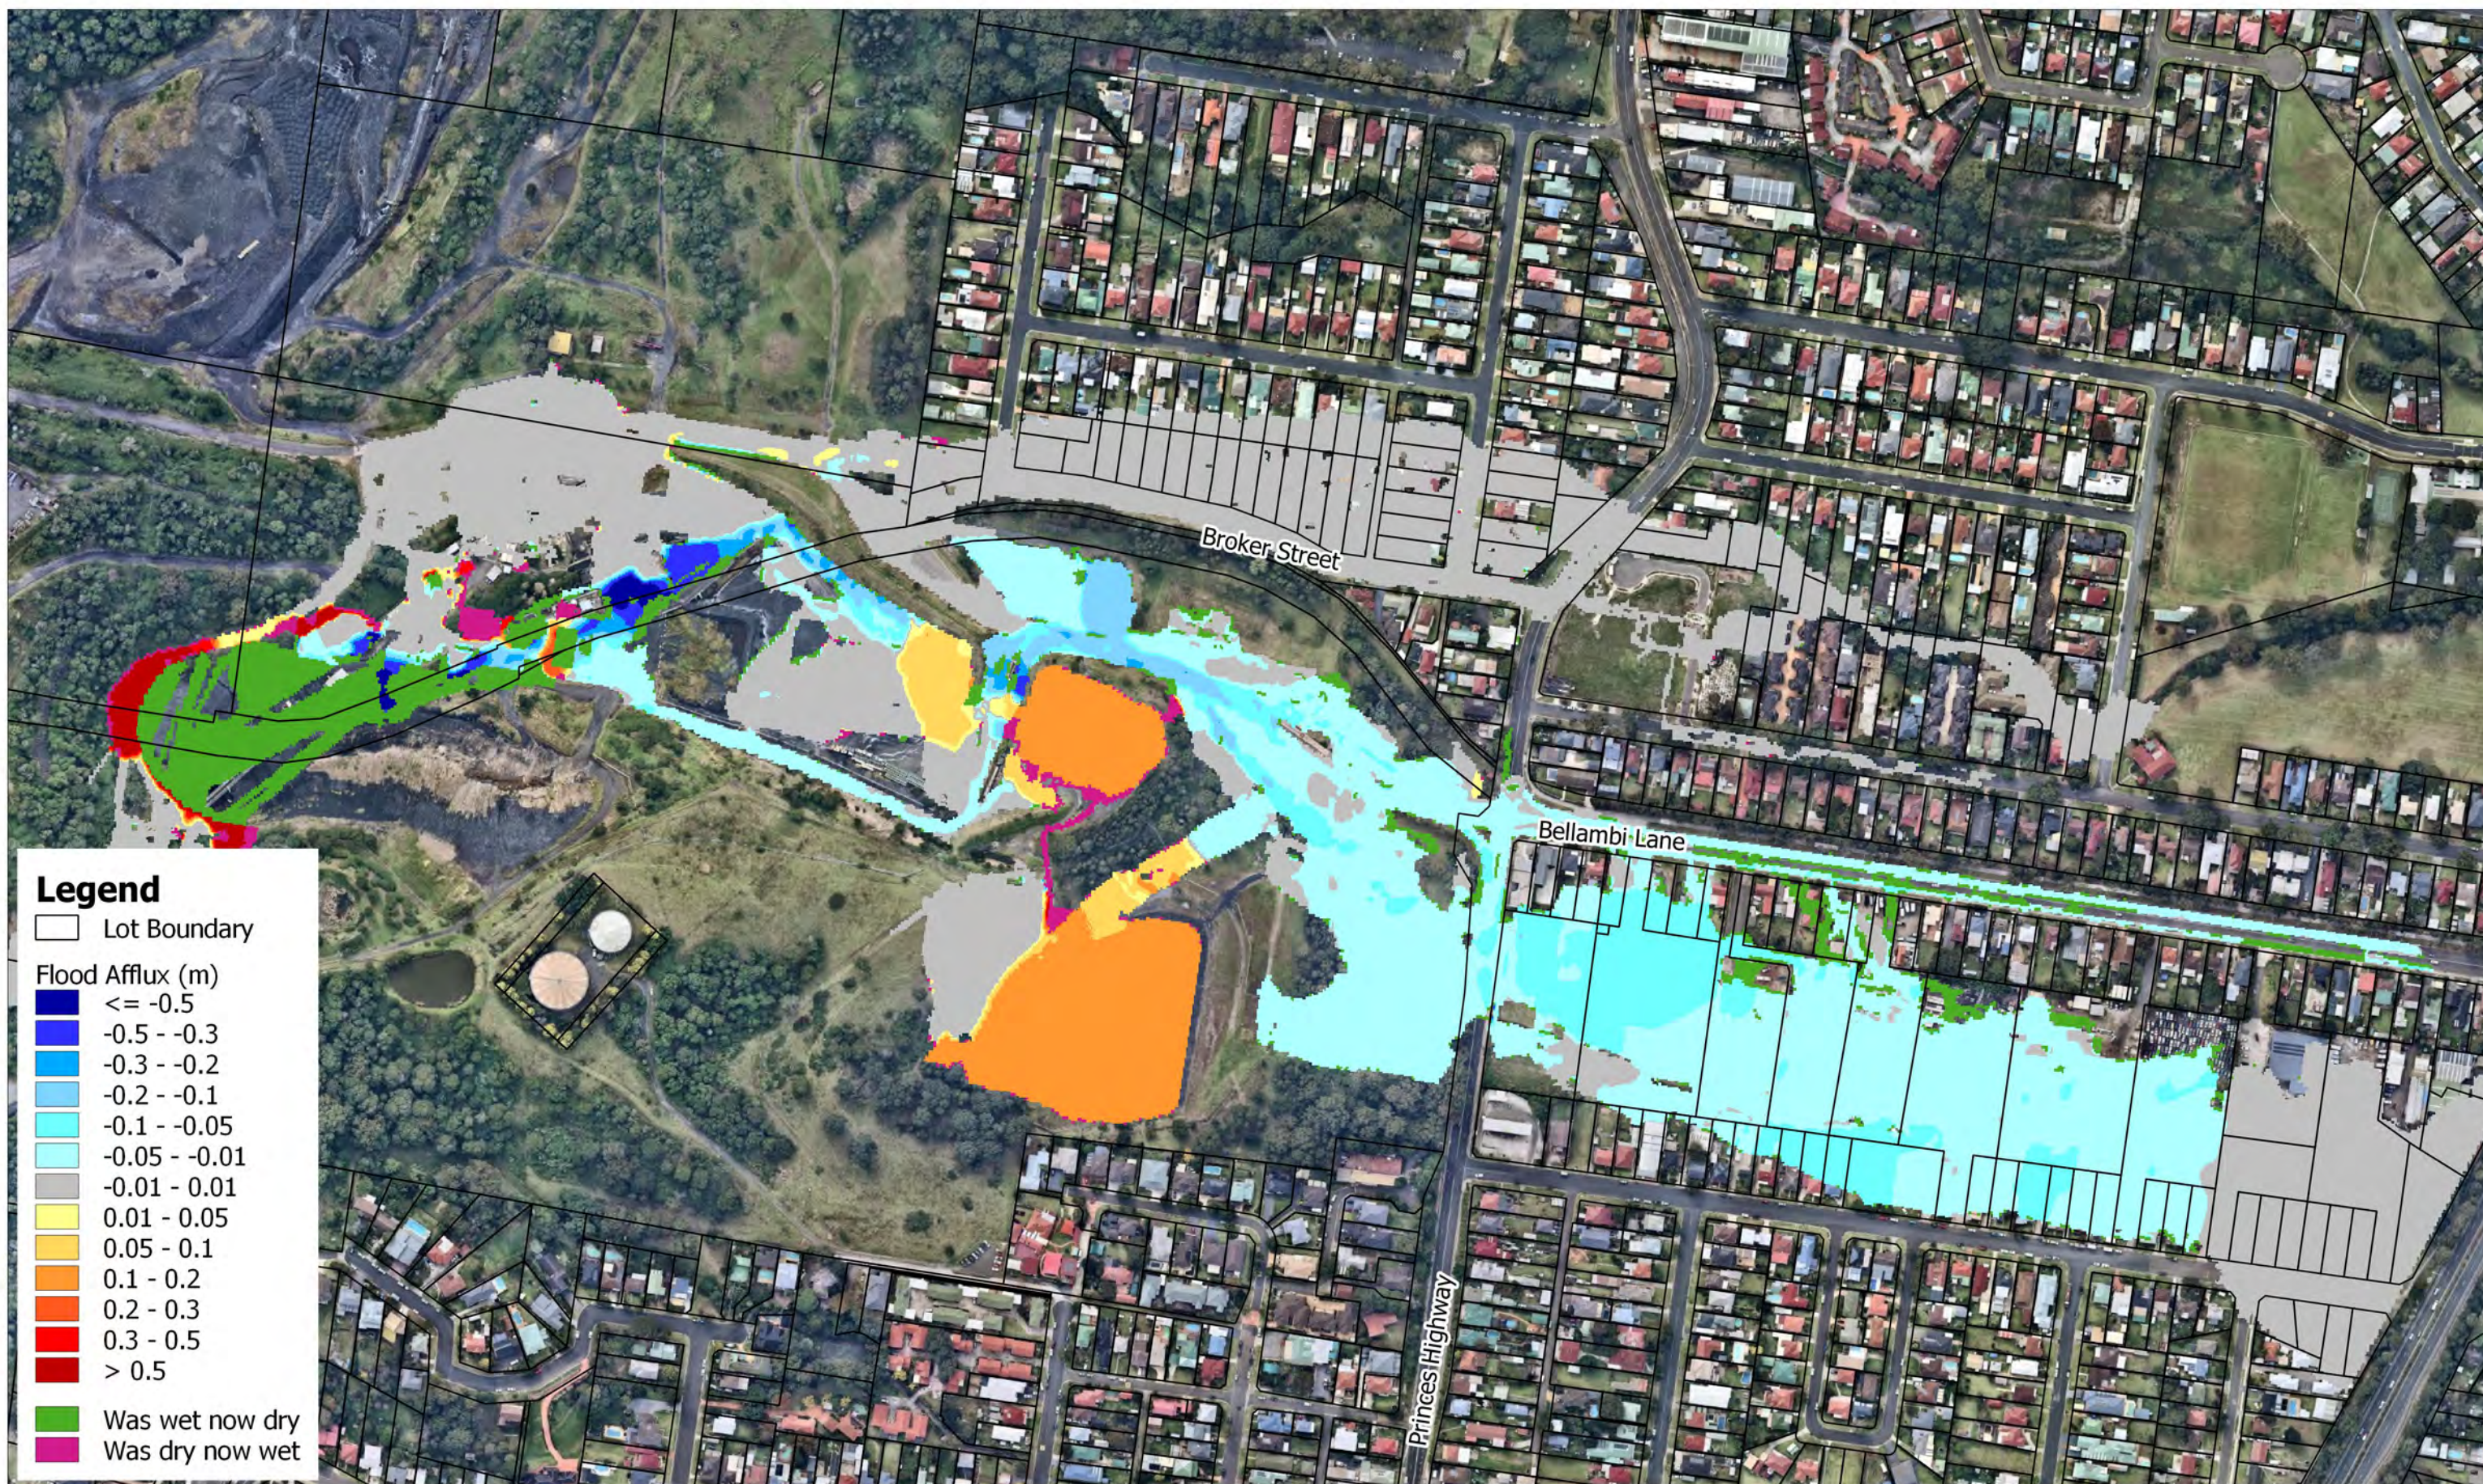
100 Year ARI Flood Event
Flood Afflux
Proposed Scenario
