# Appendix K Cultural Heritage Archival Recordings

## 7. CUST HUT

### 7.1 Description

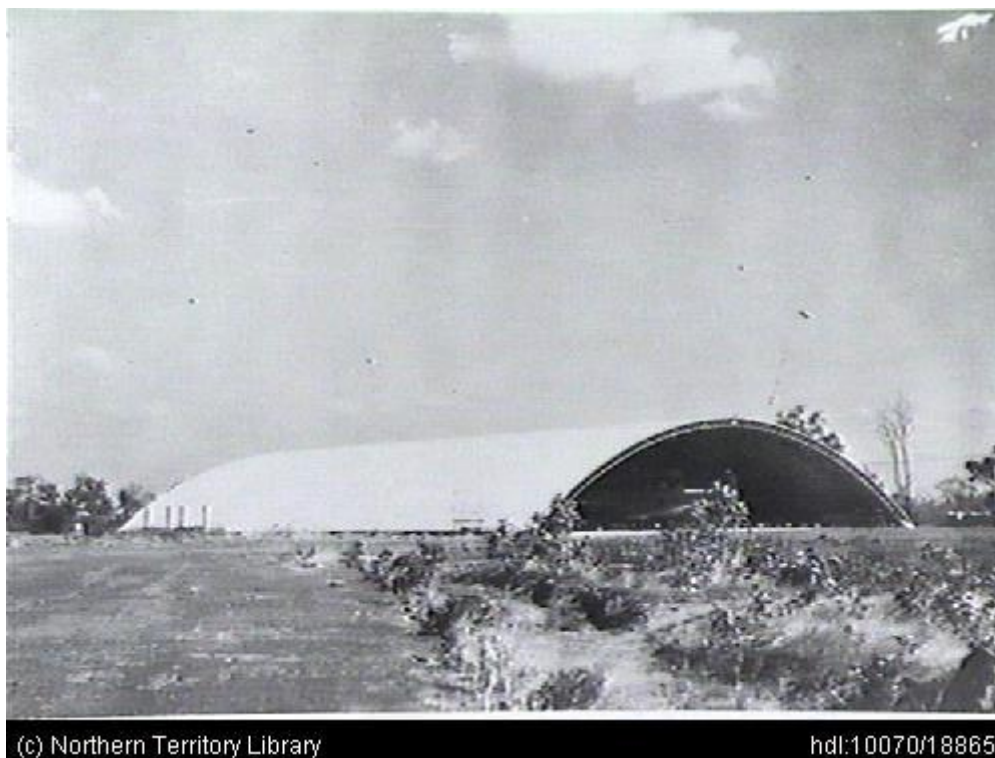
**Figure 7.1 1945 photo of a CUST Hut ('Igloo hanger'), at Winnellie, Darwin, constructed in late 1944, (Northern Territory Library <http://hdl.handle.net/10070/18865>)**

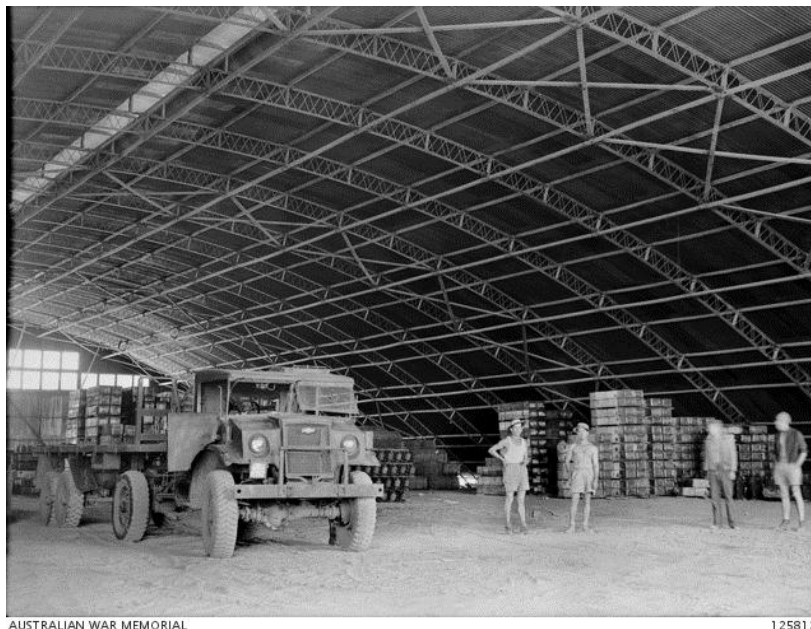
**Figure 7.3 1946 photo of CUST hut at No.2 Engineering Stores Depot, Penrith, NSW  
(Photographer Bruce Reddaway, Australian War Memorial 125812)**

*The CUST hut located within the SME at Moorebank would appear to be the only one of its kind still in Defence ownership in NSW. Historic photographs show a similar arched building at the former Penrith Engineer Stores Depot, however this building was demolished in the early 1990s. A similar arched building may have also been located at Ingleburn Defence site (Former Engineering Workshop), demolished in the late 1990s.*

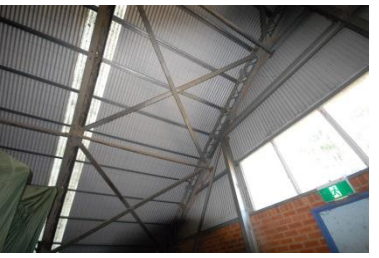
CUST 0121	CUST 0122	CUST 0123

0123	77	11-07-14	Looking at floor and west wall support and foundations	SW	-		10
0124	78	11-07-14	Looking at floor and west wall support and foundations	SW		✓	10
0125	79	11-07-14	Looking at join between west wall and roof	SSW			10
0126	80	11-07-14	Looking at join between west wall and roof	SSW		✓	10
0127	81	11-07-14	Looking at base of trusses on south edge of hut	SE			10
0128	82	11-07-14	Looking at base of trusses on south edge of hut	SE		✓	10
0129	83	11-07-14	Looking at southwest corner, showing interface wall and truss. Truss has plate cladding over it	SW		✓	10
0130	84	11-07-14	Looking at southwest corner, showing interface wall and truss. Truss has plate cladding over it	SW		✓	20
0131	85	11-07-14	Same position, looking at west wall	N			16
0132	86	11-07-14	Same position, looking at truss section in roof, angled upward	NE			15
0133	87	11-07-14	Same position, looking at truss section in roof, angled upward	NE		✓	15
