## **FIGURE 3 – BOREHOLE LOCATIONS**

## **APPENDIX A – ENGINEERING BOREHOLE LOGS**

| Project: | | | | | Proposed Development | | Test Method: Drill Rig | | | | | | |
| Project Location: | | | | | 50 Wylie Road, Kembla Grange NSW | | Date: 19/12/2012 | | Logged by: NM | | | | |

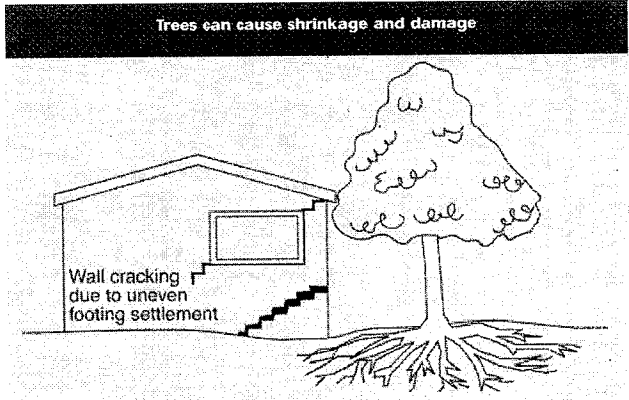
As the moisture absorption process completes its journey to the innermost areas of the building, the internal footings will rise. If the spread of moisture is roughly even, it may be that the symptoms will temporarily disappear, but it is more likely that swelling will be uneven, creating a difference rather than a disappearance in symptoms. In buildings with timber flooring supported by bearers and joists, the isolated piers will rise more easily than the strip footings or piers under walls, creating noticeable doming of flooring.

As the weather pattern changes and the soil begins to dry out, the external footings will be first affected, beginning with the locations where the sun's effect is strongest. This has the effect of lowering the external footings. The doming is accentuated and cracking reduces or disappears where it occurred because of dishing, but other cracks open up. The roof lines may become convex.

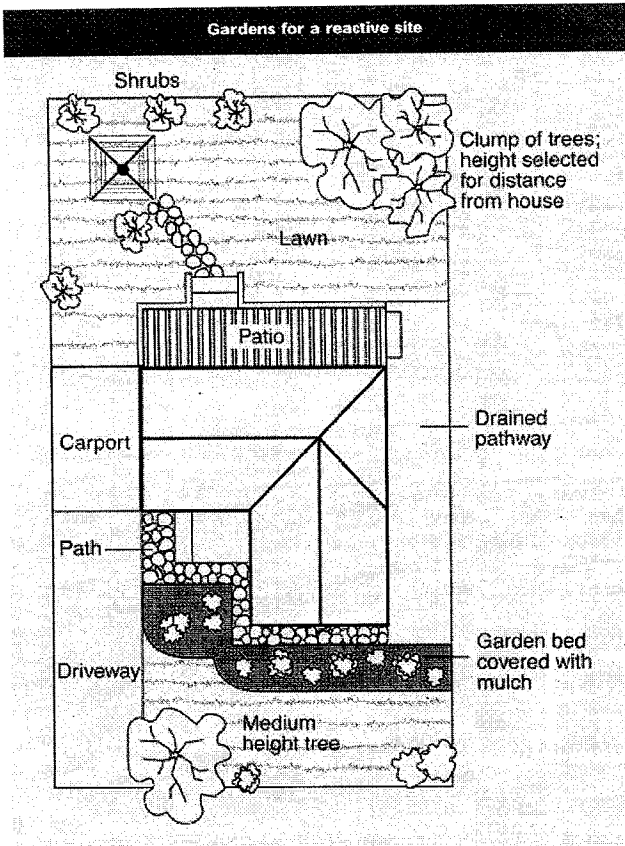
should extend outwards a minimum of 900 mm (more in highly reactive soil) and should have a minimum fall away from the building of 1:60. The finished paving should be no less than 100 mm below brick vent bases.
