RE: GROUNDWATER MONITORING NETWORK – BORE COMPLETION REPORT

RPS was engaged by Springvale Coal Pty to expand the existing groundwater monitoring network at the Centennial Springvale Coal Services operation (Coal Services). The operation is situated at Blackmans Flat, NSW.

**Springvale Coal Services
Groundwater Monitoring Network**

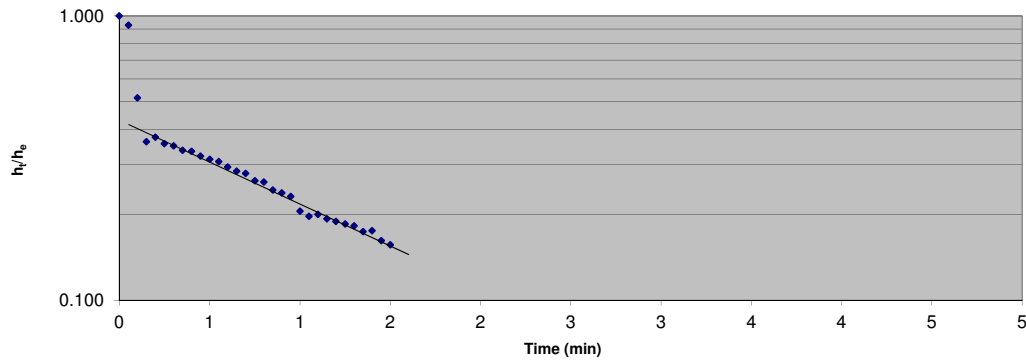
FALLING HEAD TEST

| Bore No: BH07 | Test No: #1 | Job No: S167E/E2 | Date: 26-Aug-13 | Logged by: JC |

Head - time graph (slope of graph is S)

| S | 3.0E-01 | | | where S = (log (h ₁ /h ₂))/(t ₂ - t ₁), (ie slope of plot, t in mins) |
| Permeability, k = 0.133 x S x (rc ² /L) | | | | |
