**DARLING HARBOUR LIVE**

**ACCESS REPORT FOR SSDA1**

**SYDNEY INTERNATIONAL  
CONVENTION, EXHIBITION &  
ENTERTAINMENT PRECINCT**

**Morris-Goding Accessibility Consulting**

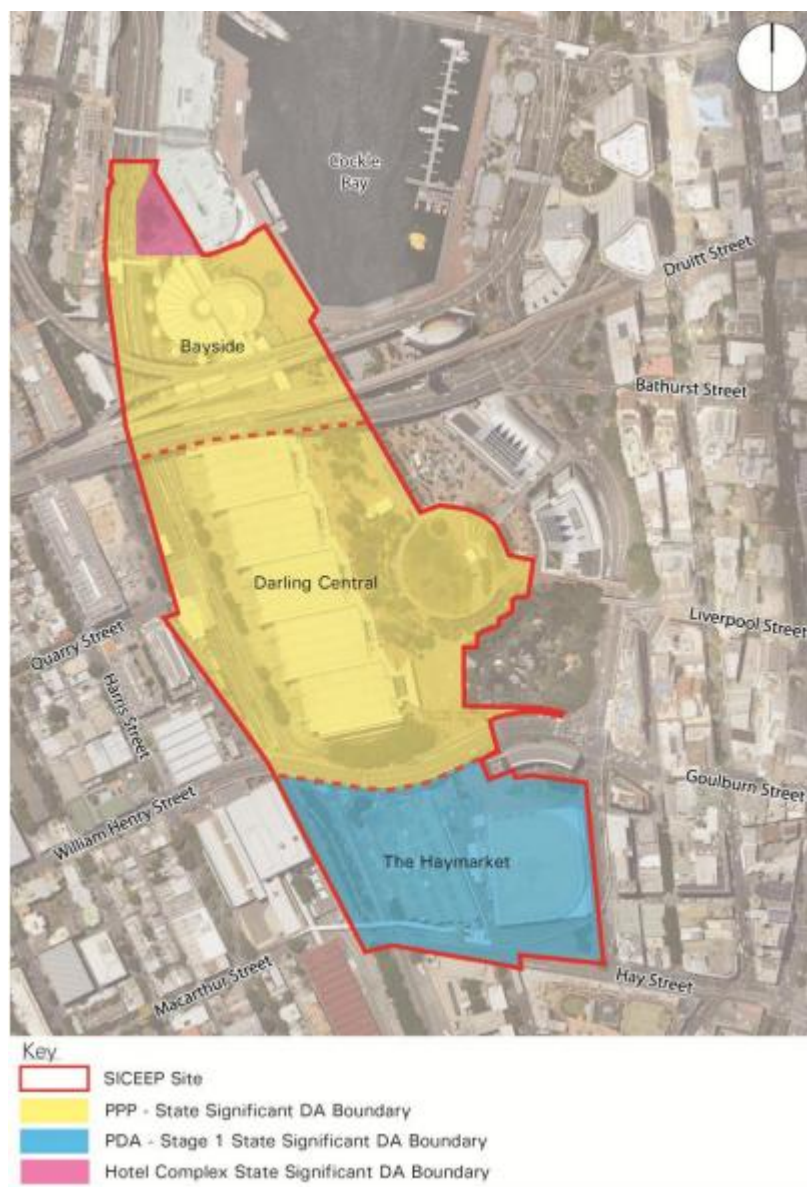
The SICEEP Site has been divided into three distinct redevelopment areas (from north to south) – Bayside, Darling Central and The Haymarket. The PPP Application Site area is located within Bayside and Darling Central as shown in the Figure below.

With an area of approximately 20 hectares, the SICEEP Site is generally bound by the Light Rail Line to the west, Harbourside shopping centre and Cockle Bay to the north, Darling Quarter, the Chinese Garden and Harbour Street to the east, and Hay Street to the south.
