Hanson Construction Materials Pty Ltd

martens consulting engineers

Land Resources Assessment:
Hanson's Brandy Hill Quarry Expansion

P1303888JR05V03 May 2016

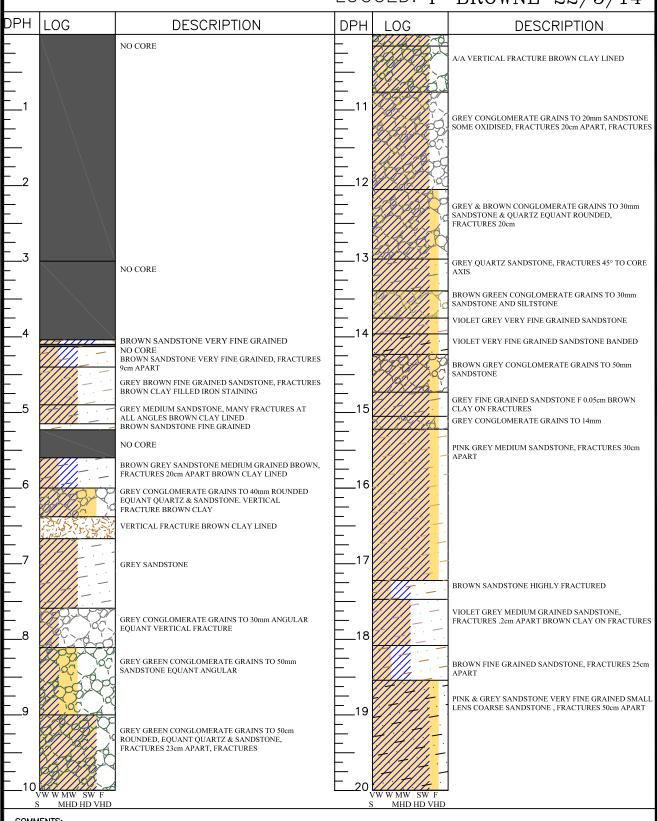
HOLE: BH-1401-DH PROJECTBRANDY HILL, ZONE 56 PAGE 1 OF 4

LOCATION:377467,6385110 GDA DRILLED: MACQUARIE DRILLING
