**ASSESSMENT OF IMPACTS ON  
SALTWATER INTAKE TUNNELS FOR SSDA6  
SYDNEY INTERNATIONAL, EXHIBITION AND ENTERTAINMENT PRECINCT -  
ICC HOTEL**

**Prepared for Lend Lease**

**Report PSM1986-021R – Rev.4**

**August 2013**

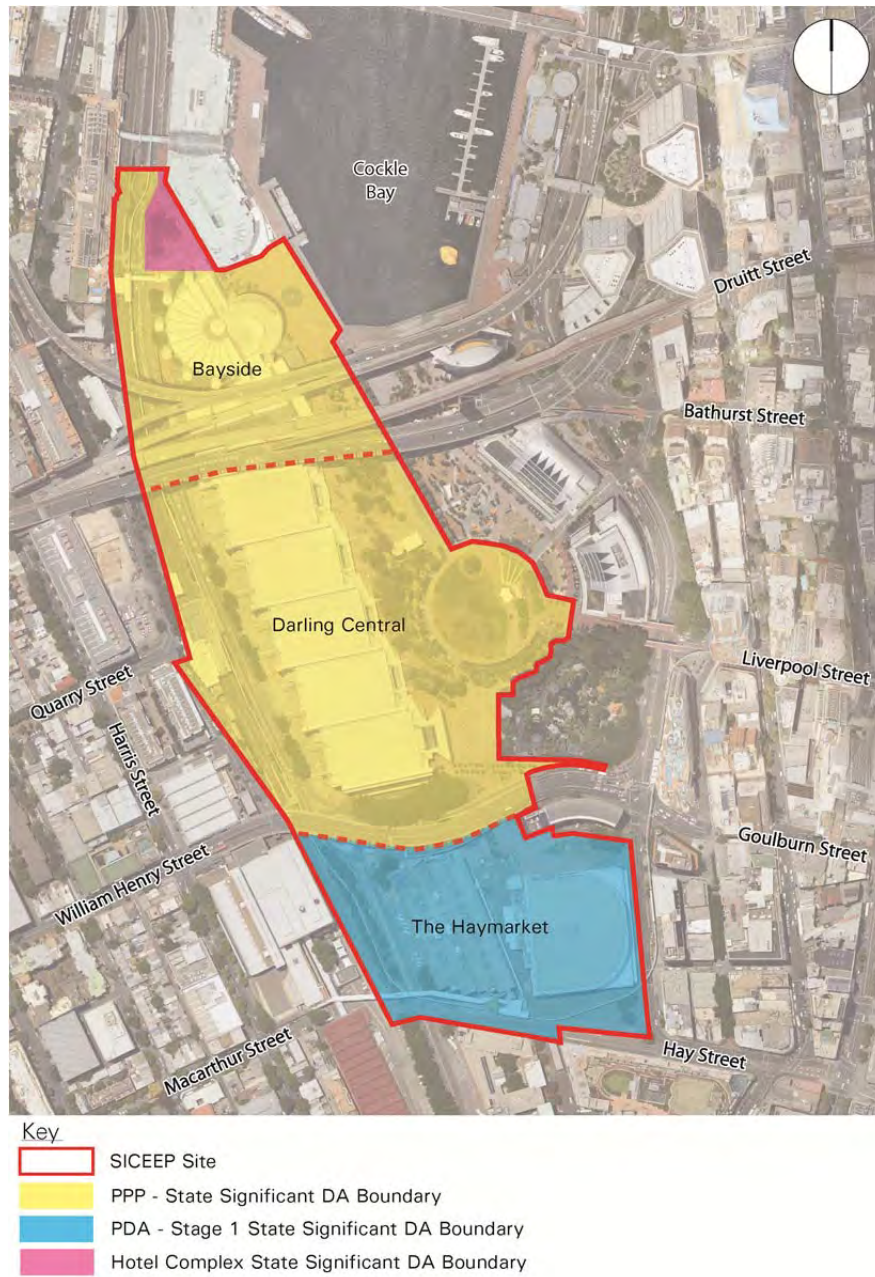
SICEEP site and redevelopment areas

The ICC Hotel Site (refer to figure below):

- is located within the northern end of the Bayside precinct;
- is bound by Harbourside Shopping Centre to the north and east, the International Convention Centre to the south and Darling Drive to the west; and
- occupies an area of approximately 3,730 m<sup>2</sup>.

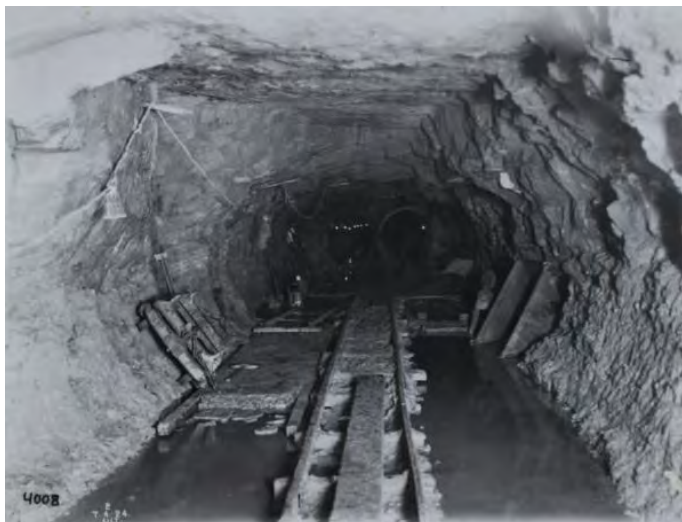
Figure 2.46: Excavation under Darling Harbour for the installation of water conduits for Ultimo Power House. State Rail Photos Series: 17420 Item: 364/44 SRNSW.

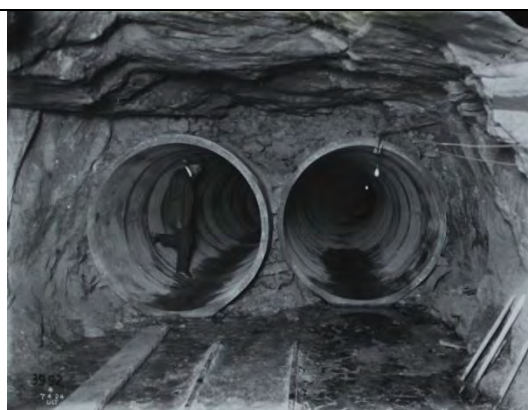
Figure 2.48: Rails in the foreground were used to cart rubble fill to the pipes. State Rail Photos Series: 17420 Item: 364/46 SRNSW.

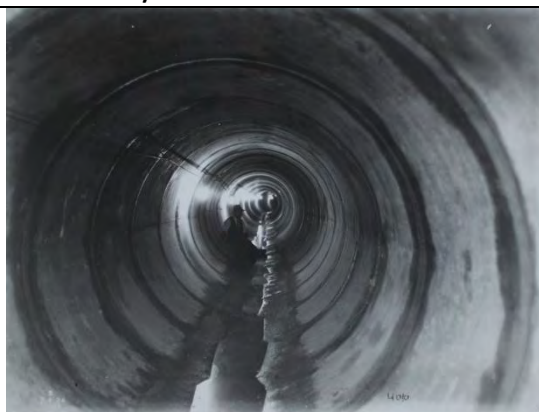
Figure 2.49: Joints between the sections of conduit are visible along the length of the water supply pipe. State Rail Photos Series: 17420 Item: 364/47 SRNSW.

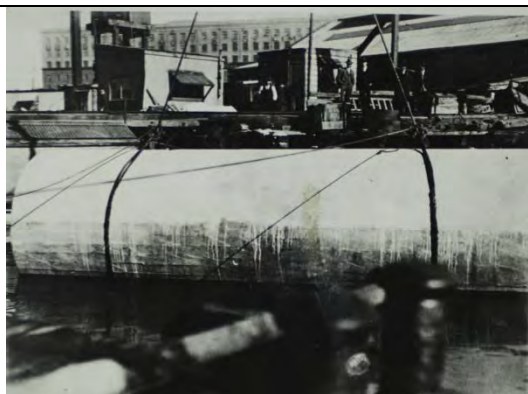
**Figure 2.51: Reinforced concrete Monier pipe being lowered into position. State Rail Photo Series: 17420 Item: 364/48B SRNSW.**

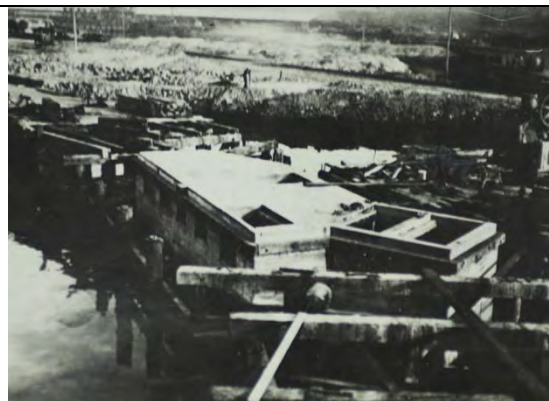
**Figure 2.52: Work undertaken at the water's edge for installation of the inlet conduits for the Ultimo Power House. State Rail Photo Series: 17420 Item: 364/48C SRNSW.**
