Conservation Management Plan for Tarwyn Park and Iron Tank

BYLONG COAL PROJECT
Response to PAC Review Report

DRAFT Conservation Management Plan

AECOM Australia Pty Ltd

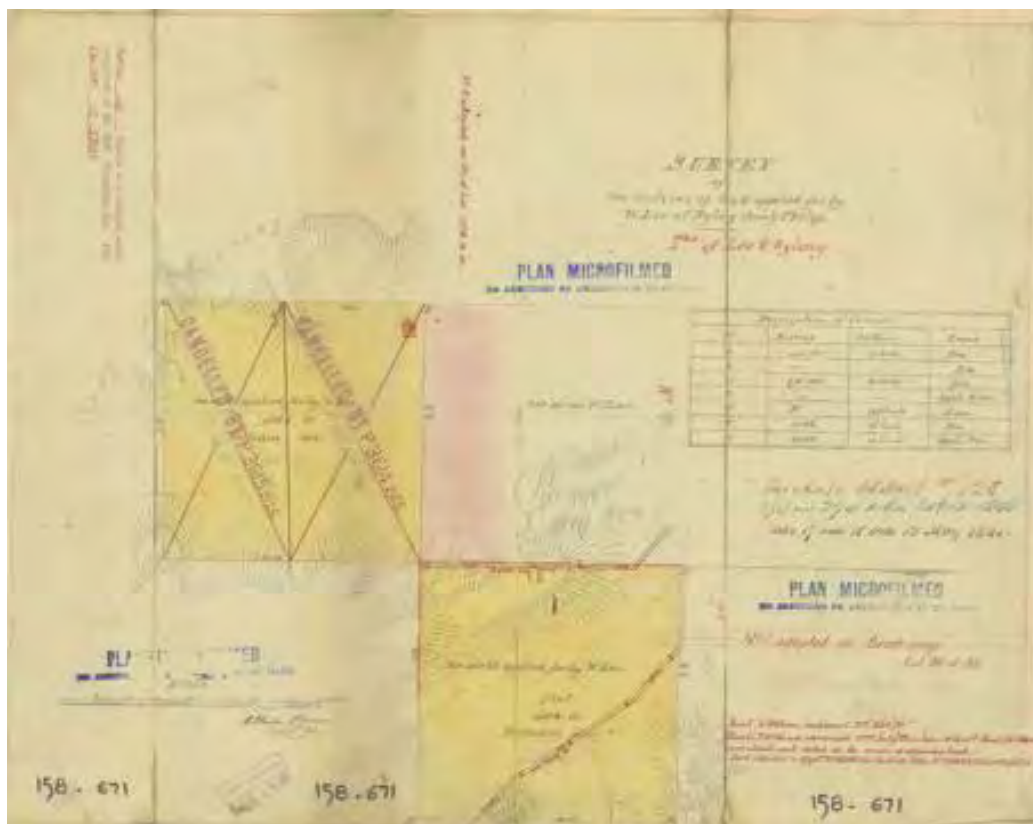
Figure 5 The survey plan of William Lee's 640 acre grant that became the core of Tarwyn Park. Note that the north point is at the right hand side of the plan. Source: P.158.671, Crown Plan

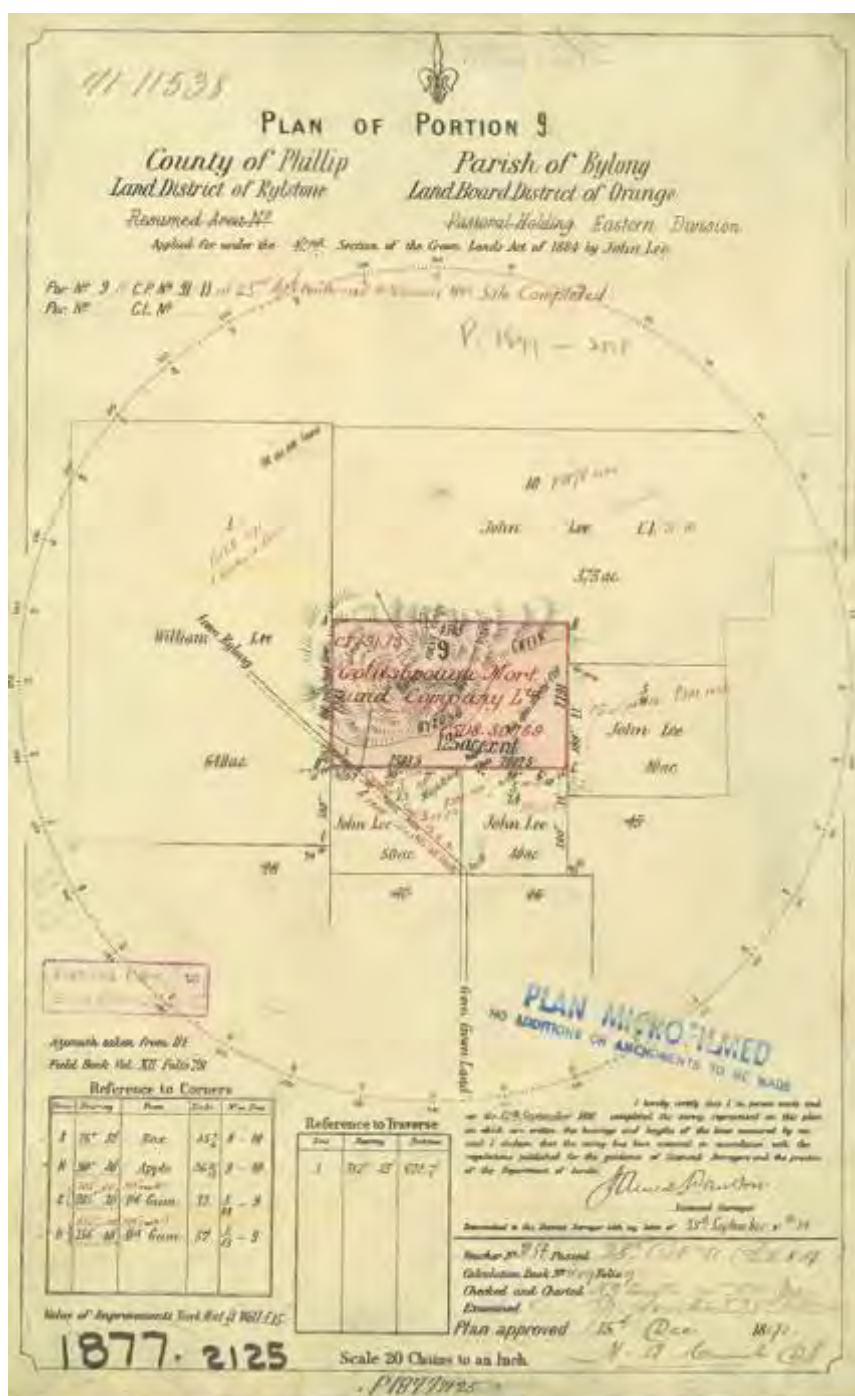
Figure 7 The Portion survey of Portion 9. Source: P.1877.2125, Crown Plan

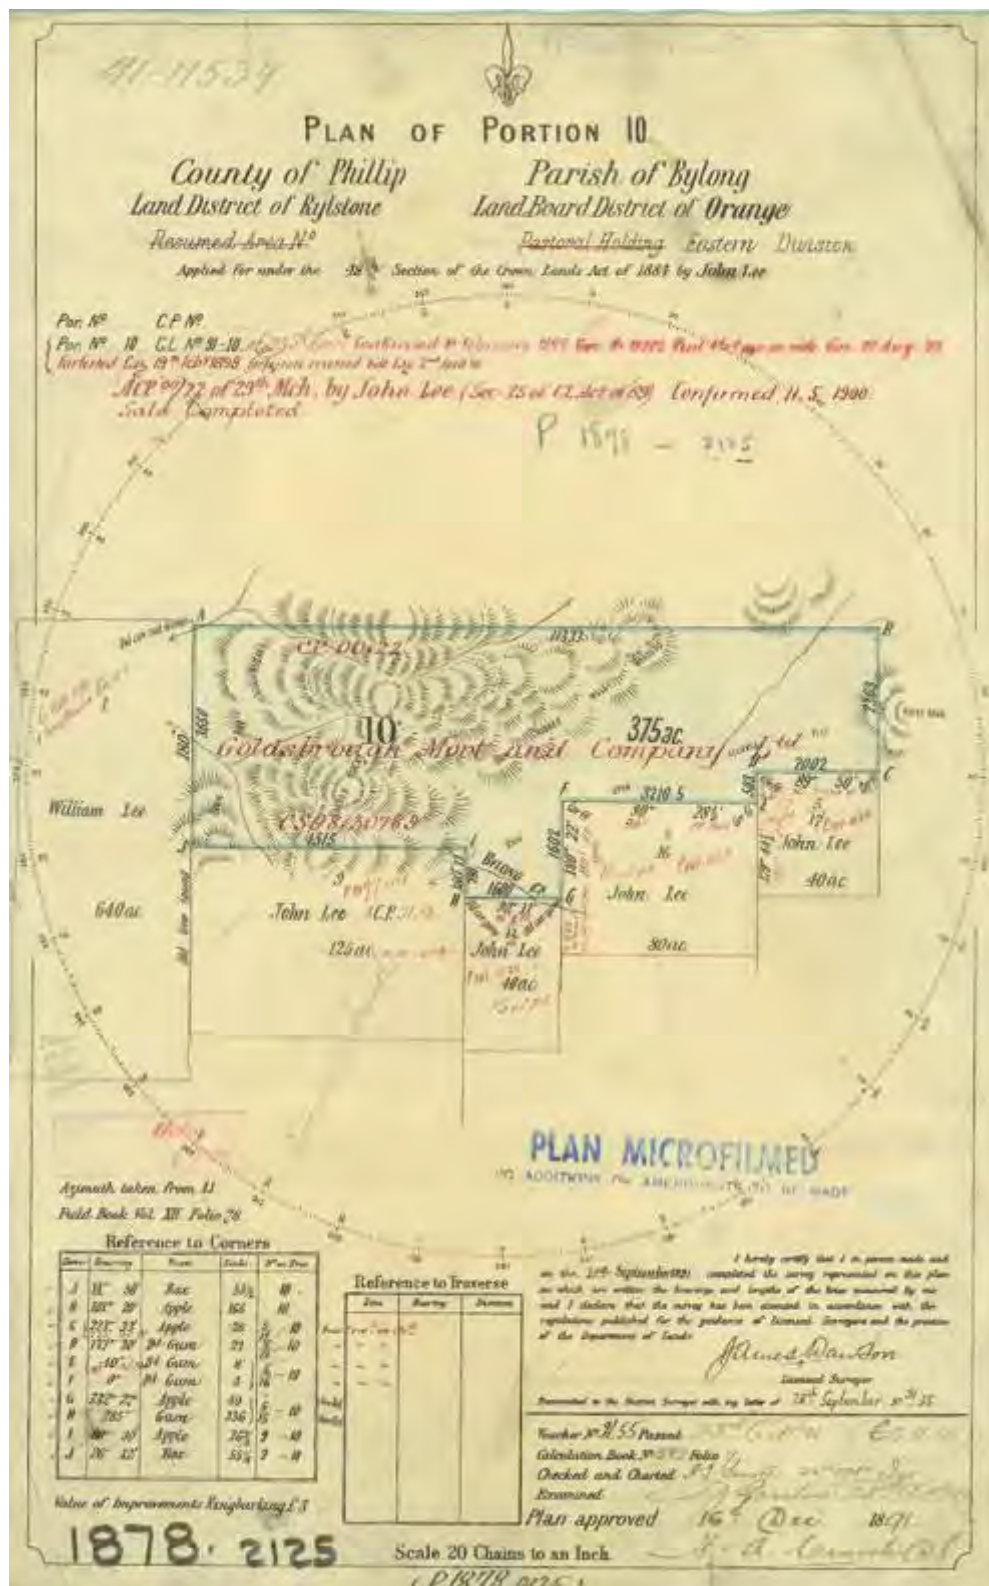
Figure 8 The Portion survey of Portion 10. Source: P.1878.2125, Crown Plan

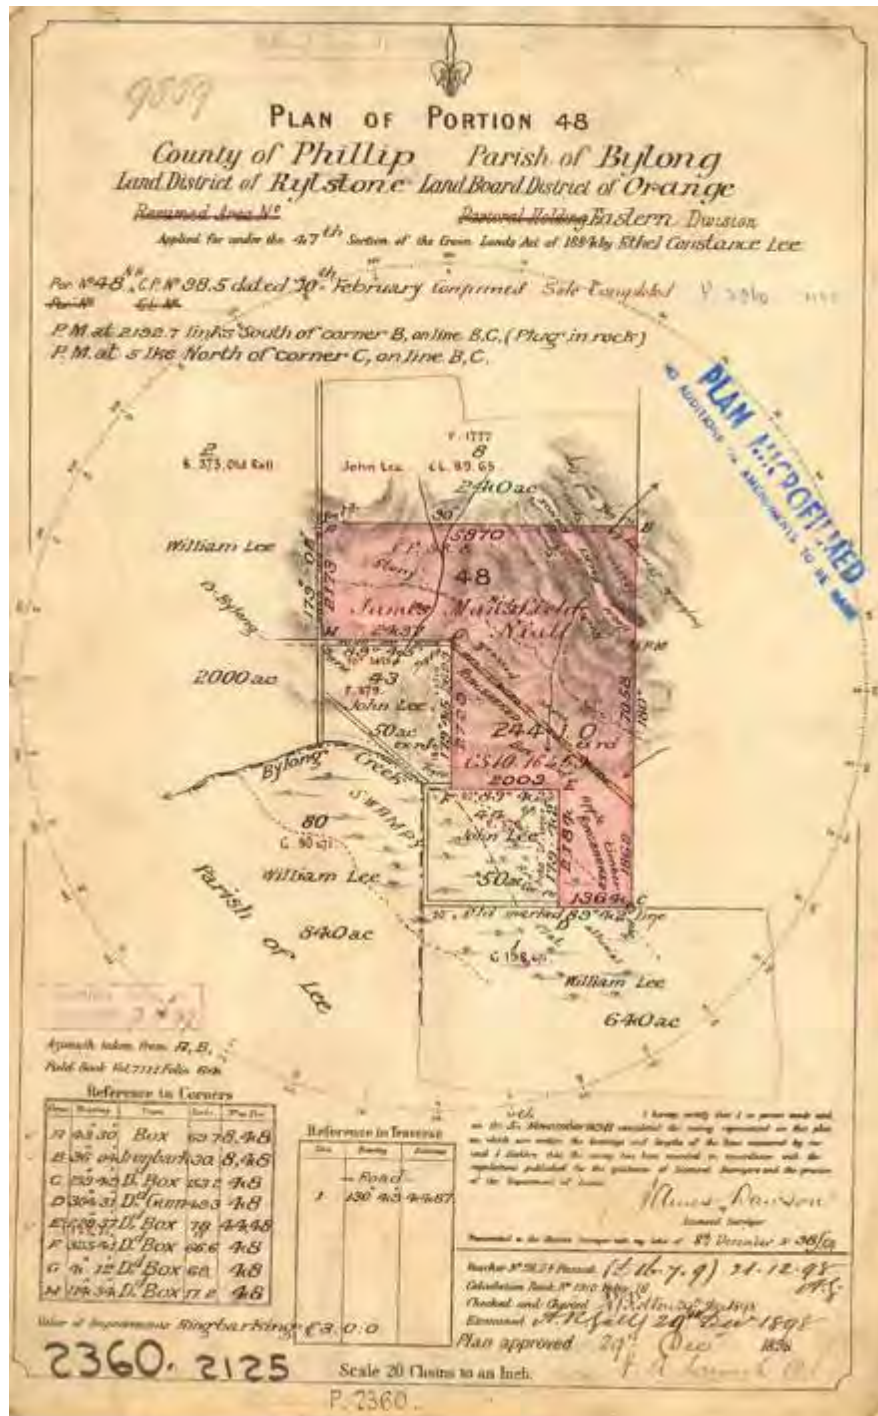
Figure 9 The Portion survey of Portion 48. Source: P.2360.2125, Crown Plan

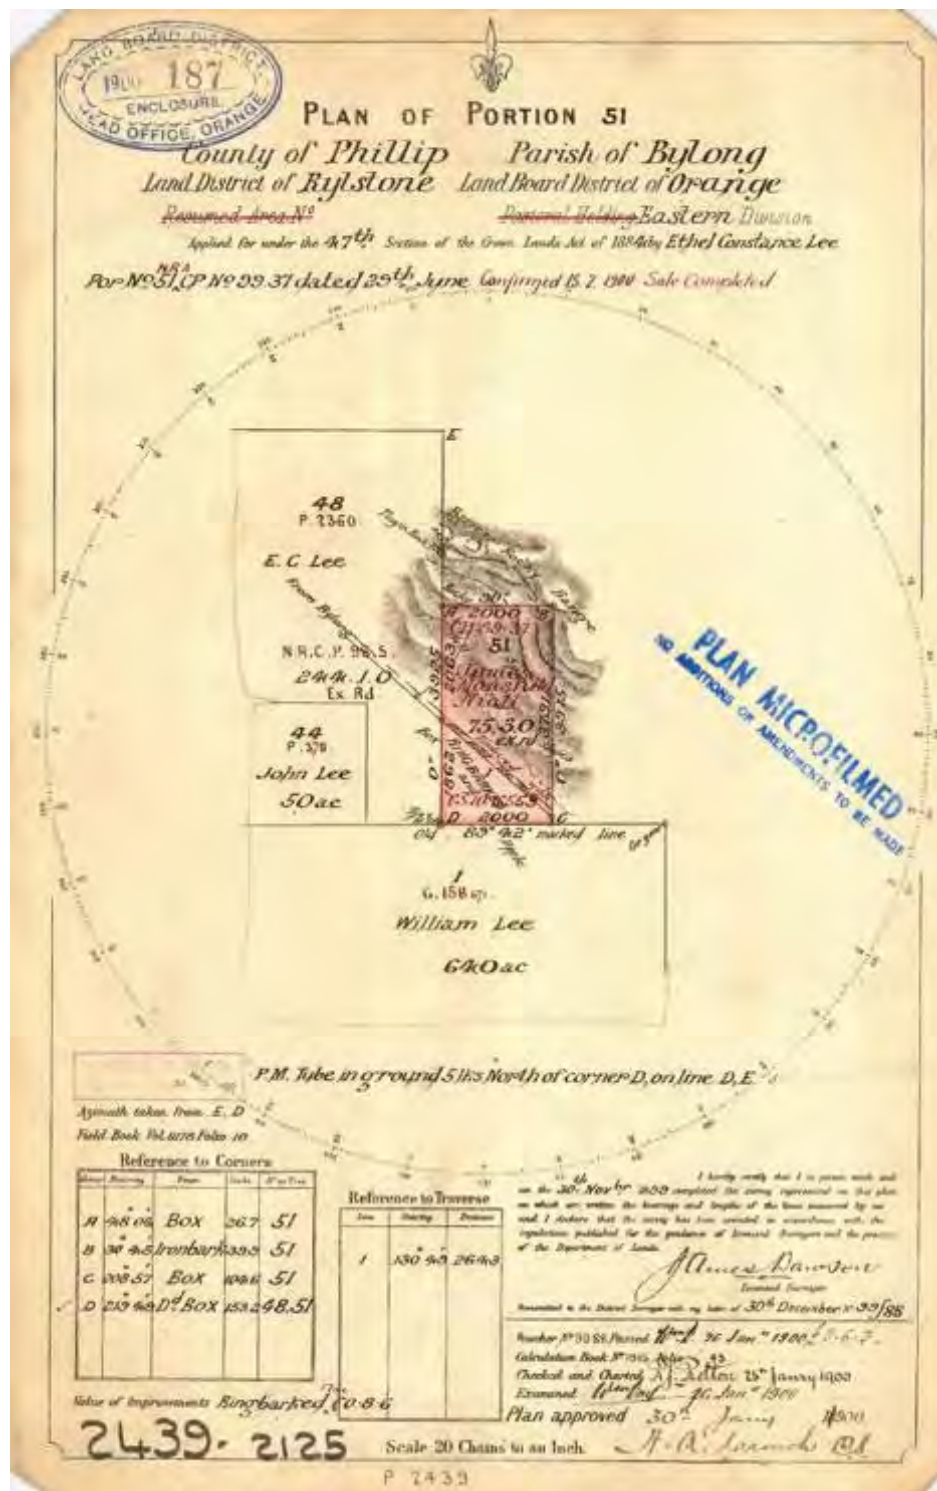
Figure 10 The Portion survey for Portion 51. Source: P.2439.2125, Crown Plan

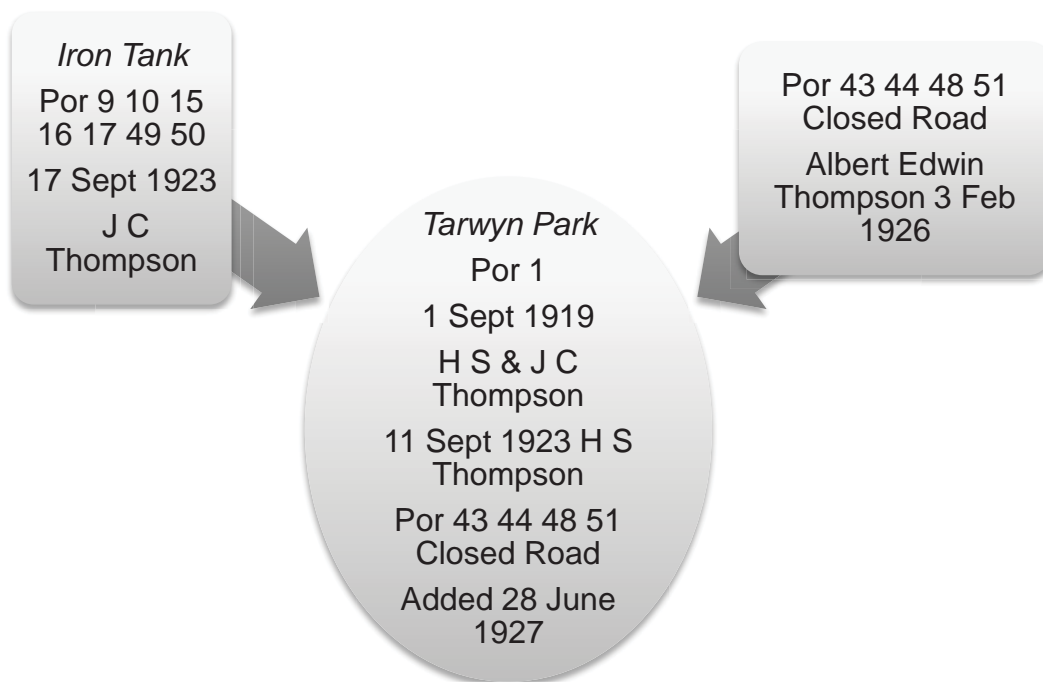
The following diagram shows in simplified form the process of amalgamation of Portions into Tarwyn Park and Iron Tank.

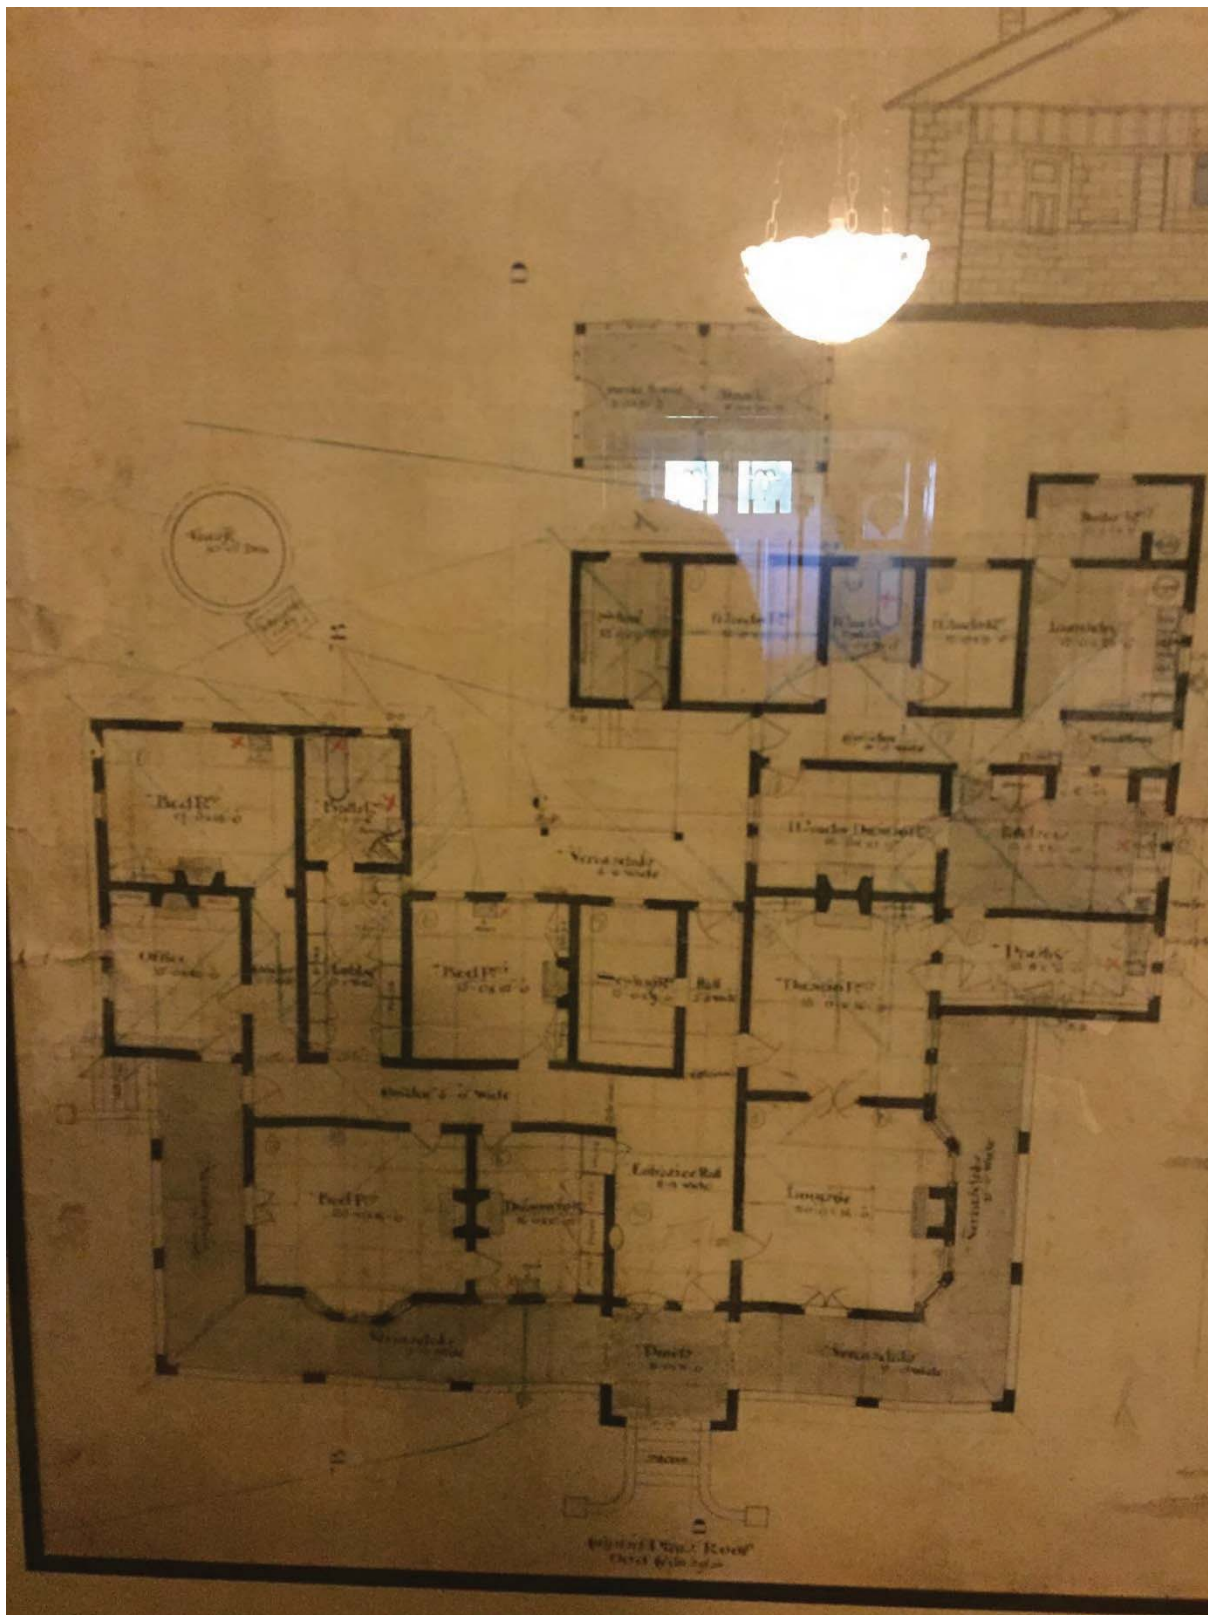
Figure 13 Floor plan of Tarwyn Park Homestead from the original architectural plans. Source: WorleyParsons

It would appear from the inspections undertaken to date, that Tarwyn Park Homestead was constructed in one phase. This is supported by newspaper reports indicating the homestead constructed in 1920 was of 22 rooms, which is roughly equivalent to the number of rooms that currently comprise the Homestead. Stuart and Megan Andrews hold the original architectural plans for Tarwyn Park Homestead. A portion of this plan was available to AECOM during the preparation of this draft CMP in the form of a photograph taken through glass (Figure 13). The original functions of the rooms and some of the annotations on the plan are not sufficiently clear enough to decipher. A comparison of the original architectural drawings and the current plans indicates five areas where alterations may have been made:

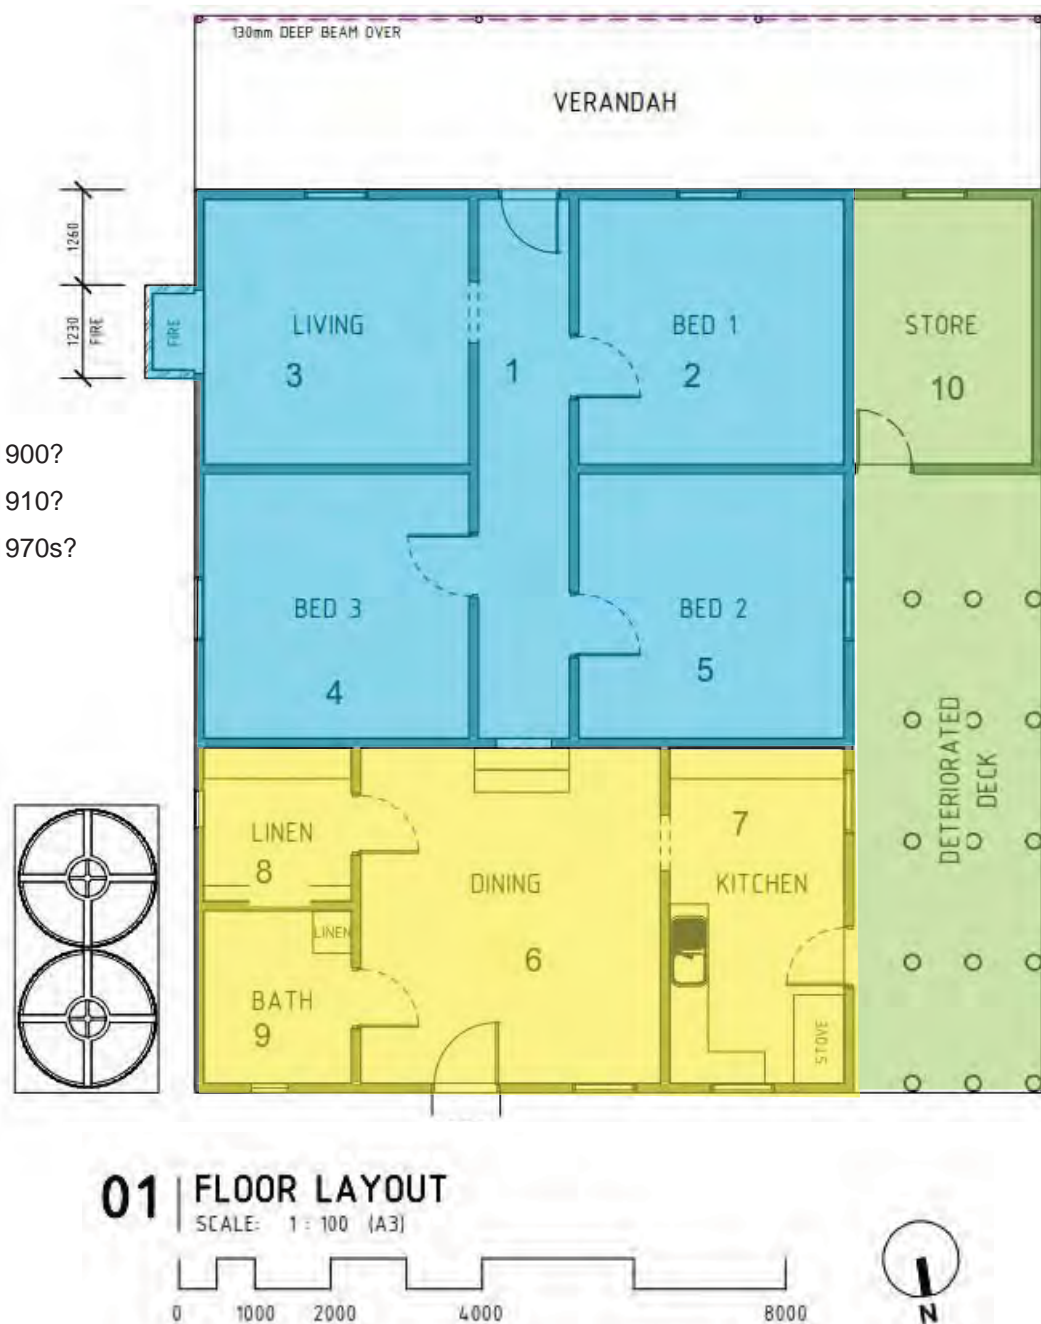
Figure 16 Phasing of the development of Iron Tank House

Iron Tank was constructed in three phases, based on the physical characteristics. The front (southern wing) can be stylistically dated to the late Victorian Georgian phase (Apperly, Irving, & Reynolds, 1989:42), suggesting a date of between 1840 and c.1900. This is based on the form of the roof – a steeply pitched hipped roof, the symmetry of the original façade and the materiality, specifically the corrugated iron, sash and fixed windows (Apperly et al., 1989:42). The northern wing, based on the prevalence of pressed metal on the interior, was probably constructed between 1900 and 1910. The deck and store room on the western side (room 10) are much later additions, probably during the 1960s or 1970s. This phasing is represented in Figure 16. There are no maps or plans that indicate the initial date of settlement at the site.

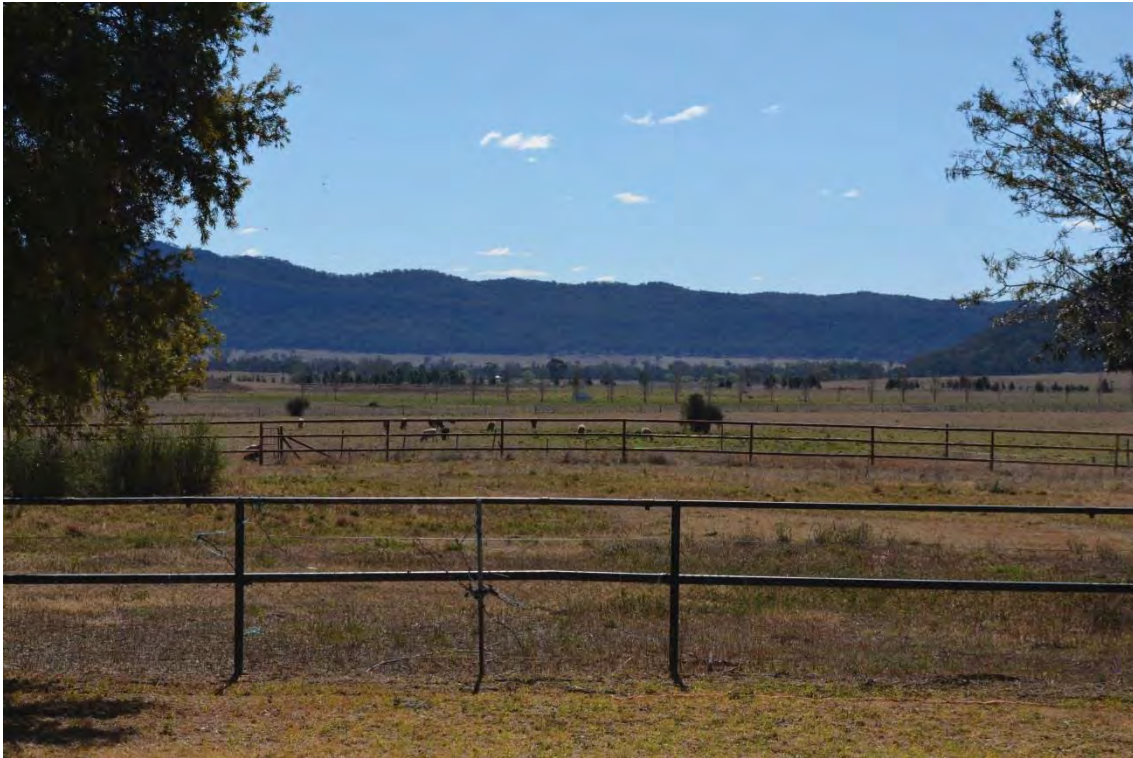
Plate 1 Tarwyn Park Homestead View 1

Notes: This image is taken from the front yard and is not representative of the more enclosed views that are available from the verandah. The open paddocks contribute to the significance of this view. These open paddocks should be maintained as evidence of the rural setting and as such, it is considered planting within the paddocks to provide vegetation screens is not appropriate. Planting for visual screening should be contained within the fenced front yard area of the Homestead. These plantings should seek to create a formal to semi-formal entrance to the Homestead as a historically and culturally appropriate response to the style and form of the Homestead.

The significant views are identified on Figure 17. The Homestead is oriented towards the northwest, and therefore views in this direction through the vegetation within the grounds of the Homestead are considered significant (View 1 of Figure 17, see Plate 1). Views from the kitchen door, located on the western side of the Homestead, are also considered to be of significance (View 2 of Figure 17, see Plate 2) as the centre of activity for the homestead. The views in both directions are across flat to gently sloping cleared paddocks, with the vegetated ranges and mountains in the distance. View 2 includes a vista towards the Lee Creek valley and the Growee Ranges in the distance.

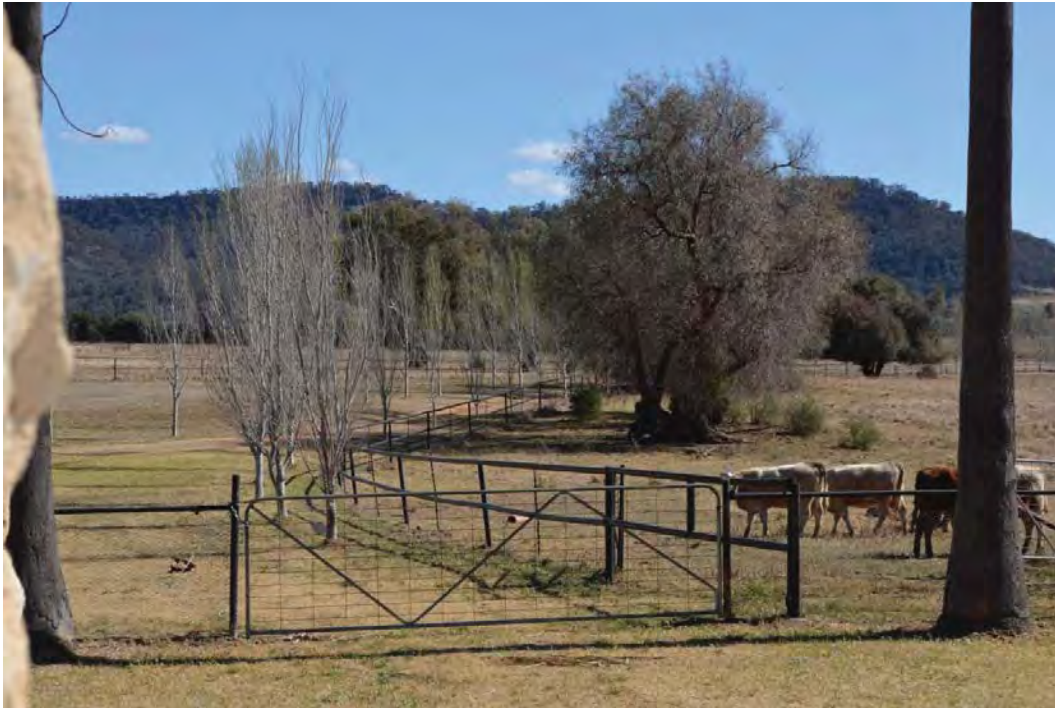
Plate 2 Tarwyn Park Homestead View 2. View west along existing driveway. Note the row of poplars (left) with the remnants of the older peppercorn trees (right) which formerly lined the driveway

Notes: The retention of the open space is the important element of this view in the long term (i.e. on mine closure), as are trees to mark the line of the driveway. A grassed earthen embankment would be appropriate during the lifespan of the mine. On the closure of the mine, reinstatement of the driveway and line of trees should be considered as an interpretive element.

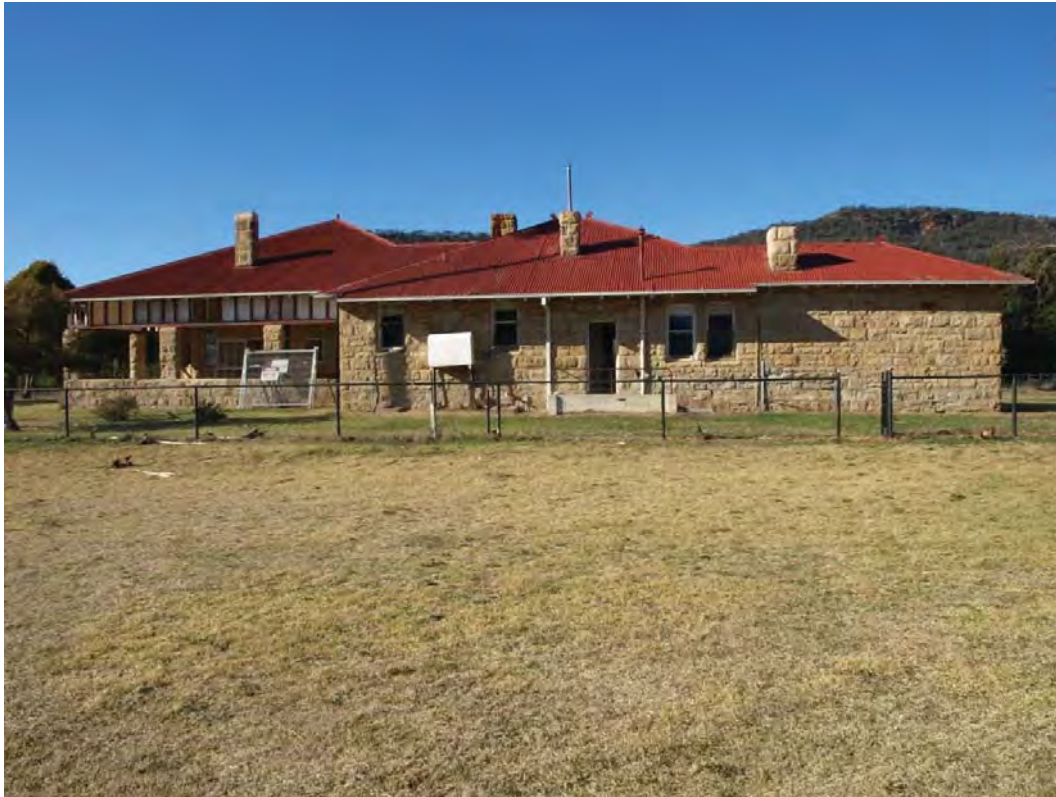
Plate 3 Tarwyn Park Homestead View 3. View east from driveway

Notes: Open views towards the Homestead from the west should be maintained within 25 metres of the house as per the known historical view.

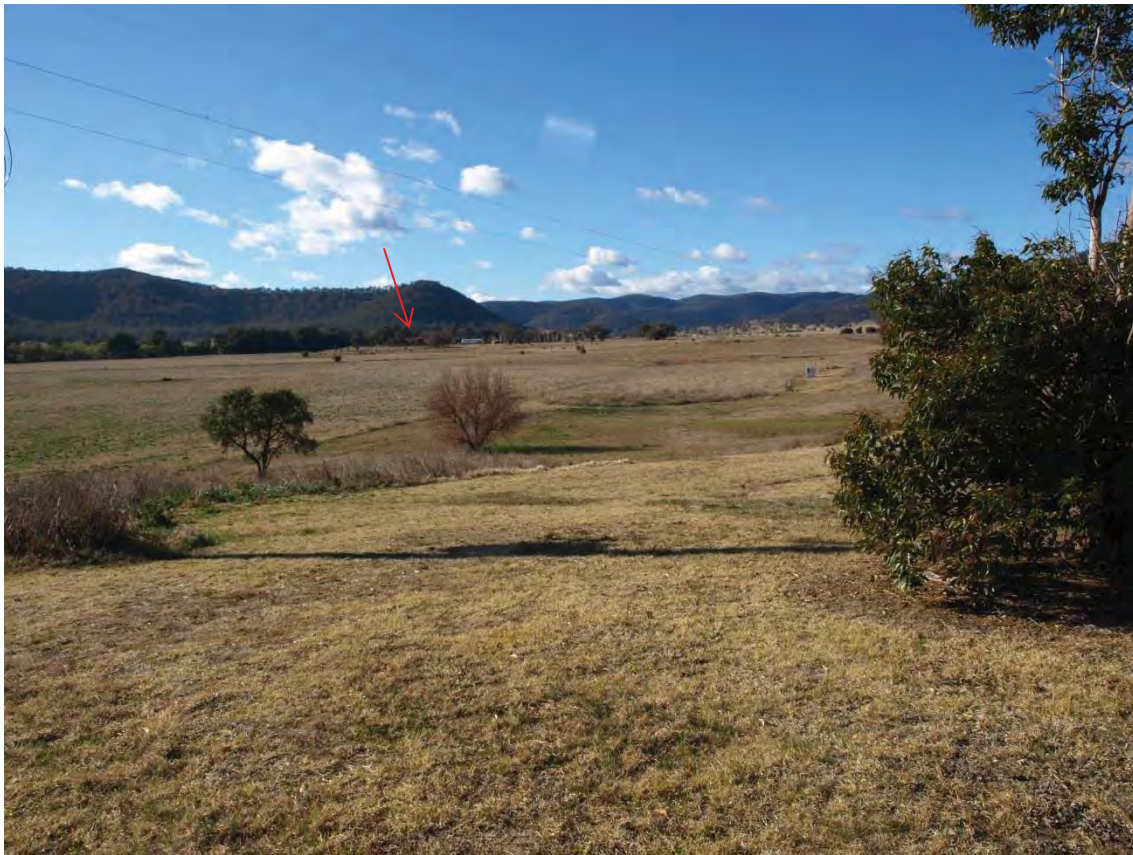
Plate 4 Tarwyn Park Homestead View 4. View south east from the KEPSCO Site Office towards Tarwyn Park Homestead. Location of Homestead denoted by arrow

Notes: The retention of the open paddocks is the important element of this view. The Project will maintain this view with impacts limited to minor amendments to the south (right side of image) associated with the Eastern Open Cut. This will not impact views towards Tarwyn Park Farm Complex.

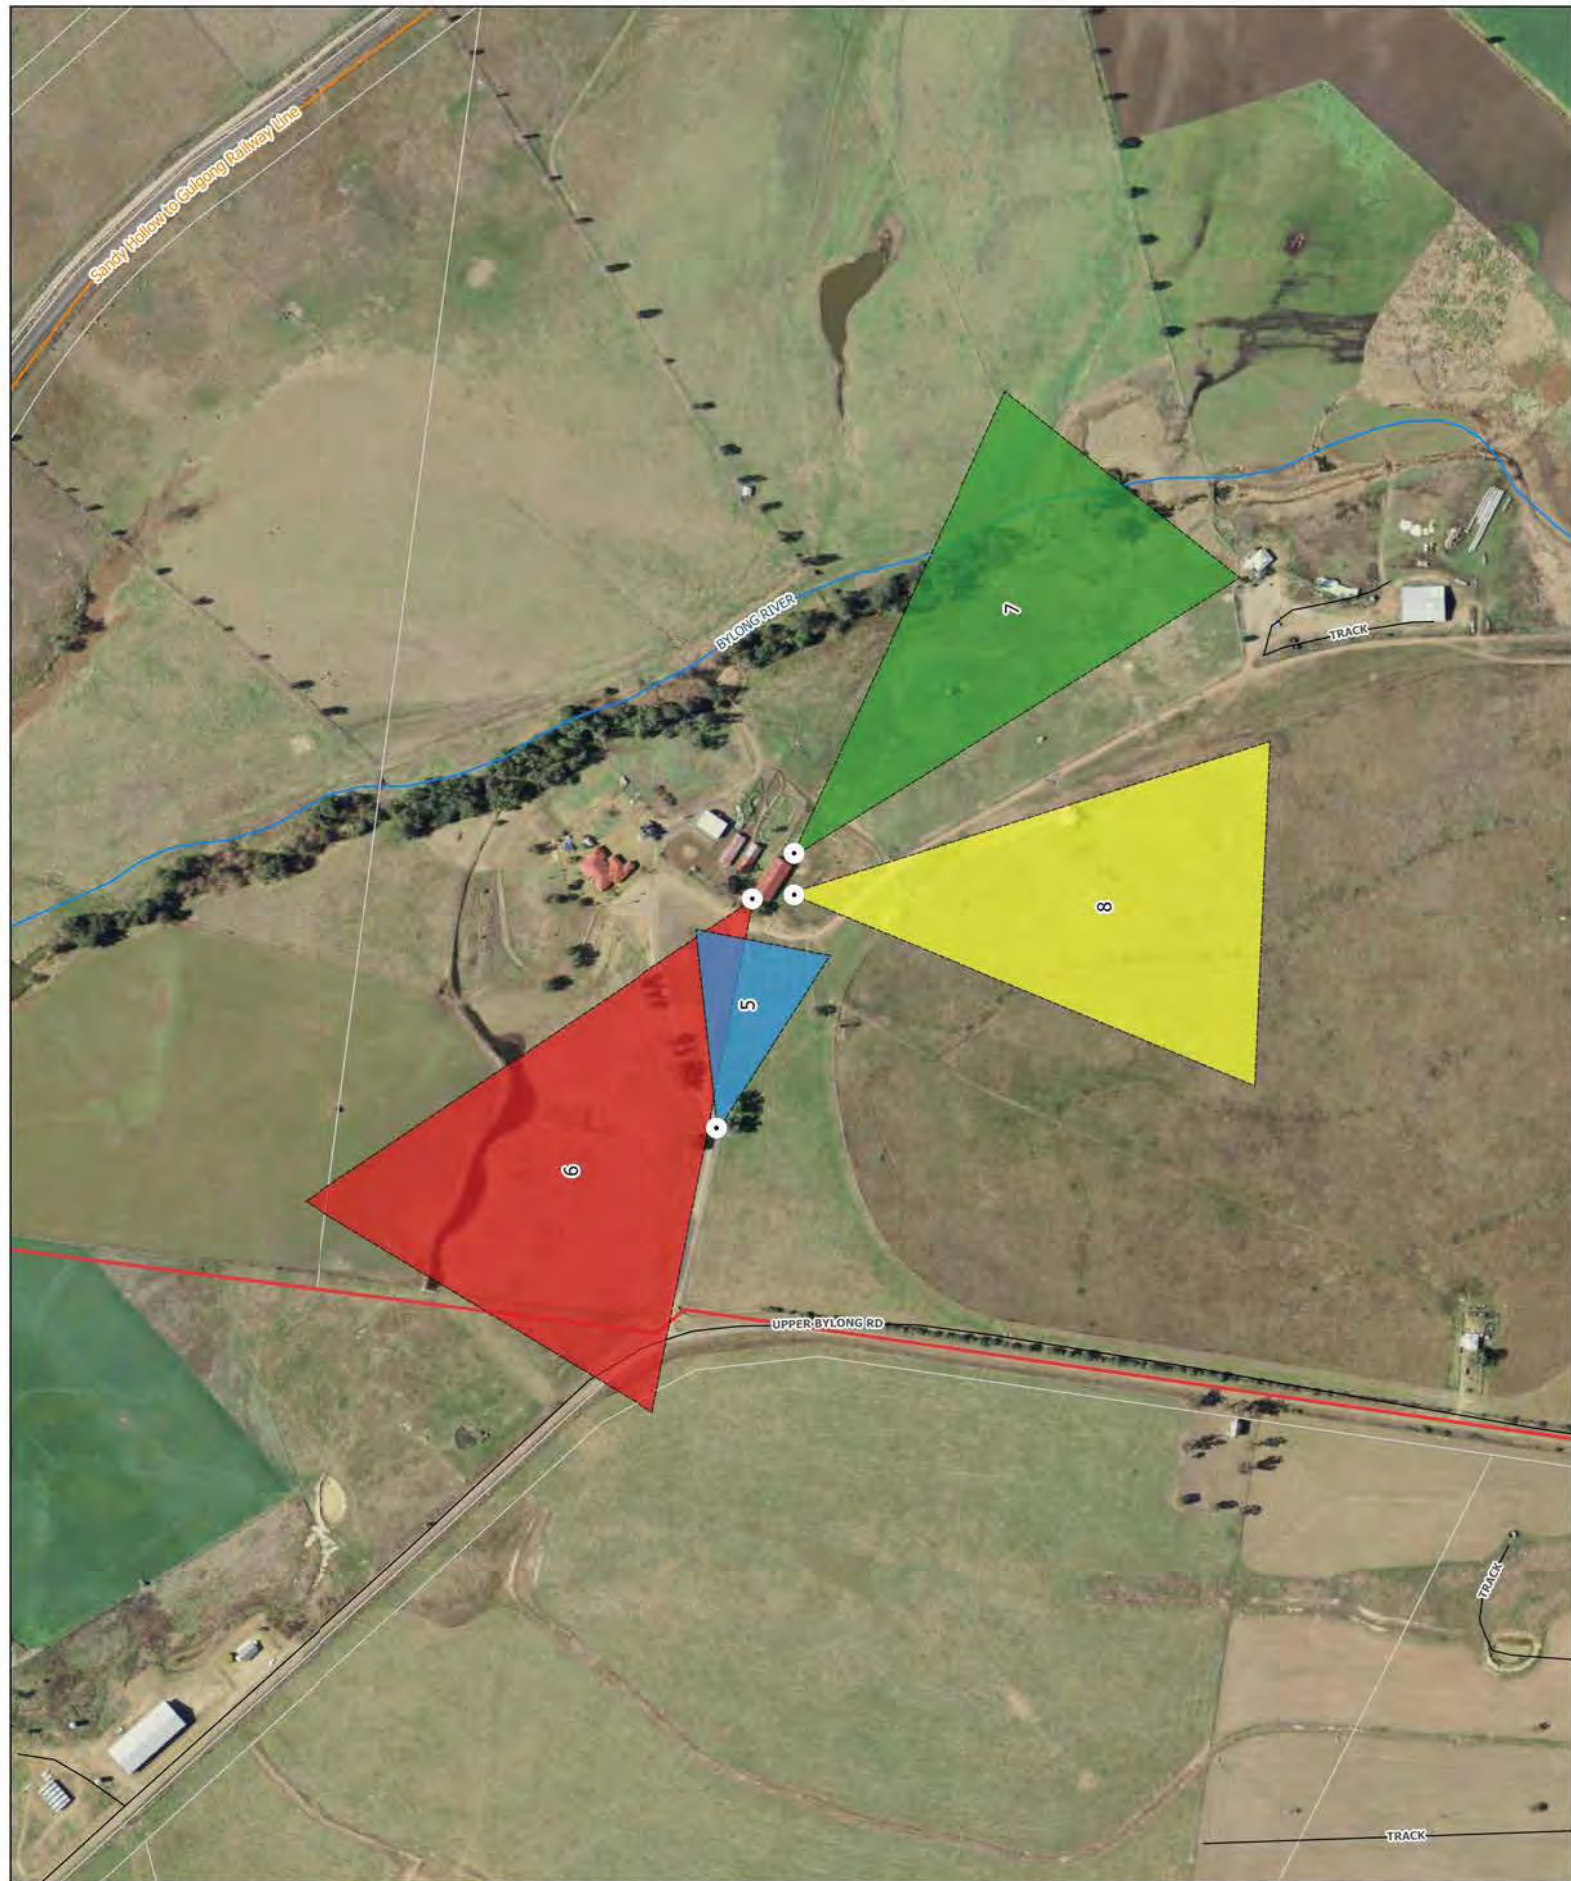
Tarwyn Park Stables View Lines

Tarwyn Park and Iron Tank Conservation Management Plan
Figure 18

As the second significant structure associated with the Tarwyn Park complex, views to and from the Stables have also been considered. Views are available from the driveway at a distance of approximately 120 m (View 5 of Figure 17, see Plate 5). The views from the doors in the northern, western and southern elevations were identified as being significant. At present, these views are of open paddocks, separated by fences.

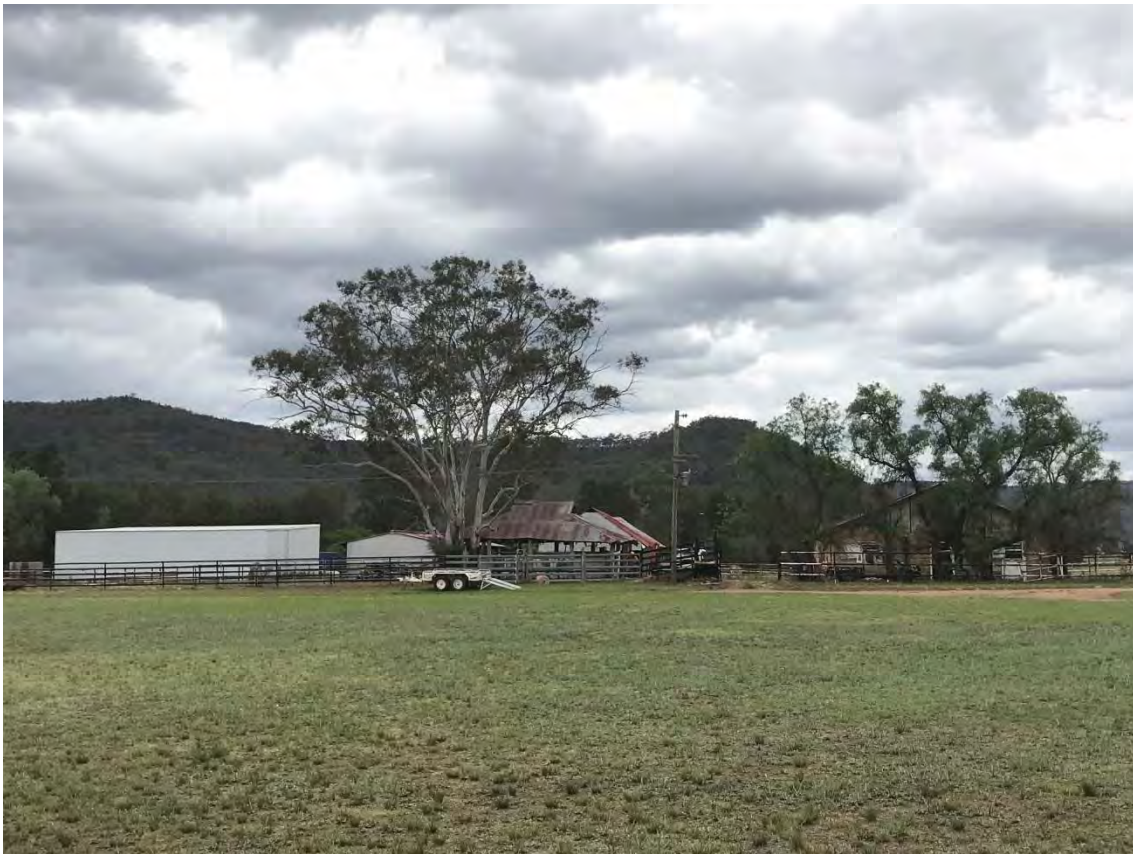
Plate 5 Tarwyn Park Stables View 5. View east from driveway towards Stables

Notes: The retention of the open space, separated by fences is the important element of this view.

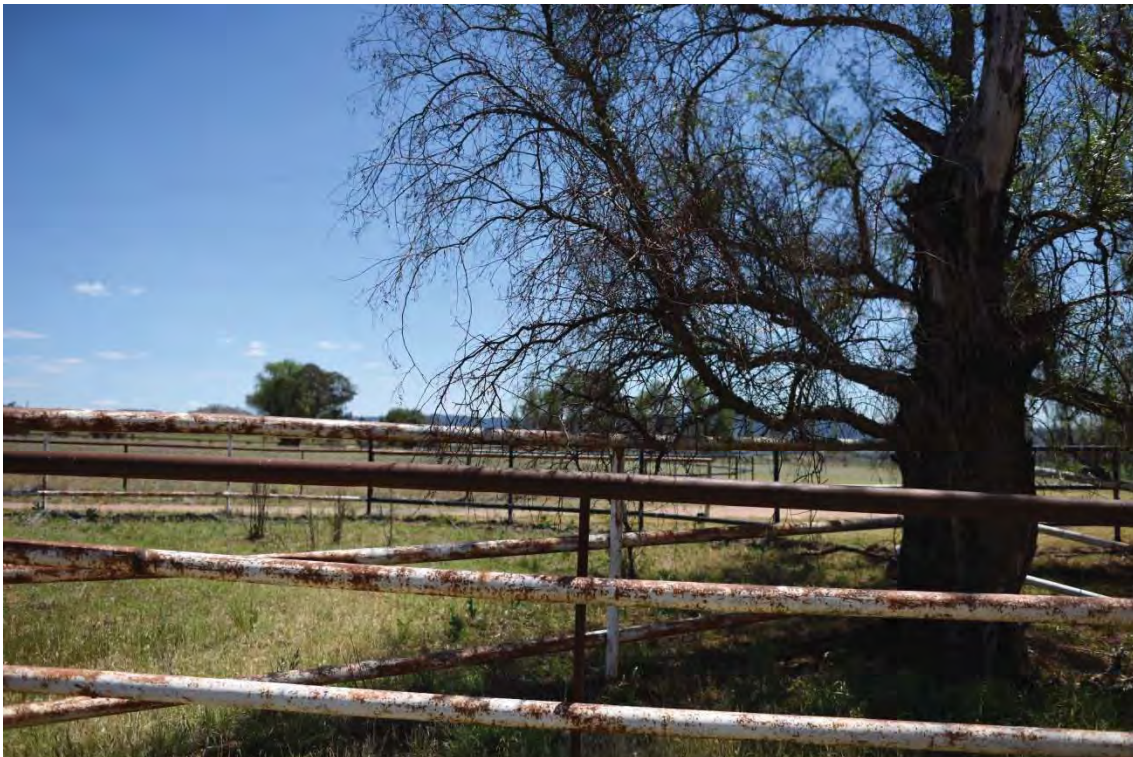
Plate 6 Tarwyn Park Stables View 6. View north from Stables

Notes: The retention of the open space is the important element of this view.

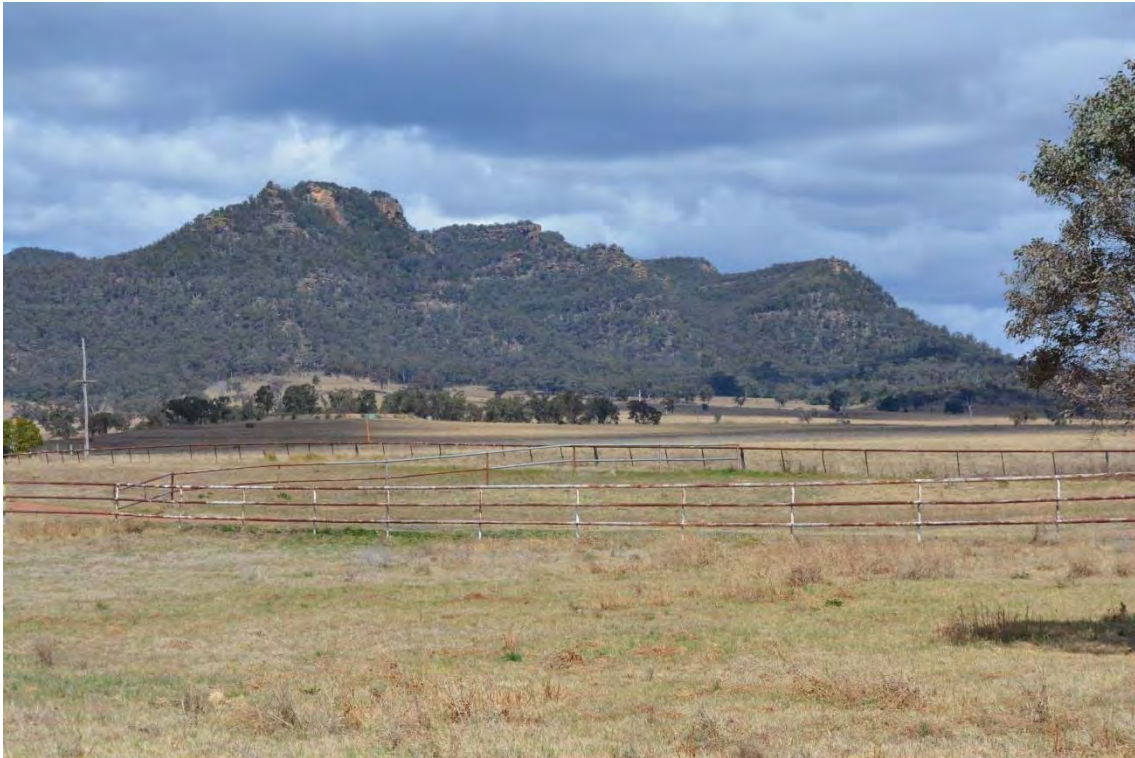
Plate 7 Tarwyn Park Stables View 6. View south-west from Stables

Notes: The retention of the open space is the important element of this view in the long term (i.e. on mine closure). A grassed earthen embankment would be appropriate during the lifespan of the mine. This view will be affected by the Project. A draft photomontage of this view at mine closure is provided for reference. The rehabilitation and management of the landscape is addressed within the *Bylong Coal Project: Visual and Landscape Analysis* (AECOM Australia Pty Ltd, 2017b).

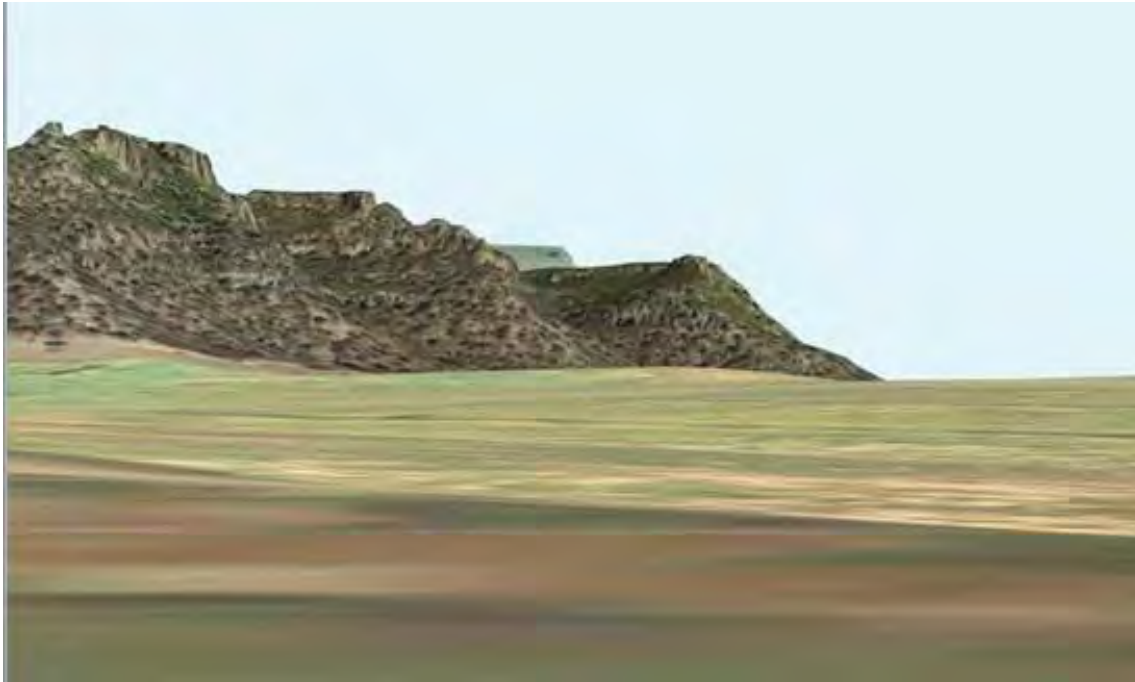
Plate 8 Tarwyn Park Stables View 6. View south-west from Stables final landform at Project closure.

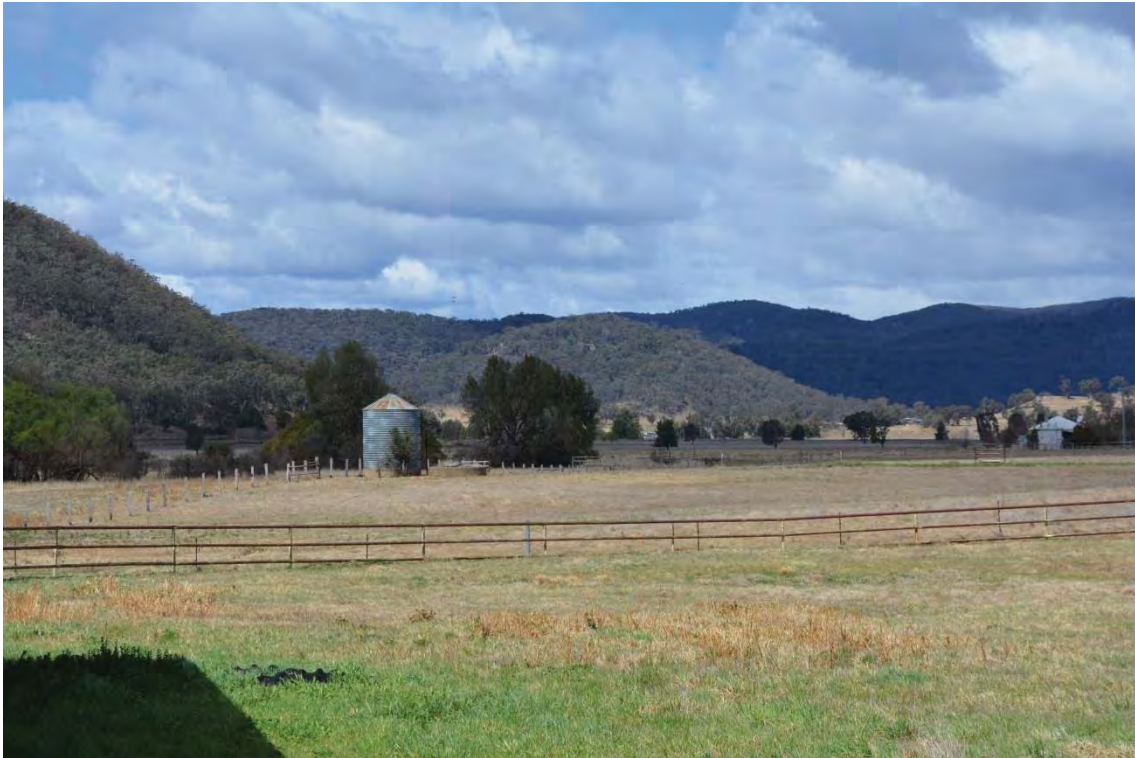
Plate 9 Tarwyn Park Stables View 6. View south from Stables

Notes: The retention of the open space is the important element of this view.
