Conservation Management Plan for Tarwyn Park and Iron Tank

BYLONG COAL PROJECT
Response to PAC Review Report

DRAFT Conservation Management Plan

AECOM Australia Pty Ltd

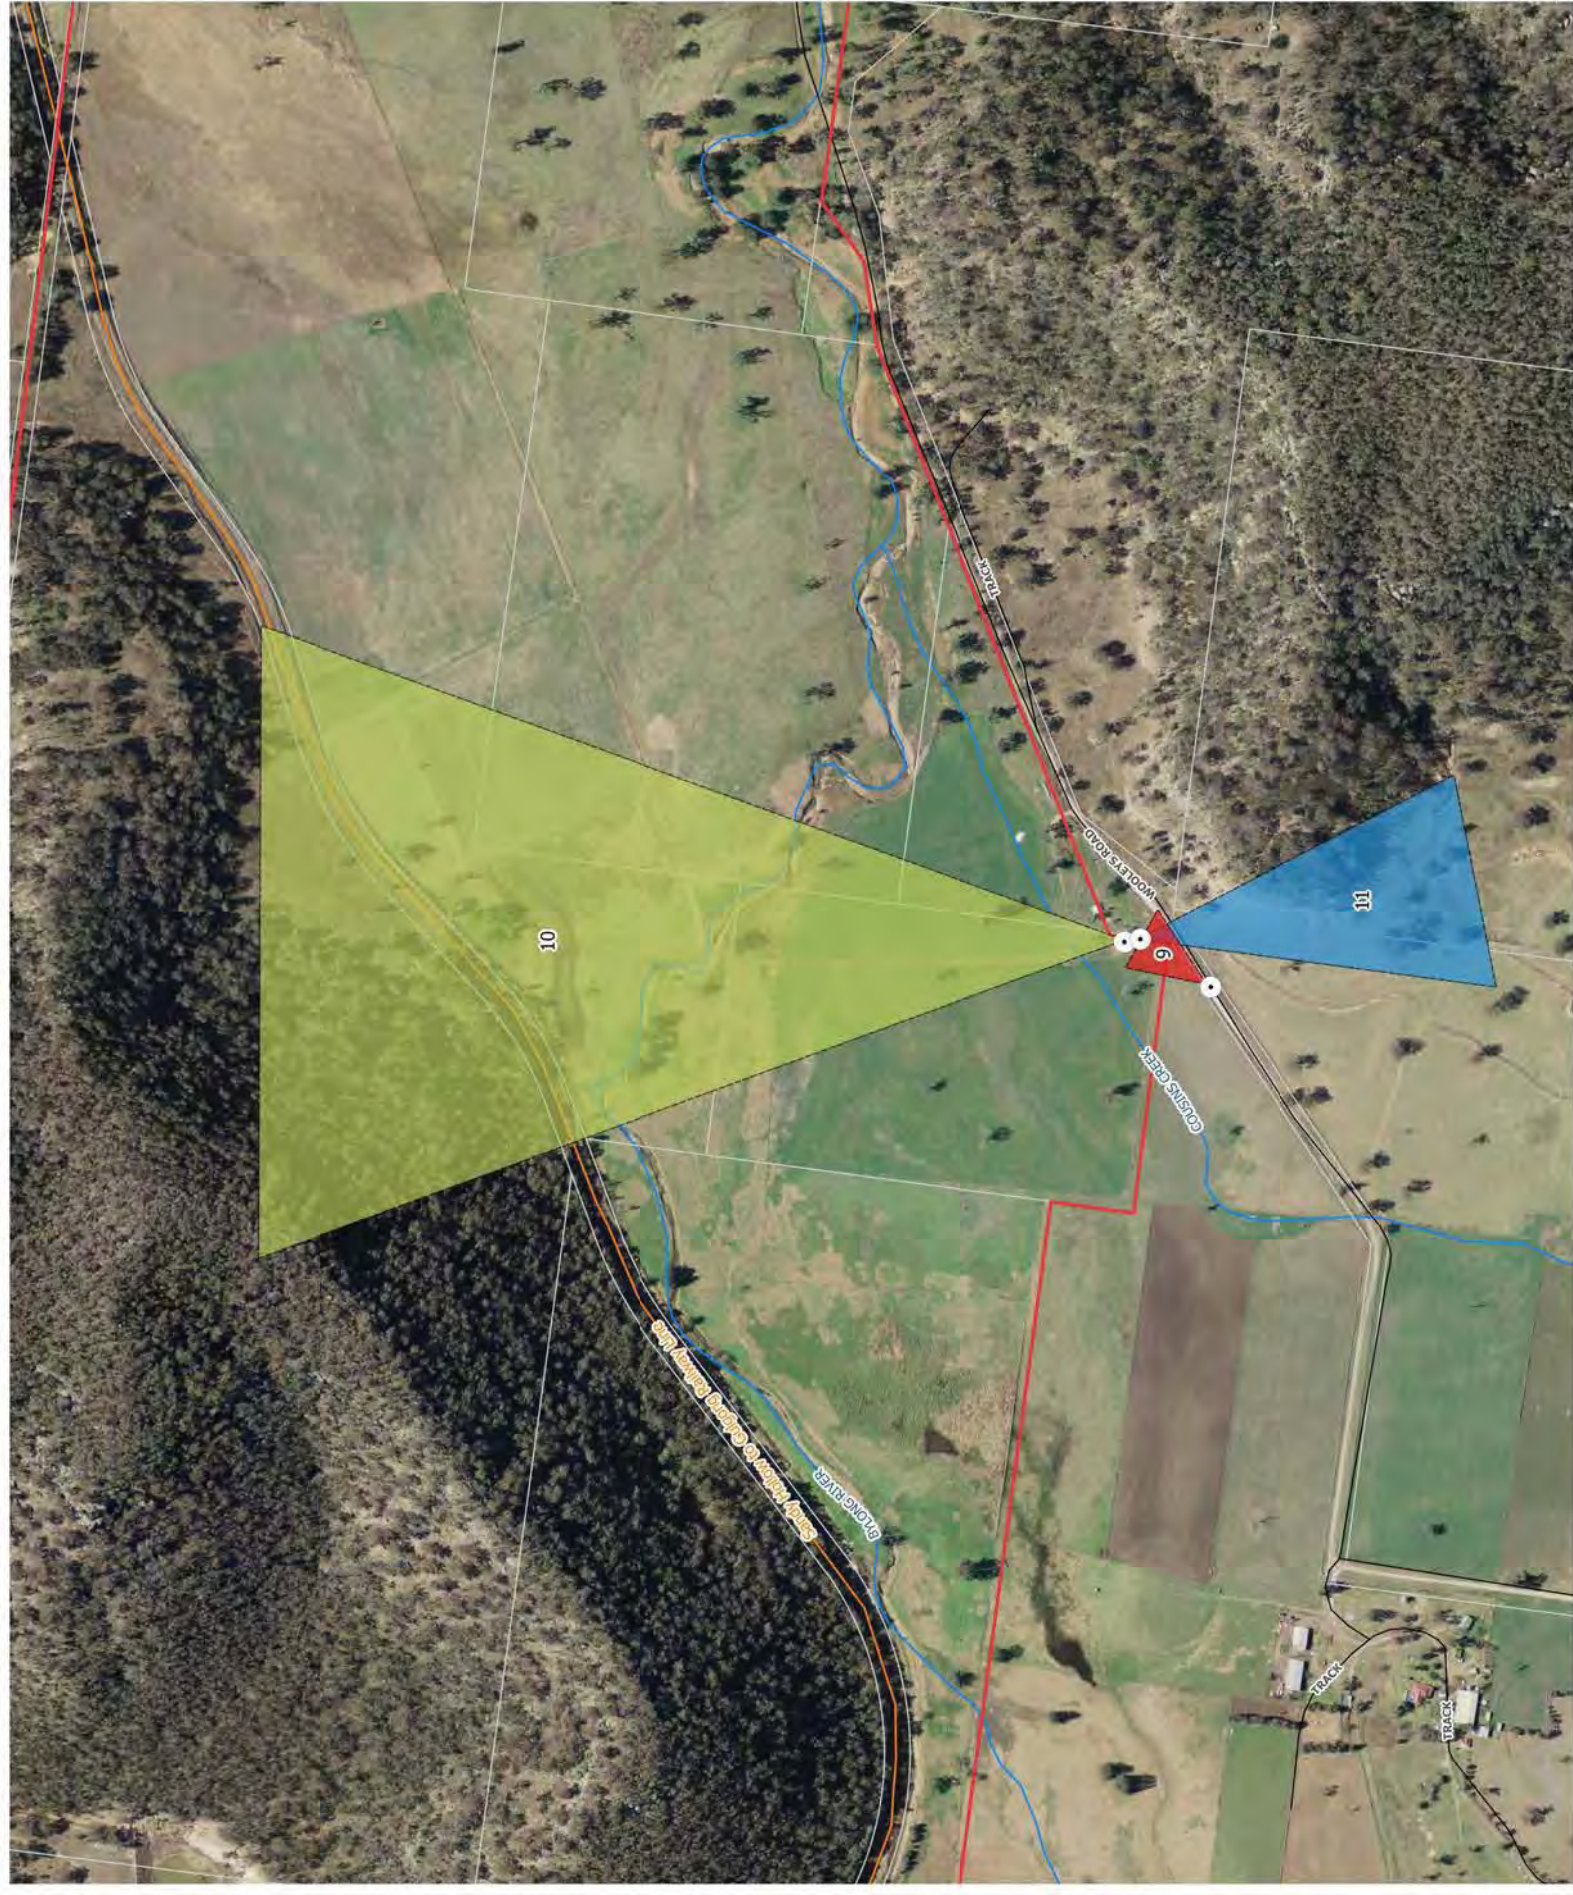
Iron Tank View Lines

Being a modest dwelling, the views to and from Iron Tank are limited in number to a view towards the house from Woolleys Road and a view from the front door towards the south and the rear door northwards. These views are shown on Figure 19. The view towards Iron Tank (View 1 of Figure 19, see Plate 10) sites the House within open rural paddocks with limited plantings directly associated with the house. The juxtaposition of the open paddocks against the native vegetation on the ranges behind creates a significant rural landscape. The views from the front door of the house, towards the south-west (View 2 of Figure 19, see Plate 11) slope upwards towards the foothills of Tal Tal Mountain. This vista is not broad and is limited by the topography. The view from the rear of the house, northward, however, is across open paddocks towards the ranges of the Great Dividing Range and the Bylong State Forest behind, which is the area of the proposed underground mining operations for the Project (View 3 of Figure 19, see Plate 12). There may be some alteration to this view associated with subsidence associated with the underground mining activities. It is considered that this will not materially effect this view as the vegetated, elevated form will remain.

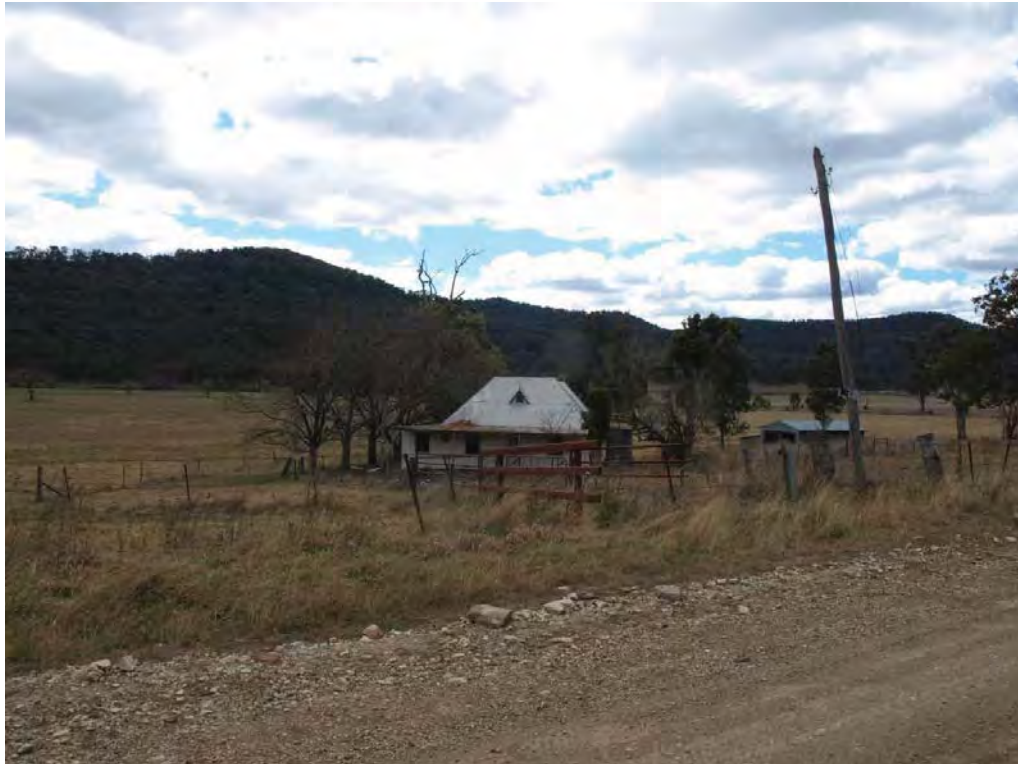
Plate 10 Iron Tank House View 1. View north from Woolleys Road towards House

Notes: The retention of the open space and the ranges behind is the important element of this view. The fencing is not sympathetic and could be removed and replaced with something of a more residential flavour.

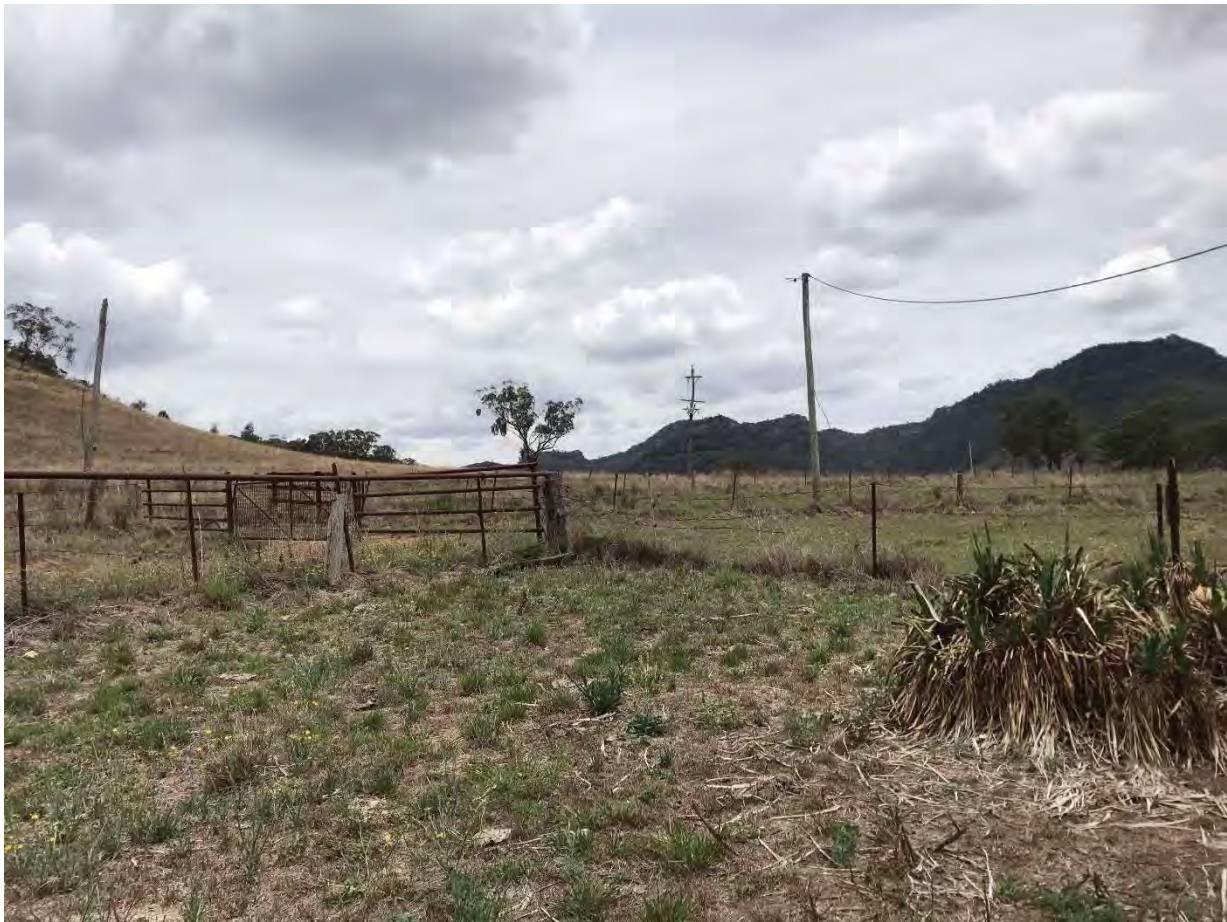
Plate 11 Iron Tank House View 2. View south from front door

Notes: The retention of the open space with views to the foothills of Tal Tal Mountain is an important element of this view.

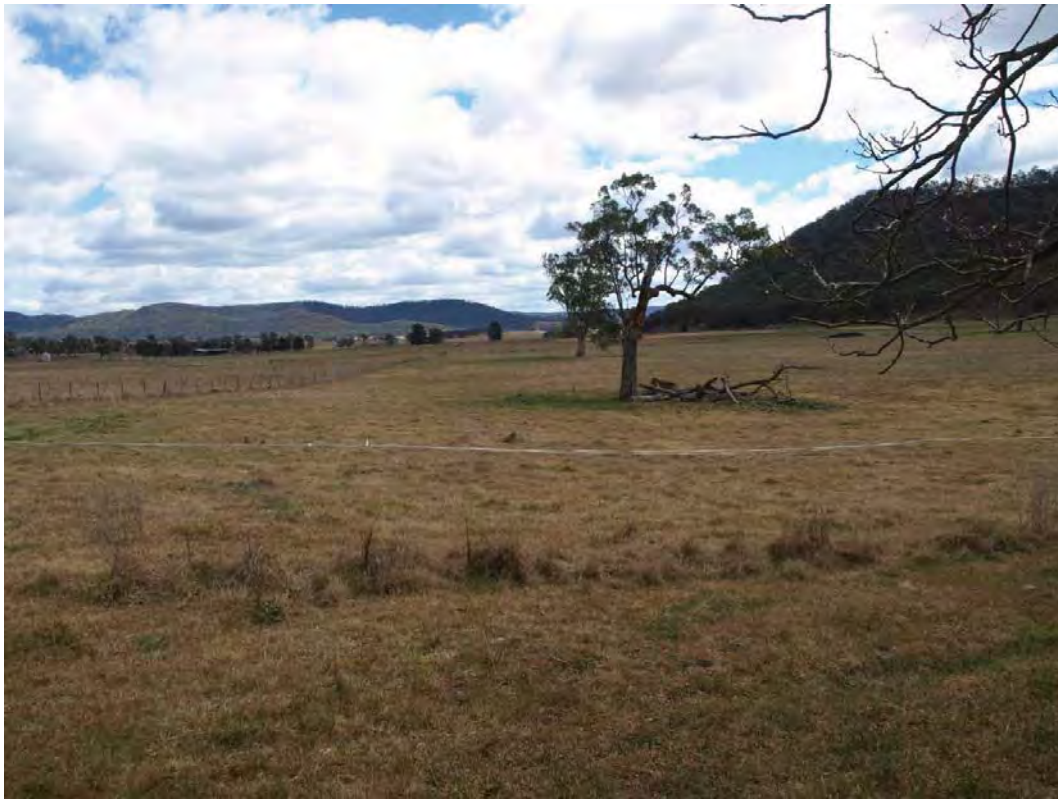
Plate 12 Iron Tank House View 3. View north-west from back door

Notes: The retention of the open space with views to the Growee Ranges in the background is an important element of this view. This view will be maintained by the Project, with some alterations occurring outside the field of vision to the south (left of image).

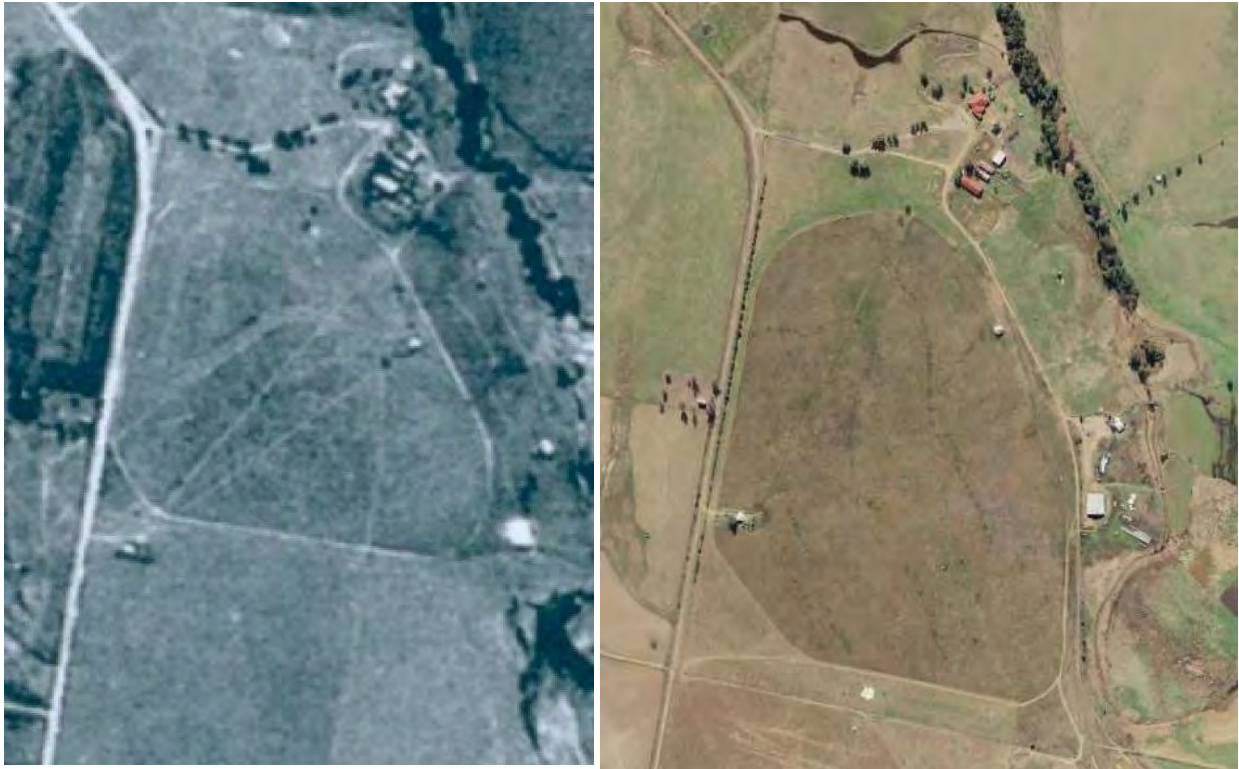
Figure 20 Extent of race horse training track 1977 and present. Source: 1977 aerial, Department of Lands Merriwa Run 8 and Six Maps, NSW Government

Located to the south west of Tarwyn Park Stables is a race horse training track. This feature is absent from the 1958 aerial (refer to Figure 22), but appears in the 1977 aerial and was therefore constructed by the Andrews. Sometime between 1977 and 1999, the training track was extended to its present extent (refer to Figure 20). It is approximately 2.1 km in circumference, roughly comparable to Flemington Racecourse (2.31 km). The training track is associated with the Andrews era of occupation.

Contour banks are primarily evident on the western side of Bylong River between Farm House 2 and the Tarwyn Park Homestead (Plate 14). A second large contour bank has been formed to the north of the Homestead. This contour can be clearly seen on aerials as retaining water and forming a quasi-wetland (Figure 20), known as a nutrient sink in NSF terminology.

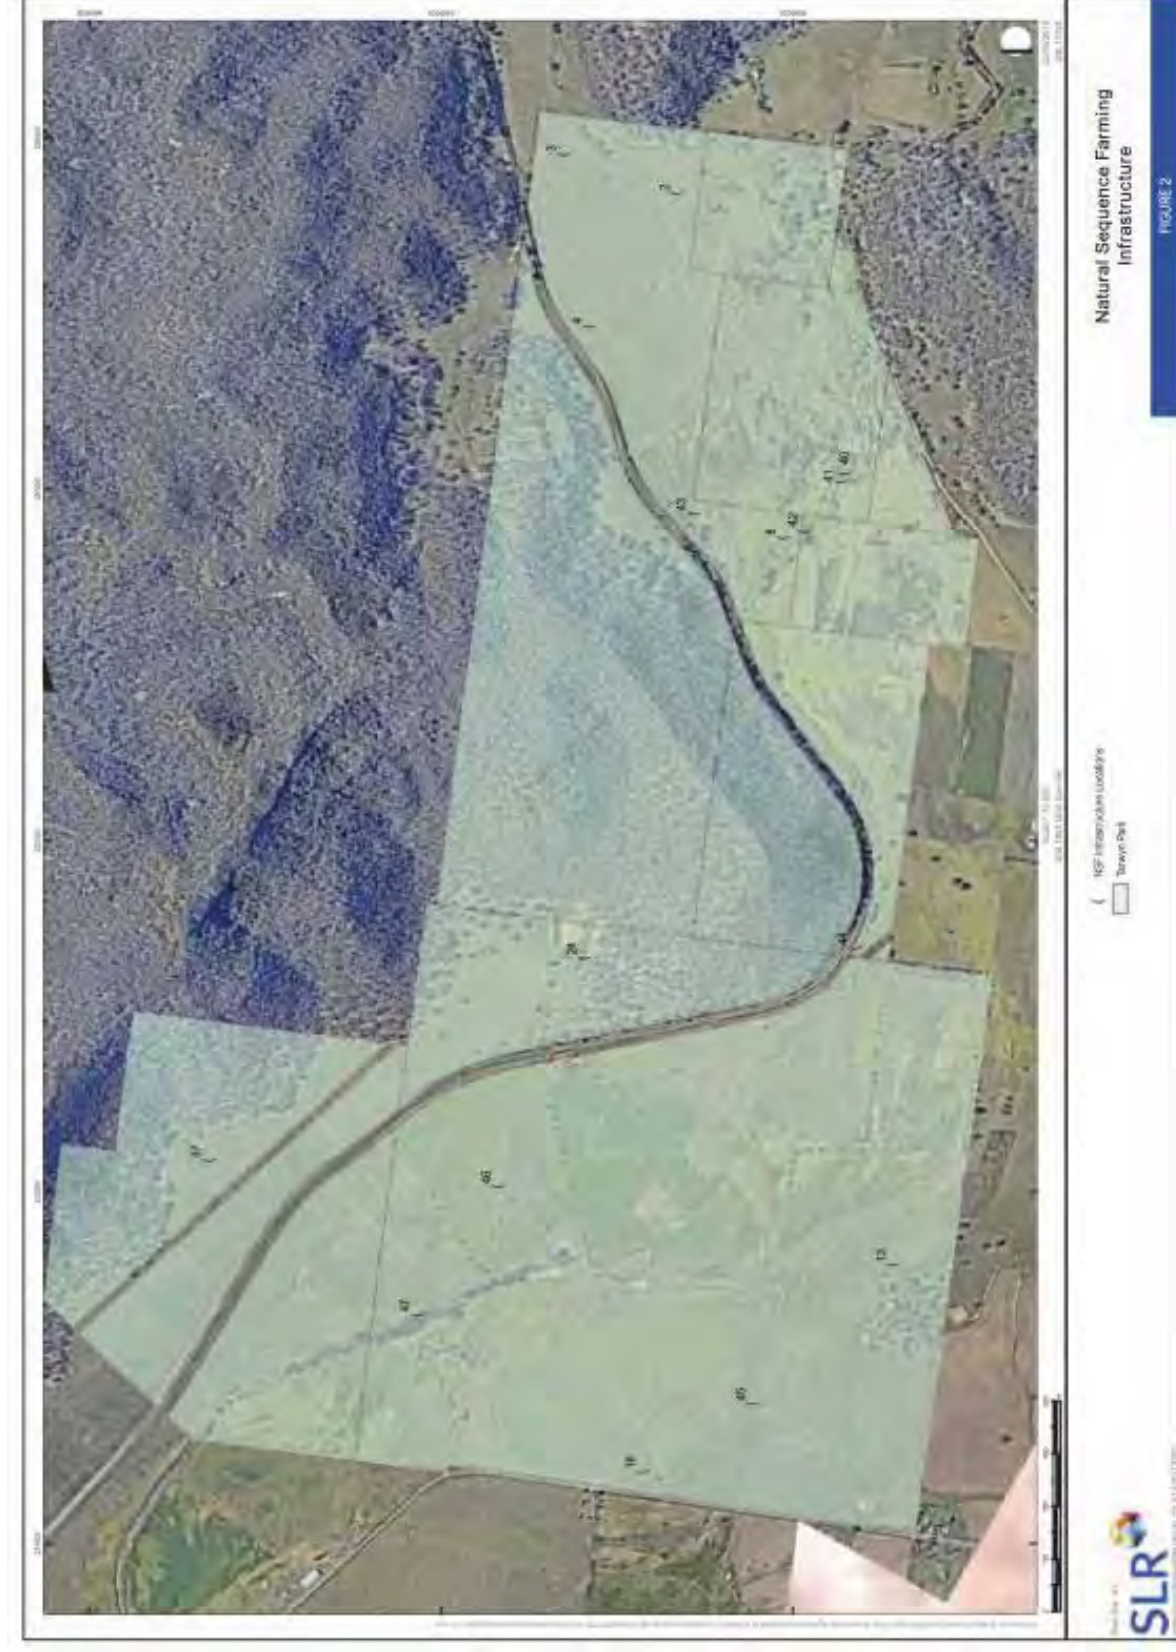
Figure 21 Features associated with Natural Sequence Farming. Source: SLR Consulting 2016:16

The features associated with NSF include contour banks, leaky weirs, nutrient sinks, nutrient delivery areas and sundry additional items, as shown in Figure 21.

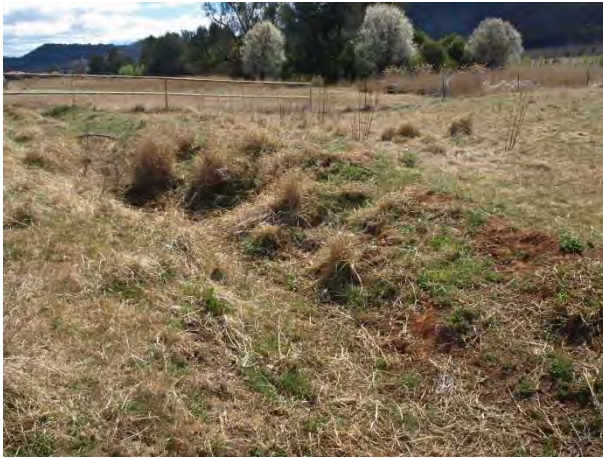
Plate 13 Contour feature on the western side of Bylong River, adjacent to Farm House 2

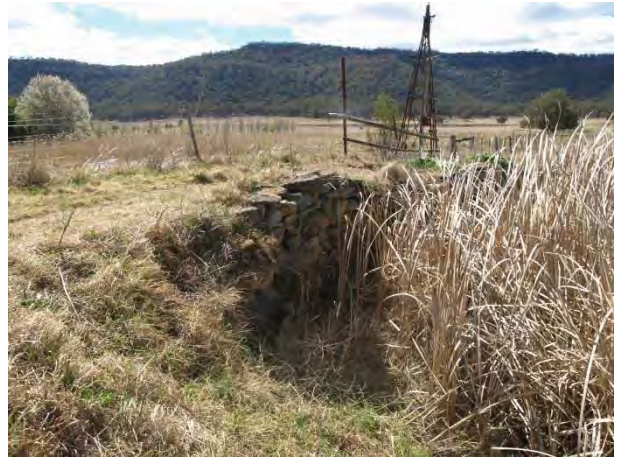
Plate 14 Dam and bridge feature north of Farm House 2

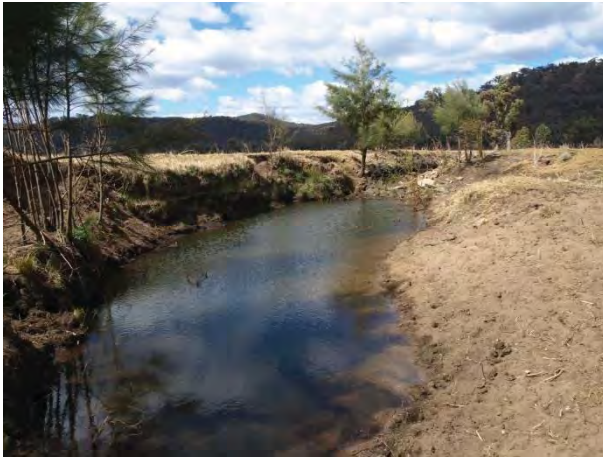
Plate 15 Leaky weir on Iron Tank property

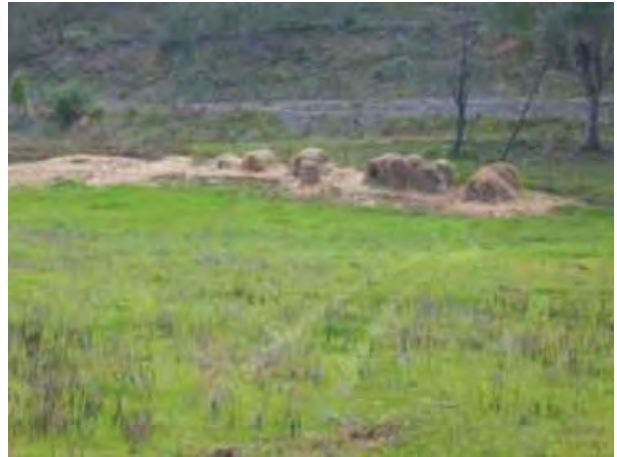
Plate 16 Decomposing hay for nutrient delivery Source: SLR Consulting 2016:18

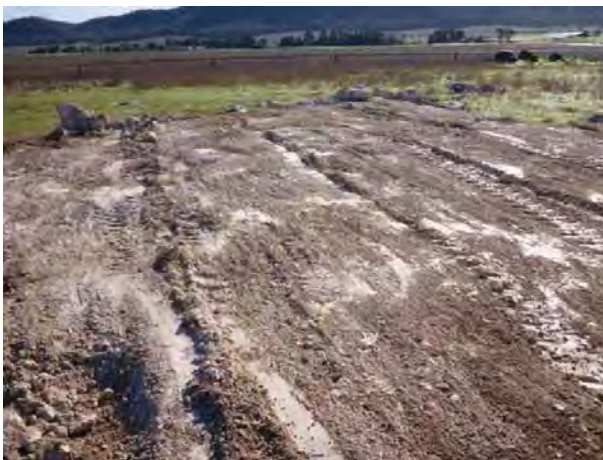
Plate 17 Lime/rock phosphate stockpile area south of racecourse. View north east. Source: SLR Consulting 2016:24

The NSF method avoids the use of fertilisers, instead preferring natural compounds, including lime and rock phosphate. There is evidence of stockpile areas for these compounds to the south of the horse training track (Plate 17).

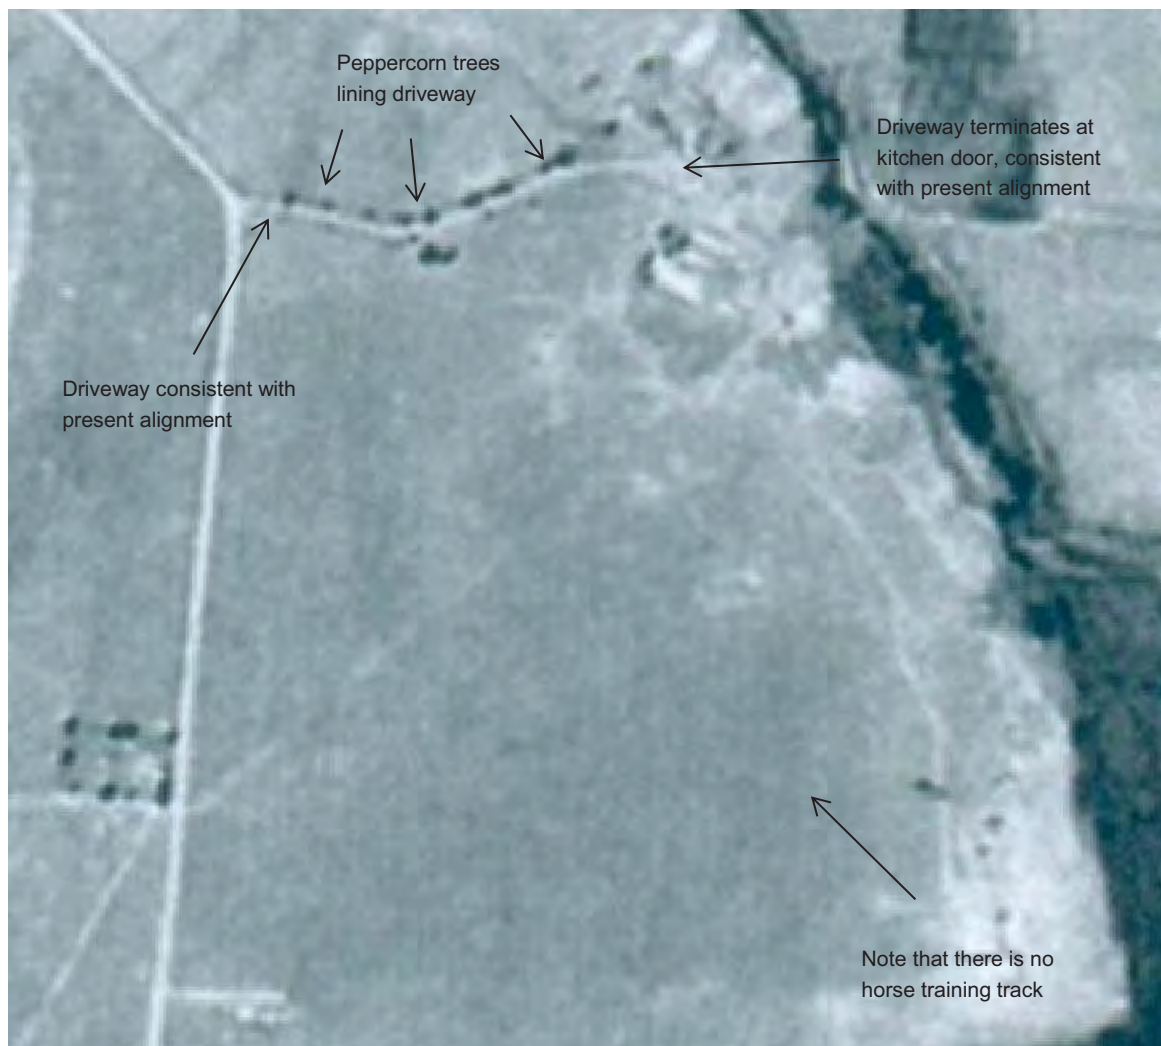
Figure 22 Excerpt from a 1958 aerial. Features of interest labelled. Source: Department of Lands, Run 8 Merriwa November 1958

The Poplars sit adjacent to a sporadic line of Peppercorn trees (*Schinus molle*, Syn. *S. areira*), which are the remnants of an earlier planting demarcating the line of the driveway. An aerial from 1958 shows the line of trees, assumed to be a consistent planting of Peppercorns, to be more regular (Figure 22). Further Peppercorn trees are located to the north of the stables, indicating this species was a favoured ornamental of the Thompson family.

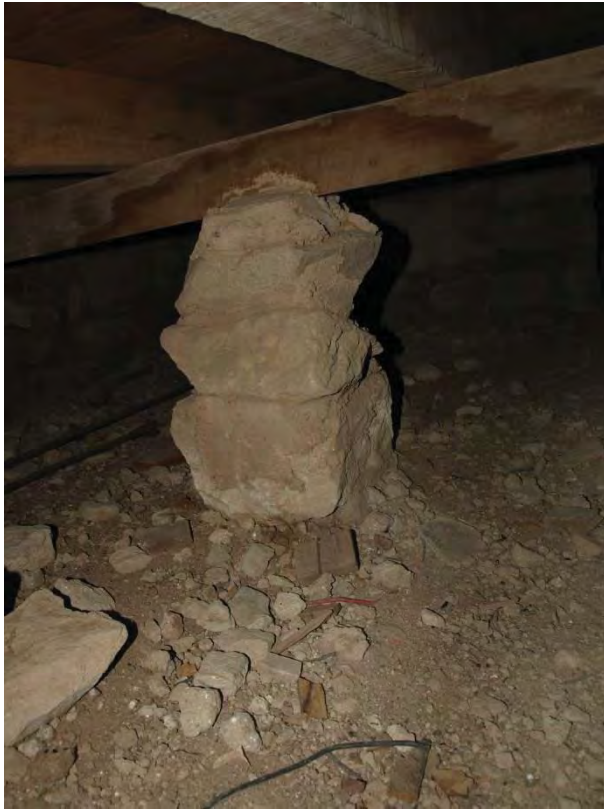
**Plate 25** Subfloor cavity beneath the pantry (room 4)

An examination of the floorboards in the pantry and kitchen (rooms 4 and 5) where they are exposed indicates that there are no gaps in the floorboards and that there is unlikely to be subfloor deposits. Subfloor deposits can comprise small items that have slipped between gaps in the floorboards. An inspection of the underfloor cavity (Plate 25 and Plate 26), which was available via inspection holes in the pantry, kitchen and staff dining room (rooms 4, 5 and 6) confirmed that the subfloor space appeared sterile, other than small amounts of construction debris. It is considered that there is low to no subfloor archaeological potential associated with Tarwyn Park Homestead.

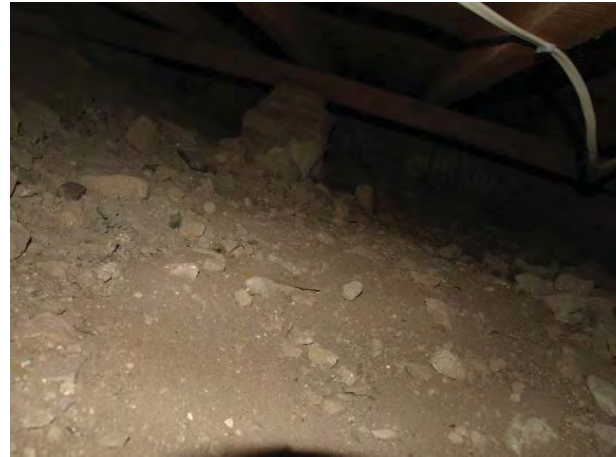
**Plate 26** Subfloor cavity beneath the kitchen (room 5)

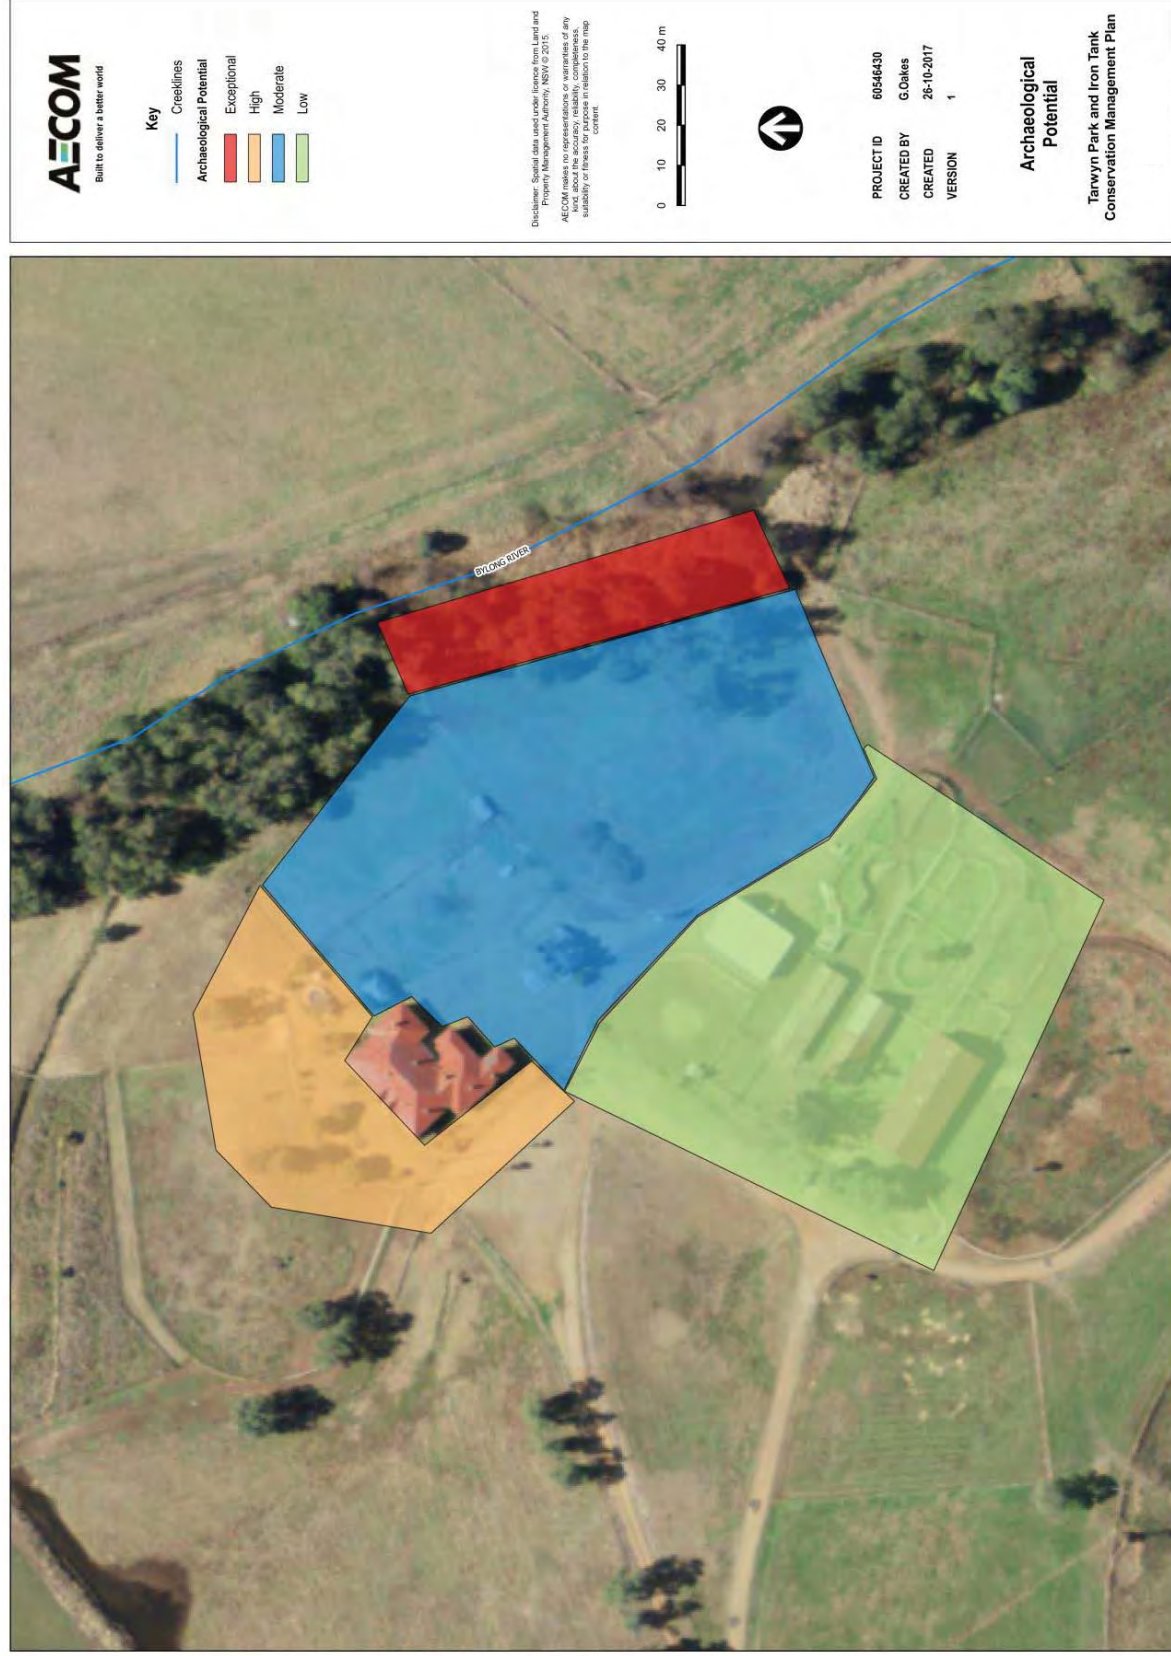
Figure 24 Features and areas of Archaeological potential associated with Tarwyn Park

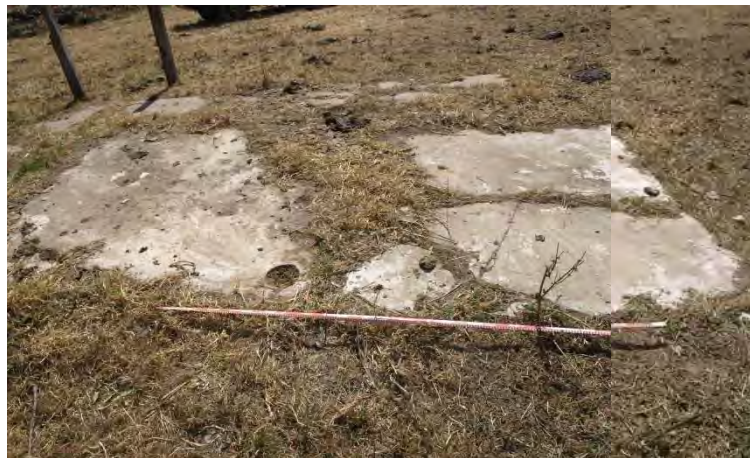
Plate 27 Concrete pad thought to be associated with former sandstone building. View north

Oral testimony indicates there was formerly a sandstone structure located to the north east (rear) of the house. This is indicated as an area of exceptional archaeological potential on Figure 25. The structure was purchased by a winery in the Hunter Valley and was relocated to form part of the cellar door buildings. The probable location of the sandstone structure is identified by a concrete pad and an associated depression (Plate 27, Plate 28)..

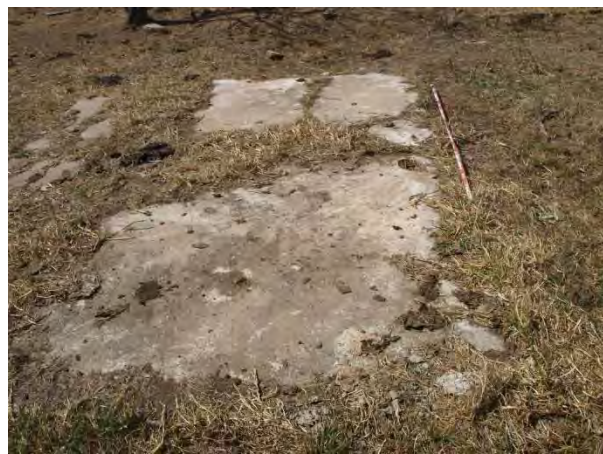
Plate 28 Concrete pad thought to be associated with former sandstone building. View west

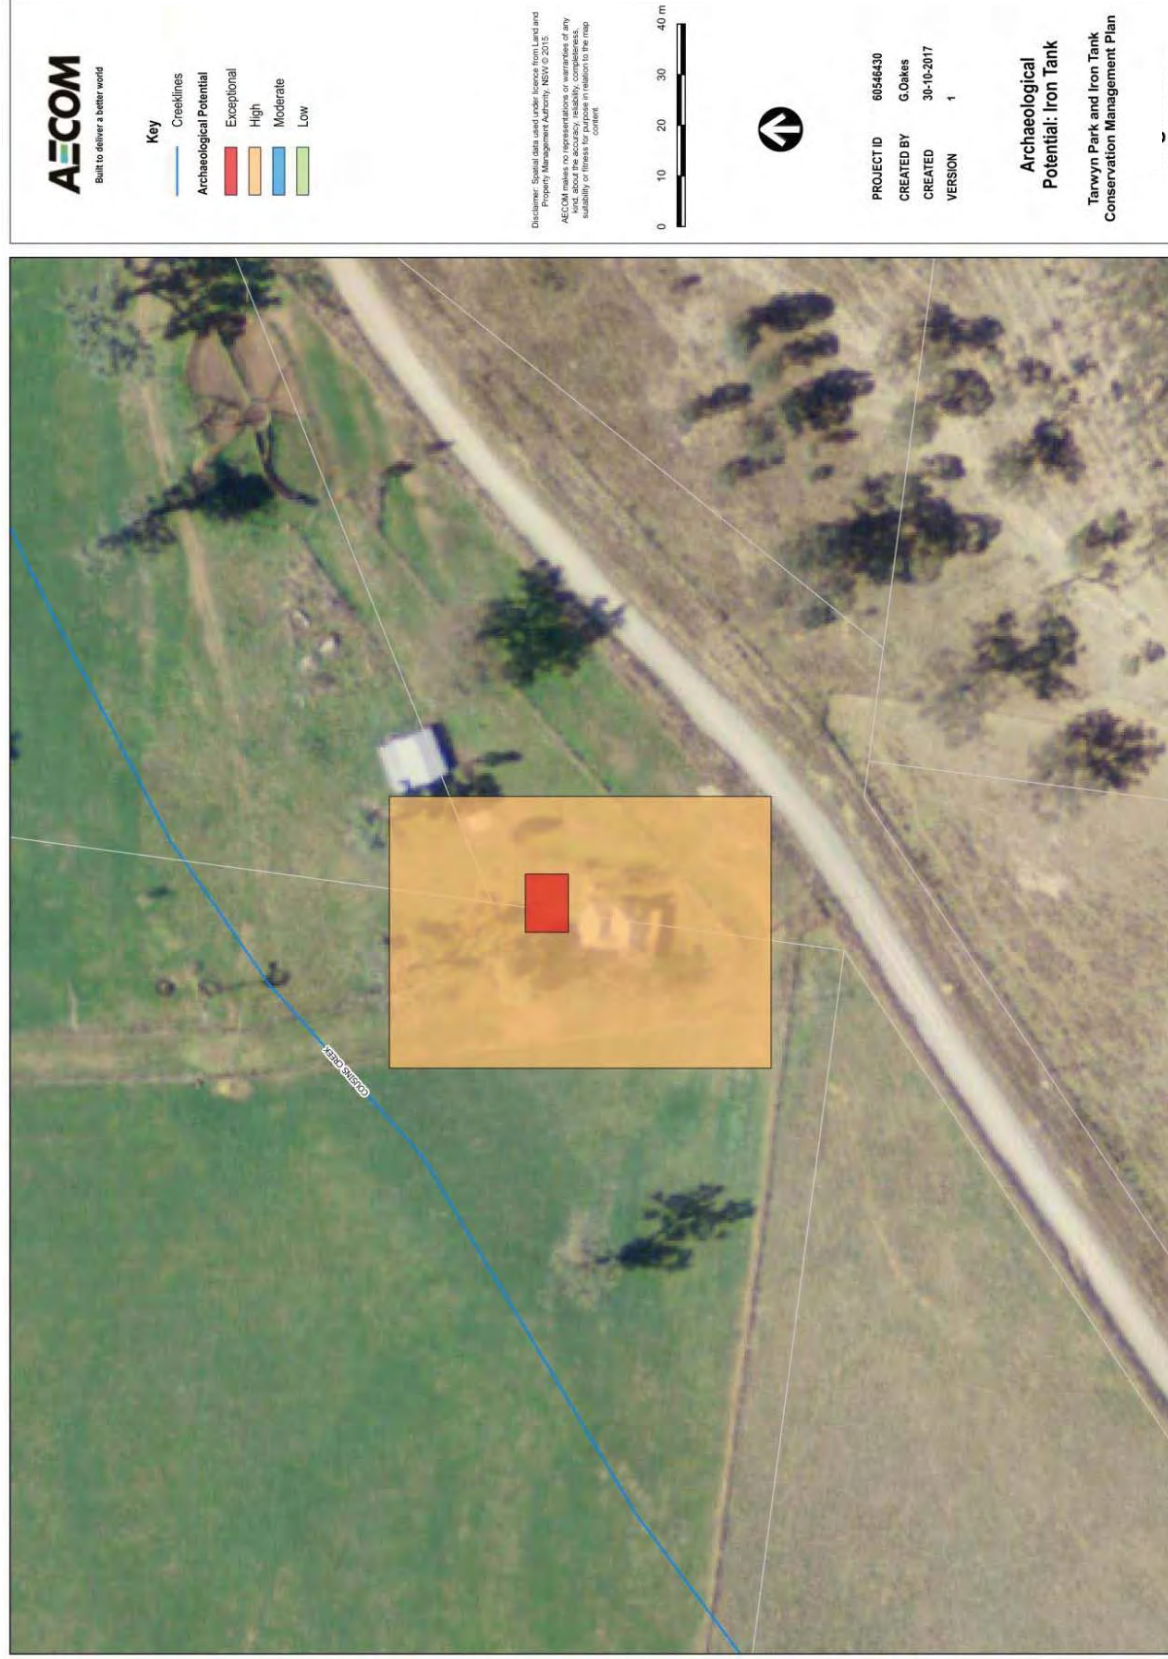
Figure 25 Archaeological potential associated with Iron Tank

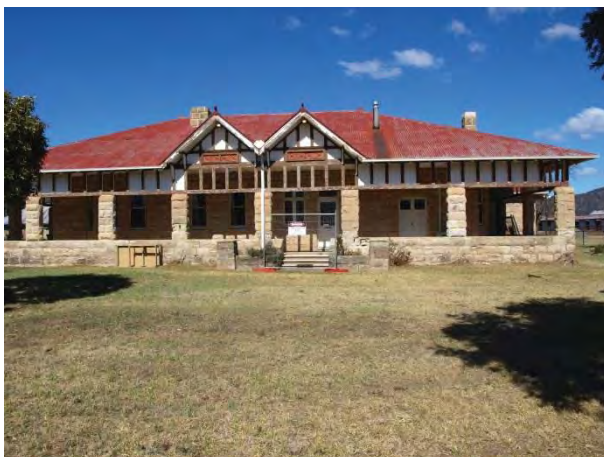
Plate 29 Overview of Tarwyn Park Homestead showing sandstone construction and corrugated iron roof

The Homestead is constructed of coursed rubble sandstone blocks with a hipped corrugated iron roof supported on timber joists (Plate 29). There is evidence that the corrugated iron roof is not original, but covers and earlier roof of asbestos tiles (Plate 30). The footprint has a complex form with the front, northern elevation projecting out from the body of the building, which is arrayed behind. The rear service wing of the homestead almost encloses a patio area.

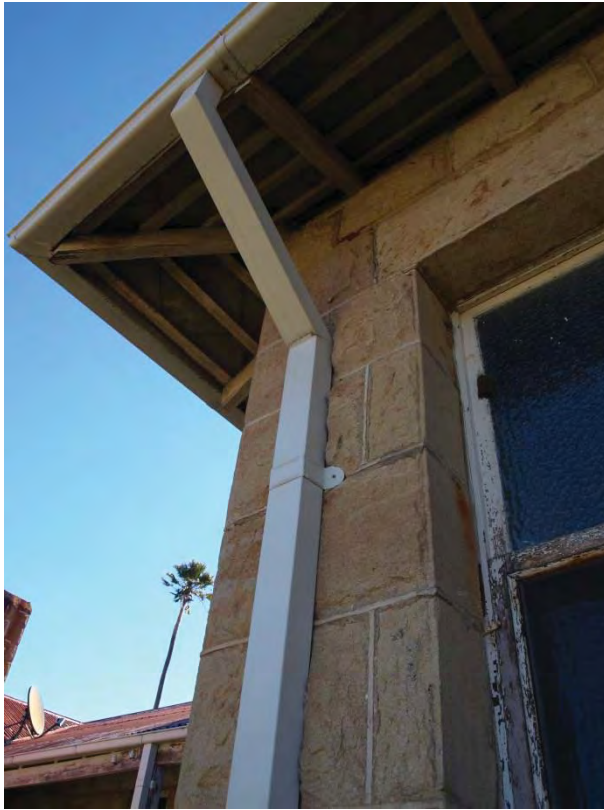
Plate 30 View under eaves on southern side showing diamond laid asbestos tile roof

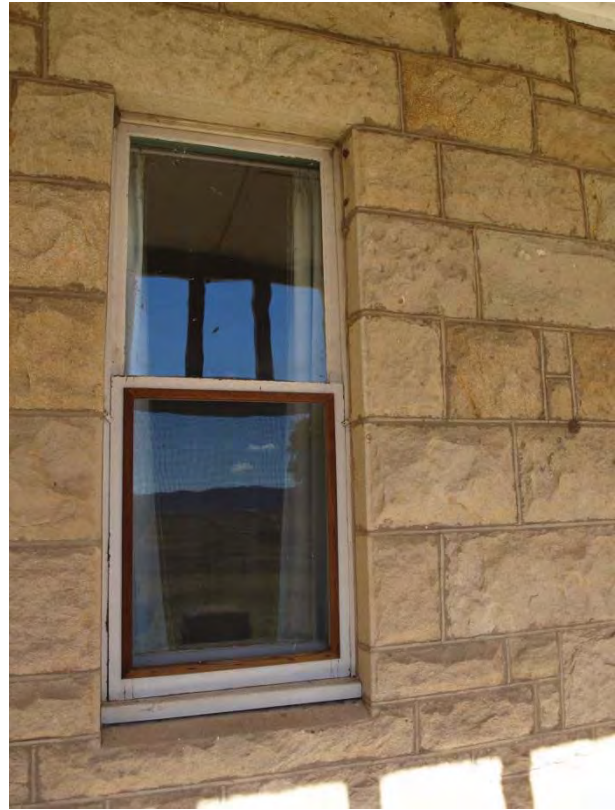
Plate 31 Representative window frame

The materiality of the building is consistent throughout, in that the windows, doors and frames are painted timber (Plate 31).

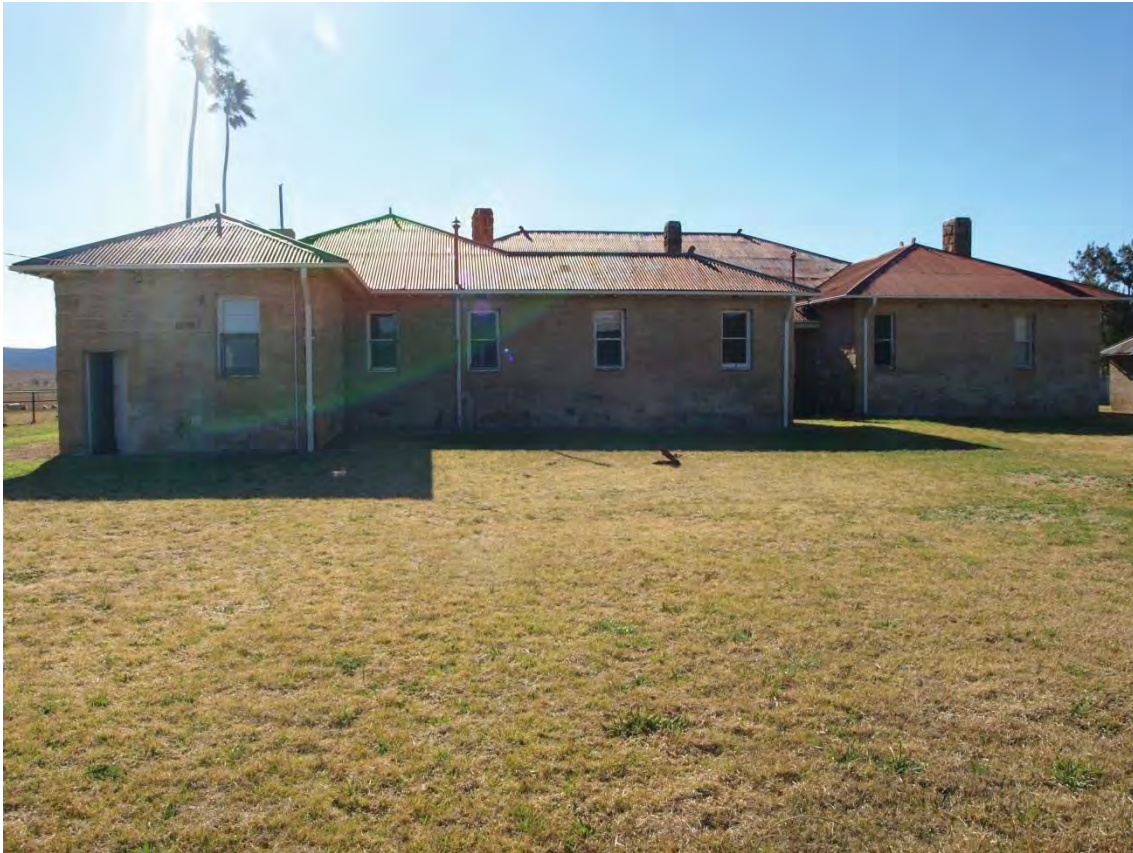
Plate 33 Overview of southern elevation

The southern elevation is broken by the entrance into the semi-enclosed patio, but otherwise is dominated by seven windows (Windows 8, 9, 16, 17, 18, 19 and 20). All are single pane, single hung sash windows. With the exception of Window 9, which is associated with a bathroom and contains rippled glass, all the windows contain plain glass.

Door 10 is a utilitarian timber panel door. The door is in an unprotected location, evident by the weathering apparent on the door and is perhaps indicative of the door being a replacement as it has no match throughout the rest of the Homestead.

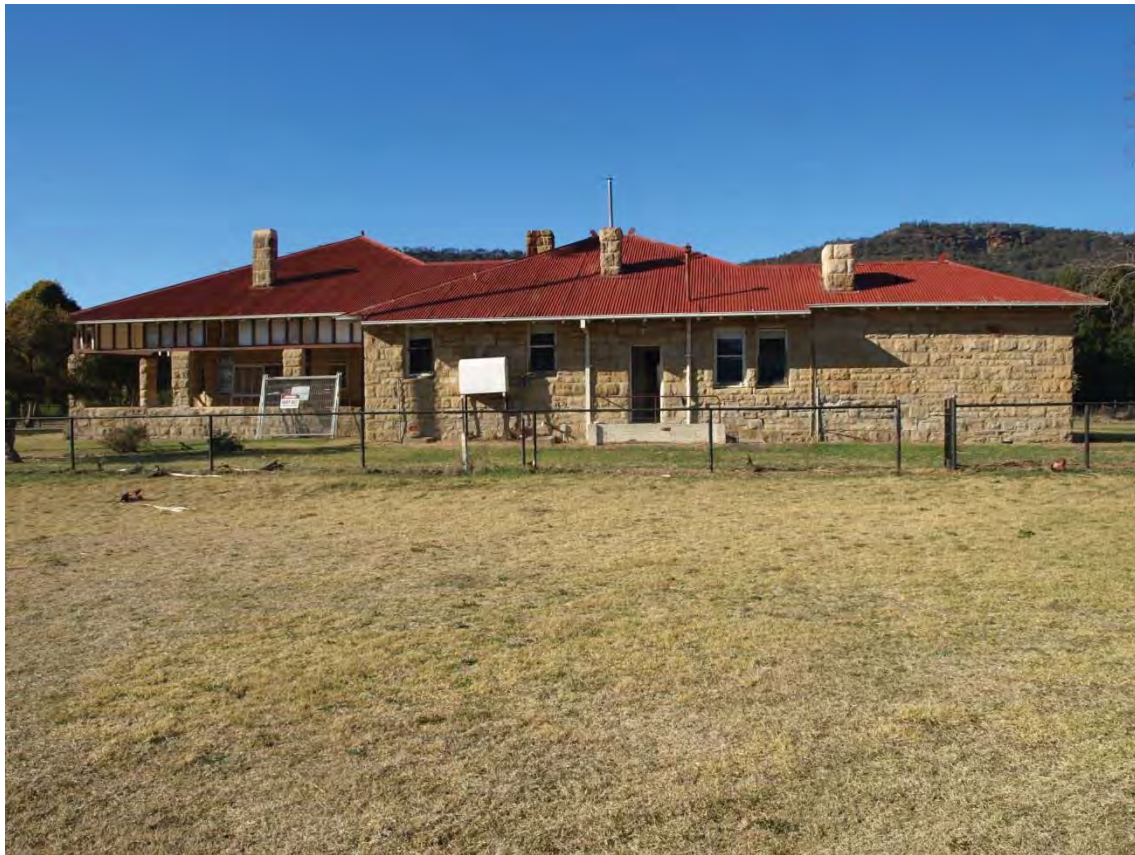
Plate 34 Overview of western elevation

The northern most portion of the elevation is covered by the wrap-around verandah. This portion of the elevation contains two single hung sash windows with plain glass, which are associated with the dining room. To the north, is a projecting bay window containing four single hung sash windows, all containing leadlight glass. While this leadlight continues the floral motif, it is slightly different in style and execution, indicating they are possibly later in date than the leadlight on the northern and eastern elevations.

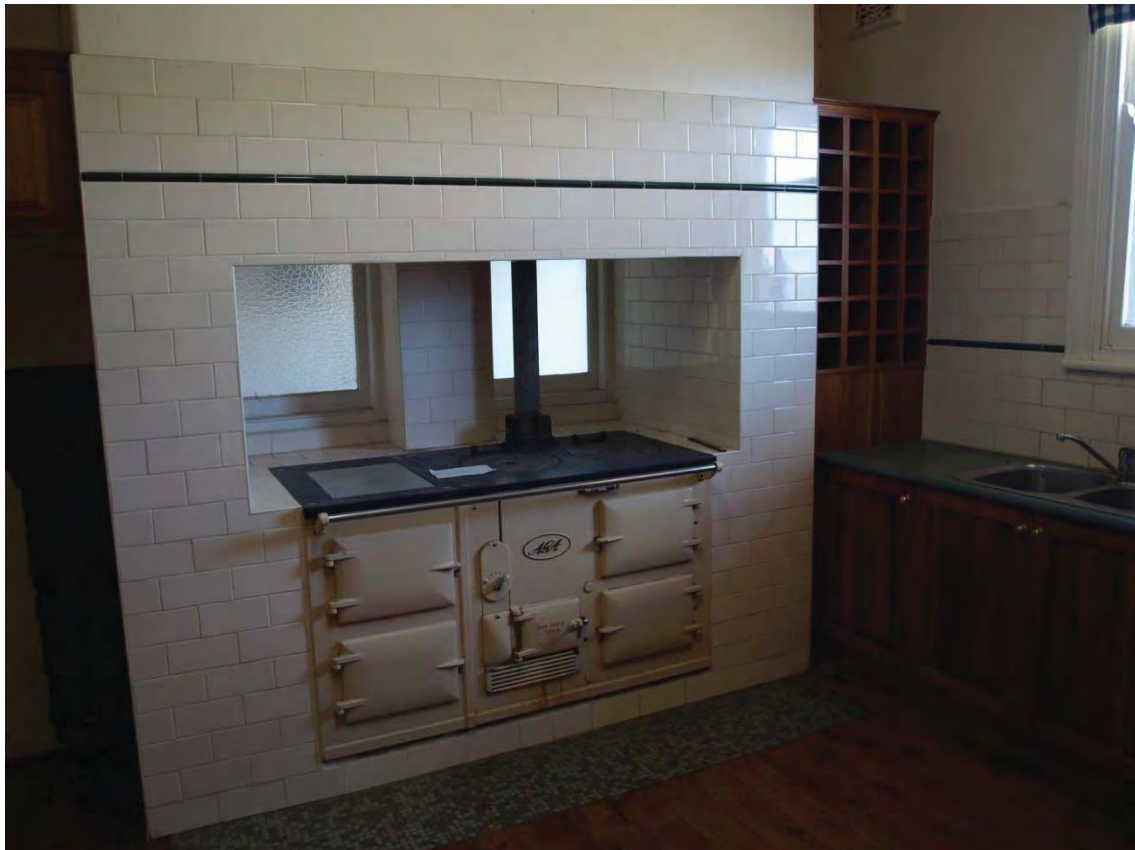
Plate 35 Former fire place showing modification to insert windows

The kitchen (room 5) is located directly to the south. The room is dominated by the fire place, which contains an AGA oven (Plate 35). Despite appearances, this configuration matches the original architectural drawings (Figure 13), with the windows through to the hallway (room 7) a device to provide light to the cook. The kitchen cupboards are of timber and are a recent replacement. While the Homestead in general retains a high degree of integrity and original features, fittings and fixtures, it is evident that the kitchen has undergone the most change.
