Conservation Management Plan for Tarwyn Park and Iron Tank

BYLONG COAL PROJECT
Response to PAC Review Report

DRAFT Conservation Management Plan

AECOM Australia Pty Ltd

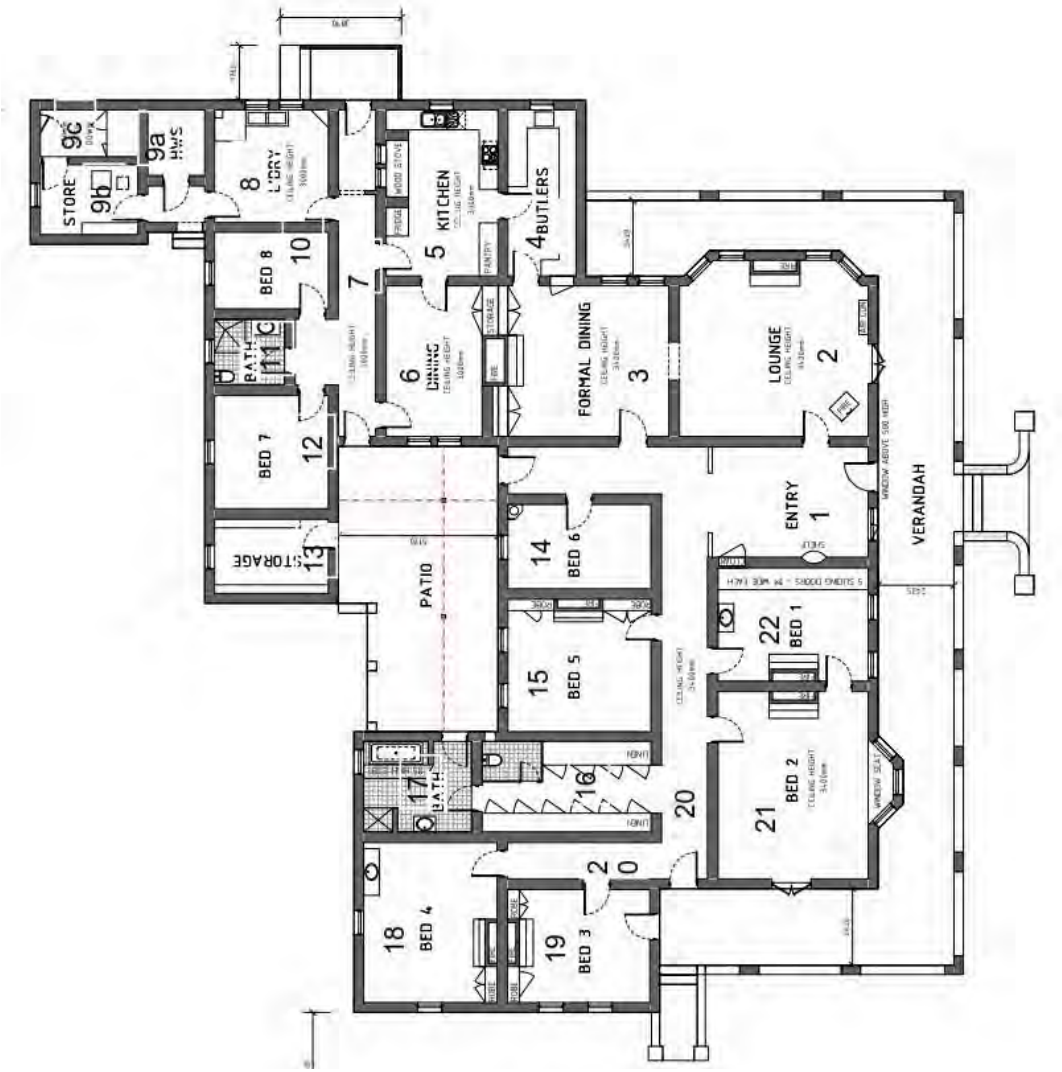
Figure 26 Tarwyn Park Homestead internal layout and room numbering

The Homestead contains 22 rooms, which are roughly grouped by function into three areas (Figure 26). The formal functions of the Homestead, including the entrance hall (room 1), formal lounge (room 2) and dining room (room 3) are located in the north-eastern corner (seen on approach from the driveway). The service centre, including the kitchen (room 4 and 5), laundry (room 8), boiler room (room 9), bathroom (room 11), storage rooms (rooms 10 and 13) and offices (room 12) are located in the south-western portion of the Homestead. The master bedroom (room 21), including a dressing room (room 22), is located in the north-eastern corner of the house, with a further four bedrooms and a bathroom located to the south.

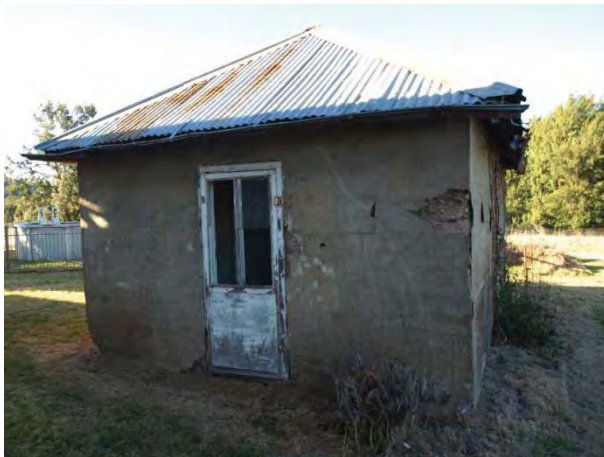
Plate 36 Vernacular Concrete Structure. View north east

To the south east of the Tarwyn Park Homestead is a rectangular structure, measuring approximately six metres by four metres (Plate 36). It contains a doorway in the western elevation and a single hung four pane sash window in the southern elevation (Plate 37). The roof is hipped and set on unmilled timber logs. The joists have been repaired in places with tongue and groove floor boards (Plate 38). The guttering has come away from the majority of the roof (Plate 37).

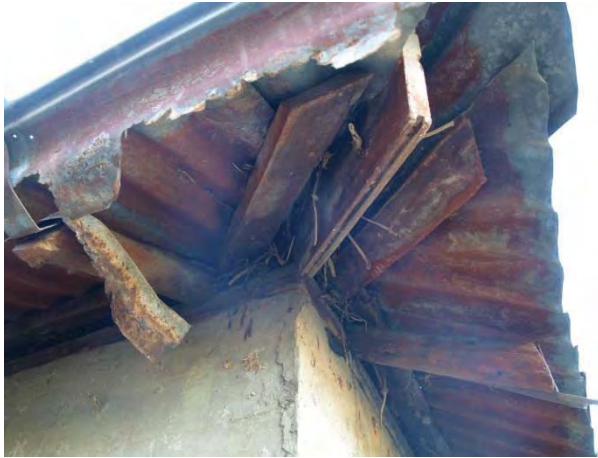
Plate 38 Vernacular Concrete Structure. Roof construction and repairs

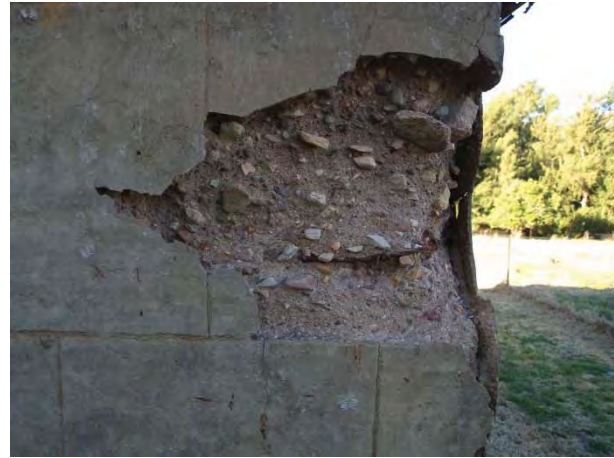
Plate 39 Vernacular Concrete Structure. Detail of concrete construction and barbed wire 'reinforcement'

The construction of the off-form concrete structure is unusual. It is formed of homemade cement created by mixing river gravel, assumed to be from Bylong River, with a binding agent, probably Portland Cement. The builder has crudely attempted to reinforce the concrete through the use of barbed wire, which has been placed horizontally within the walls (Plate 39). The structure has then been rendered, and ashlar lines incised to give the appearance of sandstone construction.

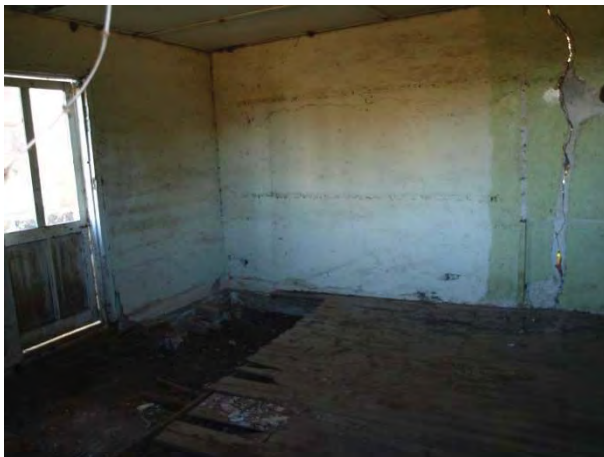
Plate 40 Vernacular Concrete Structure. View of interior

The interior has also been rendered and fitted with a timber floor, supported on timber joists. The flooring and joists have been removed from the southern portion, in proximity to the door, at some point (Plate 40). There is no indication as to the function of this structure.

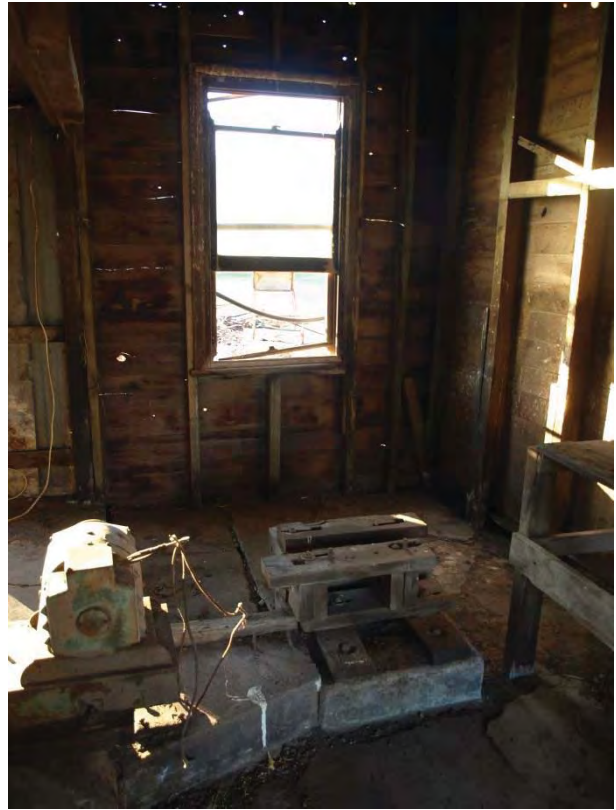
Plate 42 Garage interior showing generator mounting block

Located to the south of Tarwyn Park Homestead is a former elevated tank stand consisting of a platform supported on unmilled timber uprights. The space beneath the tank stand has been infilled with a weatherboard clad workshop, subsequently to which a generator room and open garage were appended. The fabric would suggest that these three infill construction phases occurred between the late 1940s and late 1960s. It is unclear from an initial inspection of the fabric as to whether the concrete garage or the generator shed came first. The northern workshop section is constructed of weatherboard (Plate 41), with a skillion roof form. The interior of this section was not accessed on the basis of safety concerns. On the western side is a small corrugated iron lean-to containing the mounting block for the generator (Plate 42). Appended to the southern side is the garage, the eastern and western walls of which are constructed of off-form concrete, which is buttressed on the western side (Plate 43). The corrugated iron roof is supported on unmilled timber posts. These posts contain brackets and hinges that indicate that swinging doors were formerly located along this façade (Plate 44). The eastern side has a small weatherboard lean-to, which may have been used for storage (Plate 46). The structure was formerly topped by three water tanks (Plate 47), but these were identified as structurally unsound by WorleyParsons and KEPCO and removed in 2016/7 to prevent a collapse, which may have resulted in the garage as a whole being destroyed.

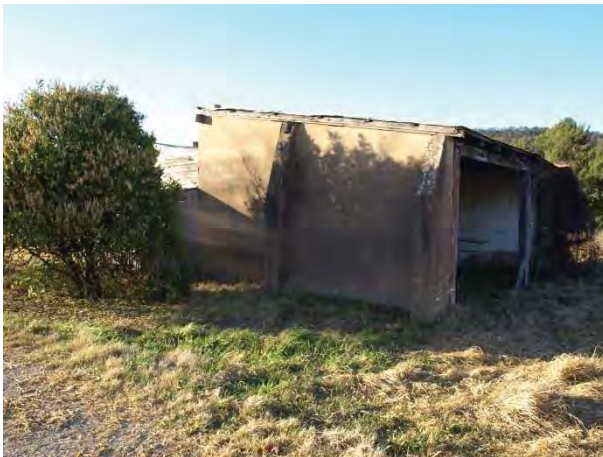
Plate 43 Garage. View north east showing buttressing to western wall

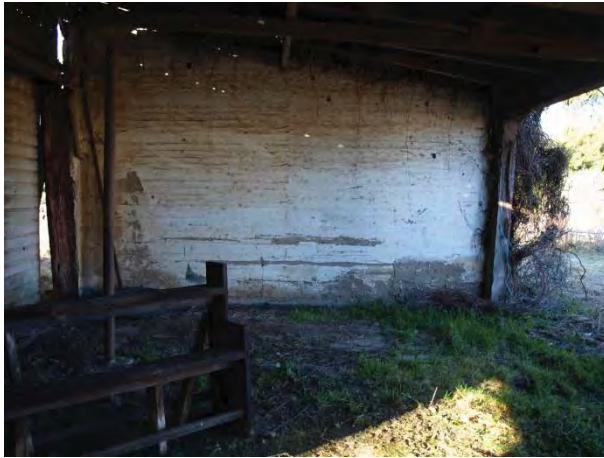
**Plate 45** Garage interior showing off-form concrete wall

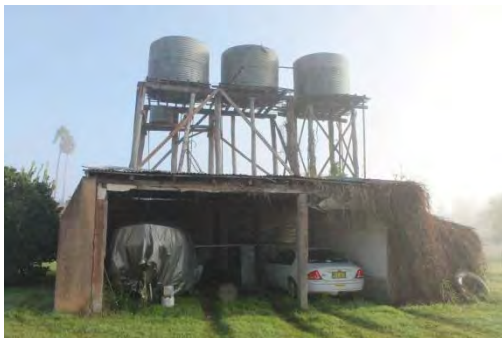
**Plate 47** Garage view north in 2014 showing former tank stand and tanks**3.4.4 Tarwyn Park Stables**

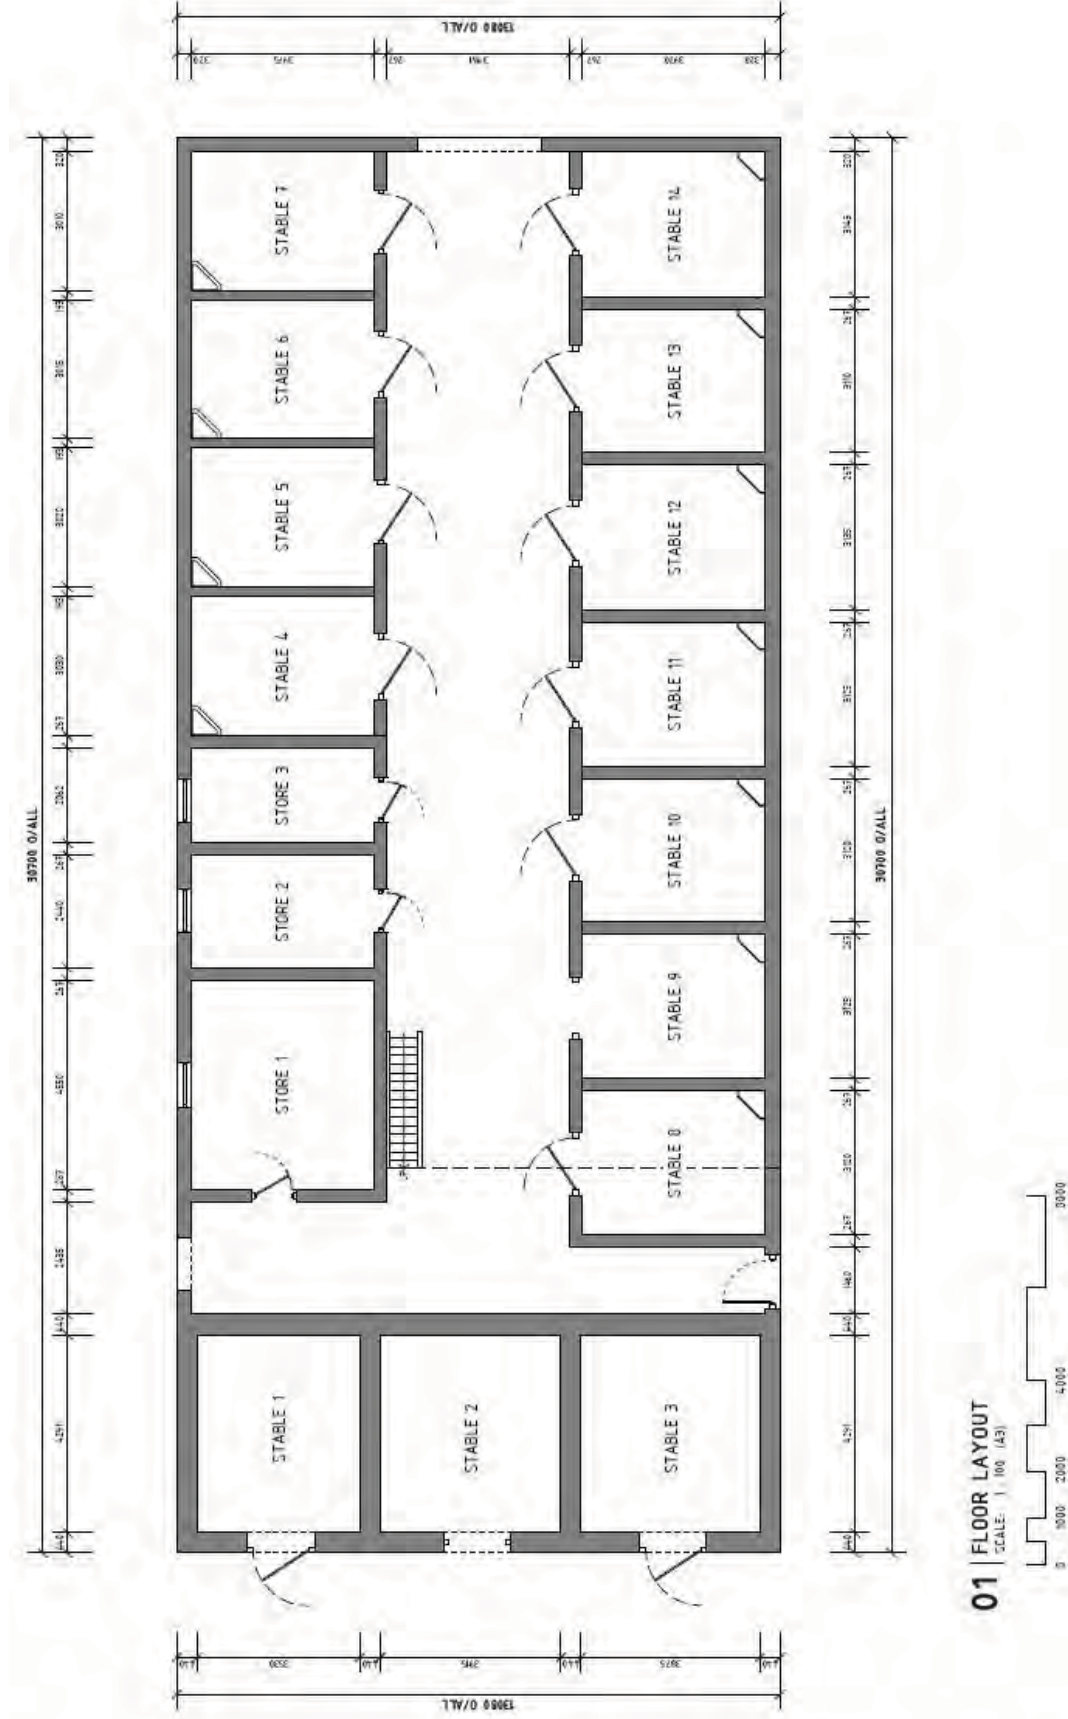
Figure 27 Floor plan of Tarwyn Park Stables

In addition, the northern elevation contains three doors, leading into three individual stalls, which are separate from the main body of the stables (Figure 27). The easternmost stall is timber lined. The other two stalls are rendered and painted in two tones – white on the upper portion and a blue-grey below. The render is in poor condition and has come away from large portions of the walls, exposing the random rubble construction underneath.

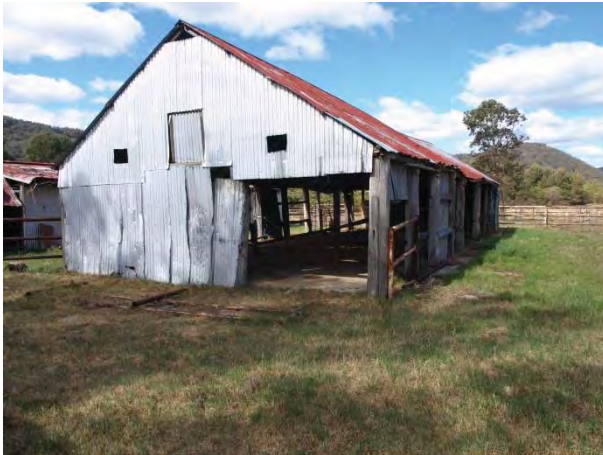
Plate 48 Corrugated Iron Shed. View south

Directly to the east of the sandstone stables described in Section 3.4.4, is a corrugated iron structure (Plate 48), which consists of a rectangular building supported on unfinished timber uprights. The structure is open along much of the eastern and western sides, although there is at the southern end a small enclosed space (Plate 49), possibly used to store hay or similar. The floor of the structure consists of concrete, incised with a square pattern to stop hooved animals from slipping (Plate 50).

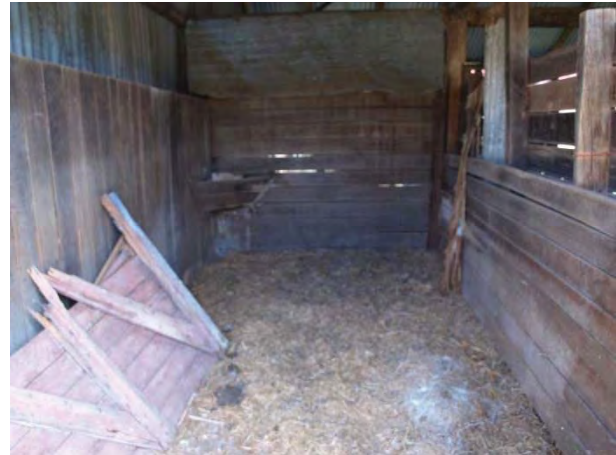
Plate 49 Annex at southern end of corrugated iron shed

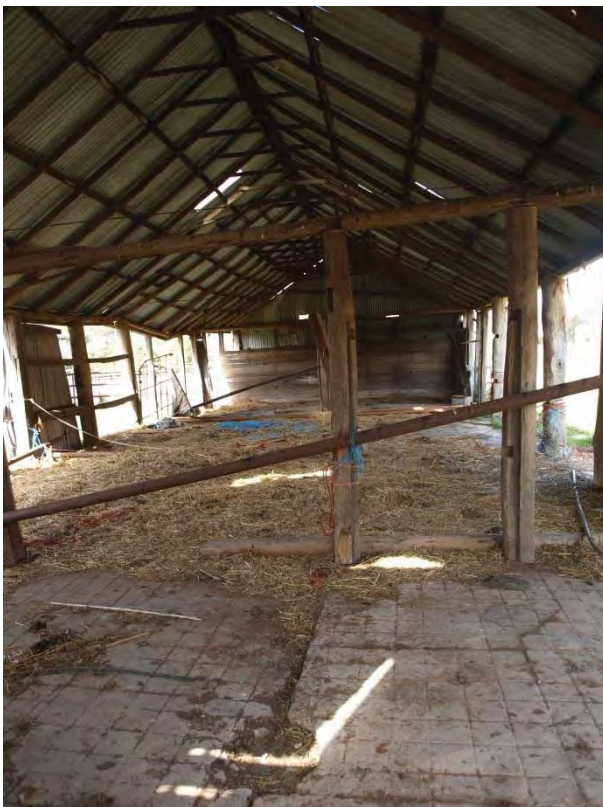
Plate 50 Corrugated Iron Shed interior showing open sides and incised concrete floor

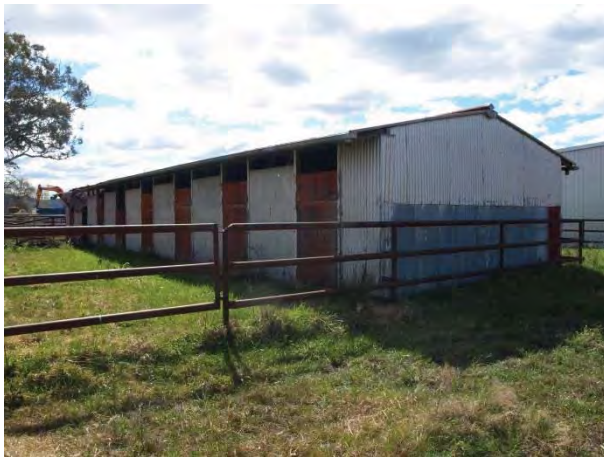
Plate 51 Corrugated Iron Stables. View north

To the east of the sandstone stables and to the south of the corrugated iron shed is a corrugated iron stable containing 14 stalls (Plate 51), separated by a breezeway (Plate 52) which divides the northern seven stalls from the seven stalls to the south. The stables are framed with dressed timber posts and beams. While the exterior is lined with corrugated iron, the interior stall divisions are of vertical timber (Plate 53). The floors are of concrete, with one of the stalls containing a horse's hoof print adjacent to a child's (Plate 54).

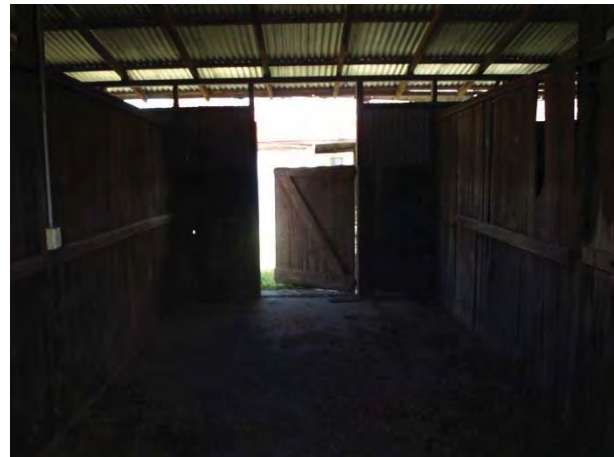
Plate 52 Central breezeway

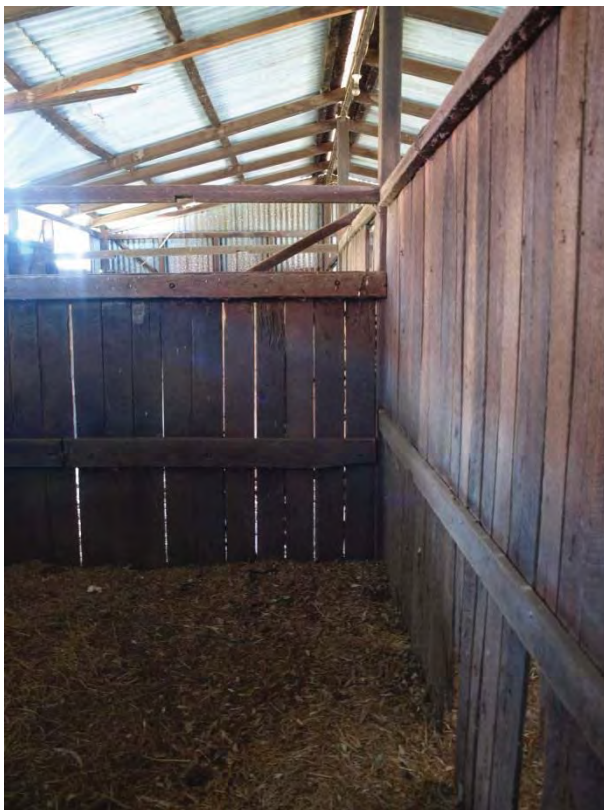
Plate 53 Interior timber stall divisions

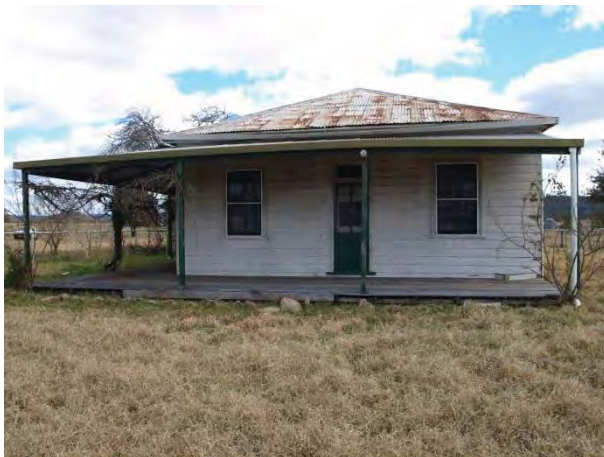
Plate 55 Farm House 2 front façade. View north

Farm House 2 is located approximately 500 metres south east of Tarwyn Park Homestead. It consists of an 'L' shaped weatherboard cottage and a separate sandstone structure of a single room. The southern side presents as the 'front' containing a central door, flanked by four pane sash windows (Plate 55). Farm House 2 is constructed of timber weatherboard on a timber frame with timber doors and window frames (Plate 55). The corrugated iron roof has a hipped form and a verandah and deck that wraps around the southern and western sides (Plate 56). The verandah would appear to be a later addition.

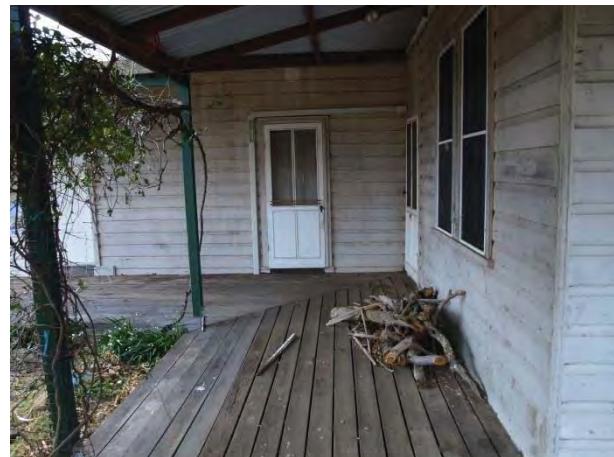
Plate 56 Farm House 2. Verandah return along northern and western sides

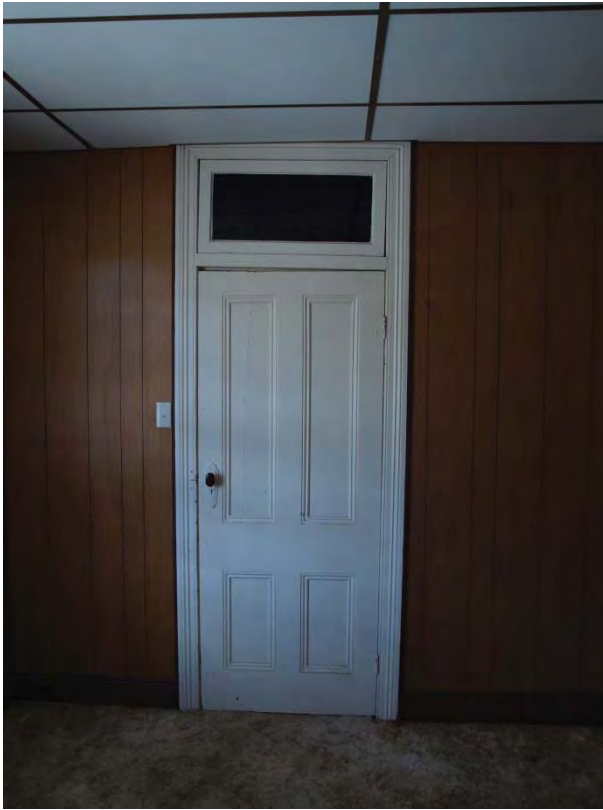
Plate 57 Farm House 2. Bedroom 1 showing door 6 with transom

The cottage was probably constructed in two stages, with the southern portion being the original and consisting of five rooms. The front door (Plate 58) opens into a corridor, which proceeds past bedrooms (Plate 57) to the west and east before opening into a living room to the east, with a third bedroom to the west. The living room contains a fireplace constructed of brick, which is rendered and painted, although in exceedingly poor condition (Plate 59). On the exterior, the chimney associated with this fireplace has been clad in sandstone. The fireplace is double sided and opens onto the kitchen on the other side.

The structure of the building does not appear to have been modified, with the majority of doors, including door furniture, and windows appearing to be original. This includes the front door (door 7) and the doors to bedroom 1 (Door 6) and bedroom 2 (Door 5), all of which retain their transoms, including glass. The interior walls, however have been relined with timber and a false ceiling added (Plate 57), probably in the 1970s. An examination of the ceiling in room 1 noted that the false ceiling does not clear the door frame (Plate 57), indicating that it is probable that the earlier ceiling was not removed and is preserved above. The bedrooms and living room are carpeted, which is in very poor condition. It is unclear whether the original floor is preserved beneath, but it is anticipated that this would be so.

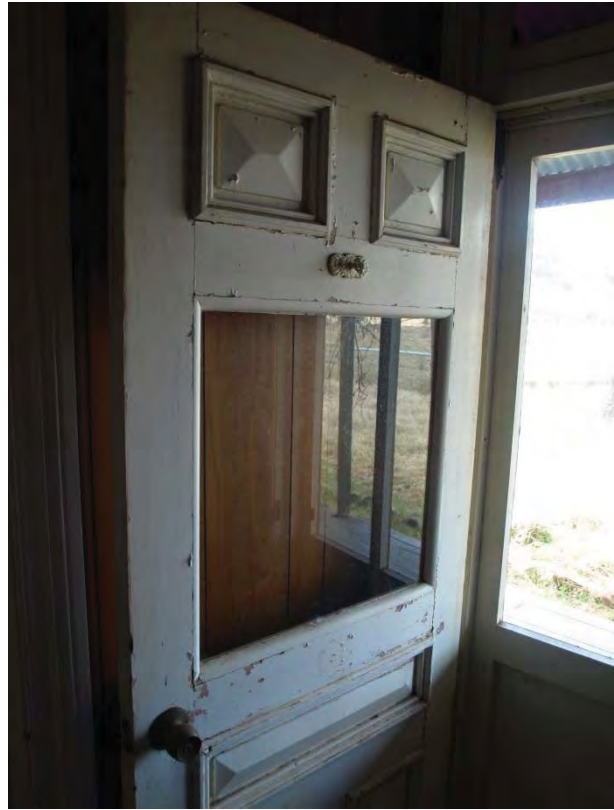
Plate 58 Farm House 2. Detailing of front door

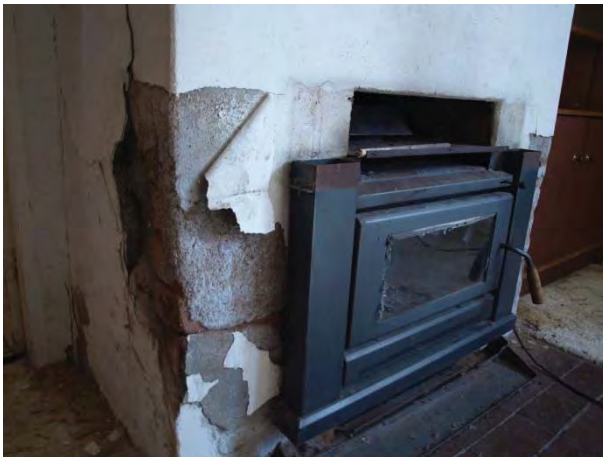
Plate 59 Farm House 2. Living room fireplace showing rendered brick construction

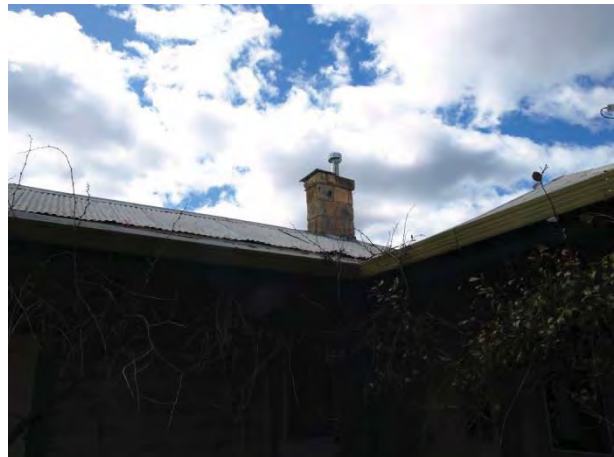
Plate 60 Farm House 2. Living room and kitchen chimney

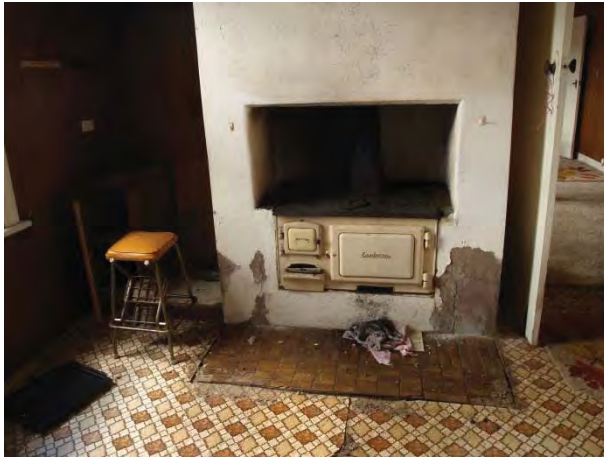
Plate 61 Farm House 2. Kitchen showing Metters stove and general condition

The kitchen contains timber cabinetry, in keeping with the timber panelling of the walls and a vinyl floor. The fireplace has been fitted with a Meters Kookaburra stove typical of the 1940s and 1950s (Plate 61). All modern appliances have been removed from the kitchen.

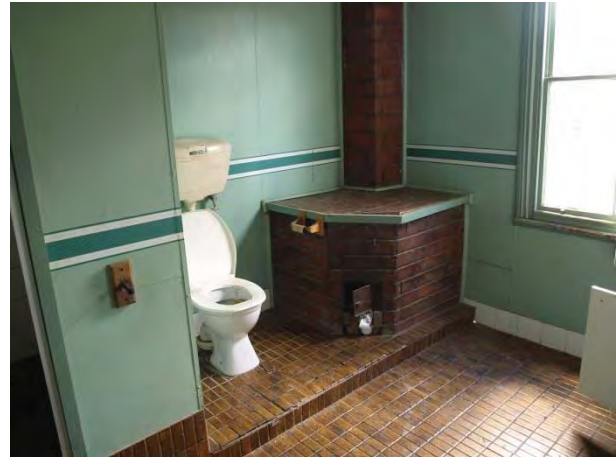
Plate 62 Farm House 2. Overview of bathroom, including copper

The bathroom, located at the rear (north) of the cottage, off the kitchen, appears to have been added at a later date. It contains a shower, vanity with basin, toilet and a built-in brick wood fired copper with an associated chimney (Plate 62 and Plate 63). The brick of the copper is different in size and colour to that used to construct the fireplace in the living room/kitchen, which are of a poorer quality and appear to be earlier. The floor in the bathroom is tiled, with the walls covered in plasterboard and painted green, with a green and white frieze.

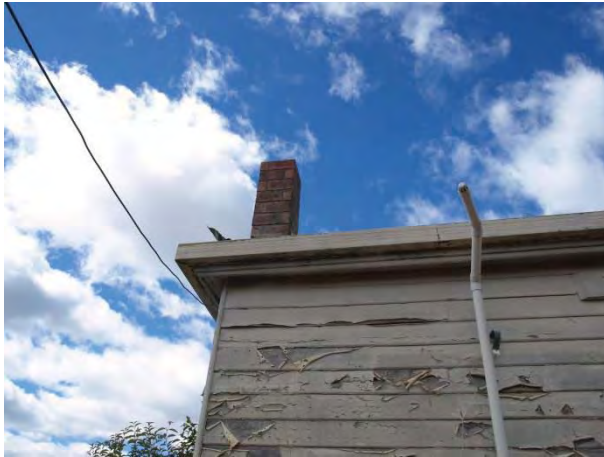
Plate 63 Farm House 2. Bathroom chimney

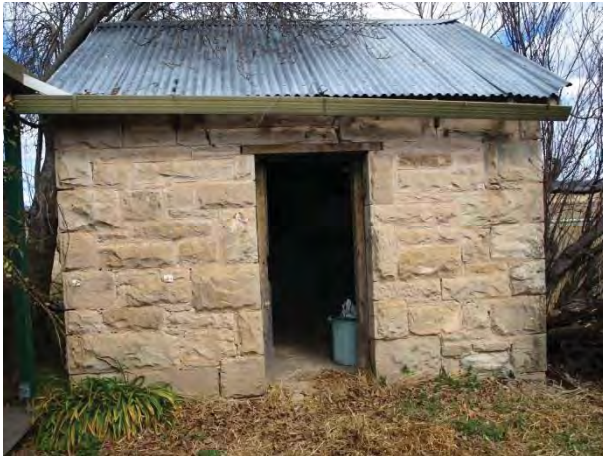
Plate 64 Sandstone structure associated with Farm House 2. View west

Located to the north west of Farm House 2 is a single room structure built of dressed sandstone, which matches, in style and finish, the Tarwyn Park Stables. The structure is rectangular, measuring approximately three metres by two metres with a gabled corrugated iron roof (Plate 64). Guttering has been added at a later date, but is in poor condition, coming away on the eastern elevation. It has a wood framed doorway with a timber lintel in the eastern elevation, although the door itself has been removed. There are two small (c. 20 x 30 cm) windows under the eaves on the northern and southern elevations (Plate 65). Water pipes have been inserted in through a hole in the eastern wall to feed a laundry tub and washing machine connection located in the south-eastern corner (Plate 66).

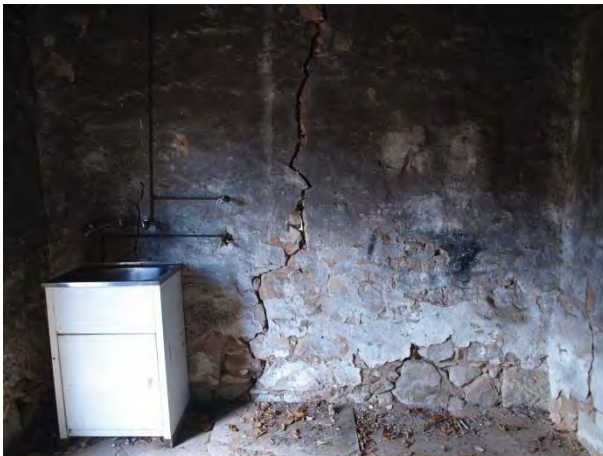
Plate 66 Sandstone structure associated with Farm House 2. Laundry tub and associated pipework

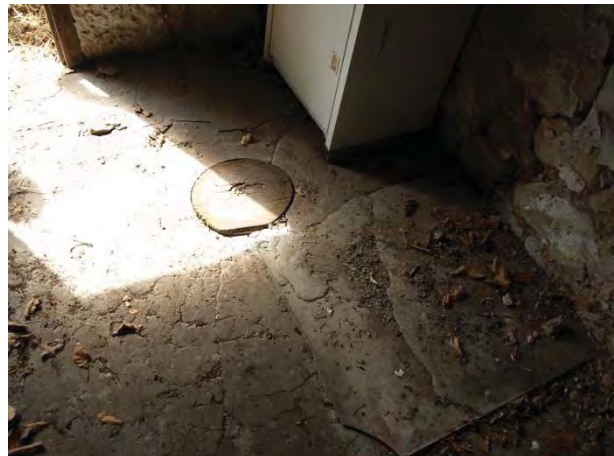
Plate 67 Sandstone structure associated with Farm House 2. Interior concrete floor with sawn off timber post

The interior has a concrete floor, in poor condition, which contains a sawn off timber post (Plate 67). The function of this item is unclear. Likewise, the walls have been rendered, but the render is in poor condition with repairs having been made in concrete (Plate 68). Tongue and groove timber boards have been used to create a tray ceiling. This may be a later modification as the ceiling partly obscures the windows under the eaves. Electrical conduit and a florescent light tube have been fixed to the ceiling.

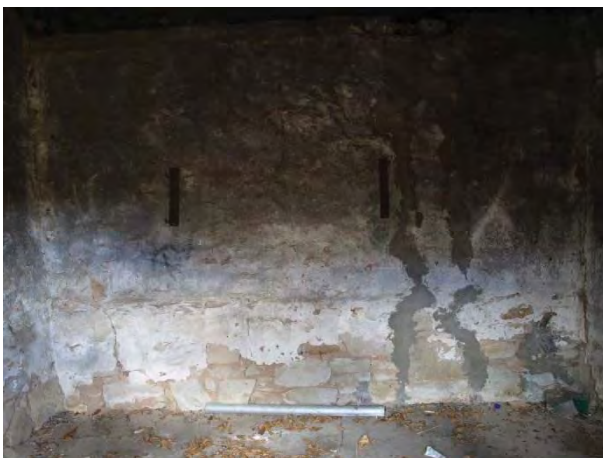
Plate 68 Sandstone structure associated with Farm House 2. Interior of western wall showing repairs to the render in concrete

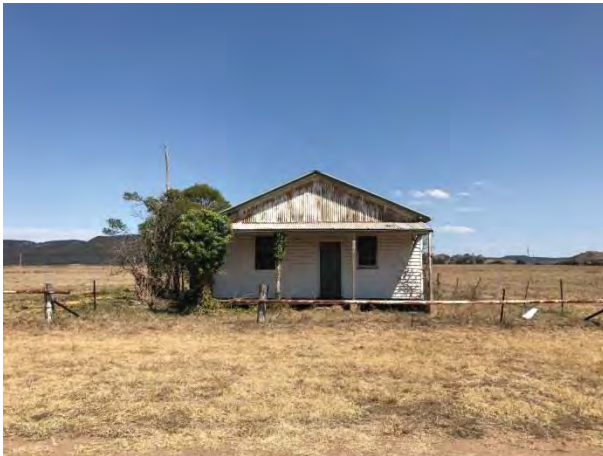
Plate 69 Farm House 1 front elevation. View west

Approximately half way between Tarwyn Park Homestead and Farm House 2 is a weatherboard cottage. The cottage is oriented to the east and this elevation presents with a simple verandah supported on timber posts. The elevation contains a centralised door flanked by two single hung sash windows of 12 panes (Plate 69). The rear of the cottage is also covered with a verandah, part of which has been enclosed. Otherwise this elevation features a single door (Plate 70). The southern elevation also contains a door, plus a single window (Plate 71). The western elevation contains two single hung sash windows of 12 panes (Plate 72). The cottage has been partially clad in vinyl weatherboard – namely the front and half of the western elevation (Plate 69 and Plate 73). This weatherboard covers the corrugated iron cladding evident throughout the rest of the building, including the roof and gable ends.

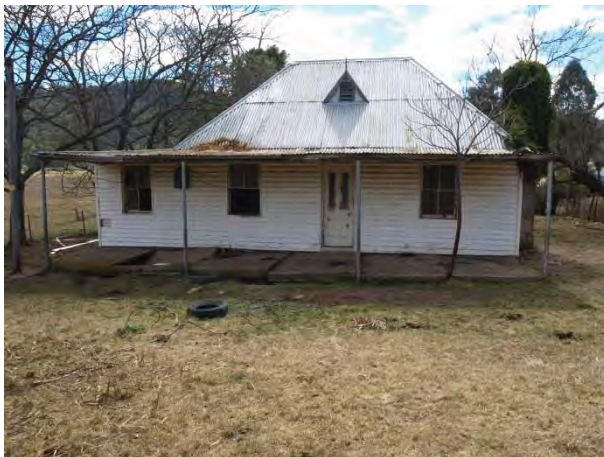
Plate 73 Iron Tank House front elevation. View north

Iron Tank House is oriented south and faces Woolleys Road. It presents a steeply hipped roof form, with a decorative dormer element of corrugated iron (Plate 73). The house consists of two four roomed houses that have been conjoined to create an eight roomed house. Each 'wing' has a separately hipped roof, the profile of which is evident when viewing the house from the east or west (Plate 74). The house is set on timber stumps. There is a flat roofed addition projecting from the western side of the front elevation. The façade would originally have been symmetrical – a central door flanked by windows, however a window was inserted in the flat roofed addition. Possibly at the same time, a verandah was added, which is supported on steel poles. The original timber weatherboards have been overlayed with vinyl weatherboards. The front door is a traditionally detailed four pane timber door, the upper two panels being fitted with glass. The windows are single hung four pane sashes (Plate 73).

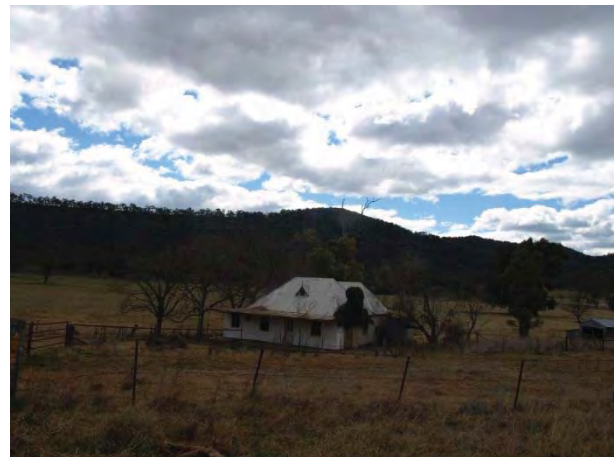
Plate 74 Iron Tank House viewed from Woolleys Road. Note double hipped roof form

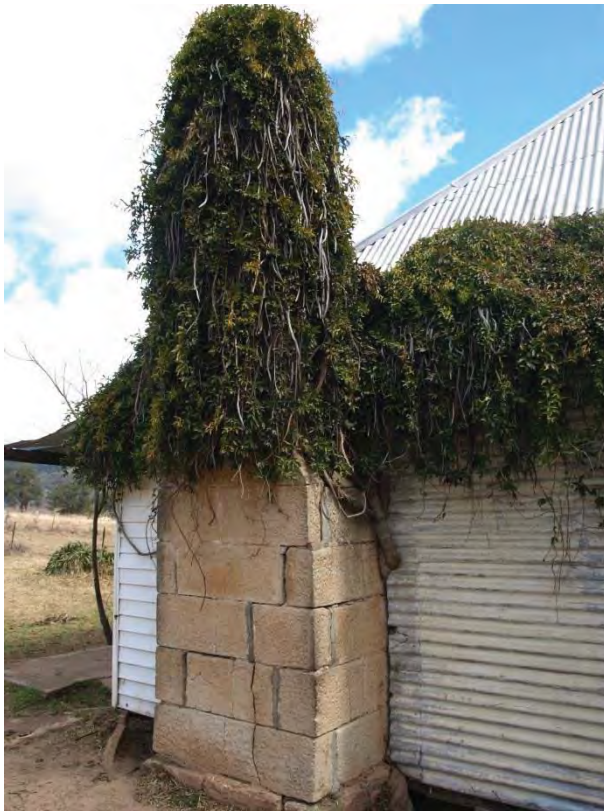
**Plate 75 Iron Tank House. Chimney in eastern elevation**

The western elevation contains a sandstone chimney, which is covered in an unidentified creeper (Plate 75). The creeper would be compromising the structural integrity of the chimney and should be removed as soon as possible. This elevation is fitted with one 12 pane single hung sash window and a fixed smaller, square four pane window.

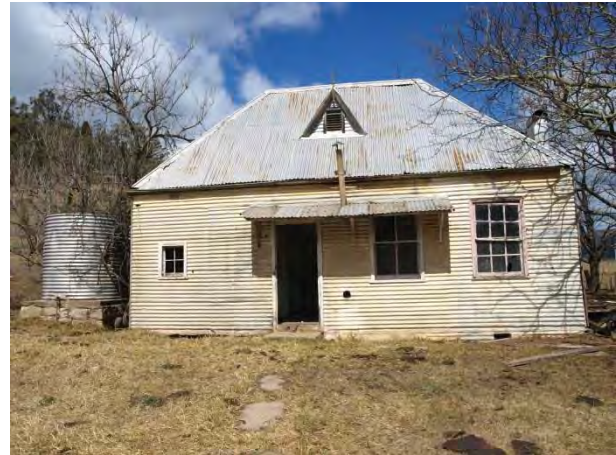
**Plate 76 Iron Tank House. Northern (rear) elevation**

The rear (northern) façade is unsymmetrical in its arrangement, with the door being placed off-centre, with a fixed small, square four pane window on one side and two sash windows on the other (Plate 76). The door and one of the sash windows is protected by a bullnose awning, accentuating the unsymmetrical presentation. The sash windows differ in their construction, the first containing four panes, like those seen on the front elevation, while the second contains 12 panes, indicating a probable earlier date of manufacture.

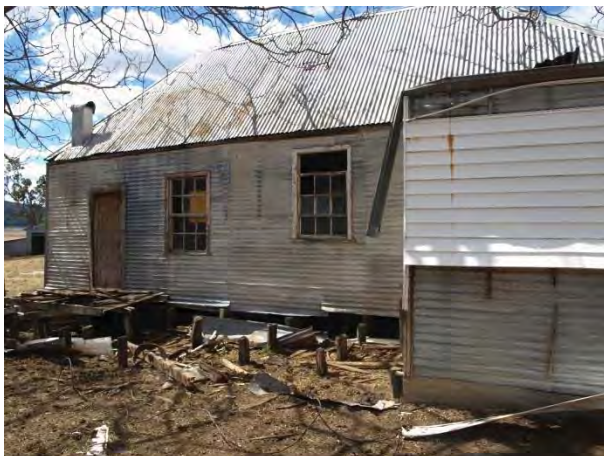
**Plate 77 Iron Tank House. Overview of northern elevation with flat roofed addition at right of image****3.5.1.2 Interior**

The eastern elevation contains the projecting flat roofed addition. The corrugated iron was covered by vinyl weatherboards, but these have mostly been lost. The body of the house contains two windows, identical to the 12 pane window described in the northern elevation (Plate 77). The windows are set at different heights, due to an internal step in the house, used to navigate the slope of the land. There is also a timber door in this elevation, which leads to a timber deck area that has largely fallen apart. This deck would have provided access from the body of the house to the flat roofed addition, which has no internal access. This deck may also have been roofed at some point, but it is unclear from the remaining evidence.

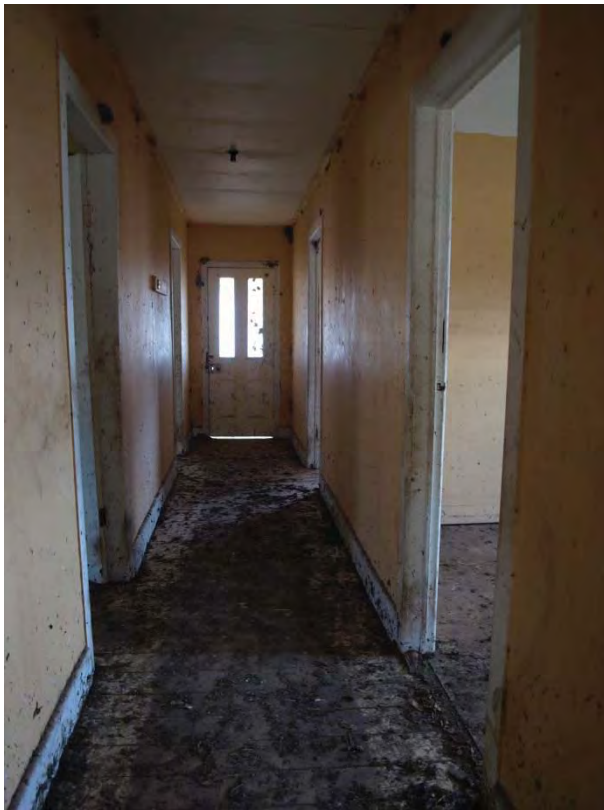
Plate 78 Iron Tank House. Corridor (room 1)

The two separate wings of the house are different in their materiality and layout. The southern wing opens from the front door into a corridor (room 1, Plate 78), with two rooms opening off each side (rooms 2-5). The walls are of plasterboard, painted or decorated with wall paper (Plate 79 and Plate 80). The corridor has a standard flat ceiling, but the bedrooms, with the exception of room 2, have a tray vaulted ceiling form (Plate 81). Room 3 contains the fireplace associated with the sandstone chimney described above (Plate 82). There is no mantelpiece; it would appear that the fireplace may have been covered over with fibrous cement sheeting. The hearthstone has cracked and there are significant gaps in the structure, which is more evident from the interior.

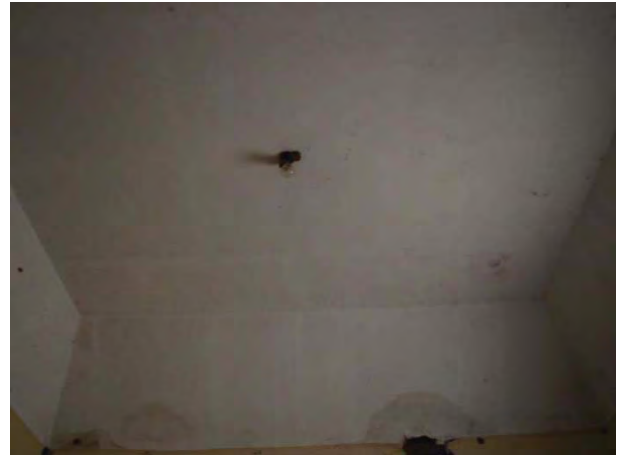
Plate 81 Iron Tank House. Tray vaulted ceiling in room 2

The internal doors have been removed from the house in this wing. The door frames are simple in their profile. The rooms with tray vaulted ceilings have no cornice. The cornice in the corridor and room 2 has a quarter round profile.

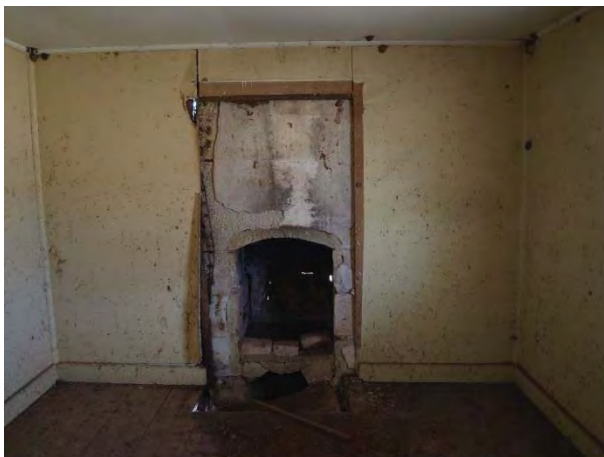
Plate 82 Iron Tank House. Sandstone fireplace

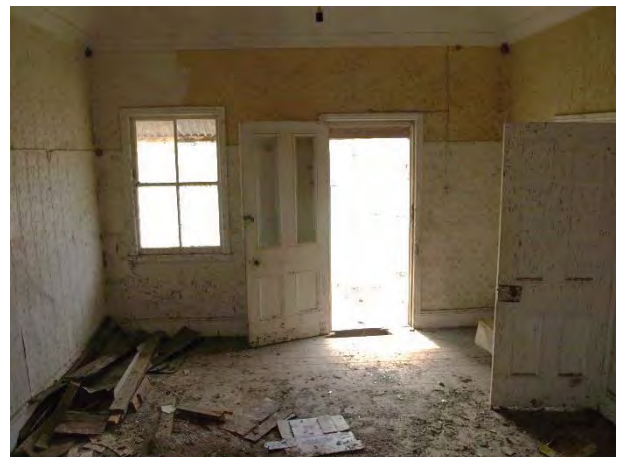
Plate 83 Iron Tank House. Room 6 view north

The interior of the northern wing presents entirely differently. There is a step down from the southern to the northern wing. The space in the northern wing is not regularly arranged. The corridor opens into a wide space (room 6, Plate 83), which covers approximately two thirds of the width of the structure, with a long narrow room on the western side – the kitchen (room 7, Plate 84) and two smaller rooms on the eastern side – a storeroom (room 8, Plate 85) and a washroom (room 9, Plate 86). The walls and ceilings in the northern wing are clad in pressed metal. In room 6, the pressed metal is elaborate, with a floral motif (Plate 87 and Plate 88), whereas the balance of the rooms have a simpler coffered style ceiling and standing seam walls (Plate 89). The tray vaulted ceiling form continues throughout the northern wing. Also evident throughout the interior of the house is timber flooring.

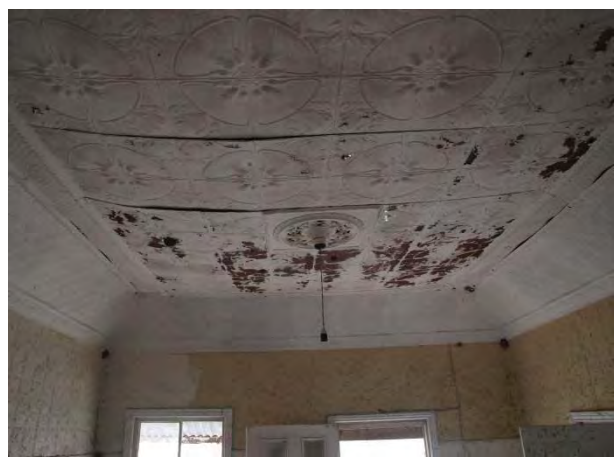
**Plate 87** Iron Tank House. Pressed metal ceiling in room 6

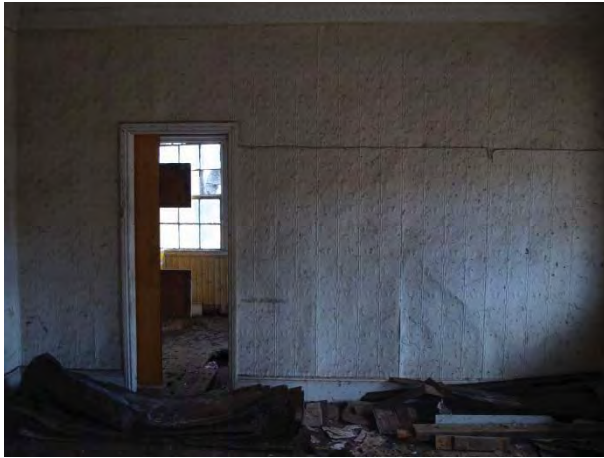
Plate 88 Iron Tank House. Pressed metal wall in room 6. Note elaborate floral design

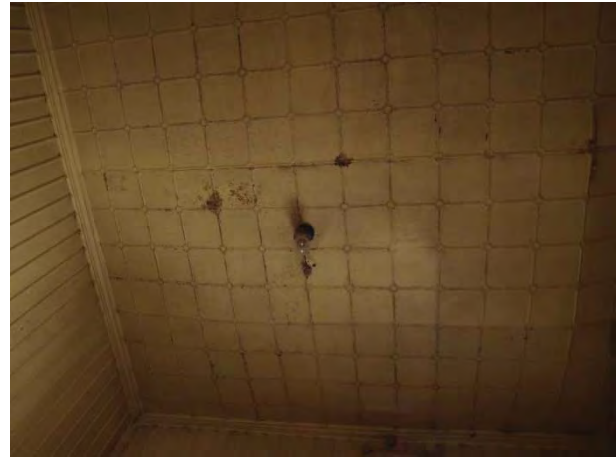
Plate 89 Iron Tank House. Pressed metal ceiling in room 8. Note coffered ceiling and standing seam wall designs

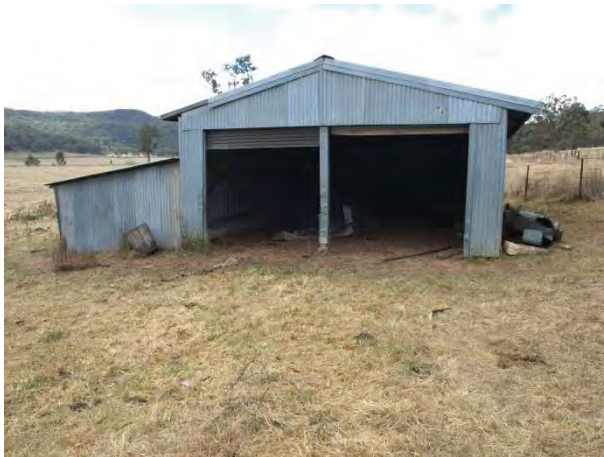
Plate 90 Iron Tank machinery shed/garage. View east

Located to the north east of Iron Tank House is an iron framed structure probably used as a combined machinery shed and garage (Plate 90). The structure is clad in corrugated iron, with two roller doors on the western side. The roof has a simple gabled form. Along the northern side, a skillion roofed lean-to has been constructed, supported on undressed timbers (Plate 91). The space has been enclosed with chicken wire and has been interpreted as a chicken coop.

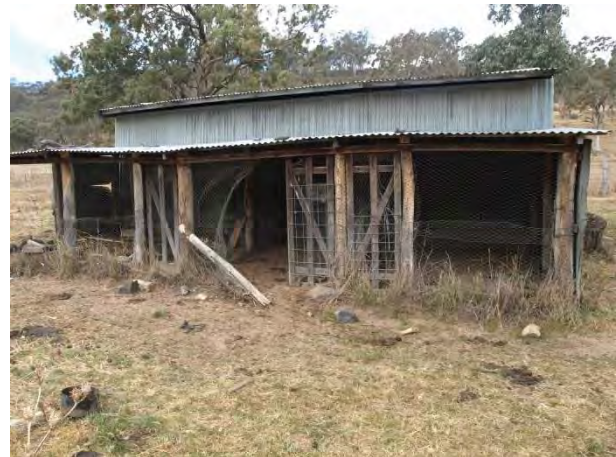
Plate 91 Iron Tank machinery shed/garage. View south showing chicken coop

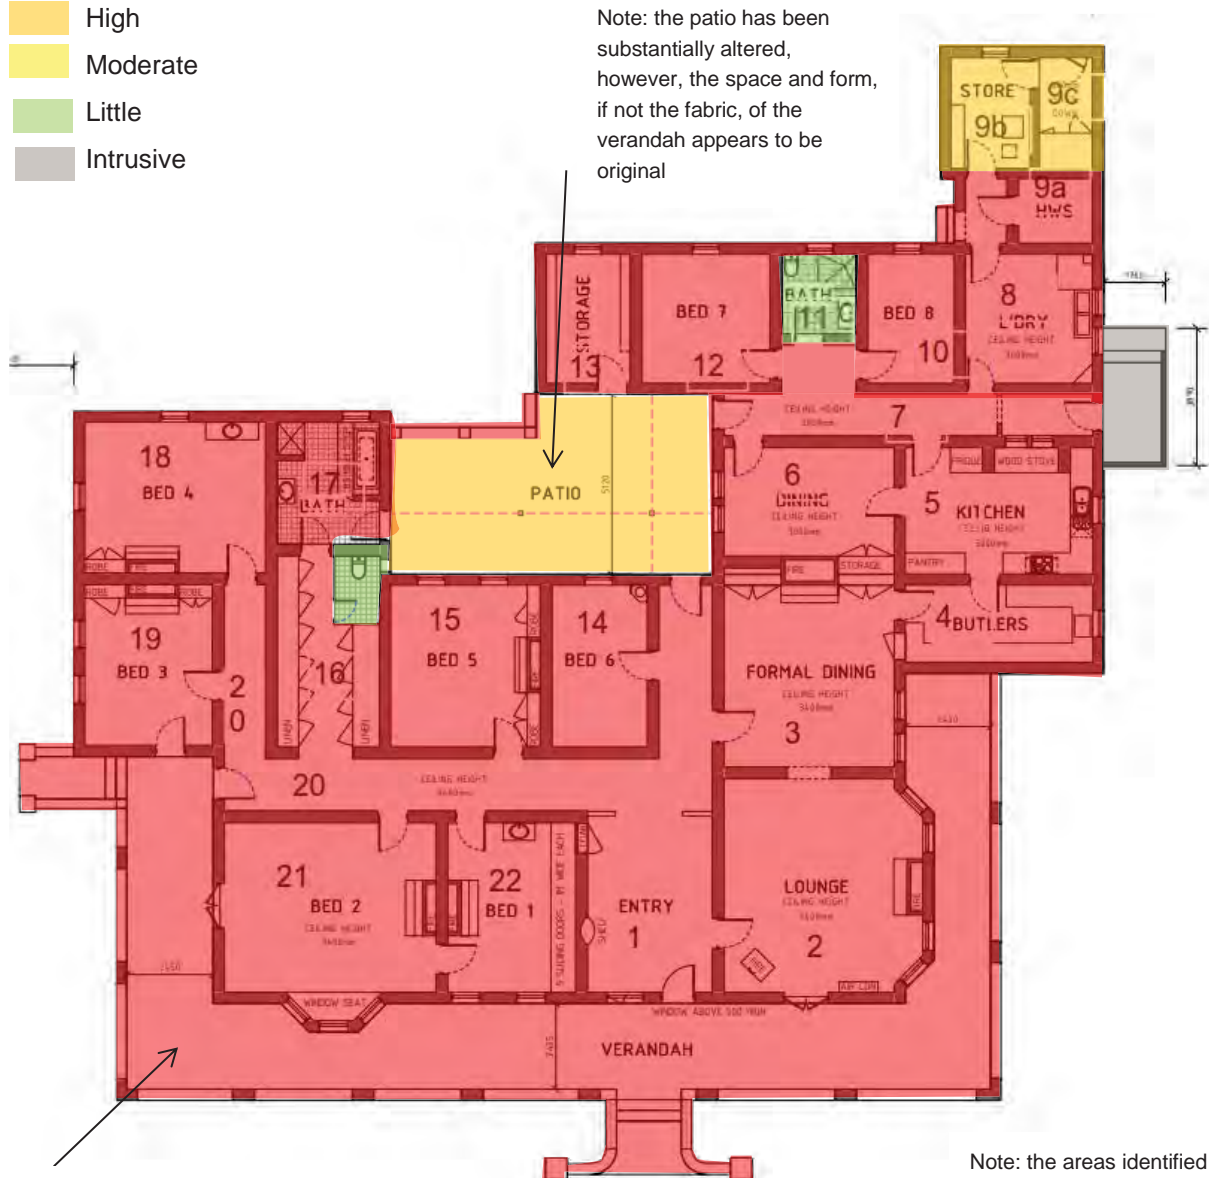
Note: the patio has been substantially altered, however, the space and form, if not the fabric, of the verandah appears to be original

Note: the form of the verandah is of exceptional significance. The concrete verandah floor is intrusive and may be causing damage to the sandstone.

Figure 28 Significance of internal spaces of Tarwyn Park Homestead
