Conservation Management Plan for Tarwyn Park and Iron Tank

BYLONG COAL PROJECT
Response to PAC Review Report

DRAFT Conservation Management Plan

AECOM Australia Pty Ltd

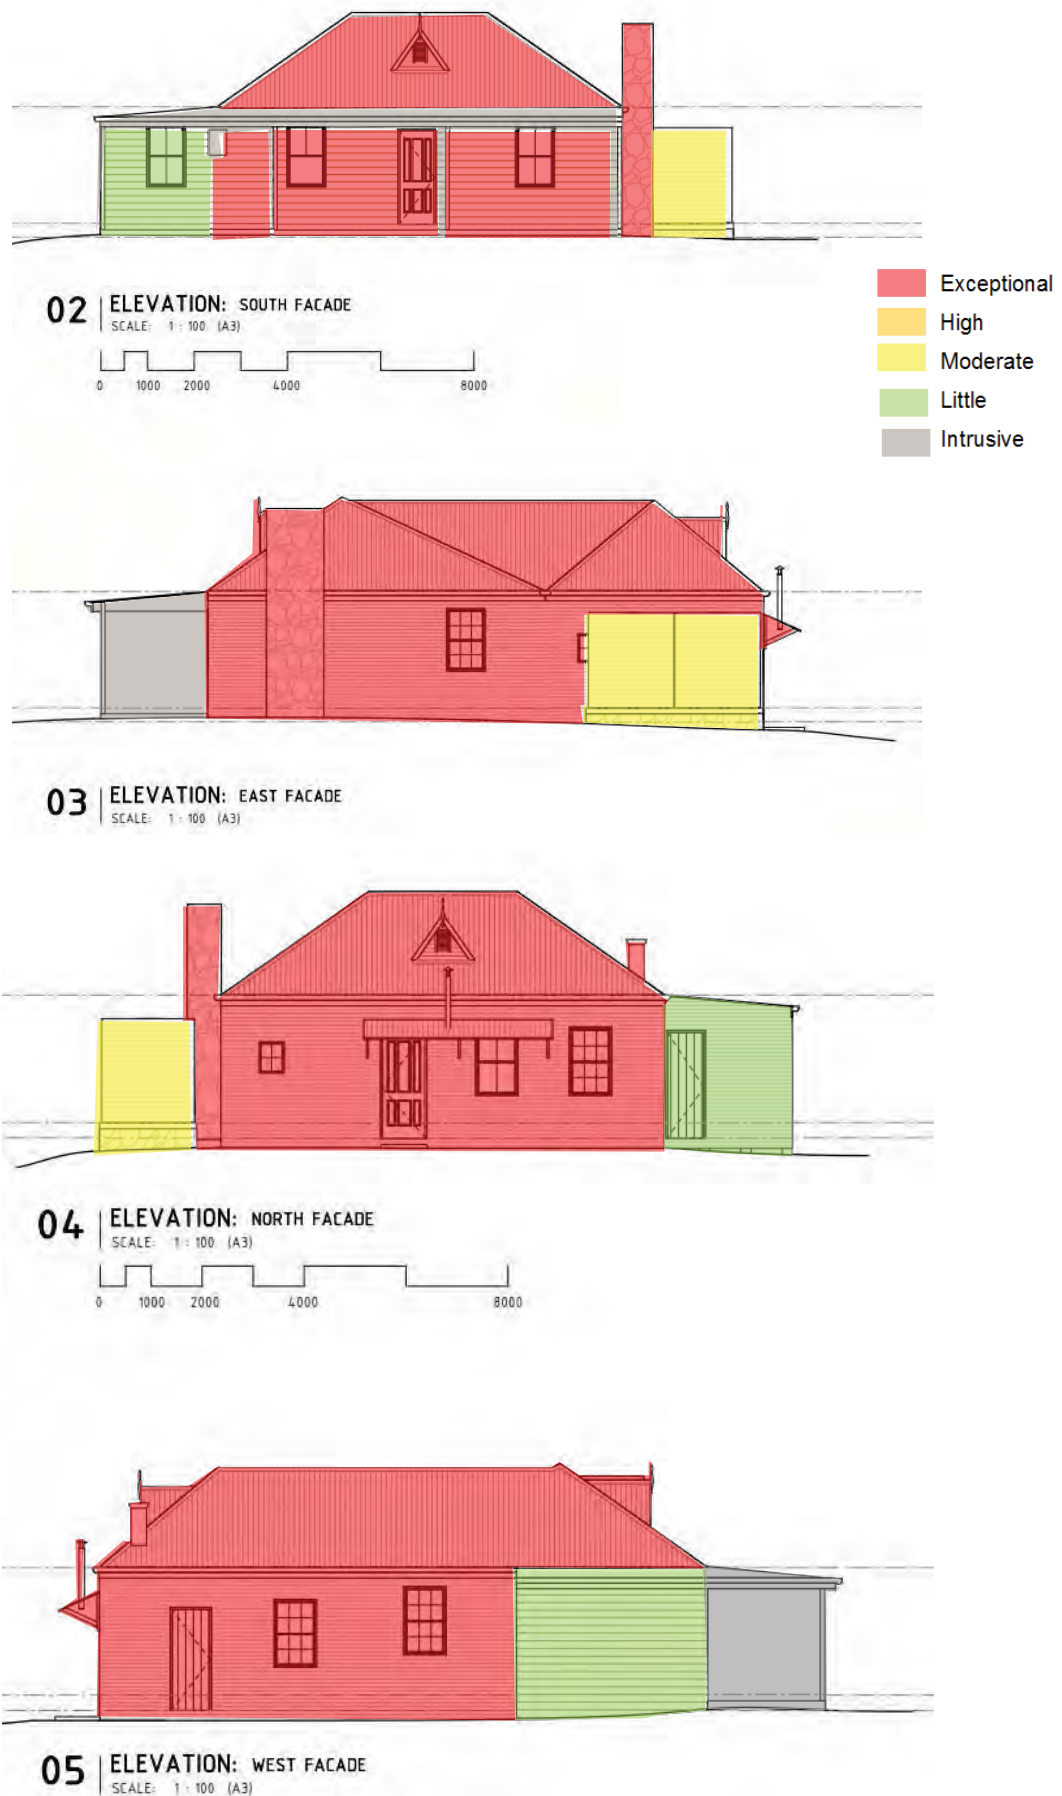
**Figure 31 Significance of elevations of Iron Tank House**

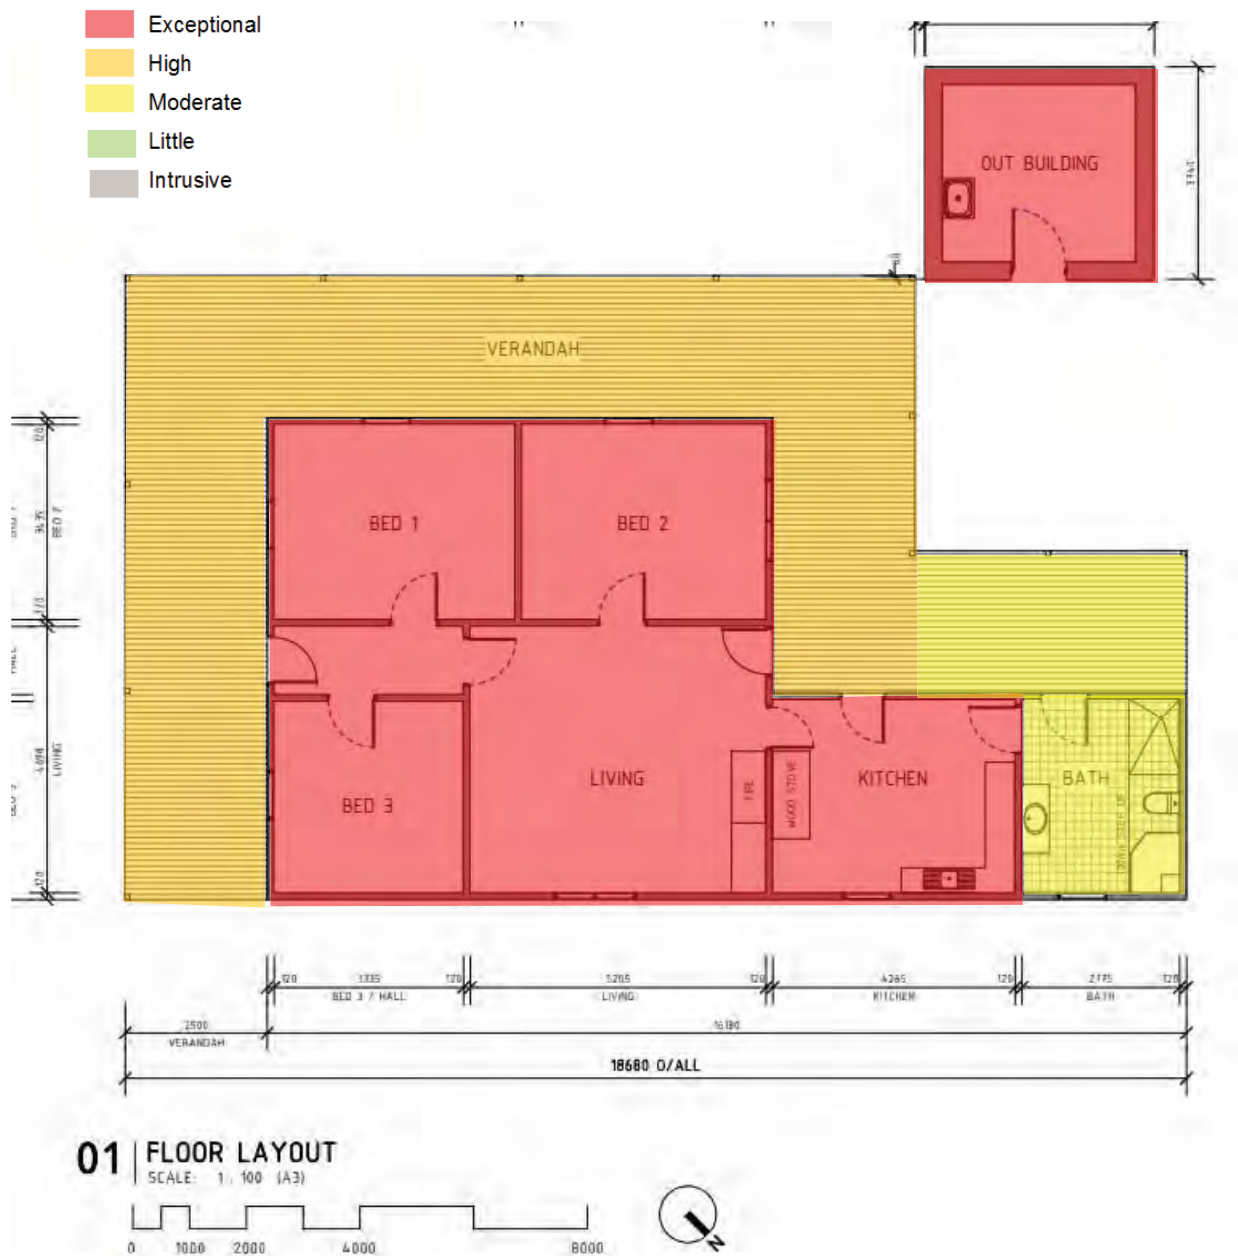
Figure 32 Significance of internal spaces of Farm House 2

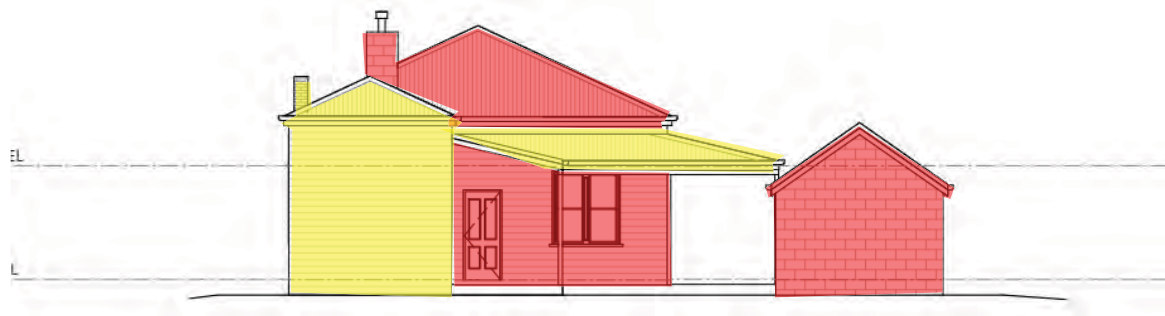
04 | ELEVATION: NORTH-WEST FACADE
SCALE: 1:100 (A3)

Note:
Associated
Sandstone
Structure sits in
front of Farm
House 2 in this
view

Figure 33 Significance of elevations of Farm House 2

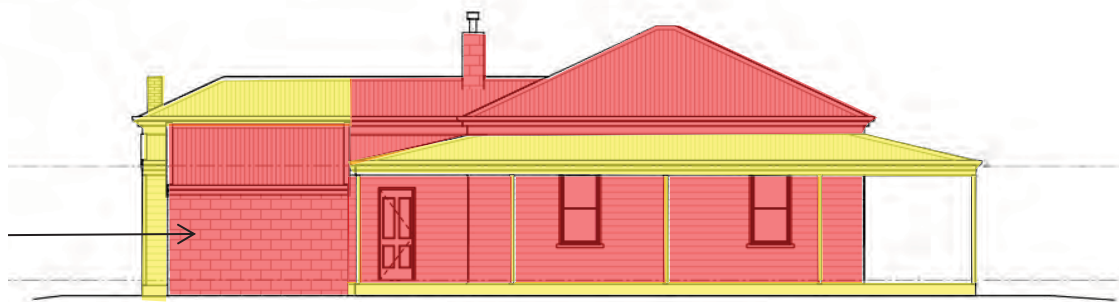
05 | ELEVATION: SOUTH-WEST FACADE
SCALE: 1:100 (A3)

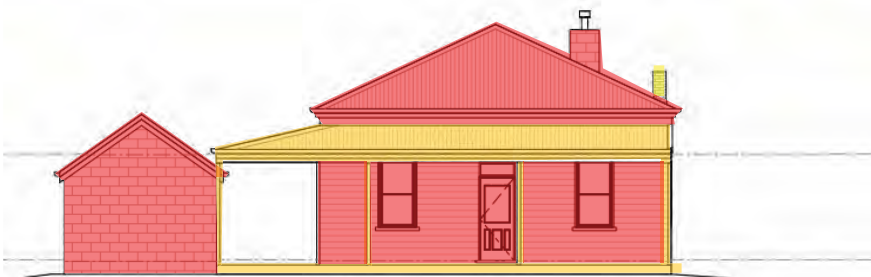
02 | ELEVATION: SOUTH-EAST FACADE
SCALE: 1:100 (A3)

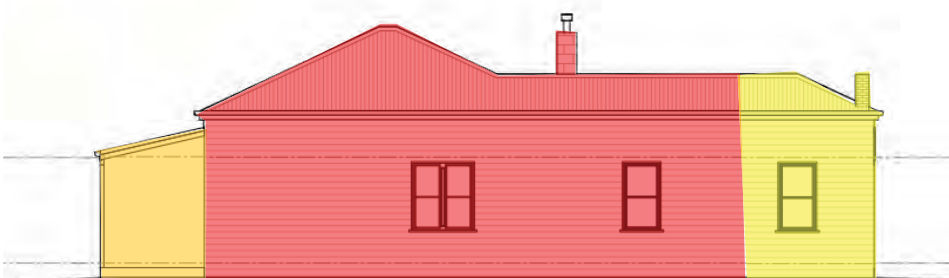
03 | ELEVATION: NORTH-EAST FACADE
SCALE: 1:100 (A3)

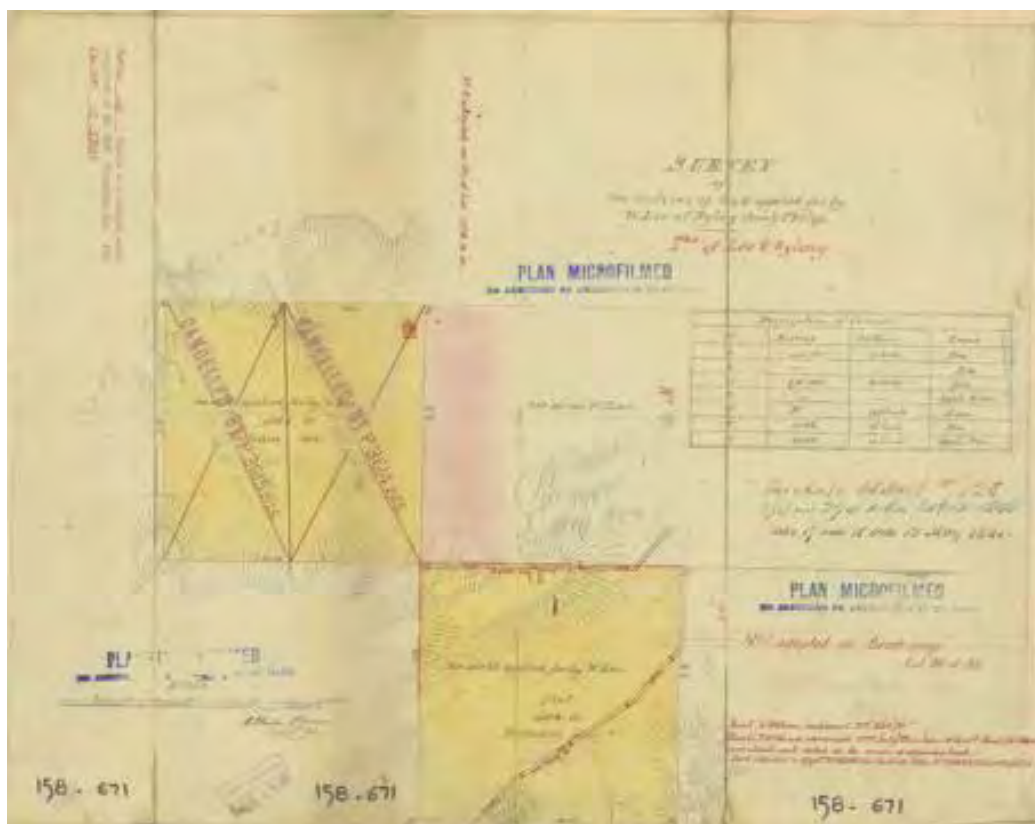
Figure 4 The survey plan of William Lee's 640 acre grant that became the core of Tarwyn Park. Note that the north point is at the right hand side of the plan. Source: P.158.671, Crown Plan

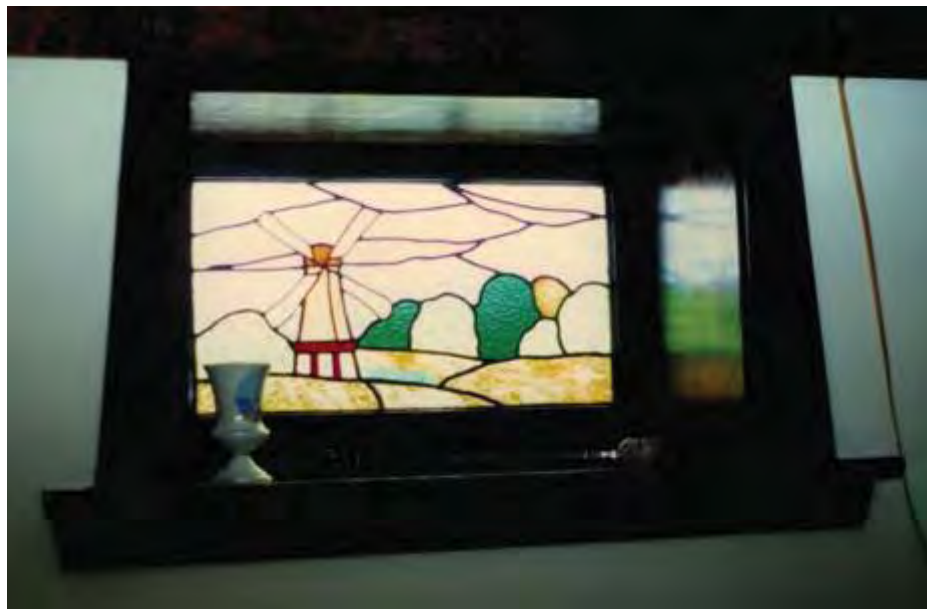
Figure 17 The Dutch windmill stained glass window seen in many houses built in the 1920s. Source: Author photo

In addition, examination of the images showing these features strongly suggests that the original design for the house used design features that were commonly available in its construction period. Majolica tiles with Dutch inspired images were part of a suite of design elements available to home builders. For example, a standard small stained glass window available during the 1920s featured a Dutch windmill in a landscape. These small windows often at the side of Californian bungalows erected during the 1920s can still be seen on number of surviving examples.

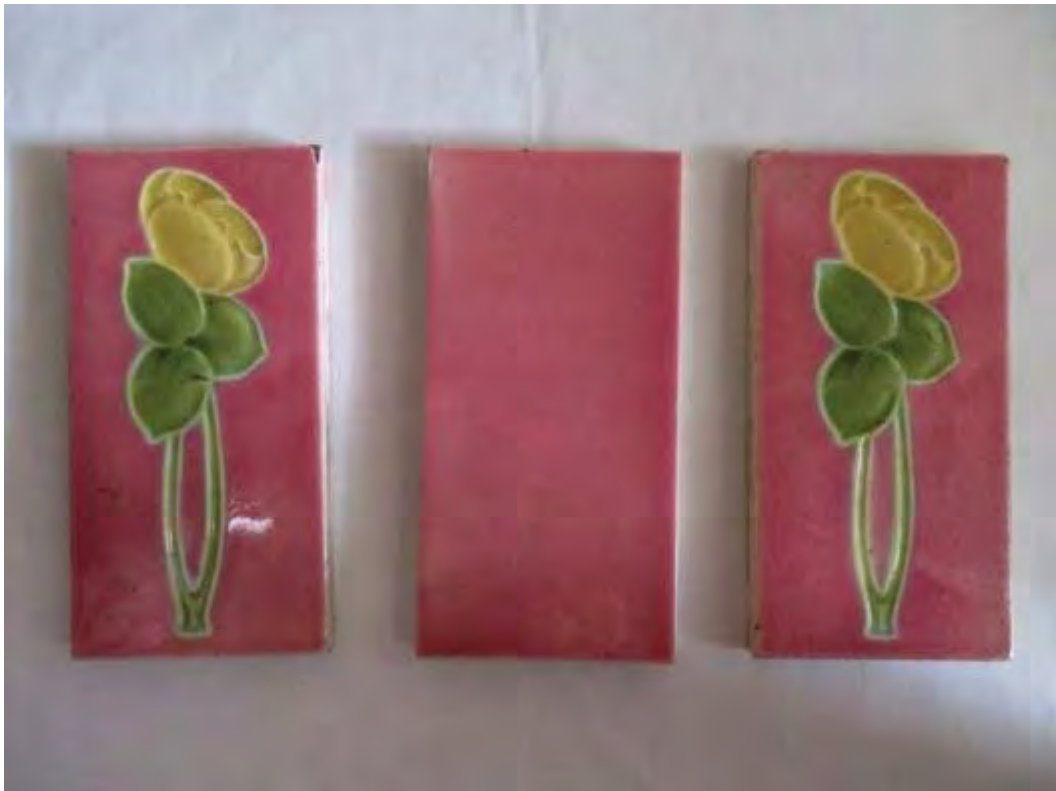
Figure 18 Daffodil pattern majolica tiles from a 1920s house similar to the Dutch and tulip tiles in Tarwyn Park. Source: Author photo

The majolica tile with what appears to be an interpretation of a tulip has striking similarities to majolica tiles, which I hold. These tiles were rescued from a house I owned in the 1970s. They had been ripped from the fireplace by a previous owner and left under the house from where I rescued them. The manufacturers name on the back is given as 'G & T Ltd, England' around a number 9. That number possibly refers to the stock number. The house was built in 1926 by a speculative building company. These features were probably stock materials available from any building materials supplier. An image of these tiles is below.

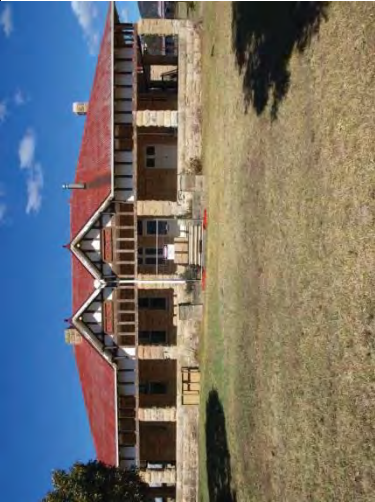
Asbestos tiles (covered over by corrugated iron)	Original?	L	P	<p>Overview of corrugated iron roof, front elevation</p>

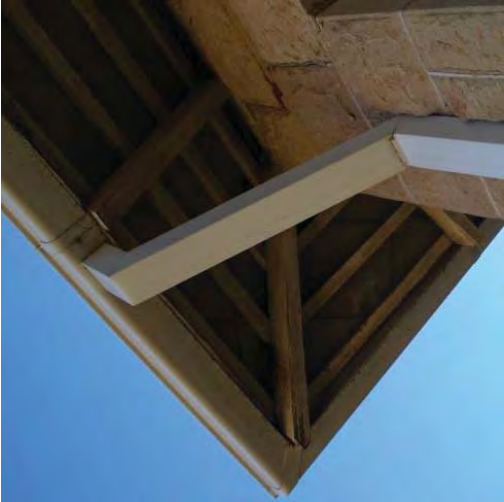
<p>Asbestos roof tiles, laid in a diamond pattern visible under eaves on eastern elevation</p>

Plate 30 View under eaves on southern side showing diamond laid asbestos tile roof

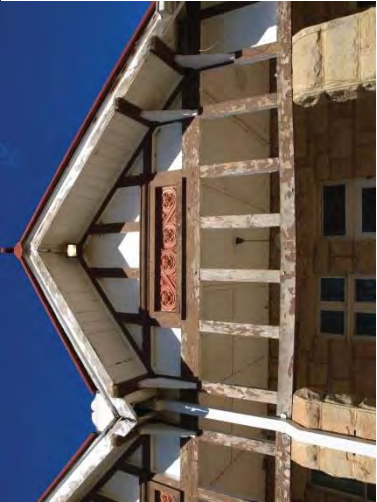
Element	Component	Materials	Time Period	Grading	Condition	Image
	Gables	Timber half-framing Asbestos panelling	Original Original	E L	P V (to be replaced like-for-like with non-hazardous material)

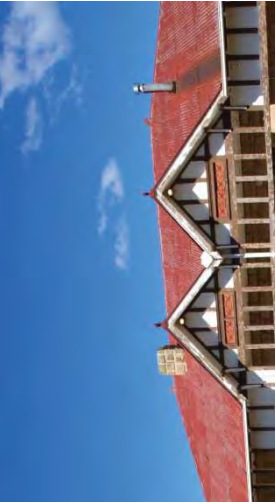
Element	Component	Materials	Time Period	Grading	Condition	Image
	Chimney	Sandstone Chimney Metal flue	Original Late 20 th C - Modern	E I	F F

<p>Original sandstone chimney (left) and late 20th C to modern metal flue (right)</p>
	Verandah	Sandstone piers and half wall Concrete floor	Original Mid 20 th C	E M	V F

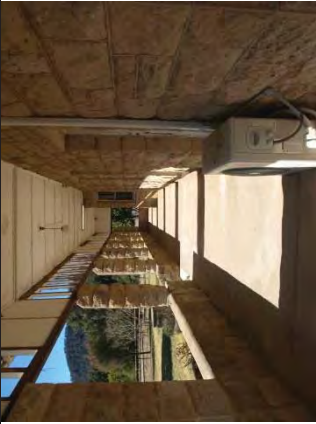
<p>View east along northern elevation verandah</p>

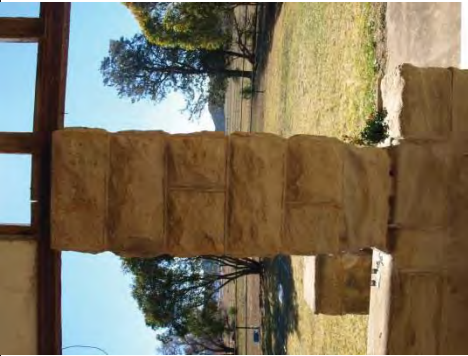
<p>Sandstone verandah pier showing weathering</p>

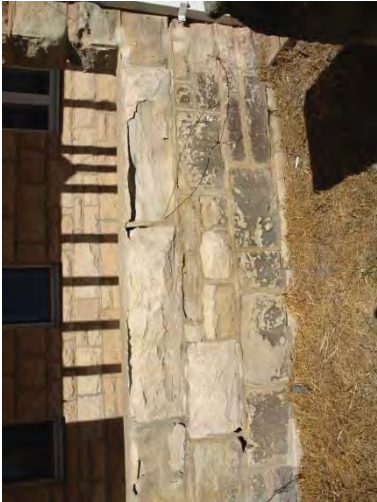
<p>Sandstone verandah half wall showing weathering</p>

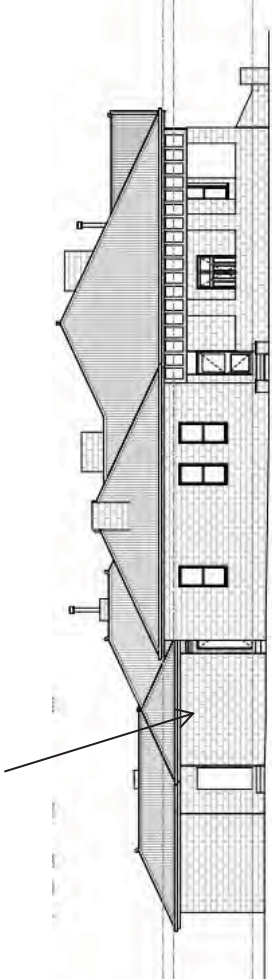
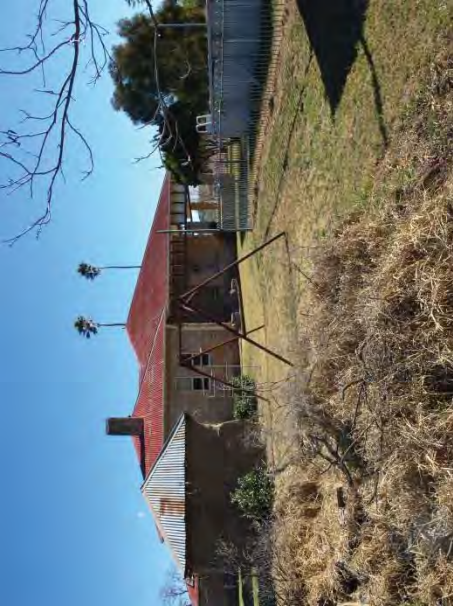
<p>03 ELEVATION, LEFT FACADE SCALE 1:100 (A3) or 1:200 (A4)</p>

Eastern façade	Eastern façade	<p>Vernacular Concrete Structure</p>

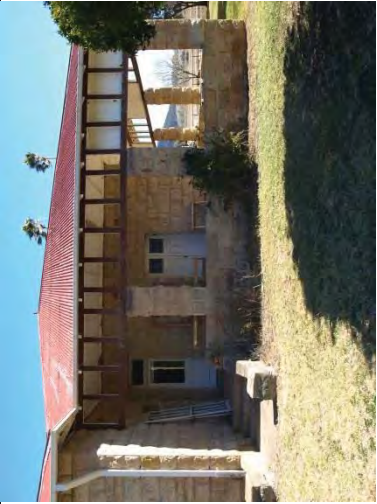
<p>Overview of verandah section to northern portion of elevation</p>

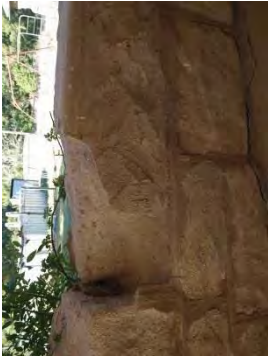
<p>Example of weathering to sandstone half wall</p>
		Asbestos panelling	Original	L	V (to be replaced like-for-like with non-hazardous material)	
		Sandstone piers	Original	E	V	
		Sandstone half wall	Original	E	V	
		Concrete stairs	Mid 20 th C	M	G

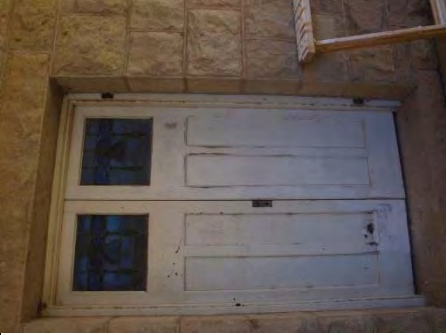
Element	Component	Materials	Time Period	Grading	Condition	Image
	Door 2	Opening Timber frame French doors (including leadlight) Sandstone sill	Original Original Original Original	E E E E	G F F G

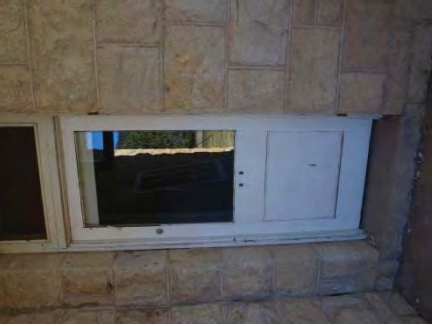
Door 3 Note: identical to door 6	Opening Timber frame Timber panel and glass door Lock Transom (including glass) Flyscreen	Original Original Mid 20 th C Modern Original Modern	E M L I M L	G F F G G G

Door 6 Note: identical to Door 3	Opening Timber frame Timber panel and glass door Lock Transom (glass missing) Flyscreen	Original Original Mid 20 th C Modern Original Modern	E M L I M L	G F F G G G

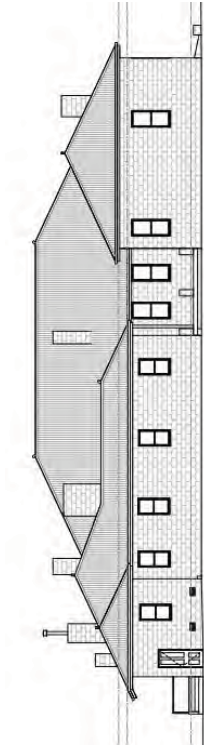
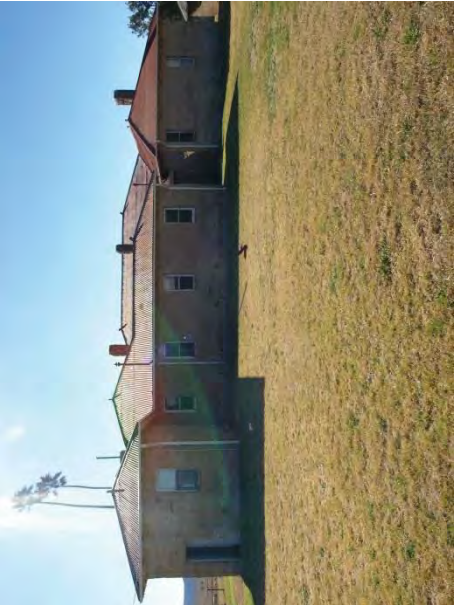
<p>04 ELEVATION - REAR FACADE SCALE 1 : 100 (A4) or 1 : 200 (A3)</p>

Southern (rear) façade

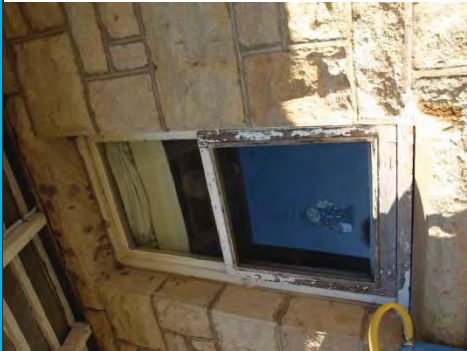
Element	Component	Materials	Time Period	Grading	Condition	Image
	Window 23	Opening	Original	E	G

Frame	Mid 20 th C	M	P	
		Single hung sash, two pane	Mid 20 th C	L	F	
		Flyscreen	Modern	L	F	
	Hot water system	Oil tank system, for AGA (not inspected)	Modern	I	Not inspected

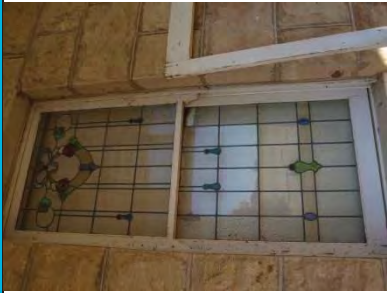
Element	Component	Materials	Time Period	Grading	Condition	Image
	Window 29	Opening	Original	E	G

Frame	Mid 20 th C	M	P	
		Single hung sash, two pane	Mid 20 th C	L	F	
		Leadlight	Early 20 th C	E	F	
		Flyscreen	Modern	L	F	
	Verandah Wall	Timber half-framing	Original	E	P

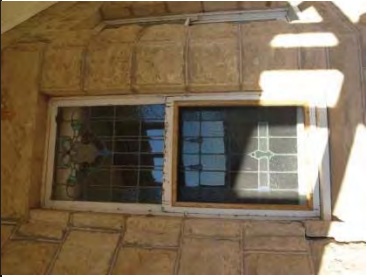
Asbestos panelling	Original	L	V (to be replaced like-for-like with non-hazardous material)	
		Sandstone piers	Original	E	V	
		Sandstone half wall	Original	E	V	
		Concrete stairs	Mid 20 th C	M	G	
	Window30	Opening	Original	E	G

Frame	Mid 20 th C	M	P	
		Single hung sash, two pane	Mid 20 th C	L	F	
		Leadlight	Early 20 th C	E	F	
		Flyscreen	Modern	L	F

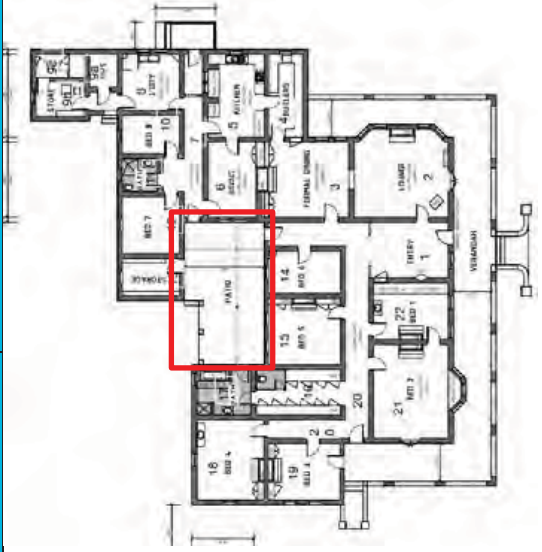
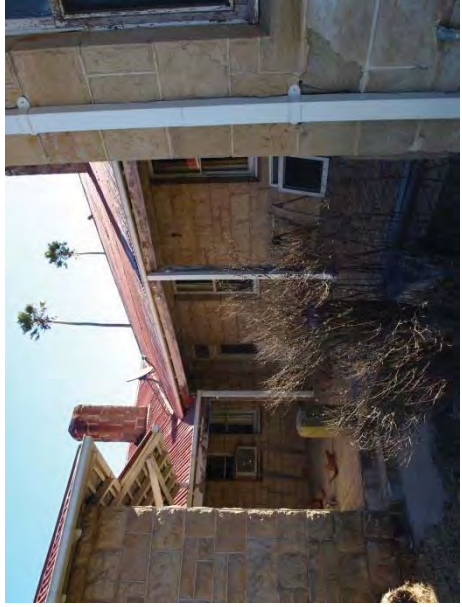
Element	Component	Materials	Time Period	Grading	Condition	Image
Patio (rear)

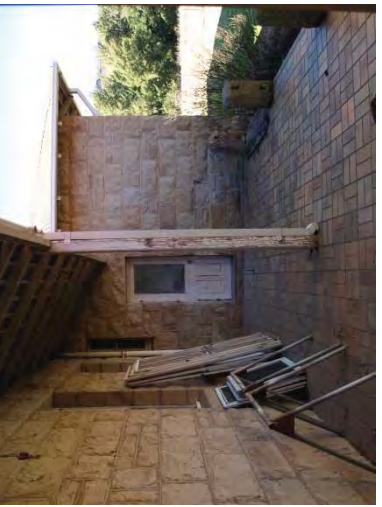
Walls	Sandstone	Original	E	F

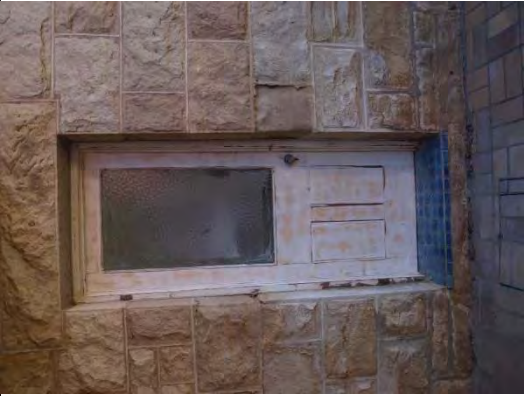
Element	Component	Materials	Time Period	Grading	Condition	Image
	Door 5	Opening	Original	E	G

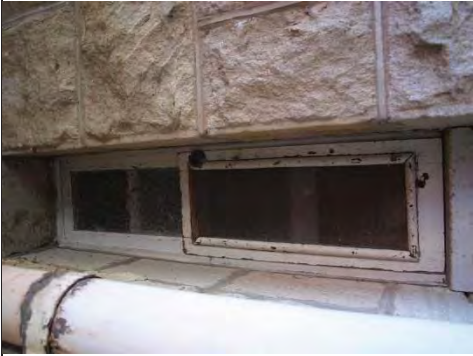
Timber frame	Mid 20 th C	L	P	
		Timber panel and glass door	Mid 20 th C	L	P	
		Knob	Mid 20 th C	L	P	
		Door sill - tile	Late 20 th C	L	F	
	Window 10	Opening	Original?	M	G

Frame	Mid 20 th C	M	P	
		Single hung sash, two pane	Mid 20 th C	L	F	
		Flyscreen	Modern	L	F

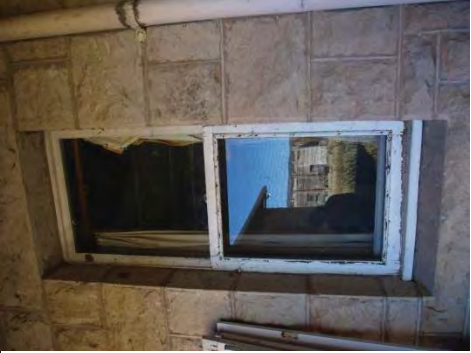
Element	Component	Materials	Time Period	Grading	Condition	Image
	Window 11	Opening Frame Single hung sash, two pane	Original Original? Original?	E M M	G P F

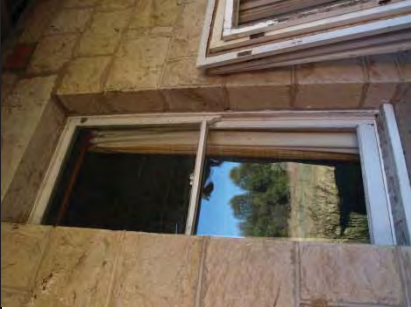
Window 12	Opening Frame Single hung sash, two pane	Original Original? Original?	E M M	G P F

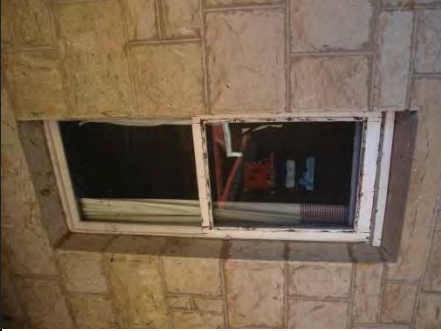
Element	Component	Materials	Time Period	Grading	Condition	Image
	Window 13	Opening Frame Single hung sash, two pane	Original Original? Original?	E M M	G P F

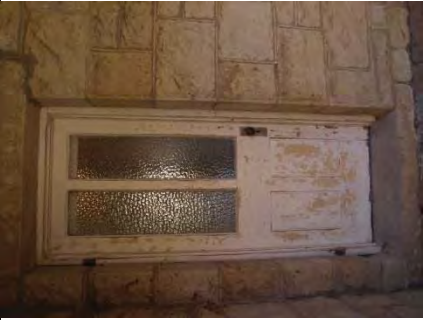
Element	Component	Materials	Time Period	Grading	Condition	Image
	Door 7 Note: Identical to door 11	Open Timber frame Four panel timber frame door Lock	Original Mid 20 th C Mid 20 th C Mid 20 th C	E L L L	G P P P

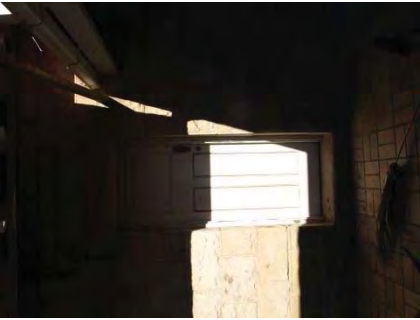
Door 8	Opening Timber frame Three panel timber door Knob Lock	Original Original Original Original? Mid 20 th C	E M E E? L	G F F F F

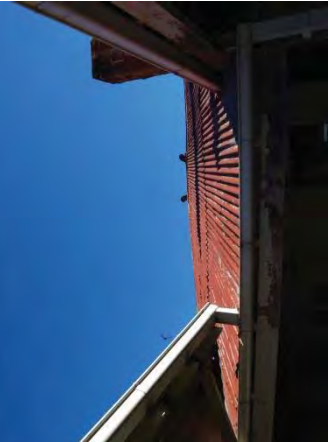
Element	Component	Materials	Time Period	Grading	Condition	Image
	Rainwater goods	Guttering Downpipe	Modern Original – Mid 20 th C	L M	G P

<p>View of guttering from patio, view north Refer to window 10 for view of downpipe</p>
	Sewer vent to bathroom	Metal	Mid 20 th C	L	F

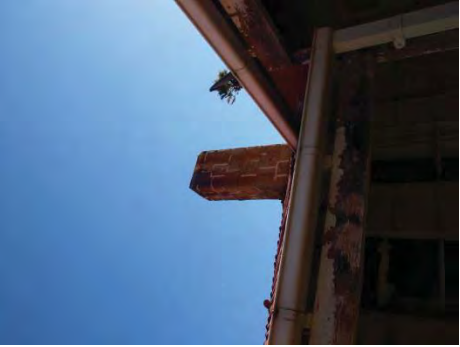
Element	Component	Materials	Time Period	Grading	Condition	Image
	Chimney from patio	Sandstone	Original	E	F

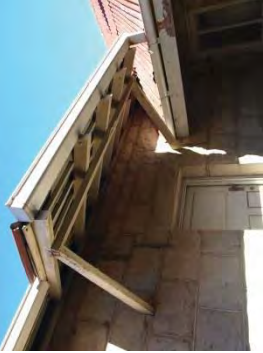
South section of patio veranda	Timber frame Corrugated iron roof	Original – early 20 th C Late 20 th C - Modern	M L	F F

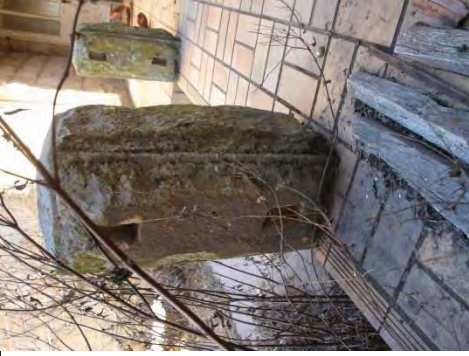
Element	Component	Materials	Time Period	Grading	Condition	Image
	Patio fence posts	Sandstone	Original	E	F

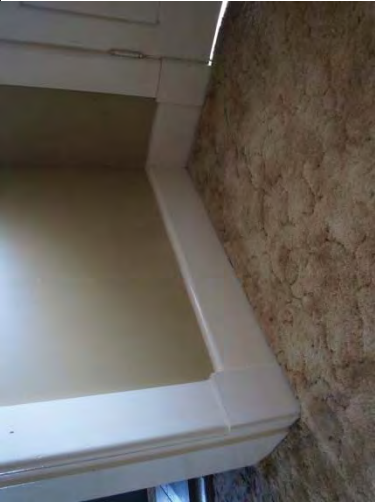
Element	Component	Materials	Time Period	Grading	Condition	Image
	Floor	<p>Carpet</p> <p>Timber boards (timber boards not inspected)</p> <p>Skirting</p>	<p>Modern</p> <p>Original?</p> <p>Original?</p>	<p>L</p> <p>E?</p> <p>H?</p>	<p>F</p> <p>Unknown</p> <p>G</p>

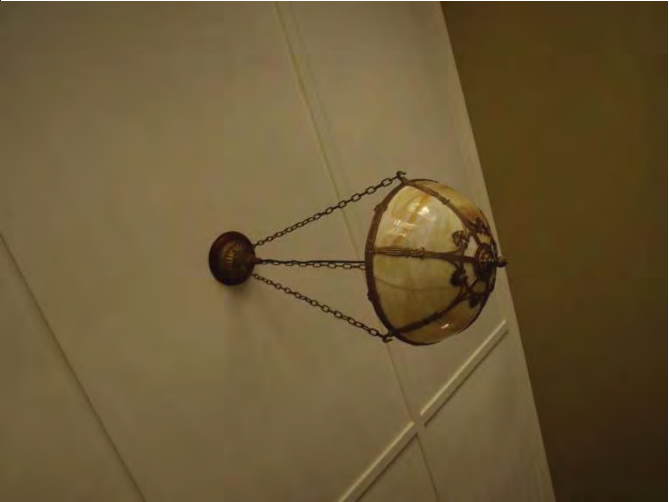
Ceiling	<p>Asbestos sheeting?</p> <p>Brass and glass light fitting</p>	<p>Original</p> <p>Original</p>	<p>H</p> <p>E</p>	<p>G</p> <p>G</p>

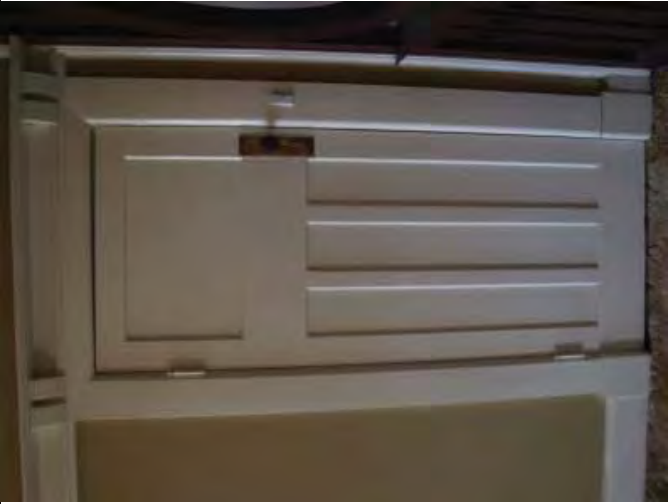
Element	Component	Materials	Time Period	Grading	Condition	Image
	Coat Closet	Opening	Original	E	G

Four panel timber door	Original	E	G	
		Door knob	Original	E	G

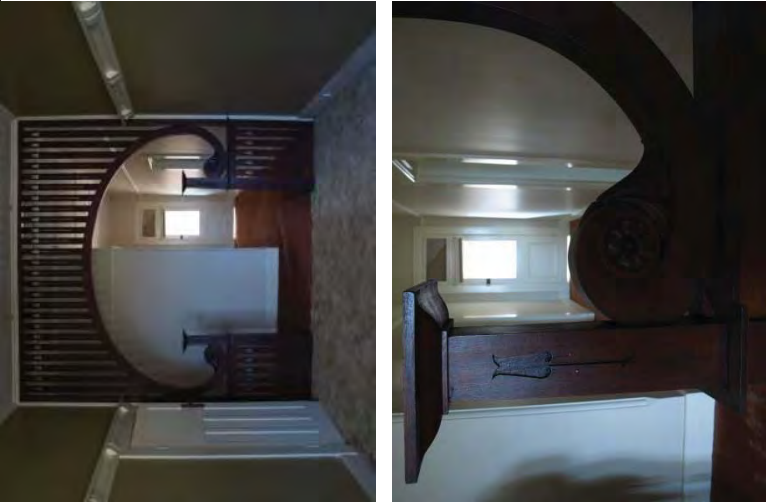
Element	Component	Materials	Time Period	Grading	Condition	Image
	Entrance frame	Turned timber with tulip elements	Original	E	G

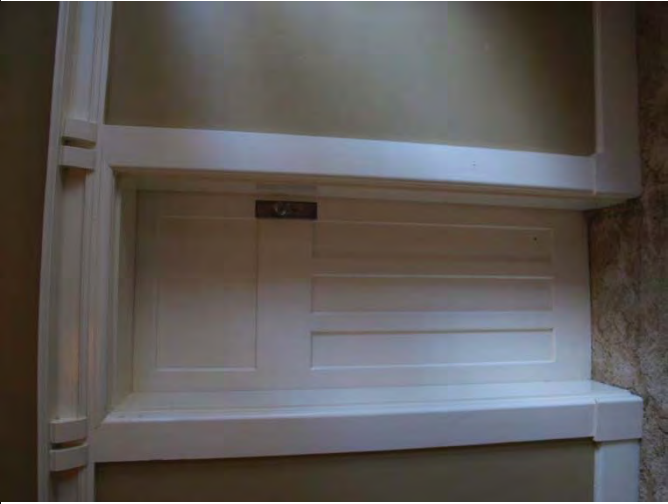
Element	Component	Materials	Time Period	Grading	Condition	Image
	Door 13	Four panel timber door Door knob	Original Late 20 th C	E I	G G

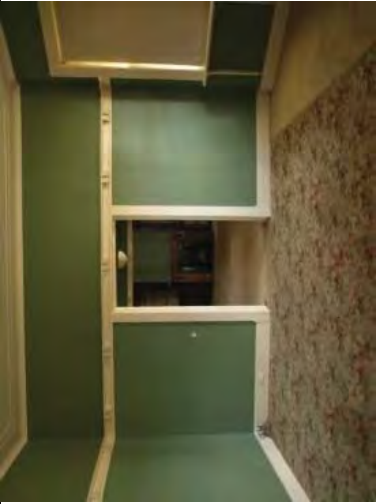
Element	Component	Materials	Time Period	Grading	Condition	Image
	Walls	Rendered concrete	Original	E	G

Paint (colour)	Modern	H	G	
		Corbelled picture rail	Original	E	G

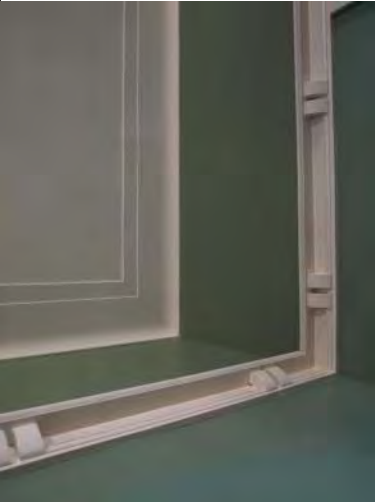
Element	Component	Materials	Time Period	Grading	Condition	Image
	Ceiling	Ceiling — gyprock	Mid-Late 20 th C	L	G

Note: the ceiling is not panelled as seen in rooms 1 and 3 and the style of the cornice is not seen elsewhere in the Homestead	Light fittings	Modern	L	G

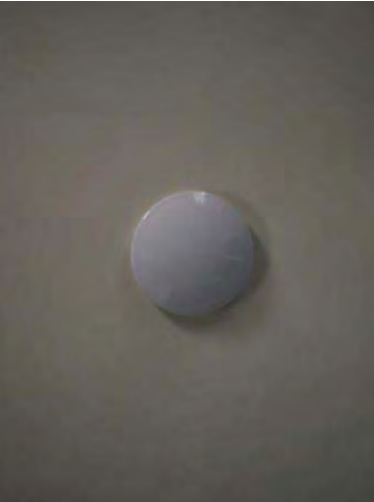
Cornice	Modern	L	G

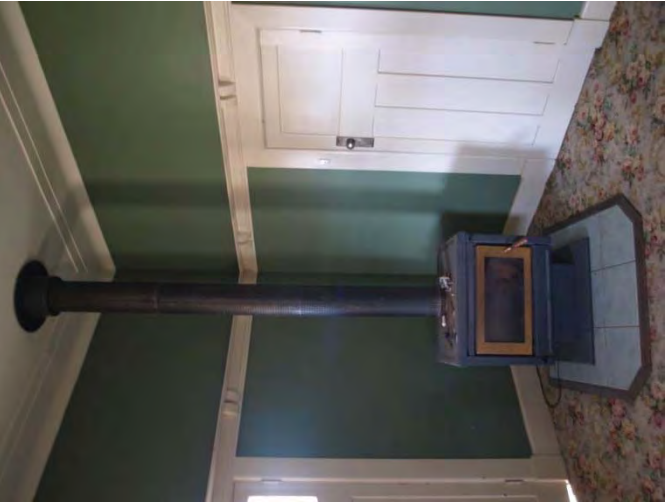
Element	Component	Materials	Time Period	Grading	Condition	Image
	Wood burning fire	Wood burning fire and flue Tile surround	Late 20 th C	I	F

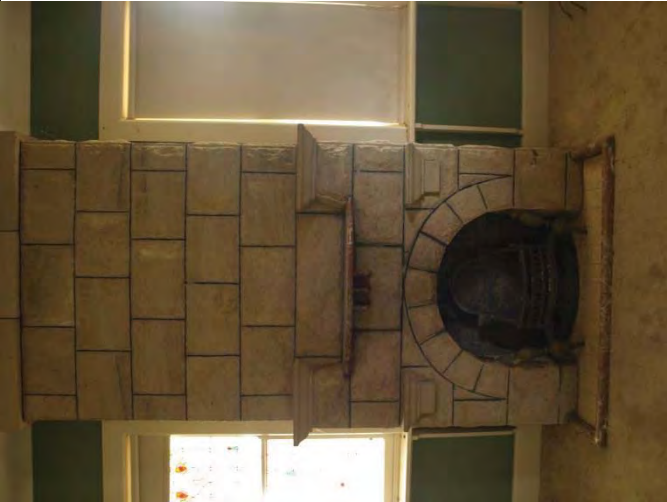
Element	Component	Materials	Time Period	Grading	Condition	Image
	Fireplace	Sandstone breast and marble mantle	Original	E	G

Metal grate	Original	H	P	
		Tiles	Mid 20 th C?	L	G	
		Marble surround	Original	E	F	
Room 3 Dining Room

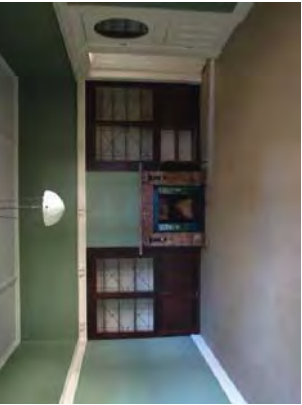
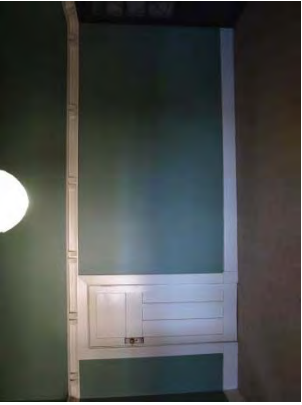
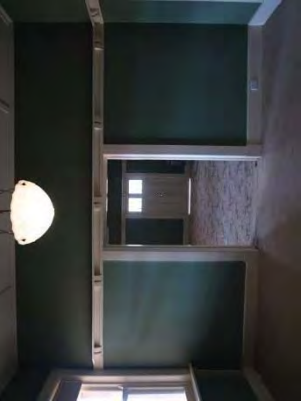
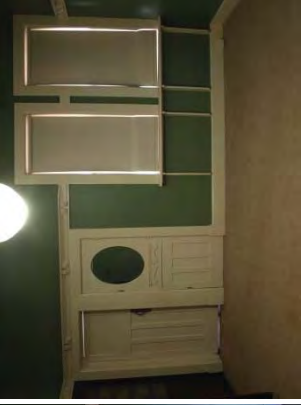
Element	Component	Materials	Time Period	Grading	Condition	Image
	Ceiling	<div> <div>Panelled asbestos (?) sheeting</div> <div>Light fitting</div> <div>Cornice</div> </div>	<div>Original</div> <div>Original</div> <div>Original</div>	<div>E</div> <div>E</div> <div>E</div>	<div>G</div> <div>G</div> <div>G</div>

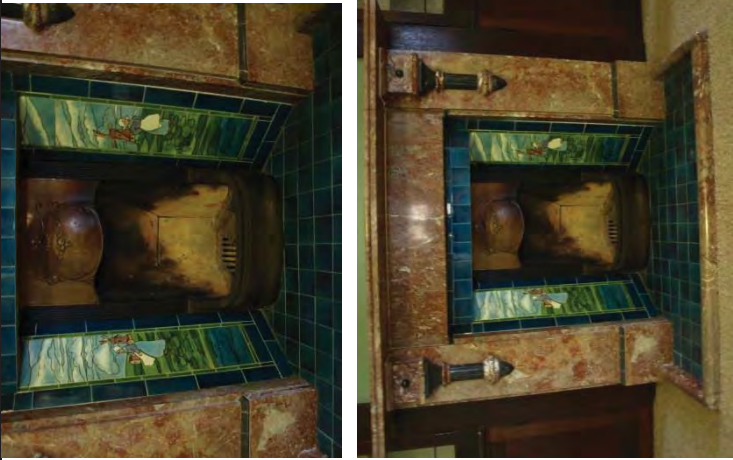
Element	Component	Materials	Time Period	Grading	Condition	Image
	Fireplace	Fireplace	Original	E	G

Marble mantle and surround	Original	E	G	
		Tiles	Original	E	G	
		Metal grate	Original	E	G

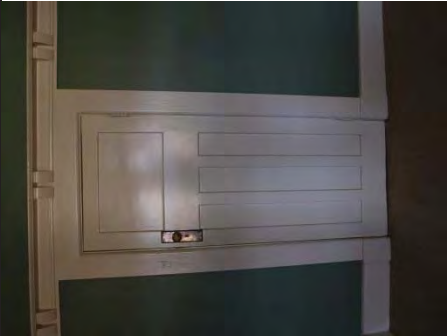
Element	Component	Materials	Time Period	Grading	Condition	Image
	Door 15	Four panel timber door Door knob	Original Late 20 th C	E I	G G

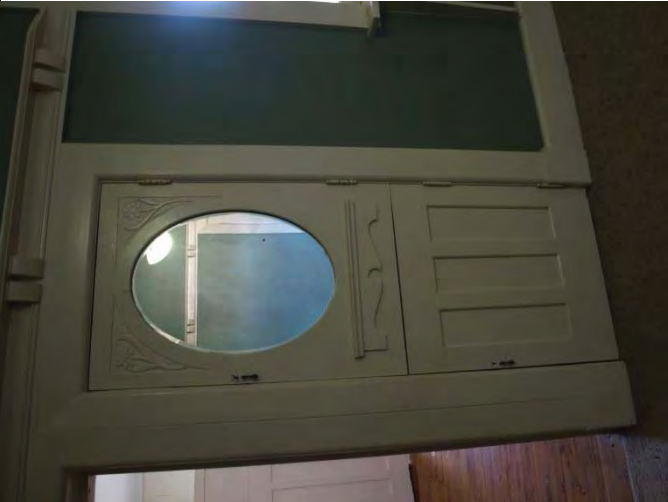
Servery door	Timber frame Timber door mirror	Original Original Original	E E E	G F G

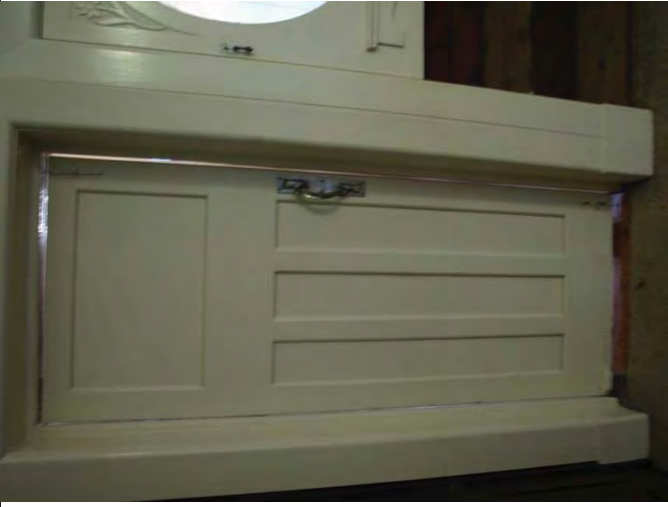
Element	Component	Materials	Time Period	Grading	Condition	Image
	Door 16	Four panel timber door Door handle	Original	E	G

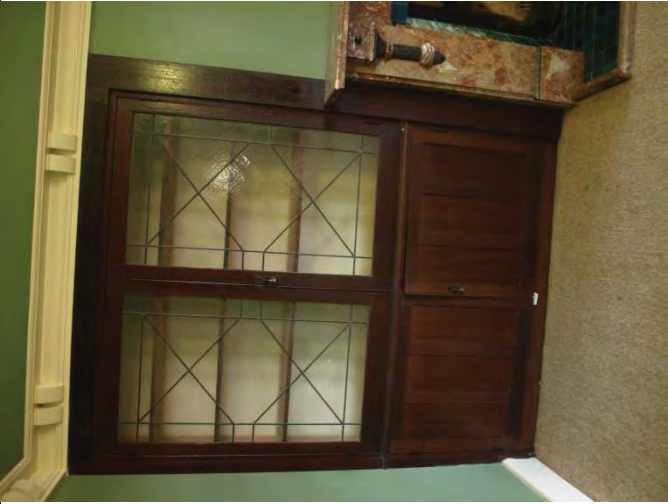
Element	Component	Materials	Time Period	Grading	Condition	Image
	Built-in cabinets	Timber Lead light windows	Original Original	High High	F F

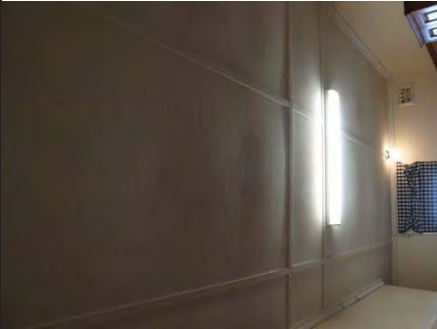
Element	Component	Materials	Time Period	Grading	Condition	Image
	Ceiling	<p>Panelled asbestos sheeting</p> <p>Cornice</p>	<p>Original</p> <p>Original</p>	<p>H</p> <p>H</p>	<p>F</p> <p>F</p>

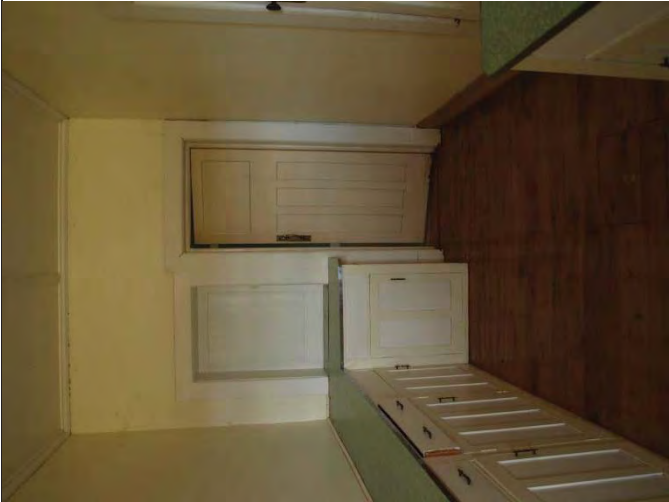
Walls	<p>Rendered and painted</p> <p>Tiles (above sink)</p>	<p>Original</p> <p>Modern</p>	<p>E</p> <p>L</p>	<p>F</p> <p>F</p>

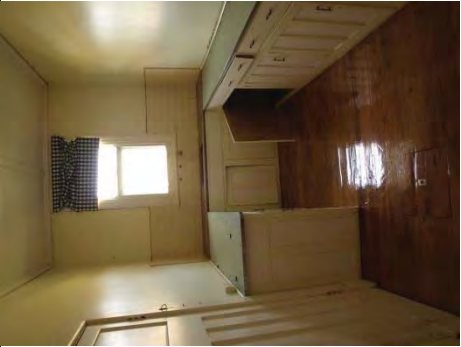
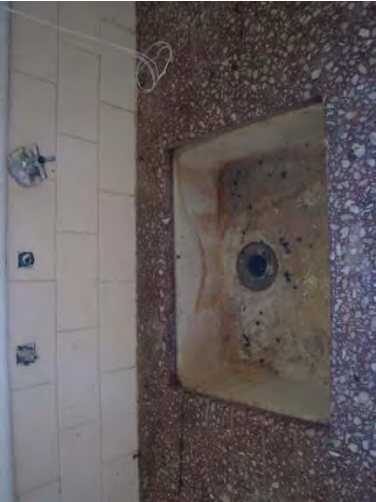
Element	Component	Materials	Time Period	Grading	Condition	Image
	Cupboards and draws	Painted timber	Original	E	F

Laminate bench top	Early 20 th C	M	P	
		Composite stone bench top & sink	Original	E	F

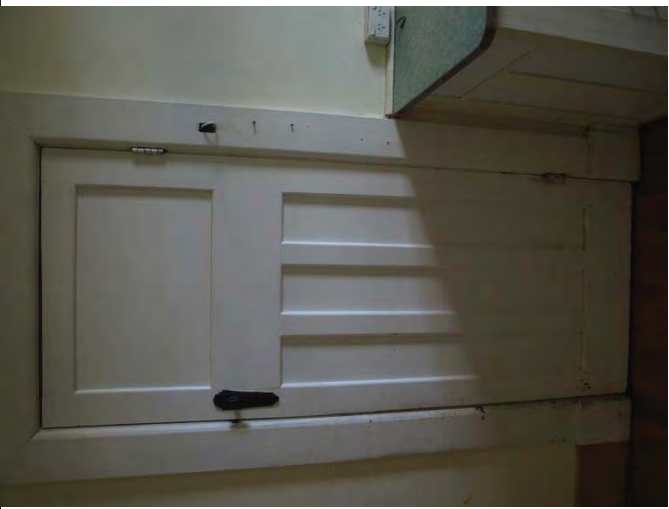
Element	Component	Materials	Time Period	Grading	Condition	Image
	Door 17	Opening	Original	E	G

Timber frame	Original	E	G	
		Four panel door	Original	E	G	
		Door knob	Original	E	G	
		Height indicators (Andrews family)	Modern	H	F

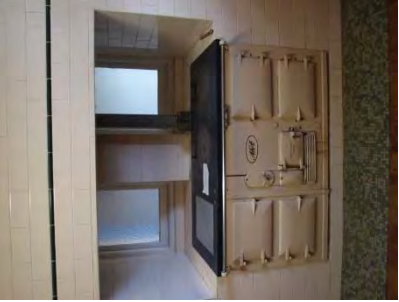
Element	Component	Materials	Time Period	Grading	Condition	Image
	AGA	AGA oven	Early 20 th C	H	G

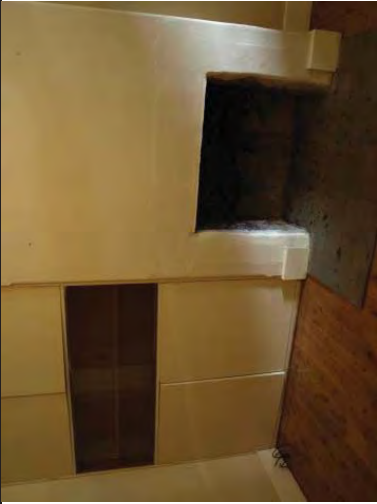
Element	Component	Materials	Time Period	Grading	Condition	Image
Room 6 Lounge 2	Fireplace	Built in brick Mantel removed other than timber skirting	Original	H	F

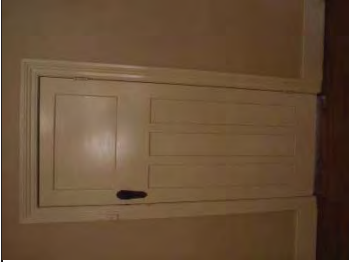
Built in shelving	Timber and glass	Mid-Late 20 th C	I	F	
	Door 19	Four panel timber door Door knob	Original	E	G

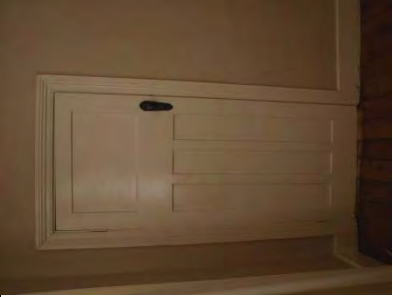
Element	Component	Materials	Time Period	Grading	Condition	Image
	Door 20	Four panel timber door Door knob	Original	E	G

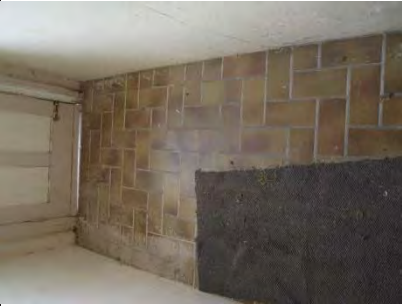
Element	Component	Materials	Time Period	Grading	Condition	Image
	Entry tiling	Ceramic tiles	Mid-Late 20 th C	L	F

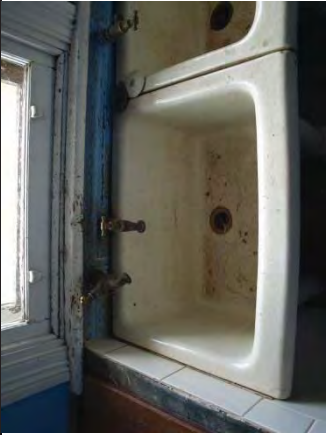
Element	Component	Materials	Time Period	Grading	Condition	Image
	Sink	Ceramic sink Tapware	Mid 20 th C Mid 20 th C	M L	F P

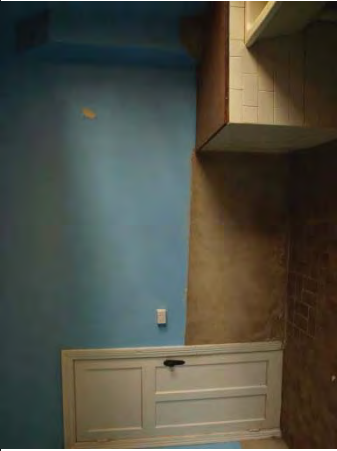
Walls	Rendered masonry Paint	Original Modern	E L	P (evidence of rising salt attack) F

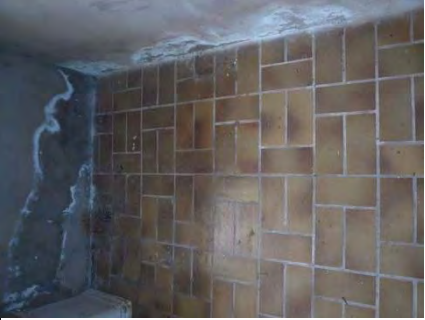
Floor	Ceramic tiles	Modern	L	F

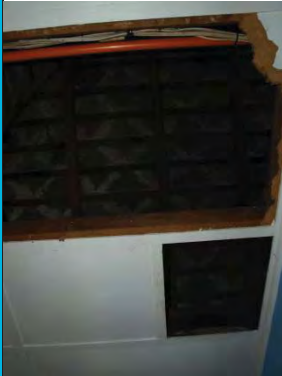
Element	Component	Materials	Time Period	Grading	Condition	Image
	Ceiling	Fibre board	Modern	L	P

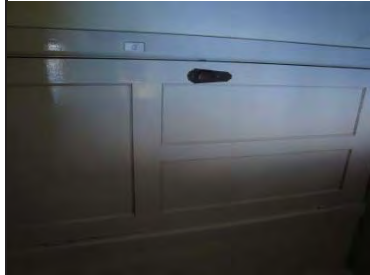
Door 26 (Room 9a)	Three panel door Door knob	Early-Mid 20 th C	H	F
