Conservation Management Plan for Tarwyn Park and Iron Tank

BYLONG COAL PROJECT
Response to PAC Review Report

DRAFT Conservation Management Plan

AECOM Australia Pty Ltd

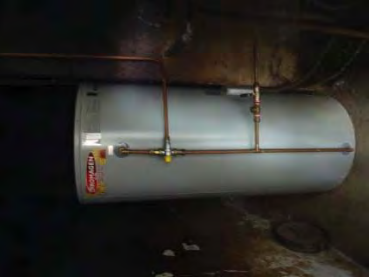
Element	Component	Materials	Time Period	Grading	Condition	Image
	Hot water system (Room 9a)	Hot water system	Modern	L	Not checked.

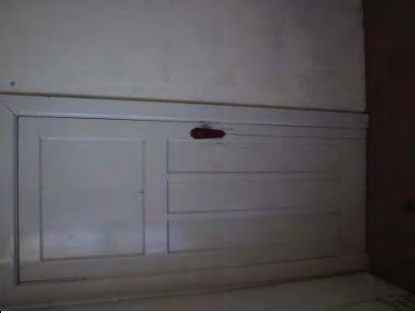
Door 28 (Room 9b)	Four panel timber door Door knob	Original	H	G

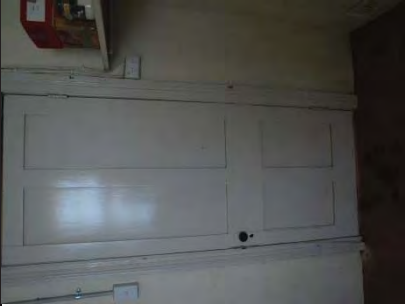
Element	Component	Materials	Time Period	Grading	Condition	Image
	Door 27 (room 9b)	Four panel door Door knob	Late 20 th C Late 20 th C	L L	F F

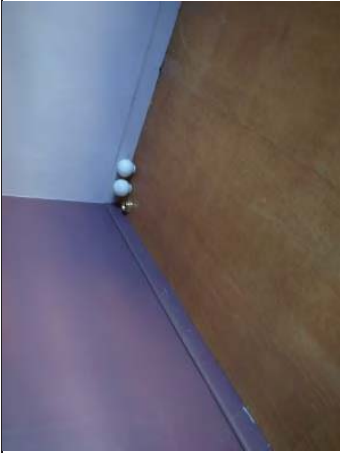
Room 12 Office	Floor	Plywood covering unknown flooring	Modern	I	G

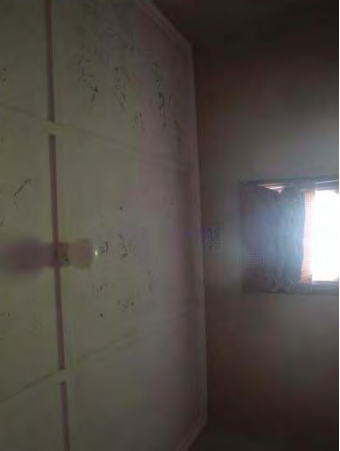
Element	Component	Materials	Time Period	Grading	Condition	Image
	Ceiling	Asbestos sheeting	Original	L	P

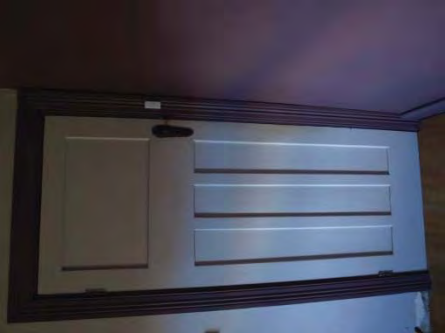
Door 21	Four panel door Door knob	Original Original	H H	F F

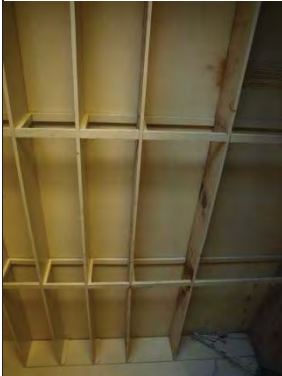
Shelving	Timber and metal frame shelving	Mid 20 th C to modern?	M	F

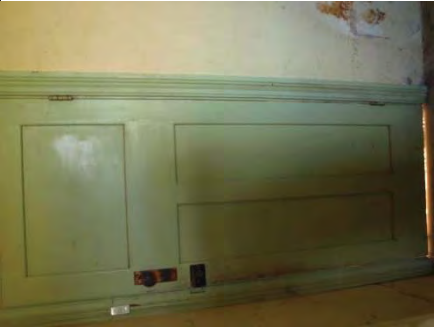
Element	Component	Materials	Time Period	Grading	Condition	Image
	Door 8	Three panel door Door knob	Mid 20 th C Mid 20 th C	L L	F F

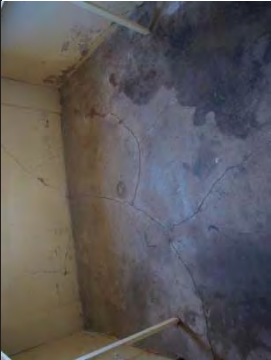
Floor	Concrete	Original?	L	P

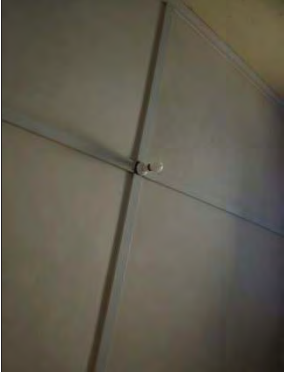
Ceiling	Asbestos sheeting	Original	L	F

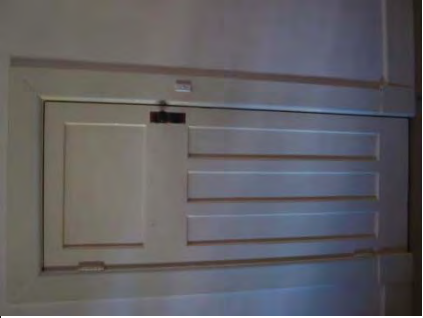
Door 28	Four panel door Door knob	Original Original	H H	F F

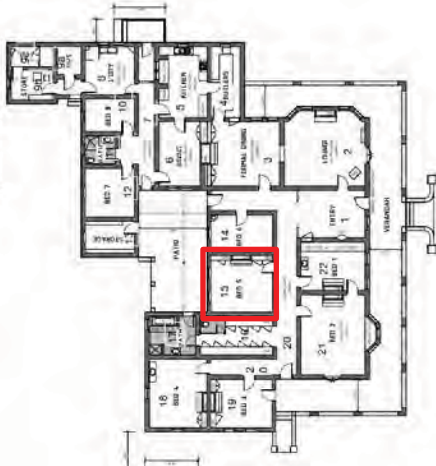
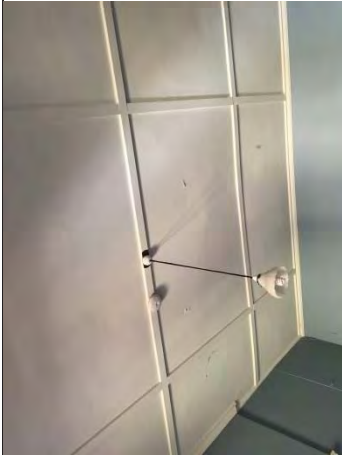
Element	Component	Materials	Time Period	Grading	Condition	Image
Room 15

Ceiling	Asbestos panelling	Original	H	F

Light fitting	Original/mid 20 th century	H	G (appearance only)	
		Smoke alarm	Modern	L	Not tested	
		Cornice	Original	M	F

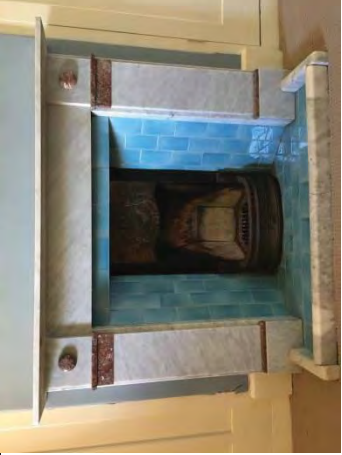
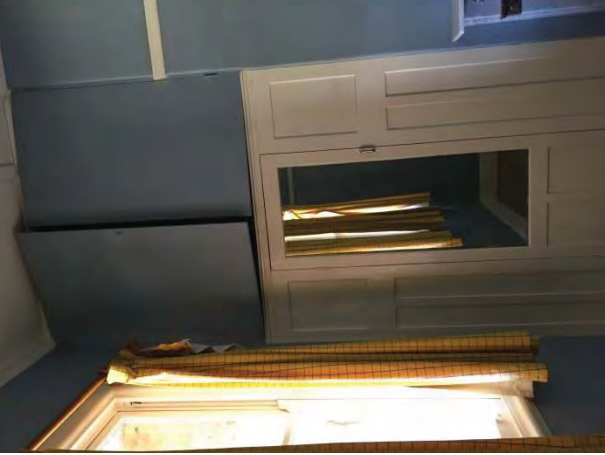
Picture Rail	Original	E	G	
		Fireplace	Original (all components)	E	G	
		<ul style="list-style-type: none"> • mantle – two tone granite • tiles – blue rectangular • grate – beaten metal with copper plate (largely worn away) 			G	
		Built-in cupboards	Original	H	G	
		<ul style="list-style-type: none"> • framing • doors • mirror • handles 	Original Original Modern Modern

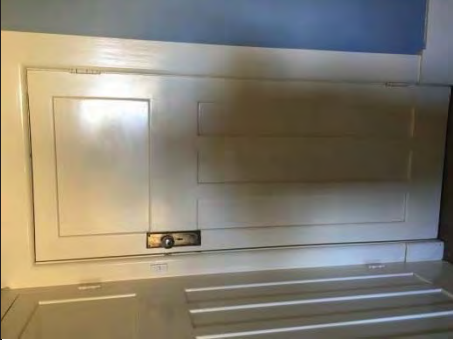
Element	Component	Materials	Time Period	Grading	Condition	Image
	Door 29	Four panel door Door knob	Original Mid 20 th Century	E L	G G

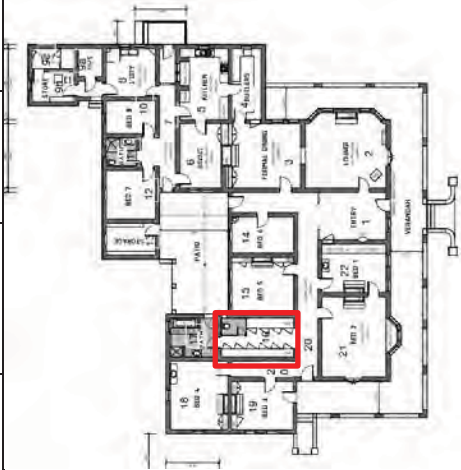
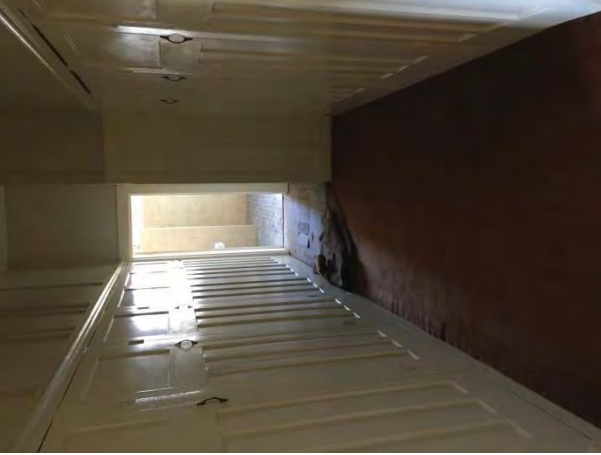
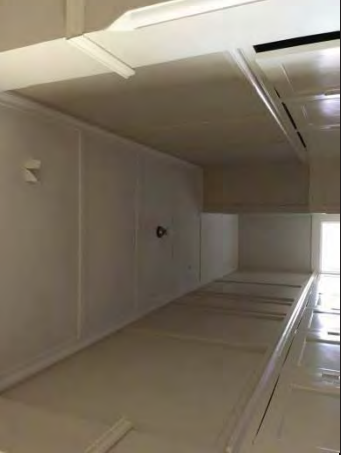
Room 16a

Element	Component	Materials	Time Period	Grading	Condition	Image
	Wall	Built-in Cupboards <ul style="list-style-type: none"> • frames • doors • door handles 	Original Original Late 20 th Century	E E L	G G G

Ceiling	Asbestos panelling Light fitting	Original Modern	H L	F F (appearance only)

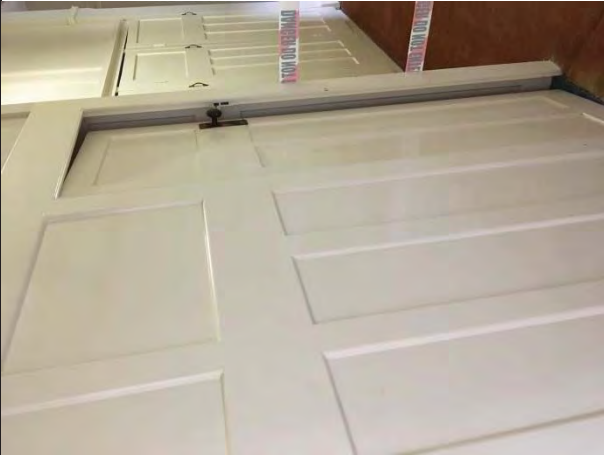
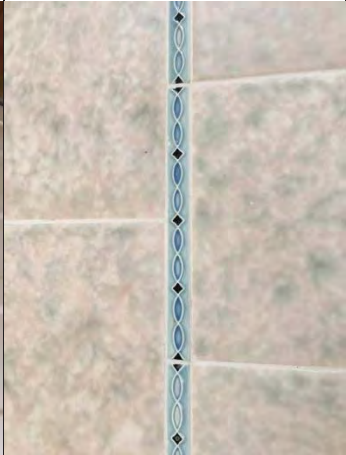
Element	Component	Materials	Time Period	Grading	Condition	Image
	Door 30	Three panel door	Late 20 th Century	M	F

Door knob	Late 20 th Century	L	F	
Room 16b – toilet	Walls	Tiles (matching room 17)	Mid 20 th Century	M	F

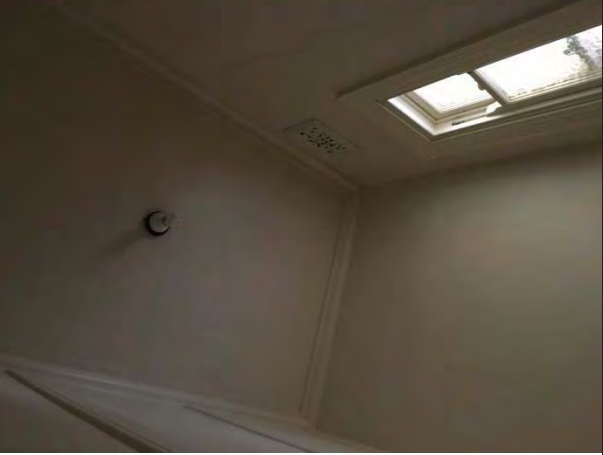
Element	Component	Materials	Time Period	Grading	Condition	Image
	Ceiling	Asbestos sheeting?	Original	H	G

Cornice	Original	H	G	
		Light fitting	Modern	L	G

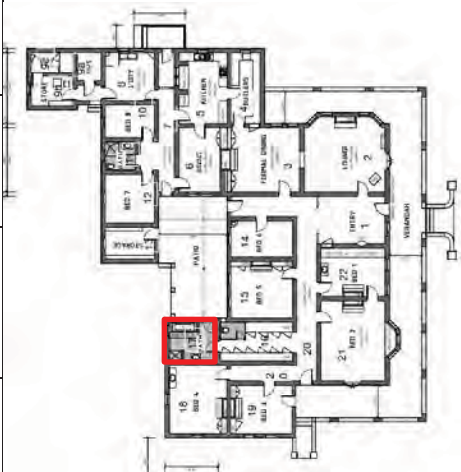
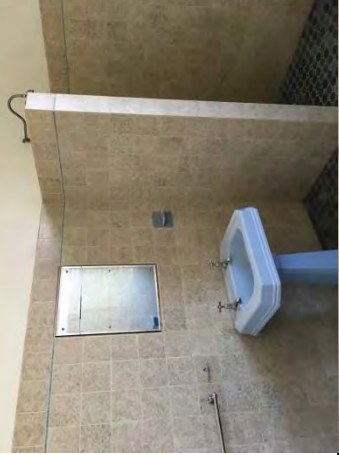
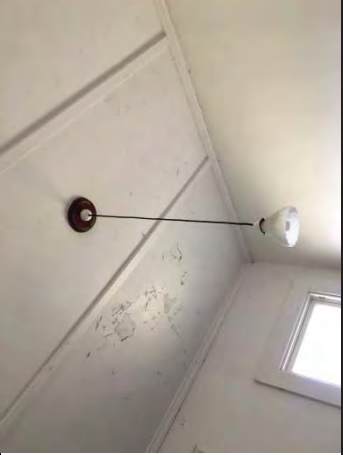
Room 17

Element	Component	Materials	Time Period	Grading	Condition	Image
	Wall	Tiles (matching room 16b)	Mid 20 th Century	M	F

Air vent	Original	M	F	
	Ceiling	Asbestos sheeting	Original	H	G

Cornice	Original	H	G	
		Light fitting	Mid 20 th Century	M	G (appearance only)	
	Floor	Tiles	Mid 20 th Century	L	P

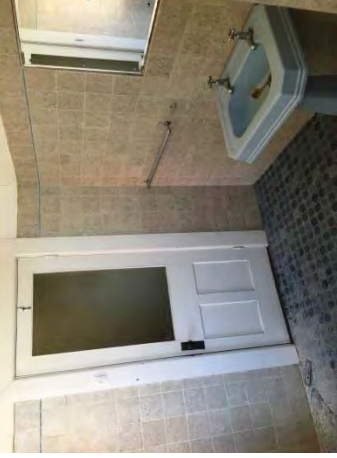
Element	Component	Materials	Time Period	Grading	Condition	Image
	Door 31	Three panel door with opaque, textured glass Door knob	Mid 20 th Century Mid 20 th Century	L L	F F

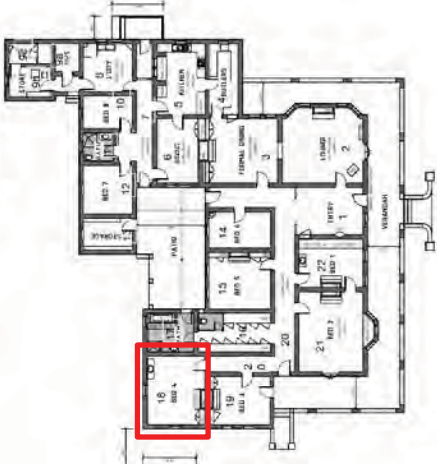
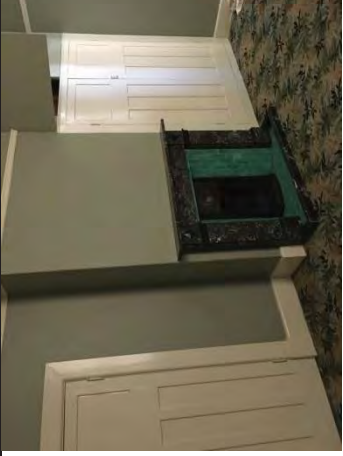
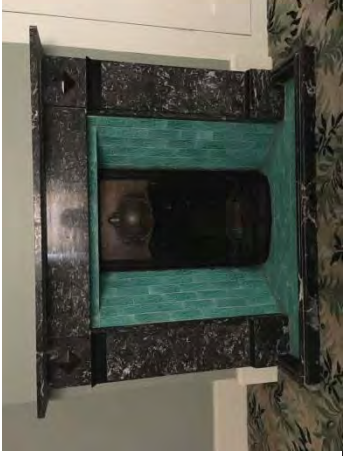
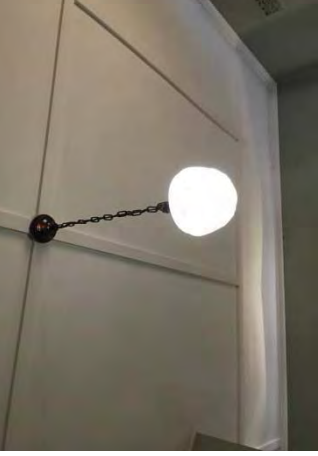
Room 18

Element	Component	Materials	Time Period	Grading	Condition	Image
	Wall	Skirting	Mid 20 th Century	L	G

Picture Rail	Original	E	G	
		Fireplace	Original (all components)	E	G	
		<ul style="list-style-type: none"> • mantle – two tone granite • tiles – teal rectangular • grate – beaten metal with copper plate (largely worn away) 			G	
		Built-in cupboards	Original	H	G	
		<ul style="list-style-type: none"> • framing • doors • mirror • handles 	Original Original Modern Modern			
	Ceiling	Sink	Modern Modern	H	G

Asbestos sheeting and panels	Original	H	G	
		Light fitting	Original	H	G (appearance only)	
	Floor	Carpet	Modern	L	F	
		Floor boards	Original?	H	Not inspected

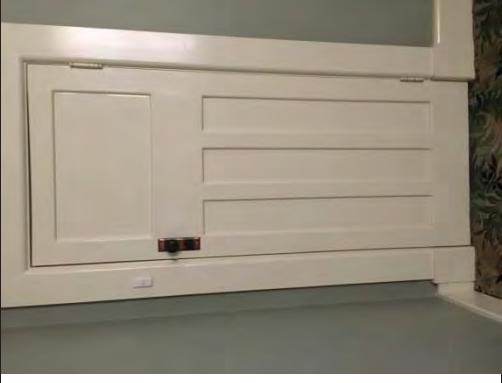
Element	Component	Materials	Time Period	Grading	Condition	Image
	Door 32	Four panel door Door knob	Original Mid 20 th Century	H L	G G

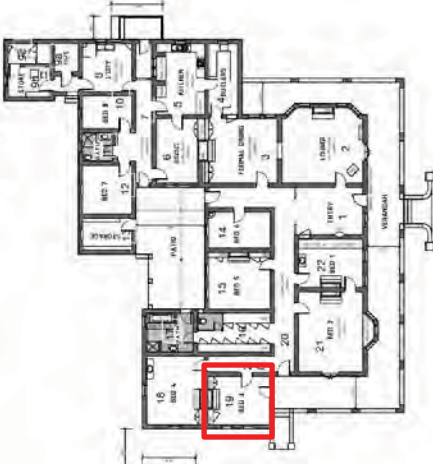
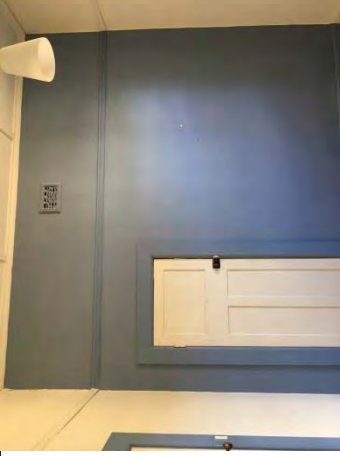
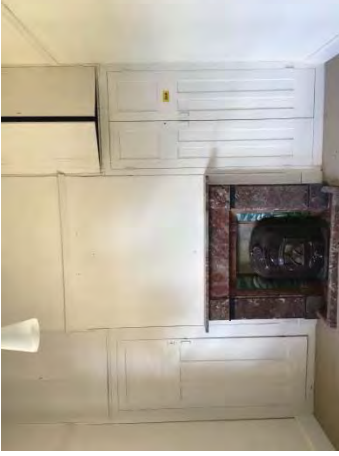
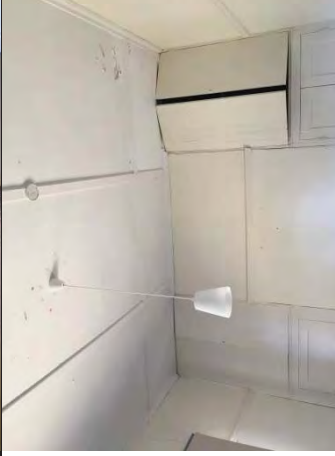
Room 19

Element	Component	Materials	Time Period	Grading	Condition	Image
	Wall	Skirting	Mid 20 th Century	L	G

Picture Rail	Original	E	G	
		Fireplace	Original (all components)	E	G	
		<ul style="list-style-type: none"> • mantle – two tone granite • tiles – Dutch scene • grate – beaten metal with copper plate 			G	
		Built-in cupboards <ul style="list-style-type: none"> • framing • doors • mirror • handles 	Original Original Modern Modern	H	G	
	Ceiling	Asbestos sheeting and panels	Original	H	G

Light fitting	Modern	L	G (appearance only)

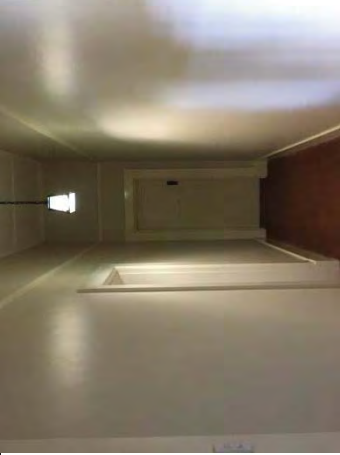
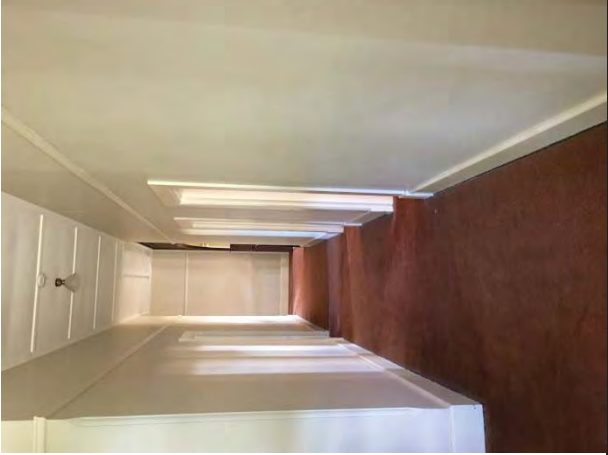
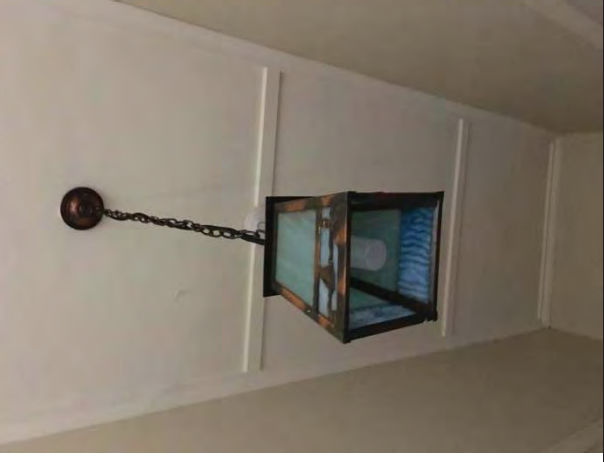
Element	Component	Materials	Time Period	Grading	Condition	Image
	Wall	Skirting	Original	H	F

Picture Rail	Original	H	G

Element	Component	Materials	Time Period	Grading	Condition	Image
	Ceiling	Asbestos sheeting and panels	Original	H	G

Light fitting in east wing of hall <ul style="list-style-type: none"> Brass and glass lead light depicting a ship and lighthouse 	Original	H	G (appearance only)	
		Light fitting in north wing of hall	Modern	L	G (appearance only)	
		Smoke alarm	Modern	L	G (appearance only)	
	Floor		Modern?	L	P	
Room 21			Original	E	Not inspected

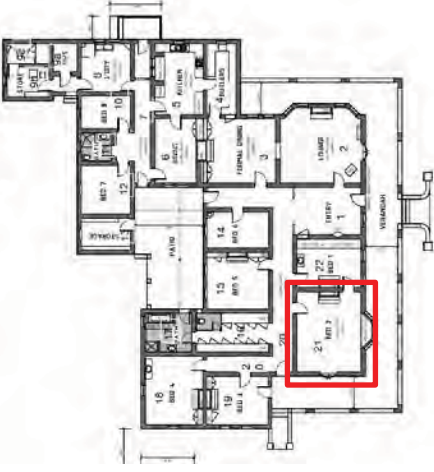
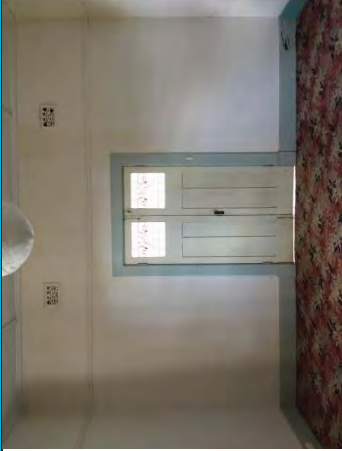
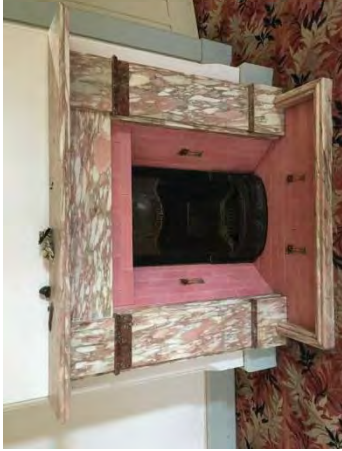
Element	Component	Materials	Time Period	Grading	Condition	Image
	Wall	Skirting	Original	M	P

Picture Rail	Original	E	G	
		Fireplace	Original (all components)	E	G	
		<ul style="list-style-type: none"> • mantle – two tone granite • tiles – pink rectangular with tulip feature tiles • grate – beaten metal with copper plate (largely worn away) 			G	
					F/P	
	Ceiling	Asbestos sheeting and panels	Original	H	P (paint peeling)

Light fitting <ul style="list-style-type: none"> • Brass and moulded milk glass 	Original	H	G (appearance only)

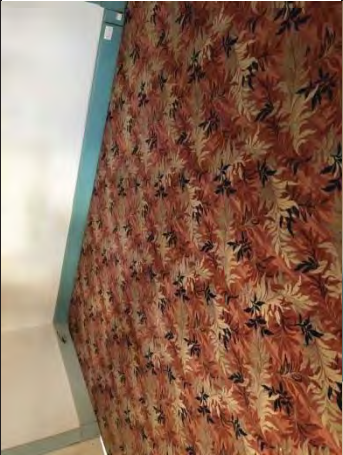
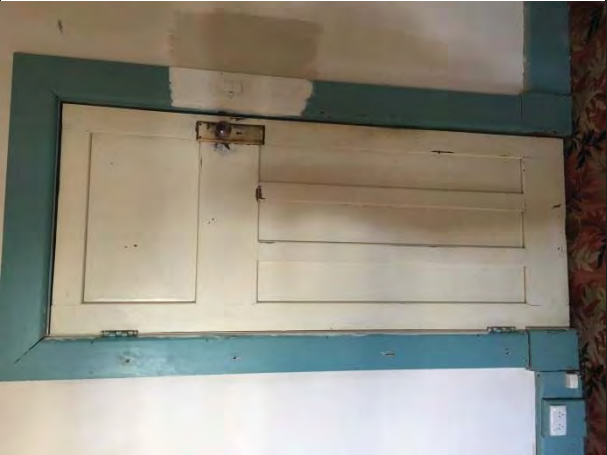
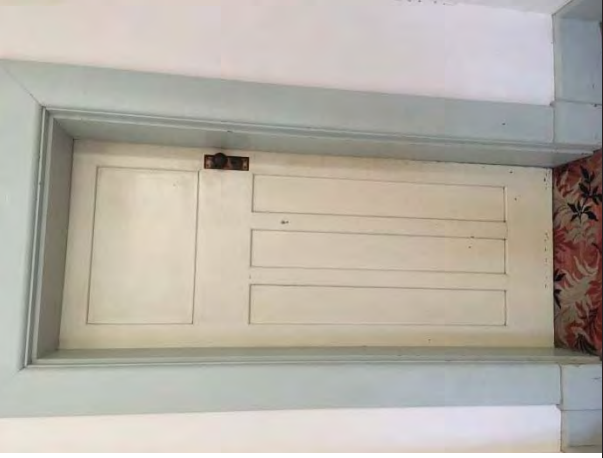
Door 34	Four panel door Door handle	Original Late 20 th Century	E L	P P

Element	Component	Materials	Time Period	Grading	Condition	Image
	Door 36	Four panel door Door knob	Original Late 20 th Century	E L	F F

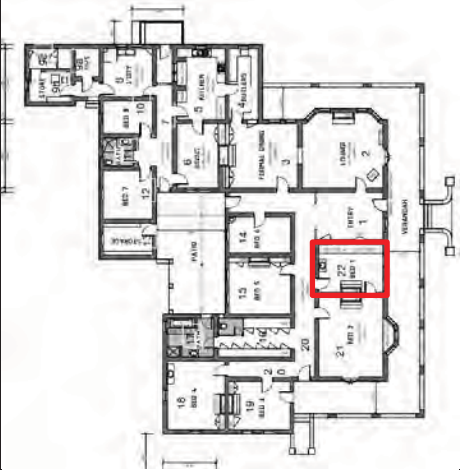
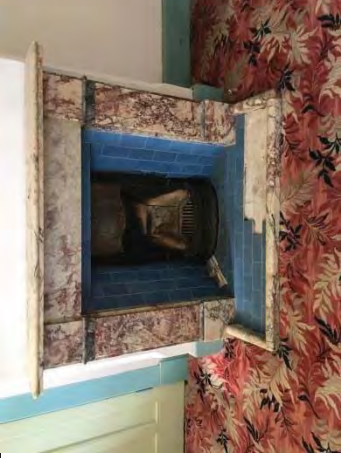
Room 22

Element	Component	Materials	Time Period	Grading	Condition	Image
	Wall	Skirting	Original	M	P

Picture Rail	Original	E	G	
		Fireplace <ul style="list-style-type: none"> • mantle – two tone granite • tiles – blue • grate – beaten metal with copper plate (largely worn away) and cast iron 	Original (all components)	E	G	
		Sink <ul style="list-style-type: none"> • vanity • sink • tapware • tiles 	Original Original Late 20 th C Modern	H H L L	P F P G	
		Built-in Robe	Modern	L	F

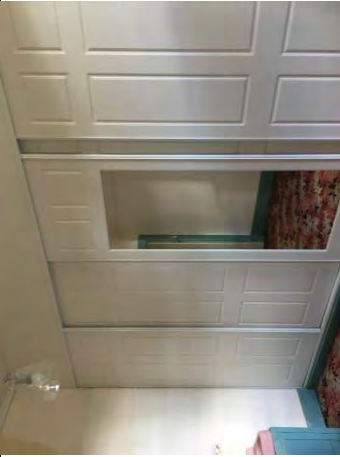
Ceiling	Asbestos sheeting and panels Light fitting <ul style="list-style-type: none"> • Metal and glass 	Original Modern	H I	P (paint peeling) G (appearance only)

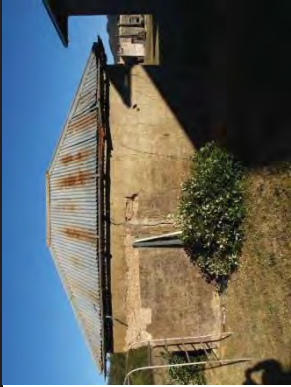
Element	Component	Materials	Time Period	Grading	Condition	Image
Northern façade	Wall	Unreinforced concrete pise	Original	H	P

Render, including ashlar line markings	Original	H	P

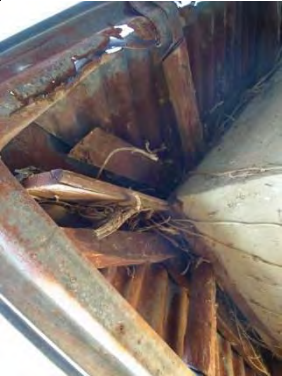
Element	Component	Materials	Time Period	Grading	Condition	Image
	Roof	Corrugated iron Guttering Timber battens	Early-Mid 20 th C Late 20 th C Original?	H L H	P P P

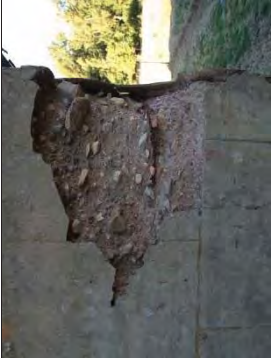
Southern façade	Wall	Unreinforced concrete pise Render, including ashlar line markings	Original Original	H H	P P

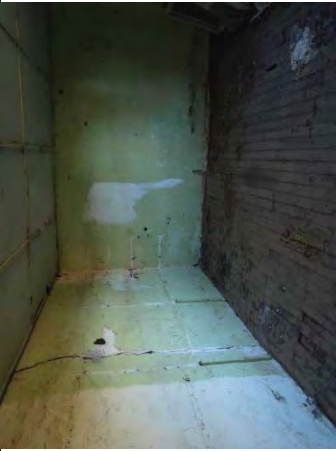
Element	Component	Materials	Time Period	Grading	Condition	Image
Western façade	Window					
	Wall	Unreinforced concrete pise Render, including ashlar line markings	Original Original	H H	P P	 
Interior	Walls	Render Paint	Original Mid-Late 20 th C	L L	P P

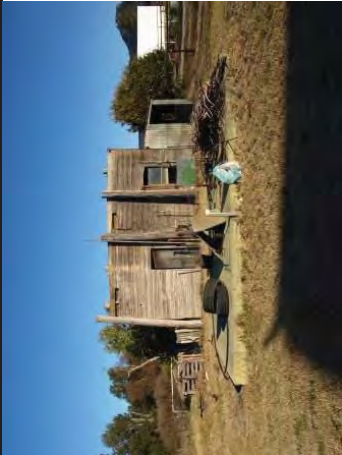
Element	Component	Materials	Time Period	Grading	Condition	Image
Northern façade	Wall	Tank stand unmilled timber uprights	Original	H	F

Note: the phasing of the garage indicates that it was constructed in four phases. The tank stand was the initial structure, followed by the weatherboard structure and then the concrete garage and corrugated iron generator shed. The fabric would suggest that the three infill construction phases occurred between the late 1940s and late 1960s. The time period given below has been augmented by the addition of an informational note indicating whether the fabric relates to Phase 1, Phase 2 or Phase 3. It is unclear from an initial inspection of the fabric as to whether the concrete garage or the generator shed came first and therefore the garage has arbitrarily been assigned Phase 2 and the generator shed Phase 3. There is an additional un-phased lean-to structure on the eastern side that may have been used as a chicken roost.

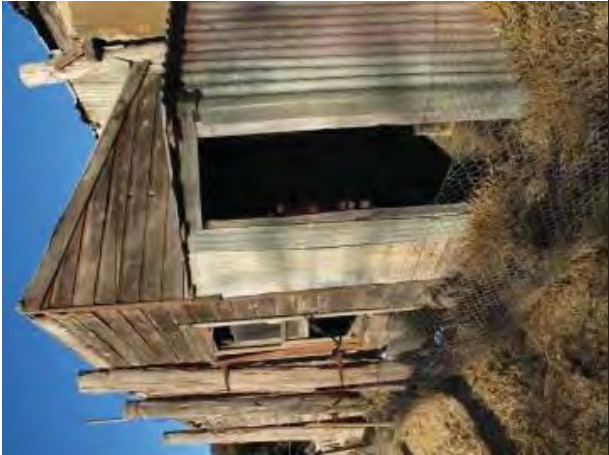
Timber weatherboard	Mid 20 th C (Phase 1)	L	P	
		Corrugated iron (generator shed)	Mid 20 th C (Phase 3)	L	P

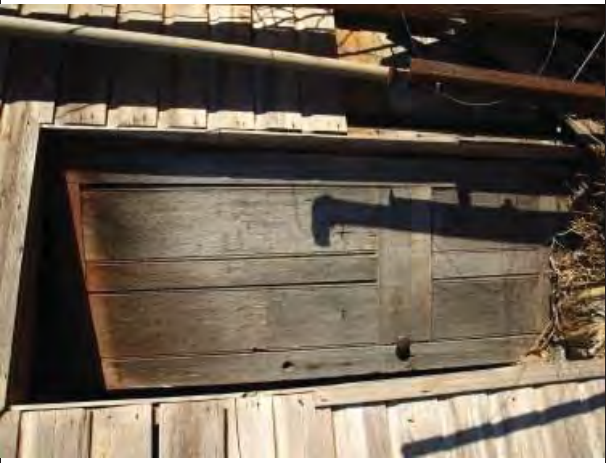
Element	Component	Materials	Time Period	Grading	Condition	Image
	Door	Interior four panel door Door knob	Mid 20 th C (Phase 1)	L	P

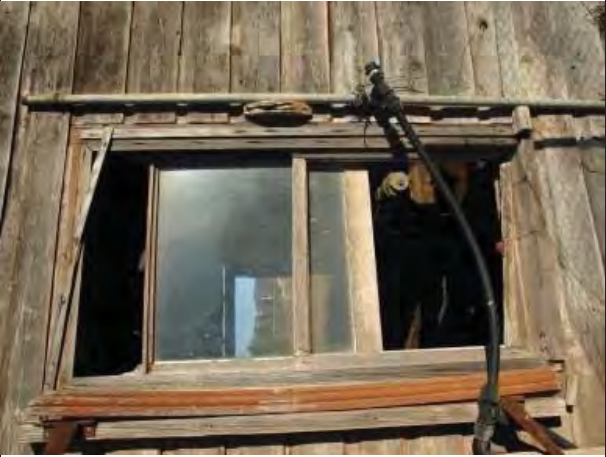
Element	Component	Materials	Time Period	Grading	Condition	Image
	Window	Timber frame double hung sash window	Mid 20 th C (Phase 1)	L	VP

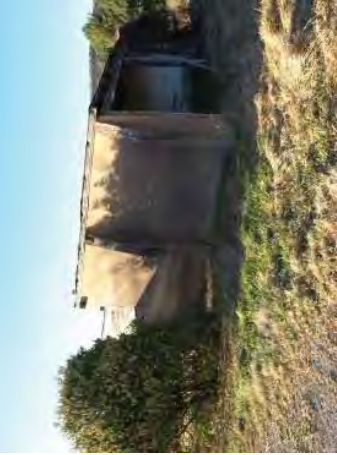
Element	Component	Materials	Time Period	Grading	Condition	Image
Southern façade	Concrete Garage	Concrete wall – formwork	Late 20 th C (Phase 2)	L	F

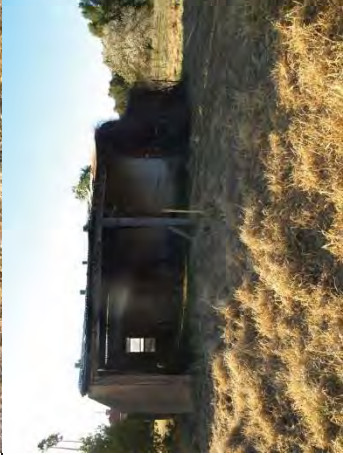
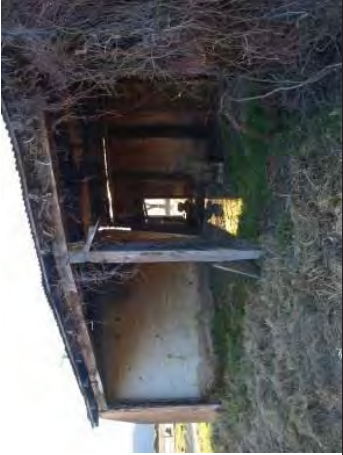
Beams	Timber supports – milled timber	Late 20 th C (Phase 2)	L	P

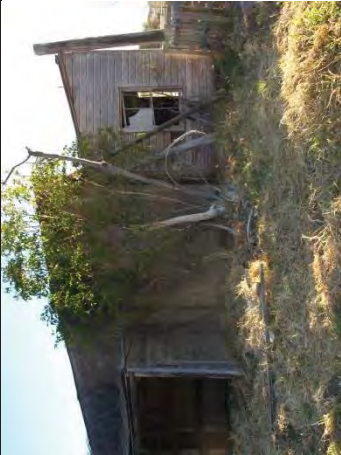
Element	Component	Materials	Time Period	Grading	Condition	Image
Eastern façade	Wall	Timber weatherboard	Mid 20 th C (Phase 1)	L	P

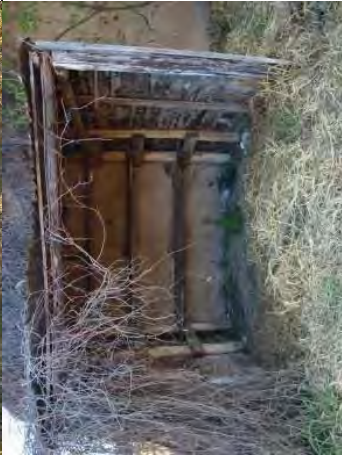
Concrete	Mid 20 th C (Phase 2)	L	F	
	Chicken roost	Timber weatherboard on timber frame with corrugated iron roof	Late 20 th C	L	P

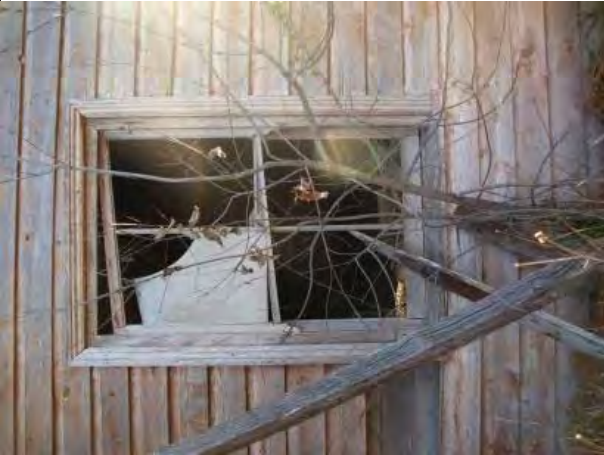
Element	Component	Materials	Time Period	Grading	Condition	Image
	Window	Single hung four pane sash window	Mid 20 th C (Phase 1)	L	VP

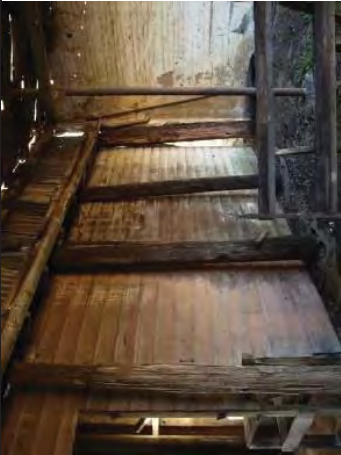
Interior						
Interior	Interior beams	Unmilled uprights	Original (tank stand)	H	F

Metal support	Mid 20 th C (Phase 2)	L	P	
	Walls	Unlined weatherboard	Mid 20 th C (Phase 1)	L	P	
		Formwork concrete	Mid 20 th C (Phase 2)	L	F	
		Unlined corrugated iron	Mid 20 th C (Phase 3)	L	P

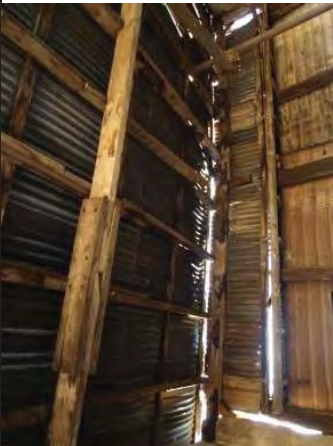
Element	Component	Materials	Time Period	Grading	Condition	Image
	Ceiling	Unlined corrugated iron on timber batons	Mid 20 th C (Phase 1, 2 & 3)	L	P

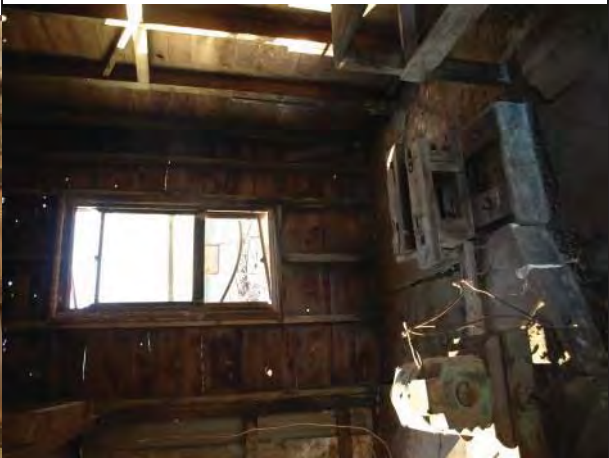
Interior fittings	Concrete generator bed (generator removed)	Mid 20 th C (Phase 3)	L	F

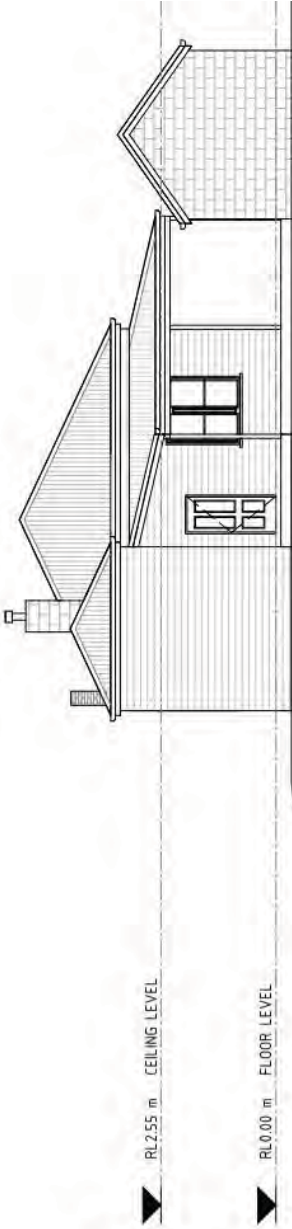
Element	Component	Materials	Time Period	Grading	Condition	Image
North-west façade

Wall	Weatherboard	Early 20 th C	H	P

Roof	Corrugated iron	Late 20 th /Modern	H (form)	F	
		Satellite Dish x2	Modern	L	L	
	Chimney	Red Brick	Early 20 th C	H	F	
	Door 8	Hollow core door	Modern	I	P	
	Window 8	Four pane, single hung sash windows	Original (Late 19 th C)	H	P	
	Window 9	Four pane, single hung sash windows	Original (Late 19 th C)	H	P

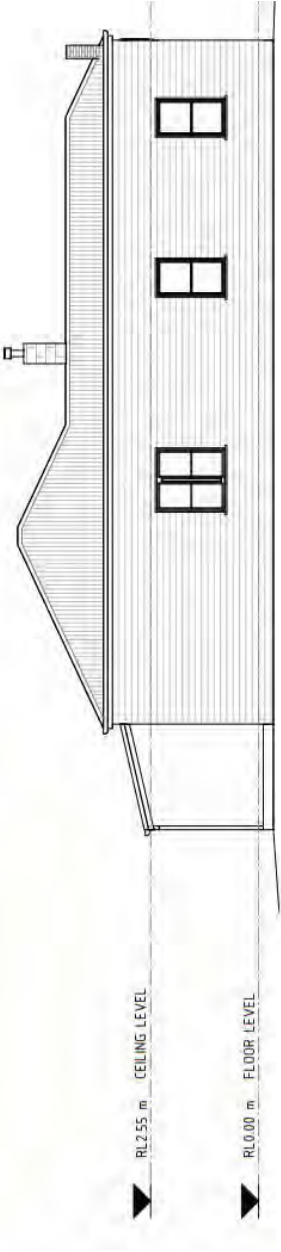
Element	Component	Materials	Time Period	Grading	Condition	Image
North-east façade

Window 1	Four pane, single hung sash windows	Original (Late 19 th C)	H	P

Window 2	Four pane, single hung sash windows	Original (Late 19 th C)	H	P	
	Window 3	One pane, single hung sash windows	Original (Late 19 th C)	H	P	
	Wall	Weatherboard	Original (Late 19 th C)	H	P

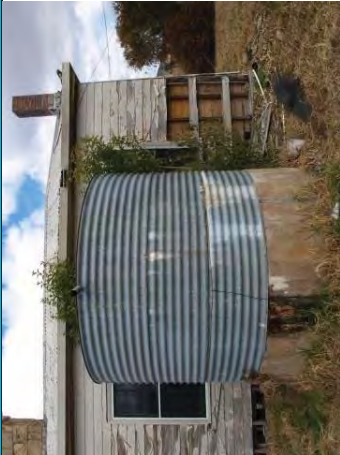
Element	Component	Materials	Time Period	Grading	Condition	Image
	Tank	Corrugated iron tank	Modern	L	P

Concrete base	Modern	L	F	
South-east façade

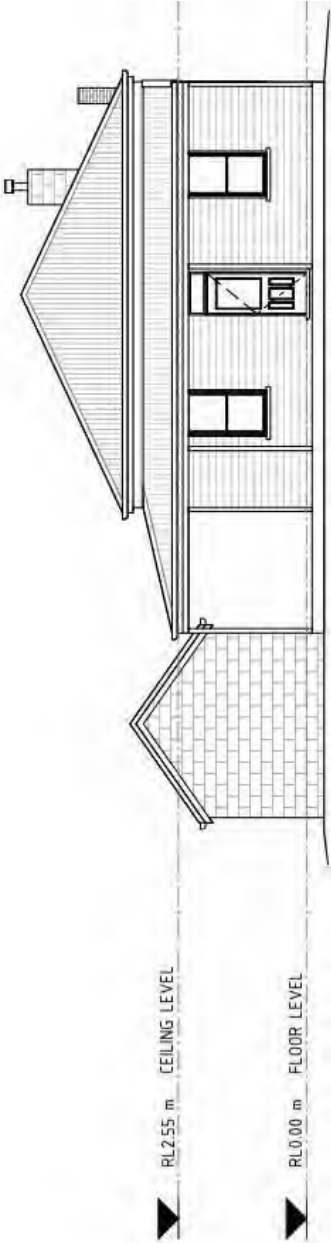
Door 7	<ul style="list-style-type: none">• Complex seven panel door with decorative moulding and central glass panel• Door bell• Door knob• Fly screen	Original	H	F

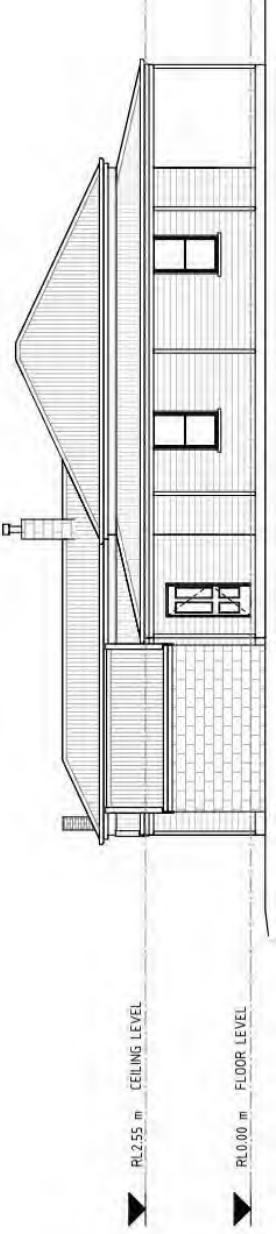
Wall	Weatherboard	Original & Early 20 th C	H	P

Element	Component	Materials	Time Period	Grading	Condition	Image
	Kitchen chimney	Sandstone	Original (Late 19 th C)	H	F	 
		Metal Flue	Late 20 th C/Modern	L	F	
	Window 6	Four pane, single hung sash windows	Original (Late 19 th C)	H	P	 
	Window 7	Four pane, single hung sash windows	Original (Late 19 th C)	H	P	
	Door 1	Hollow core door	Modern	L	P	 
		Door knob	Modern	L	P

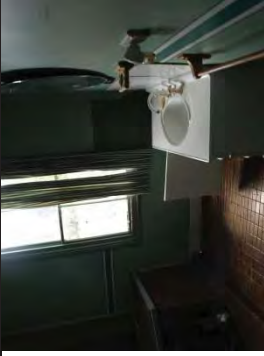
Element	Component	Materials	Time Period	Grading	Condition	Image
	Vanity	Vanity Tapware Sink	Modern Modern Modern	L L L	P P P

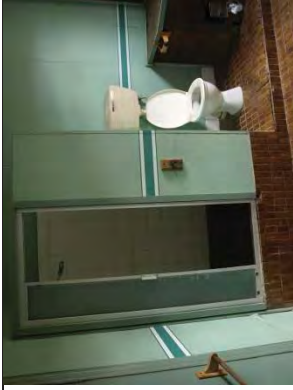
Shower	Shower head Tiles Shower screen (glass)	Modern Modern Modern	L L L	P P P

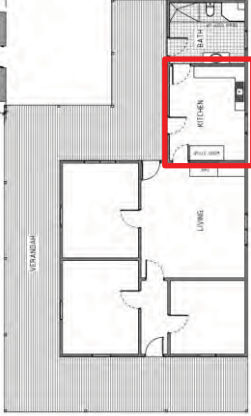
Kitchen					
	Walls	Timber panelling over timber frame Note: Intrusive investigations were not undertaken. It is not known whether earlier/original wall coverings are preserved beneath the timber panelling.	Late 20 th C	I	F

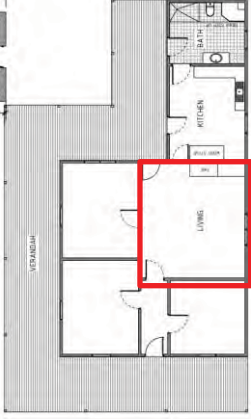
Door 3	Hollow core door Door knob	Modern Modern	L L	F F	
Living Room

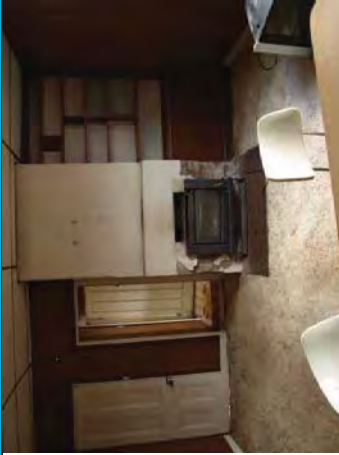
Element	Component	Materials	Time Period	Grading	Condition	Image
	Wall	Timber panelling Note: Intrusive investigations were not undertaken. It is not known whether earlier/original wall coverings are preserved beneath the timber panelling.	Late 20 th C	I	F

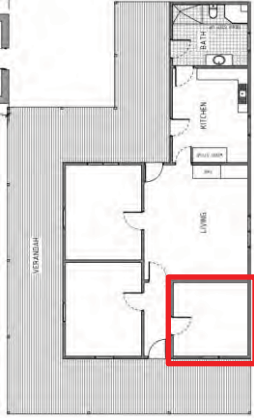
Ceiling	Medium Density Fibreboard panelling Note: Intrusive investigations were not undertaken. It is not known whether earlier/original ceiling is preserved beneath the panelling.	Late 20 th C	I	F	
	Fireplace	Fireplace/breast – brick with concrete render Wood burning fire	Original Modern	H L	P F	
	Fireplace tiling	Tile	Late 20 th C	L	P	
	Built in shelving	Timber	Late 20 th C	L	F	
	Door 8	Four panel door Door knob	Original/Early	M	F	
	Floor	Carpet	Modern	I	VP	
		Timber boards	?	?	Not inspected	
Bedroom 1

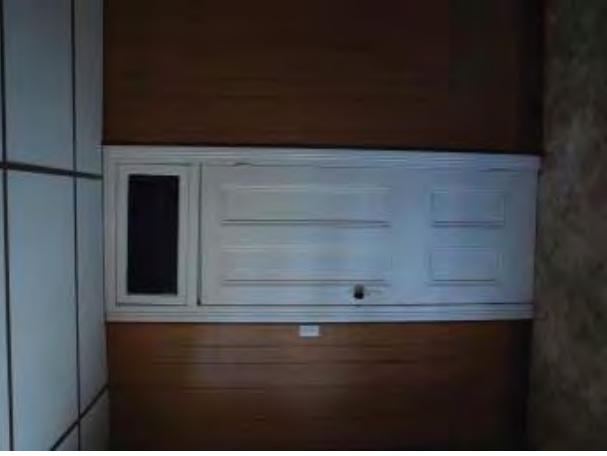
Element	Component	Materials	Time Period	Grading	Condition	Image
	Door 6	Four panel door Door knob Transom	Original Early 20 th C Original	H M H	G G G

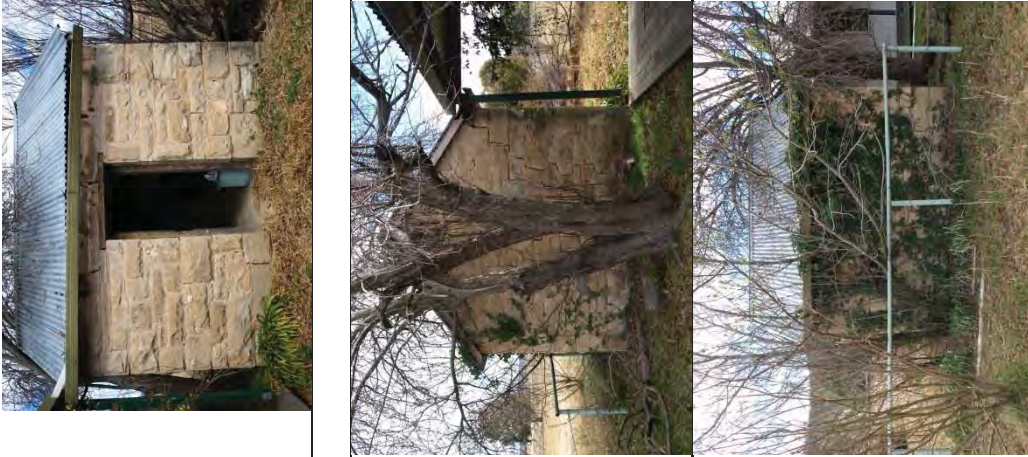
Element	Component	Materials	Time Period	Grading	Condition	Image
North east façade	Walls	Sandstone – un-coursed squared rubble	Mid/Late 19 th C	E	P

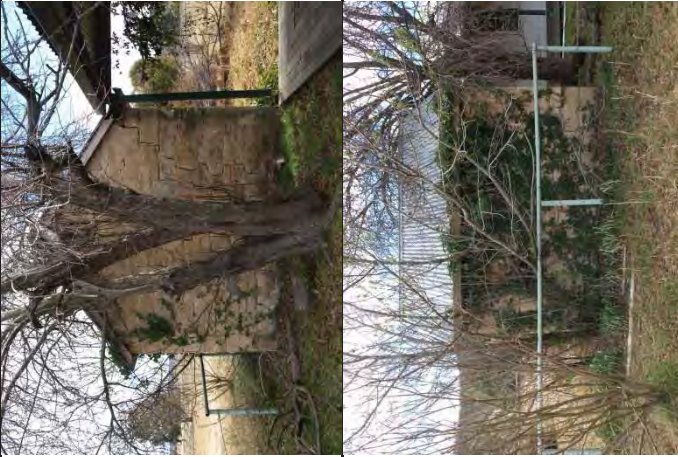
Door opening	Frame – timber <small>Note: the door has been removed at some point</small>	Mid/Late 19 th C	H	F	
	Roof	Corrugated iron sheeting	Late 20 th C	E (form only. Material of little significance and may be replaced as required with like for like)	P	
South east façade	Guttering	Iron – squareline profile	Modern	I	VP

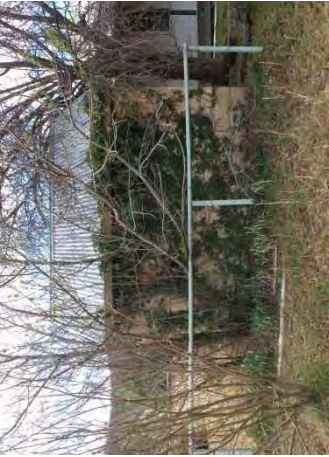
Walls	Sandstone – un-coursed squared rubble	Mid/Late 19 th C	E	P	
	Window	Facia board - timber Frame – timber Pane – fly mesh (no glass)	Late 20 th C Mid/Late 19 th C	L H	F F	
South west façade	Walls	Sandstone – un-coursed squared rubble	Mid/Late 19 th C	E	P

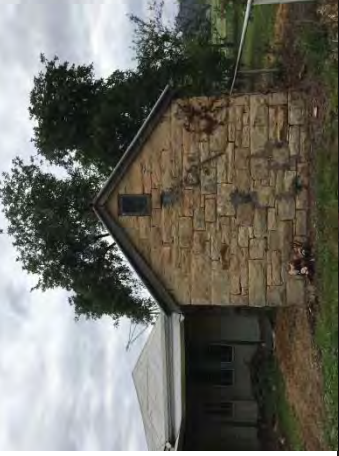
Element	Component	Materials	Time Period	Grading	Condition	Image
North west facade	Walls	Sandstone – un-coursed squared rubble	Mid/Late 19 th C	E	P

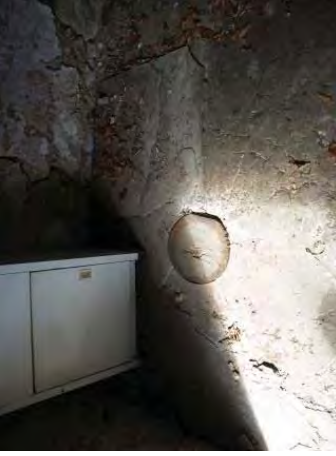
Walls	Random Rubble	Mid/Late 19 th C	E	P	
		Plaster	Original?	H	VP	
	Fittings	Pipes	Late 20 th C/Modern	L	Not inspected

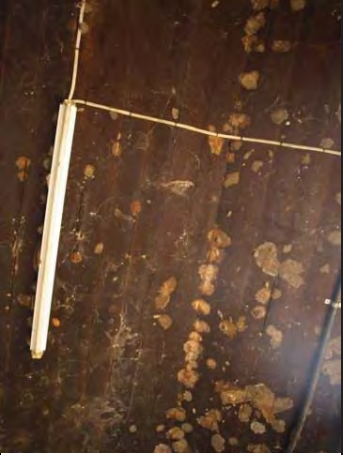
Element	Component	Materials	Time Period	Grading	Condition	Image
	Ceiling	Tray vaulted, timber panelled ceiling Florescent light, wiring and conduit	Early Addition	H	P

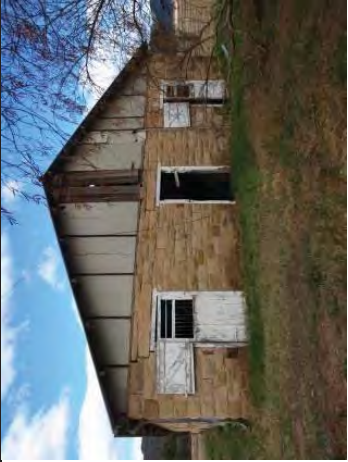
Northern façade	Walls	Sandstone— un-coursed squared rubble Fibrous sheeting (Gables)	Original ?	E L	P VP

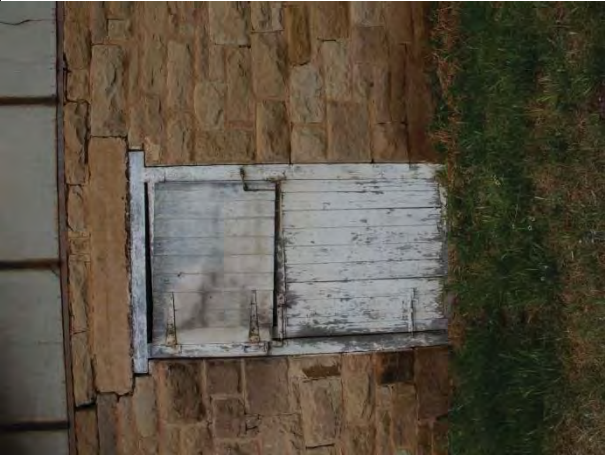
Element	Component	Materials	Time Period	Grading	Condition	Image
	Stable 1 doors	Double hung timber doors with metal bars	Original?	H	VP

Hinges	Original?	H	P	
		Latches	Original?	H	P

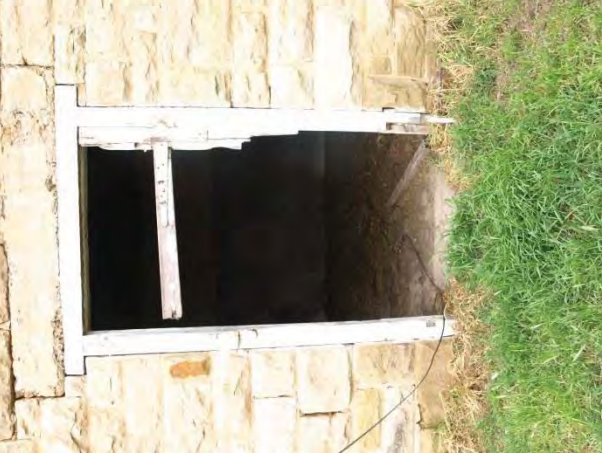
Element	Component	Materials	Time Period	Grading	Condition	Image
	Stable 2 doors	Double hung timber doors with metal bars	Original?	H	Failed/Missing

Note: broken door piece is inside Stable 2. Material should be reinstated if possible	Hinges	Original?	H	P/Missing	
		Latches	Original?	H	Missing

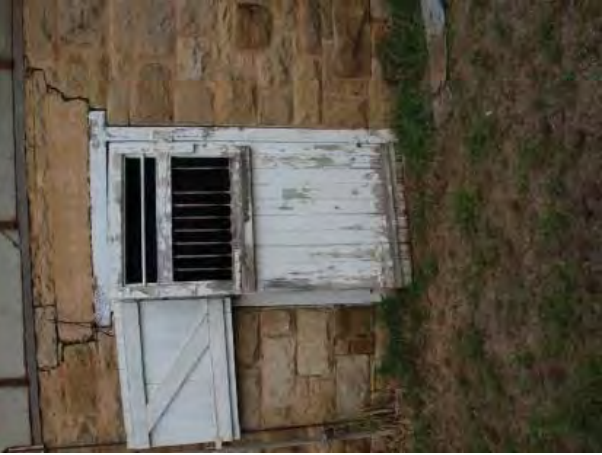
Element	Component	Materials	Time Period	Grading	Condition	Image
	Stable 3 doors	Double hung timber doors with metal bars	Original?	H	VP

Hinges	Original?	H	P	
		Latches	Original?	H	P

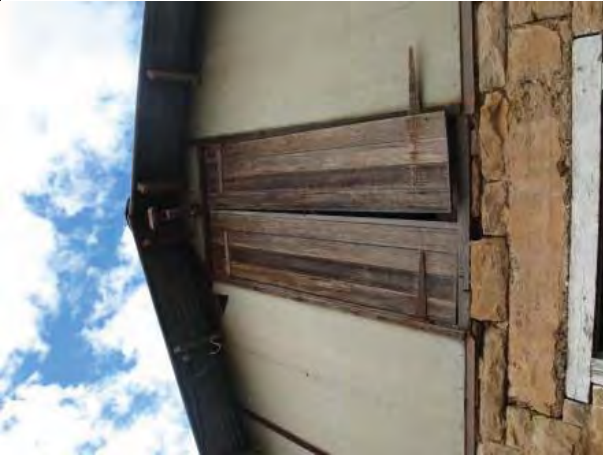
Element	Component	Materials	Time Period	Grading	Condition	Image
	Hay/loft door	Timber	?	H	F

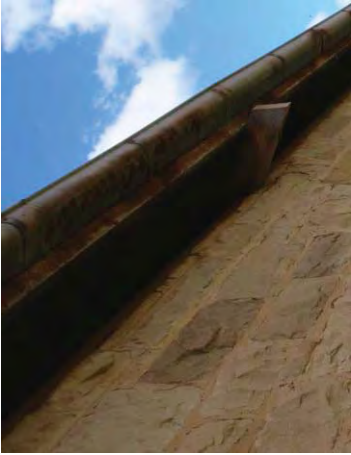
Door knob	?	M	P	
	Roof	Corrugated iron sheeting	Late 20 th C	E (form only, material may be replaced like-for-like)	F

Louvered Roof skylights	Late 20 th C	L	Not inspected	
		Guttering – Quad profile	Late 20 th C	L	P	
		Eaves – wire netting	Late 20 th C	L	F

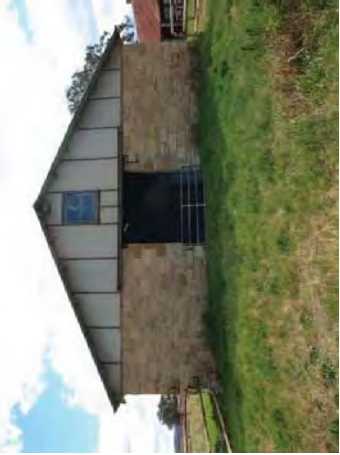
Element	Component	Materials	Time Period	Grading	Condition	Image
Southern façade						
Southern façade	Walls	Sandstone – un-coursed squared rubble Fibrous sheeting (Gables) External light	Original ? Modern	E L L	P/V/P VP Not inspected

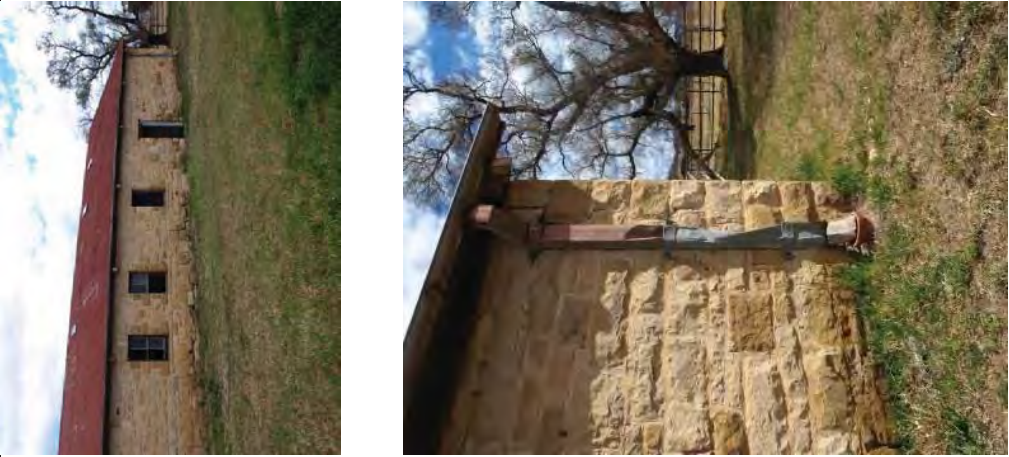
Element	Component	Materials	Time Period	Grading	Condition	Image
Eastern façade	Wall	Sandstone – un-coursed squared rubble Downpipe – square profile Drain - brick	Original	E	P

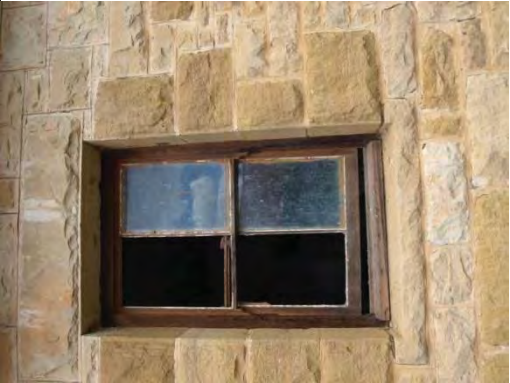
Element	Component	Materials	Time Period	Grading	Condition	Image
	Window 1	Timber framed four pane single hung sash window	Original	H	VP

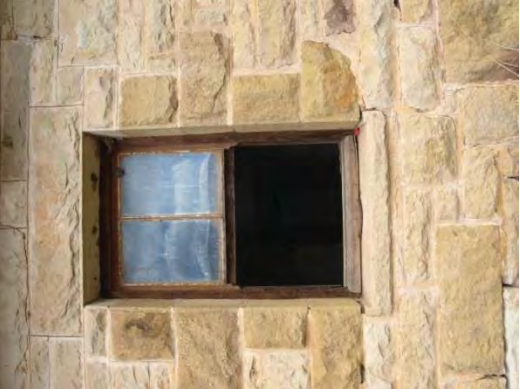
Window 2	Timber framed four pane single hung sash window	Original	H	VP

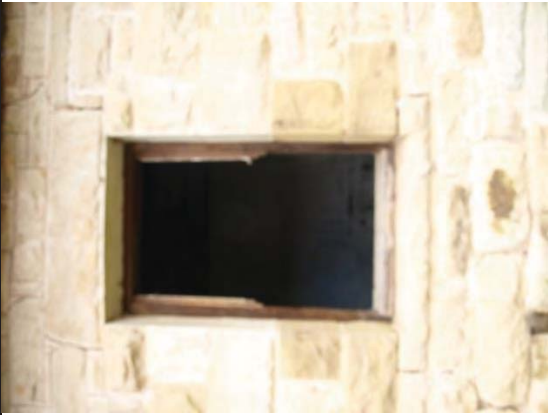
Element	Component	Materials	Time Period	Grading	Condition	Image
	Window 3	Timber framed four pane single hung sash window	Original	H	Failed

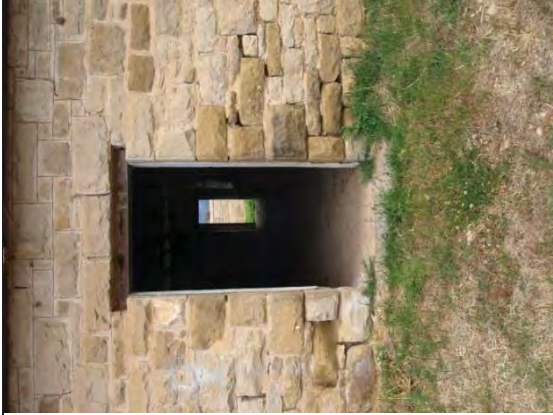
Door Note: door itself is missing	Frame	?	L	P
