Conservation Management Plan for Tarwyn Park and Iron Tank

BYLONG COAL PROJECT
Response to PAC Review Report

DRAFT Conservation Management Plan

AECOM Australia Pty Ltd

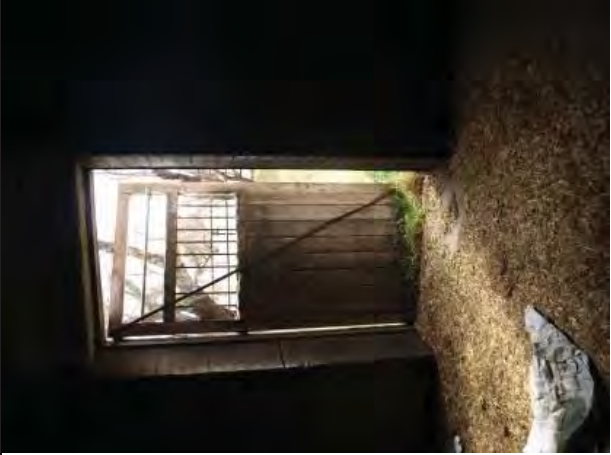
Element	Component	Materials	Time Period	Grading	Condition	Image
Interior						
Stable 1	Walls	Random rubble sandstone Timber board on timber batons	Original	E	P

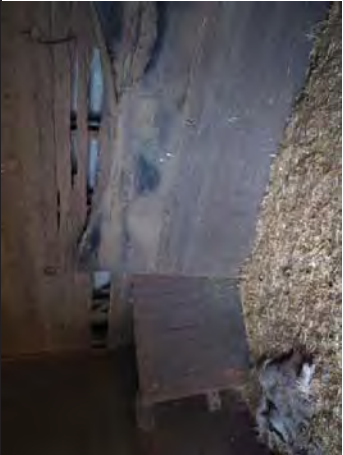
Element	Component	Materials	Time Period	Grading	Condition	Image
	Floor	Concrete	Original?	M	F

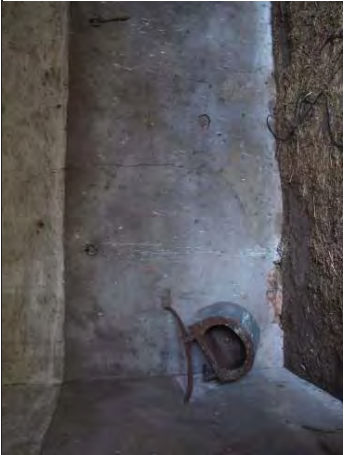
Room 2	Walls	Random rubble sandstone Render <ul style="list-style-type: none"> Two tone paint 	Original Original? Original?	E H H	P VP VP

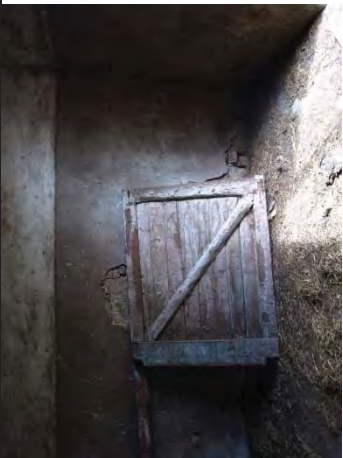
Element	Component	Materials	Time Period	Grading	Condition	Image
	Floor	Concrete	Original?	M	F

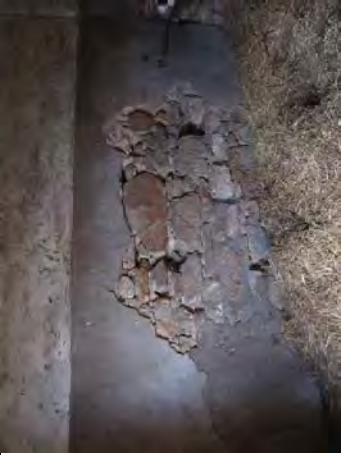
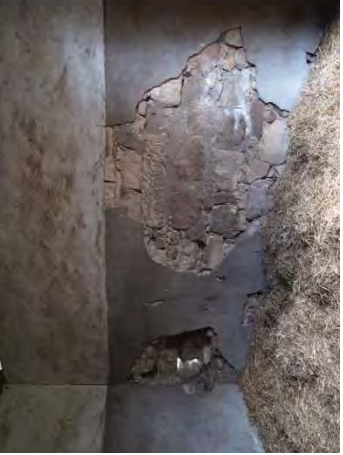
Element	Component	Materials	Time Period	Grading	Condition	Image
Room 3	Walls	Random rubble sandstone Render <ul style="list-style-type: none"> • Two tone paint • Modern concrete repairs 	Original Original? Original? Modern	E H H I	P VP VP P

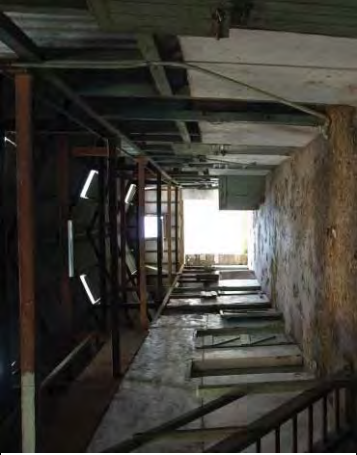
Element	Component	Materials	Time Period	Grading	Condition	Image
Internal circulation space						
Internal circulation space	Floor	Concrete	Late 20 th C/Modern	L	F

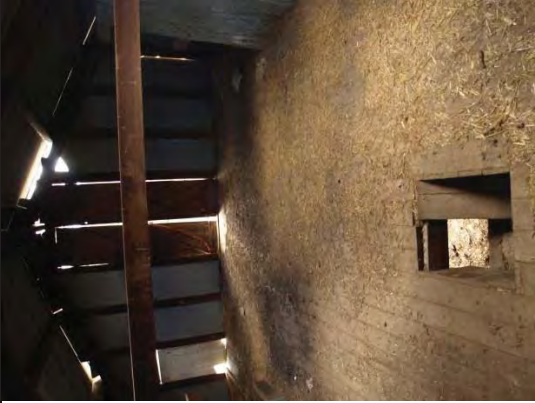
Element	Component	Materials	Time Period	Grading	Condition	Image
Loft	Floor	Timber	Original?	M	F

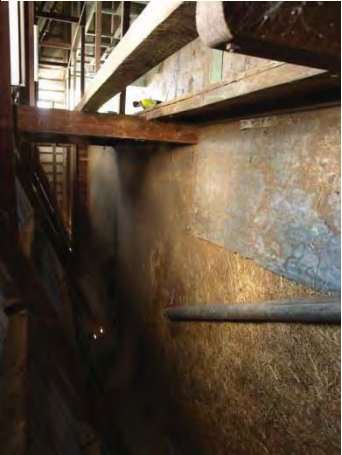
Element	Component	Materials	Time Period	Grading	Condition	Image
	Stairs	Timber railing Timber steps (open riser)	Original?	H	F

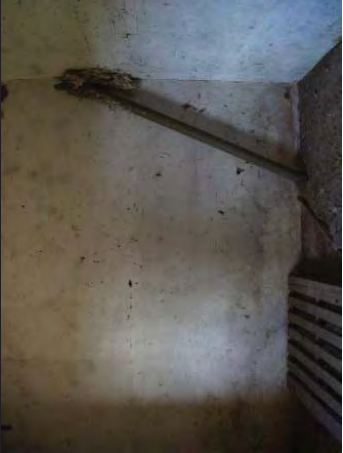
Element	Component	Materials	Time Period	Grading	Condition	Image
Store 1	Walls	Random rubble sandstone Render Paint	Original Original? Original?	E H H	P VP VP

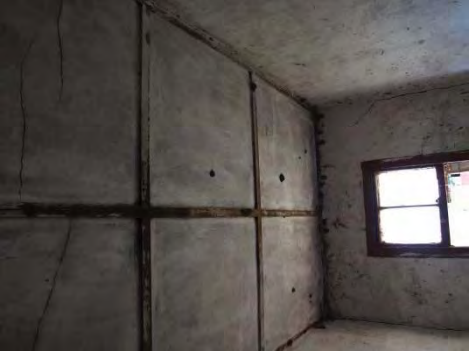
Element	Component	Materials	Time Period	Grading	Condition	Image
	Ceiling	Fibrous Sheet	Original	M	P

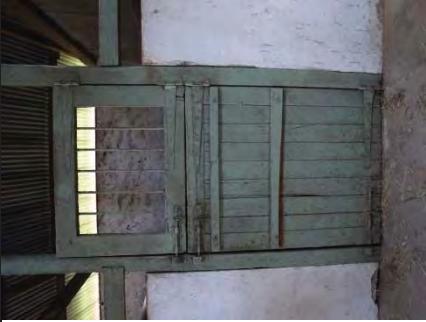
Element	Component	Materials	Time Period	Grading	Condition	Image
Stall 12	Stable Door	Timber frame and metal bars Hinges Bolts	Original? Original? ?	H H ?	F F F

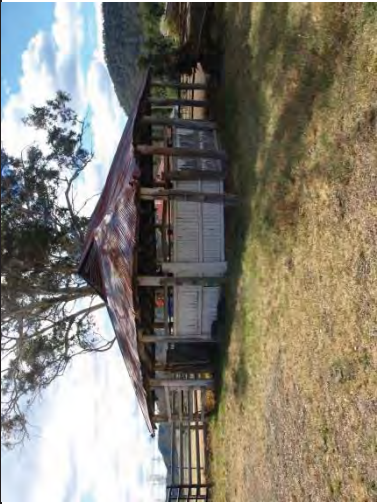
Note: investigation of the fabric indicates that the roof superstructure was constructed first, probably in the 1930s, with the timber panel walls being added at a later date.

Element	Component	Materials	Time Period	Grading	Condition	Image
Horse Ring	Roofing	Corrugated iron with venting on timber beams Unmilled timber uprights	Original Original	H H	P P

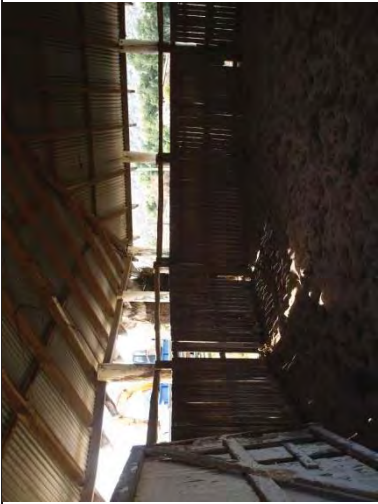
Inner fencing	Timber framing and lining	Mid/Late 20 th C	M	P

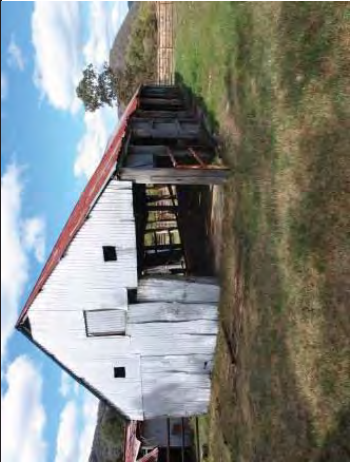
Element	Component	Materials	Time Period	Grading	Condition	Image
Shed 1	Walls	Corrugated iron on timber frame	Early/Mid 20 th C	M	P

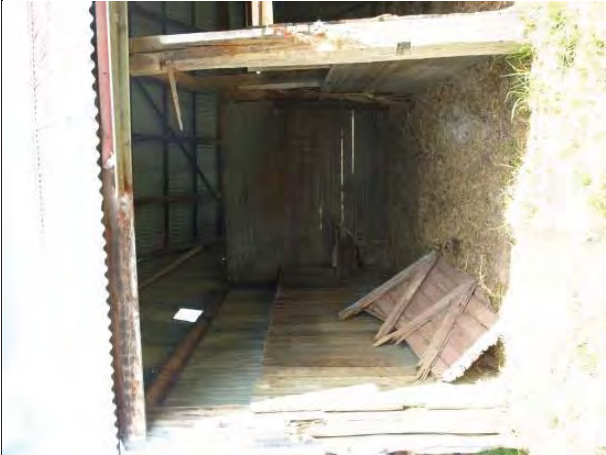
Stall	Timber lining on timber batons	Early/Mid 20 th C	M	P

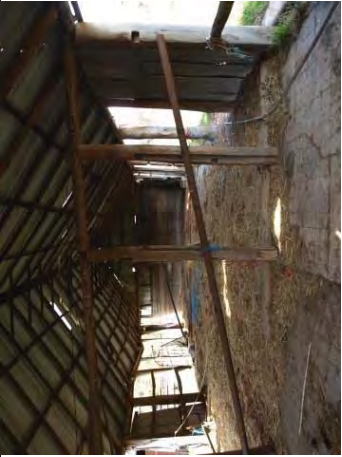
Element	Component	Materials	Time Period	Grading	Condition	Image
	Timber framing	Unmilled timber uprights, beams and braces	Early/Mid 20 th C	M	P

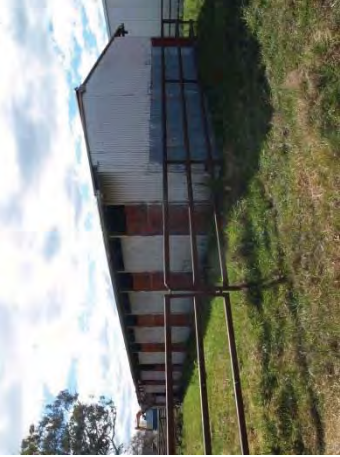
Element	Component	Materials	Time Period	Grading	Condition	Image
Corrugated Iron Stables	External Walls	Corrugated iron	Modern	L	F

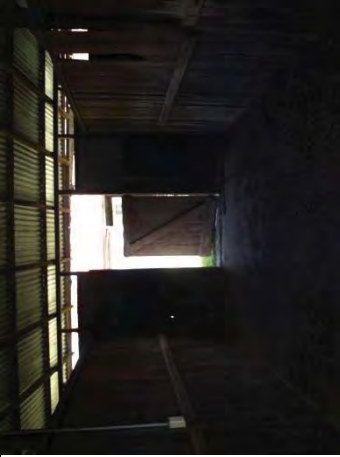
Inner Walls	Timber panelling on timber supports	Modern	L	F

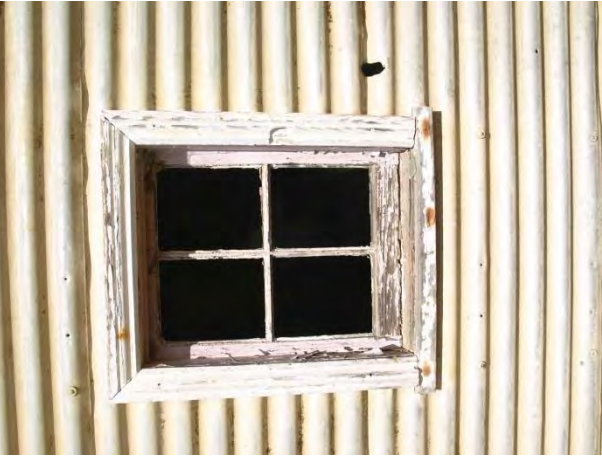
Element	Component	Materials	Time Period	Grading	Condition	Image
	Window 1	Fixed timber framed four panel window	Early 20 th C	H	VP

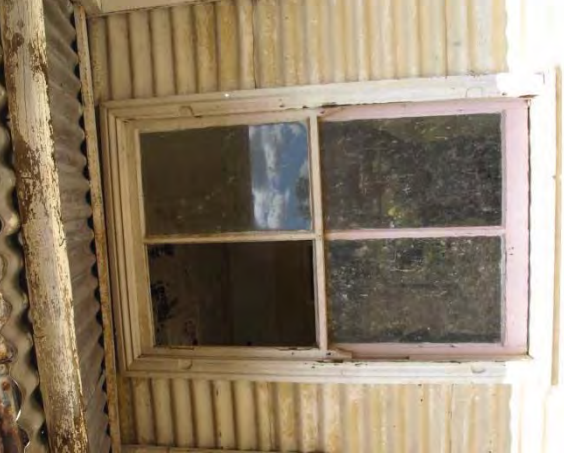
Element	Component	Materials	Time Period	Grading	Condition	Image
	Window 2	Timber frame single hung sash four pane window	Early 20 th C	H	VP

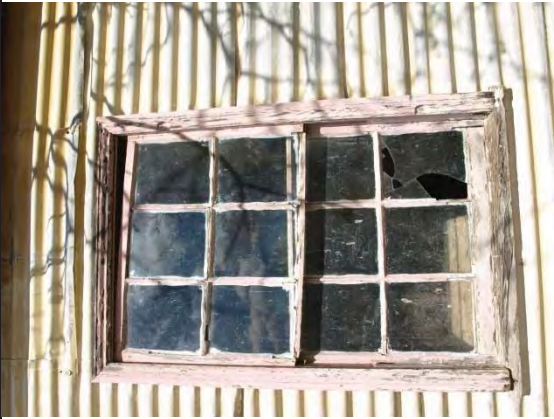
Element	Component	Materials	Time Period	Grading	Condition	Image
	Window 3	Timber frame single hung sash 12 pane window	Early 20 th C	H	P

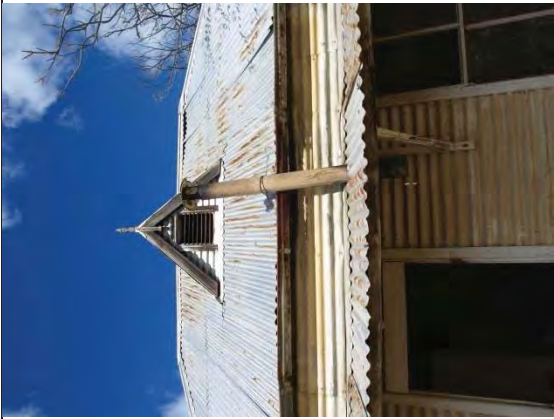
Awning	Corrugated iron on timber frame	Original?	M	P

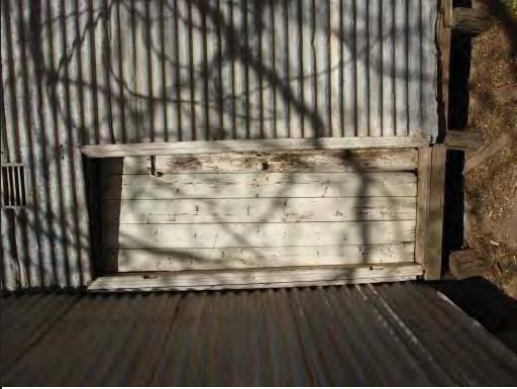
Element	Component	Materials	Time Period	Grading	Condition	Image
	Door 2	Timber panel	Late 20 th C?	L	P

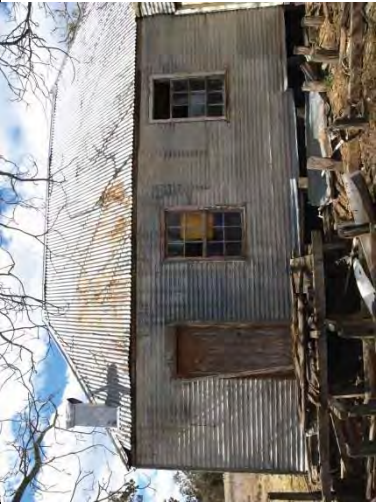
Element	Component	Materials	Time Period	Grading	Condition	Image
North façade	Chimney	Iron sheeting	Late 20 th C	L	F

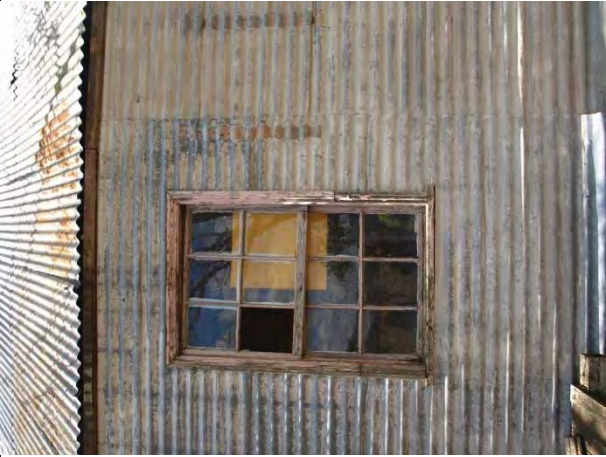
Wall	Corrugated iron	Early 20 th C	H	F	
	Deck	Timber	Late 20 th C	L	Failed	
	Window 4	Timber frame single hung sash 12 pane window	Early 20 th C	H	P

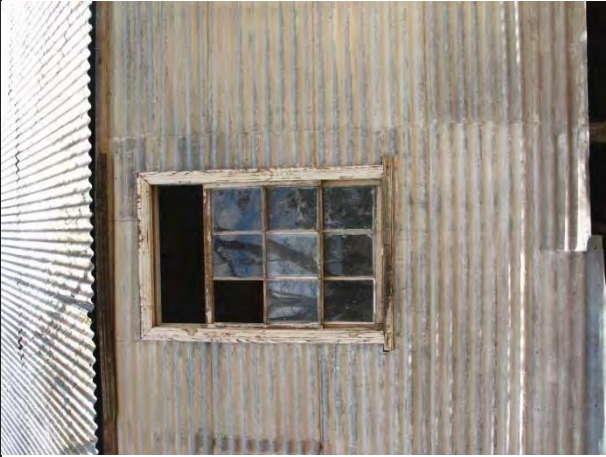
Element	Component	Materials	Time Period	Grading	Condition	Image
	Window 5	Timber frame single hung sash 12 pane window	Early 20 th C	H	P

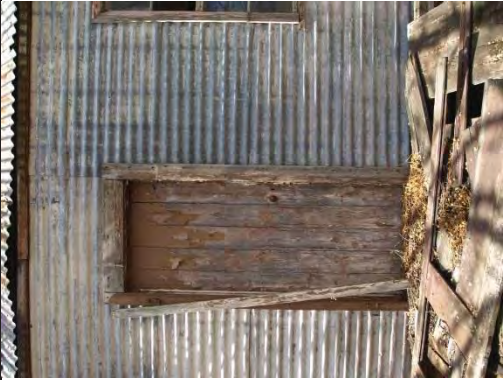
Door 3	Timber panel	Mid/Late 20 th C	L	P

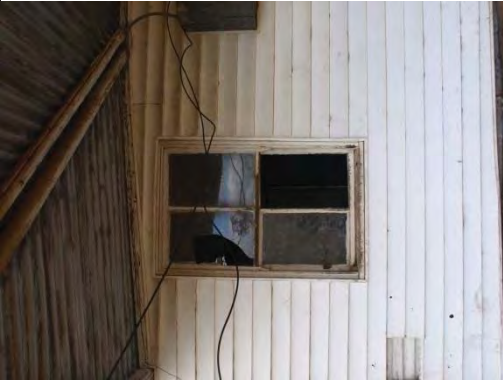
Element	Component	Materials	Time Period	Grading	Condition	Image
	Window 6	Timber frame single hung sash four pane window	Late 19 th C	H	VP

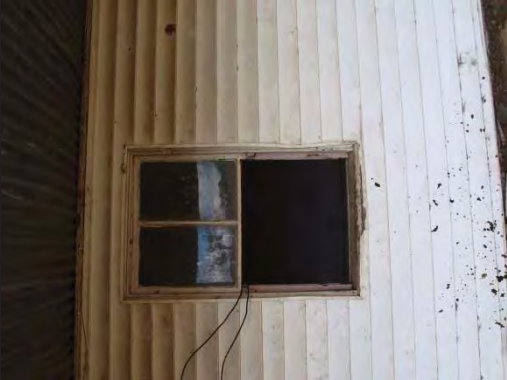
Window 7	Timber frame single hung sash four pane window	Late 19 th C	H	VP

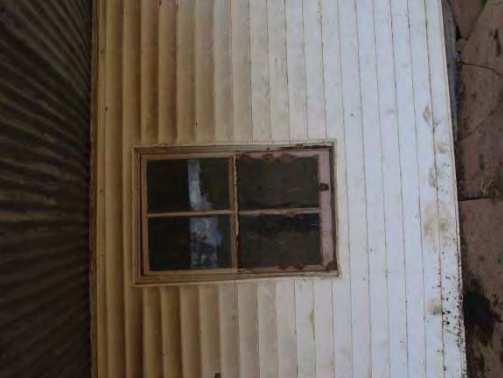
Element	Component	Materials	Time Period	Grading	Condition	Image
	Window 8	Timber frame single hung sash four pane window	Late 19 th C	H	VP

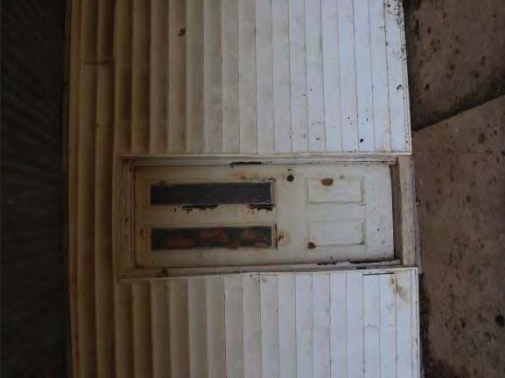
Door	Four panel door Glass panels Door knob	Mid 20 th C Mid 20 th C Mid 20 th C	L L L	P F P

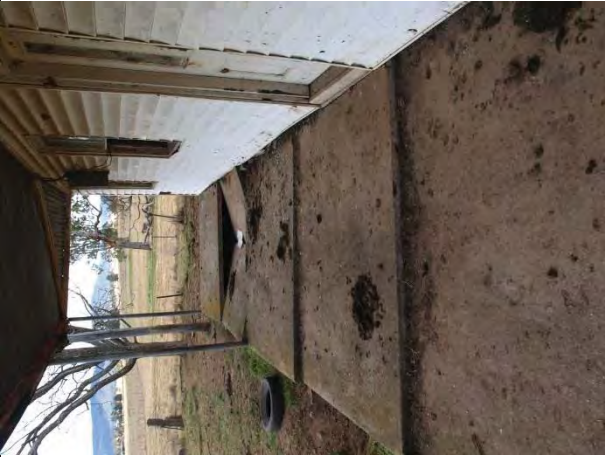
Element	Component	Materials	Time Period	Grading	Condition	Image
	Verandah	Concrete floor Steel support posts Timber beams	Late 20 th C/Modern	I	P

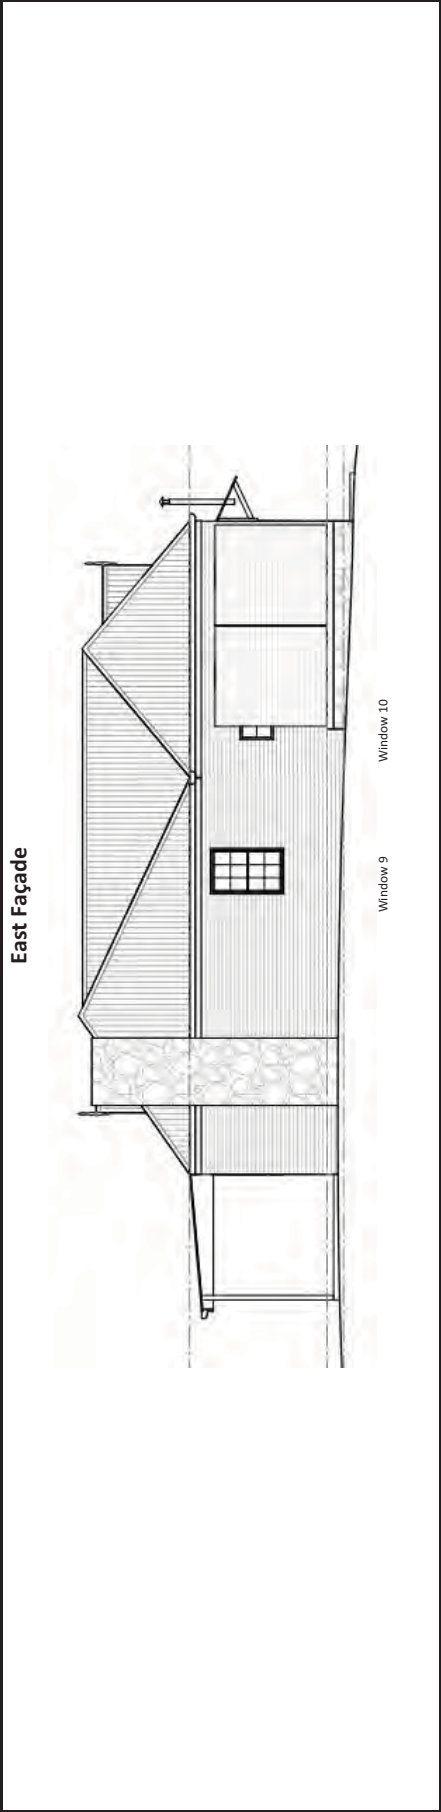
Element	Component	Materials	Time Period	Grading	Condition	Image
East façade	Wall	Corrugated iron	Late 19 th C & Early 20 th C	H	F

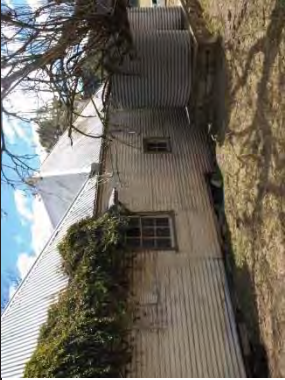
Tanks	Corrugated iron tank Sandstone and concrete base	Modern Early 20 th C	L M	Not inspected F

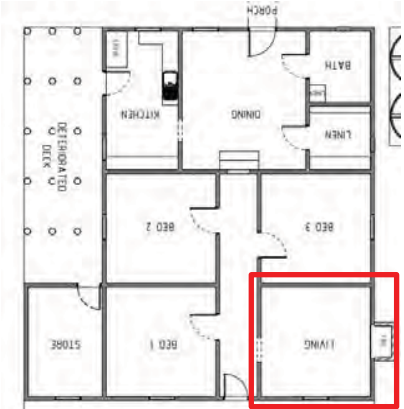
Room 3 – Living Room

Element	Component	Materials	Time Period	Grading	Condition	Image
Room 3	Walls	Plasterboard	?	L	VP

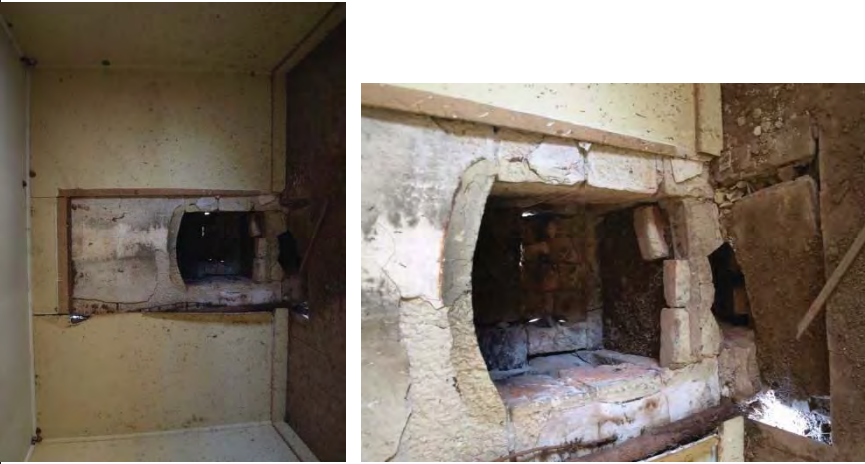
Fireplace	Sandstone and brick Render	Late 19 th C Late 19 th C	H H	VP VP	
	Floor	Timber boards	?	M	P

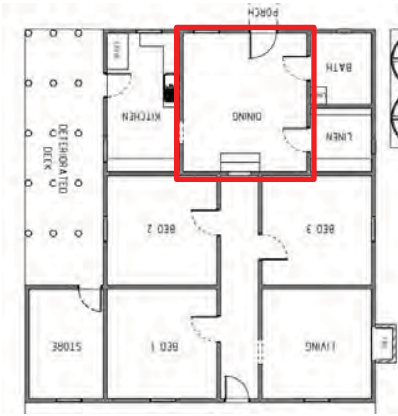
Element	Component	Materials	Time Period	Grading	Condition	Image
<div> <div>Room 6 – Dining Room</div>

</div>						
Room 6	Ceiling	Pressed metal (tray vaulted form) Light fitting	Early 20 th C Early 20 th C	H L	P Not inspected

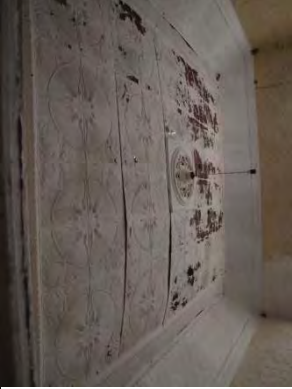
Walls	Pressed metal	Early 20 th C	H	P

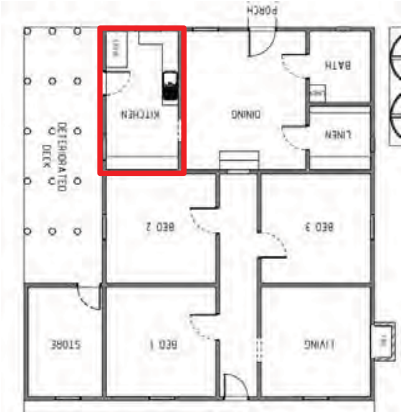
Room 7 – Kitchen						
Room 7

Ceiling	Pressed metal Light fitting	Early 20 th C	H	P

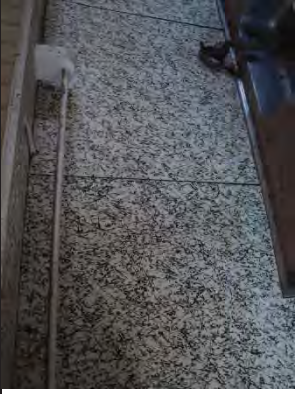
Element	Component	Materials	Time Period	Grading	Condition	Image
	Wall	Pressed metal – standing seam pattern Sink backsplash	Early 20 th C Late 20 th C	H L	P P

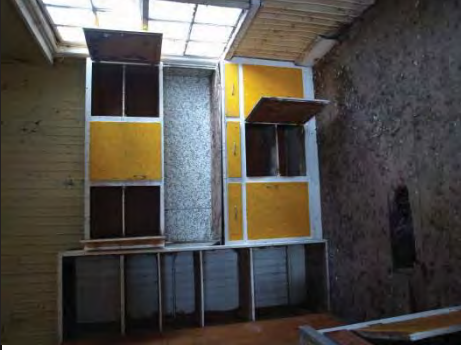
Fittings and fixtures	Kitchen cabinetry (fibre board) Stove & Oven	Late 20 th C Late 20 th C	L L	P Not inspected

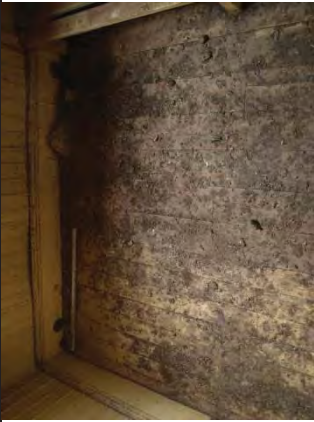
Walls	Pressed metal – standing seam pattern	Early 20 th C	H	F

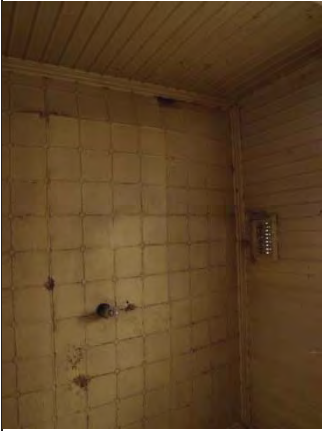
Ceiling	Pressed metal – square pattern	Early 20 th C	H	F	
	Door	Timber four panel door Door knob	Early 20 th C	H	F

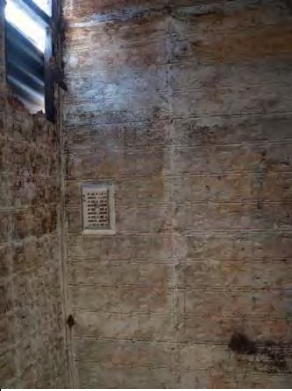
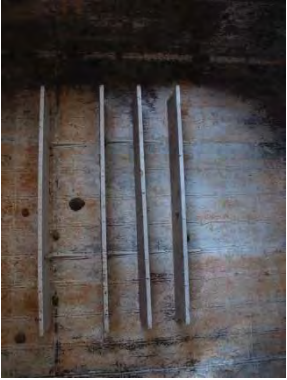
Wall	Pressed metal – floral pattern	Early 20 th C	M	VP

Shelving		Late 20 th C	M	VP	
	Ceiling	Pressed metal – square pattern	Early 20 th C	M	VP

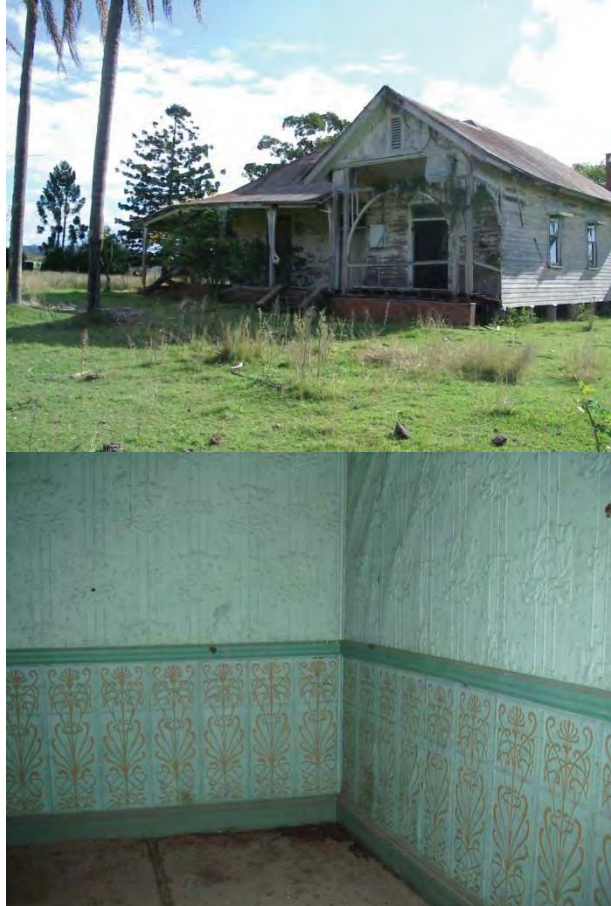
Item Name, No., Address and Significance	Image
<p>Disputed Plains Homestead – 1480 Bentley Rd, Bentley. LGA: Richmond Valley Listing: Richmond Valley LEP #1001</p> <p>The homestead is historically significant providing evidence both of early settlement (c1866) and, more specifically pastoral-based land use. It is associated with the Alexander Armstrong family of Disputed Plains, who were noted horsemen and women. It is representative of the second generation homesteads built during the period 1910 -1920. Pressed metal ceiling and wall linings are a feature of this homestead.</p>

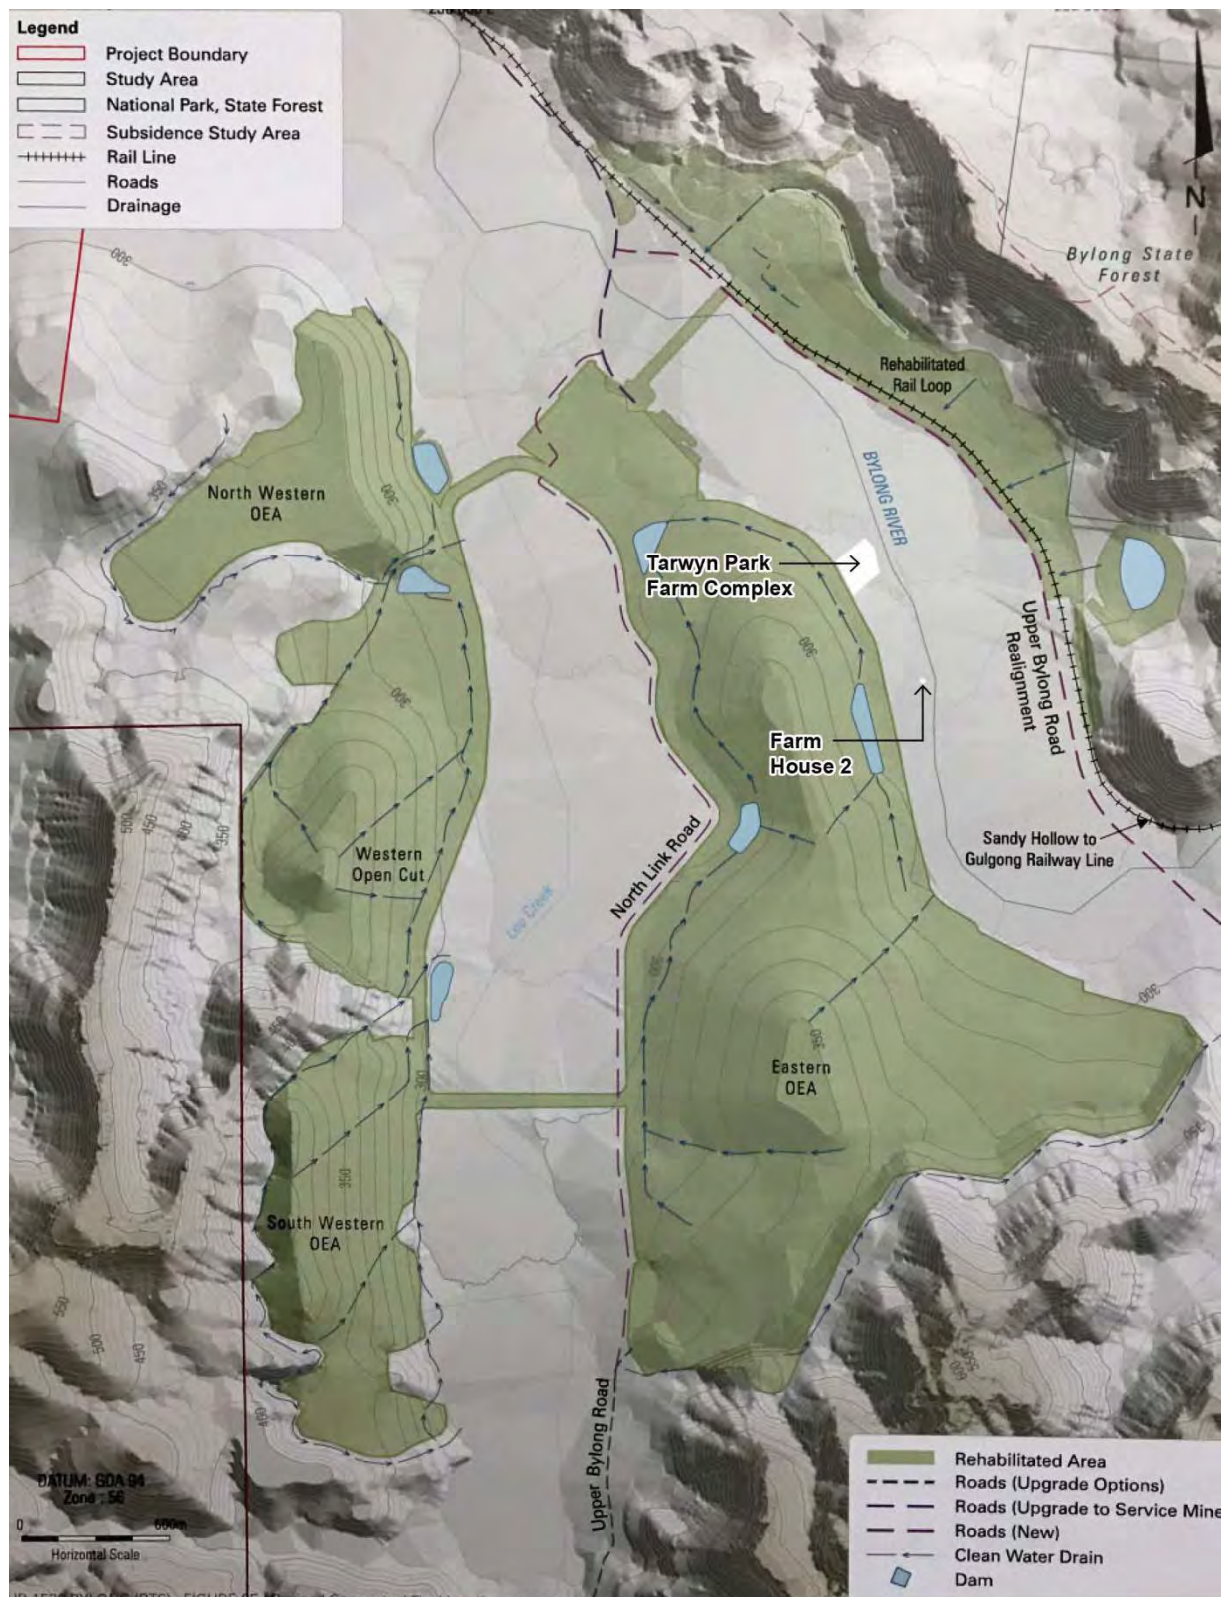
Figure 5 Conceptual open cut mine plan – revised conceptual final landform – Year 25

CONCEPTUAL FINAL LANDFORM

Figure 5 shows the revised conceptual final landform following Project Year 25. The completion of the Eastern OEA including filling of the Eastern void would take place over the following 15 years using coarse and fine reject materials generated from the processing of coal from the underground mine. All MIAs and other works areas will also have been subject to rehabilitation following mine closure.

Figure 5 shows the revised conceptual final landform at Year 25. The completion of the Eastern OEA including filling of the Eastern Open Cut void would have taken place over the preceding 15 years using coarse and fine reject materials generated from processing of coal recovered from the underground mine.

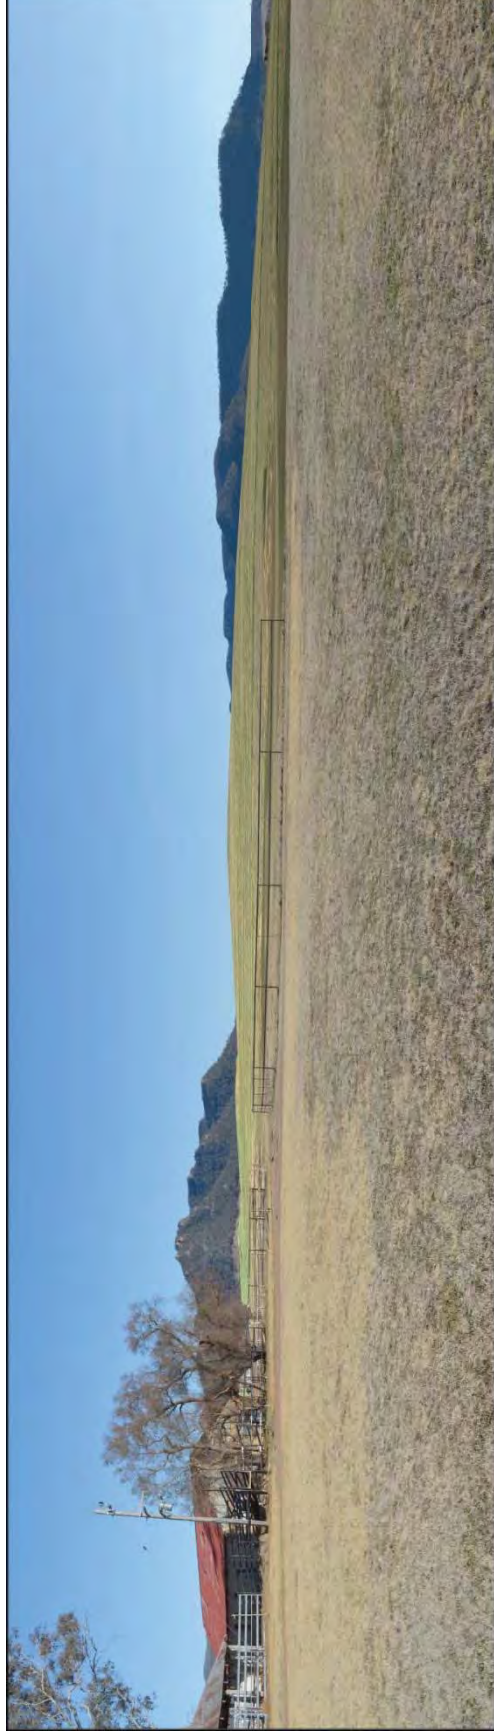
Figure 18 View A – Final landform view from above location

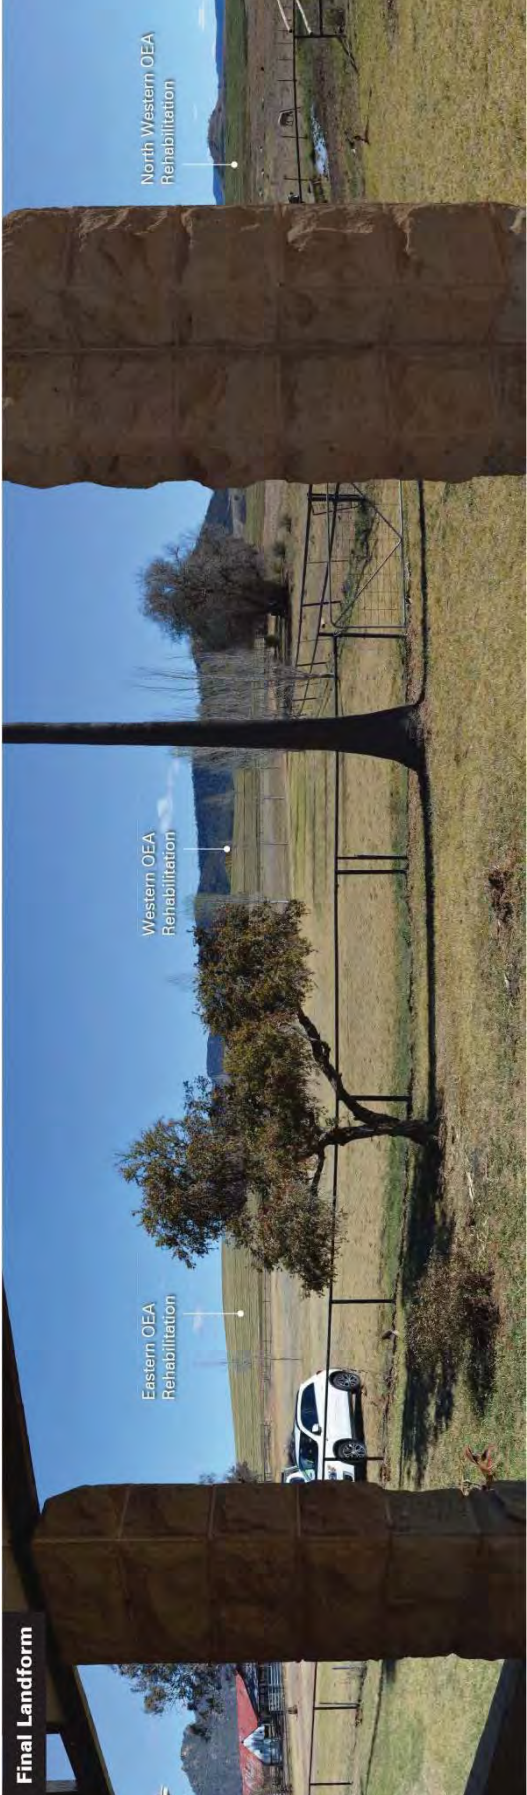
Figure 22 View B – Final landform view from above location

The view of the conceptual final landform for the Project from the Tarwyn Park Homestead (refer Figure 22) when compared to the existing situation is broadly similar to View A – Final Landform as above, with the key differences being:

- The view is seen within the context of the Homestead, with paddock fencing, including for the house yard and cultural plantings
- The original and recent driveway plantings are a key feature of the view these;
- The stables, associated out buildings and two large trees remain an integral part of this view, particularly when seen against the backdrop of Tal Tal Mountain;
- The seen area of the new Eastern OEA landform would be reduced over that for View A due to screening by: the driveway trees; the two small trees in the immediate foreground; the large peppercorn tree in front of the stables, and the large eucalypt in front of the horse ring;
- The view extends beyond the forested northern end of the Growee Range, incorporating the cleared Telstra tower hill and open views across the Growee Valley to the Mount Penny Range.

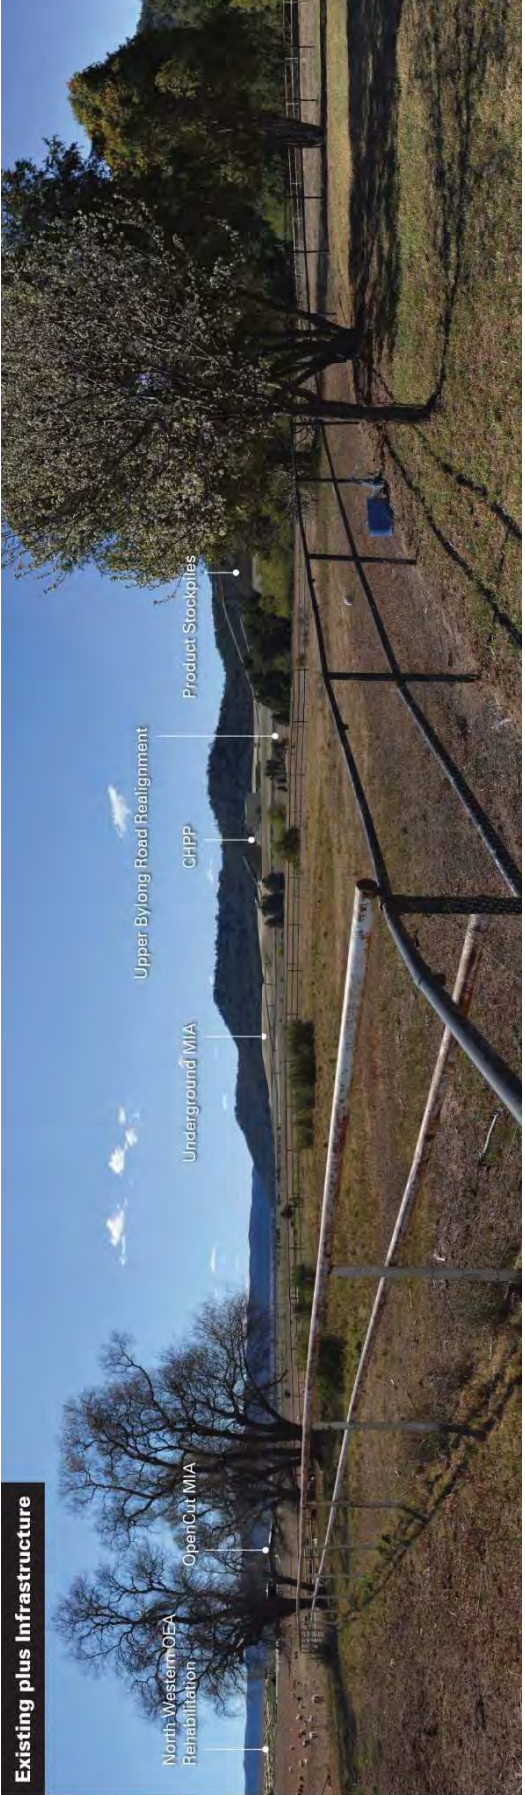
Figure 24 View C – View with mine infrastructure in place

Figure 23 shows the existing evenly falling cleared lower pastoral slopes upslope of the Sandy Hollow to Gulgong Railway Line. This area will be subject to a final landform that will retain the working platforms with associated batters grading up to 3H:1V. This would include platform areas such as the: rail loop; Underground MIA; the mine water dam (filled) at the eastern end of the site, in addition to any batters associated with transitions between the Bylong Range and the Sandy Hollow to Gulgong Railway Line. Given that the site will be rehabilitated to present, it is expected that all areas downslope of the existing tree line will be rehabilitated to pasture.

A further measure provided for within the EIS is the provision of a screen planting of trees along the downslope edge of the East Link Road (re-routed Upper Bylong Road). Refer Figure 35. This work would be commenced shortly after completion of the new road. This planting would be expected to substantially screen views from the Tarwyn Park Farm Complex towards the site of the retained land forming platforms upslope of the Sandy Hollow to Gulgong Railway Line including Underground MIA, CHPP and rail loop (refer Figure 24).

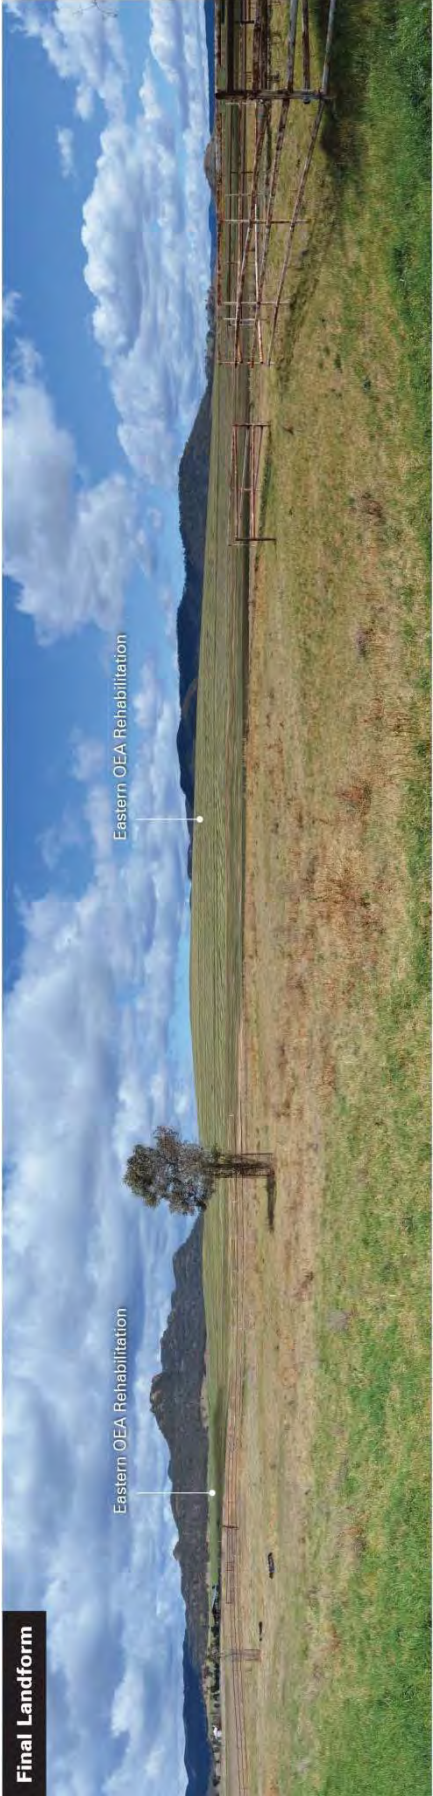
Figure 26 View D – Final landform view from Tarwyn Park Stables looking south-east clockwise through to west

The visually dominant ranges of Tal Tal Mountain are substantially unchanged in seen area. The Growee Range is still visible, although reduced in seen area due to the proximate location of northern end of the Eastern OEA landform.

The rehabilitated knoll of the Eastern OEA removes the view of the open pastoral plain and the Our Lady of the Sacred Heart Church (to be removed). However, the pastoral context of the landscape is conserved, and the open views to the Bylong River floodplain (left of frame) and the Telstra tower hill (right of frame) are retained.

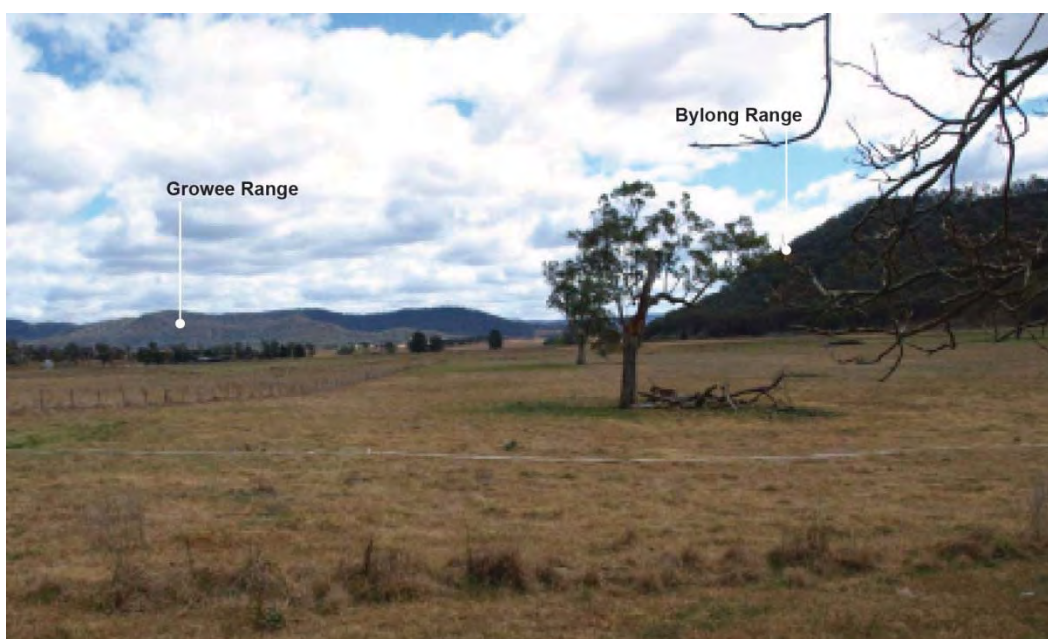
Figure 30 View 11 - View looking west from the back door of Iron Tank Farm House towards the Project

This view, depicted in Figure 30, looks west from the back door of the Iron Tank Farm House across the Bylong River floodplain to the Bylong Range in the foreground to right of frame, and buildings of the former Upper Bylong (i.e. Upper Bylong Post Office, Upper Bylong Public School and Upper Bylong Hall) in the middle ground to centre of frame. These elements are seen against the backdrop of the Growee Range at a distance of some five kilometres.

This view would be subject to a moderate level of change resulting from the Project, including: change in the form of the valley floor with the addition of the new Eastern OEA stretching across the full width of the view; and lifting of the line of forest cover to the Growee Range, from visually close to the valley floor, to well up the slope of the lower eastern spur, including the removal of the northern forested end of the spur and replacement with new landform to grazing with cut face up to 50 metres high and in the order of up to 400 m wide.

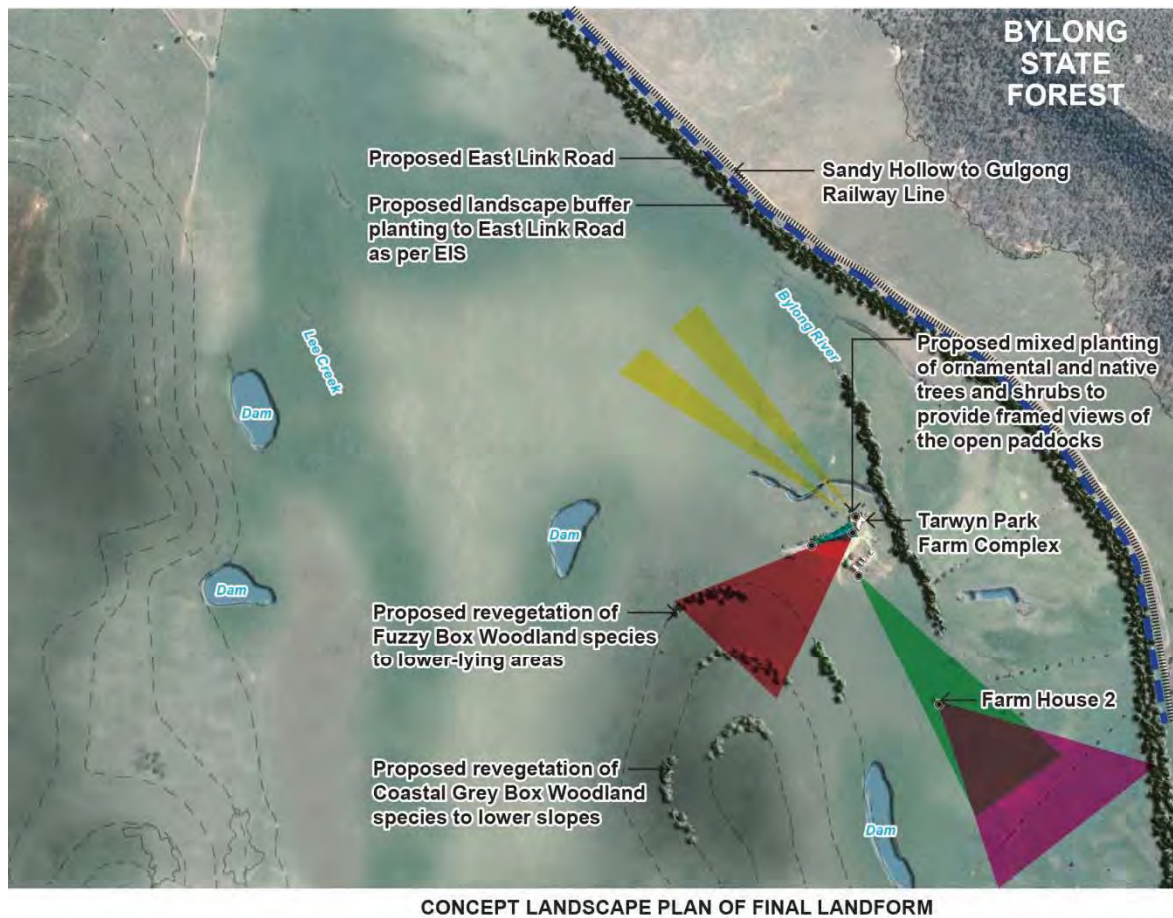
KEY: Important Heritage views reinstated.

- Views (framed) of open paddocks retained
- View from the homestead after project period with stands of trees
- View from Farm House 2 retained
- View south from south side of stables retained

The conceptual landscape design for the final landform addresses, where practicable, views to Project infrastructure identified in Section 6.2.1. Refer Figure 35.

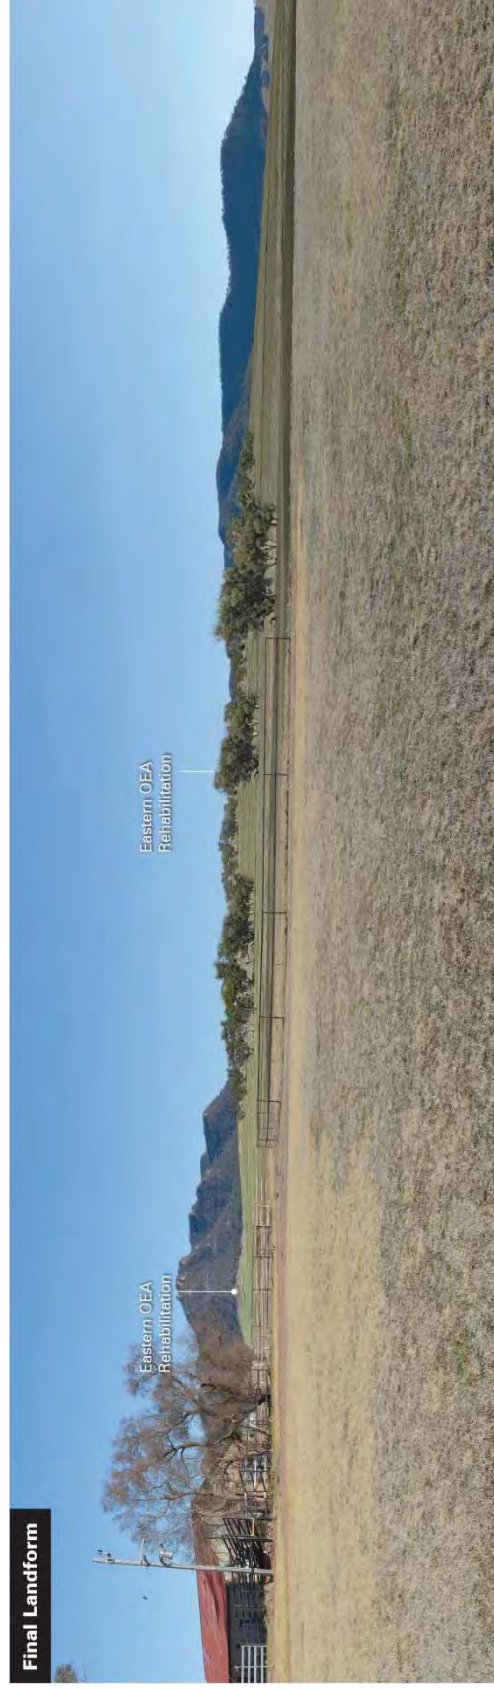
Figure 36 View A: Proposed view with landscape mitigation in place, taken from a location about 50 metres west of Tarwyn Park Homestead looking south (left of frame) through to west

Figure 36 shows an artist's impression of the proposed remediated view with stands of Fuzzy Box Woodland and Coastal Grey Box Woodland planted into the final landform. The proposed landscape treatment can be seen to:

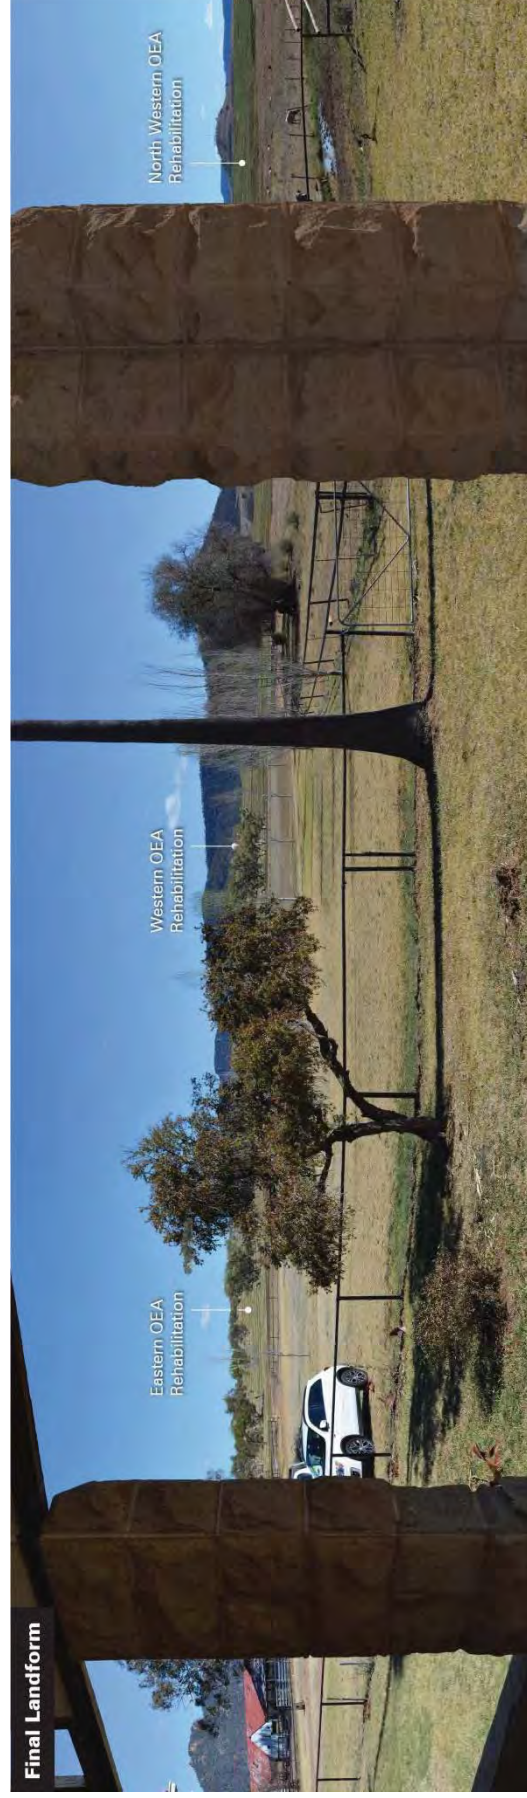
Figure 37 View B: Proposed view with landscape mitigation in place, taken from the front verandah of Tarwyn Park Homestead looking south-east (left of frame) through to west

Figure 37 shows an artist's impression of a similar view and outcomes to View A, framed by the verandah posts and subject to partial interruption by existing trees in the foreground, including retained driveway trees. As above, the proposed landscape treatments can be seen to provide an effective screen to the reinstated lower slopes, while also providing long views across the open paddocks to right of frame.
