Conservation Management Plan for Tarwyn Park and Iron Tank

BYLONG COAL PROJECT
Response to PAC Review Report

DRAFT Conservation Management Plan

AECOM Australia Pty Ltd

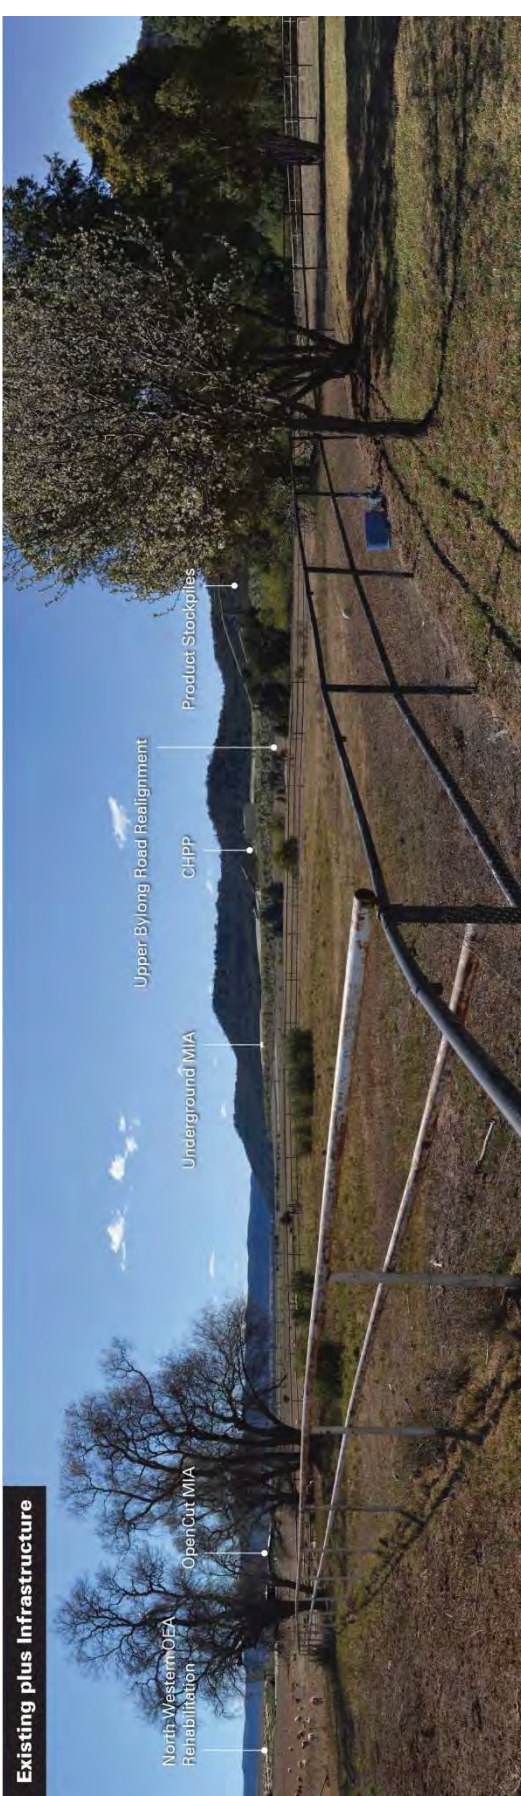
Figure 38 View C: Proposed view with landscape mitigation in place, taken from the front garden of Tarwyn Park Homestead, looking west (left of frame) through to north-east

Figure 38 shows an artist's impression of the proposed road corridor planting alongside the East Link Road with the Project still in progress. Following mine closure, all rail loop infrastructure will be removed and the site rehabilitated to present as a natural environment. It is not the intention to reshape the site back to pre-development landform levels and grades but to ensure the site is stable, free draining and revegetated. The proposed landscape treatment can be seen to provide a moderate to high level of screening to the post-mining landscape behind.

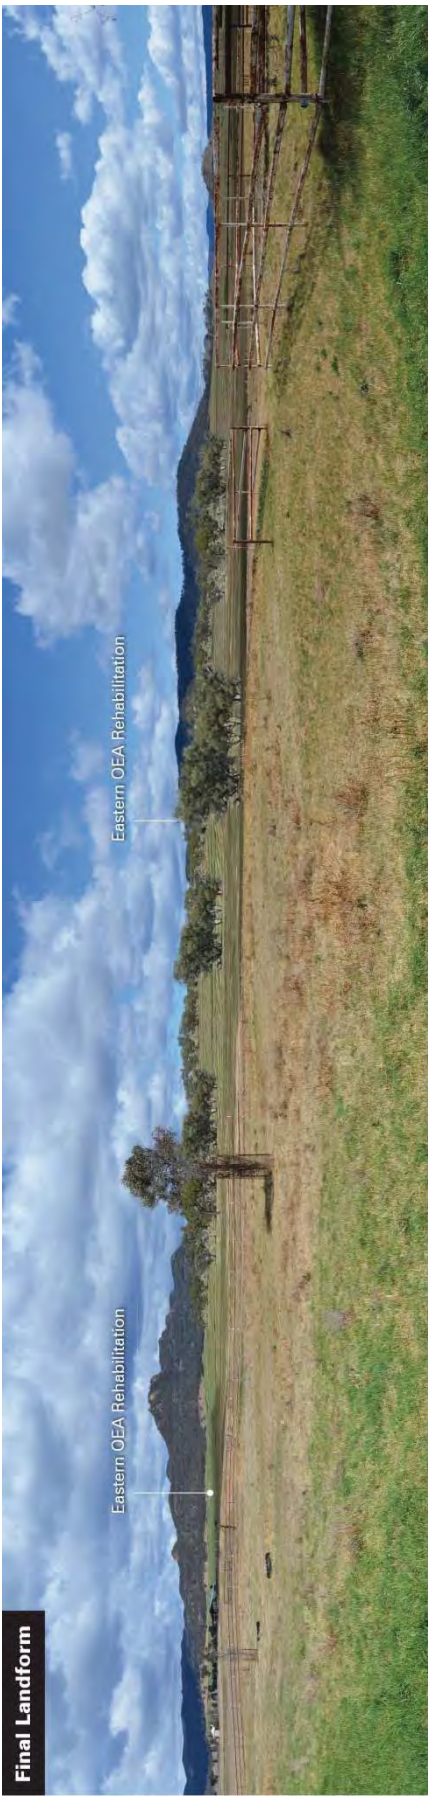
Figure 39 View D: Final landform with landscape mitigation in place taken from Tarwyn Park Stables looking south-east (left of frame) clockwise through to west

Figure 39 shows an artist's impression of a similar view and outcomes to View A. The distinct line of the final landform seen against the Growee Range is effectively reduced, providing an increased level of visual integration between the landform and the Growee Range.

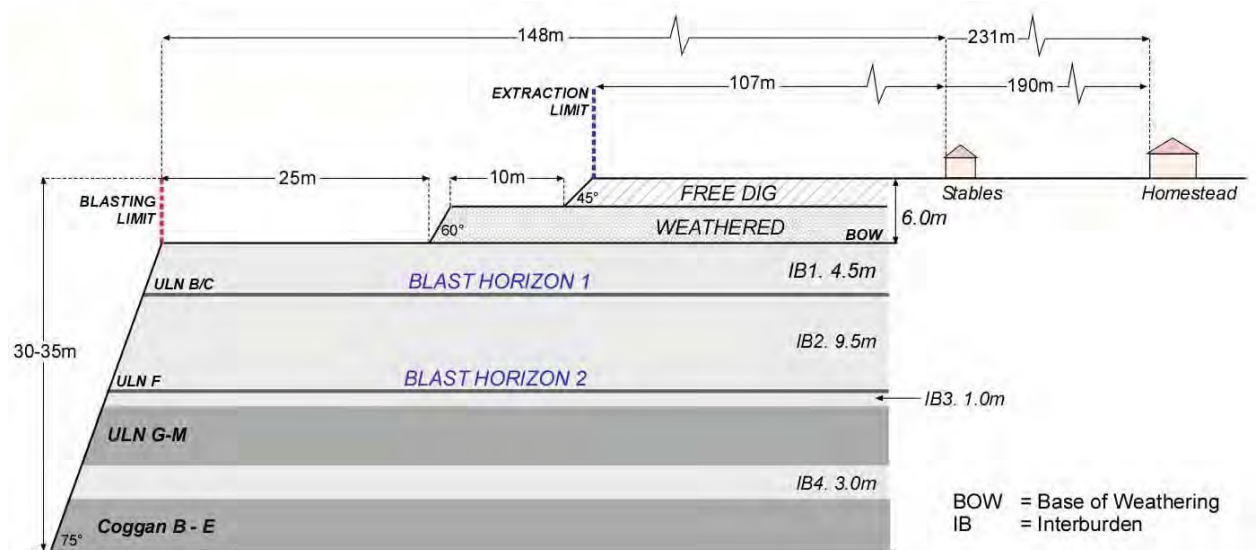
The cross section shown in **Figure 2** has been prepared based on our interpretation of drill hole data from exploration bores BYO269CH, BYO277CH, BYO278CH and BYO368LX and is considered to be typical near the Tarwyn Park Homestead and Stables. A 10 m wide berm assuming free dig material has been allowed for in the cross section. A further 25 m berm has been allowed for to remove the weathered material.

Figure 2 – Geological Cross Section near Homestead and Stables (interpretation)

The interpreted cross section shows:

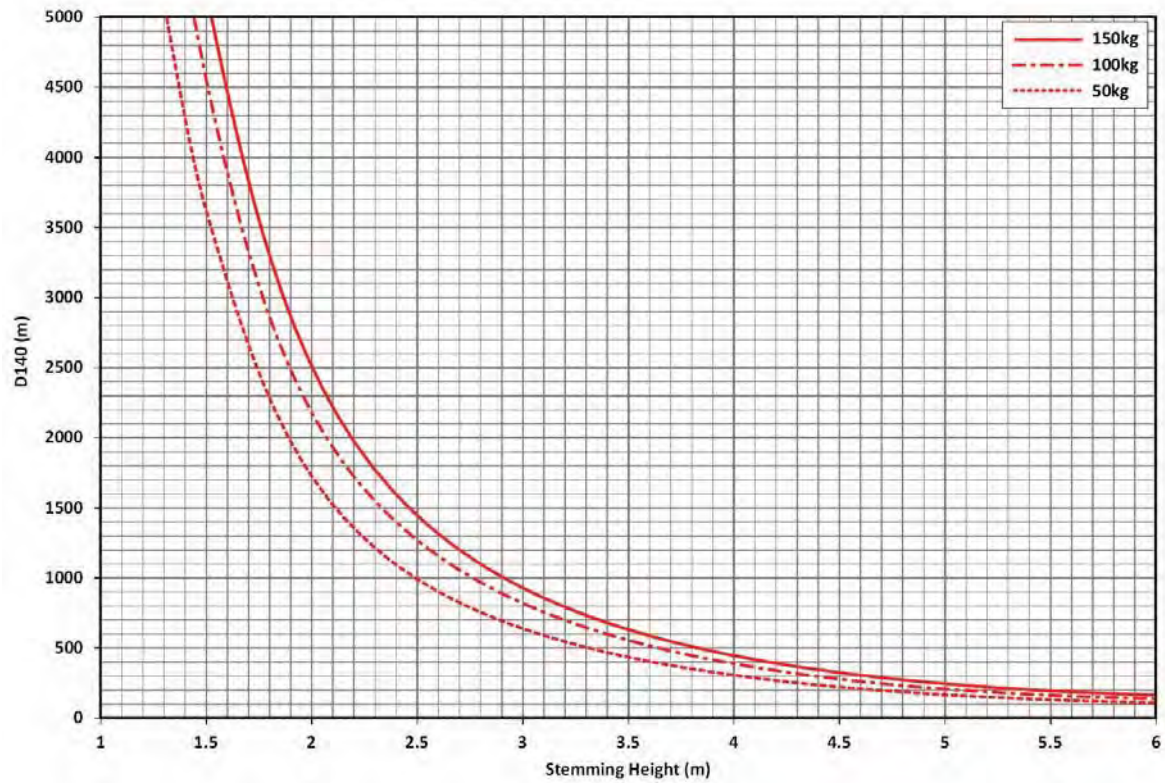
Figure 3 – D140 (dBL) vs Stemming Height for different charge masses

The relationship between airblast (140 dBL distance), charge mass and stemming height is represented in the diagram **Figure 3**. The relationship between airblast and distance is shown in the regression diagram **Figure 4** for 140 dBL and 133 dBL at the 230 m datum.

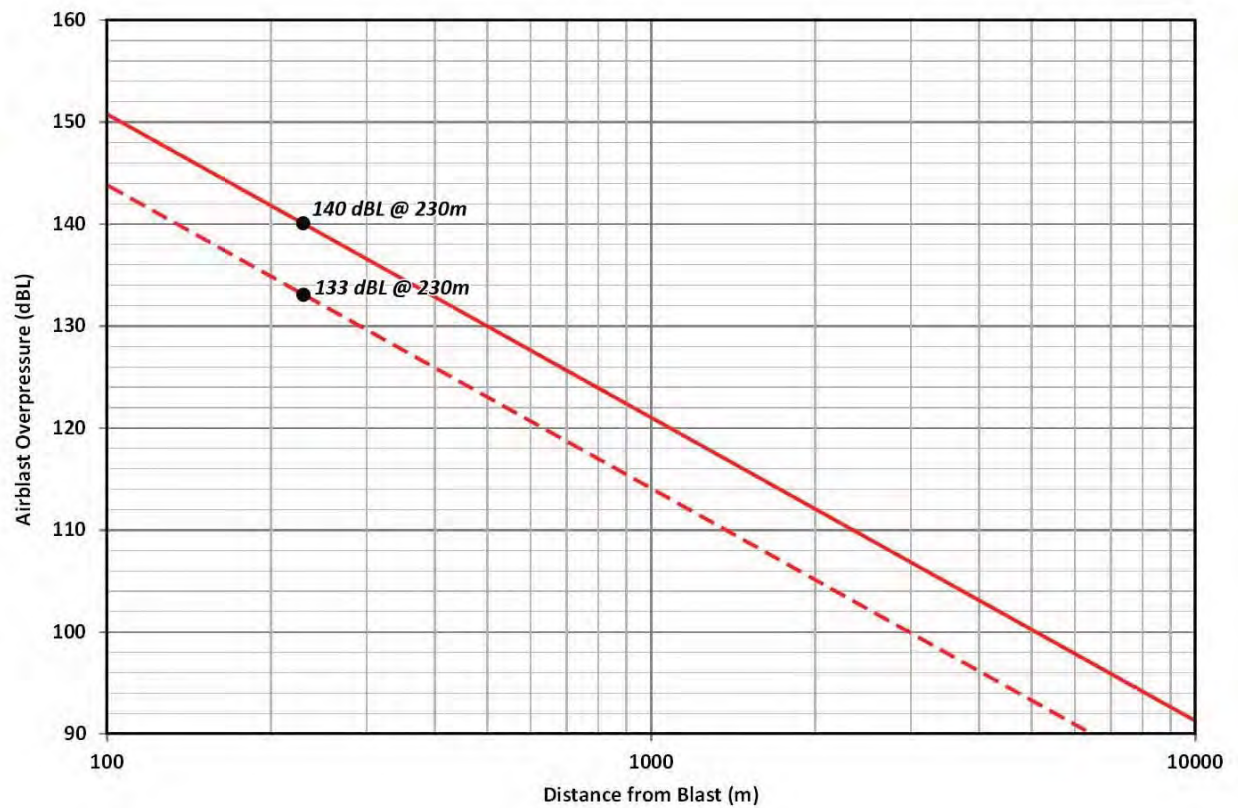
Figure 4 – Airblast Regression (dBL vs Distance)

Airblast attenuates at 9 dBL with doubling of distance. A level of 140 dBL at 230m would attenuate to 115 dBL at 1500m. Compliance with the 115 dBL (95%) limit at external sensitive sites can be incorporated in environmental design elsewhere in the mining areas when blasting closer to the other sensitive sites.

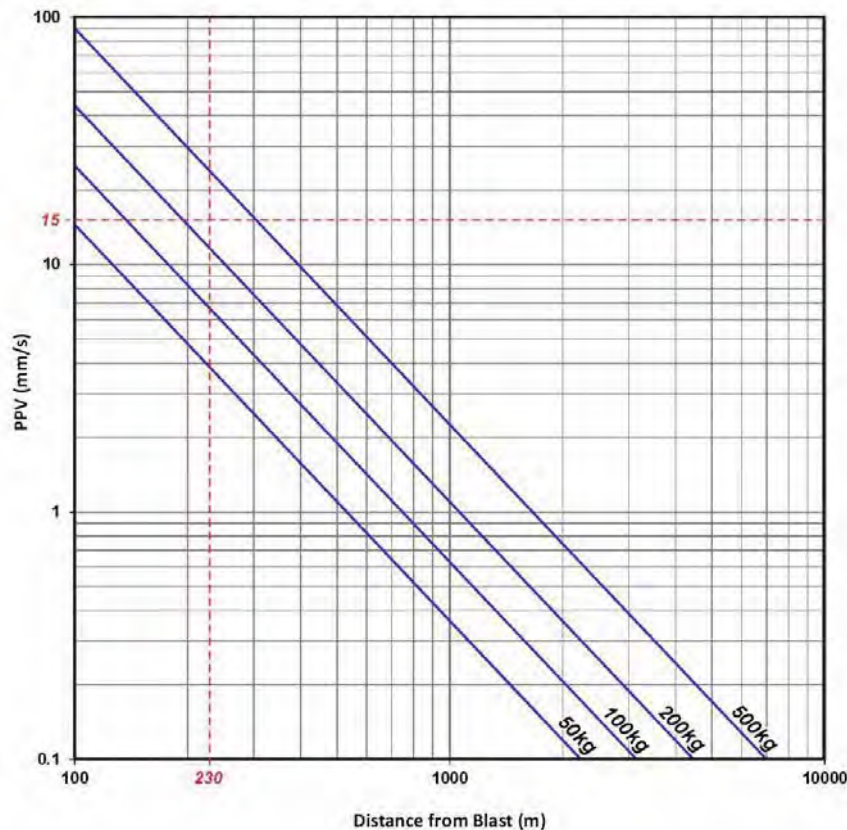
Figure 5 –PPV, Charge Mass and Distance

The Site Constant of 1000 has been found from experience at close distance blasting at similar open cut coal mines (e.g. Mangoola, Moolarben and Liddell). The model should be calibrated at the Bylong Coal Project by initial blast vibration monitoring after early blasting commences. This model is represented in **Figure 5**, showing the relationship between PPV, charge mass and distance.

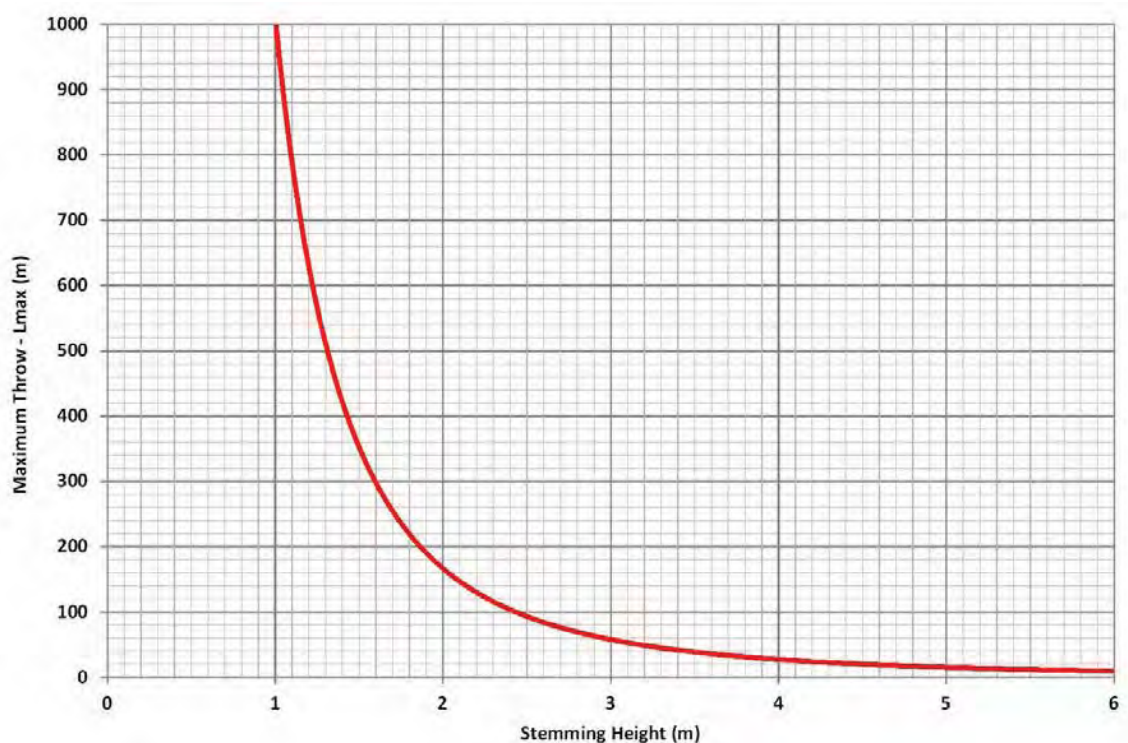
Figure 6 –Stemming Height and Maximum Flyrock Throw for 229 mm diameter holes (49.4 kg/m)

The flyrock model for maximum throw (L_{max}) from choke blasts is demonstrated in **Figure 6**.

The stemming height used to limit airblast will determine the flyrock throw. The minimum recommended exclusion zones for blasting introduces the concepts of Factors of Safety for different potential receivers.

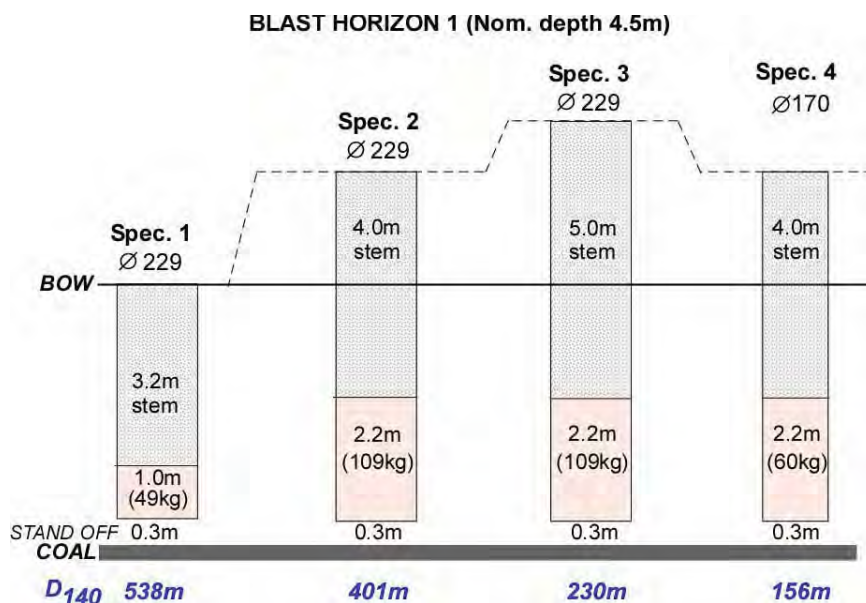
The proposed loading specifications are shown in the cross sections **Figure 8**.

The loading profiles shown in **Figure 8** have the explosive charge placed in the unweathered material (solid) so most of the explosive energy will be absorbed below the BOW. The role of the weathered material is to prevent cratering and the premature ejection of the energy into the atmosphere.

A better solution to control airblast to 140dBL at the Homestead is to leave 2-3m of the rock classified as weathered in situ to provide additional blast confinement. This solution would require the soil and clay overburden to be stripped down to the 2m (or 3m) horizon above the BOW and to use this horizon as the drilling platform.

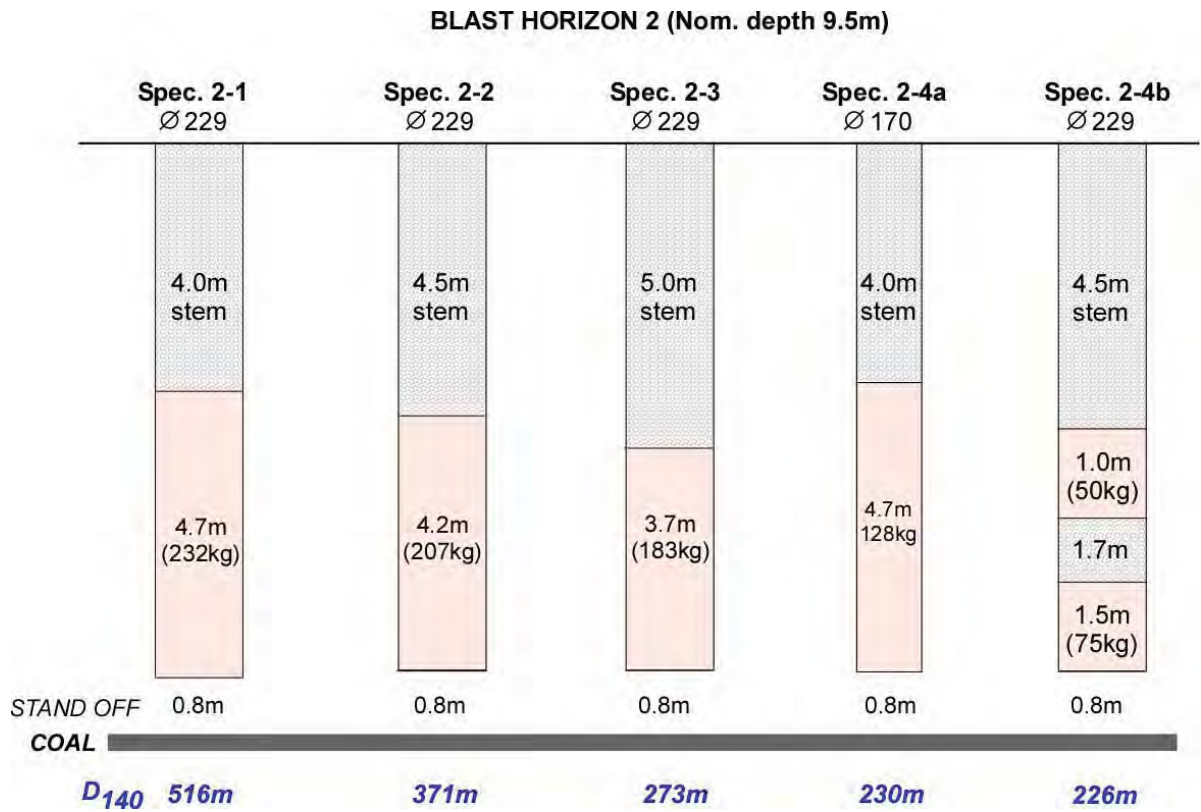
Figure 10 – Blast Horizon 2 Hole Loading Profiles

Cross sections of the proposed loadings are shown in **Figure 10**.

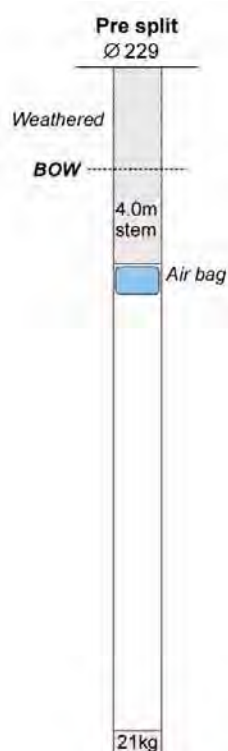
Figure 12 – Indicative pre split blast hole loading

Charge length = $\frac{21}{49.4} = 0.42\text{m}$.

The loading suggested by this blast design is shown in **Figure 12**.
