CPP Project 6029

Subject: Wind Engineering – Barangaroo South Building R7

Ref: (1) CPP report, Barangaroo Masterplan, dated December 2013

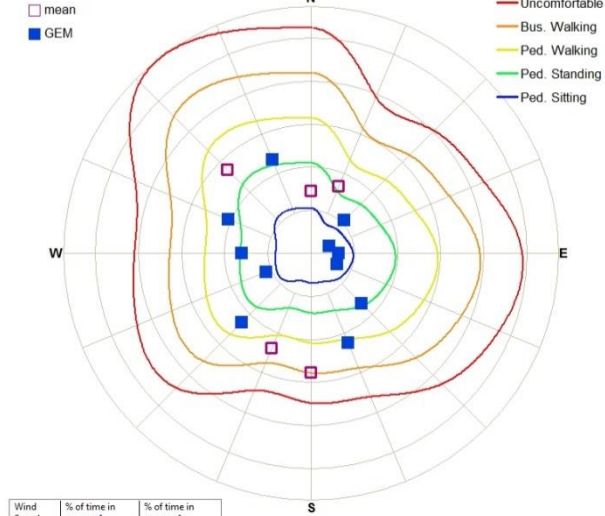
LOCATION 111

Wind Speed (m/s)	% of time in excess of Mean	% of time in excess of GEM
2.0	35.0	38.7
4.0	12.9	12.4
6.0	3.9	2.8
8.0	0.8	0.4
10.0	0.1	0.0
5.6	5.0	Ped Standing
11.5	0.022	Pass
5.3	Ped Standing	5.0
10.8	Pass	0.022

Figure 5: Directional results

It is evident from Figure 4 and Figure 5 that strong wind events tend to occur for winds from the south and north-west quadrants and are caused by the proximity of R7 to Building C5, which is exposed to southerly winds, and the open nature of the harbour to the west. The wind conditions in the open space area to the east of R7, Location 111 in Figure 3, would be suitable for café style activities for about 85% of the time, and for

outdoor dining for 60% of the time. As the wind conditions in this area are governed by the taller building massing, to improve the wind conditions around the building local amelioration techniques such as vertical screening would be required.
