GEOTECHNICAL INVESTIGATION: NEW 11-FLOOR BUILDING AT LISMORE BASE HOSPITAL

Uralba Street, Lismore

New South Wales Health Infrastructure

GEOTALST01618AN-AF
8 March 2012

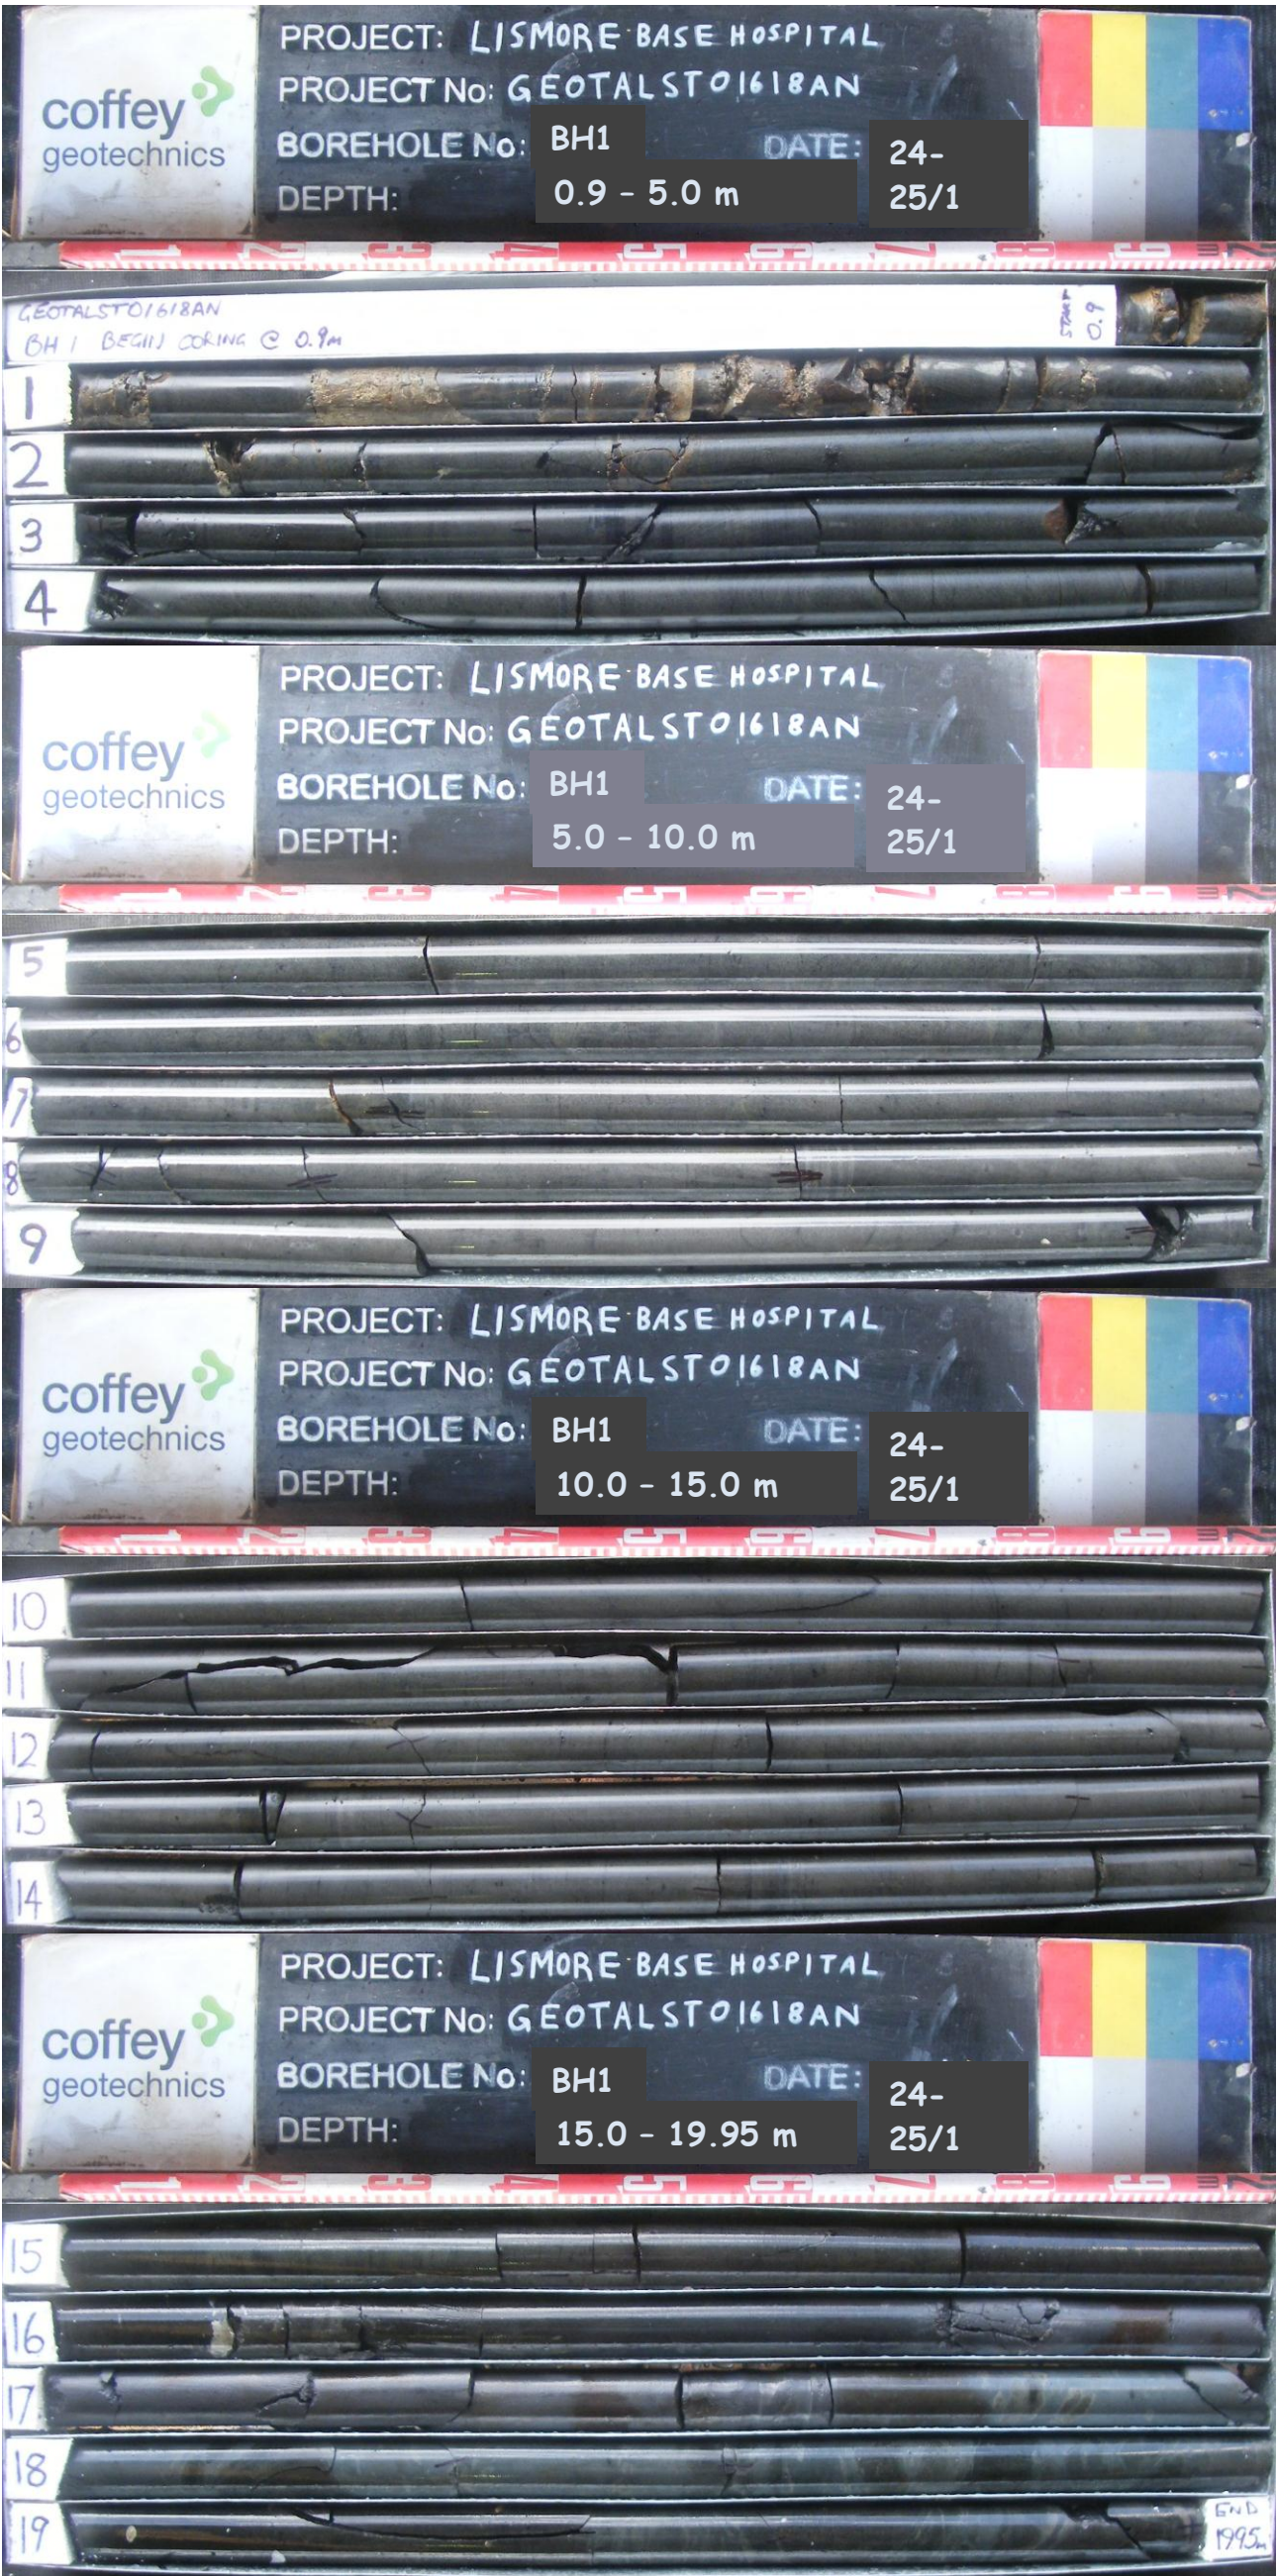
SPECIALISTS MANAGING THE EARTH	client:	NEW SOUTH WALES HEALTH INFRASTRUCTURE	
approved			project:	LISMORE BASE HOSPITAL NEW 11 FLOOR STRUCTURE	
date	2013-02-14		title:	CORE PHOTOGRAPHS – BH1	
scale	NTS		project no:	GEOTALST01618AN-AD	figure no: FIGURE 4
original size	A3

- Figure 1: Site Plan with Investigation Location
- Figure 2: Geotechnical Cross Section Across Slope
- Figure 3: Geotechnical Cross Section Along Slope
- Figure 4: Core Photographs – BH1
- Figure 5: Core Photographs – BH2
- Figure 6: Core Photographs – BH3

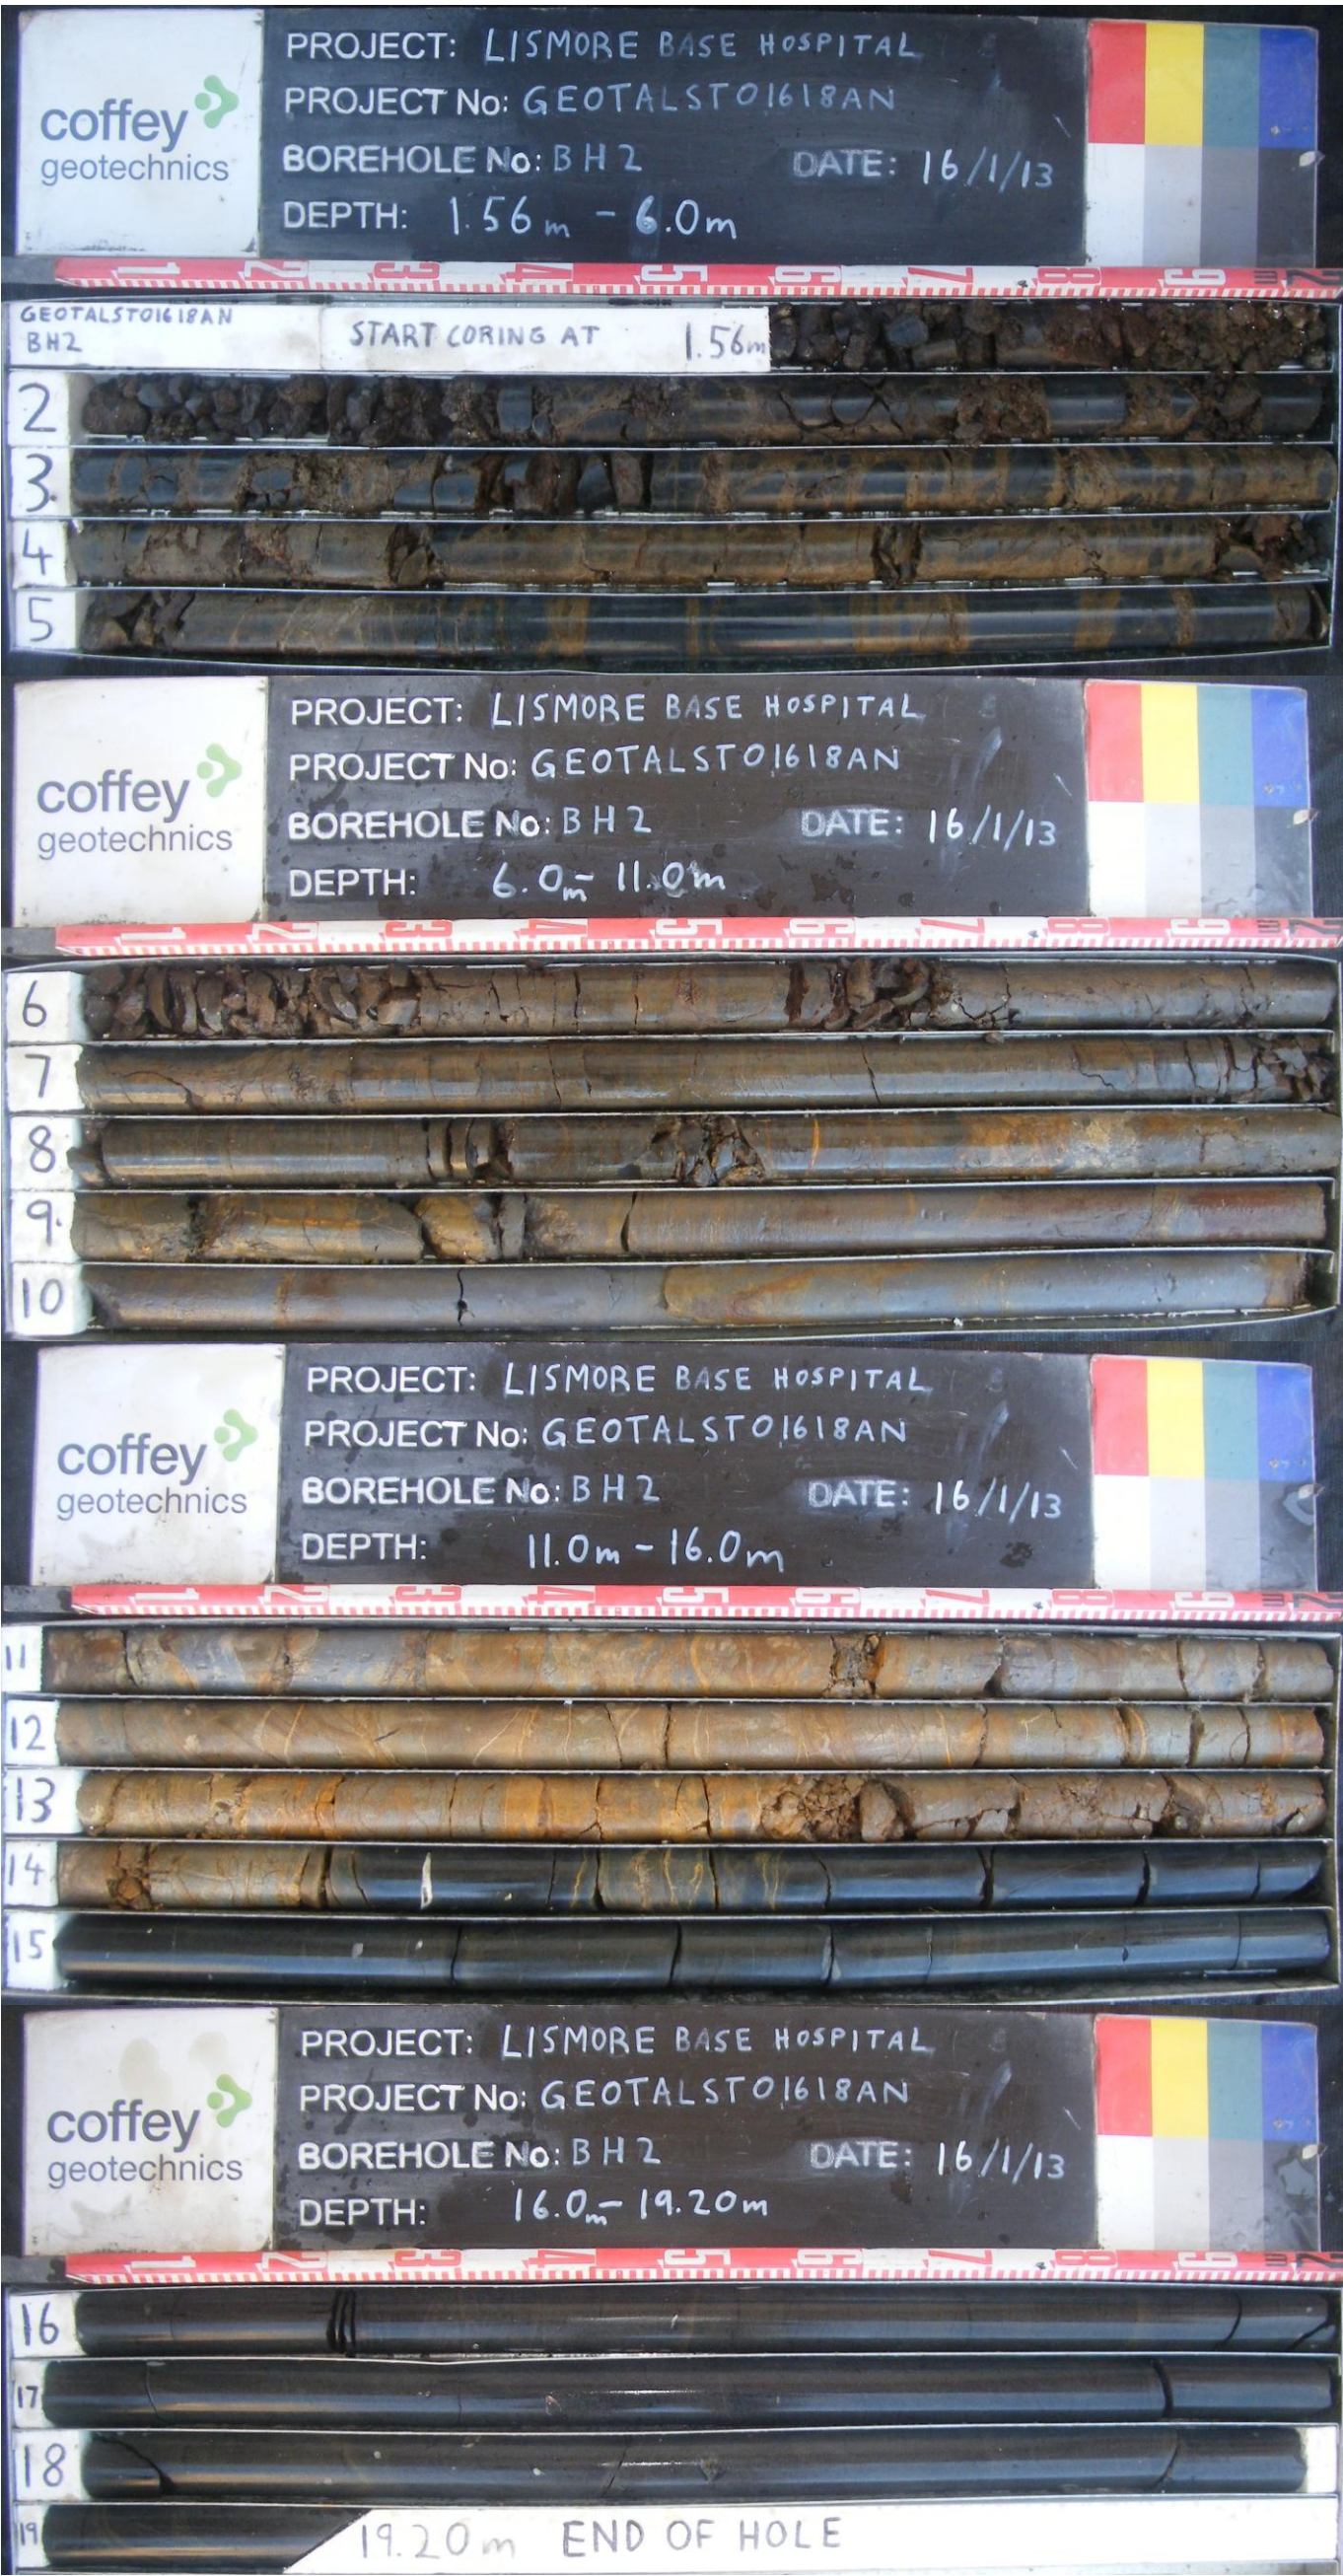
SPECIALISTS MANAGING THE EARTH	client:	NEW SOUTH WALES HEALTH INFRASTRUCTURE	
approved			project:	LISMORE BASE HOSPITAL NEW 11 FLOOR STRUCTURE	
date	2013-02-14		title:	CORE PHOTOGRAPHS – BH2	
scale	NTS		project no:	GEOTALST01618AN-AD	figure no: FIGURE 5
original size	A3

The weathering profile of the upper basalt is complex. It appears that extensive and variable weathering has occurred in the upper basalt at the north-western quadrant of the site (BH2). This weathering is consistent with observed cutting exposures above, and the footing exposures visible
