Campbell's Stores
7-27 Circular Quay West, The Rocks
Statement of Heritage Impact

October 2015

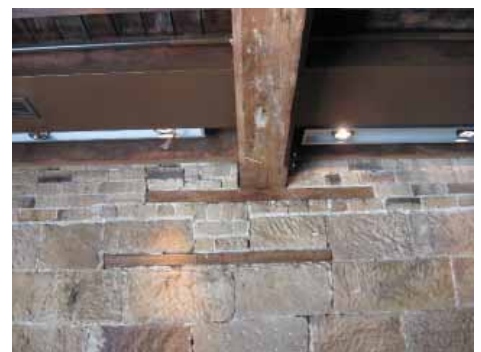
Figure 2.9
Second level wall indicating a main beam for the third level floor that was added c.1885, and its raised position relative to the position of the original roof beam 'pocket' with brick infill, to its lower left. Note the change from stonework to brickwork with the third level addition

A 1882 Dove plan shows the Stores, known at this time as the Metcalfe Bond, as 11 bays and two storeys (Figure 2.10 with the notation of '2' on each bay). With an 1887 revision to the plans, the Stores had an additional level, which was constructed of brick (Figures 2.9 & 3.8).⁶

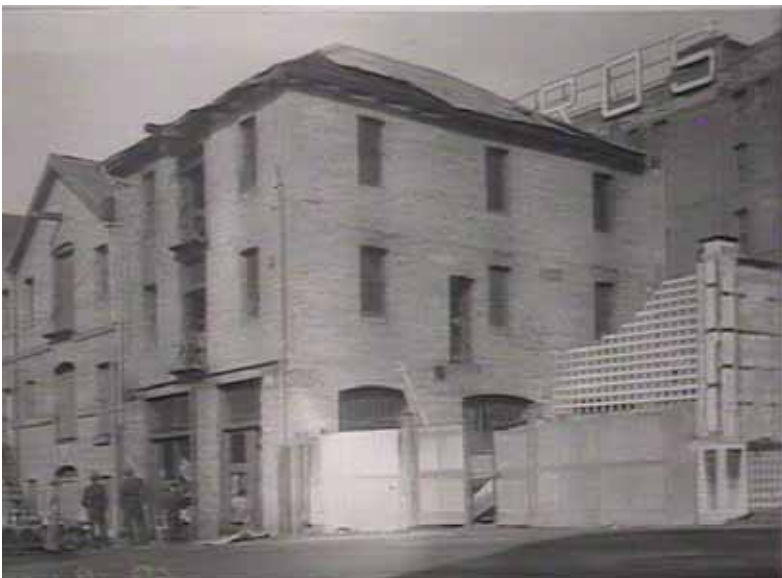
Figure 2.14

Pre-WWI photograph of the east and north facades of the existing Bay 11, showing the configuration of the northern wall prior to the changes introduced during the 1970s conservation and adaptive re-use program

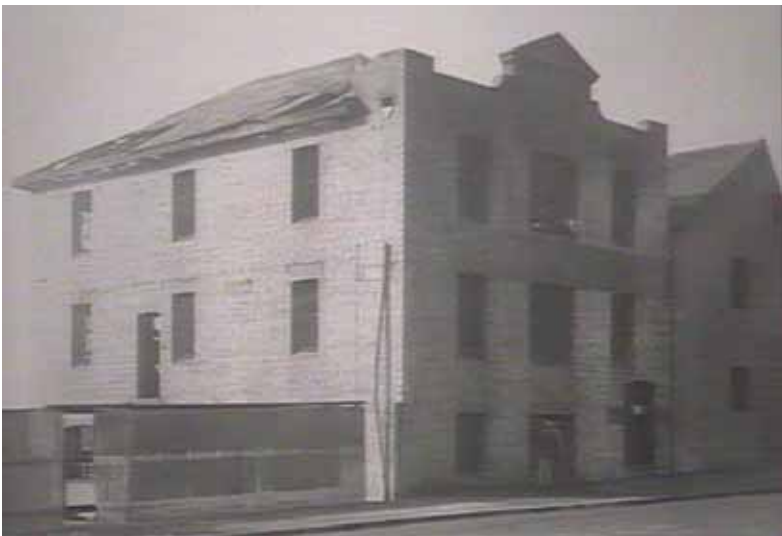
Figure 2.15

Pre-WWI photograph of the northern and western facades of the existing Bay 11, showing the configuration of the western wall and parapet. Note the hipped roof appears to be damaged, and the Hickson Road facade has yet to be altered for the roadway realignment

North elevation of Bay 11 of Campbell's Stores showing the alteration and enlargement of the windows that were lowered relative to the windows facing Hickson Road on the right (compare with Figure 2.15)

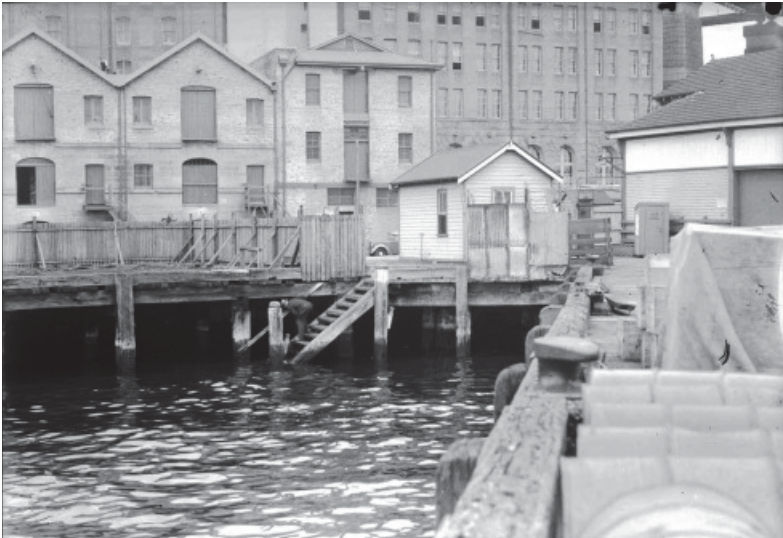
Figure 2.18

Circa 1940s photograph, showing the northern section of the Campbell's Stores (including Bay 11 prior to the construction of the roof vents) but after the re-building of the roof to a Dutch gable

At this time Hickson Road was realigned at the northern end of the Stores, 'shaving' the corner off Bays 10 and 11, the result of which is the oblique angle of the west wall (Figure 2.16). The hipped roof of Bay 11 was also altered to a Dutch gable, and it may have been at the same time as part of accommodating the alteration to the western elevation (Figure 2.18).

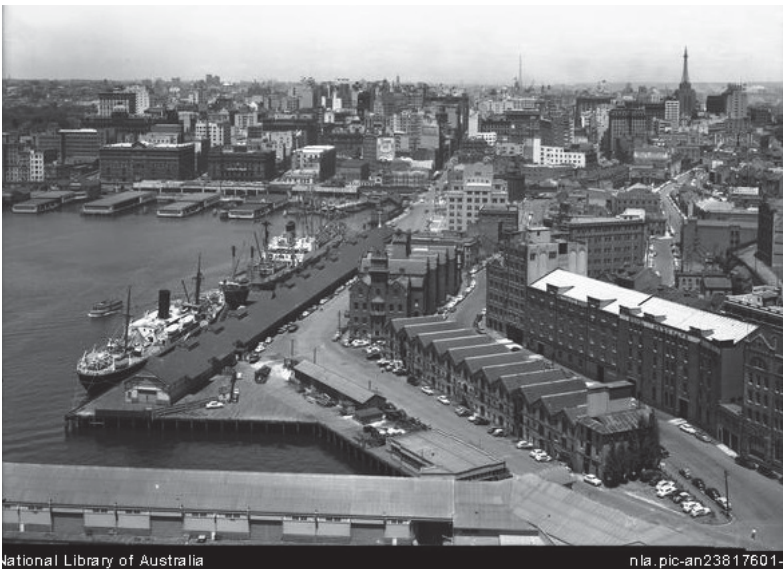
Figure 2.19

c.1950s photograph before the construction of the Overseas Passenger Terminal, and before the southern bay of the Campbell's Stores was demolished. Note the large masonry roof vent of Bay 11

In 1932 a fire in this section of the building (Bay 11) resulted in re-building and, possibly, the construction of the substantial roof vents that appear in later photographs (Figure 2.19).

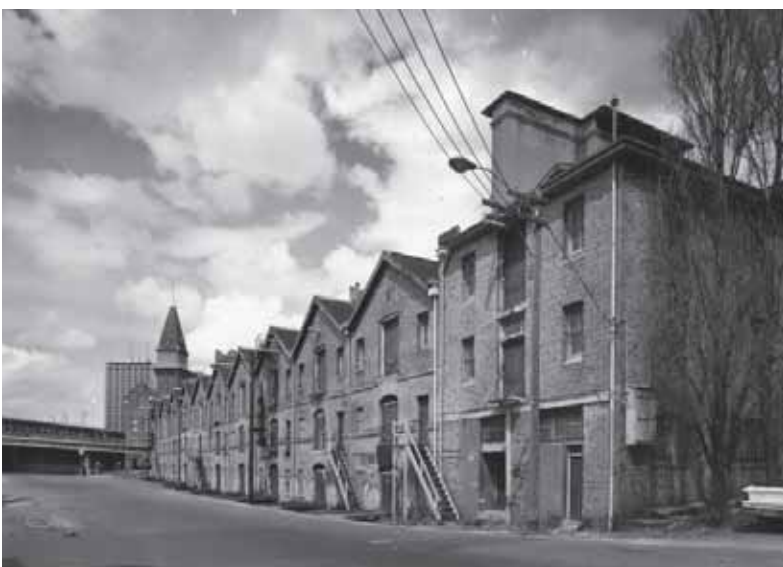
Figure 2.20

c.1961 photograph showing the northern section of the Campbell's Stores, including Bay 11 and after the construction of the bridge to the Overseas Passenger Terminal on the left. Note the location of the stairs and the prominence of the chimney duct

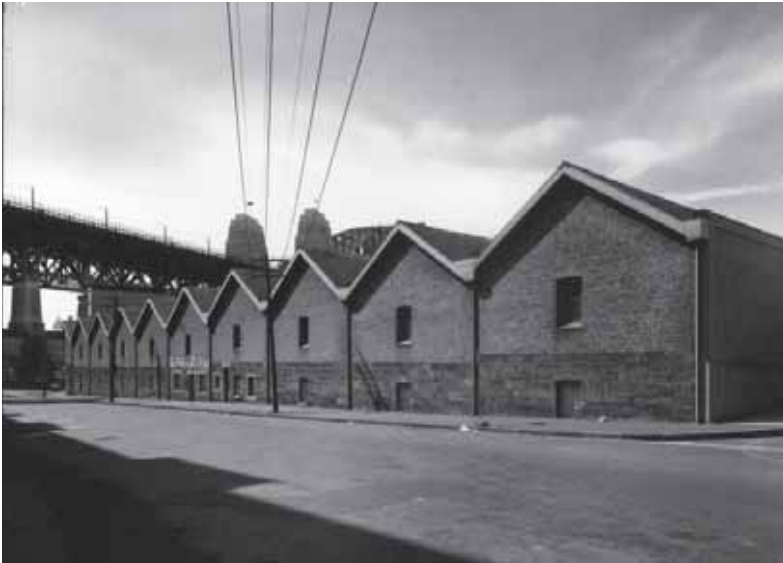
Figure 2.21

c.1961 photograph of Campbell's Stores from Hickson Road after demolition of Bay X, and the south wall finish on the right before the later brick duct enclosure.

was that the three storey building was transformed into the current two storey structure fronting Hickson Road (Figure 2.21).

The CMP notes that by 1978 new window openings had been inserted into Bays 4 and 5 of Hickson Road (Figure 2.21), and a number of the original Level 2 windows (ground floor to Hickson Road) had been enlarged into doorways.

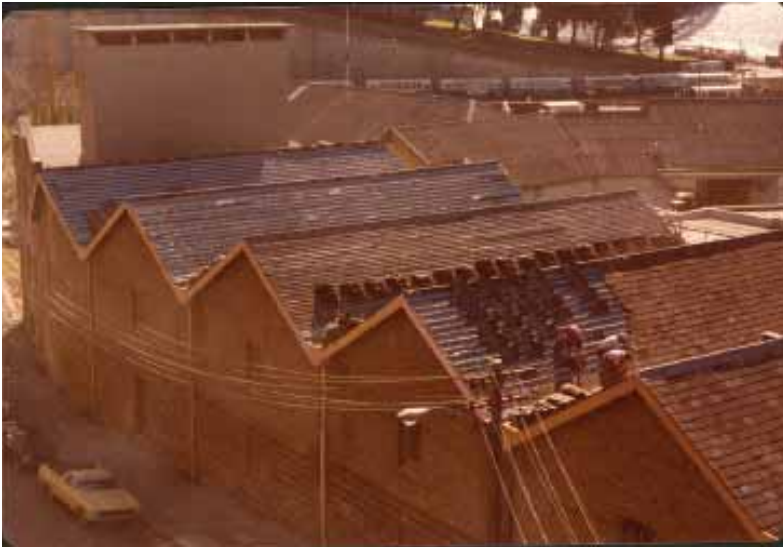
Figure 2.23
c.1970s Campbell's Stores at the time of re-roofing with slate. Note the masonry chimney/vent between Bays 10 and 11 to the upper left

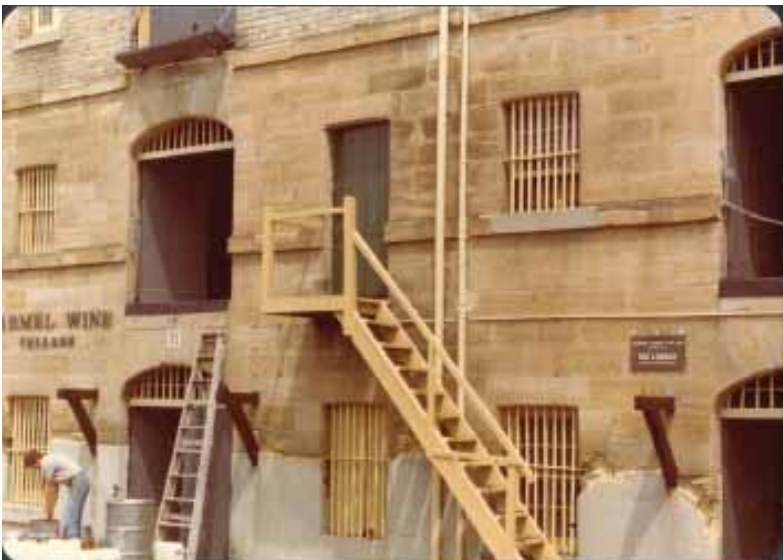
Figure 2.24
c.1970s Eastern facade of Campbell's Stores with areas of render to the ground floor level before remediation. Note the original location of the stairs to the first floor level, reflecting the original tenancy separation of each floor

- The break-up of an existing slab to the ground floor level and excavation for a new raft concrete slab-on-ground
- Works to the elevations including the removal of weathered sandstone and replacement to match (Figures 2.24-2.26)

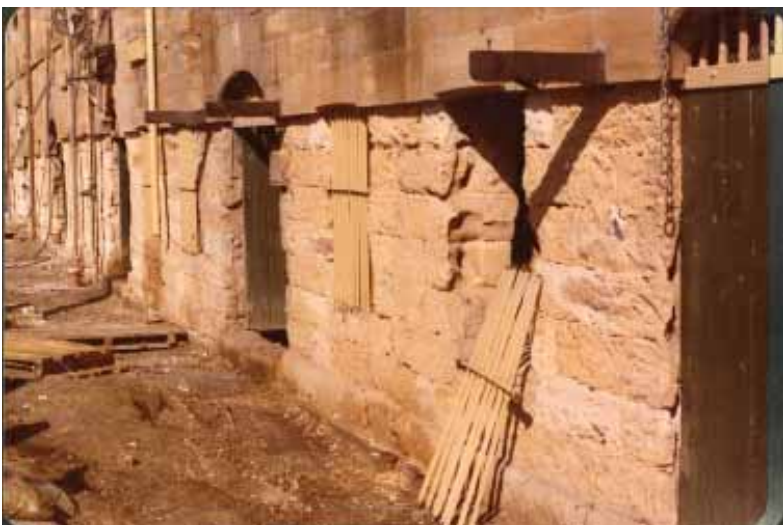
Figure 2.25
c.1970s Campbell's Stores after the removal of the weathered sandstone and before replacement, to the ground floor level of the eastern facade

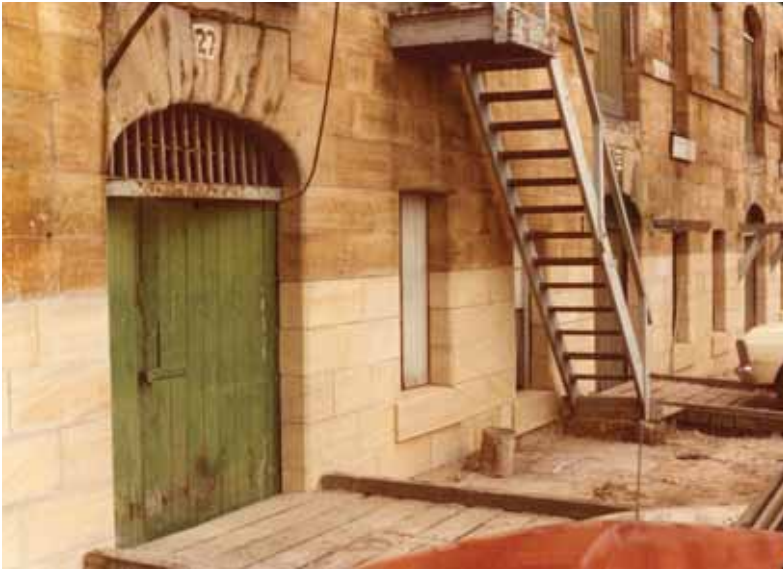
Figure 2.26

c.1970s Campbell's Stores after wall remediation and replacement sandstone to the ground floor level of the eastern facade. Note the timber 'bridges' across the stone paving

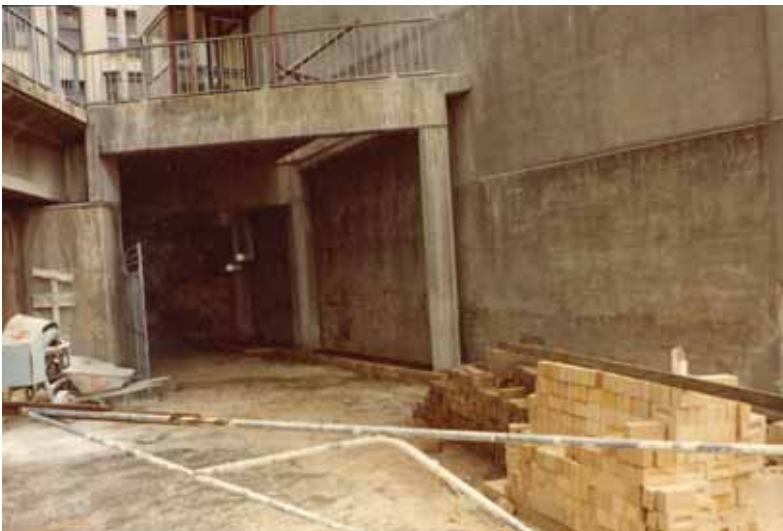
Figure 2.27

c.1970s South wall of Bay 1 of Campbell's Stores before the construction of the brick duct and the stairway. Note the render finish to the wall after the demolition of the original south bay for the construction of the bridge to the Overseas Passenger Terminal, on the left

The post-WWII period saw the western side of Sydney Cove begin to alter from commercial activity to one of tourism, as evidenced with the construction of the Overseas Passenger Terminal. This involved the demolition of the southern Bay X in 1958 to erect the elevated roadway connecting Hickson Road with the passenger terminal (Figure 2.20). The resulting exposed stone wall was covered with a render, although it is not clear as to whether this was a direct application or applied to an installed brick wall in front of the stonework (Figure 2.27).

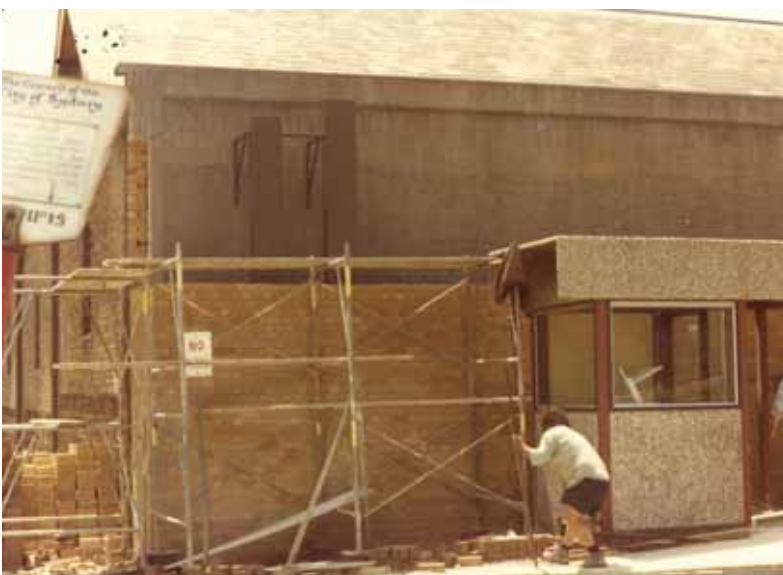
Figure 2.28

c.1970s South facade of Campbell's Stores, Bay 1 with construction of the brickwork duct over the previously rendered wall

- The construction of the brick duct to the south wall of Bay 1 with a detail indicating a previous render finish to the stonework (Figure 2.28)
- A new lowered footpath to Hickson Road
- New bathroom and stair details.

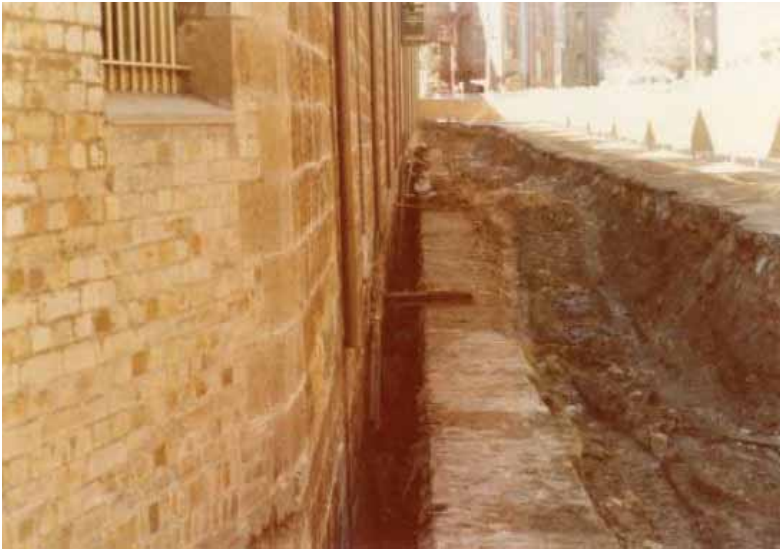
Figure 2.29

c.1970s Hickson Road footpath excavation during restoration works with Campbell's Stores on the left. Note the retaining wall next to the Stores, likely constructed c.1915 at the time of re-building Hickson Road

Hickson Road was re-built in 1914 at a higher level, taking into account the 'benching' topography, and appears to have included the 'back-filling' of the road against the rear wall of the Campbell's Stores. Photographs in the CMP indicate a substantial retaining wall approximately 300mm from the rear wall of the Stores (Figure 2.29).⁸ The result

The western, two storey facade facing Hickson Road reflects the falling topography from one street, down to the lower former street level of the current forecourt (Figure 5.4). Originally the Stores facing Hickson Road were built on grade where the topography was cut to provide a level platform upon which the structure was built (Figure 2.30). The re-building in 1915 of the roadway 'infilled' the back of the Stores, and later in the 1970s the services' tunnel was installed (Figure 2.29-2.31).

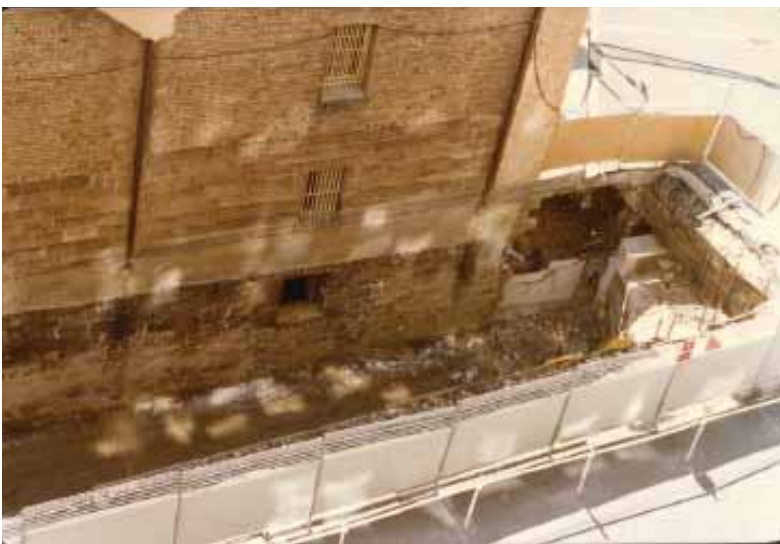
Figure 2.30

c.1970s Excavation to the Hickson Road side of Campbell's Stores during construction of the sub-floor services tunnel, with the window opening to what was the original ground floor, reflecting the back-filling required for the onstruction of Hickson Road. Note the break through to the loading dock area below the bridge to the Overseas Passenger Terminal

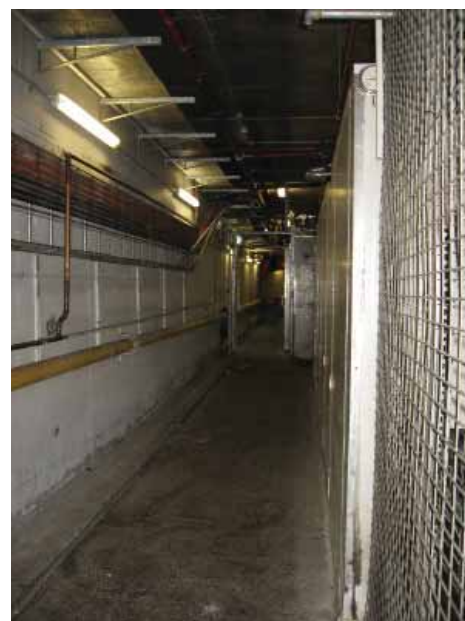
Figure 2.31

Service tunnel below the Hickson Road footpath that provides goods delivery and waste removal from the back-of-house. In addition to A/C ducting and services' reticulation, the tunnel houses coolrooms and storage

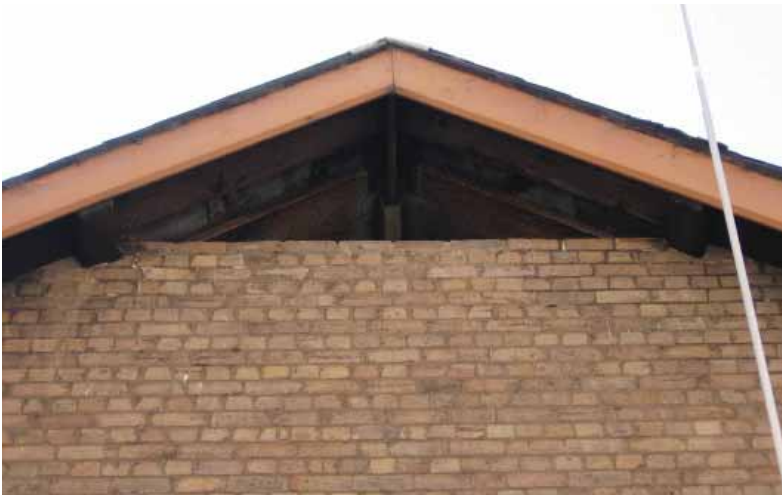
Figure 2.33 left
Hickson Road elevation detail of Bay 7 of Campbell's Stores showing the gable vent without the installation of a louvre (refer Figure 5.7)

Further conservation works for SHFA, primarily to the rainwater goods and box gutters between the bays, were detailed by Design 5 Architects, dated March 2008. Details include the installation of louvres to the Hickson Road gables of Bays 7 and 8, however this was not carried out as the openings are completely unsealed, with the interior roof structure evident from the street (Figure 2.33).

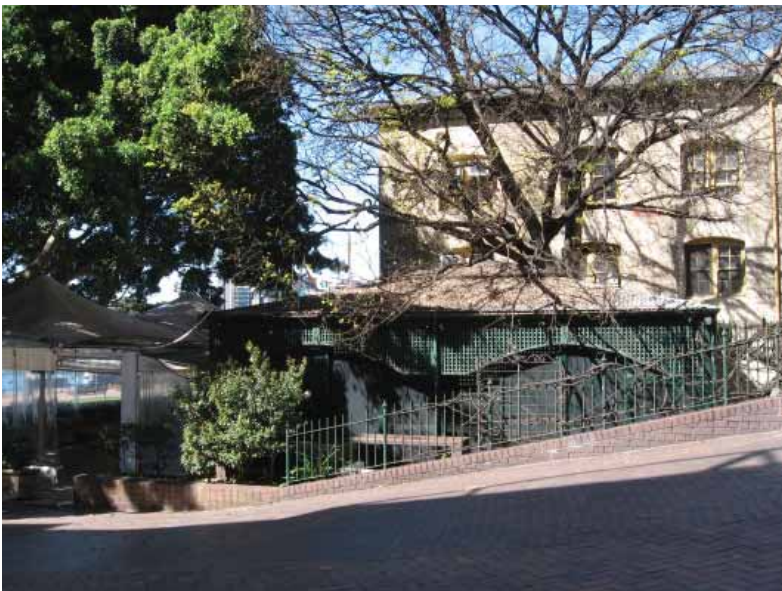
Figure 2.34
c.1990 glazed pavilion to the north of the Stores Bay 11 in the background, with pedestrian access from Hickson Road from the right, down to the Campbells Cove promenade to the left. The shadow of the Hyatt Hotel is in the foreground. Note the condition of the tree between the pavilion and Bay 11

A small glazed pavilion was built to the north of Bay 11, c.1990 (Bay 12), as a function centre and is used as a part of the *Italian Village* (Figure 2.34).

The three storey structure as it faces east, reflects the phases of development, with the first two levels built of sandstone and the later third level constructed of brickwork (Figure 3.8). The current 10 bay configuration is emphasised by the slate gable roofs to each individual bay, whereas the later Bay 11, at the north end of the row, has a differing window fenestration and a Dutch gable (Figure 3.7). There is a c.1990 glazed pavilion structure to the north of the Stores, which is used in conjunction with the adjacent restaurant (Figure 2.34).

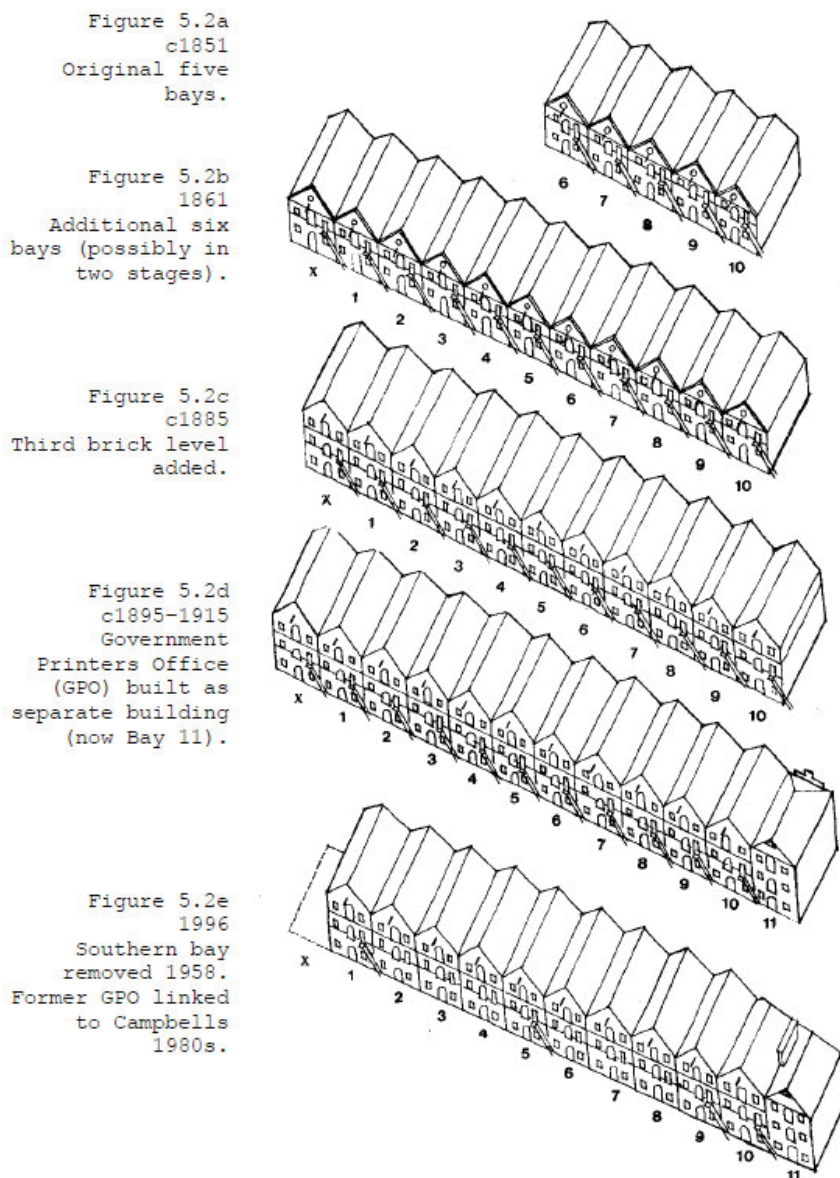
Figure 2.36
Campbell's Stores and summary of the phases of development

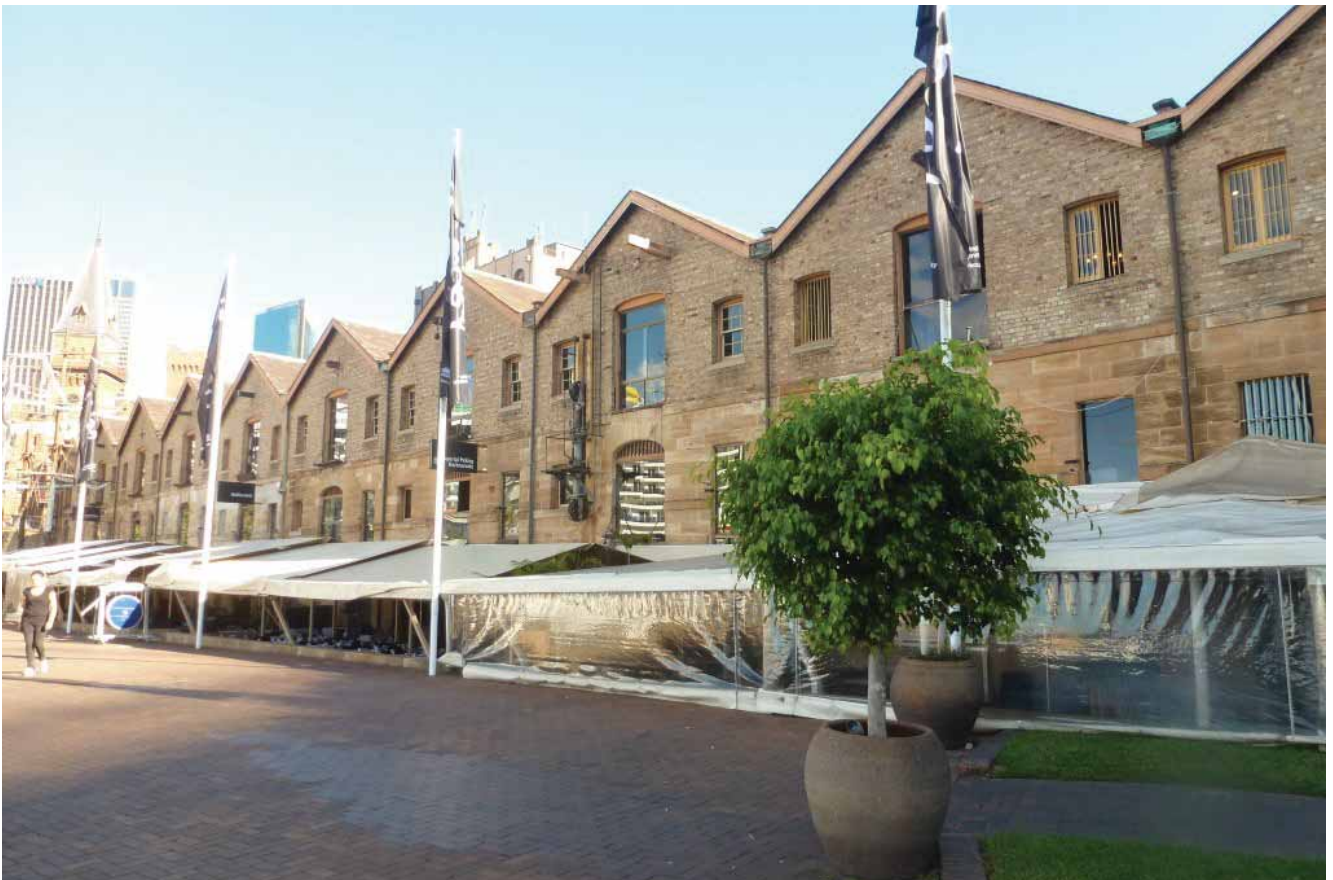
Figure 3.8
East elevation with the sunken courtyard underneath the canopies, and the ship masts to the left. Note the change in material from sandstone to brickwork at the top floor level

- The sunken court along the eastern front of the Stores
- Bay 1 south wall brickwork duct (Figure 3.3)
- The row of flag poles located along the edge of the sunken court (Figure 3.8).

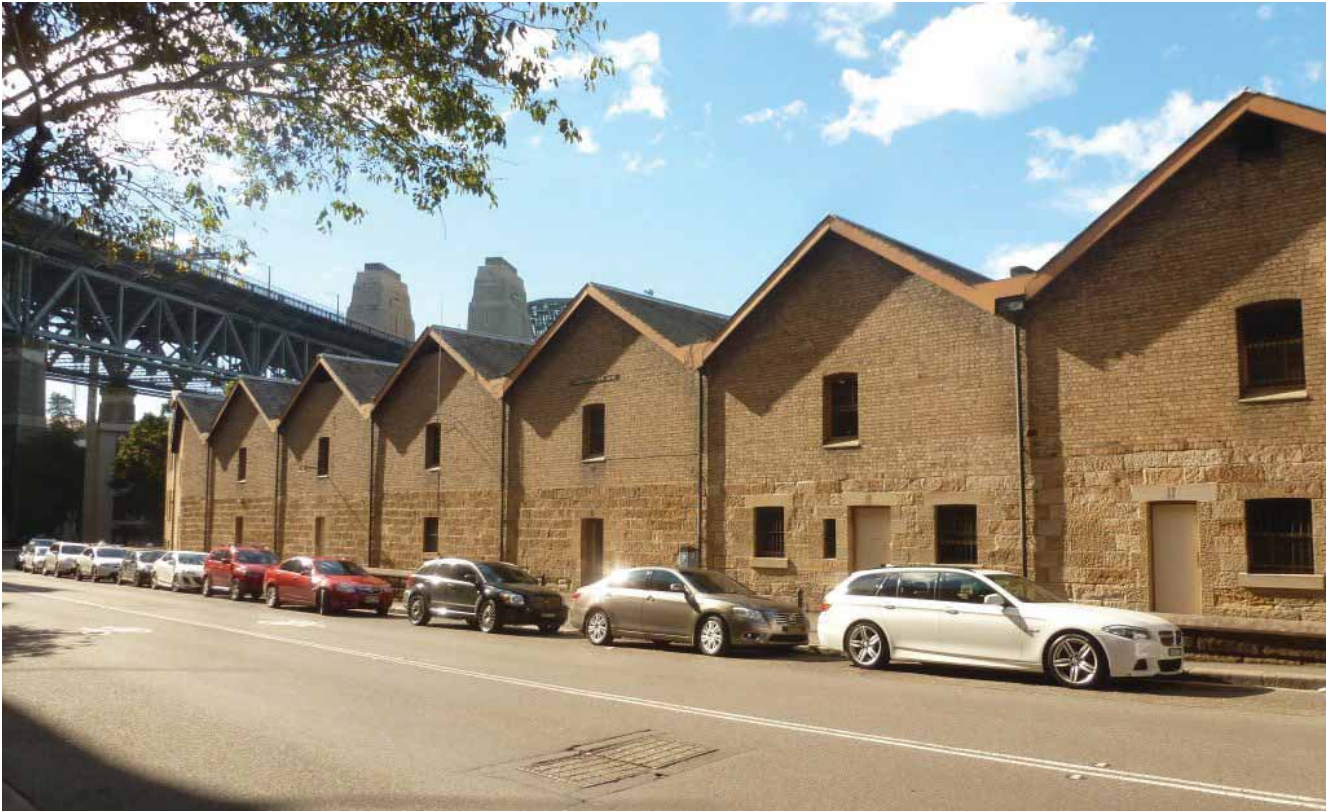
Figure 3.9

The two storey structure of the west elevation with a sandstone lower level and brickwork to the upper level. Note the simple openings of this side in contrast to the harbour elevation, and the splayed corner to the end of the building at the left. The door and window openings of the two bays on the right indicate later alterations from the original

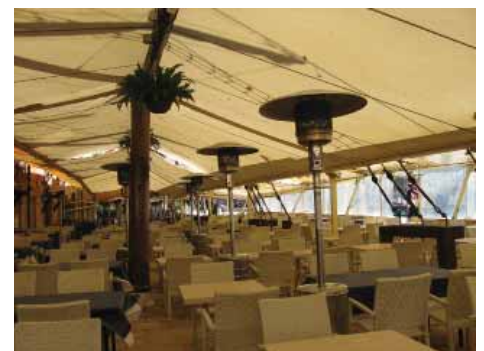
Figure 3.10

Forecourt side of the Stores within the shading canopy, with the eastern wall on the left and the promenade on the right. Note the restricted height and lack of view to the 'outside'

- Sail ship masts in the eastern forecourt to Bays 1-3
- Plastic shade canopies to the eastern forecourt for the length of the building (Figure 3.10)
- Staircase (Bay X) linking Hickson Road to the harbourside promenade (Figures 3.17 & 5.2)
- Glass pavilion to the north of Bay 11 (Bay 12)

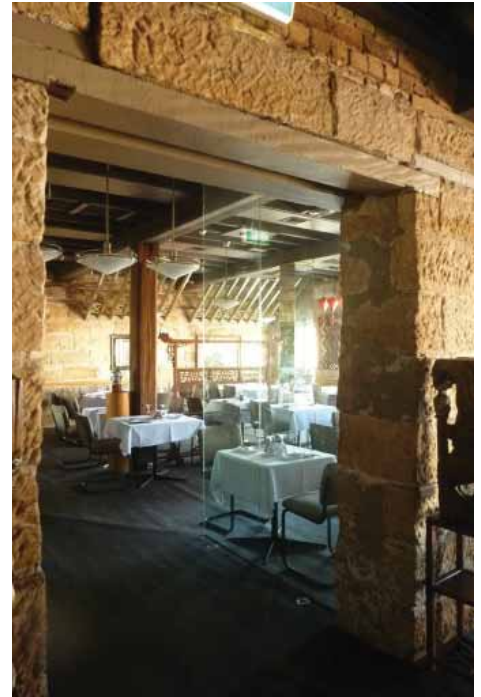
Figure 3.11

An example of an opening in a sandstone party wall to allow for expanded restaurant space. Note the brickwork of the third level addition, upper right

The interior structure is essentially a series of adjoining bays separated by sandstone party walls on the lower levels and brick walls on the top floor (Figures 3.11 & 3.16-3.18). The floor structure

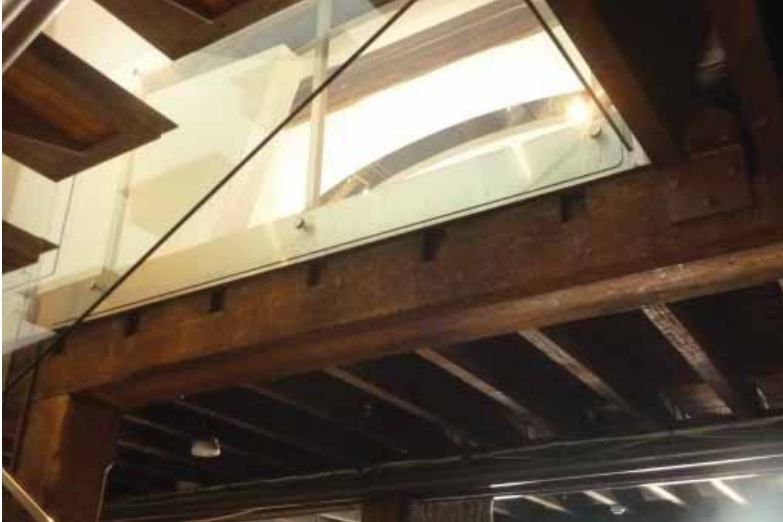
Figure 3.12
A contemporary stair opening showing the main beam structure with floor joists to one side and the notched recesses where the joists have been removed (Bay 2)

is based on hardwood posts and beams running in a north-south direction, with floor joists running from front to back and notched into the main beams (Figure 3.12).

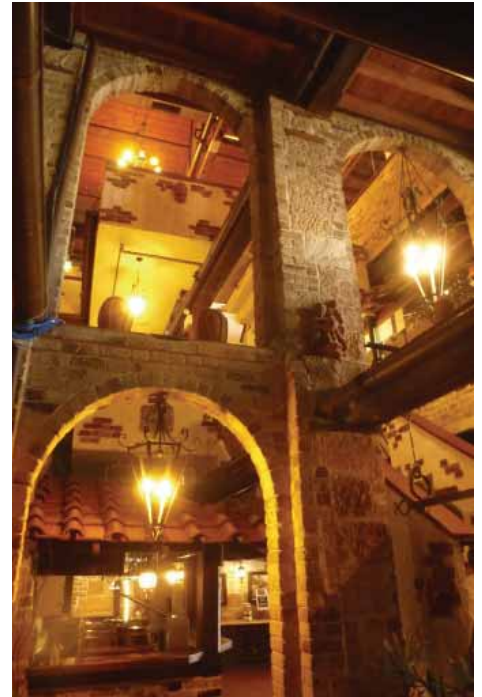
Figure 3.13
Substantial alterations to a party wall with the lining of the arch with sandstock brickwork (Bay 9 of the Italian Village)

The building has been significantly altered since it became a series of four restaurants dating from the 1970s and 1980s. With the inclusion of stairways, numerous amenities and service areas, including interior design that reflects the theme of each of the restaurants (Figure 3.13). The internal spaces as a consequence are quite complex and disparate.

Numerous openings have been inserted into the fabric of the building, including various configured voids through the floors, and new doorways through the common walls (Figure 3.15). The interior design has also included the introduction of brickwork, adjacent to and in contrast with the original sandstone walls (Figure 3.13).

The degree of fabric intervention varies but is most evident in the *Italian Village* restaurant, which has an elaborate stairway, combined with void spaces and double height, arches lined with sandstock brickwork. This is also the most 'themed' restaurant with references to Mediterranean village roofs and walls (Figure 3.13).

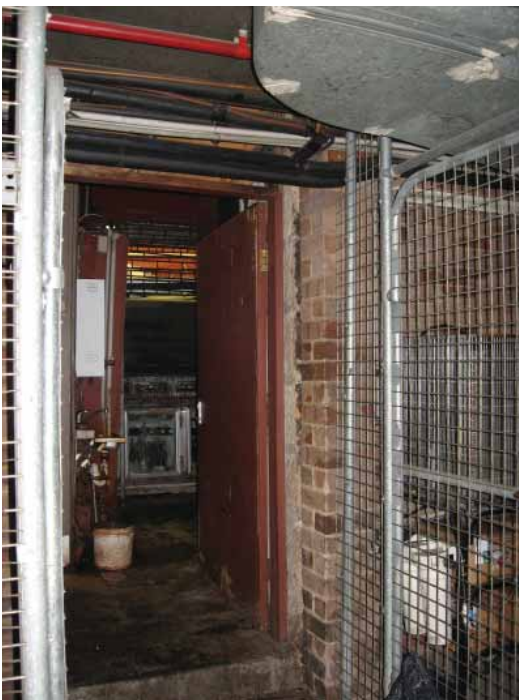
Figure 3.14
Services tunnel below the Hickson Road footpath, with a doorway to the building on the left, the original sandstone wall between the door frame and the brickwork skin next to it on the right

- The extent of toilets, kitchen storage and cold rooms, as well as floor to ceiling wall tiles to the numerous facilities, limits inspection and assessment
- Photographic evidence indicates a layer of render to the Bay 1 south wall that exists behind the extant brick duct. Although a DEM drawing detail indicates a layer of render only, a c.1970 photograph appears to reflect brickwork coursing under the render (Figure 2.27)
- The Hickson Road service tunnel is lined with a brick wall against the original west elevation stonework, and various amenities located against the inside of the original wall, makes it difficult to ascertain original openings and condition of fabric (Figure 3.14)
- A current inspection of the roof has not been carried out.

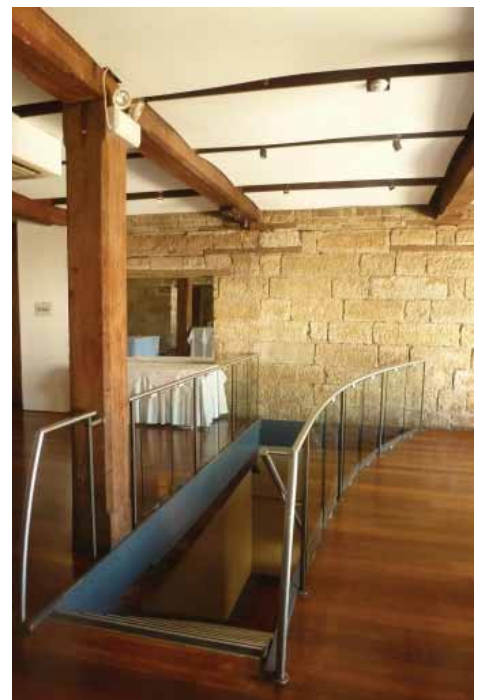
Figure 3.15
An example of a contemporary stair inserted between the column grid (Bay 5). Note the brickwork to the top of the sandstone and the infill below the beams where the former roof structure was bearing

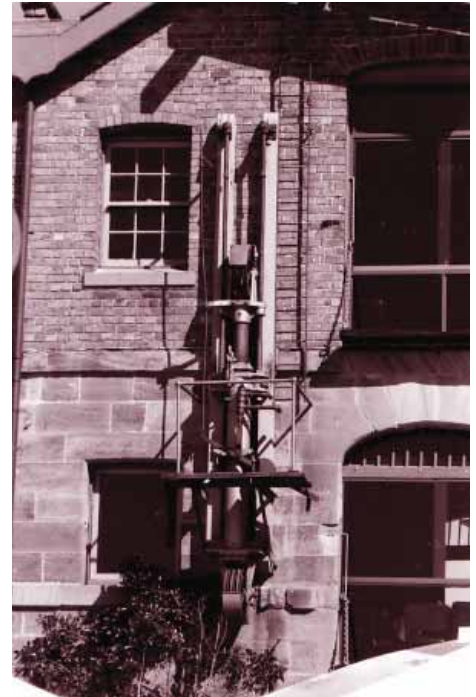
Figure 3.19
Example of materials handling technology on the face of the eastern facade

There are extant examples of industrial equipment throughout the Campbell's Stores' including attachment to the eastern facade, which provide evidence of materials handling technology (Figure 3.19). The examples reflect the stage of technology at the time, from mid-19th century basic handling, through to the introduction of motor machinery. The CMP, which provides a detailed history and description, has identified the following phases as:³

- Manual Handling
- Hydraulic Hoisting Equipment
- Gas Engine-driven Winch
- Motor-driven Winch

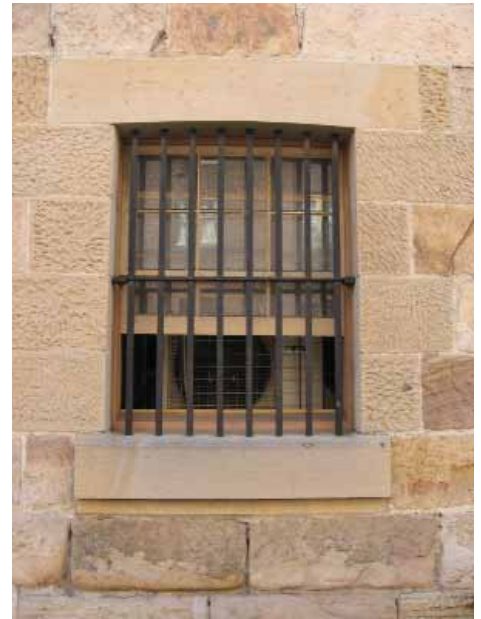
Figure 3.20
Hickson Road window with an A/C unit using the open window for ventilation

The integrity of the structure is generally good, however this has been compromised over time with the restaurant fitouts that have altered some of the window materials and position of openings, particularly along the Hickson Road elevation. A problem with the current A/C is that some of the Hickson Road windows are used directly for ventilation that has an adverse appearance on the building (Figure 3.20)

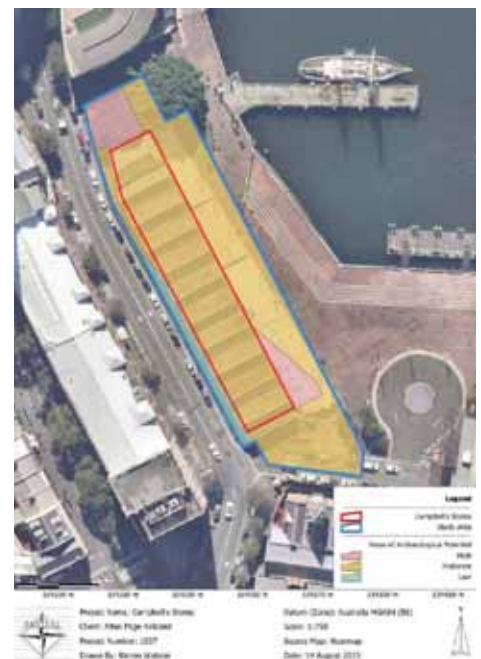
Figure 4.5
Areas of archaeological potential from the 2015 Austral Archaeology report. Note the areas of pink are 'High' potential, yellow are 'Moderate' and green are 'Low'

In addition a number of excavated test pits have been carried out to ascertain the nature and potential of sub-floor stratigraphy. The *Austral Archaeology* report notes the following areas of archaeological potential (Figure 4.5):⁶

While the 1850 stores are currently extant, there may be evidence which relates to their construction, modification, and over a century of occupation. Particularly in the area immediately to the north of the stores, there is high potential for remains of various structures constructed during the many decades the stores functioned as maritime warehouses.

This potential is lessened by various disturbances. Analysis of such disturbance combined with results from recent geotechnical investigations indicates that there is still moderate potential within the footprints of buildings, both demolished and extant. The area to the north is of particular interest, as it has been the site of numerous structures and their exact position, function and construction method is not entirely certain.

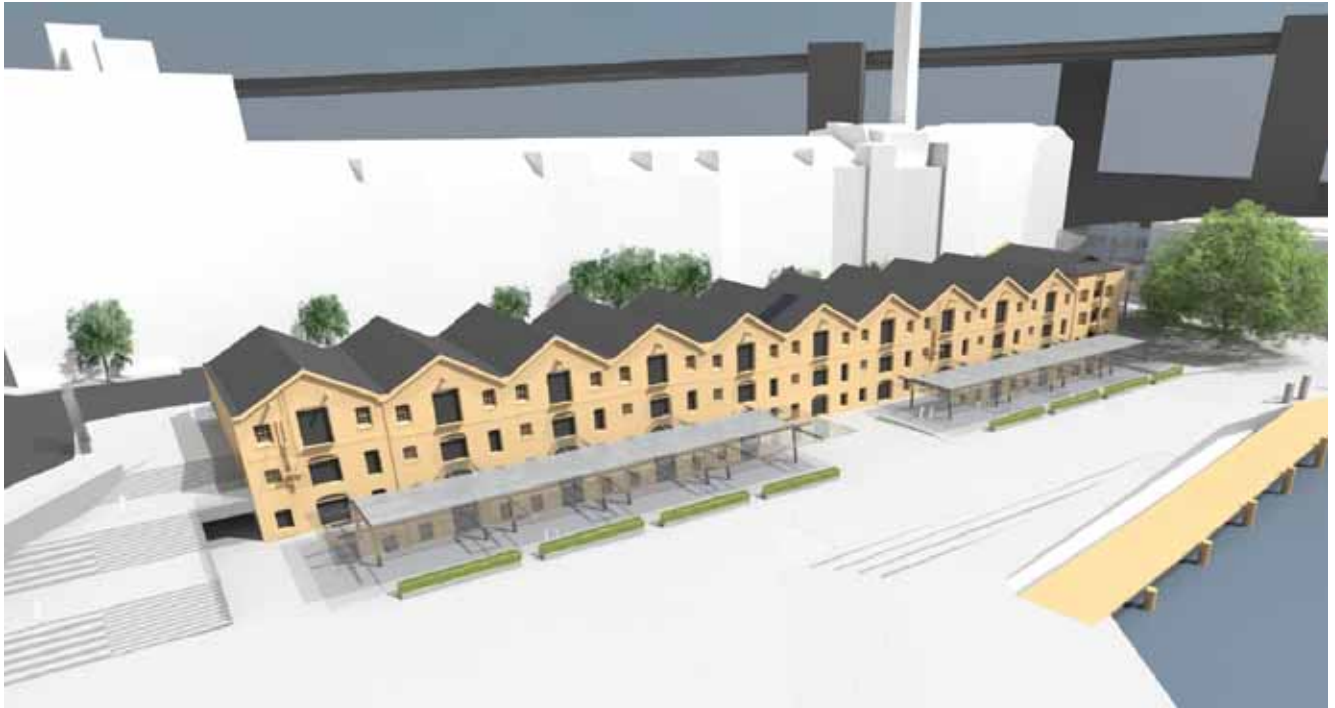
Figure 5.1

The proposed development with the lowered promenade and new canopy structure. Note the proposed reconfigured stairway for Bay X, adjacent to Bay 1 on the left

The aim of the proposal is to revitalise Campbell's Stores, to remove intrusive elements, carry out conservation and remedial works, upgrade facilities, and to provide a simple weather protective canopy structure to the external dining area fronting the foreshore promenade (Figure 5.1). The proposed works to the Stores ensures on-going viability while retaining the important significant features of the building.

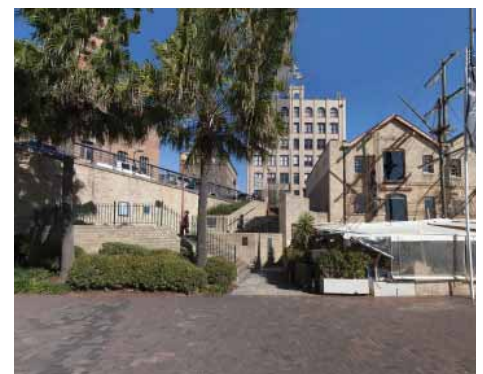
Figure 5.2

The southern stairs (Bay X) with Bay 1 of the Stores on the right and the elevated roadway to the Overseas Passenger Terminal on the left

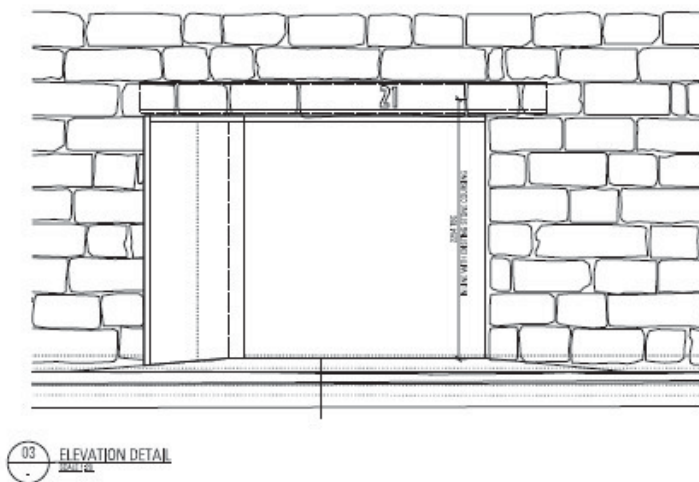
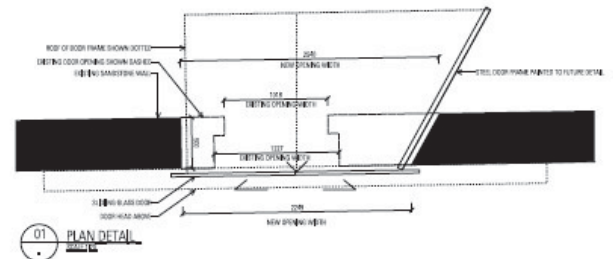
Figure 5.5 above
Proposed Hickson Road details for doorway openings for Bays 3, 6 & 9. Note the retention of the original sandstone blocks to the door head

Source: JPW part drawing SK-A-4101 (draft)

- Improved reconfiguration of the adjacent eastern forecourt to provide a level, drained area (Figure 5.4)
- The installation of a new steel free-standing glazed canopy with a column structure located three metres from the sandstone facade, which provides weather protection for the external dining area
- The construction of a new glass block clad retail building to the north of the Stores, referred to as Bay 12 (Figures 5.8 - 5.10)
- The installation of a glazed section of roofing to the east end of the Bay 6 roof, as an element of the proposed through link from Hickson Road to the Promenade (Figure 5.4)
- The installation of new entries from Hickson Road to Bays 3, 6 and 9, including wider doorways and steel sheet canopies (Figures 5.3 & 5.5)
- The installation of gable vents to the Hickson Road elevation (Figures 5.3, 5.7 & 5.7).

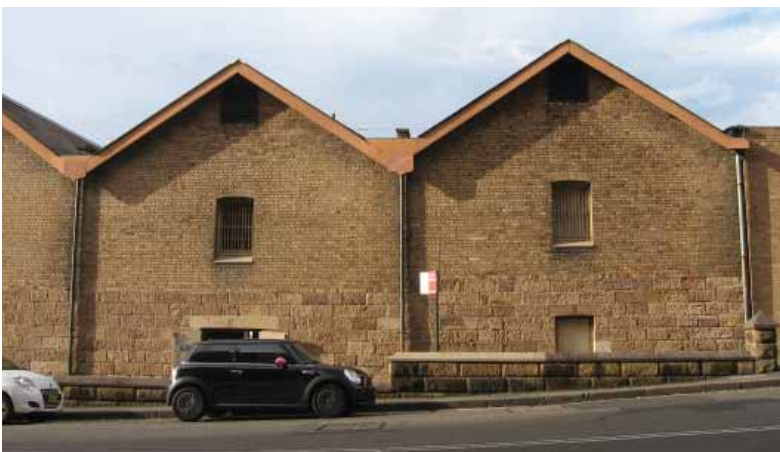
Figure 5.6 left
Hickson Road elevation (west) of the subject building with Bays 1 and 2. Note the vent openings to the gable apex, proposed to be altered

Note the two doorway openings that were later alterations of windows

The removal of some brickwork for the gable vents includes a rationalisation of the existing vents to Bays 1-4 that differ from the openings to Bays 7-8. This proposal to satisfy air conditioning is a preferred option to that of intervention through the slate roof, and is an improvement on the current circumstance where A/C units are placed directly in front of open windows and are visible from the footpath.

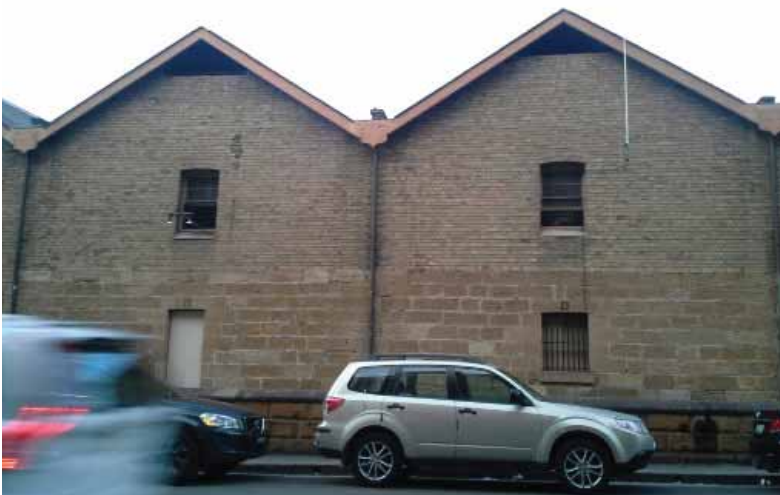
Figure 5.7
Hickson Road elevation (west) of the subject building with Bays 7 and 8 and the 2005 vent openings to the gable apex, but without any louvres. These vent openings are proposed for all the gable ends to achieve ventilation requirements.

Note the later doorway opening on the left and the original window on the right at ground level

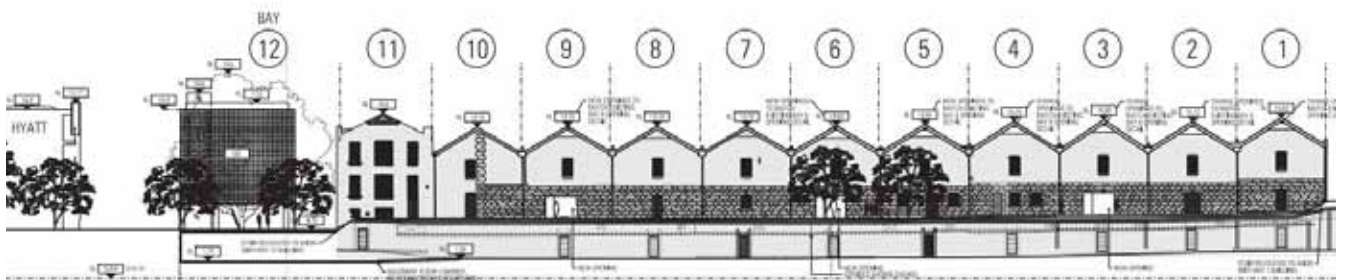
Figure 5.9
Hickson Road elevation (west) of the proposed glass block clad building (Bay 12) to the left of the Stores Bay 11. Note the height of the proposed building is in line with the Hyatt Hotel on the left and the subject building to the right

Source: Johnson Piliter Walker Drawing EA-A-2000-A, 16/10/2015

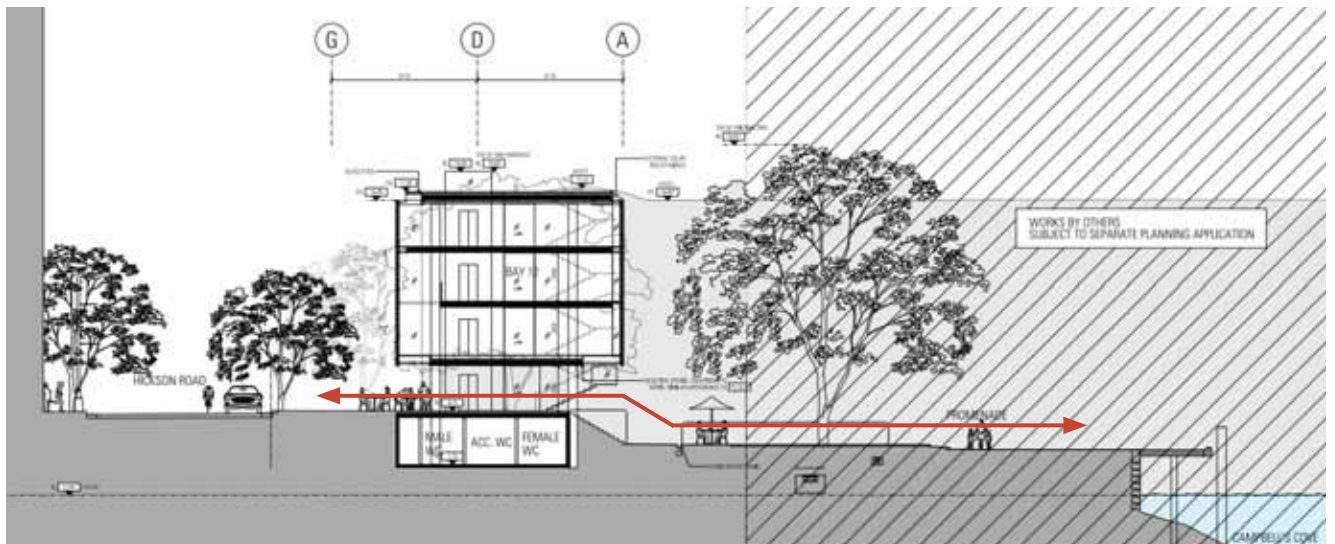
Figure 5.10
Cross section through the proposed Bay 12 building indicating the fall from Hickson Road to the Campbells Cove shoreline. Note the vista created by the undercroft of the proposed building that replaces the extant glazed pavilion

Source: Johnson Piliter Walker Drawing EA-A-3012-A, 16/10/2015

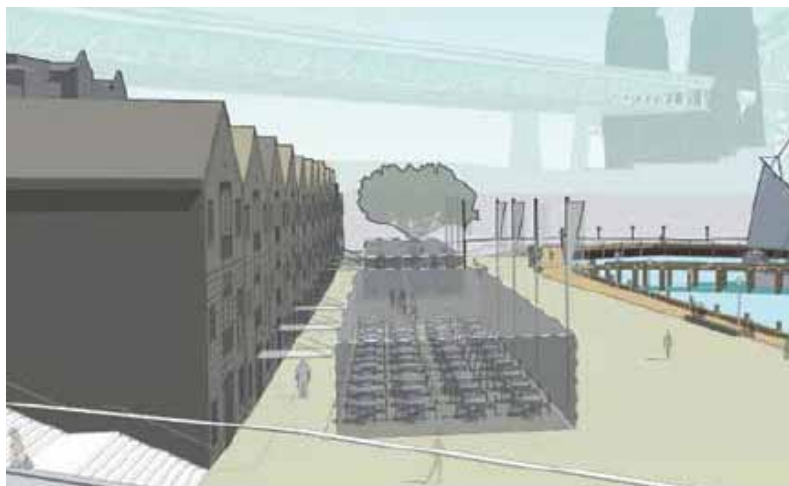
Figure 6.1

CMP Policy 13, Campbell's Stores forecourt canopy design principles

This policy also provides specific guidelines for a new canopy and the proposal follows these principles (Figure 6.1):
