Response to Submissions – Further Information re Heritage Impact

3.3 Guest Lodge & Platypus Pools

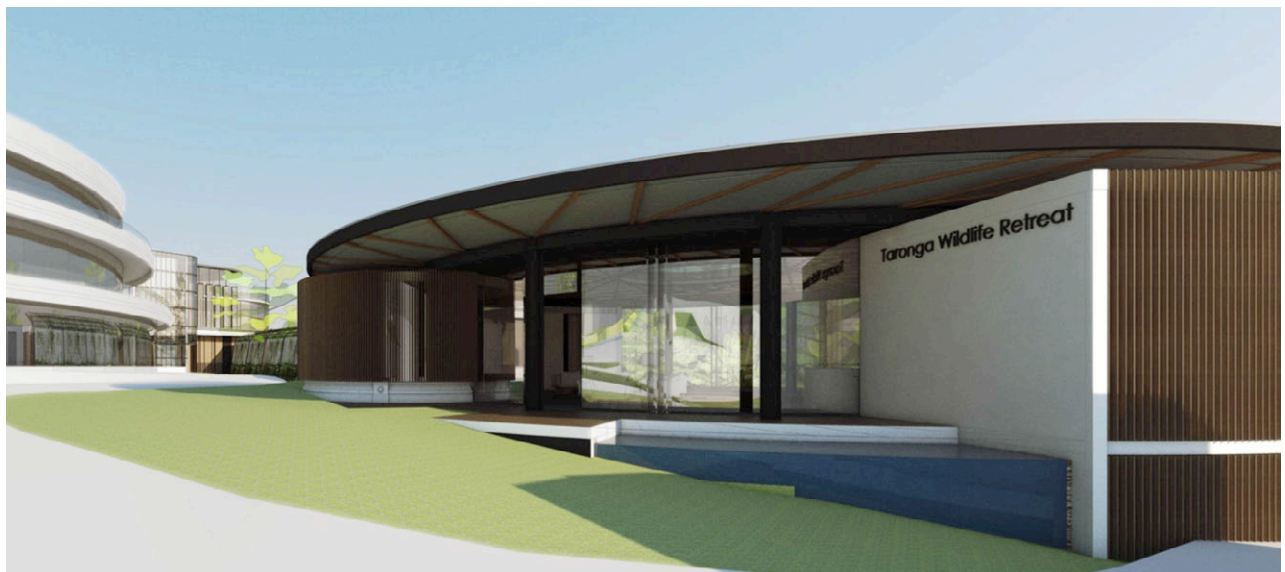
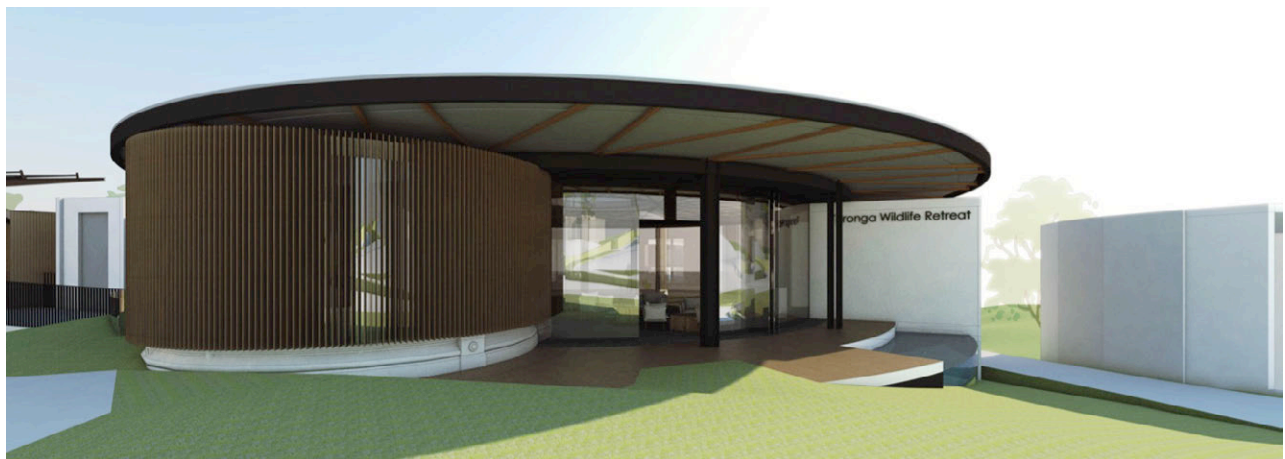
Detailed plans and perspective drawings have been developed showing in part how the 1917 fountain base will be incorporated into the lodge building. The fountain is proposed to become a reception area and office part with a circular external wall over and part forming the base of an internal counter. The ground levels are to be lowered around the former fountain to about the original levels exposing the side of the fountain to view. The adjacent entry to the building is to be via a “bridge” over platypus ponds, which will be at a lower level, to an entry deck. The interface of the deck and ponds with the fountain base is a matter for detailed design. The landscape concept shows a nesting box in front of the fountain base but this is a matter for detailed design. The perspective drawings following show the concept but the ground levels have not been reduced in the drawing though this is what is intended.

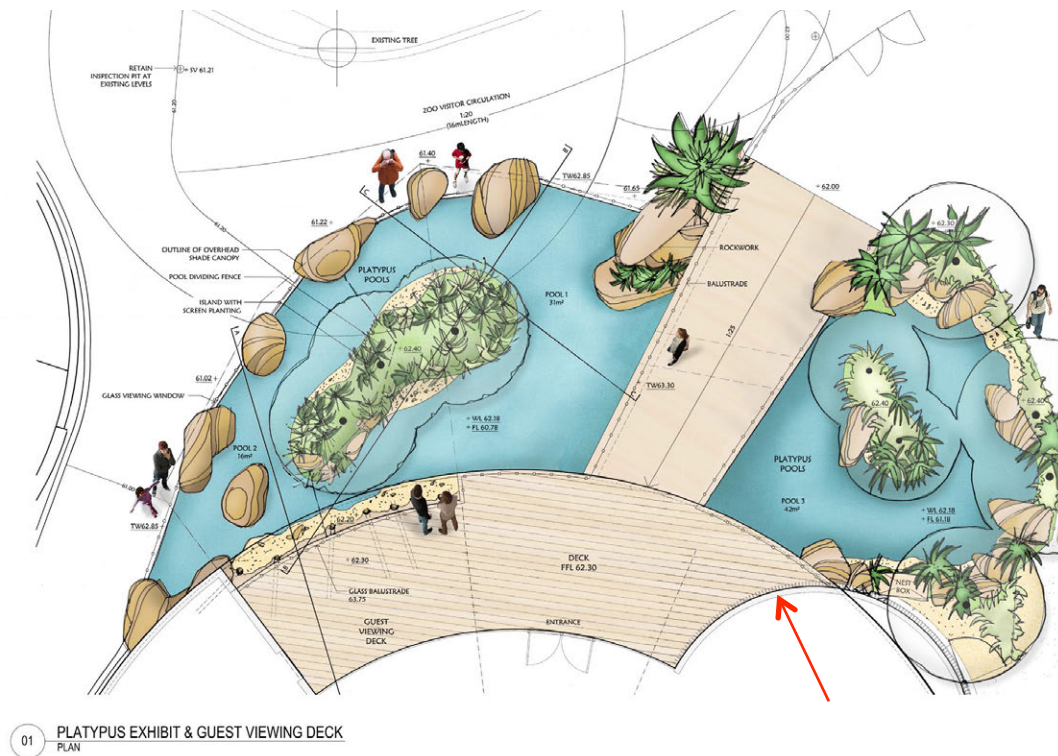
The location of the fountain base in the landscape concept plan (extracted from the EIS) above is arrowed.

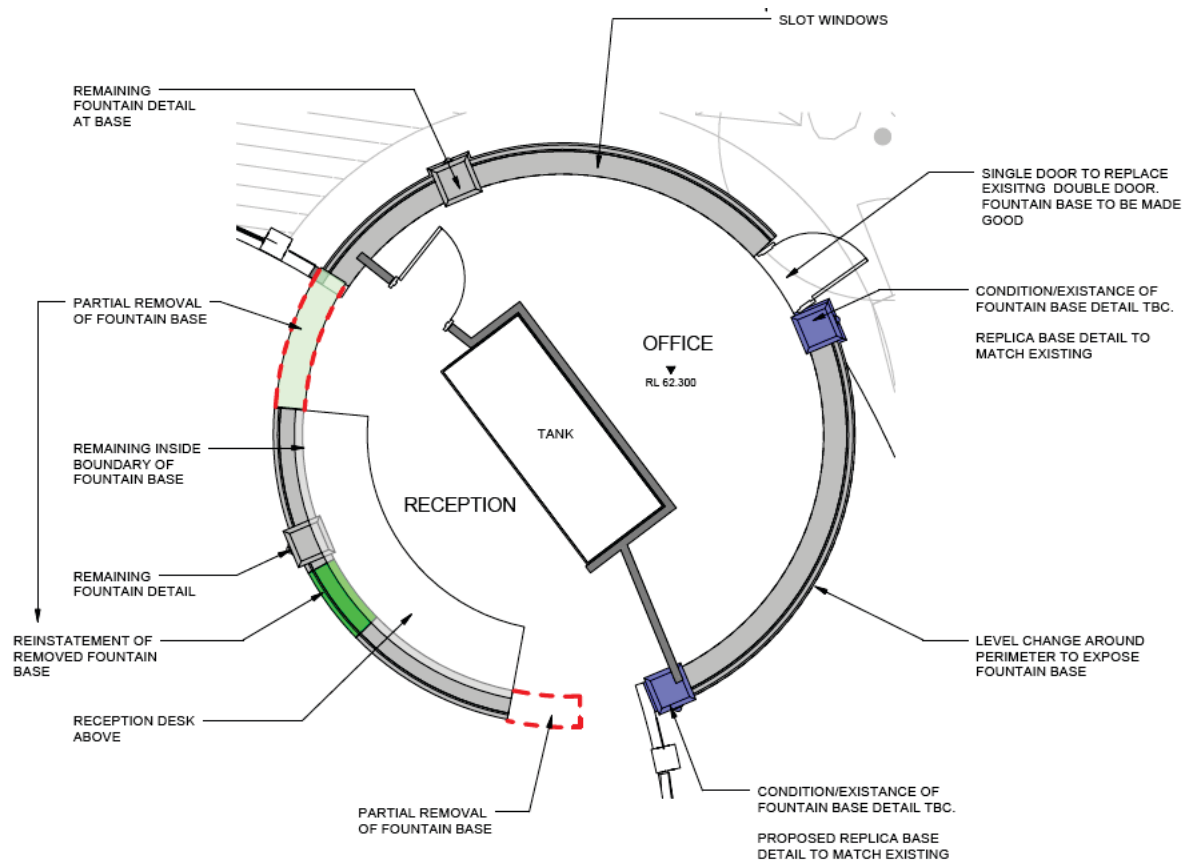
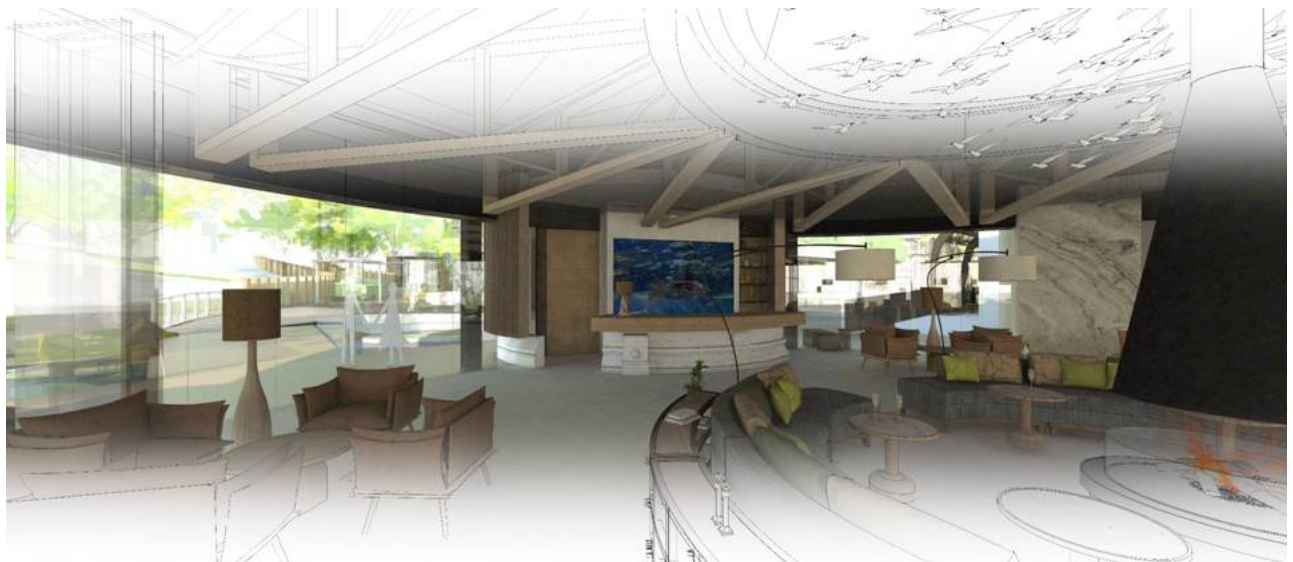
2 PROPOSED PLAN
 100928_001 SCALE 1:50

The plan shows the existing fountain base and where openings have been made in the base. The perspective drawing shows an interior view of the entry looking towards the former fountain. Source: Prepared by Cox Associates for additional information 2016.

The detailed drawing, following, shows the proposed changes to the fountain base. The masonry fountain base is generally to remain and the existing masonry wall above in part (the extent is a matter for detailed design). The new curved external wall is above the fountain base and is designed to read as a separate element distinct from the fountain base but reflecting its form. The interior floor will be approximately at the level of the existing base of the fountain, which is now buried below the existing kiosk floor slab. The curved edge of the interior of the former fountain at the junction of the floor and wall is to be retained. The hexagonal base in the centre of the fountain may be able to be retained in part as the base of the proposed fish tank but this cannot be determined until the structure is exposed after the demolition of the modern concrete floor and kiosk over.

The plan shows the existing fountain base and where openings have previously been made in the base. The two missing piers are proposed to be reinstated. The northeast existing door is proposed to be reduced to a single door enabling the missing pier to be reinstated. The south double door will be removed allowing the adjacent pier to be reinstated and a section of original fountain edge on the other side of the opening is to be removed to create access into the room. The existing opening to the southwest is proposed to be infilled to match. A new opening is proposed to the northwest to allow access to the space behind the counter.

The perspective drawing shows an interior view of the entry looking towards the former fountain. The portion facing the interior is proposed to be a counter. The modern wall now above the fountain base will be retained to the height of the underside of the counter. Fixings will be into that wall meaning fixings will not be required into the fountain base. The detail of the external wall has not been determined. The fish tank behind the counter is a reference to the former fountain – also a fishpond.

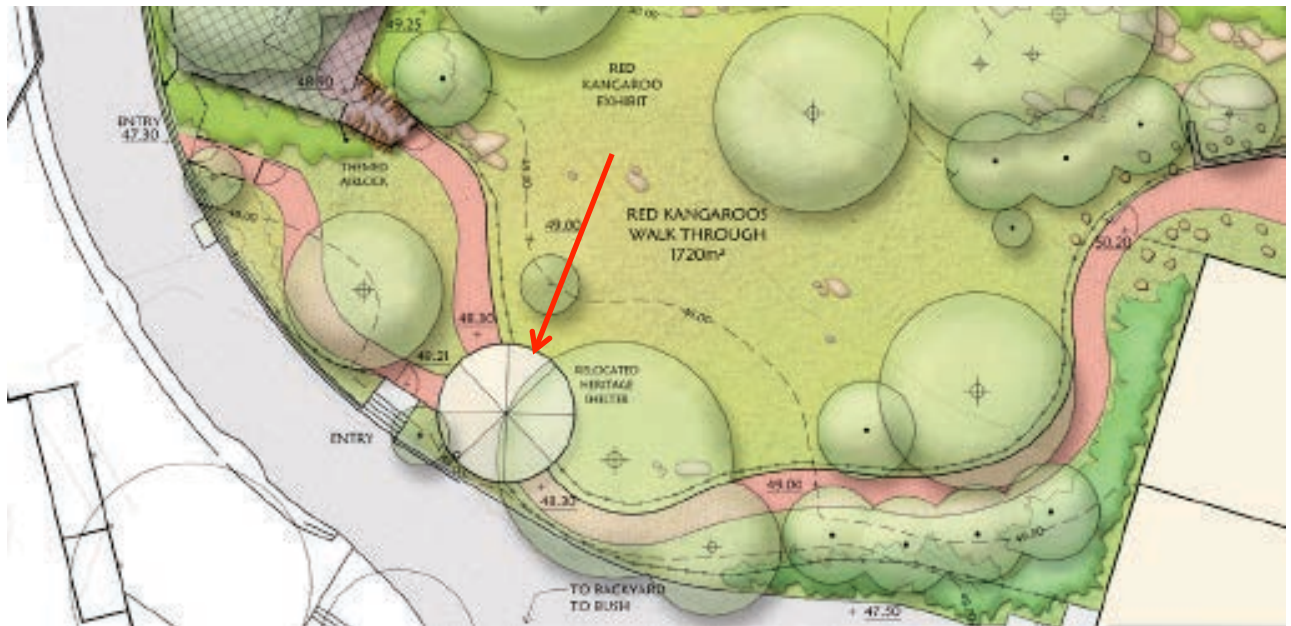
Development of construction details to relocate the kiosk / shelter will be undertaken as part of the detailed project design. This will require considerable further detailed, invasive investigation of the existing heritage structure that is inappropriate to do without DA approval. Archeological assessment of the proposed new site will also inform the detailed design and this cannot proceed until relevant approvals are obtained. The detailed architectural drawings for the relocated structure will include the concrete floor slab, circular masonry wall and connections to columns as well as the seating and openings in relation to the new paths and columns. The new location of the building will be on the Wollemi lawn and is shown on the landscape concept drawing (arrowed in extract below).

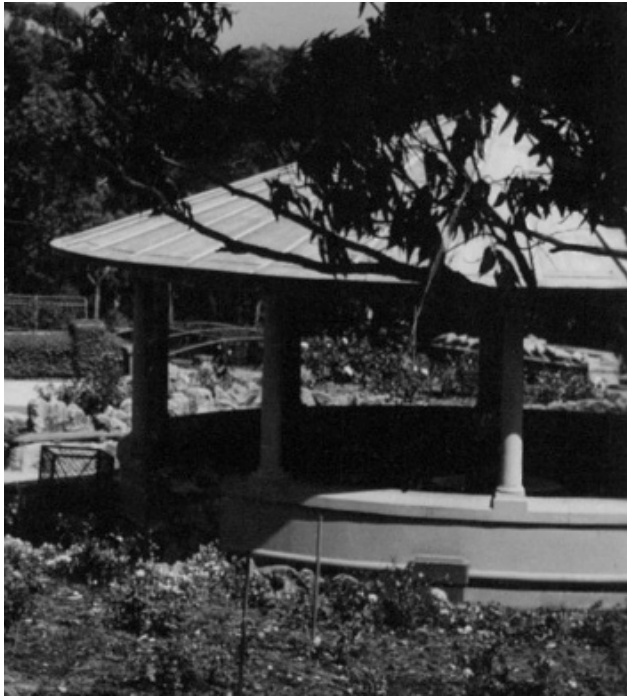
Historic image of shelter showing roof cladding detail and the wall prior to its infilling. The wall has an angled top and there is a block or column base under each column.

The structure will be rebuilt to match its former configuration as a shelter shed, using the evidence of historic photos (following) and careful assessment of the existing structure as it is being 'un-built' when original construction details may be revealed. Subject to engineering advice the roof will be removed as one element and craned to a temporary platform near its new location. At the new site a new circular concrete slab floor will be built with a footing for the central column which will match the existing hexagonal column. The walls will be masonry, either rendered brick or concrete, painted. The wall will be circular with openings at the paths designed to be between columns.

The profile of the top of the wall will match that shown in historic images unless alternate details are found during demolition at the current location. The form is triangular sloping to both the interior and exterior with rectangular column bases. It is not intended, nor considered appropriate, to recreate the fountain profile in the wall rather a plain wall at the base. The existing columns will be carefully dismantled and re-erected at the new site and the roof re-supported on them. The original colour scheme will be researched and recreated.

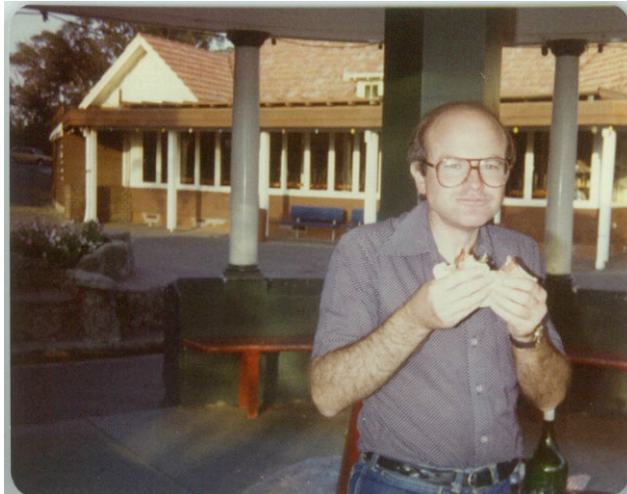
Photo shows an opening in the wall (left) and the end section of the wall adjacent the opening. The curved timber seat is visible and a support for the seat adjacent the opening.

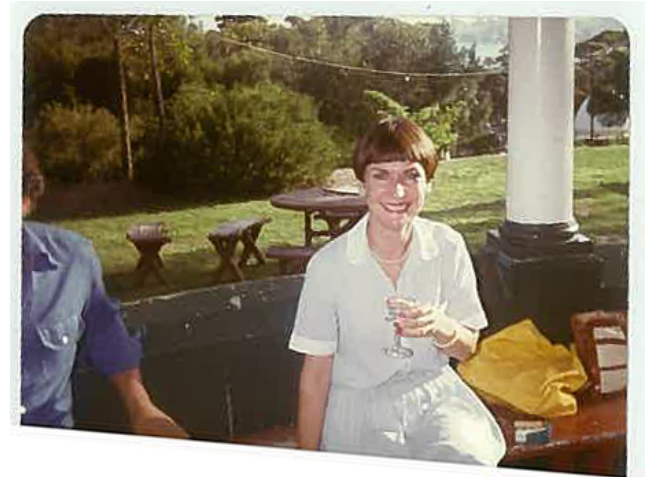
Photo shows the top of the wall and a column base and a small portion of the curved timber seat.

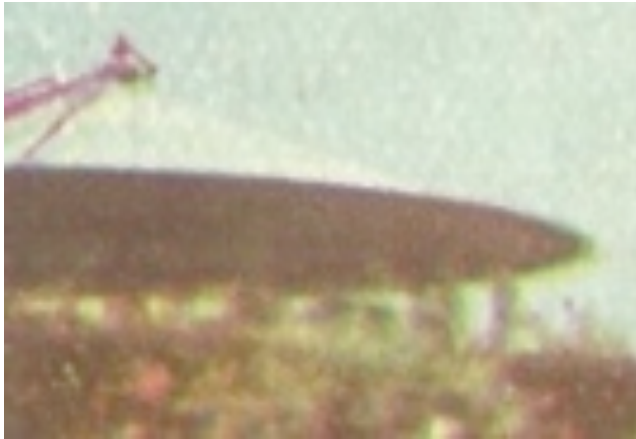
This image is poor quality but shows there is something at the top of the roof.

The current roofing material is not original and is in poor condition. Further research is needed on the original roofing material. It is possibly malthoid but there may be evidence of the original material under the current roofing. One drawing notes existing copper roofing and this may also be appropriate. The early photos and aerial photos show the layout of the rolls for the laps of the roofing material and this will be matched. It has not yet been confirmed but it is likely there was a finial on the roof. Subject to detailed research this will be rebuilt from photographic evidence (see below) and potentially physical evidence of the existing roof.

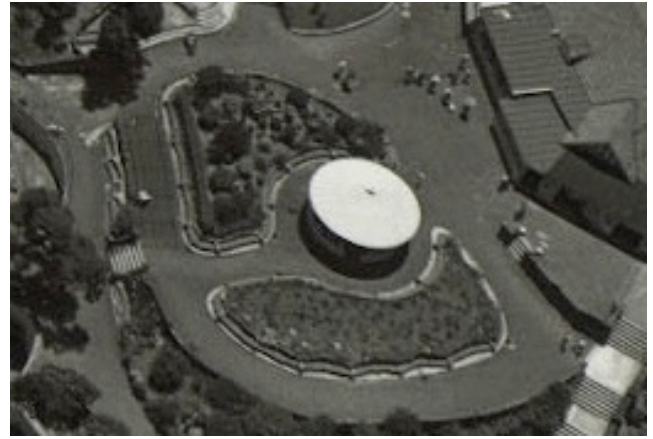
In the 1962 aerial something can be seen at the top of the roof and its shadow.

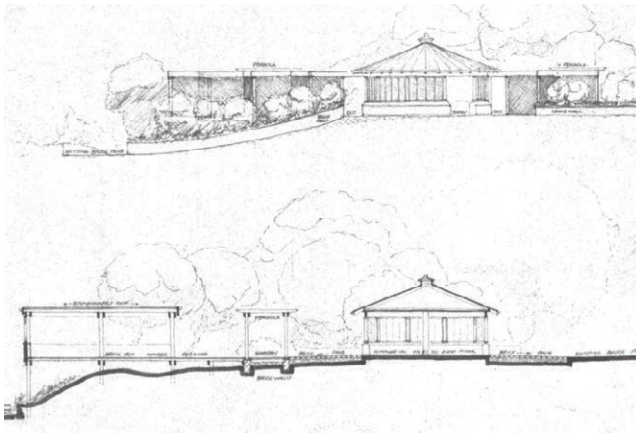
Extract of Zoo-Be-Que drawing shows a different detail at the top of the roof.

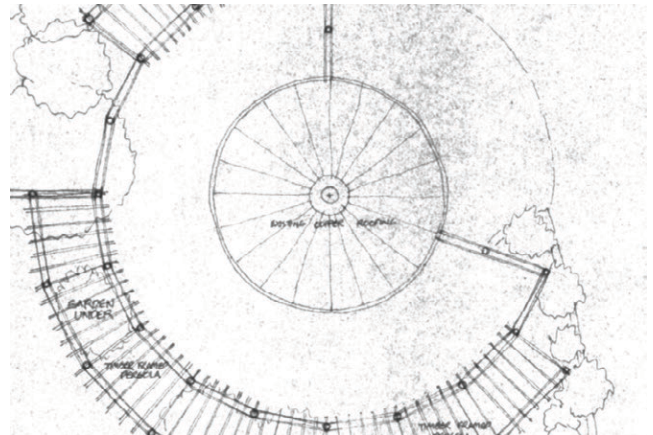
Extract of Zoo-Be-Que drawing refers to existing copper roofing.

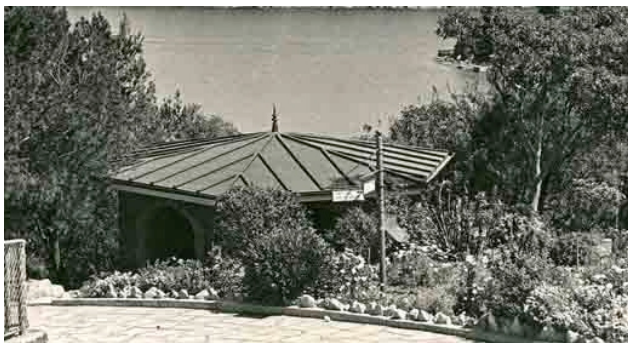
Finial on shelter to the west side of the Zoo.

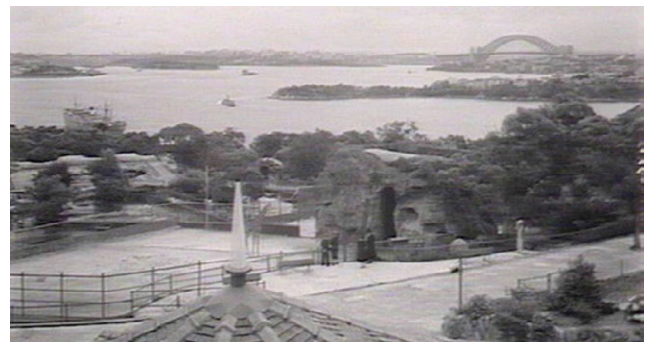
Finial on now demolished shelter.

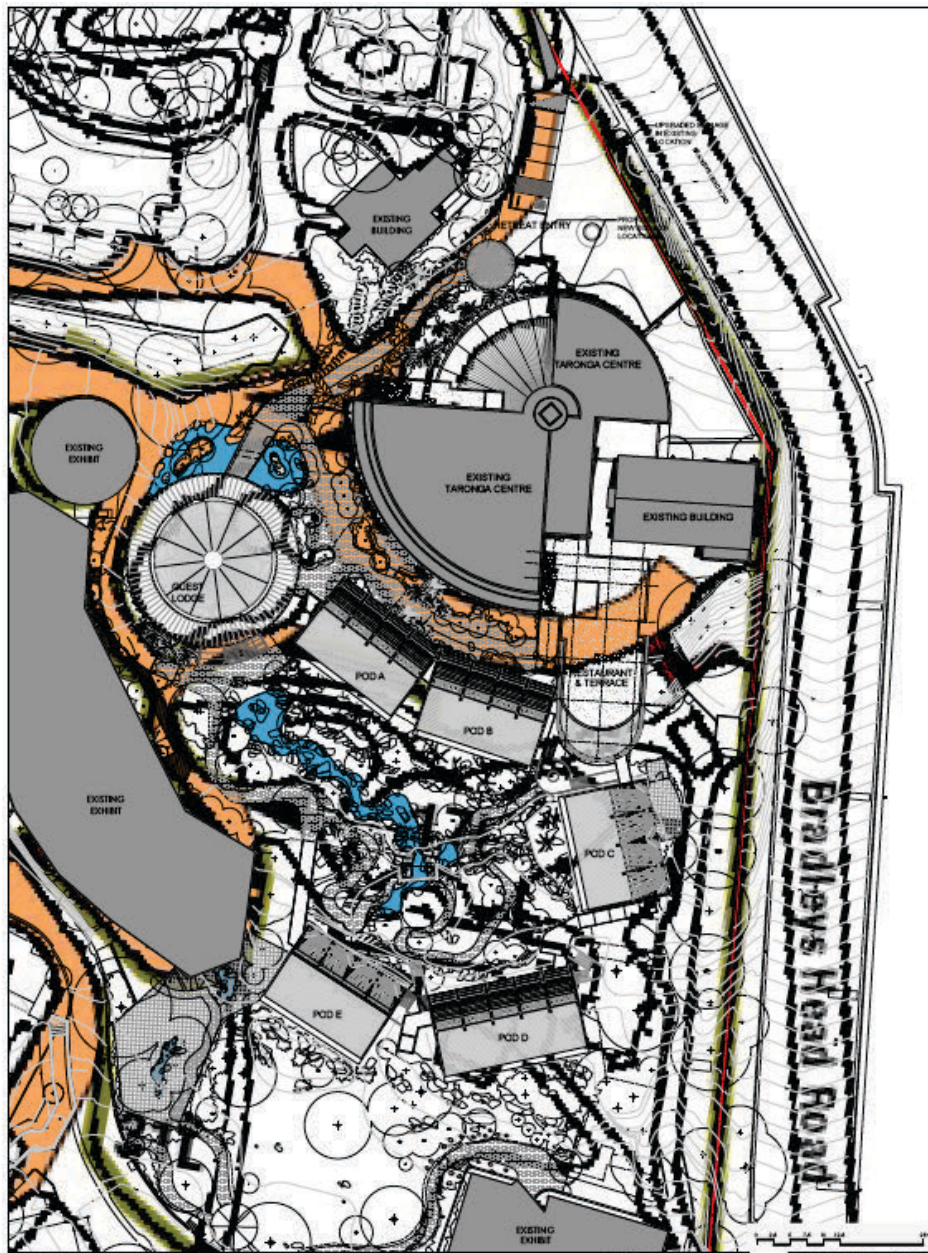
The diagram following shows the alignment of the Original and Early Paths (item 99L) from the CMS overlaid on the project's architectural plan. The dark lines are from the CMS drawing, which is at a smaller scale and does not have a high level of accuracy. Refer to Heritage Impact Statement.

The map of the original and early paths in the CMS is on a diagrammatic map and indicates the approximate extent. The extent differs in detail as the paths on the diagram are the “current” paths, which have in some cases changed from the original. The Heritage Impact Statement explains the development of the paths in this area and the detail of what has been altered at different times. Within the site all of the early paths have been resurfaced and levels changed but some alignments remain the most intact being at the top of the site (near spider monkeys) however the former steps have been removed and levels and alignment of one side changed. At the bottom of the site between the Wollemi Lawns and Elephant enclosure the path is at similar levels and alignment but the alignment on the west side is altered and the road crossing what is now the lawn has been removed. The original and early paths in the area of the project have been indicated following on an overlay of the 1975 survey and the current survey as well as on an overlay of the current survey and the architectural plans. The coloured paths indicate the areas where the alignment in part remains or is proposed to remain.

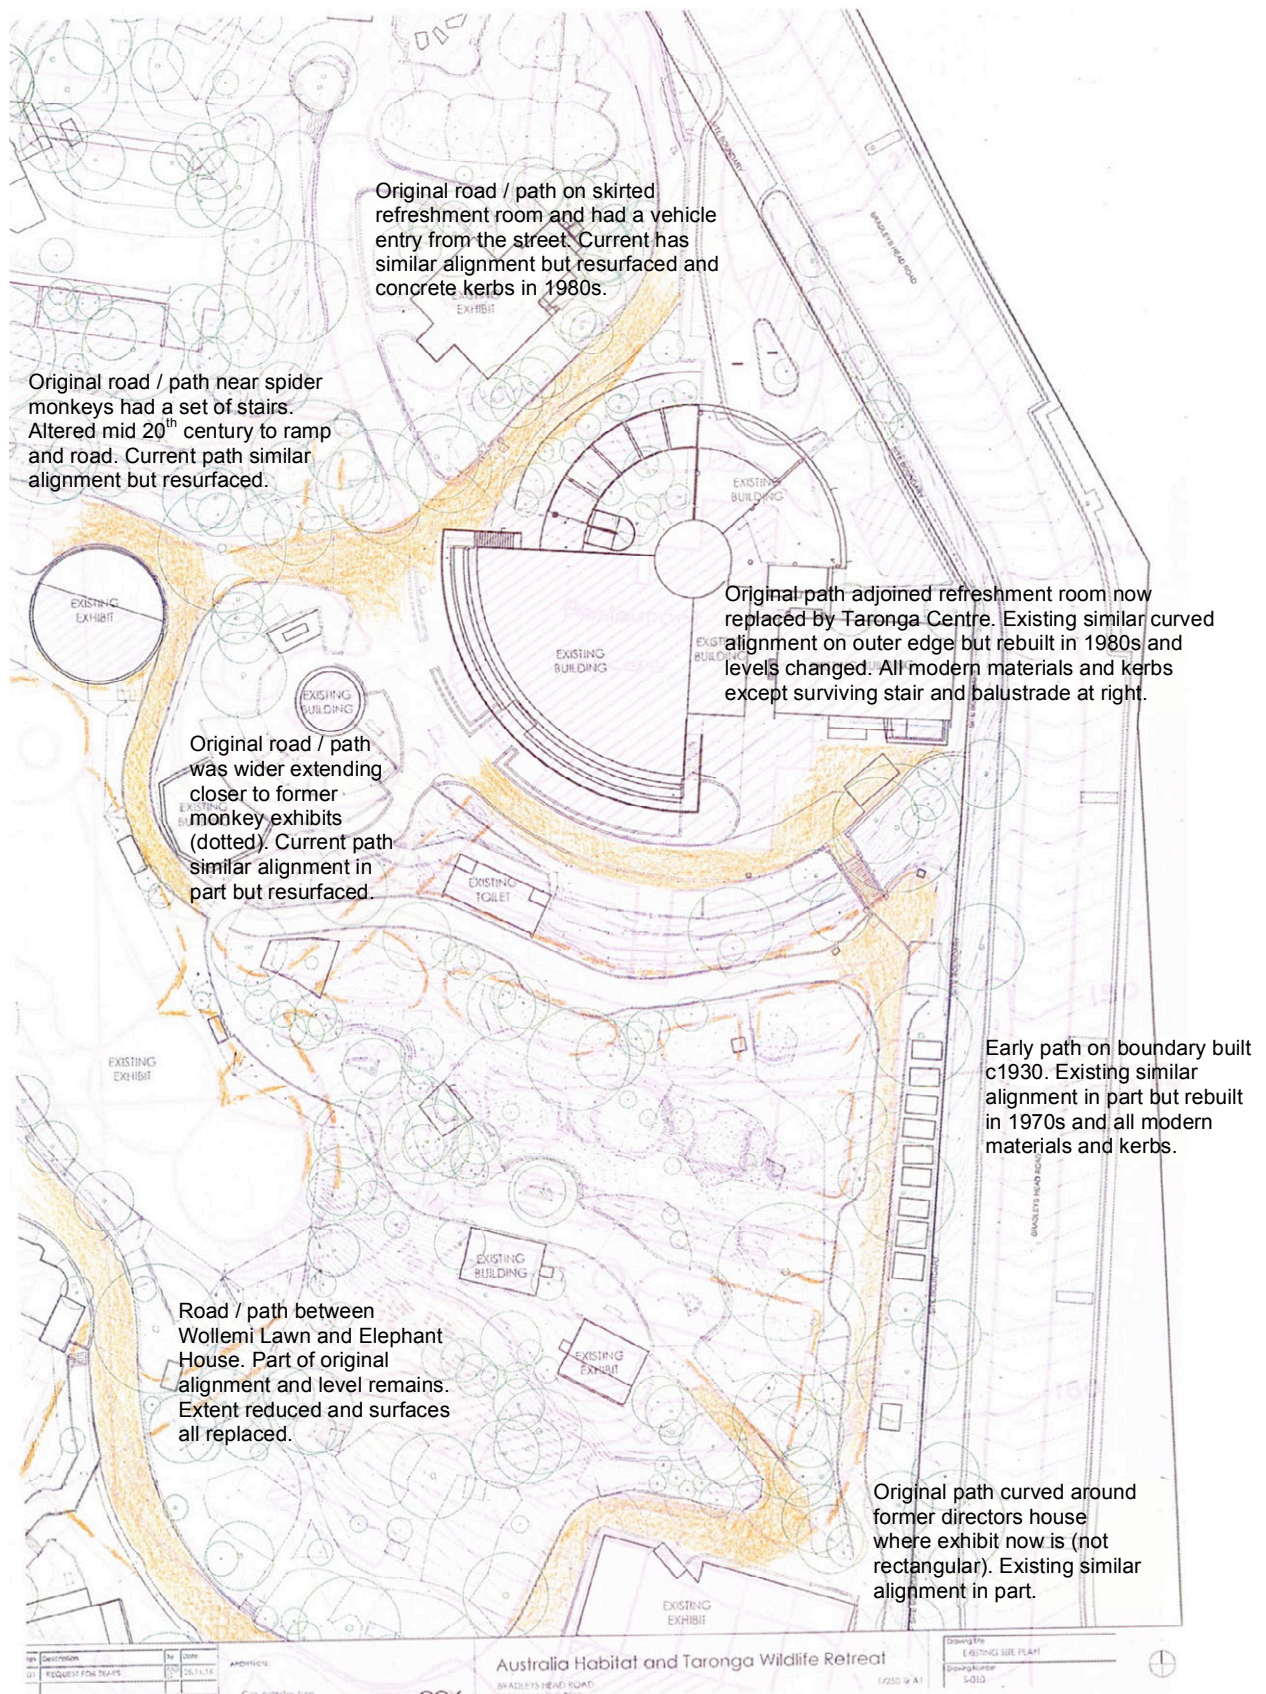
The 1975 survey is the purple lines showing the earliest detailed map available. The black lines are the 2015 survey. The coloured areas are where elements of the original or early path layout or alignment remains in part. Dotted lines indicate former extent of original or early paths near what remains.

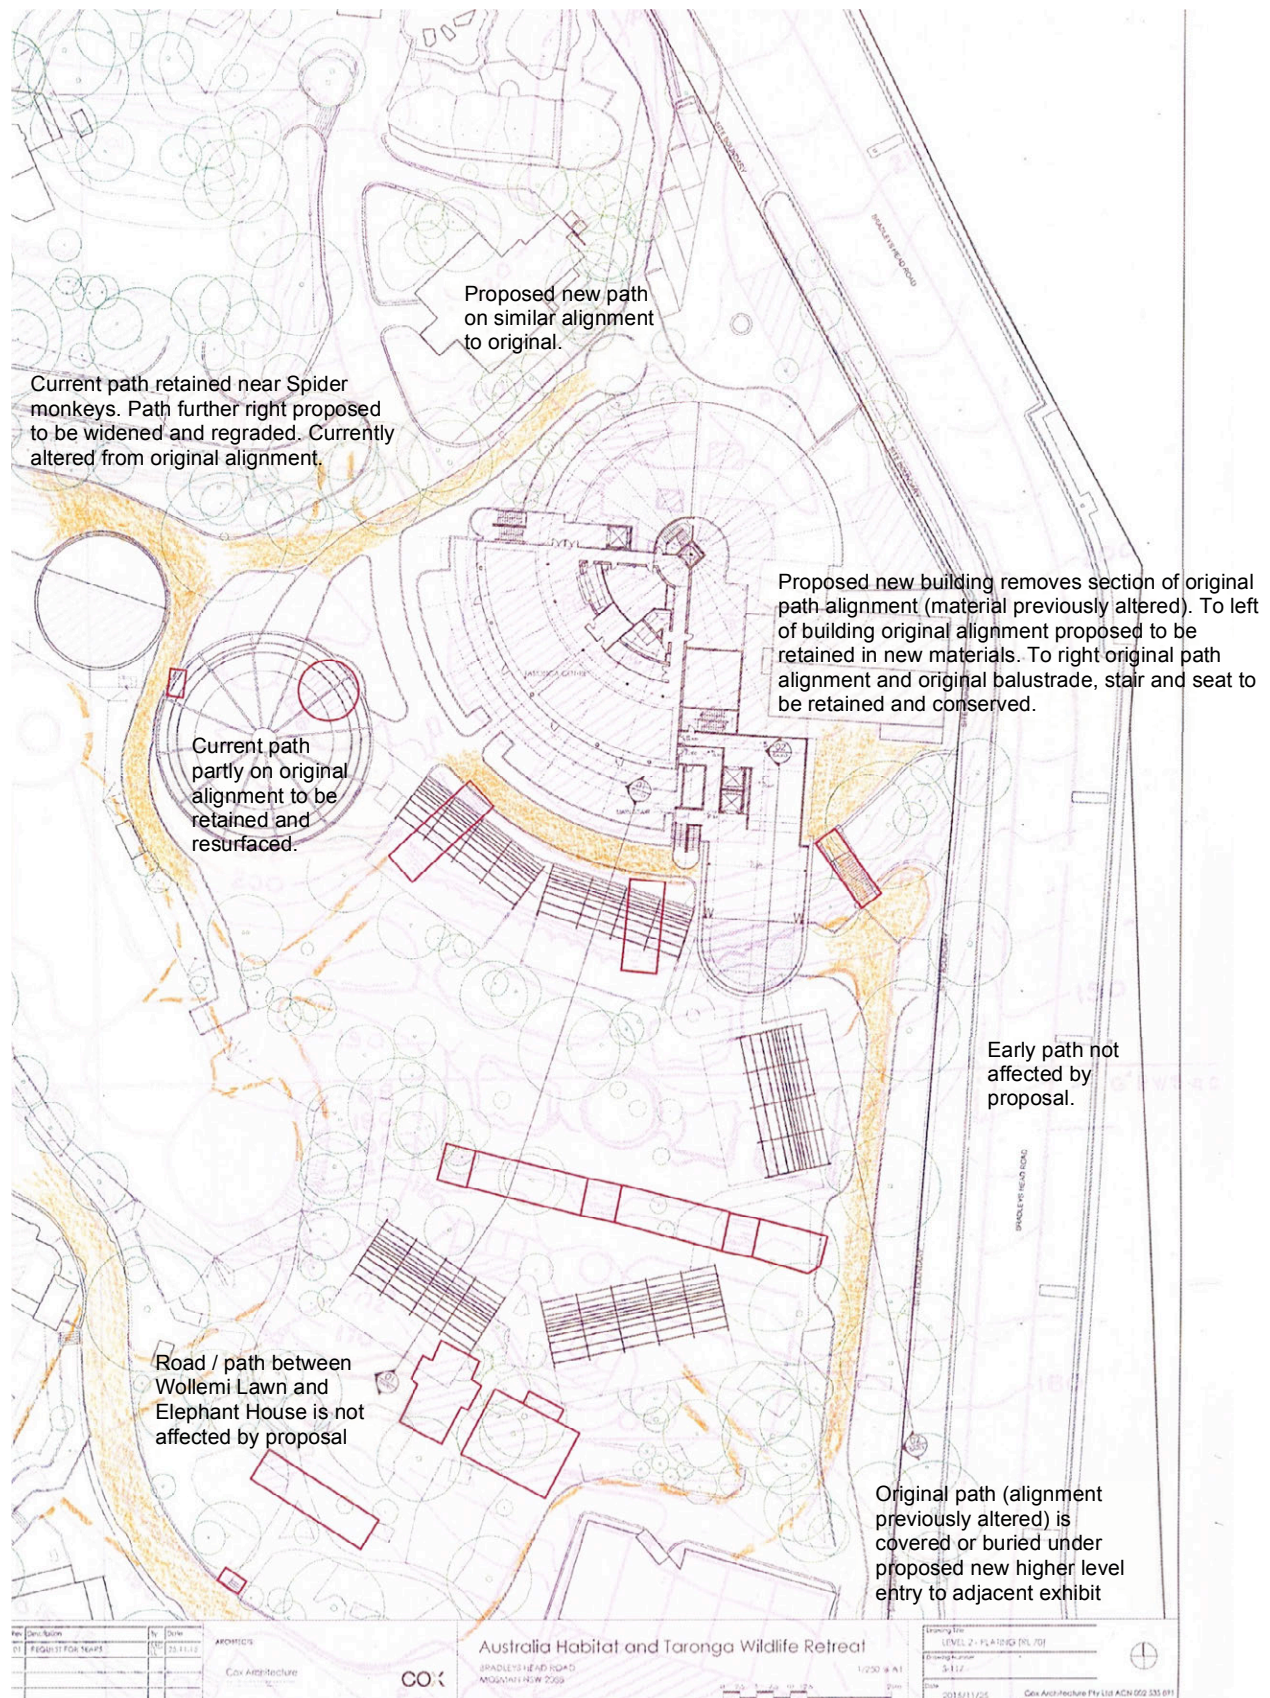
The 1975 survey is the purple lines showing the earliest detailed map available. The black lines are the proposal. The coloured areas are where elements of the original or early path layout or alignment is proposed to remain as is. Dotted lines indicate former extent of original or early paths.

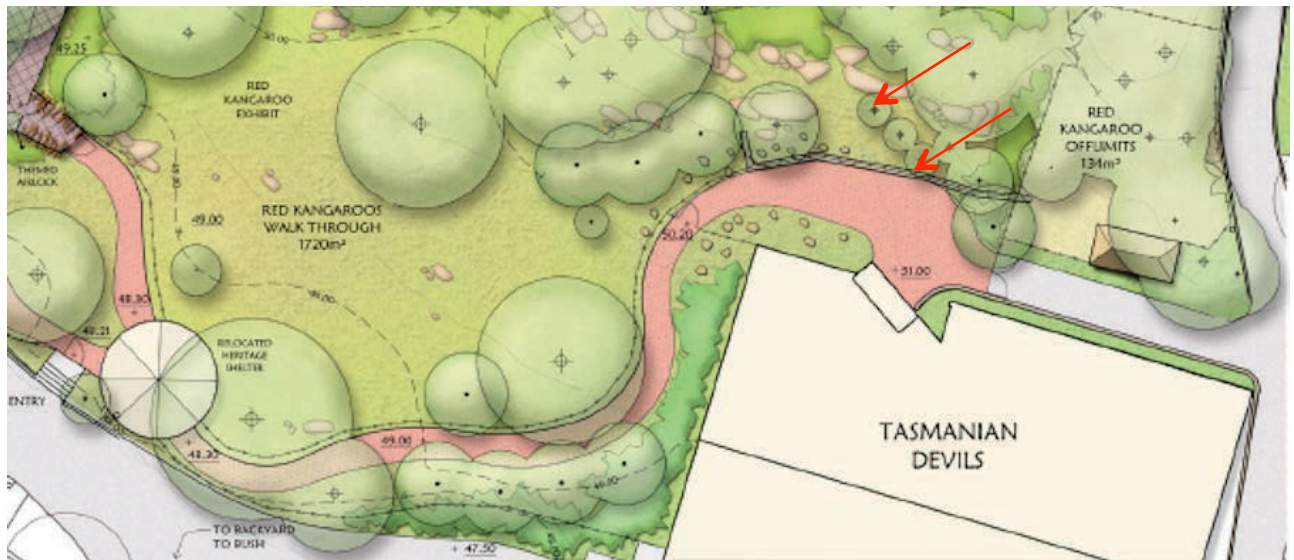
The plan above shows the existing steep path left of the building is buried and there is a new realigned path that provides access at an improved grade from the former Wollemi lawn which is at a higher level than the old path / road. The location of the Rustic Stone Wall is arrowed. There are existing stone walls within the garden bed.

The concept design for the walkway from the current Wollemi lawn to the Tasmanian Devils exhibit is shown following. The concept is not developed enough to resolve the impact on the heritage listed Rustic Stone Walls near the *Gardenia Thunbergia*. It is understood that the path will be at a higher level than the existing path and that the wall adjacent the path will be wholly or partially buried. Whole or partial burial intact can be reversible and allow future reversal. In about the location of the wall will be the enclosure fence and the row of 'tree trunks' lining the entry path. The stone walls within the garden bed will be unaltered and within the exhibit.

To mitigate impacts on the wall the detailed design should be adjusted so the footings of the fence and for the 'tree trunks' do not damage the wall. They should be on one side or the other of the wall and should be excavated and constructed using a methodology that protects the stone wall. It is noted a 3D survey has been undertaken of the wall to assist with the detailed design in this area.

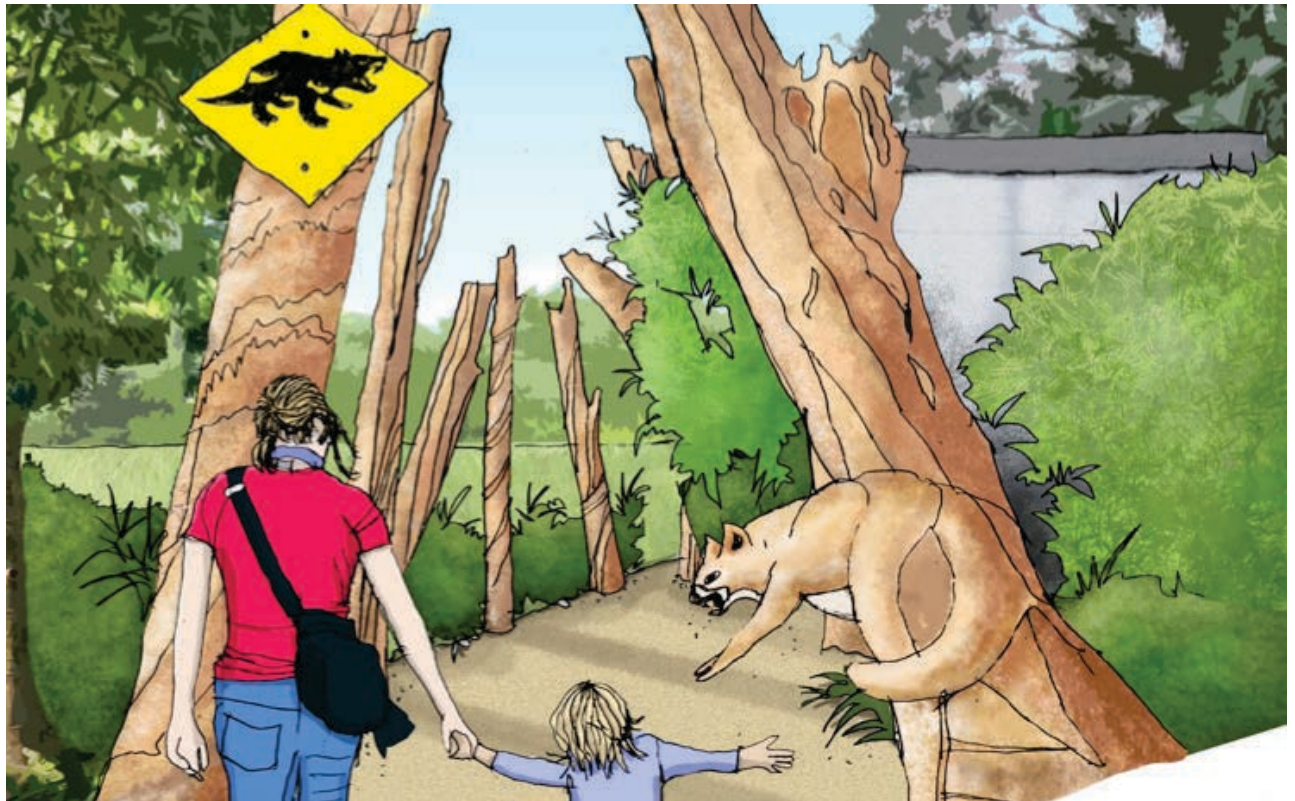
The perspective shows the concept design for the Tasmanian Devils entry which is intended to evoke walking through a Tasmanian forest. There is no indication of the fence that will be required to the left of the path nor of the rustic stone wall.
