Report on
Geotechnical Investigation

Proposed Development,
Hunter Sports High School
Pacific Highway, Gateshead

Project 81598.01
October 2015

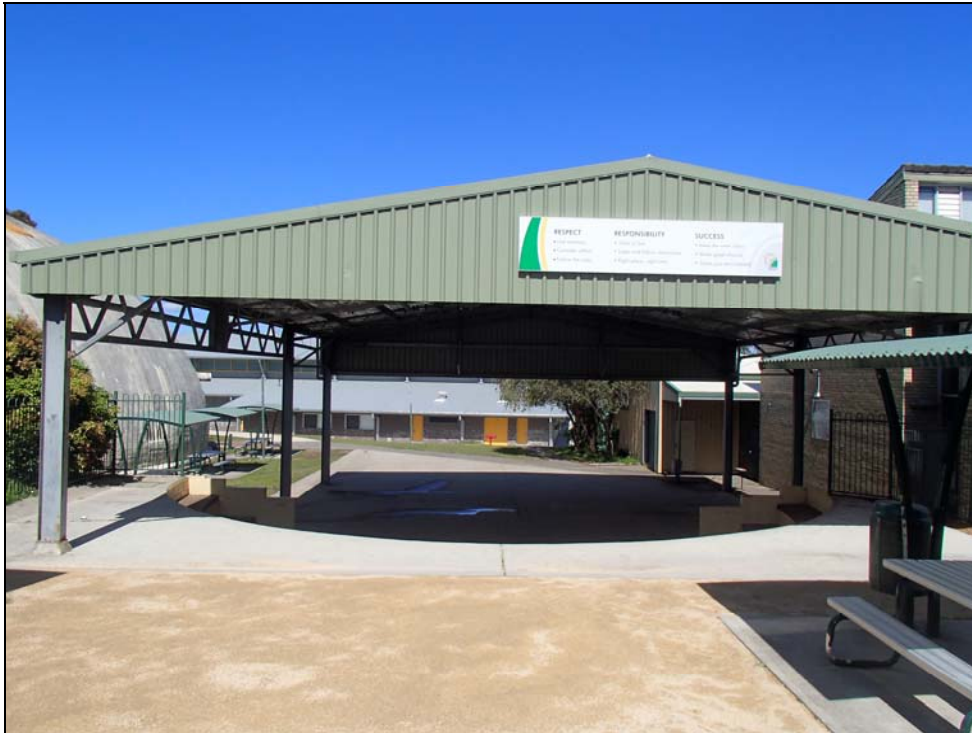
Figure 1: Looking south-west towards Bore 104 (proposed three storey building).

Existing site features are shown on Figures 1 to 3.

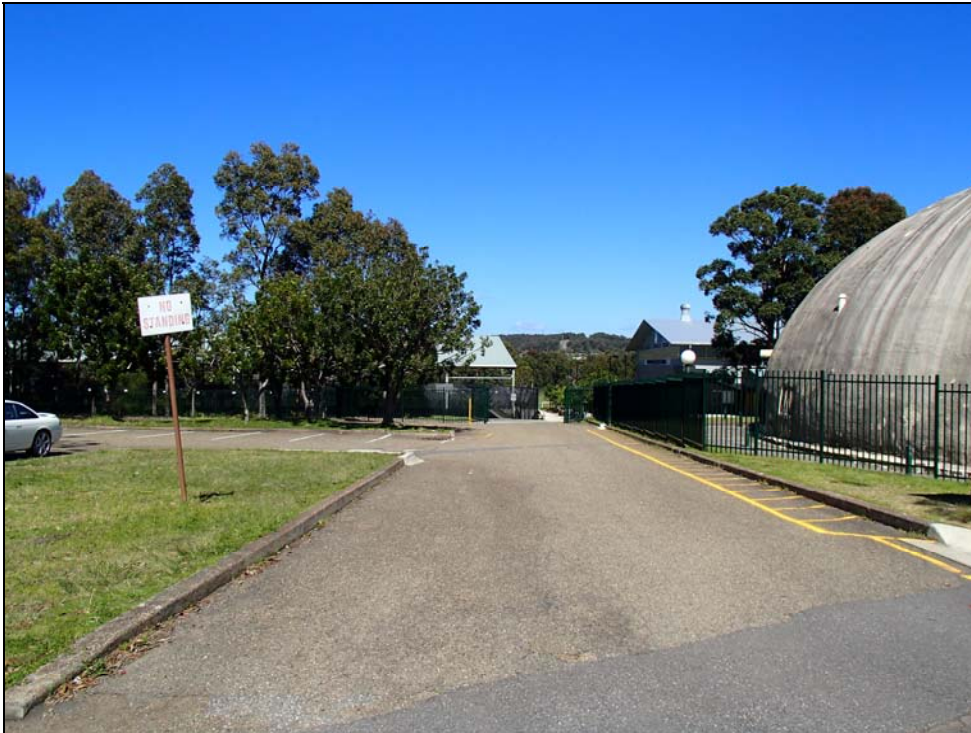
Figure 2: Looking south-west to Bore 106 (proposed gymnasium / hall to the left).

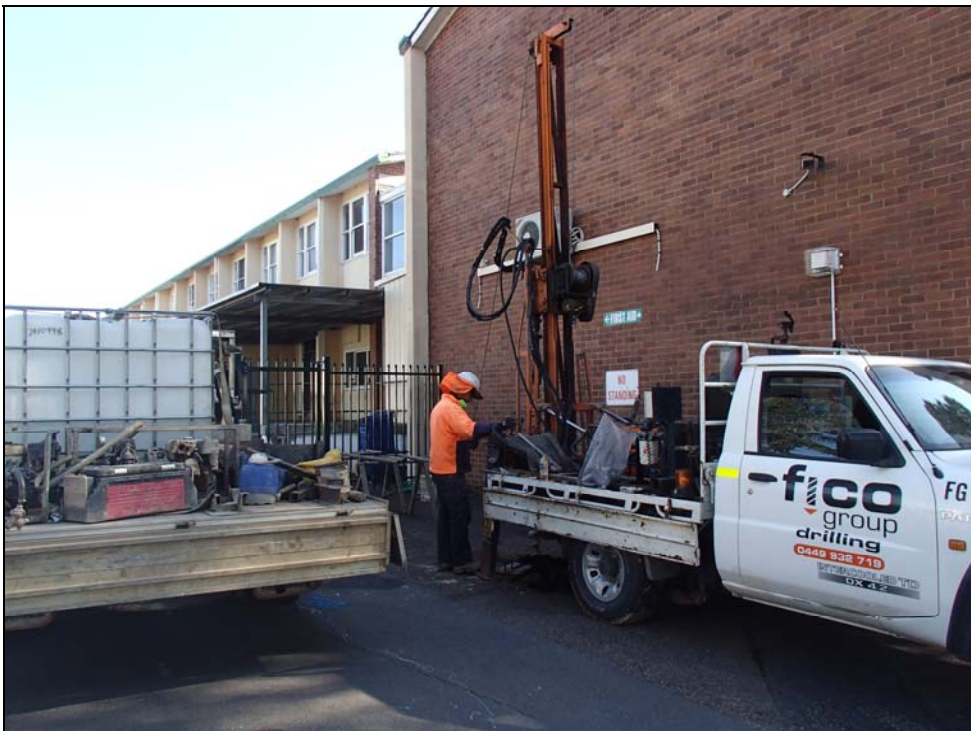
Figure 3: Looking north toward the existing Admin Block (proposed building over COLA); rig on Bore 105

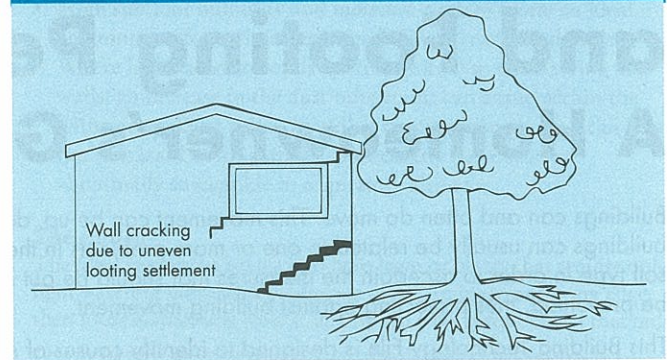
Trees can cause shrinkage and damage

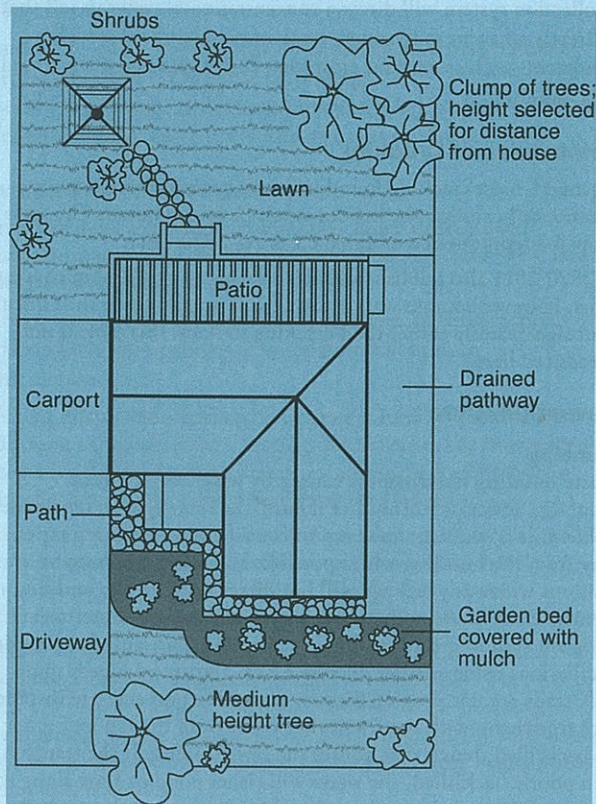
Gardens for a reactive site

extend outwards a minimum of 900 mm (more in highly reactive soil) and should have a minimum fall away from the building of 1:60. The finished paving should be no less than 100 mm below brick vent bases.

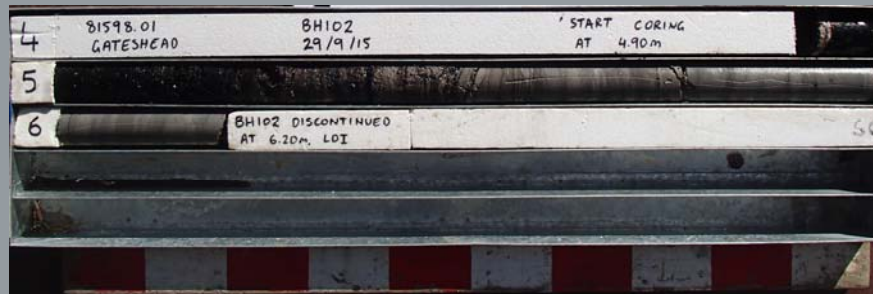
BORE BH102 PROJECT 81598.01 2015

4.90 m to 6.20 m

The subsurface conditions encountered in the bores are presented in detail in the borehole logs in Appendix B along with the core photoplates and results of the dynamic penetrometer tests. The borehole logs should be read in conjunction with the accompanying notes in Appendix A which explain the descriptive terms and classification methods used in the logs. The subsurface conditions encountered are summarised in Tables 1 to 3.

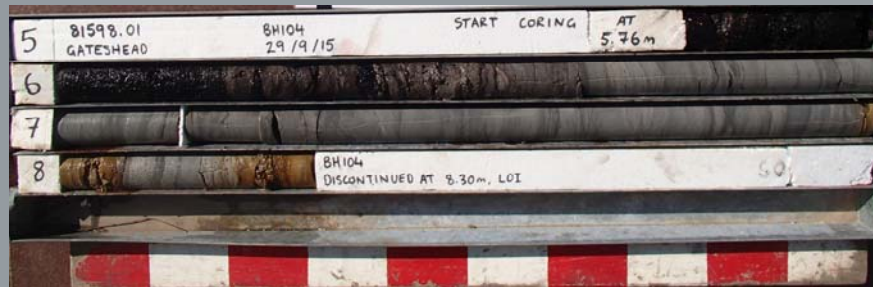
5.76 m to 8.30 m
