Bouygues Construction Australia Pty Ltd

**Dooleys Lidcombe Catholic Club
Redevelopment**

Geotechnical Investigation Report

11 July 2016

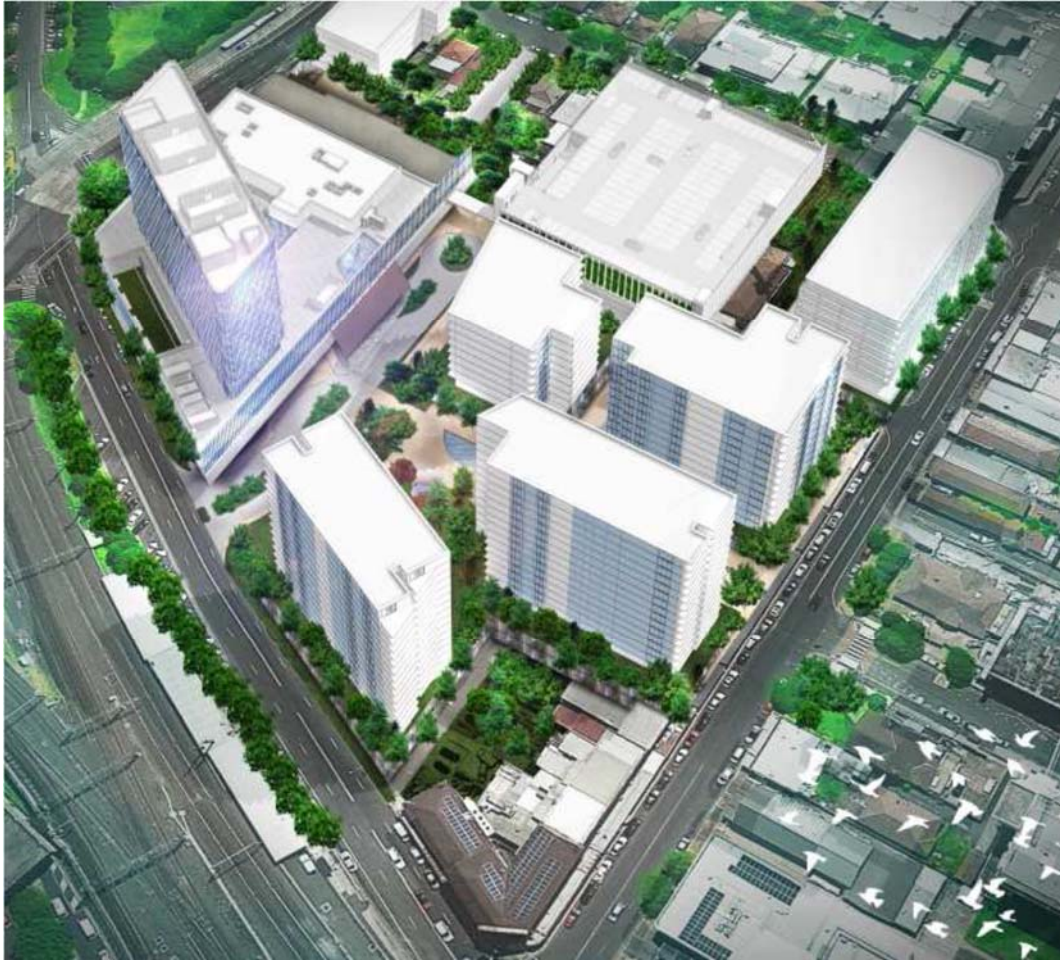
Insert 1: Club and hotel indicative representation

The proposed redevelopment comprises a 2 level club facility, a 12 level, 260 room hotel and a 2 level basement with floor level at RL10.5m. Current ground levels vary from about RL12 m to RL 15m. Insert 1 shows an indicative representation of the proposed development. The most significant structures near site are a four level residential dwelling on the corner of Ann Street and Olympic Drive (directly to the north of the structure) and the existing structures of the Dooleys Lidcombe Catholic Club.

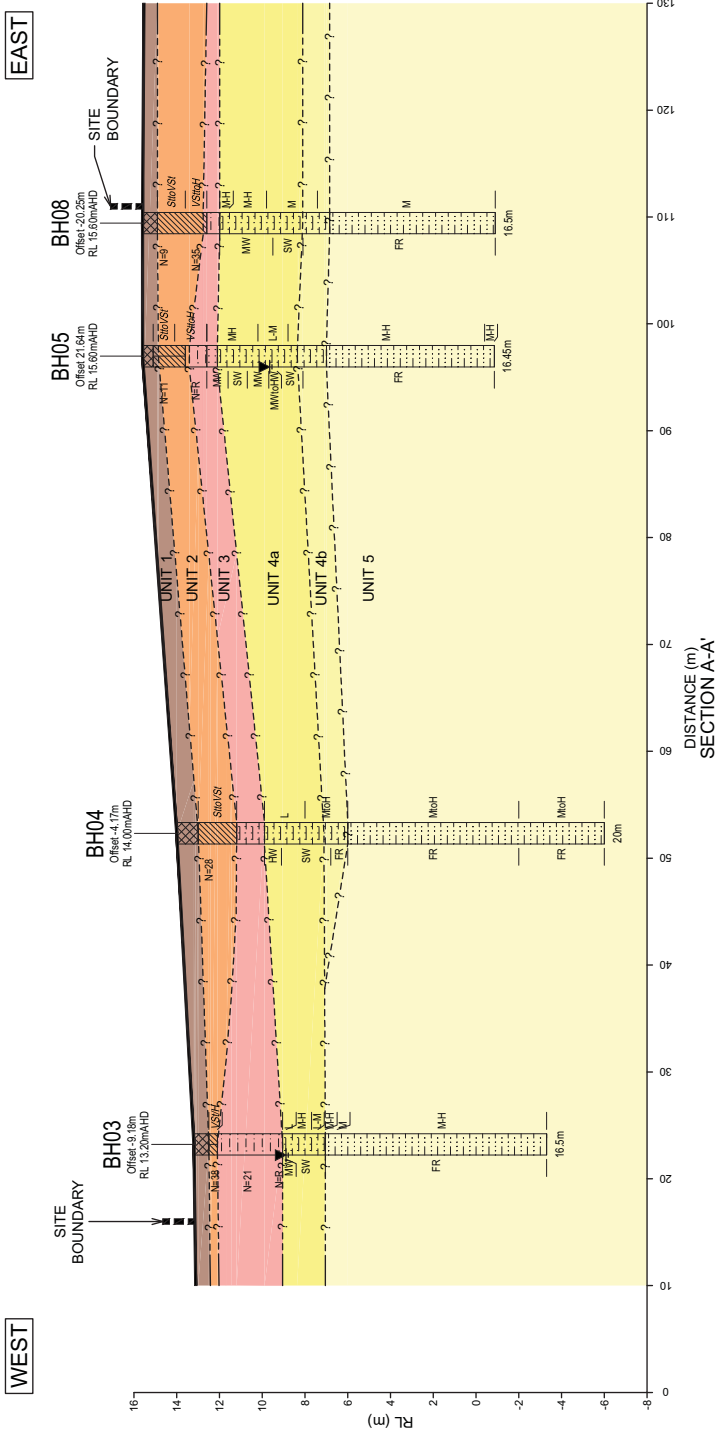
1. BOREHOLE ELEVATIONS ARE ESTIMATED FROM SUPPLIED TOPOGRAPHICAL SURVEY.
2. ALL MATERIAL BOUNDARIES ARE INTERPRETED FROM INVESTIGATION LOCATIONS.
3. BOREHOLE LOCATIONS MAY VARY FROM INTERPRETED SECTIONS.

Figures 2 and 3 present the inferred geotechnical model. This model was based on the results of the borehole drilling. Table 3 summarises the geotechnical units, and presents a description of the units, and an assessment of the rock classification in accordance with Pells, Mostyn and Walker (1998).

The proposed lower basement floor level is shown on the supplied architectural plan as RL 10.5 m, which would typically require excavation to about RL 10 m. The interpreted geotechnical sections in Figures 2 and 3 indicate that excavation to RL 10 m would generally penetrate to either Units 3 or 4a.

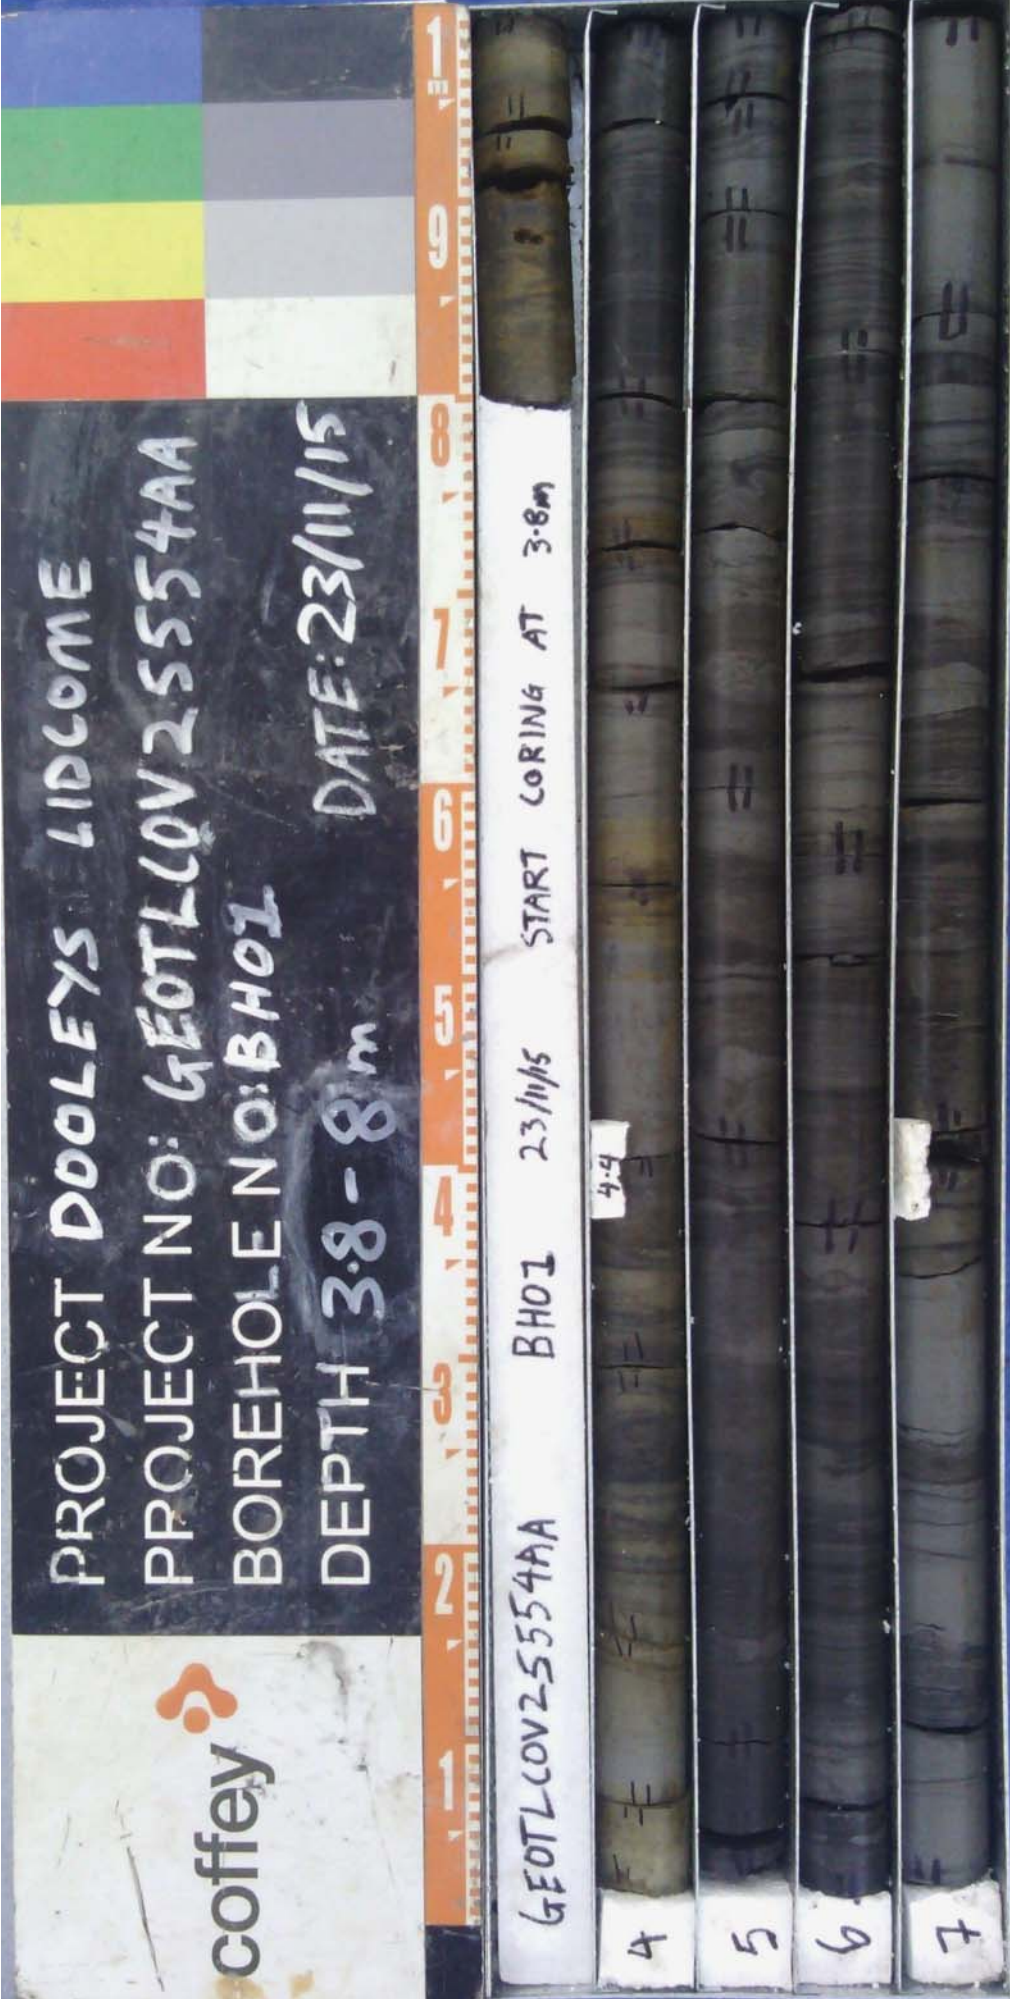
client: Bouygues Construction Australia	
drawn	RH	project: Dooleys Lidcombe Club & Hotel Development 24-28 John St, Lidcombe NSW 2141	
approved	RH	title: CORE PHOTOGRAPH BH01	
date	11/12/2015	project no: GEOTLCOV25554AA	fig no: PHOTO 1
scale	N.T.S.	rev:	
original size	A4

PointID : BH01 Depth Range: 3.80 - 8.00 m

A Coffey geotechnical engineer was present during fieldwork to identify drilling locations, record test results, log the encountered ground conditions and box the rock core. The borehole logs and rock core photographs are attached as Appendix A, together with Coffey soil and rock description and explanation sheets.

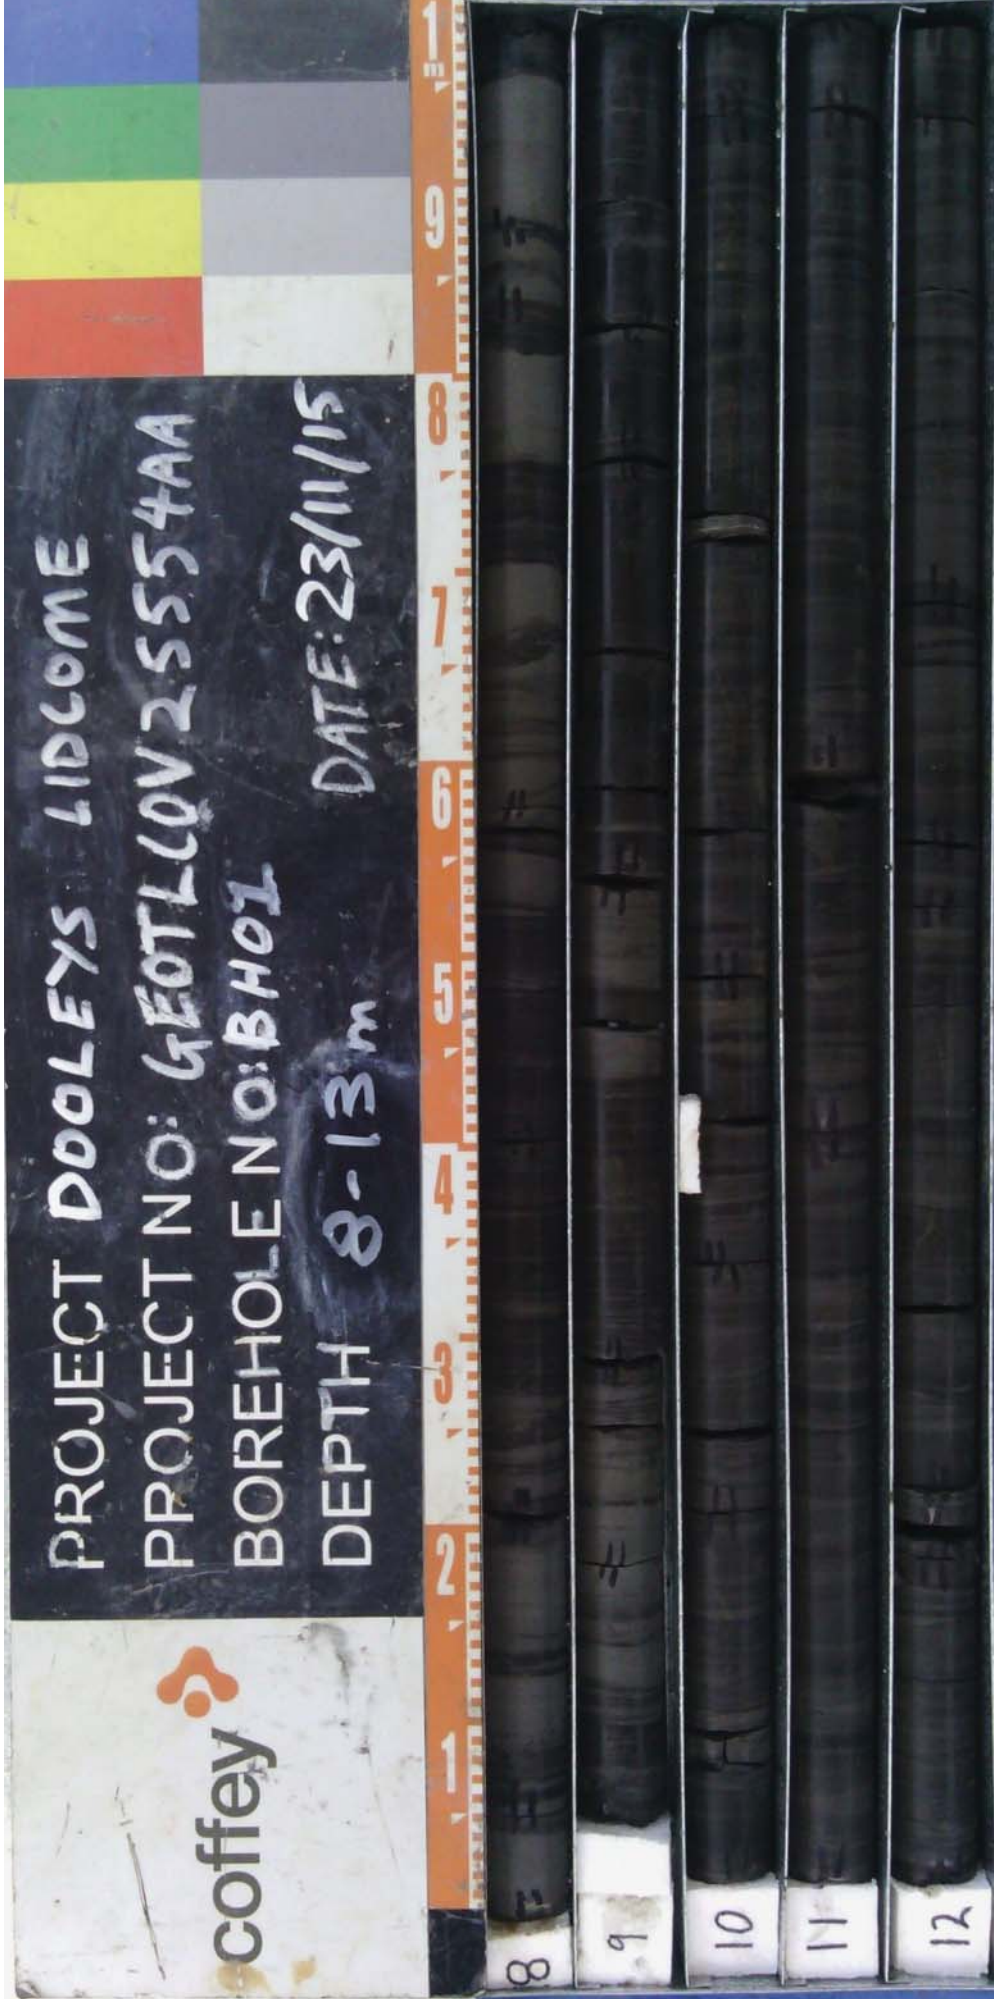
client:	Bouygues Construction Australia		
approved	RH		project:	Dooleys Lidcombe Club & Hotel Development 24-28 John St, Lidcombe NSW 2141		
date	11/12/2015		title:	CORE PHOTOGRAPH BH01		
scale	N.T.S.		project no:	GEOTLCOV25554AA	fig no:	PHOTO 2
original size	A4		rev:

PointID : BH01 Depth Range: 8.00 - 13.00 m

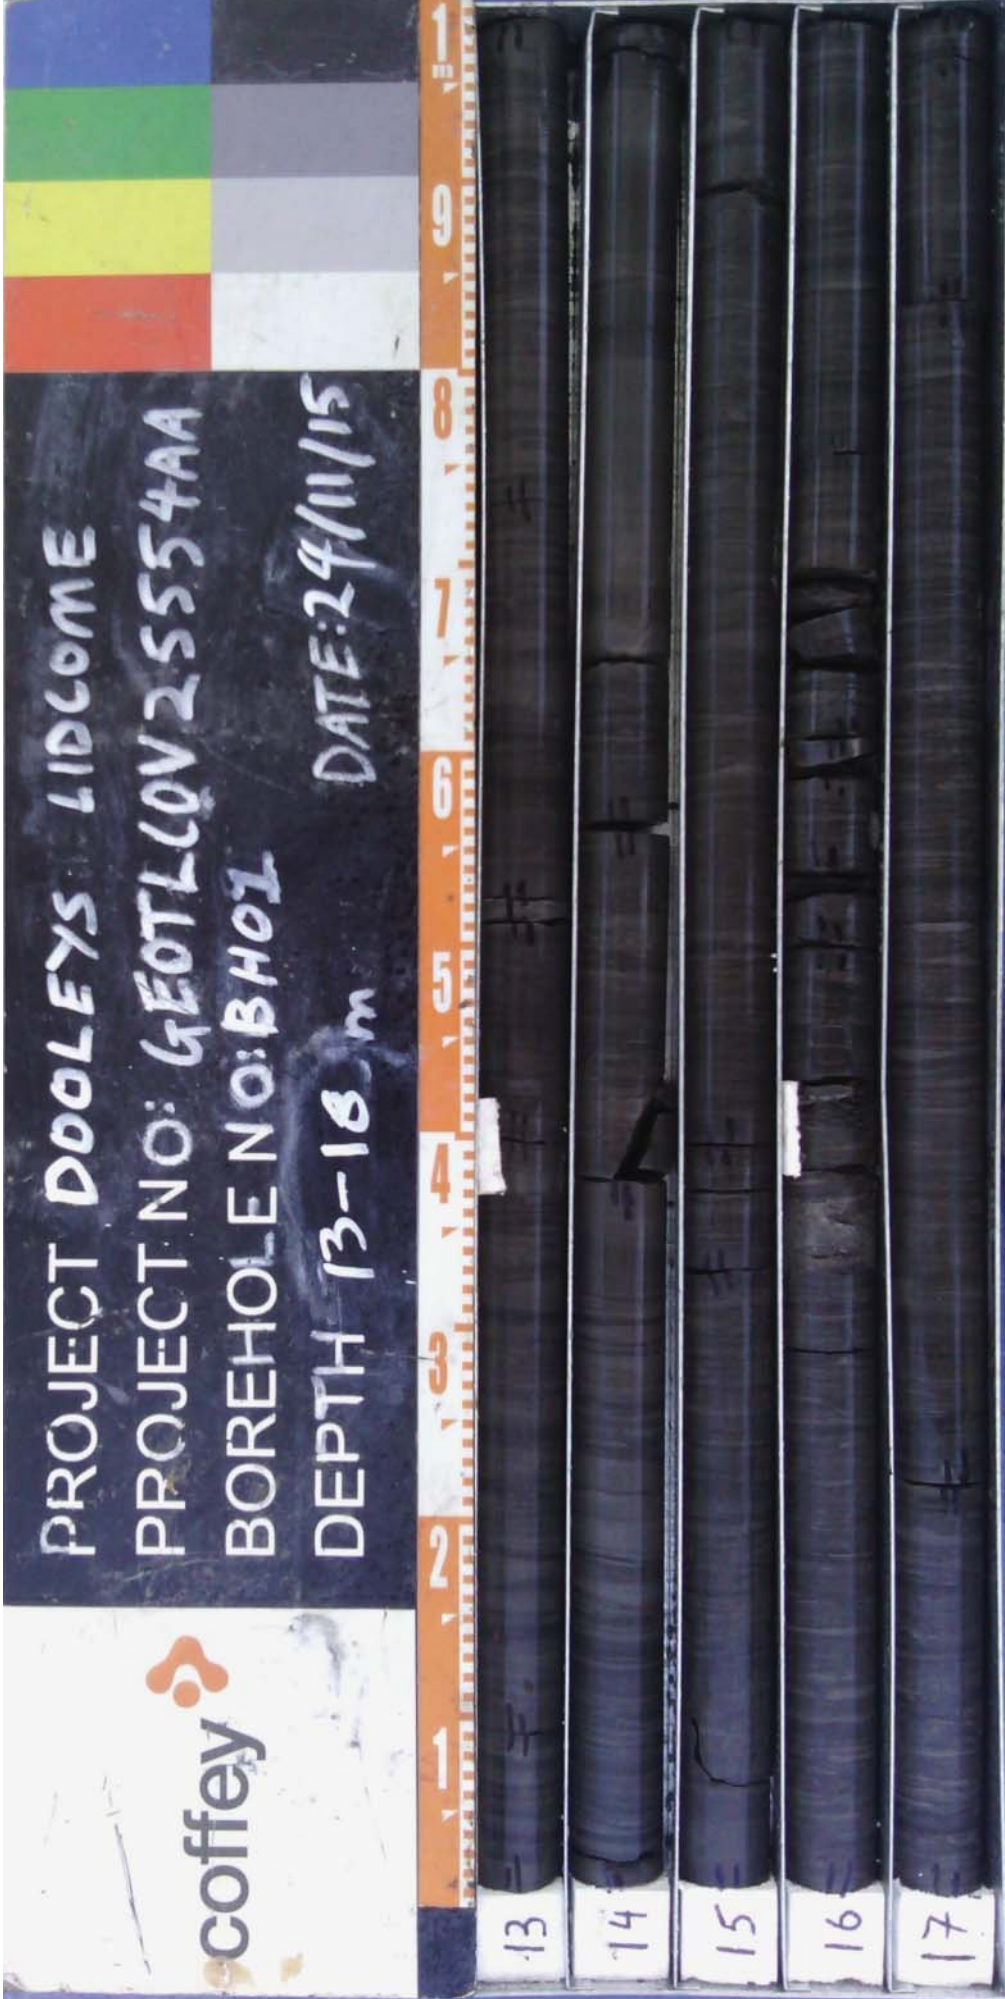
client: Bouygues Construction Australia	
drawn	RH	project: Dooleys Lidcombe Club & Hotel Development 24-28 John St, Lidcombe NSW 2141	
approved	RH	title: CORE PHOTOGRAPH BH01	
date	11/12/2015	project no: GEOTLCOV25554AA	fig no: PHOTO 3
scale	N.T.S.	rev:	
original size	A4

PointID : BH01 Depth Range: 13.00 - 18.00 m

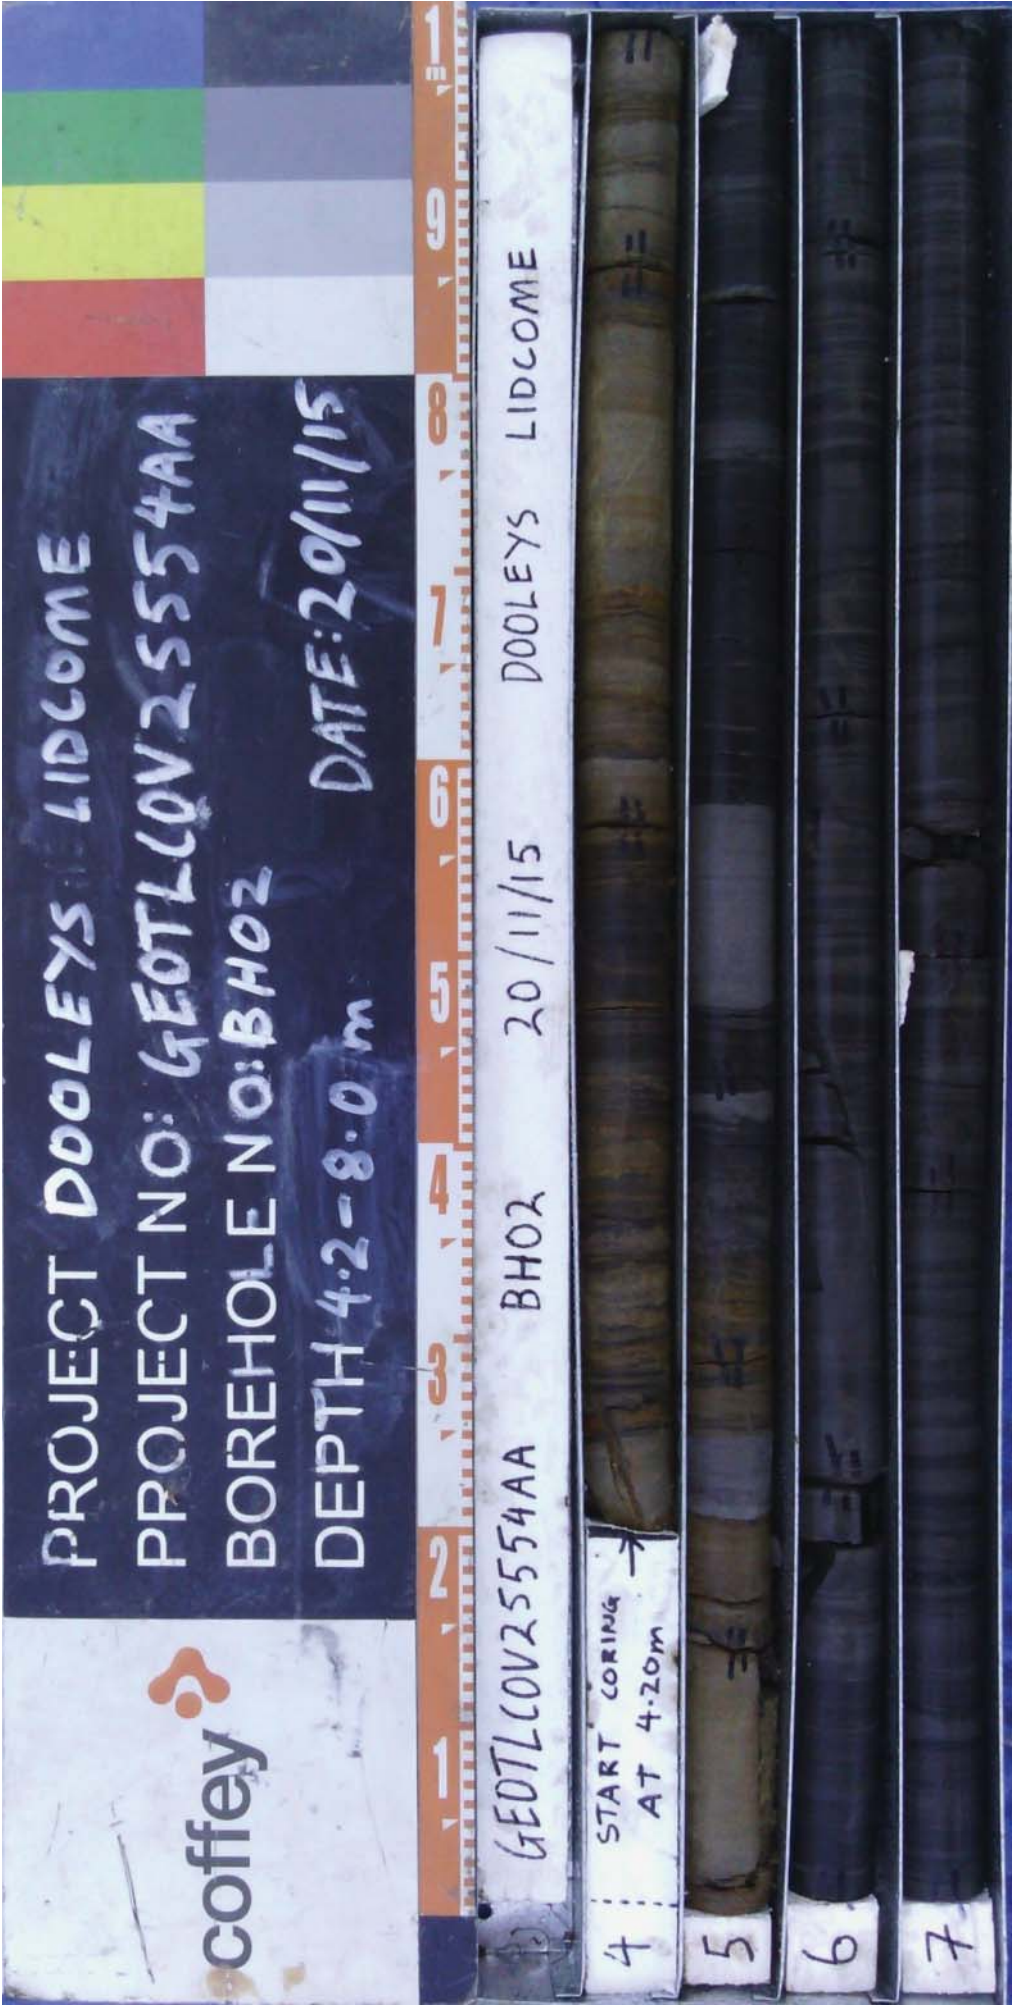
client: Bouygues Construction Australia	
drawn	RH	project: Dooleys Lidcombe Club & Hotel Development 24-28 John St, Lidcombe NSW 2141	
approved	RH	title: CORE PHOTOGRAPH BH02	
date	11/12/2015	project no: GEOTLCOV25554AA	fig no: PHOTO 5
scale	N.T.S.	rev:	
original size	A4

PointID : BH02 Depth Range: 4.20 - 8.00 m

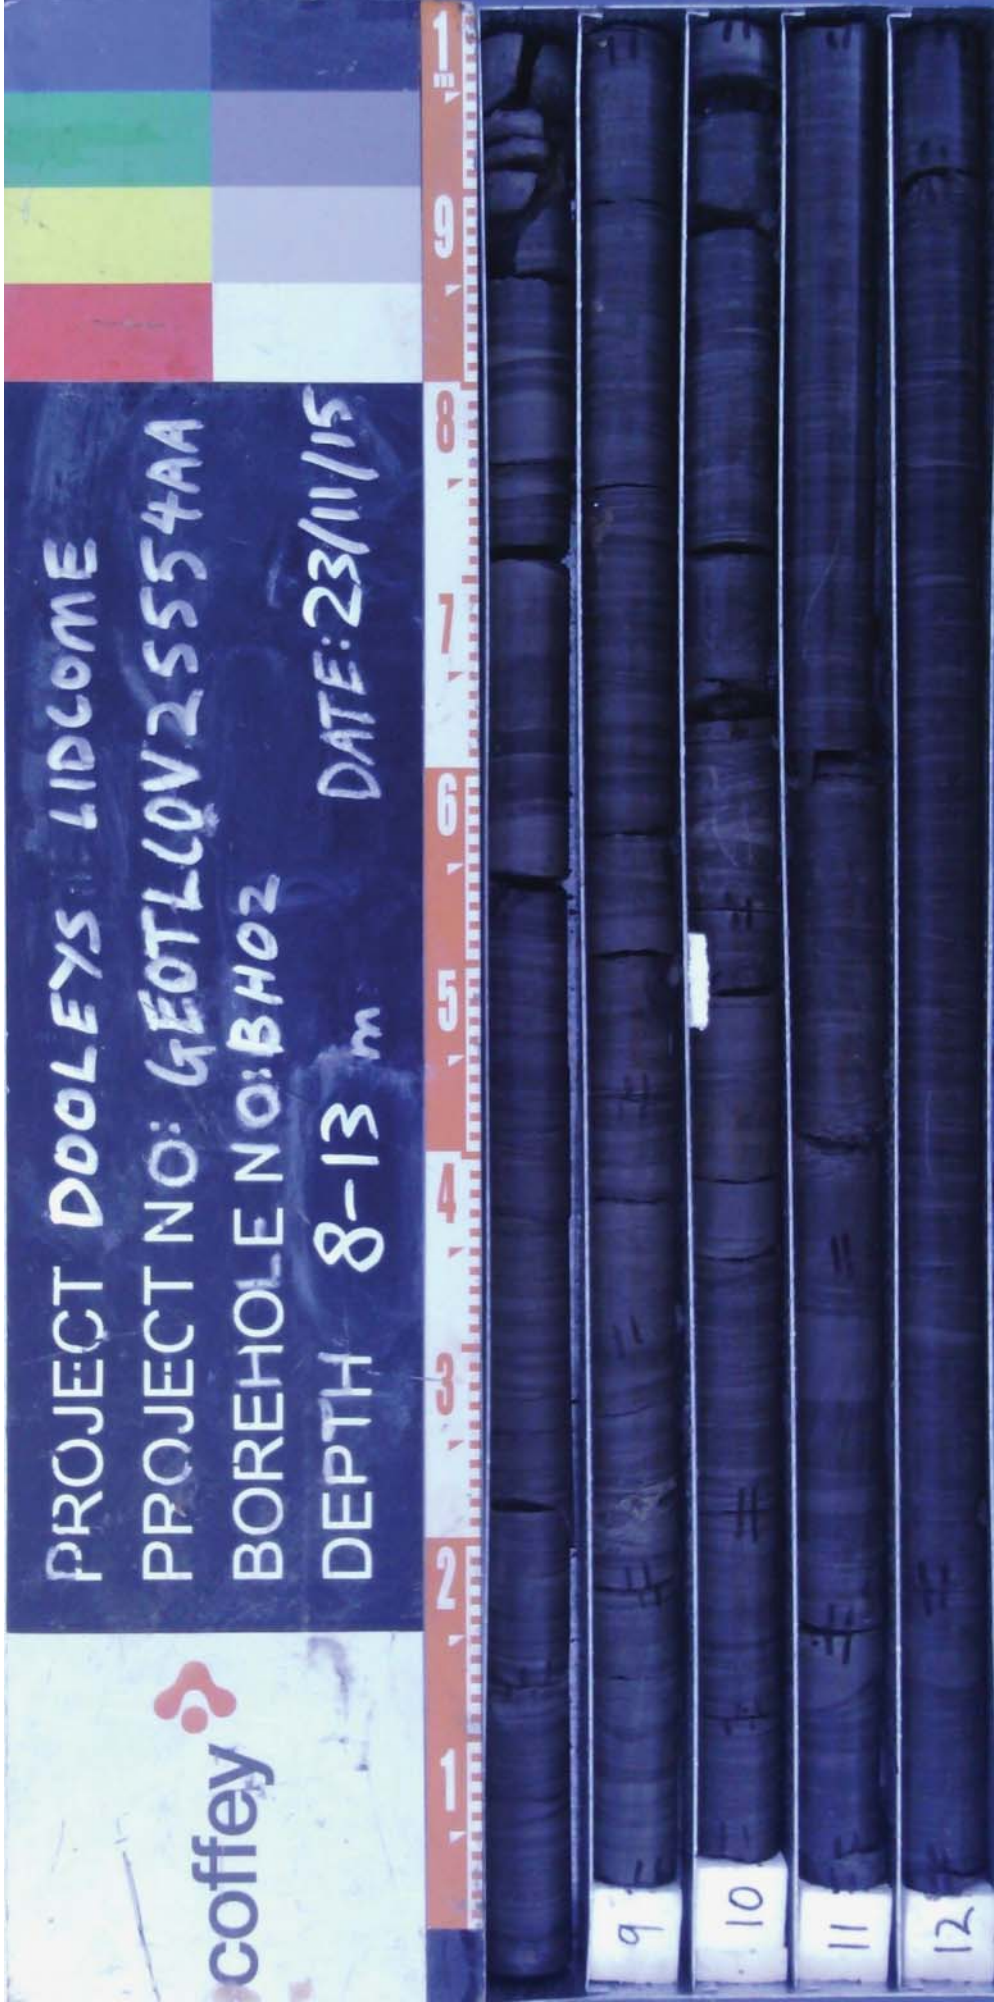
client: Bouygues Construction Australia	
drawn	RH	project: Dooleys Lidcombe Club & Hotel Development 24-28 John St, Lidcombe NSW 2141	
approved	RH	title: CORE PHOTOGRAPH BH02	
date	11/12/2015	project no: GEOTLCOV25554AA	fig no: PHOTO 6
scale	N.T.S.	rev:	
original size	A4

PointID : BH02 Depth Range: 8.00 - 13.00 m

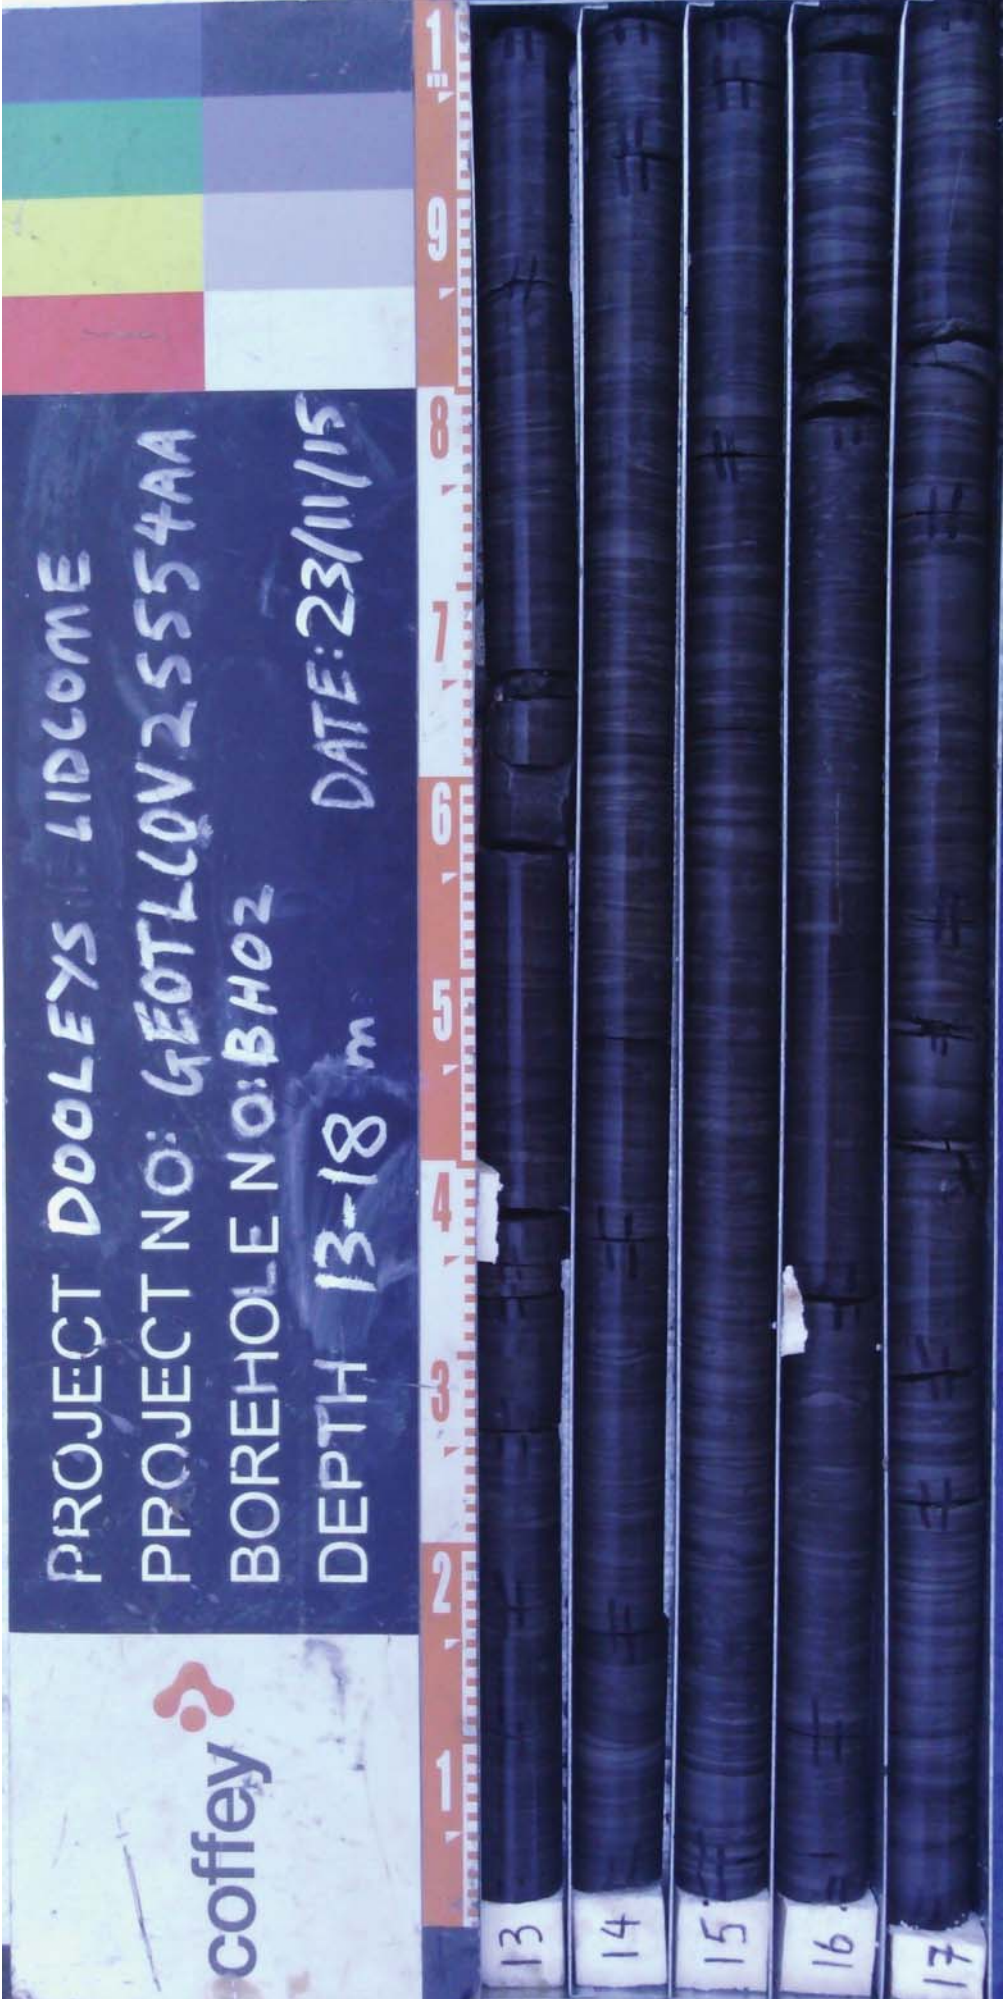
client: Bouygues Construction Australia	
drawn	RH	project: Dooleys Lidcombe Club & Hotel Development 24-28 John St, Lidcombe NSW 2141	
approved	RH	title: CORE PHOTOGRAPH BH02	
date	11/12/2015	project no: GEOTLCOV25554AA	fig no: PHOTO 7
scale	N.T.S.	rev:	
original size	A4

PointID : BH02 Depth Range: 13.00 - 18.00 m

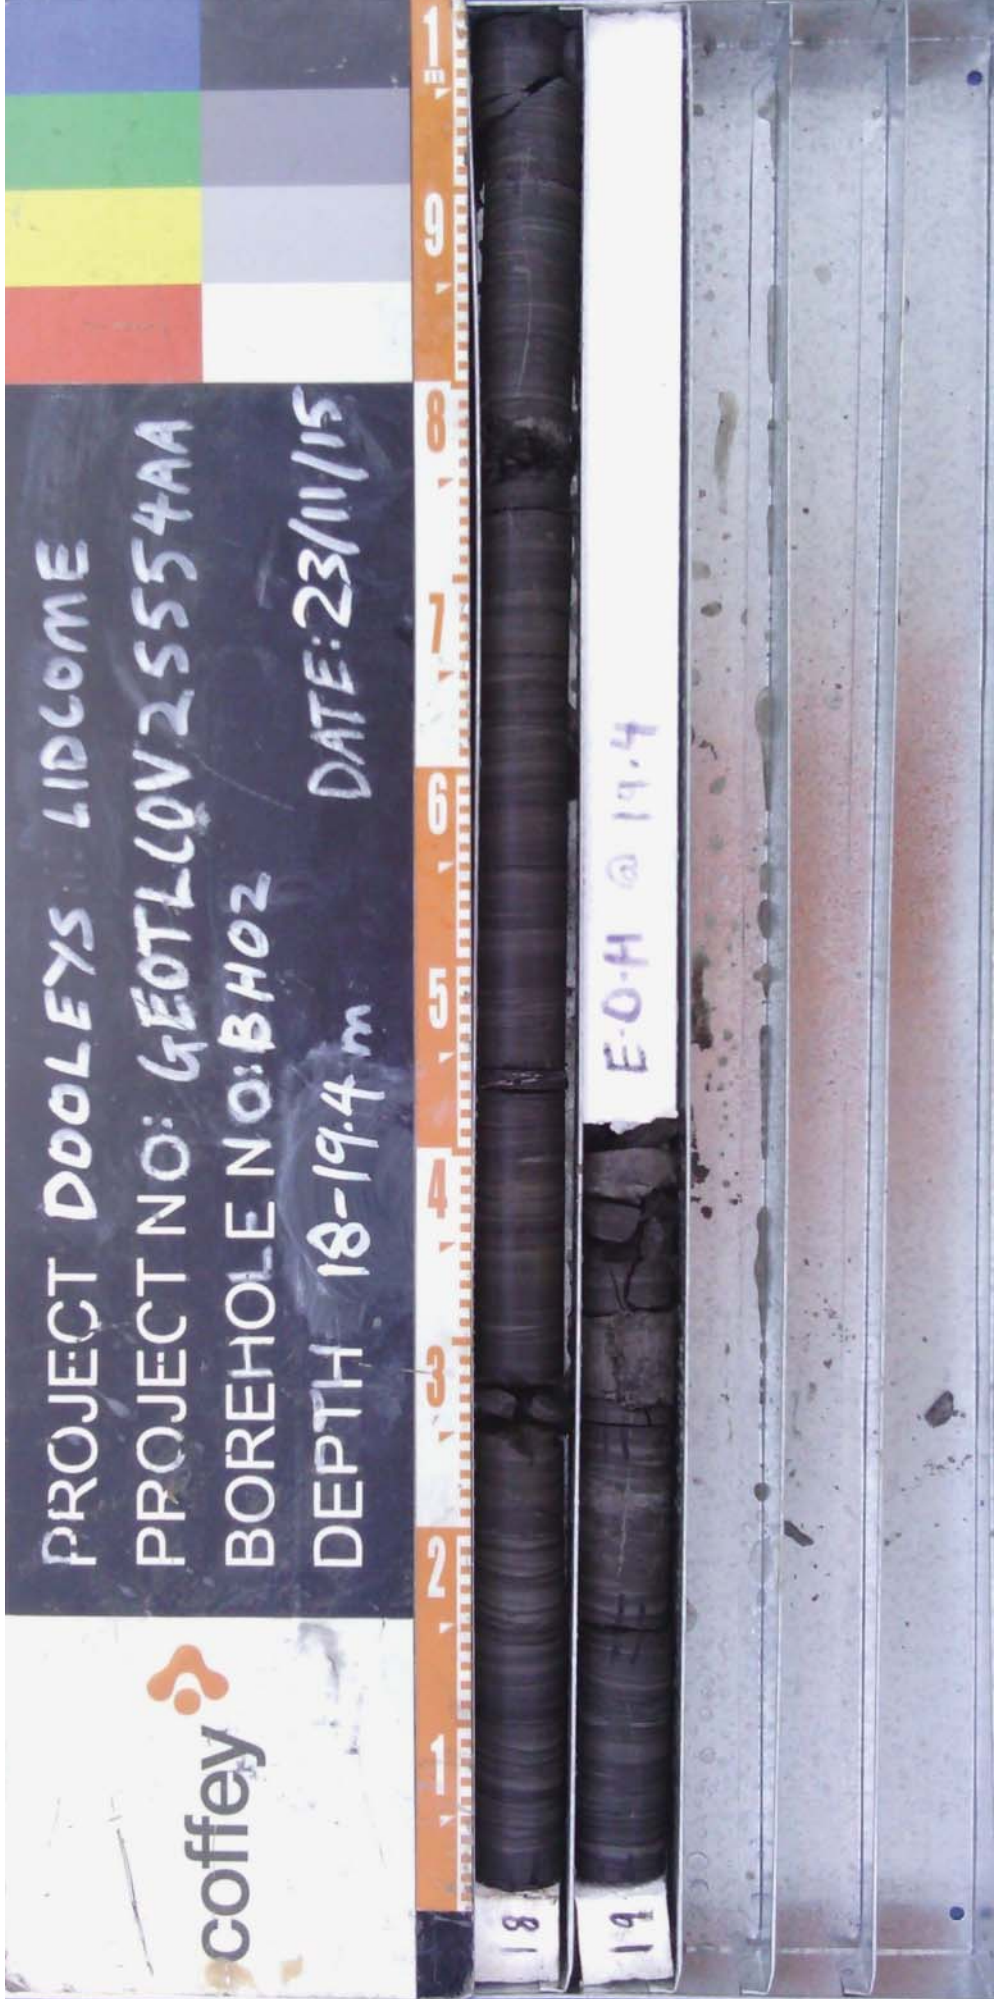
PointID : BH02 Depth Range: 18.00 - 19.40 m

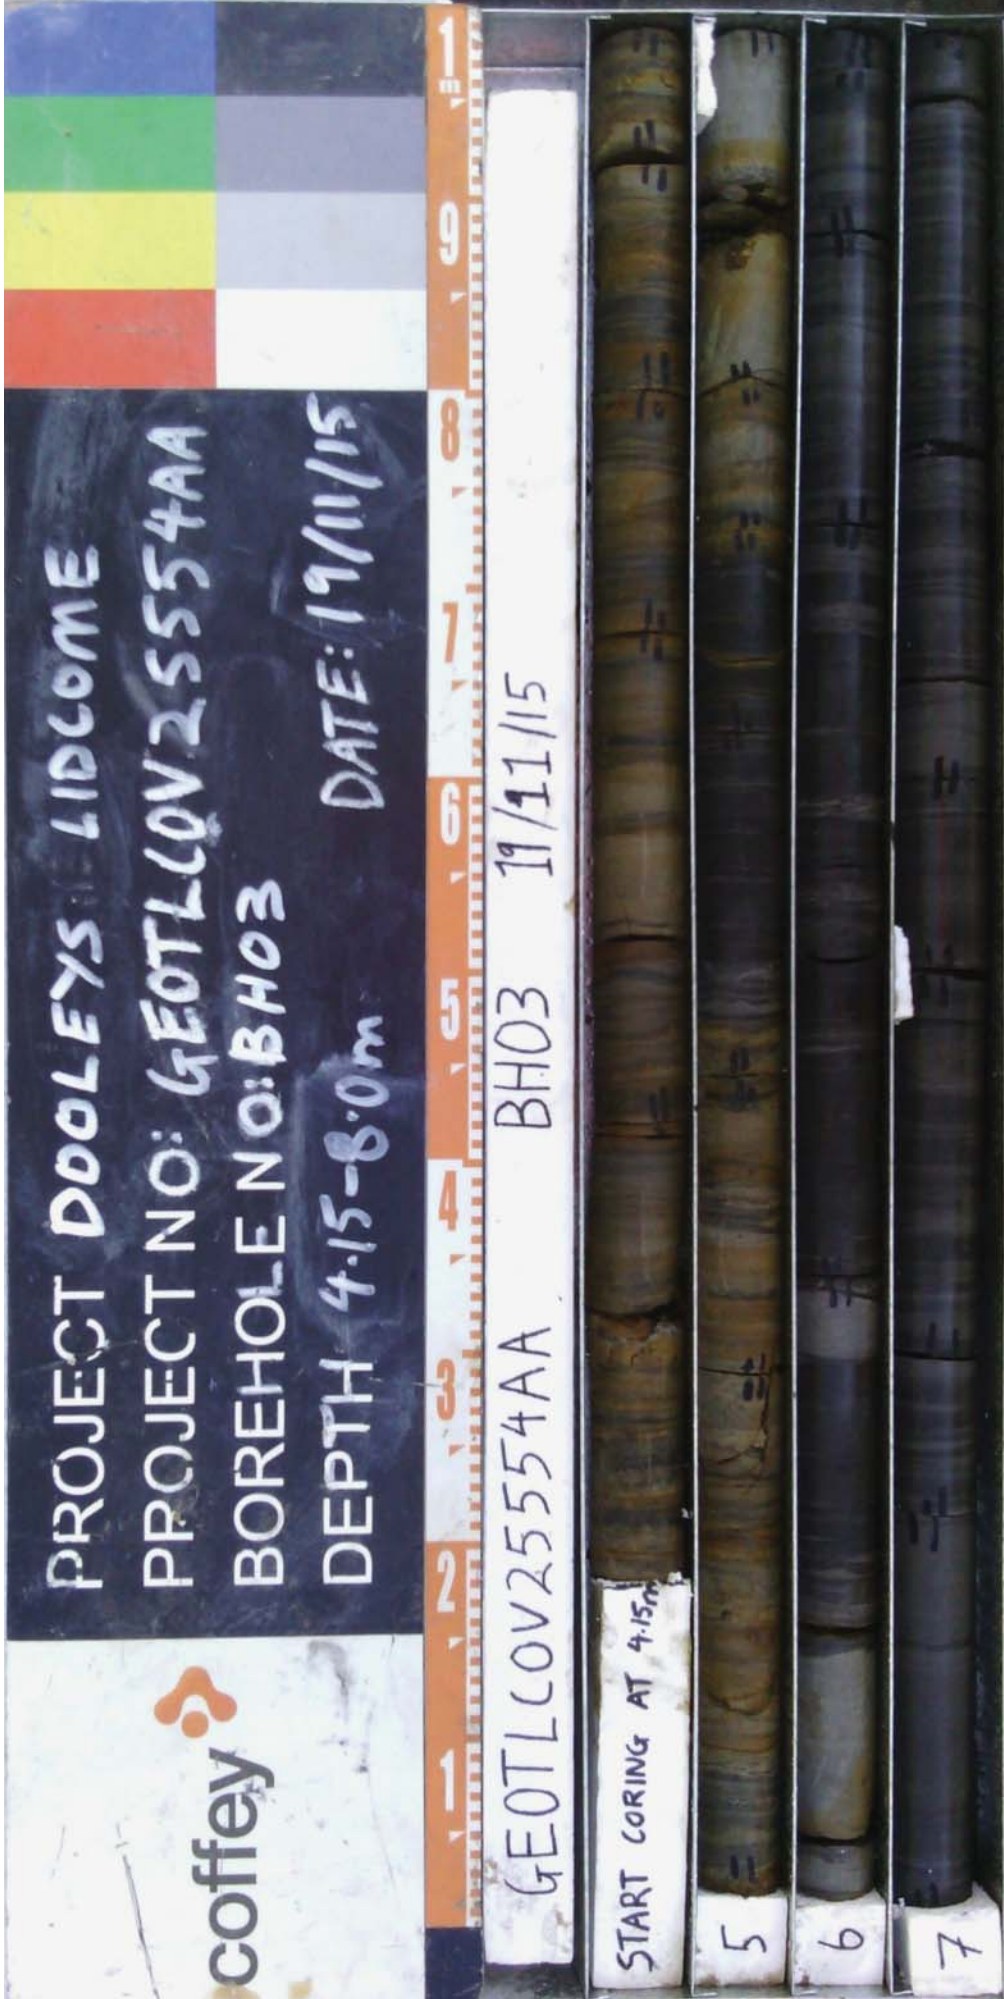
client: Bouygues Construction Australia	
drawn	RH	project: Dooleys Lidcombe Club & Hotel Development 24-28 John St, Lidcombe NSW 2141	
approved	RH	title: CORE PHOTOGRAPH BH03	
date	11/12/2015	project no: GEOTLCOV25554AA	fig no: PHOTO 9
scale	N.T.S.	rev:	
original size	A4

PointID : BH03 Depth Range: 4.15 - 8.00 m

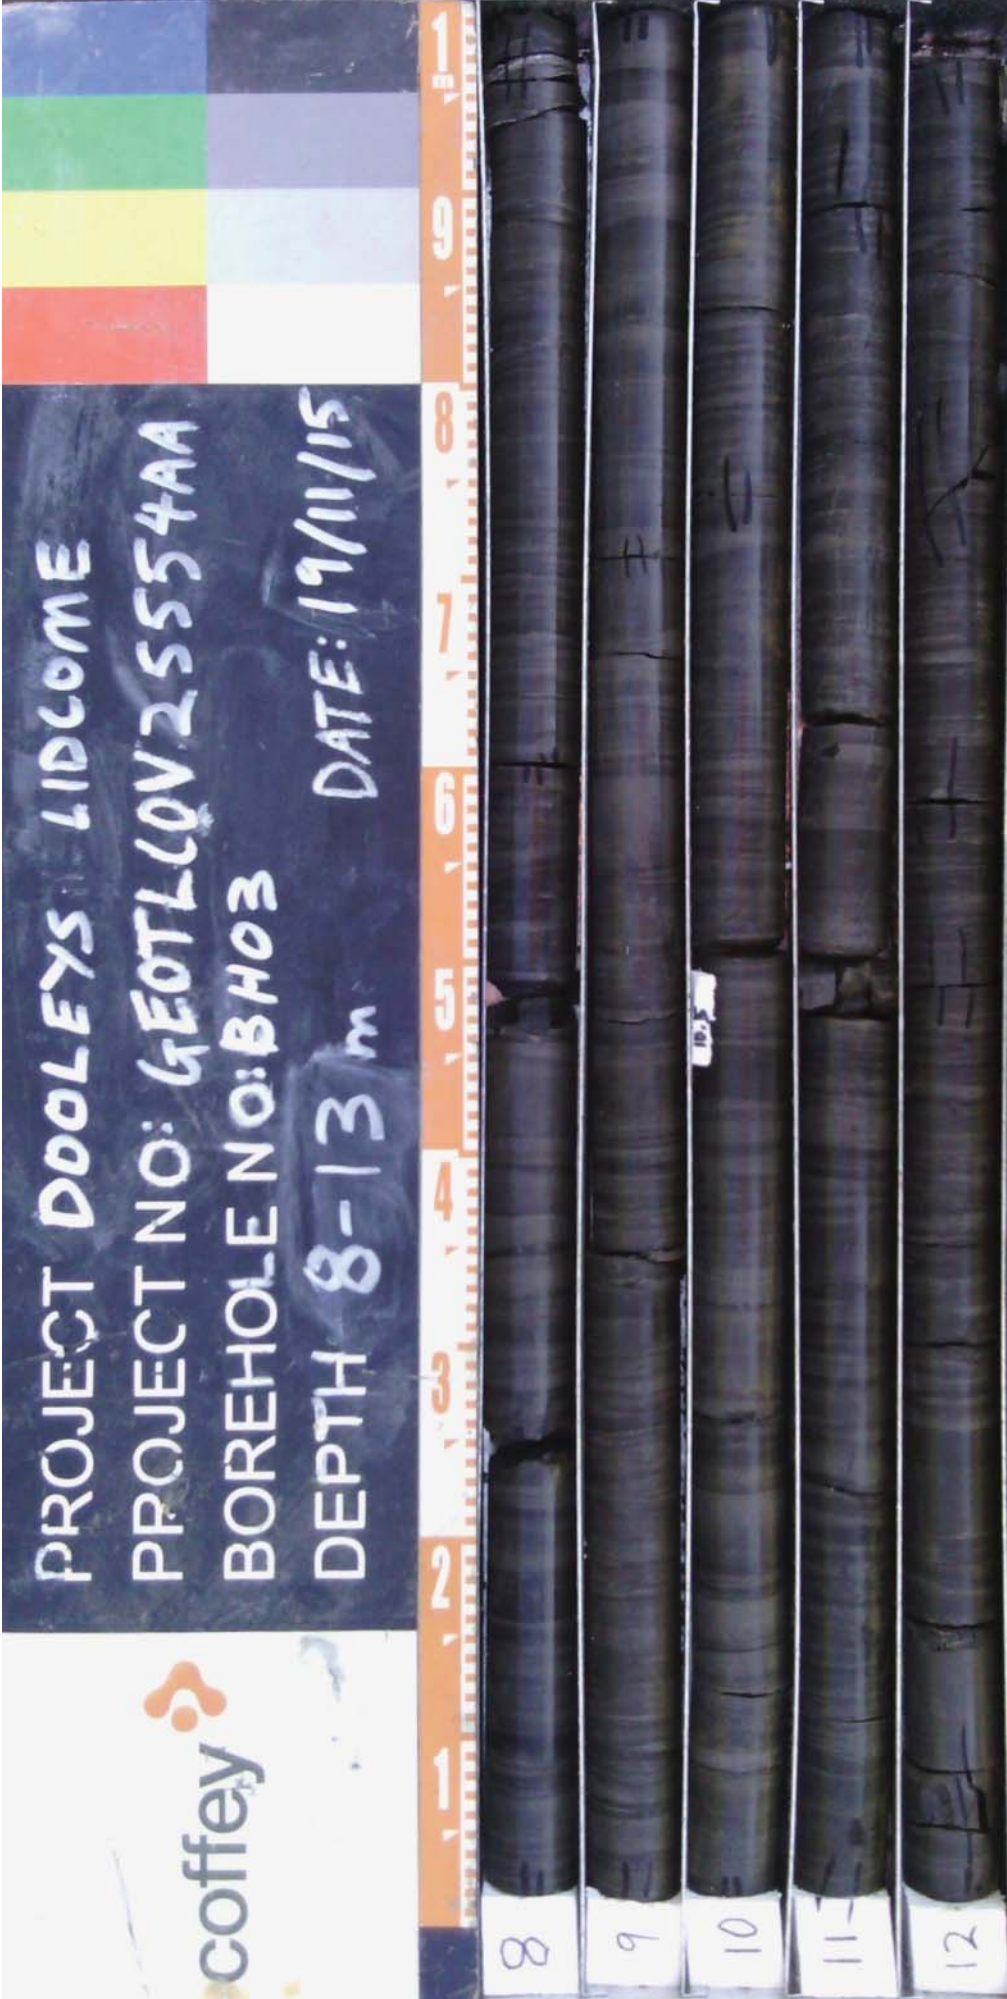
client: Bouygues Construction Australia	
drawn	RH	project: Dooleys Lidcombe Club & Hotel Development 24-28 John St, Lidcombe NSW 2141	
approved	RH	title: CORE PHOTOGRAPH BH03	
date	11/12/2015	project no: GEOTLCOV25554AA	fig no: PHOTO 10
scale	N.T.S.	rev:	
original size	A4

PointID : BH03 Depth Range: 8.00 - 13.00 m

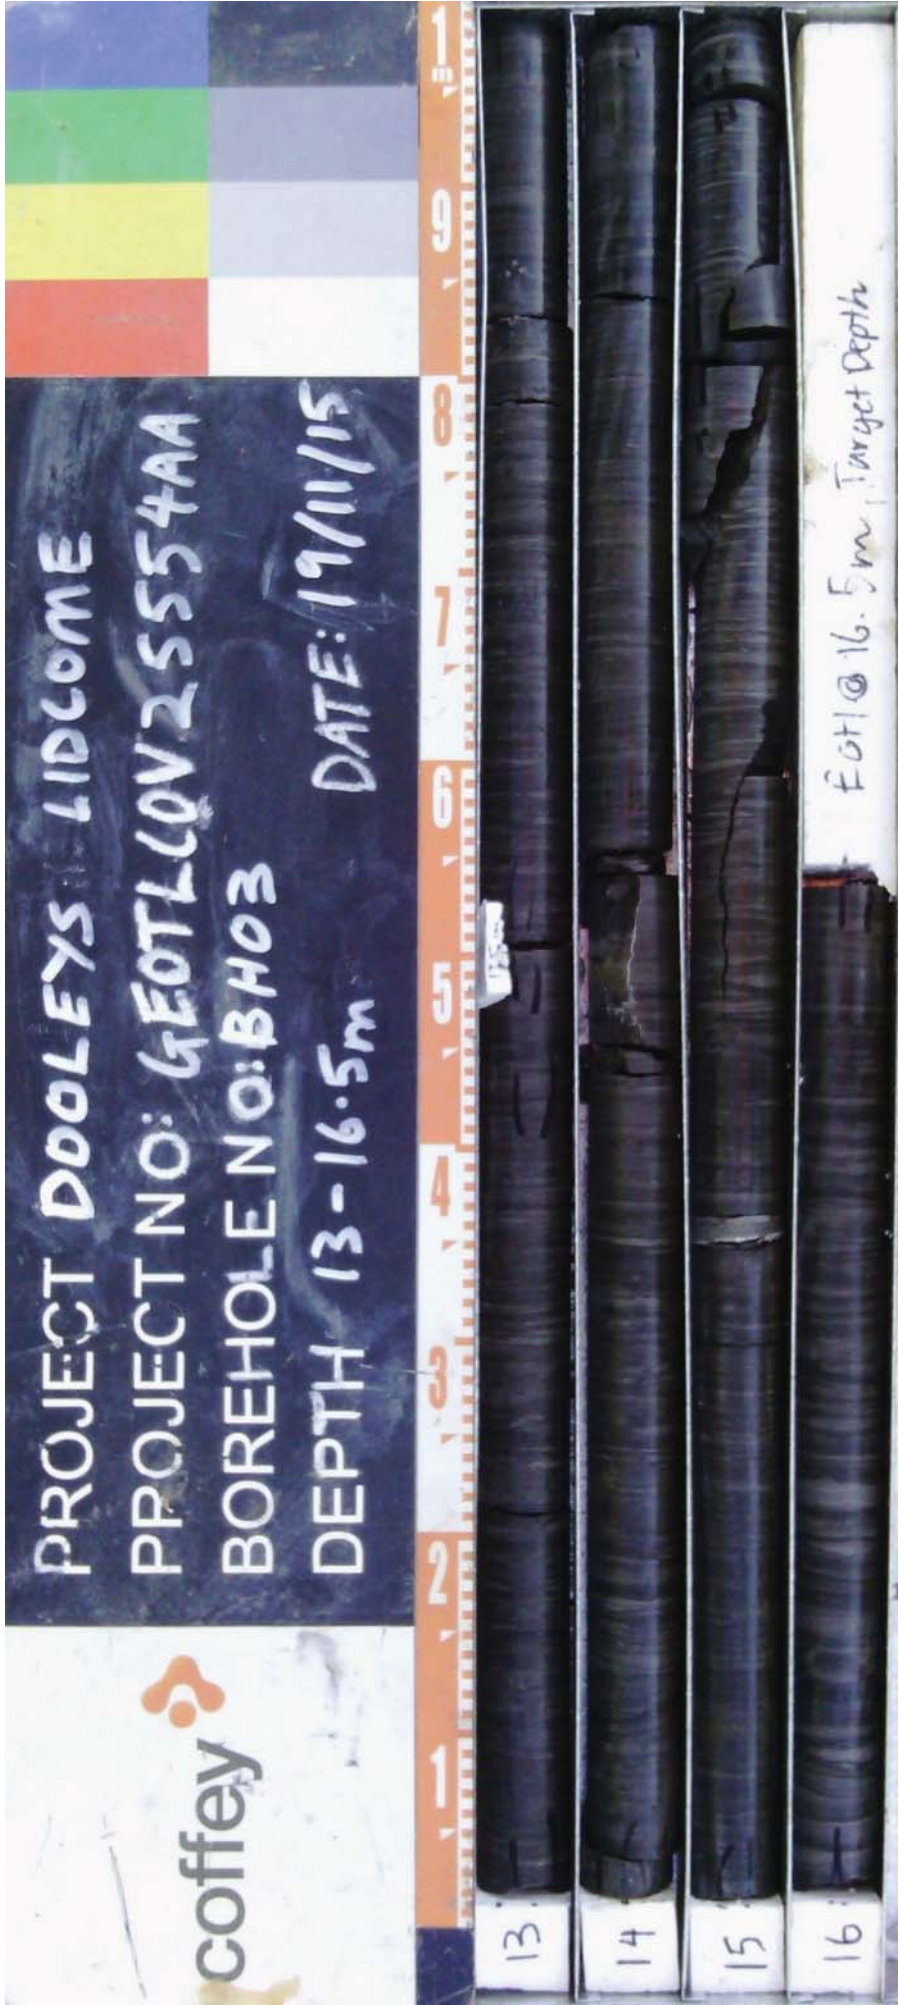
PointID : BH03 Depth Range: 13.00 - 16.50 m
