Bouygues Construction Australia Pty Ltd

**Dooleys Lidcombe Catholic Club
Redevelopment**

Geotechnical Investigation Report

11 July 2016

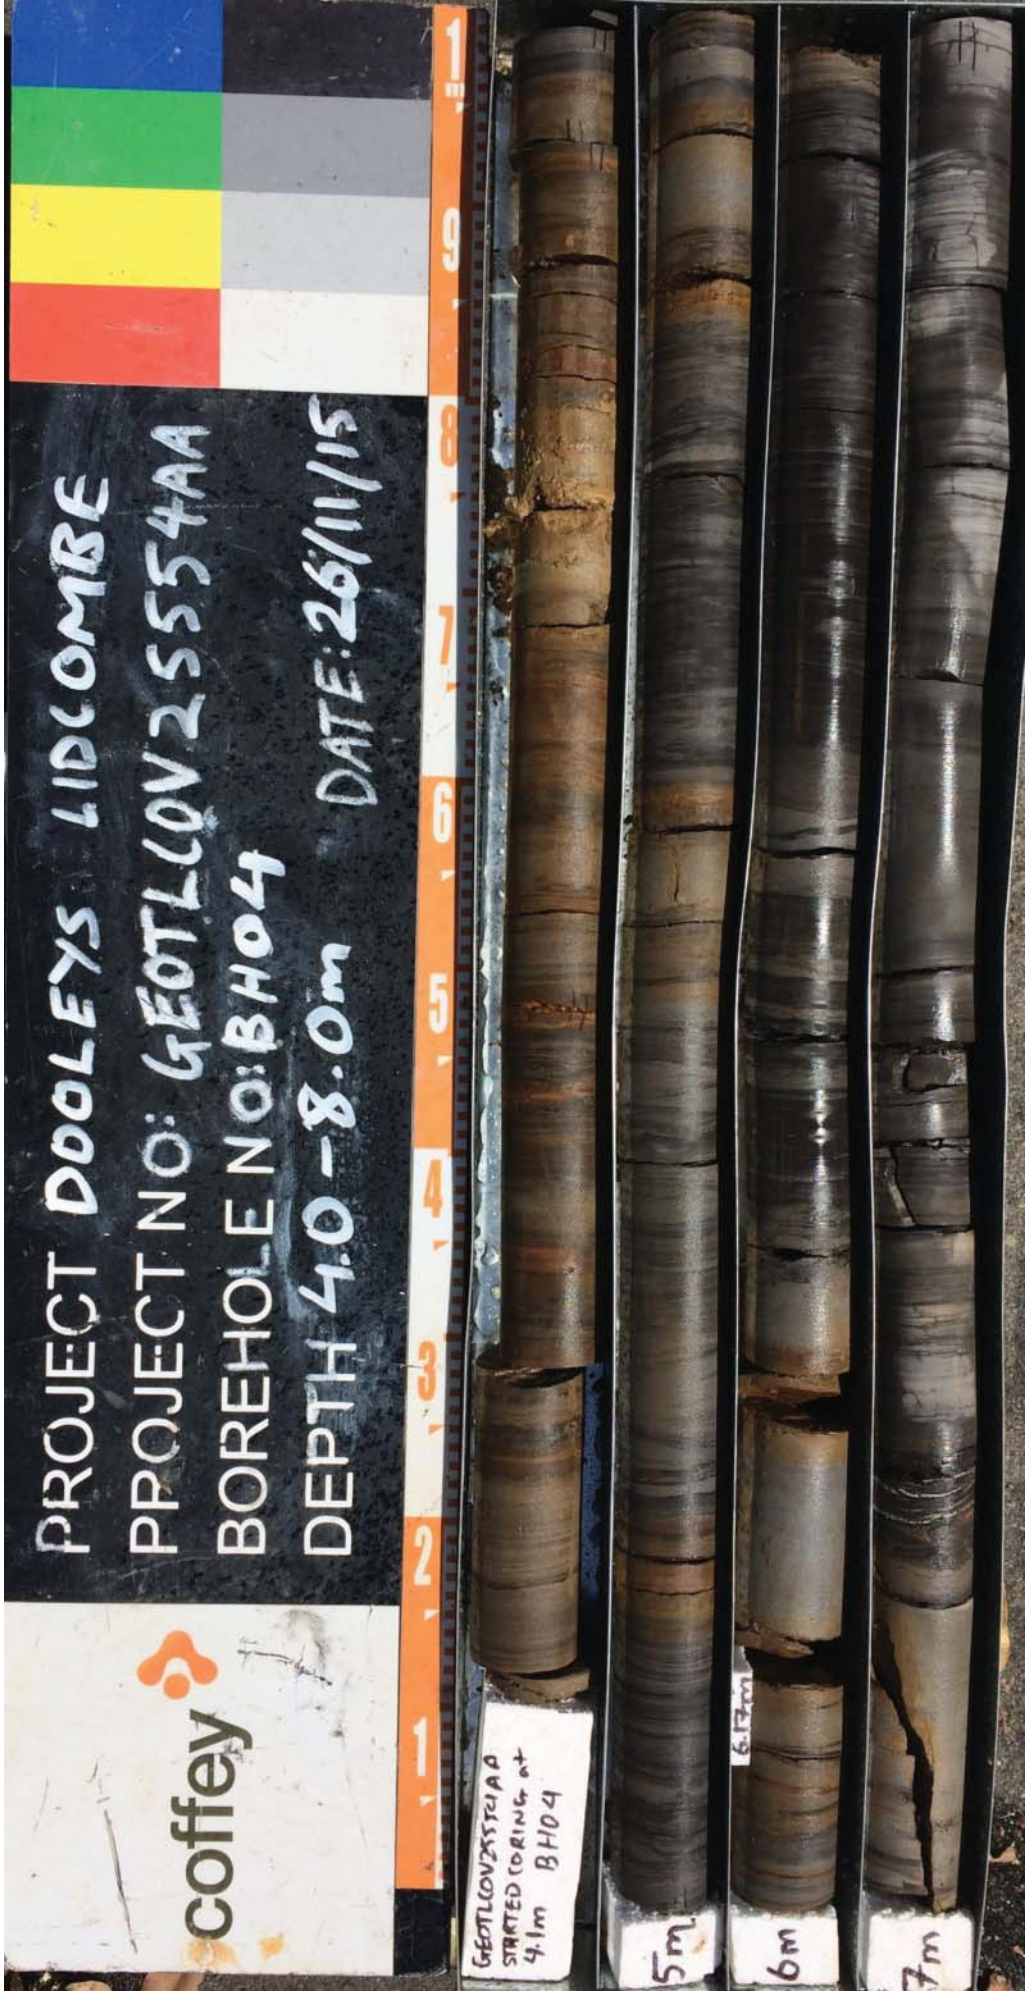
client: Bouygues Construction Australia	
drawn	RH	project: Dooleys Lidcombe Club & Hotel Development 24-28 John St, Lidcombe NSW 2141	
approved	RH	title: CORE PHOTOGRAPH BH04	
date	11/12/2015	project no: GEOTLCOV25554AA	fig no: PHOTO 12
scale	N.T.S.	rev:	
original size	A4

PointID : BH04 Depth Range: 4.00 - 8.00 m

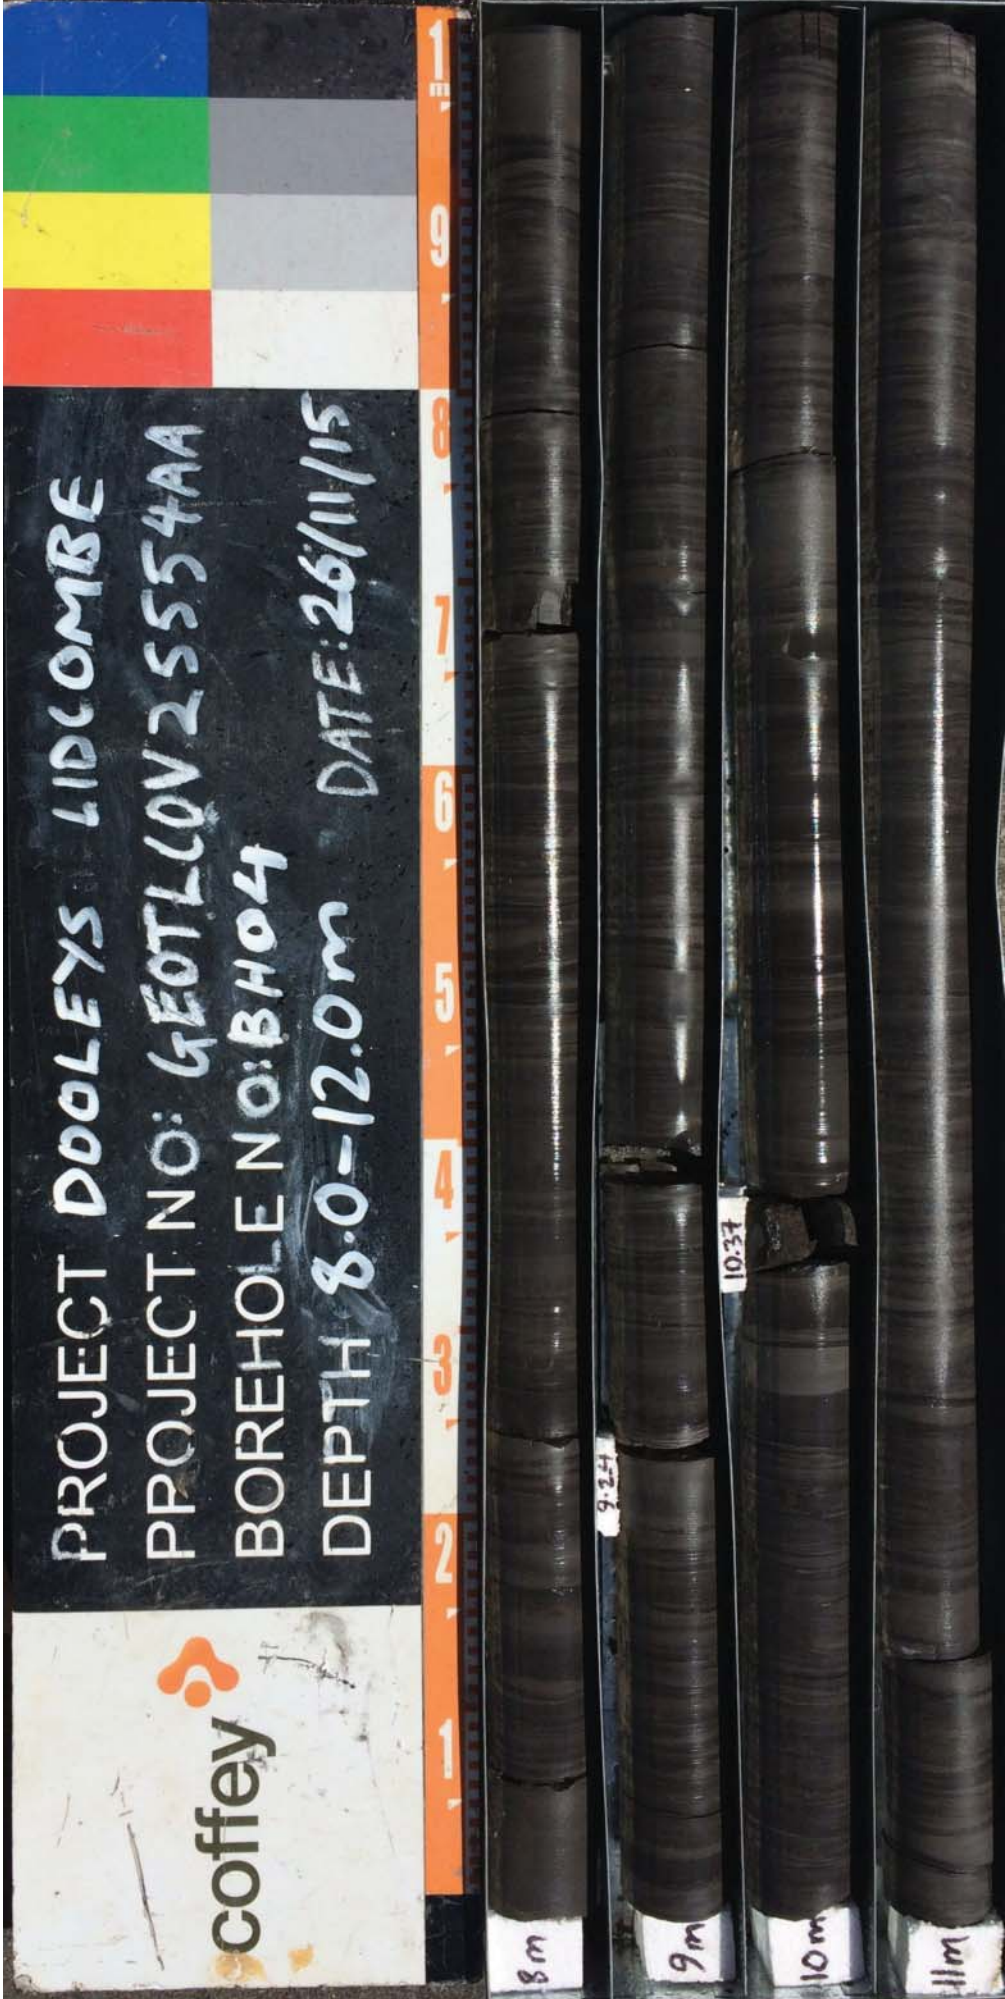
client: Bouygues Construction Australia	
drawn	RH	project: Dooleys Lidcombe Club & Hotel Development 24-28 John St, Lidcombe NSW 2141	
approved	RH	title: CORE PHOTOGRAPH BH04	
date	11/12/2015	project no: GEOTLCOV25554AA	fig no: PHOTO 13
scale	N.T.S.	rev:	
original size	A4

PointID : BH04 Depth Range: 8.00 - 12.00 m

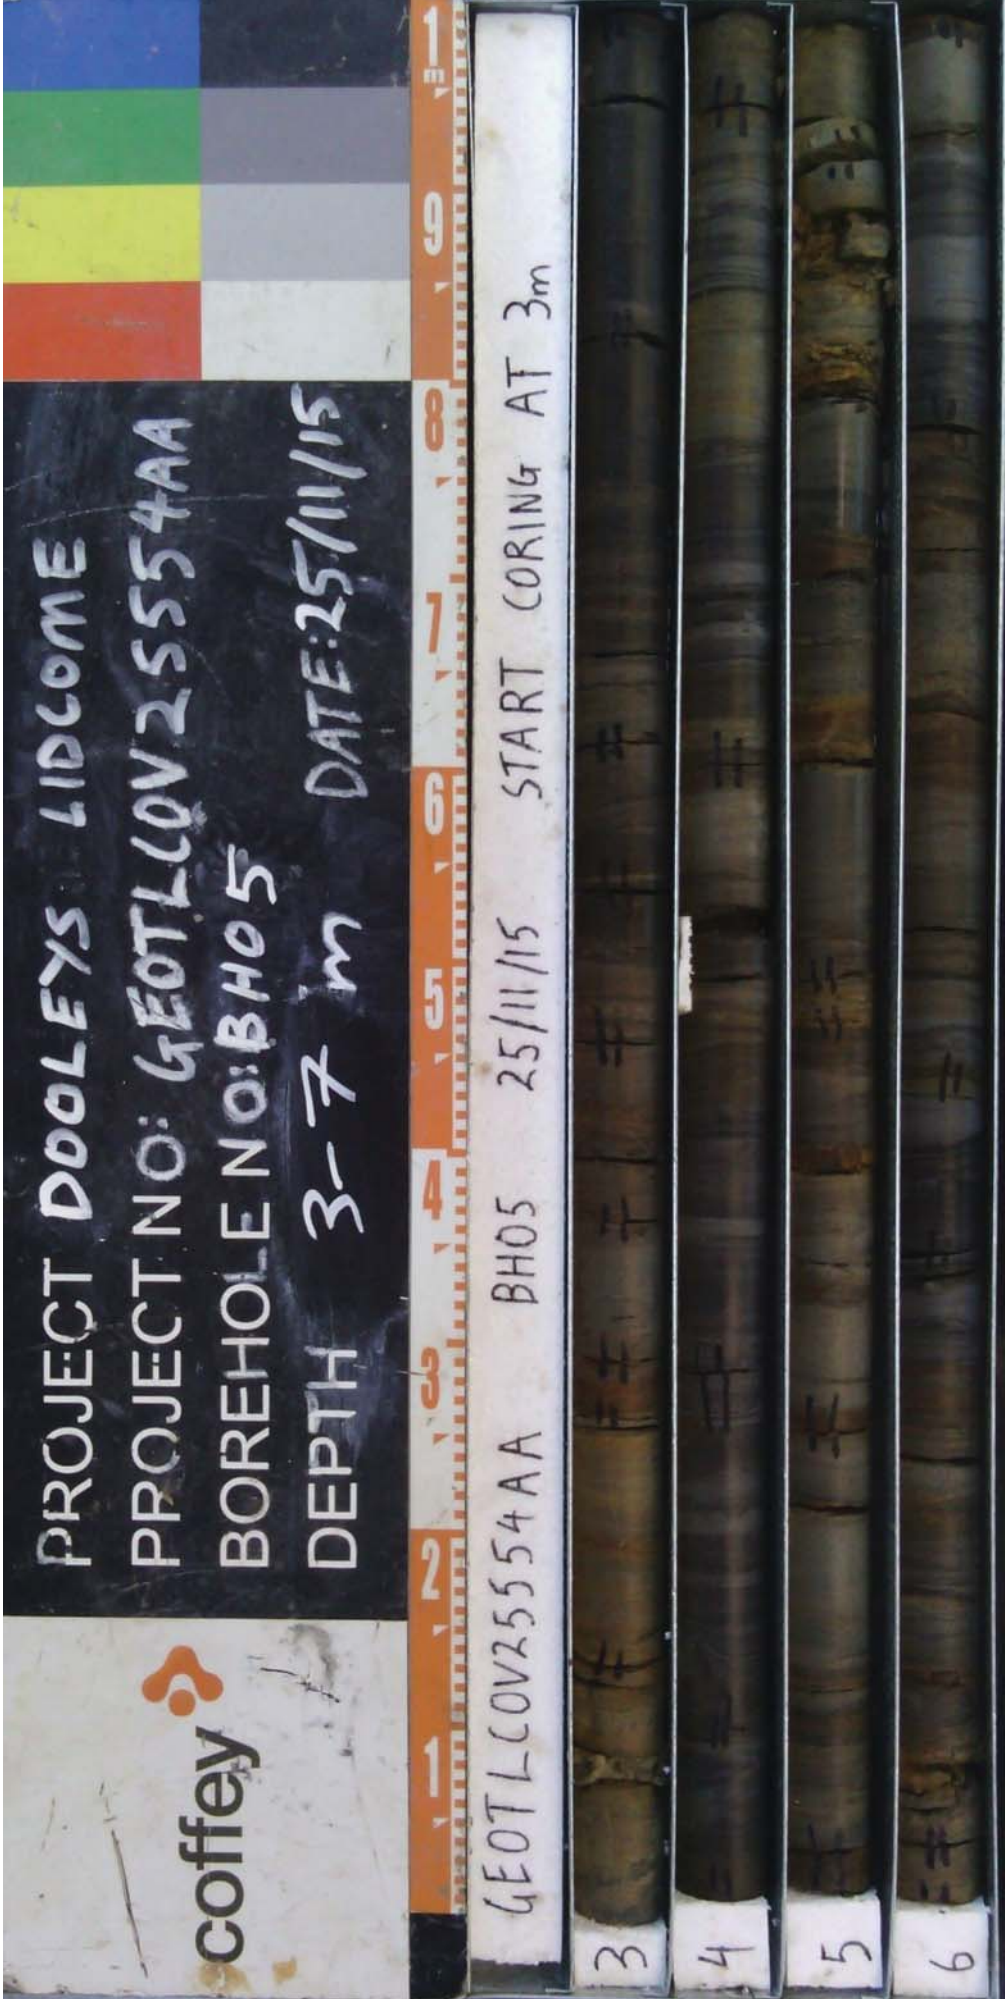
client:	Bouygues Construction Australia		
approved	RH		project:	Dooleys Lidcombe Club & Hotel Development 24-28 John St, Lidcombe NSW 2141		
date	11/12/2015		title:	CORE PHOTOGRAPH BH05		
scale	N.T.S.		project no:	GEOTLCOV25554AA	fig no:	PHOTO 16
original size	A4				rev:

PointID : BH05 Depth Range: 3.00 - 7.00 m

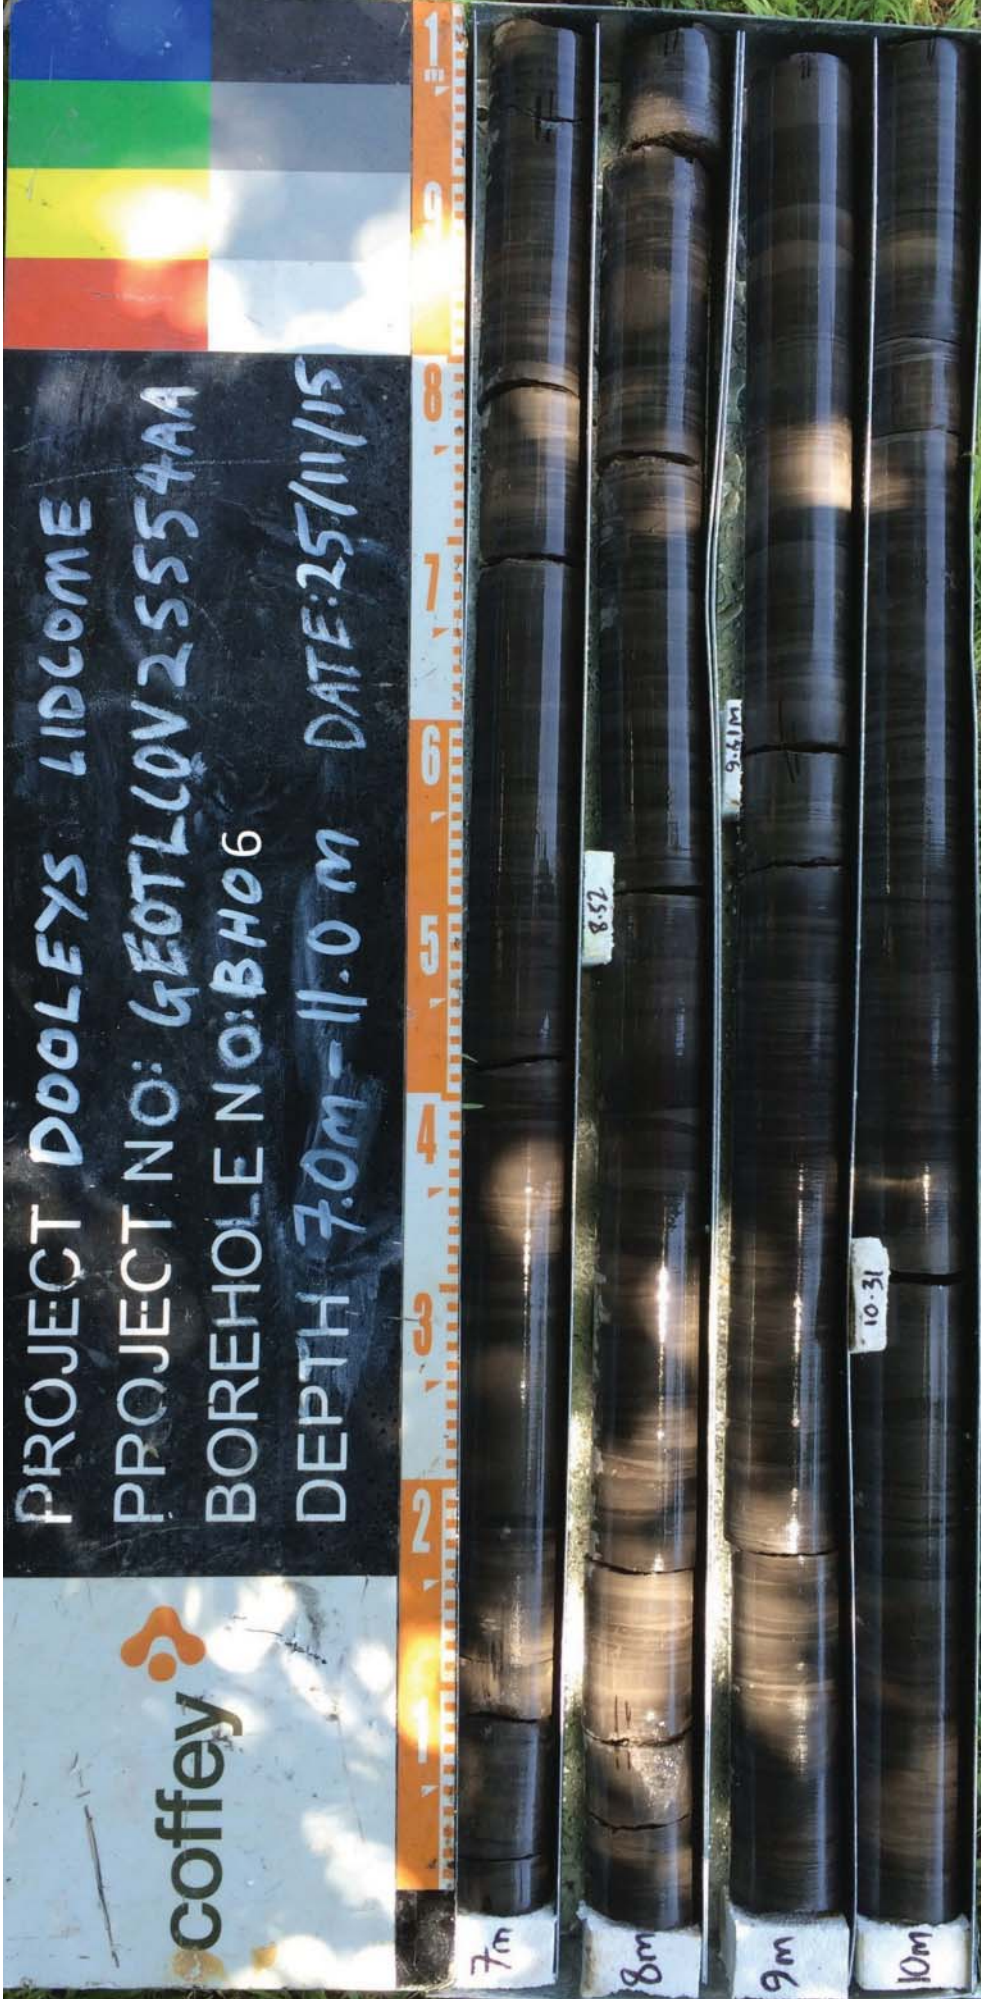
client: Bouygues Construction Australia	
drawn	RH	project: Dooleys Lidcombe Club & Hotel Development 24-28 John St, Lidcombe NSW 2141	
approved	RH	title: CORE PHOTOGRAPH BH06	
date	11/12/2015	project no: GEOTLCOV25554AA	fig no: PHOTO 20
scale	N.T.S.	rev:	
original size	A4

PointID : BH06 Depth Range: 7.00 - 11.00 m

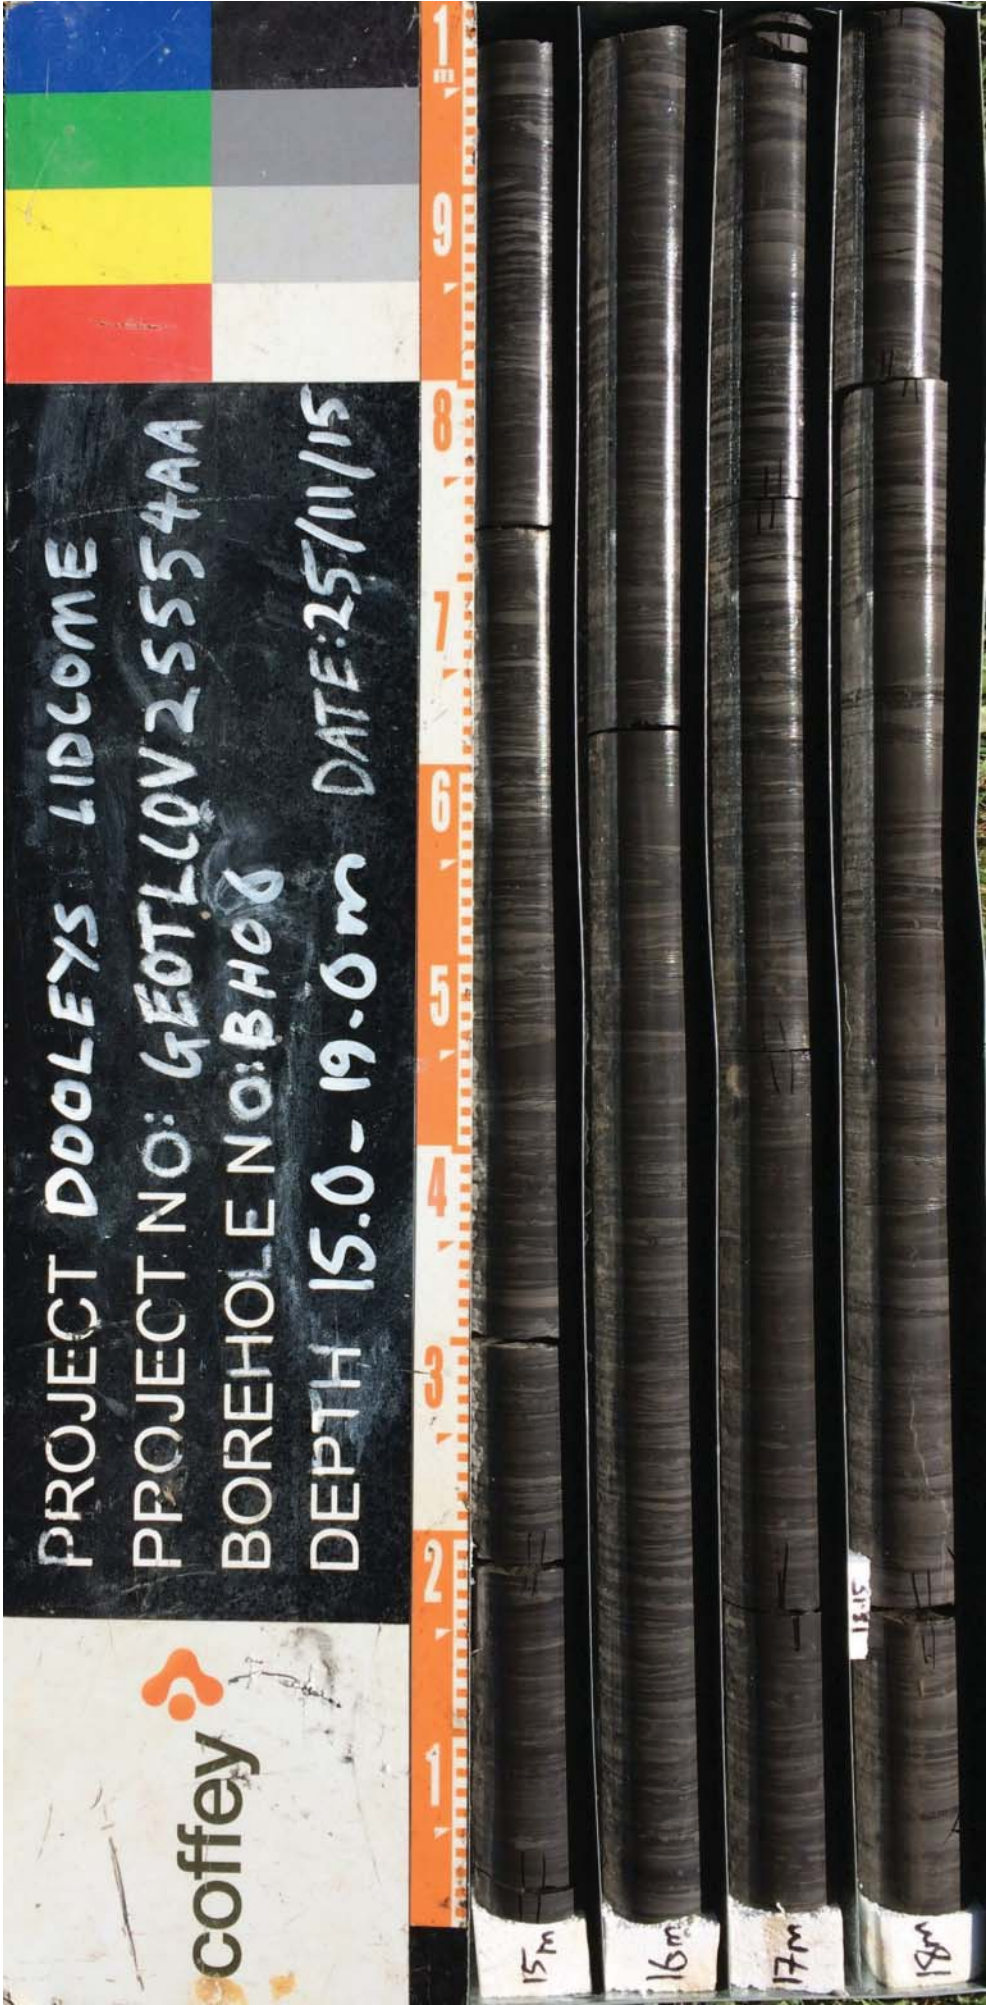
drawn	RH	<div>coffey</div> <div>client: Bouygues Construction Australia</div>	
approved	RH		
date	11/12/2015		
scale	N.T.S.		
original size	A4		
		project no: GEOTLCOV25554AA	fig no: PHOTO 22
		title: CORE PHOTOGRAPH BH06	
		project no: GEOTLCOV25554AA	rev:

PointID : BH06 Depth Range: 15.00 - 19.00 m

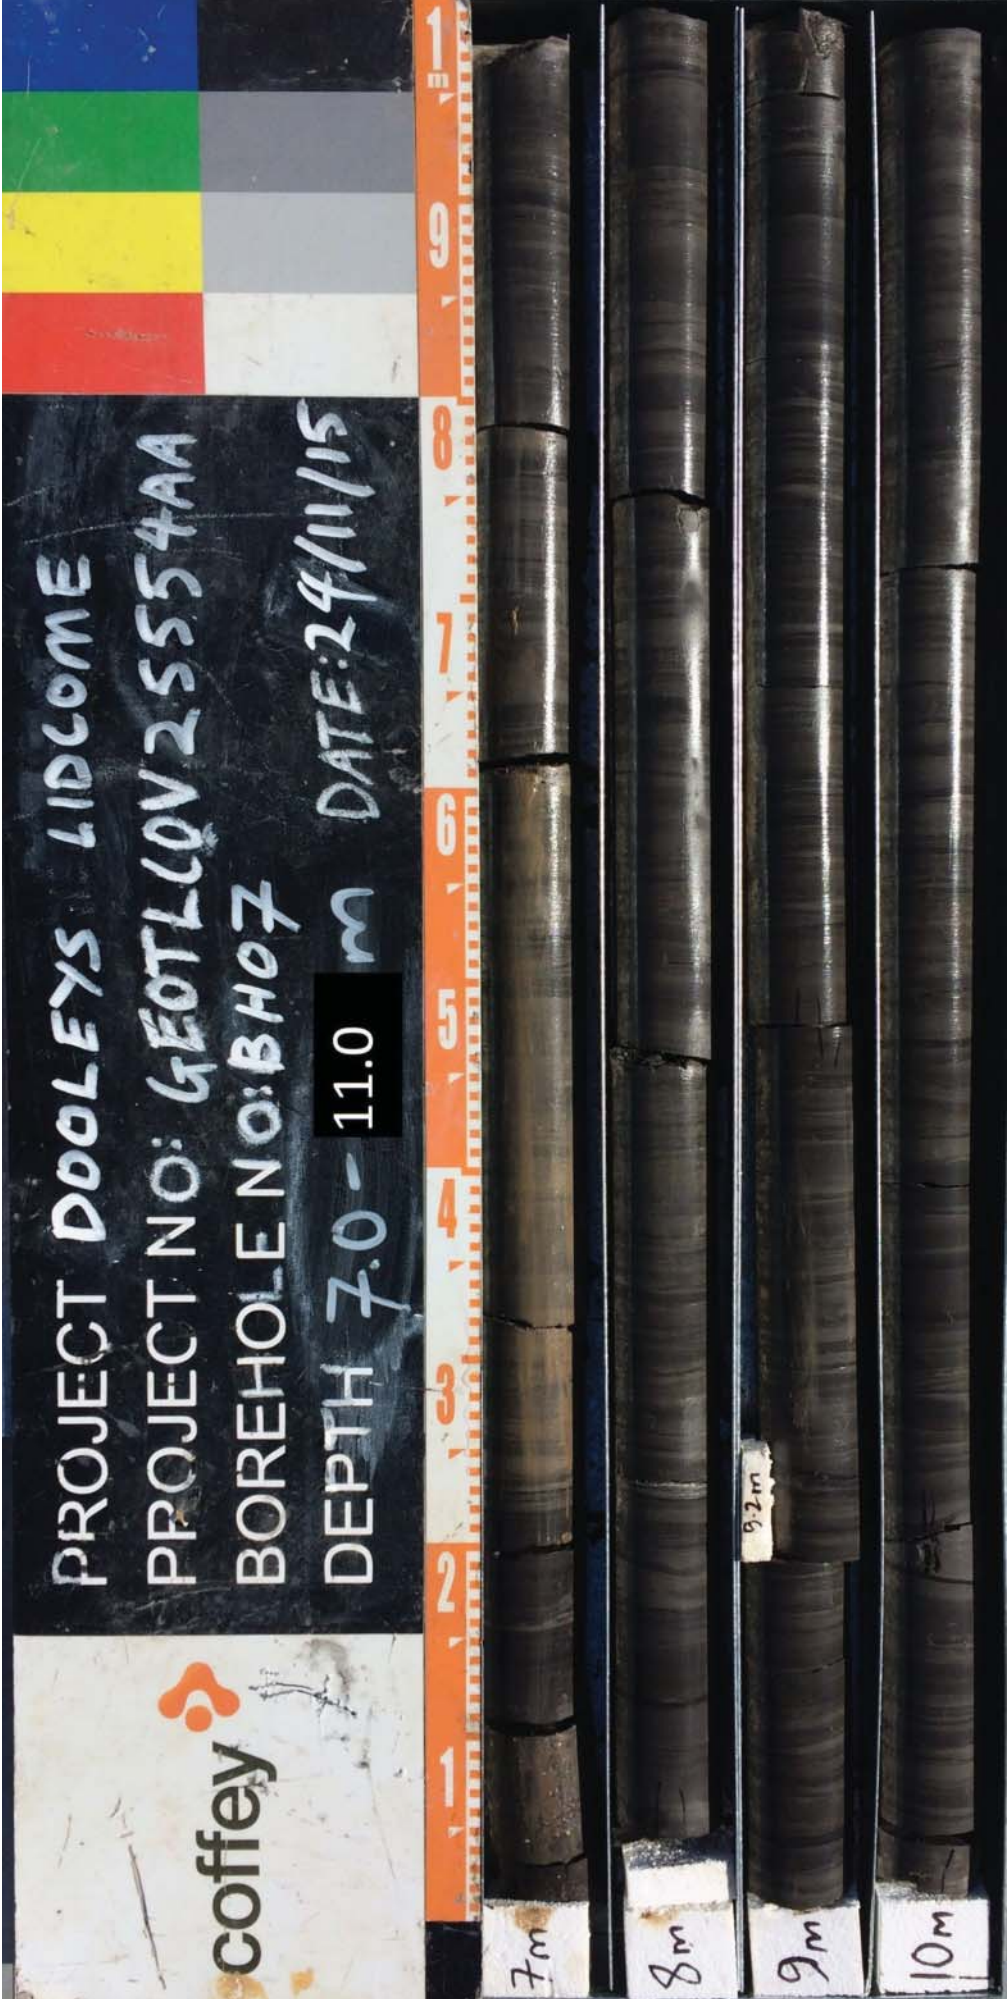
client: Bouygues Construction Australia	
drawn	RH	project: Dooleys Lidcombe Club & Hotel Development 24-28 John St, Lidcombe NSW 2141	
approved	RH	title: CORE PHOTOGRAPH BH07	
date	11/12/2015	project no: GEOTLCOV2554AA	fig no: PHOTO 24
scale	N.T.S.	rev:	
original size	A4

PointID : BH07 Depth Range: 7.00 - 11.00 m

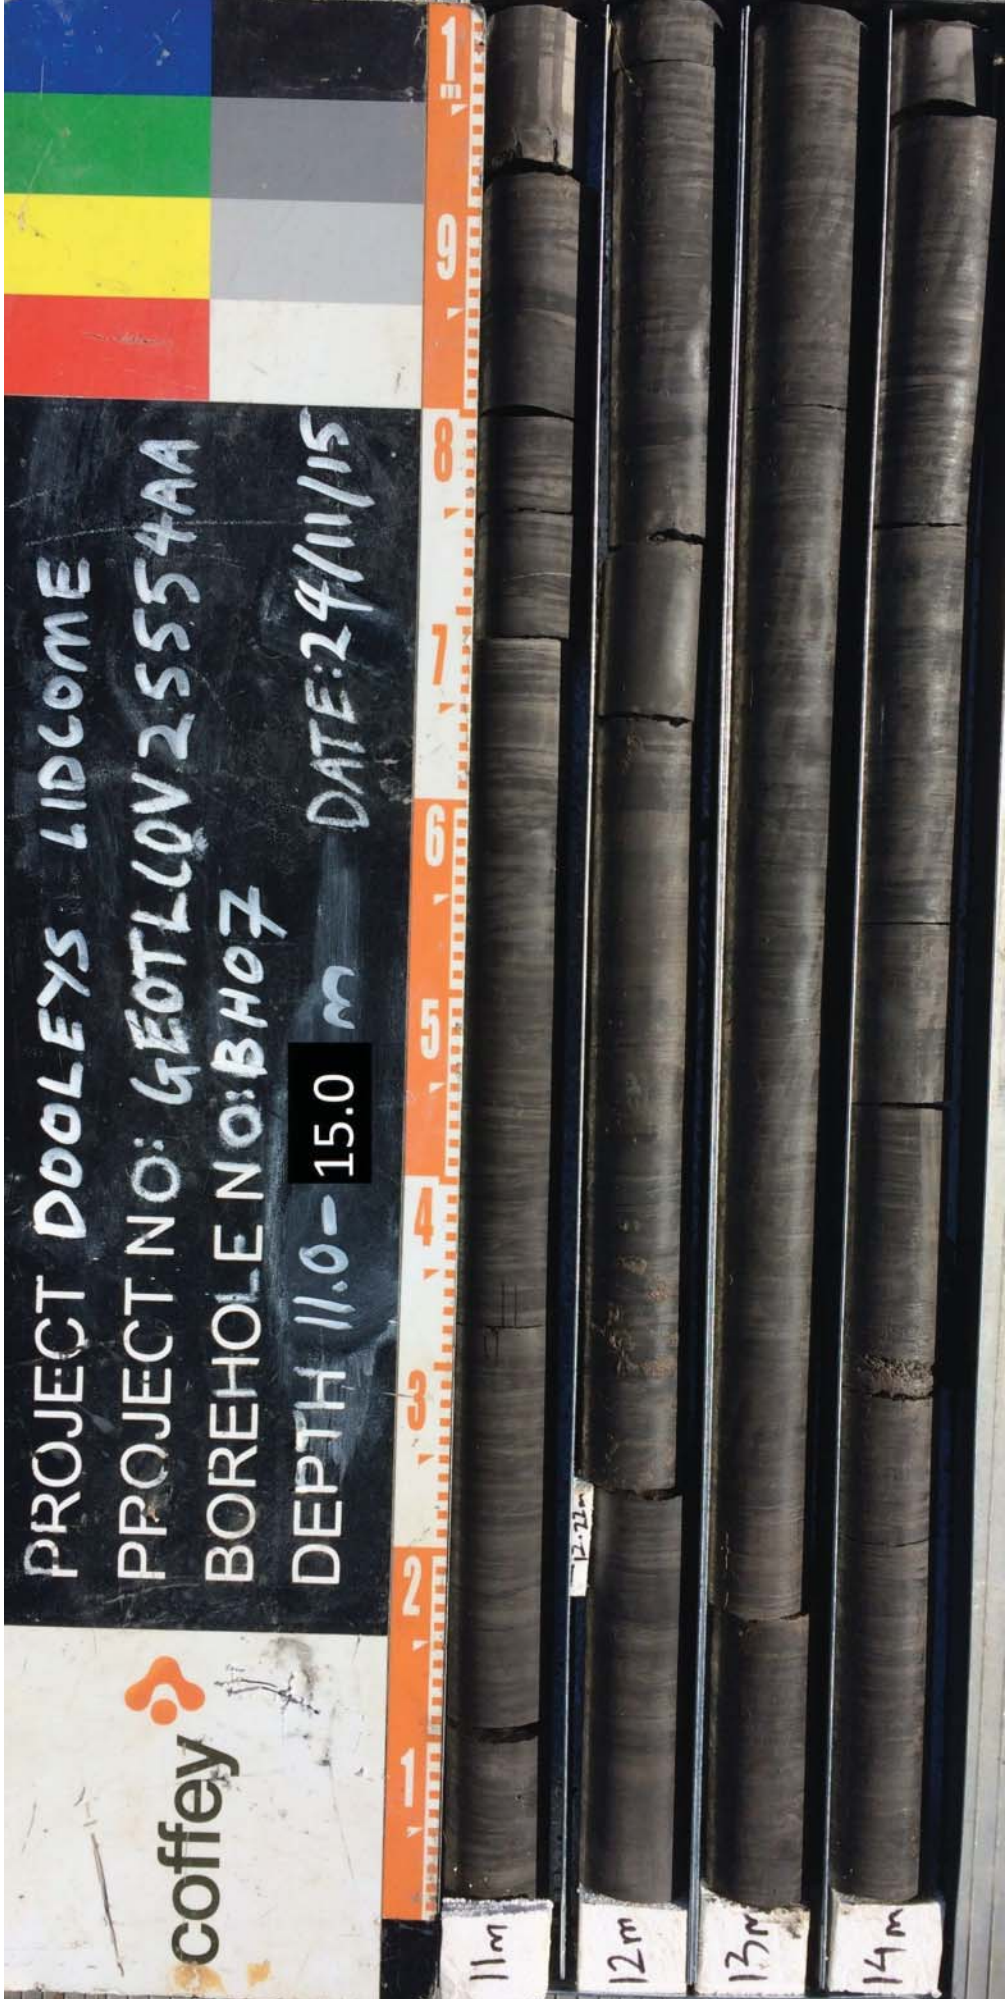
PointID : BH07 Depth Range: 11.00 - 15.00 m

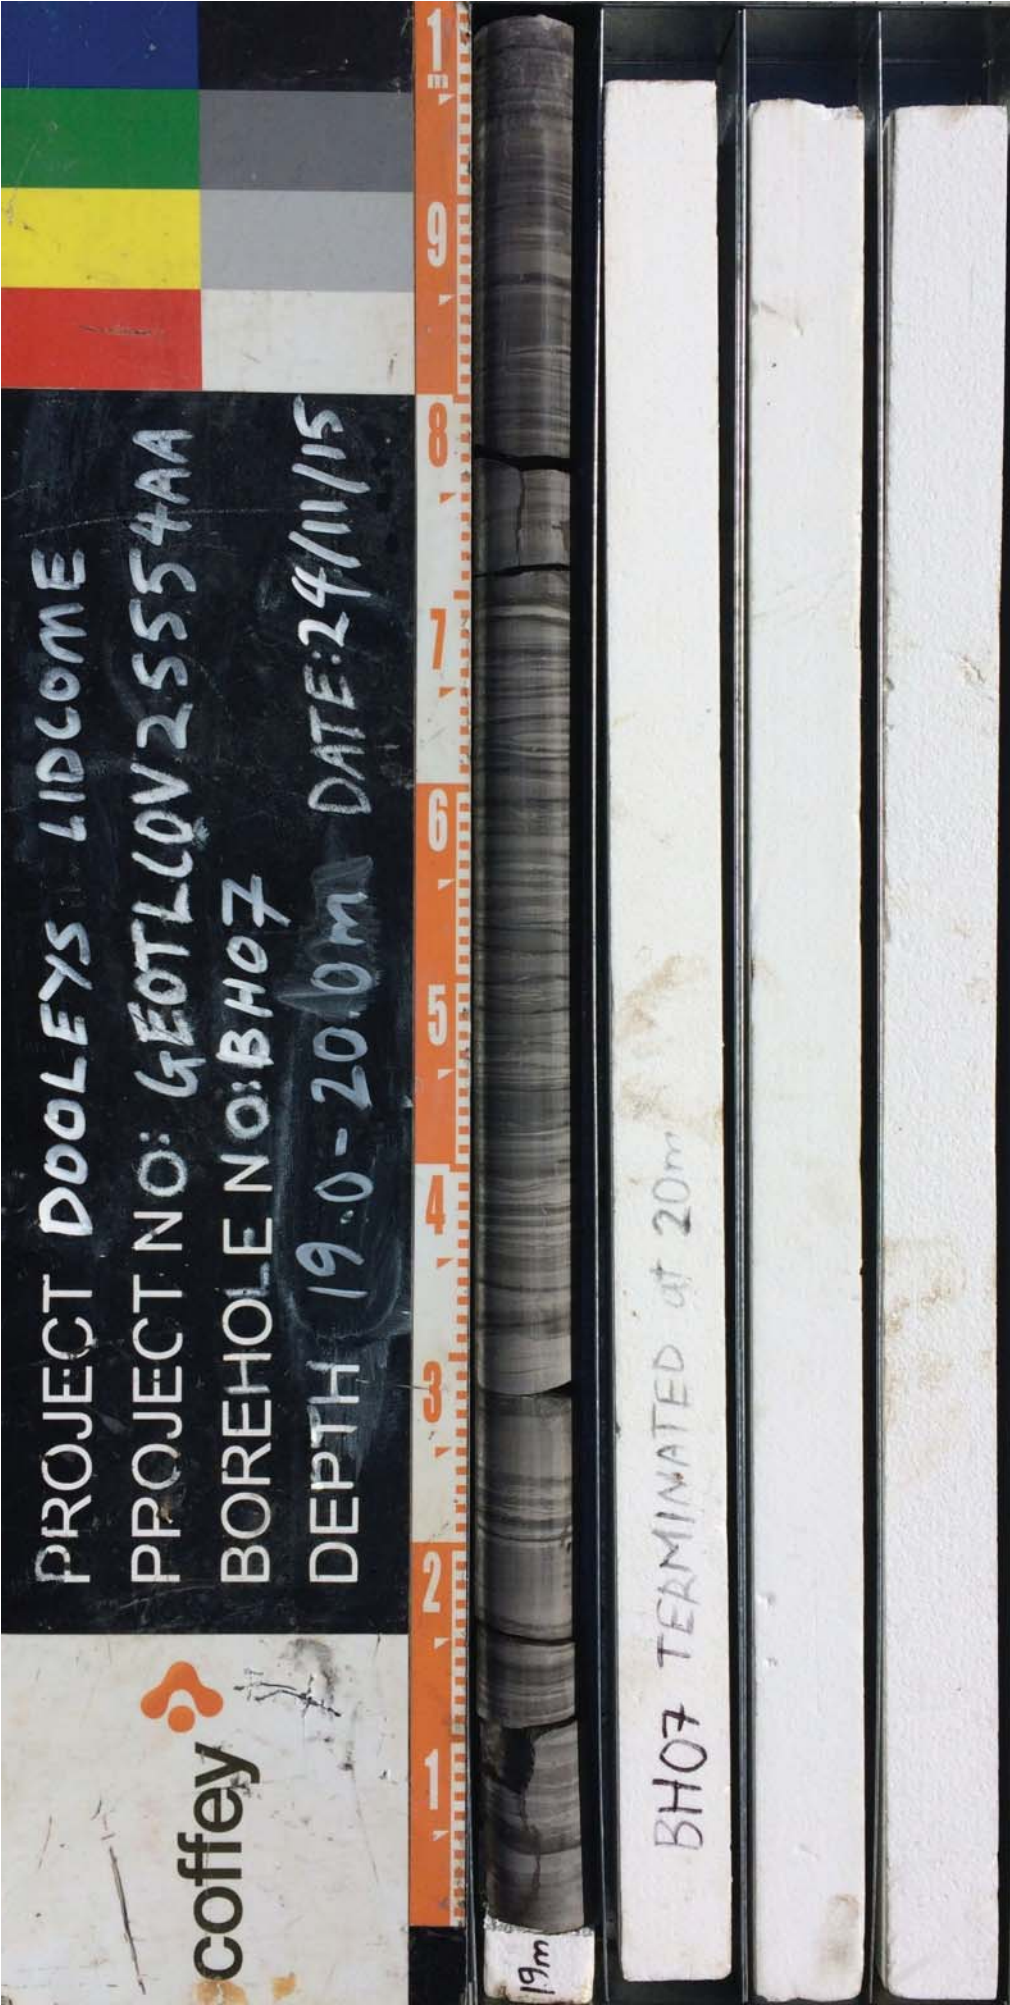
client: Bouygues Construction Australia	
drawn	RH	project: Dooleys Lidcombe Club & Hotel Development 24-28 John St, Lidcombe NSW 2141	
approved	RH	title: CORE PHOTOGRAPH BH07	
date	11/12/2015	project no: GEOTLCOV25554AA	
scale	N.T.S.	fig no:	PHOTO 27
original size	A4	rev:

PointID : BH07 Depth Range: 19.00 - 20.00 m

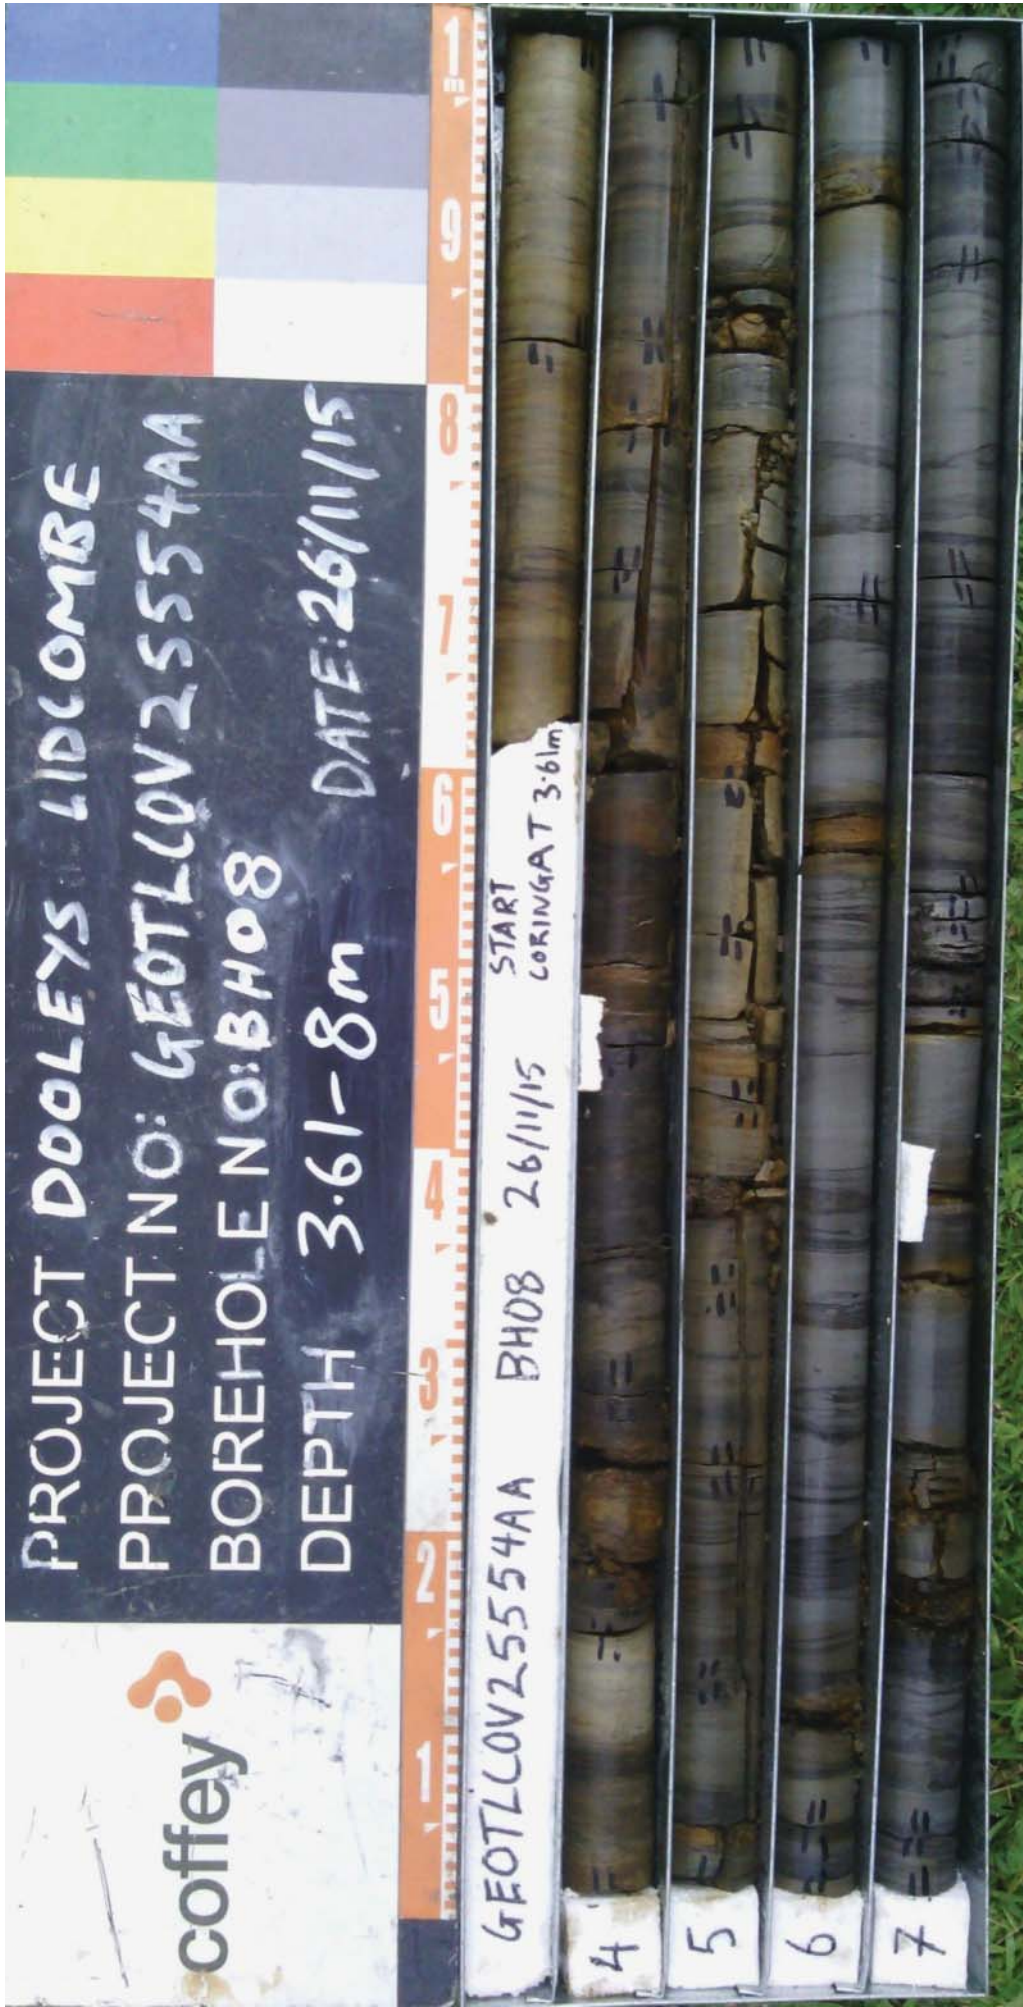
PointID : BH08 Depth Range: 3.61 - 8.00 m

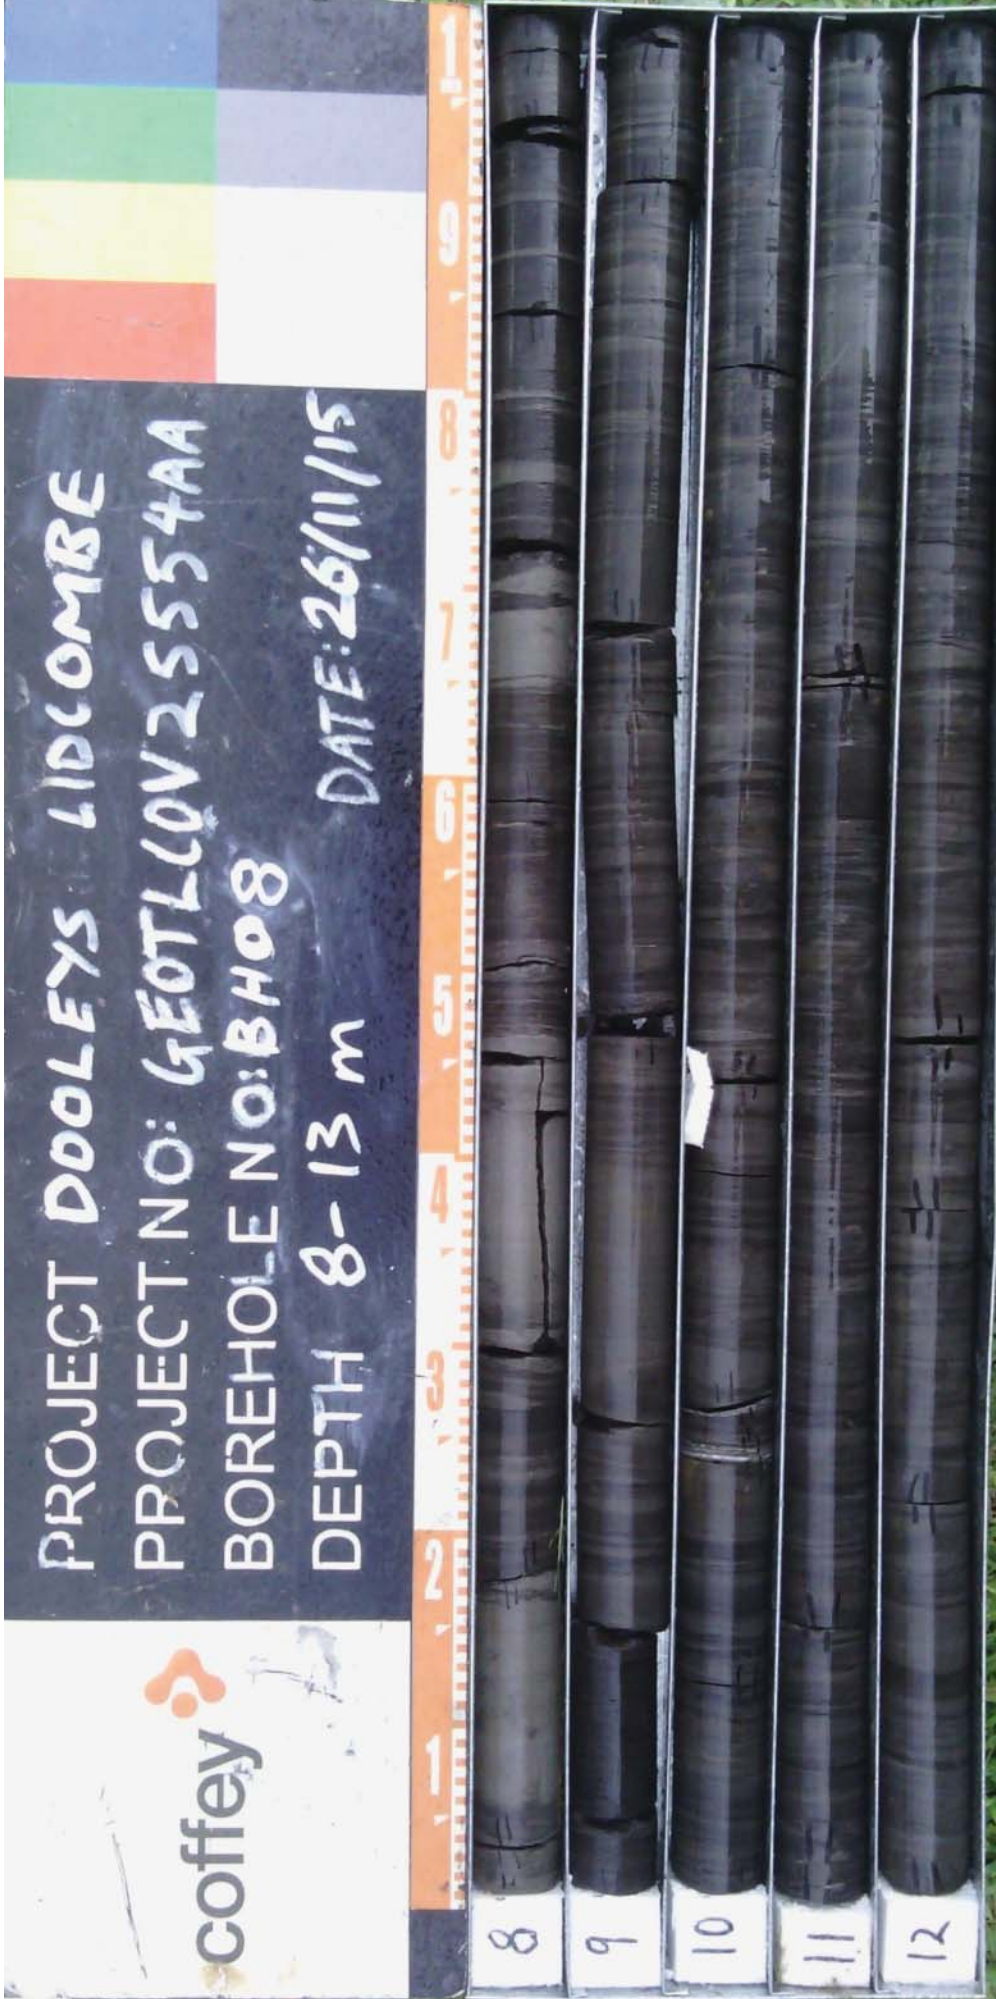
client:	Bouygues Construction Australia		
project:	Dooleys Lidcombe Club & Hotel Development 24-28 John St, Lidcombe NSW 2141		
title:	CORE PHOTOGRAPH BH08		
project no:	GEOTLCOV25554AA	fig no:	PHOTO 29
			rev:

PointID : BH08 Depth Range: 8.00 - 13.00 m
