Report on Geotechnical Investigation

Proposed North Kellyville New Primary School 120-126 Hezlett Road, Kellyville

Prepared for GHD Pty Ltd

Project 85998.00 August 2017

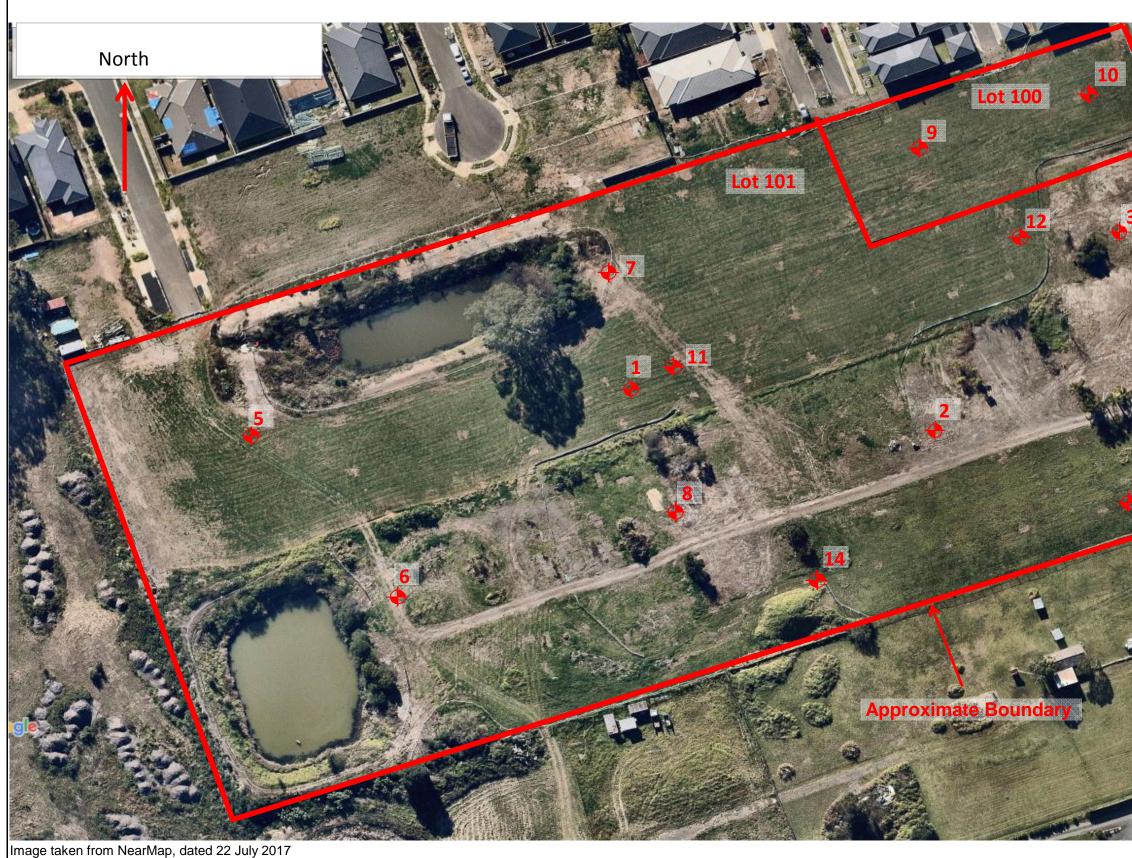
CLIENT:	GHD Pty Ltd			TITLE:	Test Location
OFFICE:	Sydney	DRAWN BY:	HDS		Proposed No
SCALE:	Not to Scale	DATE:	21.08.17		120-126 Hezle

Details of the conditions encountered in the boreholes are presented in Borehole Logs in Appendix C. Explanatory notes defining classification methods and descriptive terms used in logging the boreholes are also given in Appendix C.

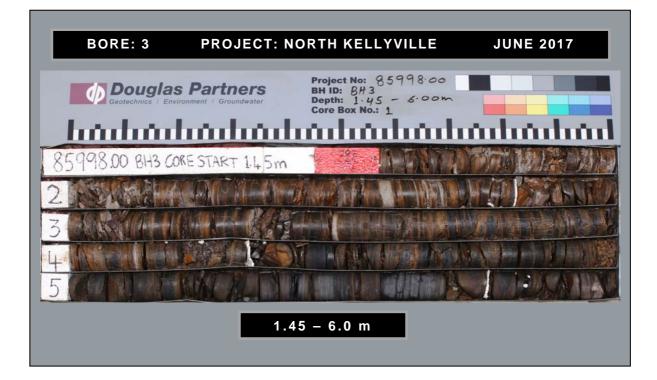
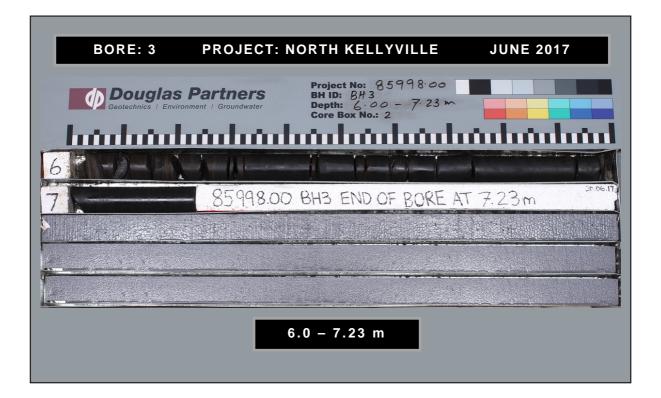
BORE No: 4 PROJECT No: 85998.00 DATE: 20/6/2017 SHEET 1 OF 1

TYPE OF BORING: 150mm diameter auger to 1.4m; NMLC-Coring to 7.23m WATER OBSERVATIONS: No free groundwater observed whilst augering REMARKS:

SURFACE LEVEL: 83 AHD EASTING: 310457 NORTHING: 6270453 DIP/AZIMUTH: 90°/--

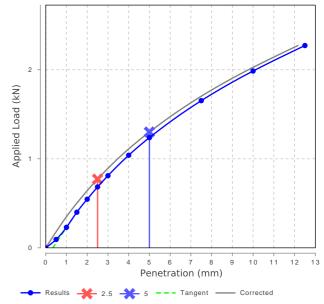
Report Number:	85998.00-2A
Issue Number:	1
Date Issued:	09/08/2017
Client:	GHD Pty Ltd
	Level 15/133 Castlereagh Street, Sydney NSW 2000
Project Number:	85998.00
Project Name:	Proposed New School
Project Location:	56-58 Hezlett Road, North Kellyville
Work Request:	1302
Sample Number:	17-1302E
Date Sampled:	28/07/2017
Sampling Method:	Sampled by Engineering Department
Sample Location:	14 (0.2-0.6m)
Material:	Orange brown silty clay filling

California Bearing Ratio (AS 1289 6.1.1 & 2.1.1)			Max
CBR taken at	5 mm		
CBR %	6		
Method of Compactive Effort	Stan	dard	
Method used to Determine MDD	AS 1289 5.	1.1 & 2	2.1.1
Maximum Dry Density (t/m ³)	1.69		
Optimum Moisture Content (%)	20.5		
Laboratory Density Ratio (%)	100.0		
Laboratory Moisture Ratio (%)	100.5		
Dry Density after Soaking (t/m ³)	1.69		
Field Moisture Content (%)	21.7		
Moisture Content at Placement (%)	20.5		
Moisture Content Top 30mm (%)	22.6		
Moisture Content Rest of Sample (%)	21.6		
Mass Surcharge (kg)	4.5		
Soaking Period (days)	4		
Swell (%)	0.0		
Oversize Material (mm)	19		
Oversize Material Included	Excluded		
Oversize Material (%)	0

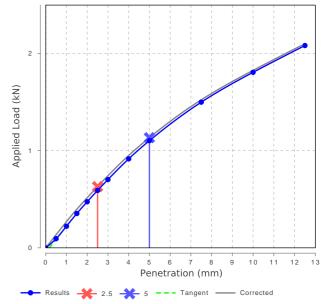
Report Number:	85998.00-2A
Issue Number:	1
Date Issued:	09/08/2017
Client:	GHD Pty Ltd
	Level 15/133 Castlereagh Street, Sydney NSW 2000
Project Number:	85998.00
Project Name:	Proposed New School
Project Location:	56-58 Hezlett Road, North Kellyville
Work Request:	1302
Sample Number:	17-1302F
Date Sampled:	28/07/2017
Sampling Method:	Sampled by Engineering Department
Sample Location:	11 (0.1-0.4m)
Material:	Grey shale

California Bearing Ratio (AS 1289 6.1.1 & 2.1.1)			Max
CBR taken at	5 mm		
CBR %	9		
Method of Compactive Effort	Stan	dard	
Method used to Determine MDD	AS 1289 5.	1.1 & 2	2.1.1
Maximum Dry Density (t/m ³)	1.70		
Optimum Moisture Content (%)	18.0		
Laboratory Density Ratio (%)	100.0		
Laboratory Moisture Ratio (%)	100.0		
Dry Density after Soaking (t/m ³)	1.69		
Field Moisture Content (%)	15.4		
Moisture Content at Placement (%)	17.8		
Moisture Content Top 30mm (%)	21.4		
Moisture Content Rest of Sample (%)	20.6		
Mass Surcharge (kg)	4.5		
Soaking Period (days)	4		
Swell (%)	1.0		
Oversize Material (mm)	19		
Oversize Material Included	Excluded		
Oversize Material (%)	0

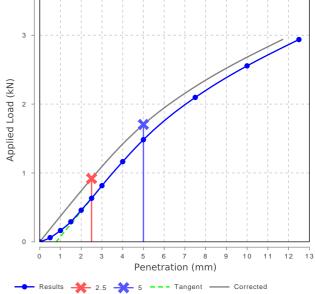
Report Number:	85998.00-2A
Issue Number:	1
Date Issued:	09/08/2017
Client:	GHD Pty Ltd
	Level 15/133 Castlereagh Street, Sydney NSW 2000
Project Number:	85998.00
Project Name:	Proposed New School
Project Location:	56-58 Hezlett Road, North Kellyville
Work Request:	1302
Sample Number:	17-1302G
Date Sampled:	28/07/2017
Sampling Method:	Sampled by Engineering Department
Sample Location:	13 (0.4-0.6m)
Material:	Red-brown silty clay filling

California Bearing Ratio (AS 1289 6.1.1 & 2.1.1)			Max
CBR taken at	5 mm		
CBR %	7		
Method of Compactive Effort	Stan	dard	
Method used to Determine MDD	AS 1289 5	1.1 &	2.1.1
Maximum Dry Density (t/m ³)	1.70		
Optimum Moisture Content (%)	19.5		
Laboratory Density Ratio (%)	100.0		
Laboratory Moisture Ratio (%)	100.0		
Dry Density after Soaking (t/m ³)	1.69		
Field Moisture Content (%)	18.4		
Moisture Content at Placement (%)	19.5		
Moisture Content Top 30mm (%)	21.0		
Moisture Content Rest of Sample (%)	20.2		
Mass Surcharge (kg)	4.5		
Soaking Period (days)	4		
Swell (%)	0.0		
Oversize Material (mm)	19		
Oversize Material Included	Excluded		
Oversize Material (%)	0
