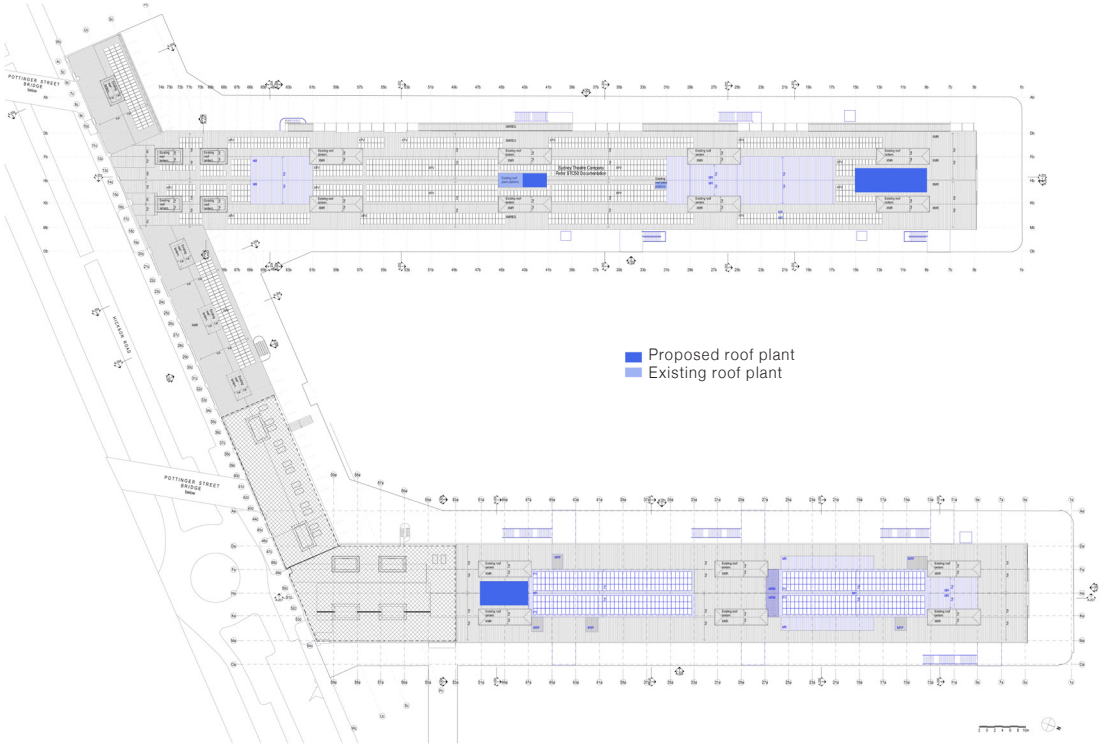
Figure 20: Roof plan showing proposed and existing plant platforms

The external roof plant is proposed to be located on simple steel framed platforms set in the valleys, between the two ridge lines, to ensure that it will not be visible from the public domain. It is not proposed to be screened.

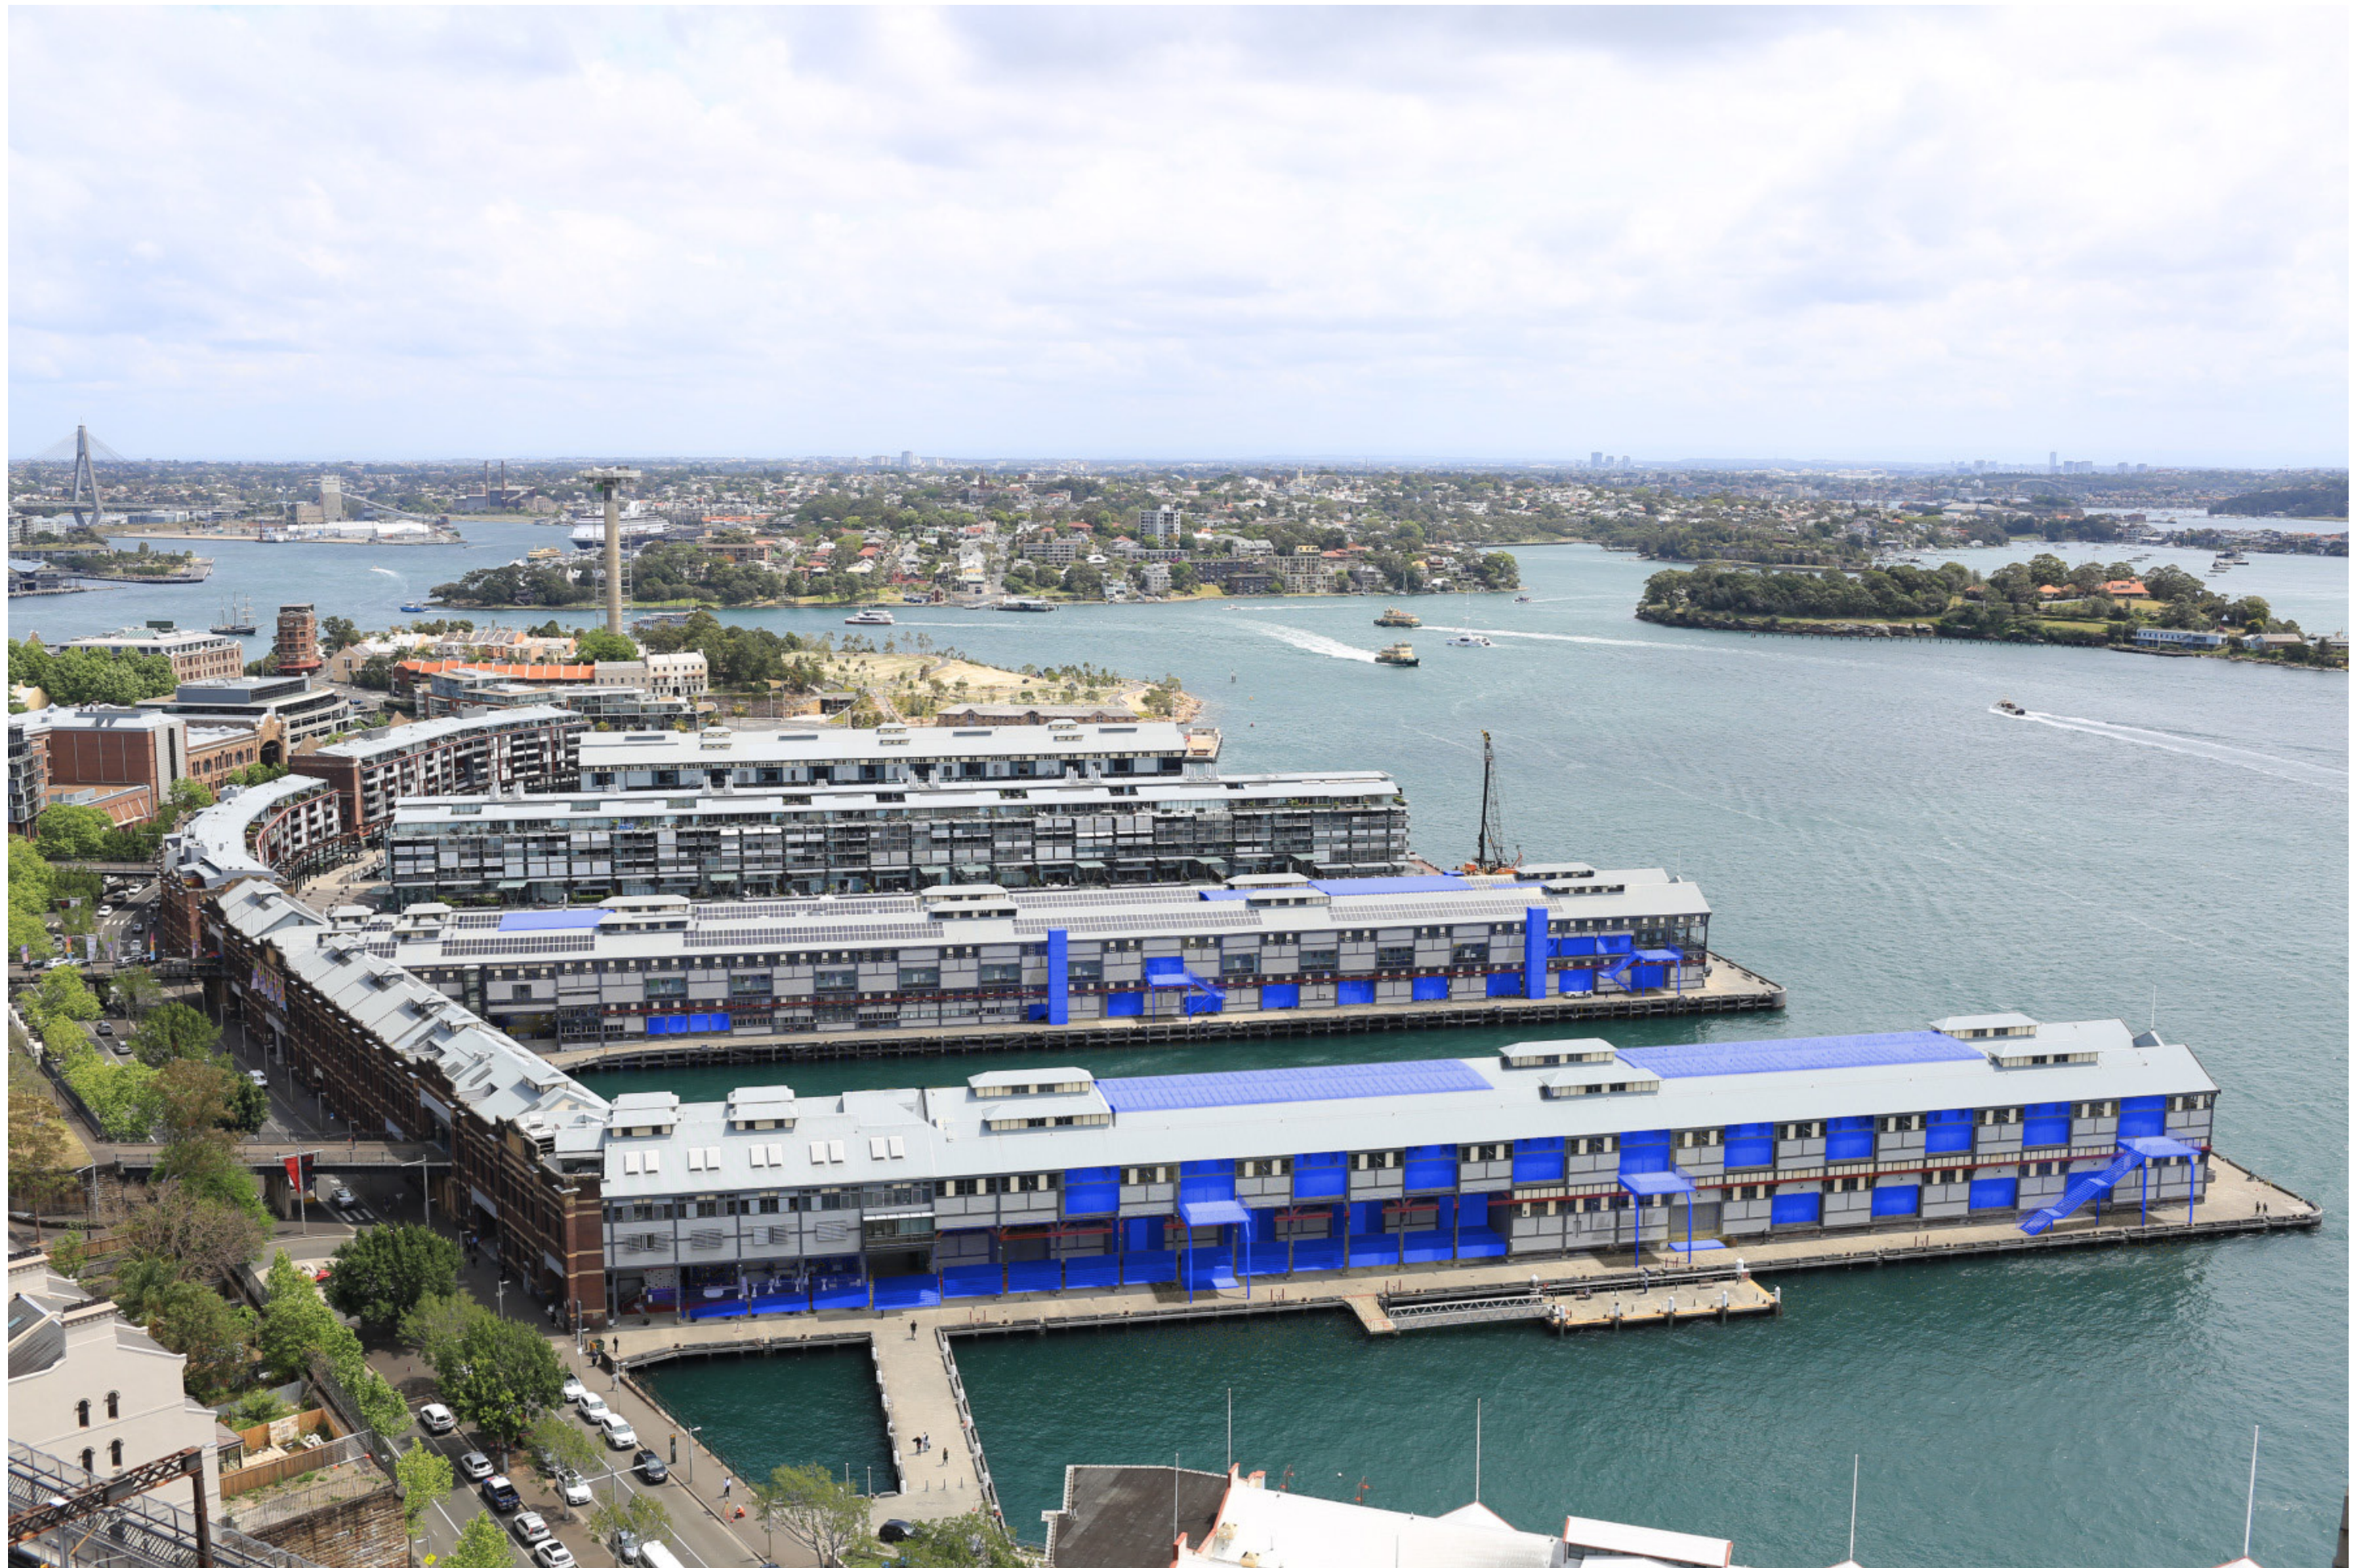
Figure 21: Visual Impact Assessment View
 Source: Mogamma 2017

The Visual Impact Assessment that accompanies the proposal, demonstrates that the roof plant will only be visible from above – from the Harbour Bridge and higher areas of Millers Point – as per the existing roof plant on Wharf 4/5, and will not compromise appreciation of the heritage significance of the place. Oblique views will not be possible, therefore screening would not prevent views from these angles.
