1 k) Original Flooring Treatment

Heritage Council Comment 1 k)

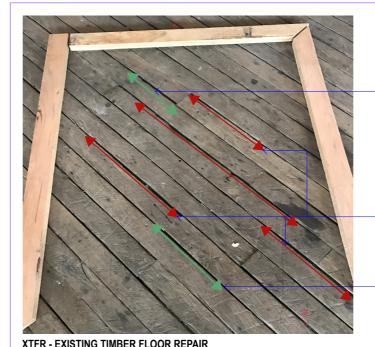
Floor Repair Notes

More than 5mm vertical height variation. Sand high section, sanding to be kept to an absolute minimum on raised boards only. Sand with 100grit only, not high polished.

More than 10mm gap between boards required to be filled. Fill gaps with scribed timber fillet.

- Timber fillets to match existing timber type.

Where possible re-use salvaged boards. No finish.

Typical floor repair to comply with DDA consultant's requirements

This is only a small representational sample only, allow to repair all visible existing timber floors.

No finish to existing floor. Minimise floor repair and sanding in line with heritage requirements.

For Level 1 floors all joints more than 5mm should be filled all gaps to be fully silicone sealed to ensure water tight seal between floors.

Provide a 3mx3m fully finished prototype of the repairs for approval by the Architect and Heritage Architect prior to undertaking any work on the existing floors.
