Report on
Detailed Site Investigation

Parramatta Leagues Club Hotel
1 Eels Place, Parramatta

Project 94523.00
December 2018

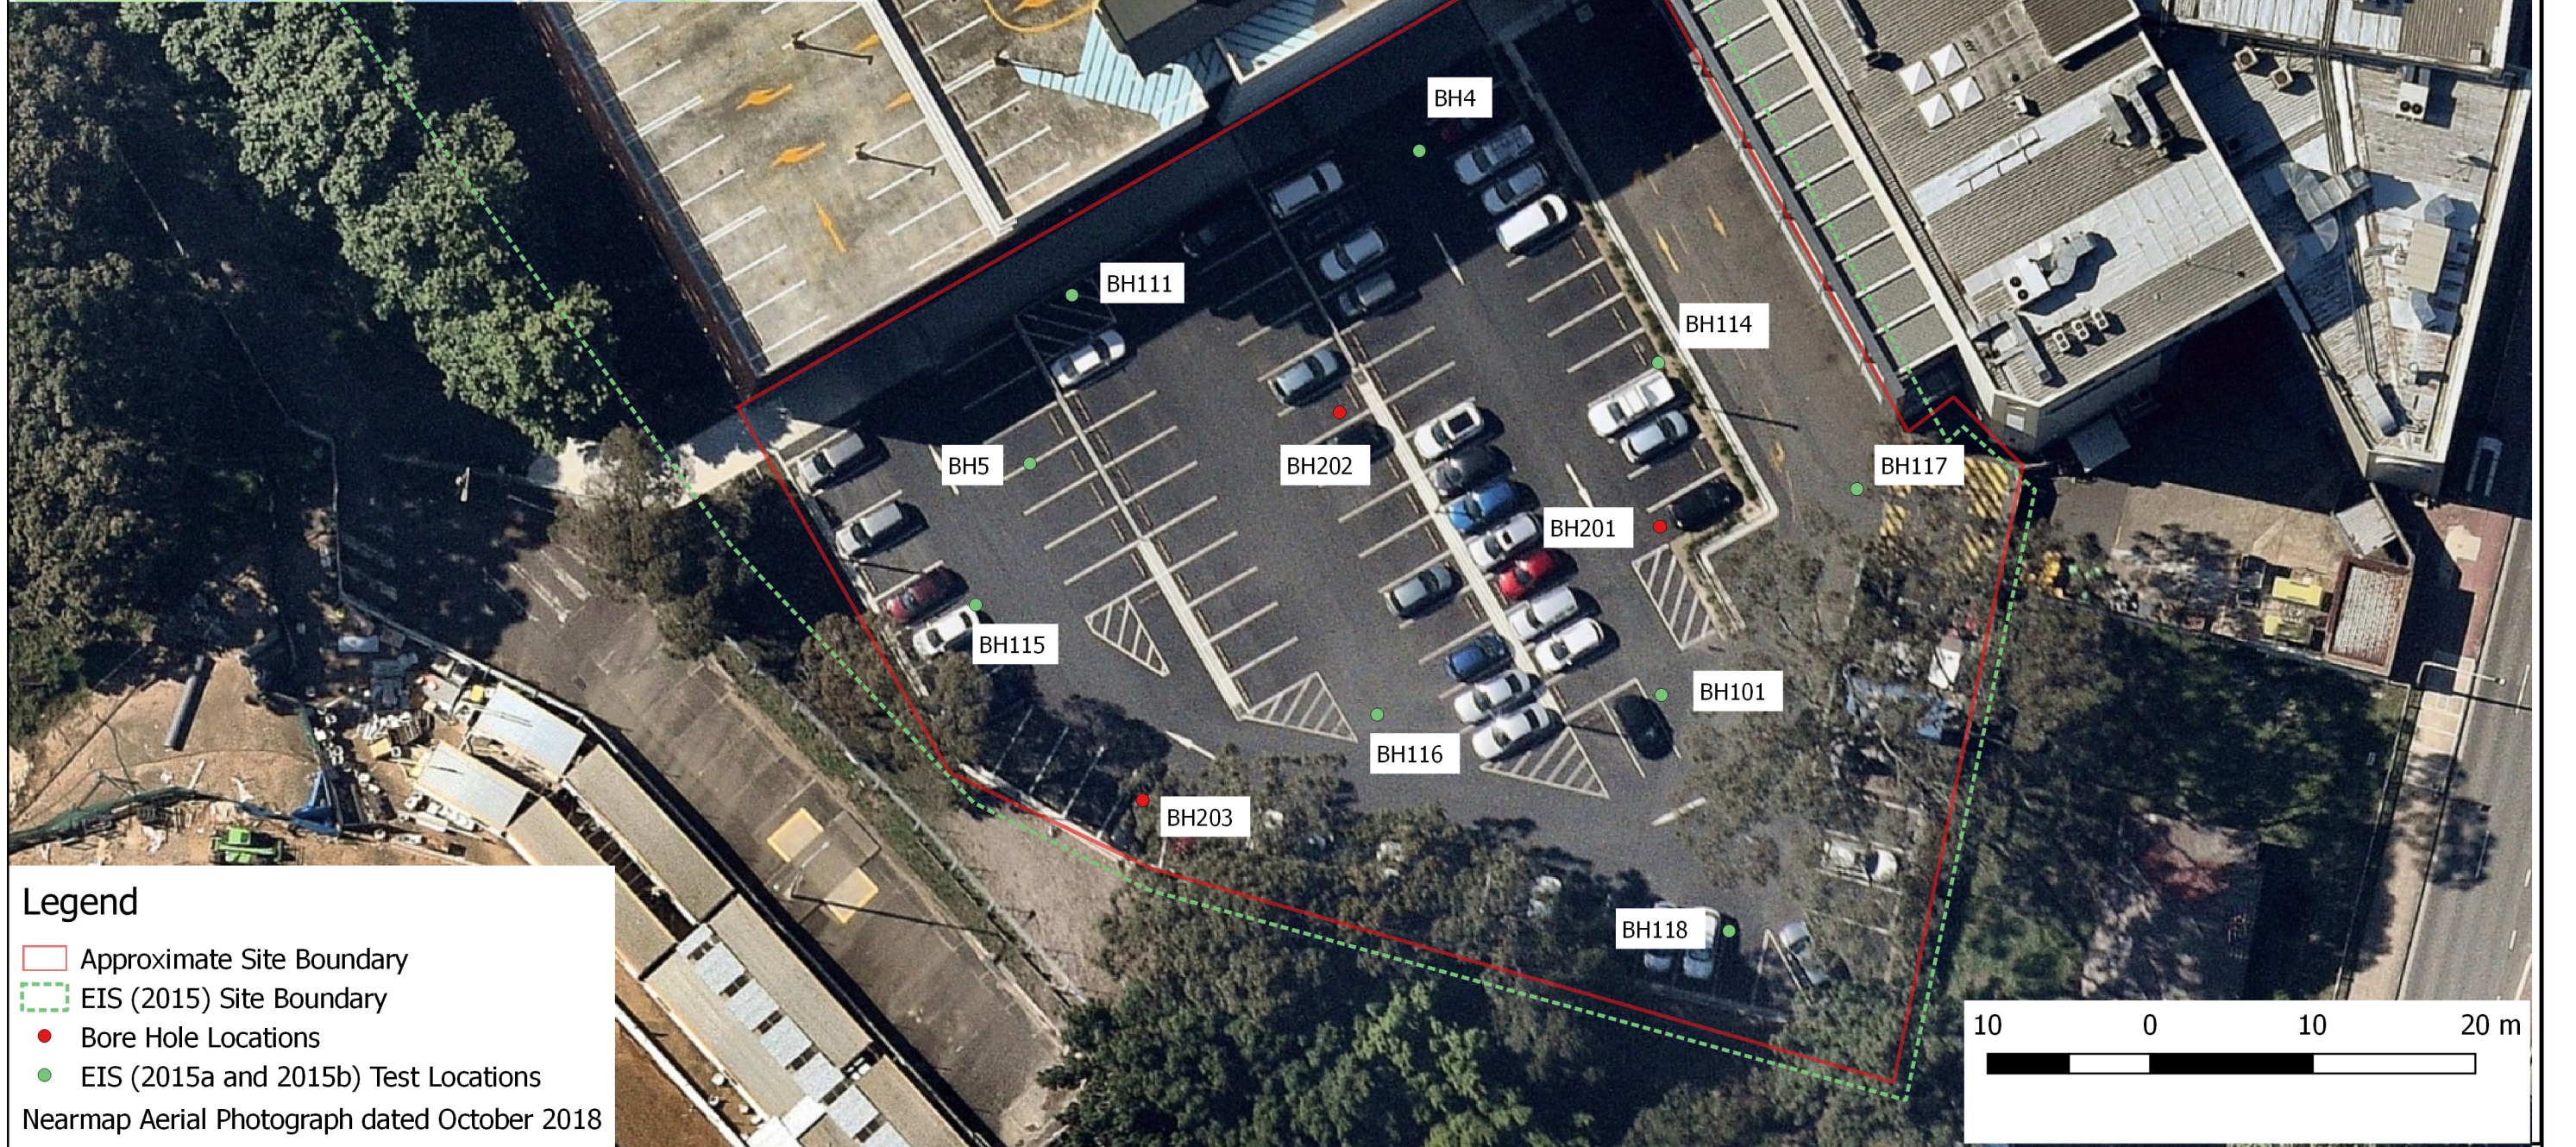
- Approximate Site Boundary
- EIS (2015) Site Boundary
- Bore Hole Locations
- EIS (2015a and 2015b) Test Locations

For a 12,500m² site a minimum of 23 sampling points are recommended (NSW EPA Contaminated Sites Sampling Design Guidelines, 1995). This investigation included the drilling of 18 boreholes, seven of which (BH101, BH111, BH114 to BH118) were located in the current site boundary. The investigation also included the results of the five boreholes drilled previously as part of EIS (2015a). The total density (23 locations) met the minimum sampling density recommended.
