Remediation Action Plan

Proposed PLC Hotel Development
1 Eels Place, Parramatta, NSW

Prepared for
Parramatta Leagues Club

Project 94523.00
December 2018

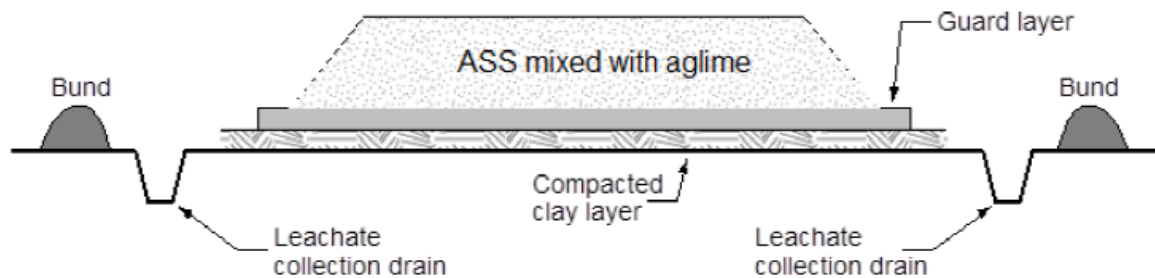
Figure 1: Schematic cross-section of a treatment pad, including clay layer, guard layer, leachate collection drain and bunding⁵

Figure 1 shows a cross section of a typical treatment pad.
