Cranbrook School - Hazardous Materials Survey and Management Plan

Client: Cranbrook School
Title: Cranbrook School - Hazardous Materials Survey and Management Plan
Document No: 2189256A-HAZ-HMP-001 RevB
Date: 3 June 2013

In April 2012, Parsons Brinckerhoff was commissioned by Cranbrook School to undertake a Hazardous Materials survey to identify and conduct risk assessments of the hazardous materials identified within all buildings located at its Rosebay Senior School Campus.

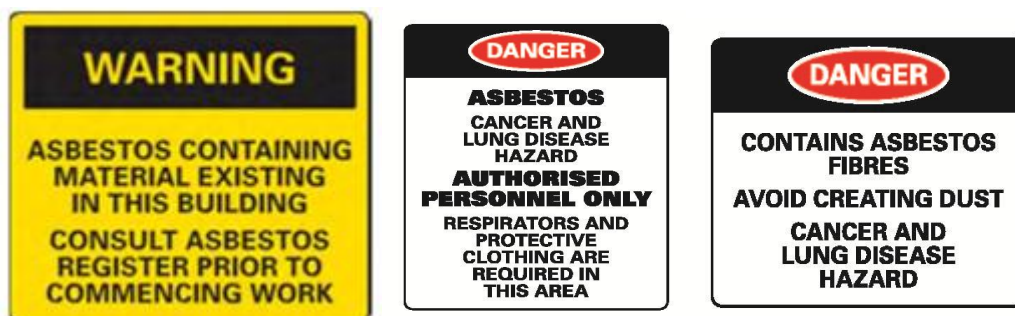
Where practicable such as on asbestos cement wall cladding and ceiling linings, asbestos warning labels should be fixed. These should be consistent with locations listed in the hazardous materials register.

An example of signage and labels that should be utilised is presented below.
