**Project No.: 63407**

**FLOODING RISK ASSESSMENT**

**STEVENSON LIBRARY UPGRADE**

**THE SCOTS COLLEGE**

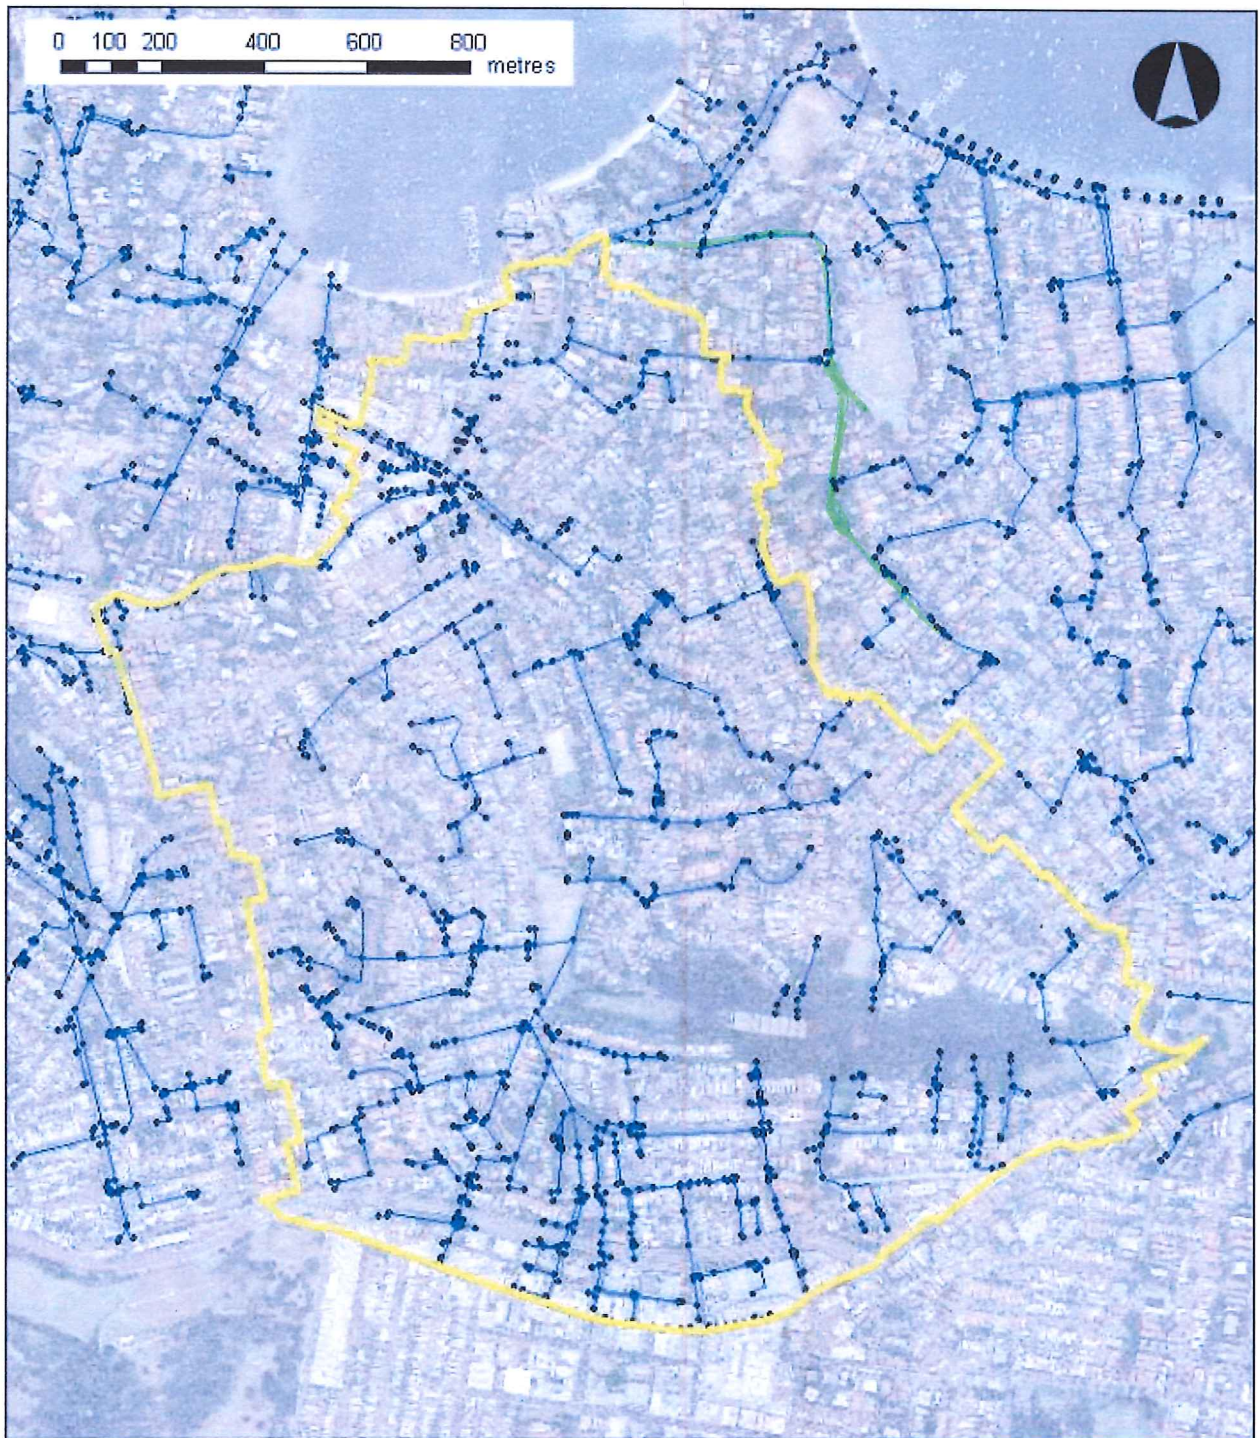
*Figure 9: Main Double Bay Modelled Area showing Aerial Photograph*

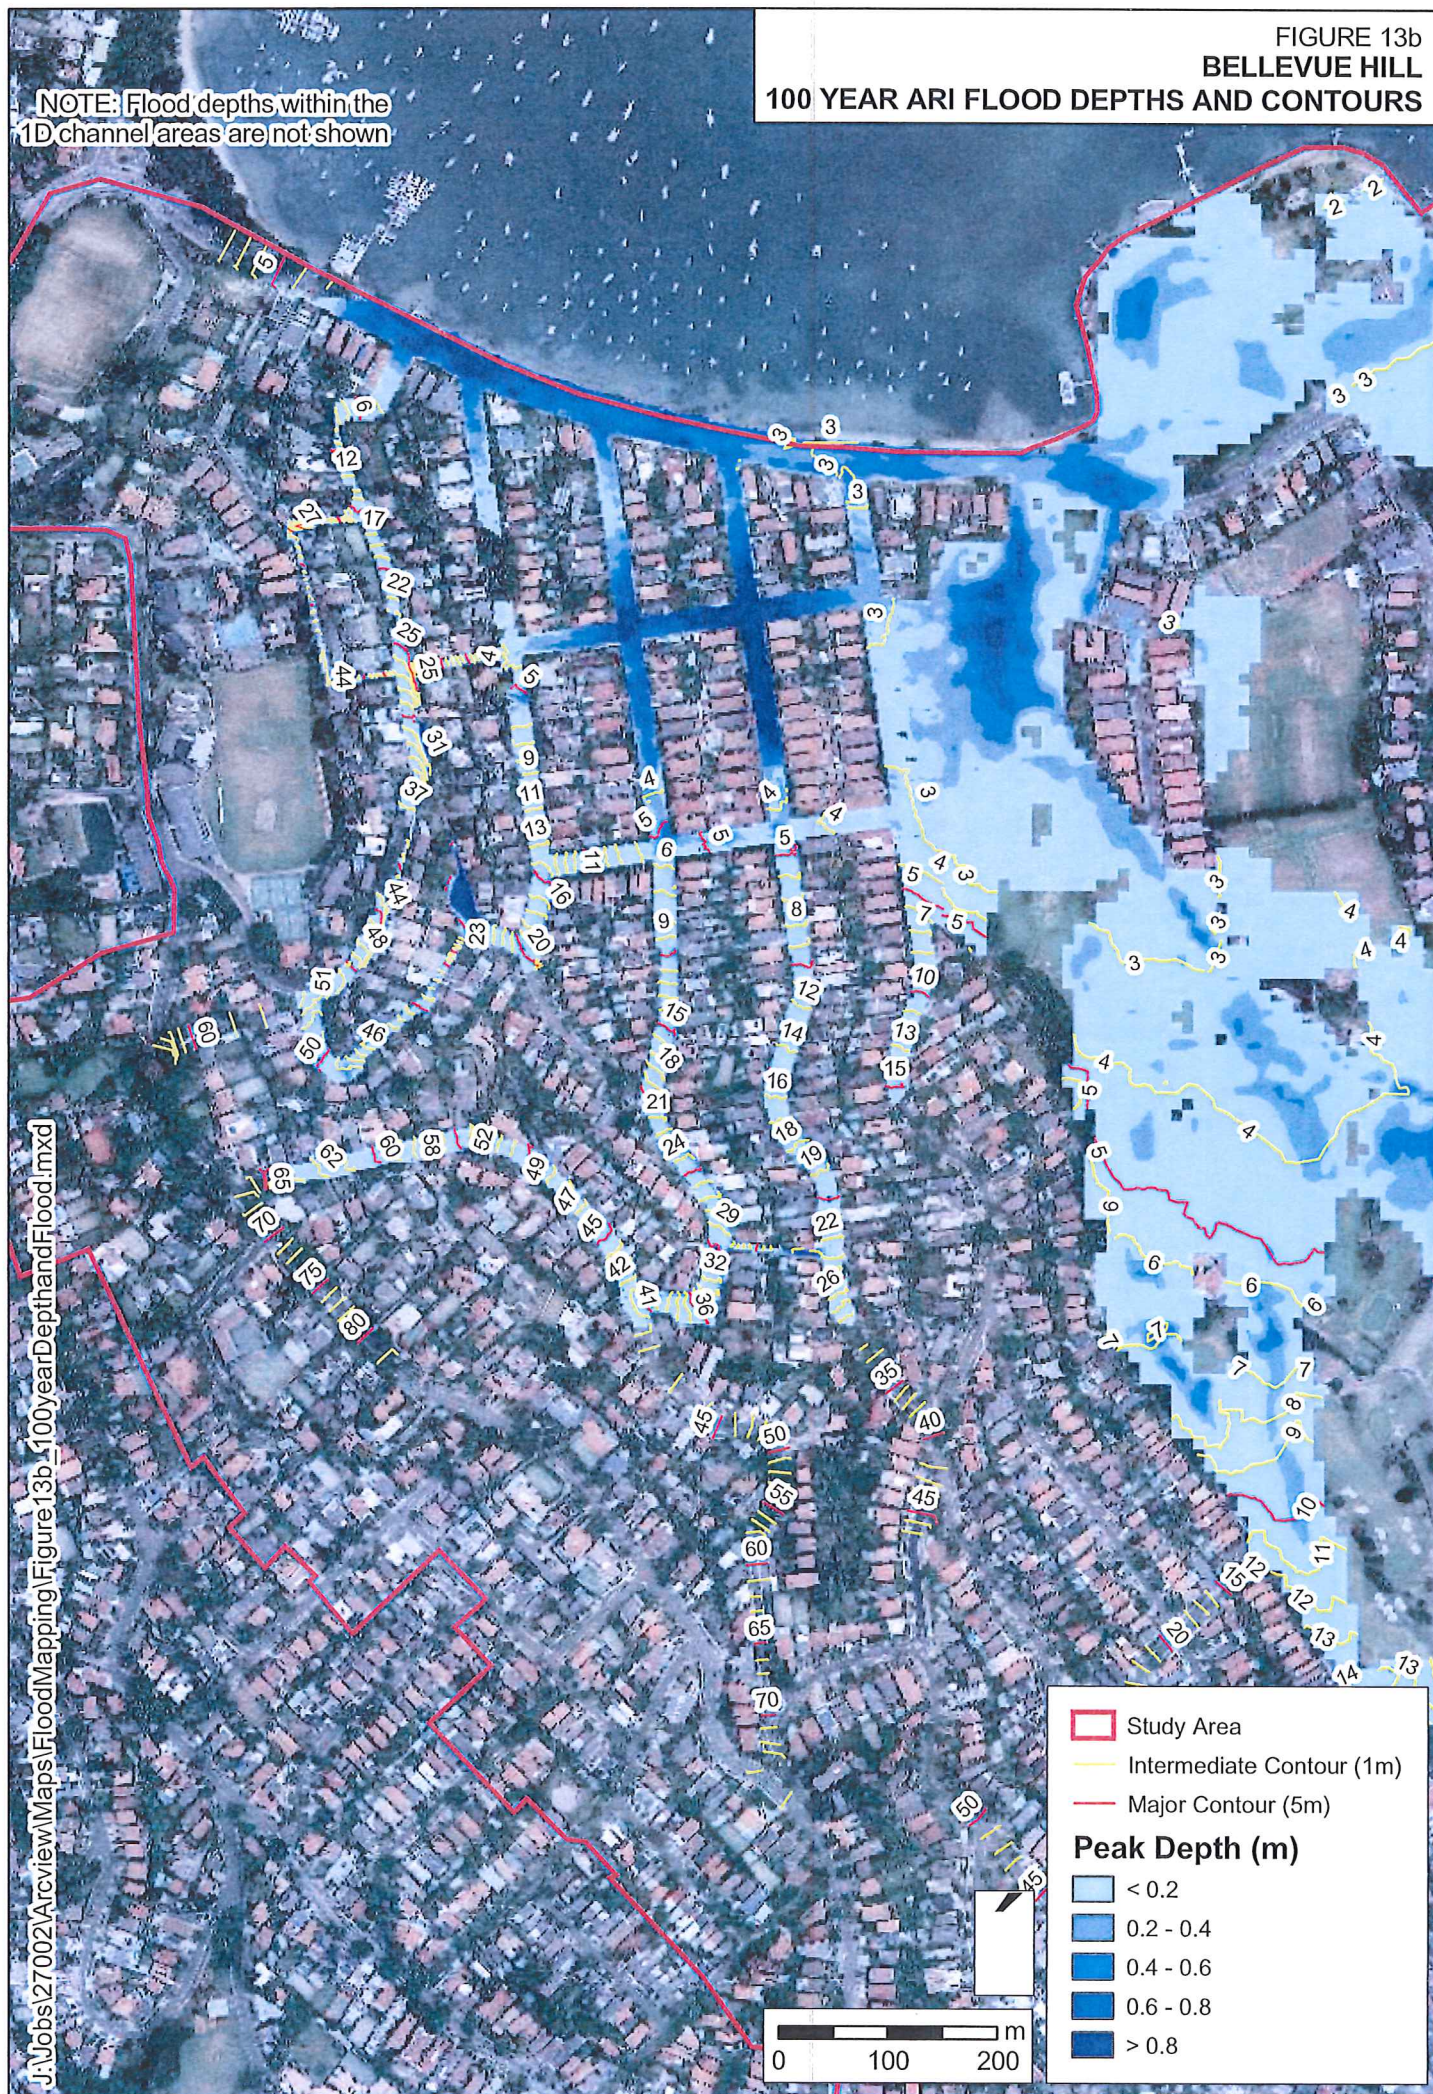
FIGURE 13b  
BELLEVUE HILL  
100 YEAR ARI FLOOD DEPTHS AND CONTOURS

NOTE: Flood depths within the  
1D channel areas are not shown

The Flood Maps from Rose Bay Flood Study – Woollahra Council (Fig 13b) confirm the Councils 100yr ARI Flood depths and contours. Refer to map attached.

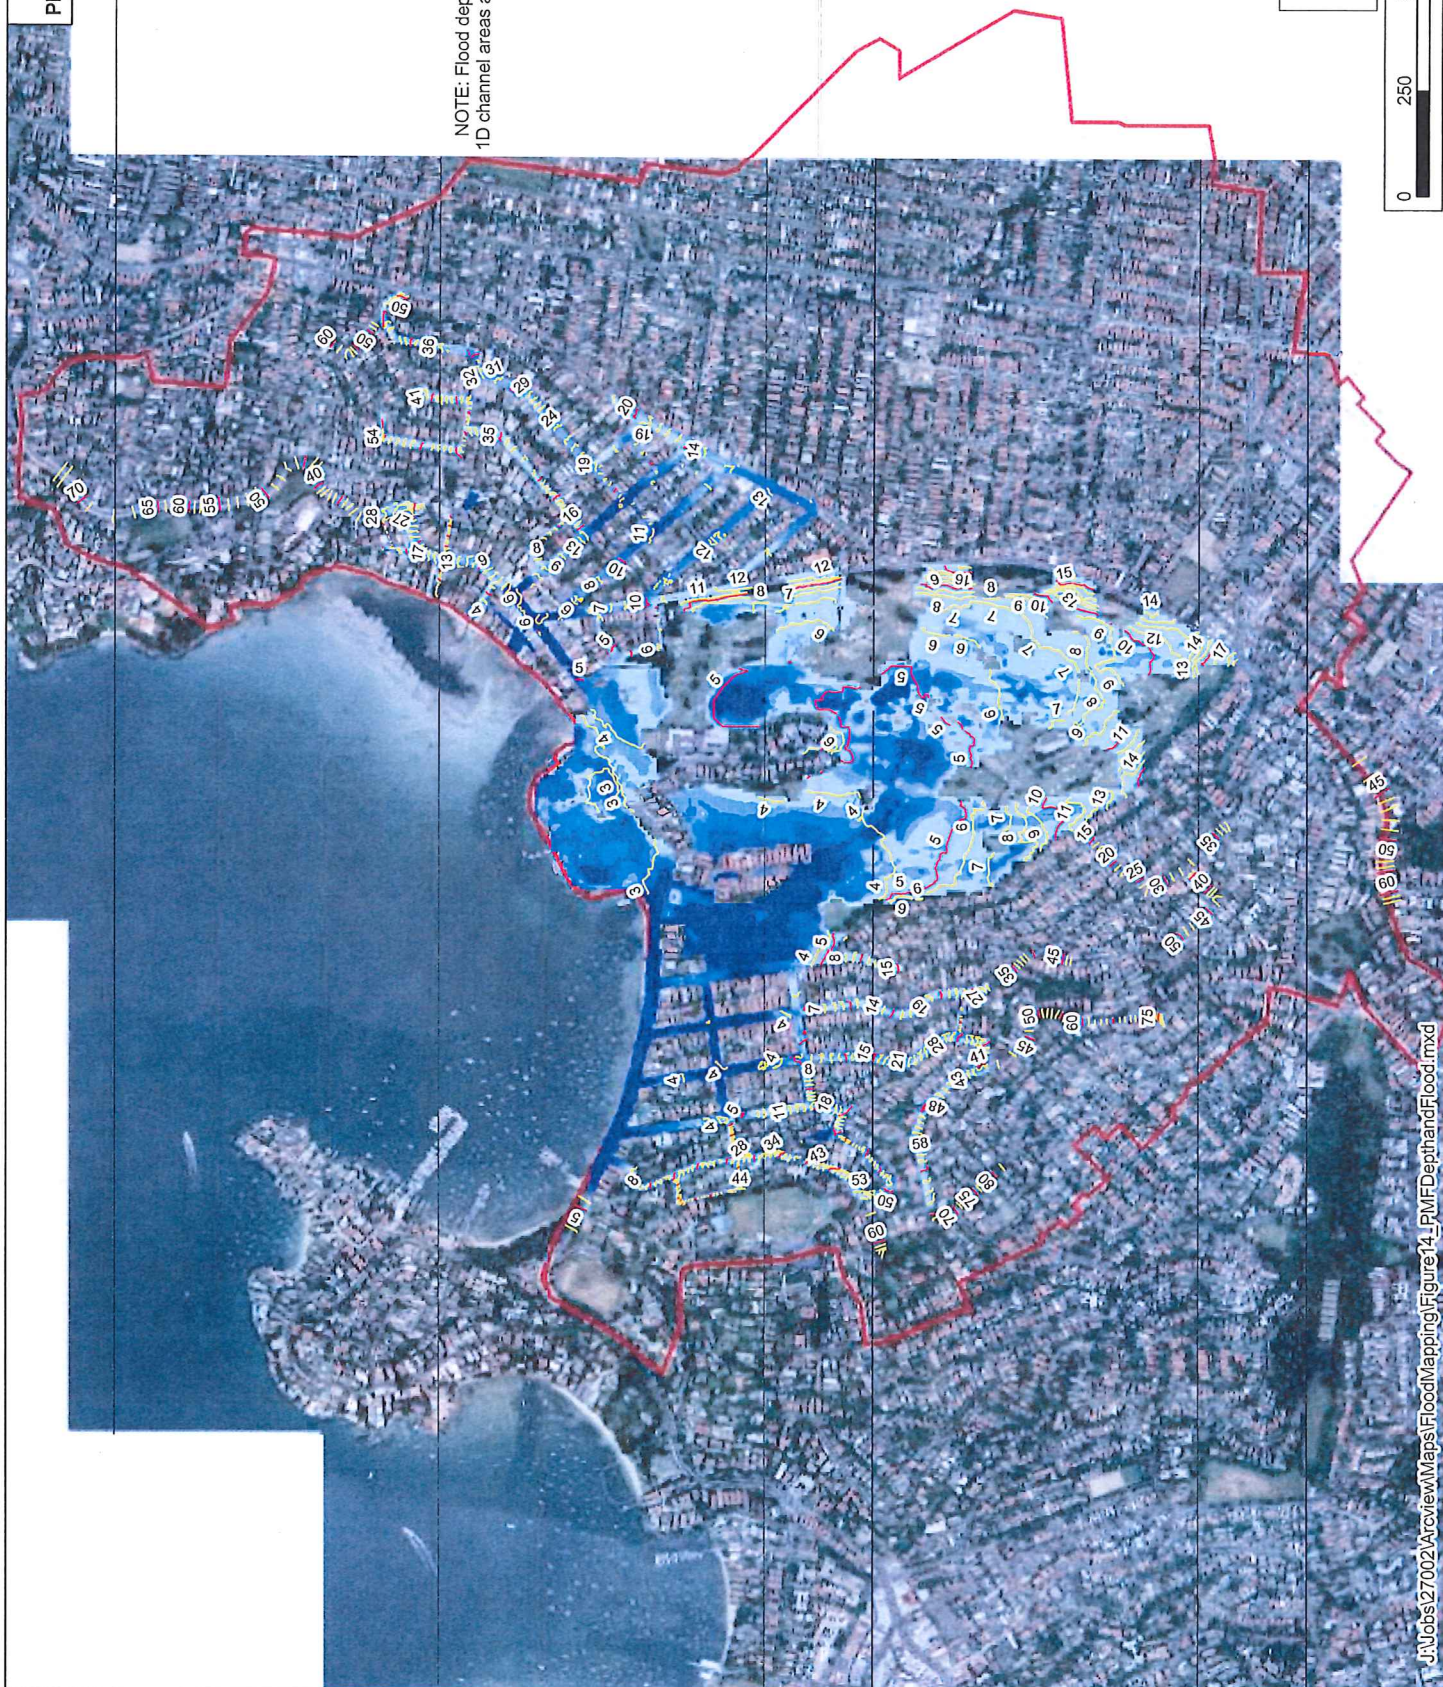
FIGURE 14  
PMF FLOOD DEPTHS AND CONTOURS

NOTE: Flood depths within the  
1D channel areas are not shown

The Flood Maps from Rose Bay Flood Studies – Woollahra Council (Fig 14) confirm the Councils PMF (Probable maximum Flood) Flood depths and contours. Refer to maps attached.
