REPORT TO  
**LORETO NORMANHURST C/- ALLEN JACK +  
COTTIER**

ON  
**REMEDIATION ACTION PLAN (RAP)**

FOR  
**PROPOSED STAGE 1 WORKS AREA**

AT  
**LORETO NORMANHURST GIRLS SCHOOL,  
91-93 PENNANT HILLS ROAD,  
NORMANHURST, NSW**

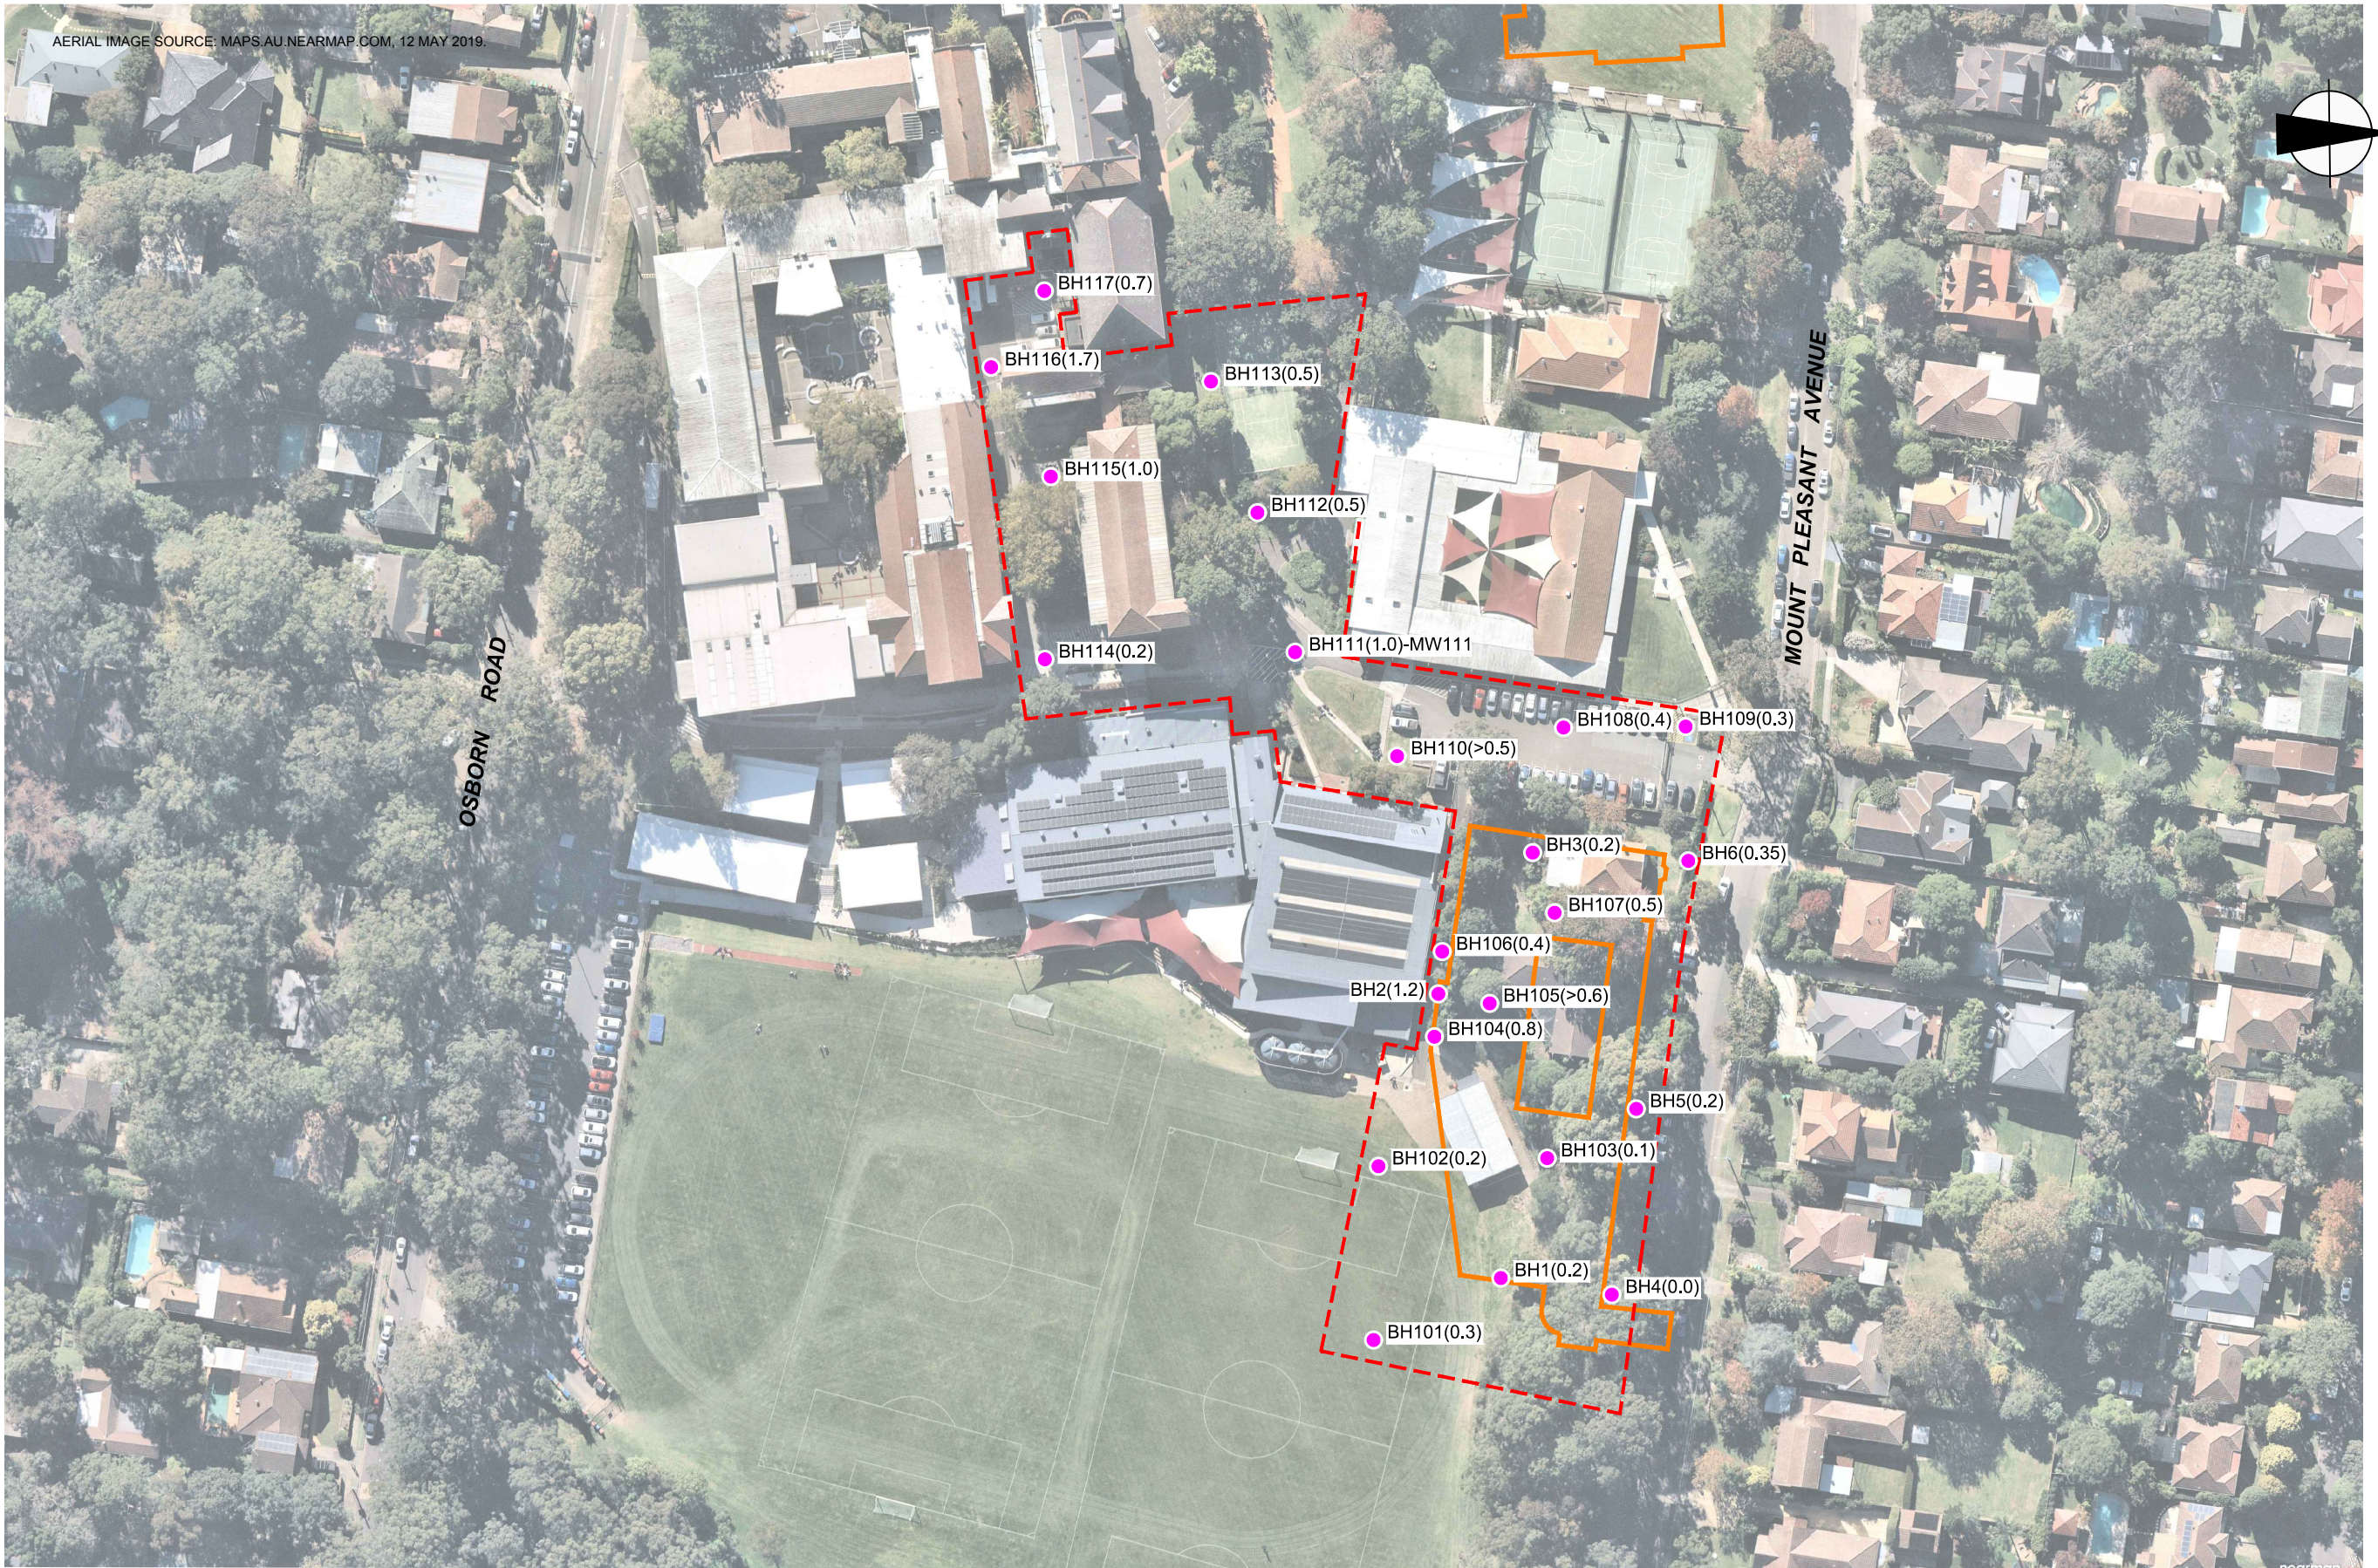
- APPROXIMATE SITE BOUNDARY
- BH (Fill Depth) BOREHOLE LOCATION, NUMBER AND DEPTH OF FILL (m)
- APPROXIMATE OUTLINE OF PROPOSED BUILDING

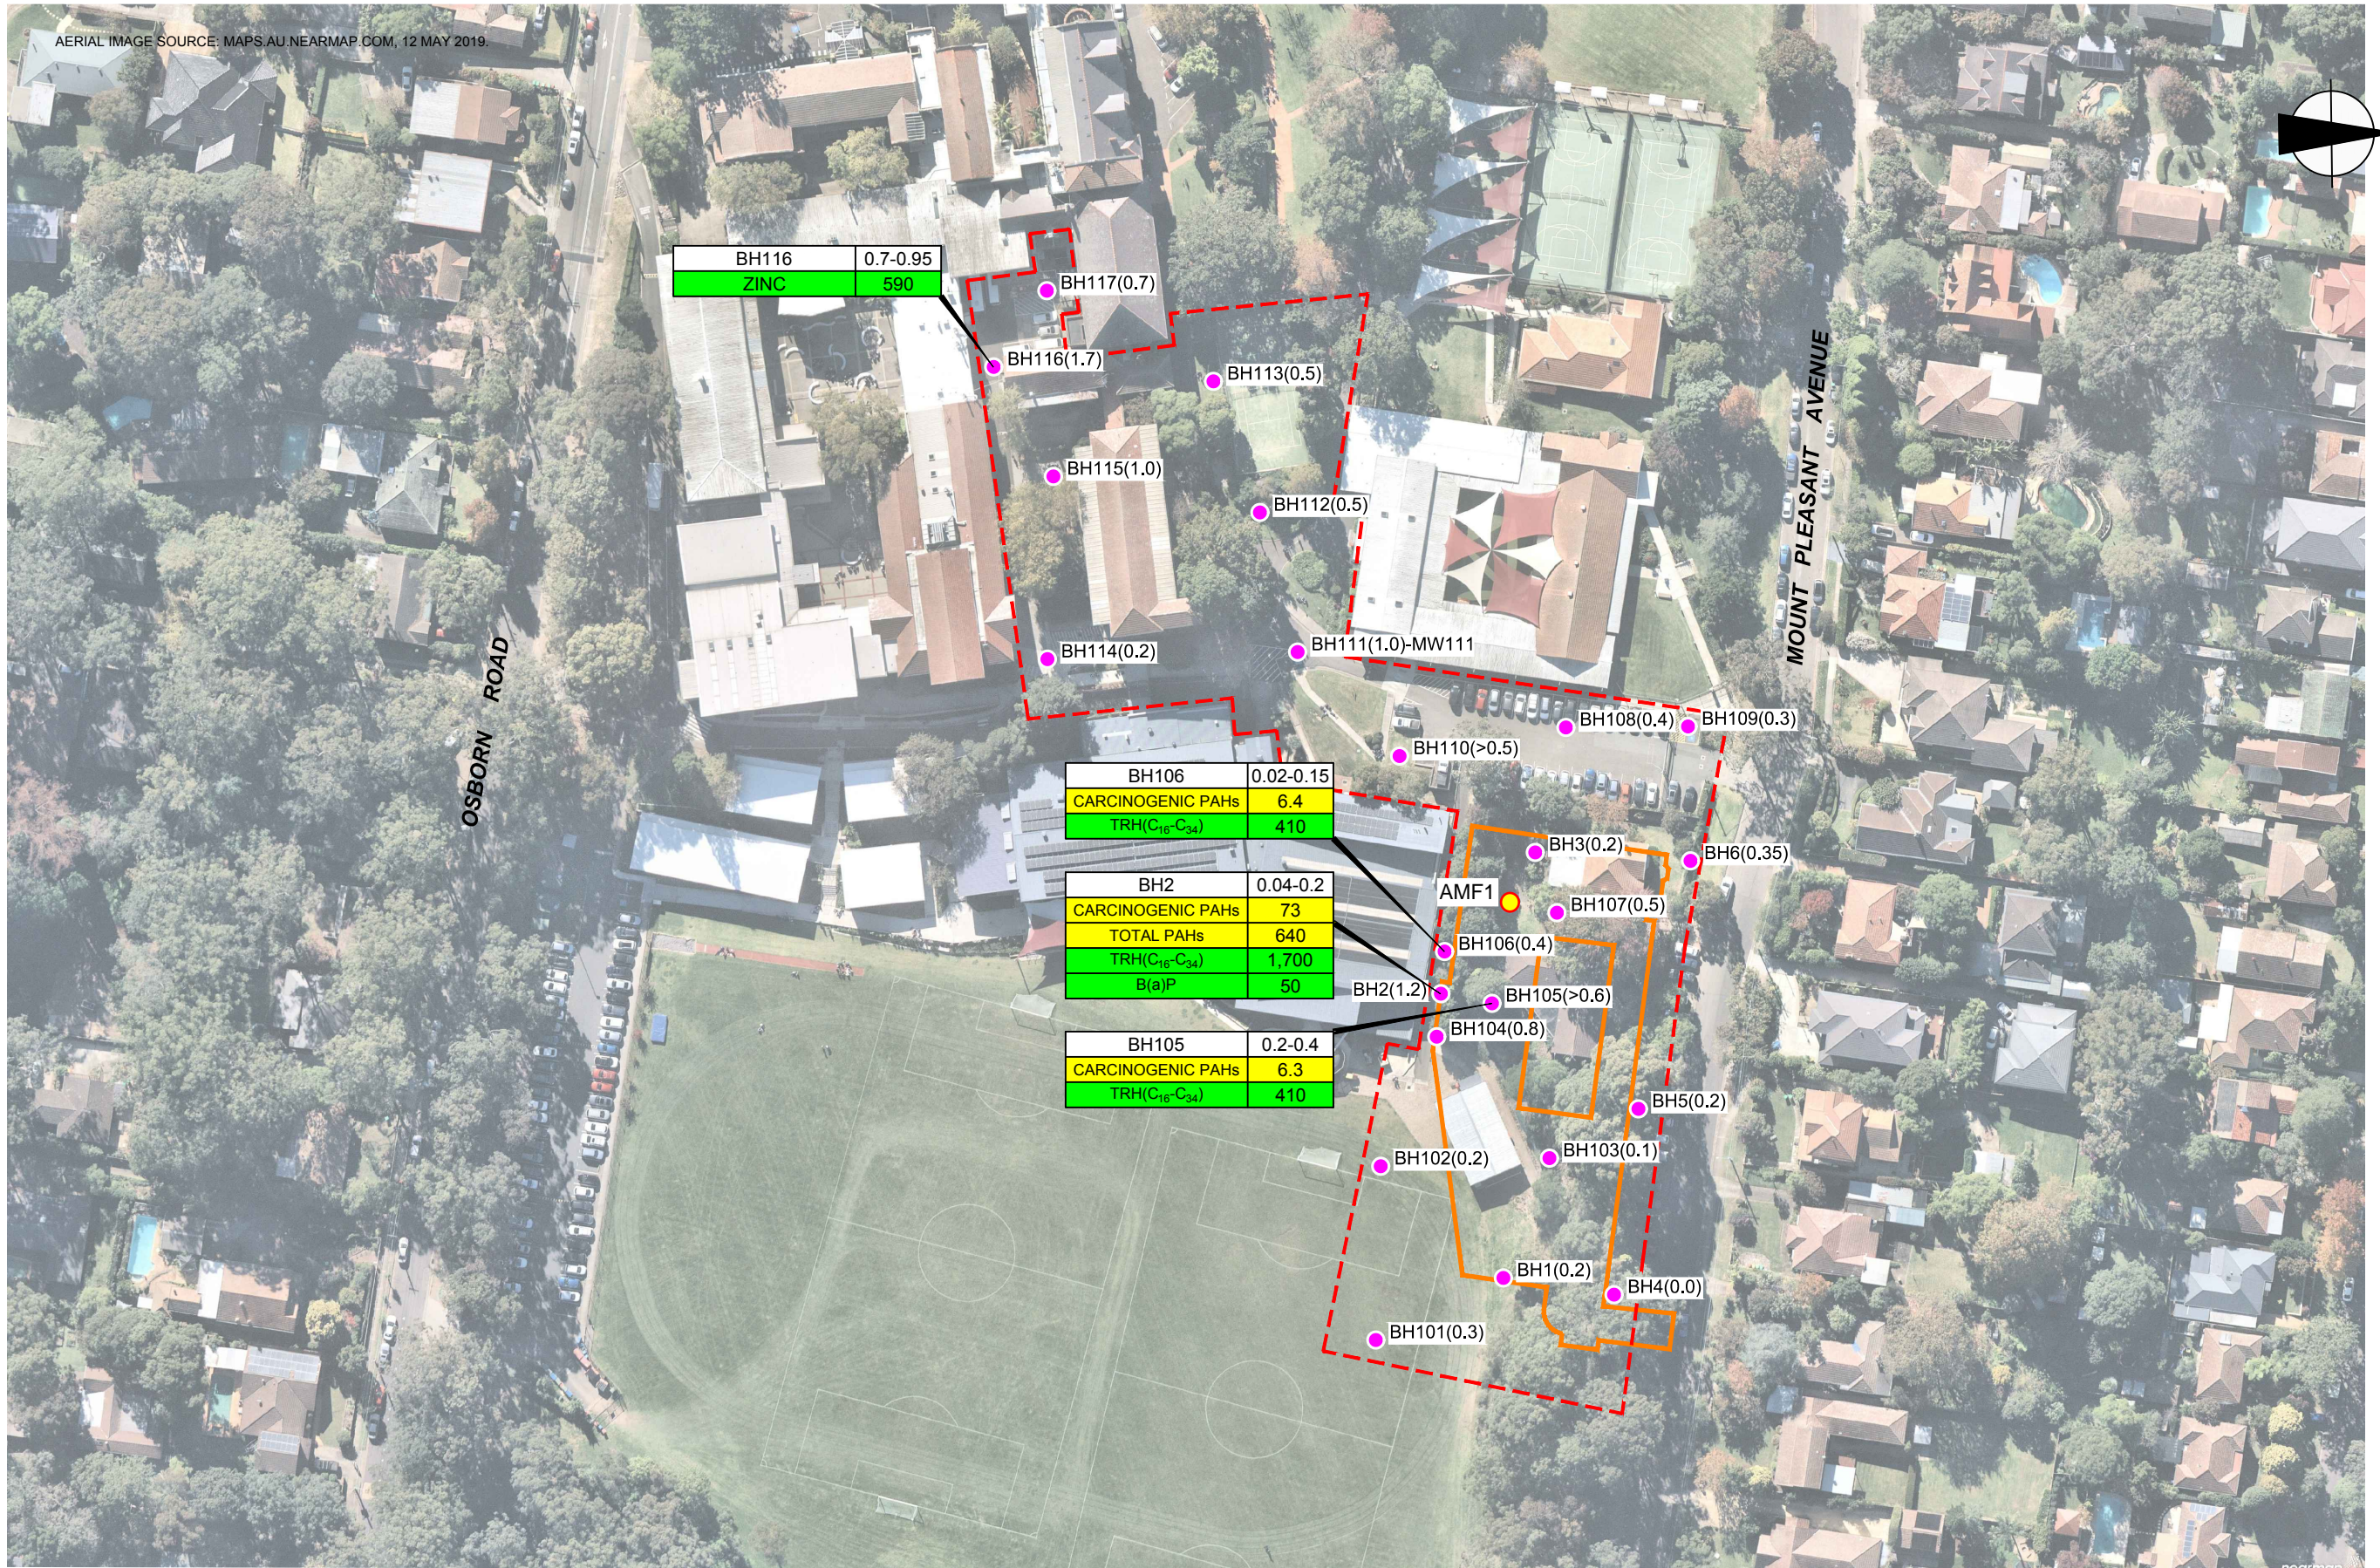
- APPROXIMATE SITE BOUNDARY
- BH (Fill Depth) BOREHOLE LOCATION, NUMBER AND DEPTH OF FILL (m)
- APPROXIMATE OUTLINE OF PROPOSED BUILDING

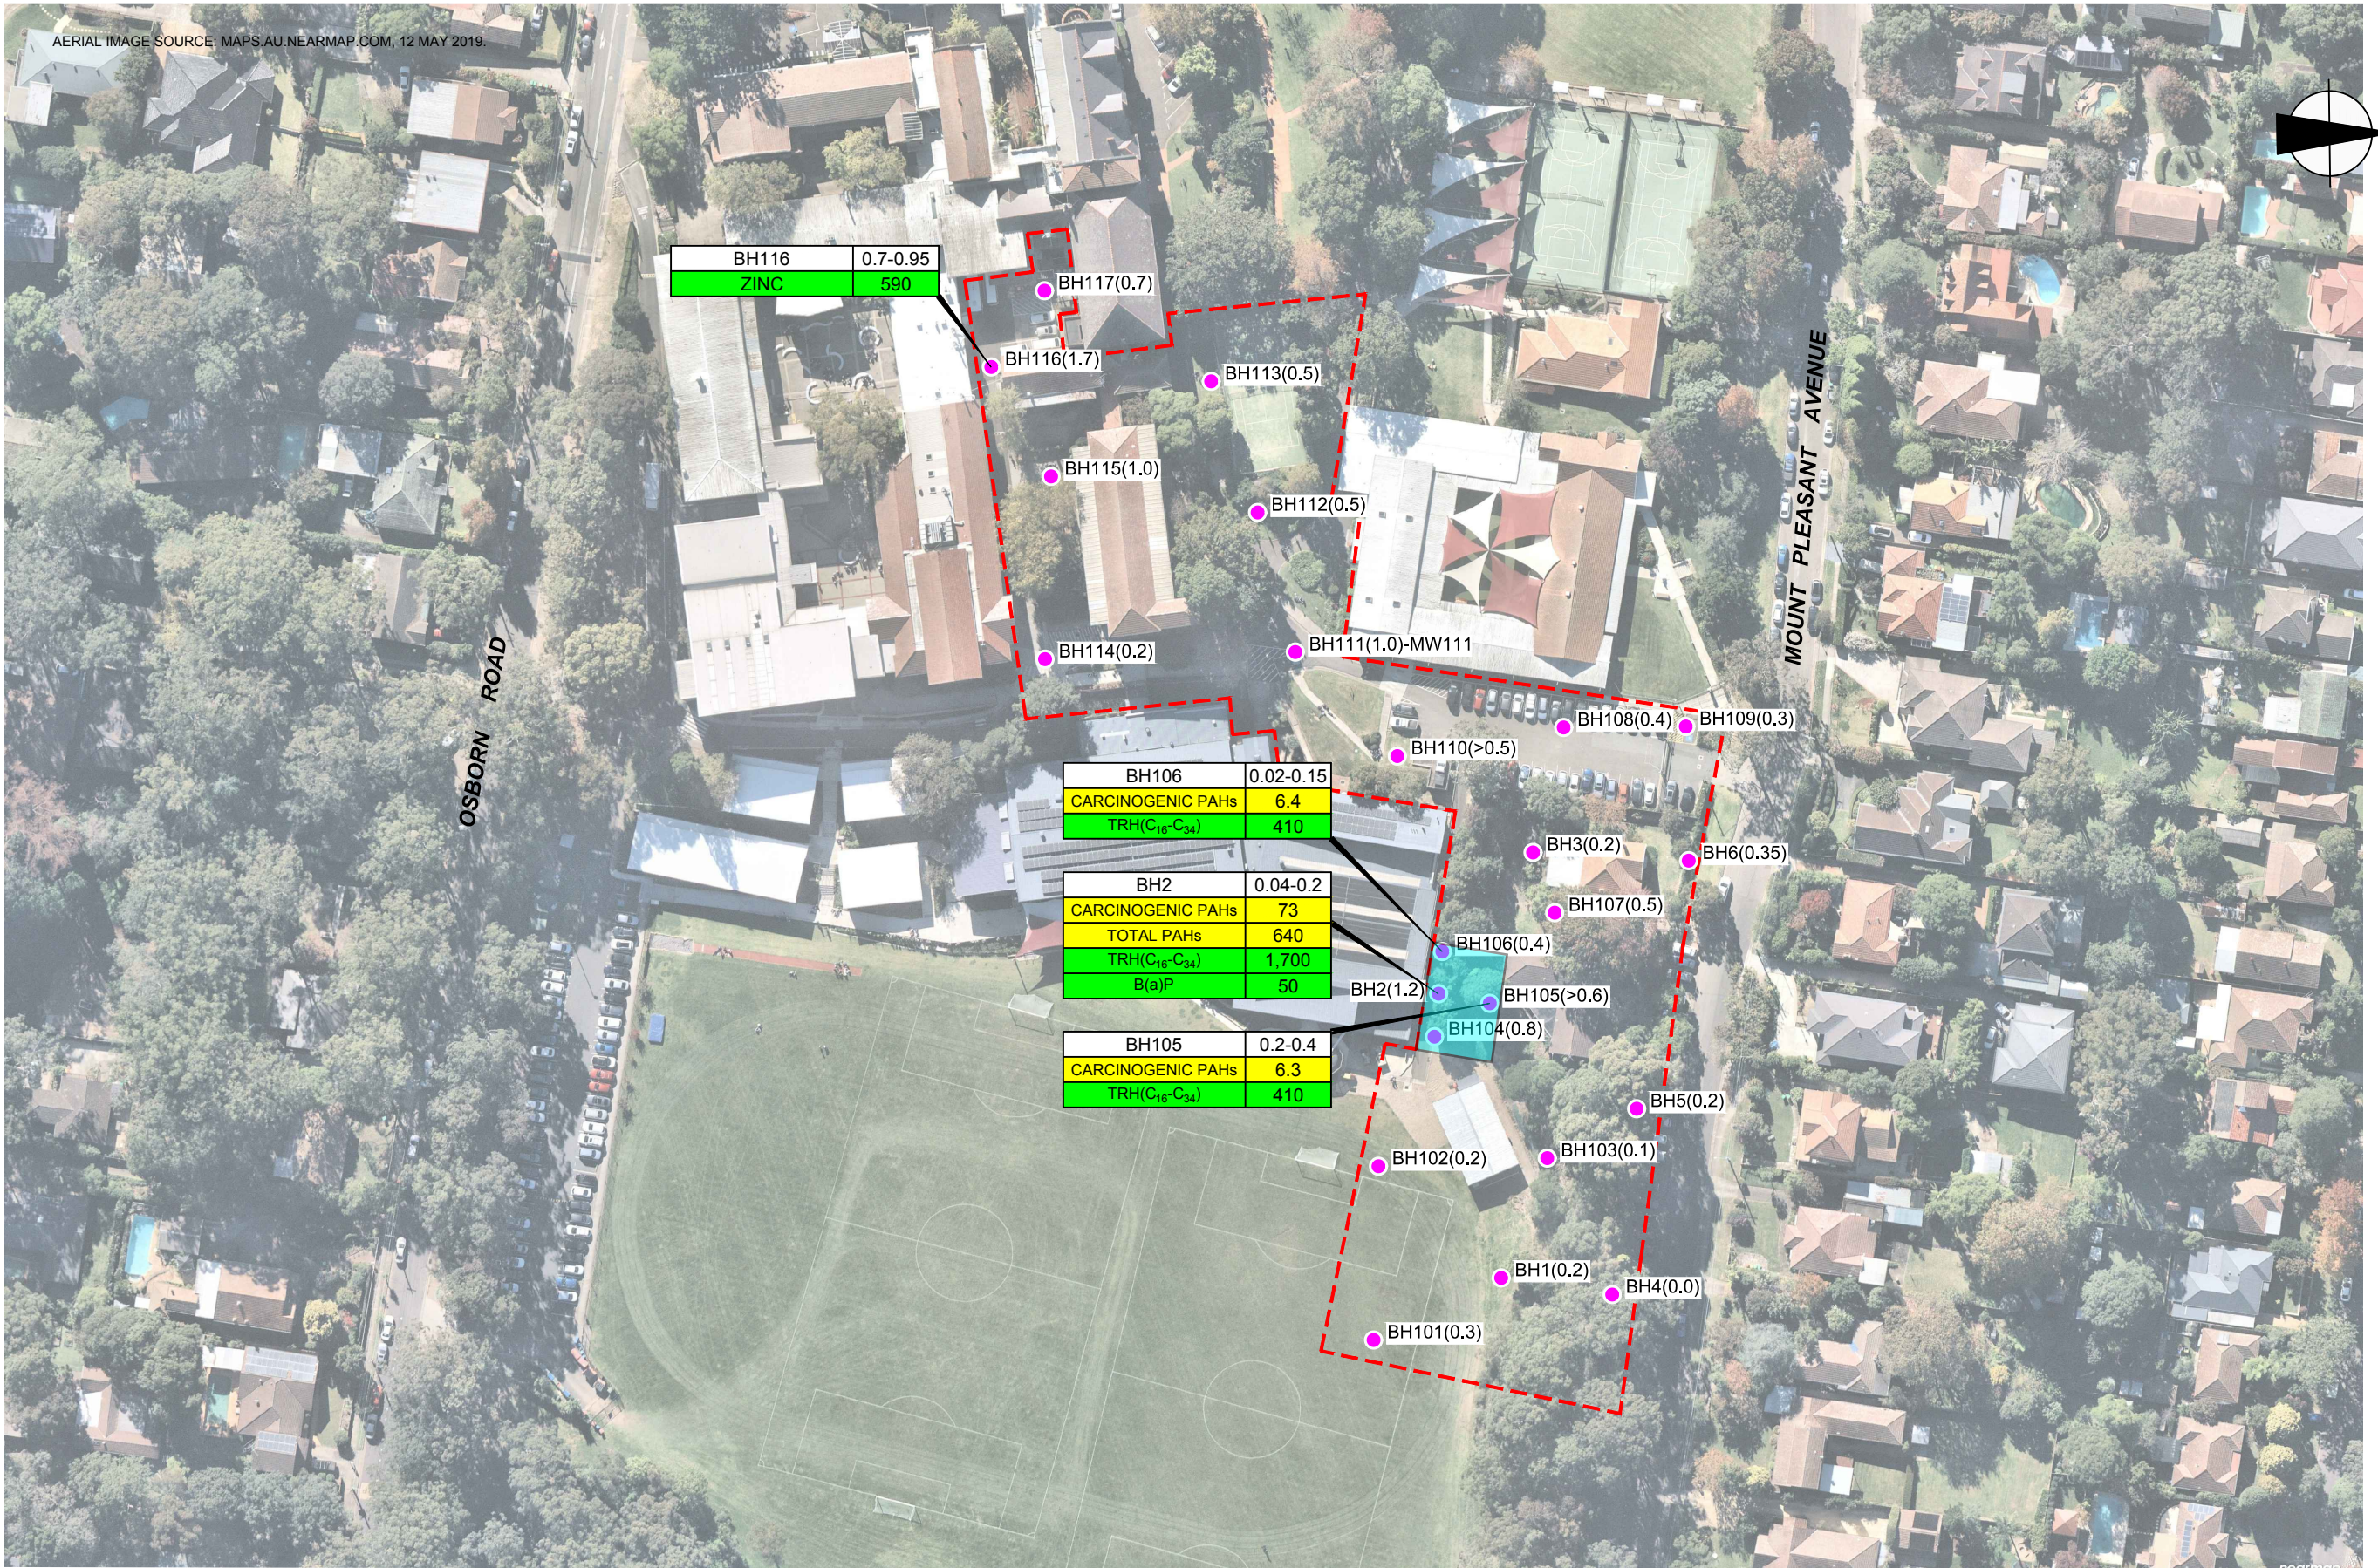
- APPROXIMATE SITE BOUNDARY
- BH (Fill Depth)
- BOREHOLE LOCATION, NUMBER AND DEPTH OF FILL (m)
- NOMINATED PAH IMPACTED REMEDIATION AREA
