Visual Impact Assessment Addendum

McPhillamys Gold Project

visual impact assessment - ADDENDUM

SEPTEMBER 2020

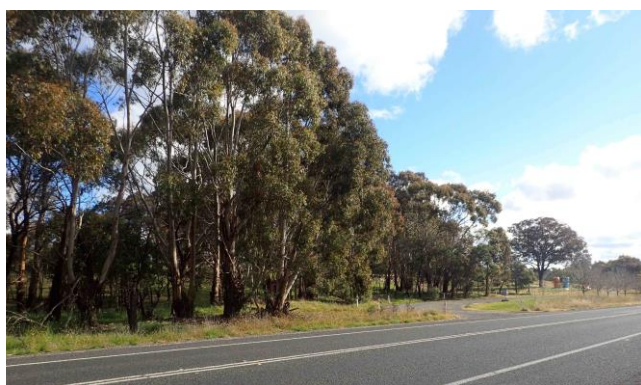
Figure 3.1 Existing Mid Western Highway intersection

View is of Mid Western Highway looking east with Project site to left of this view. This is the proposed location for amended site access road to mine infrastructure area.

The existing intersection location currently has roadside vegetation – Figure 3.1, providing some local filtering of lighting effects. Vegetation is ephemeral and may not provide permanent mitigation of lighting effects at the intersection.

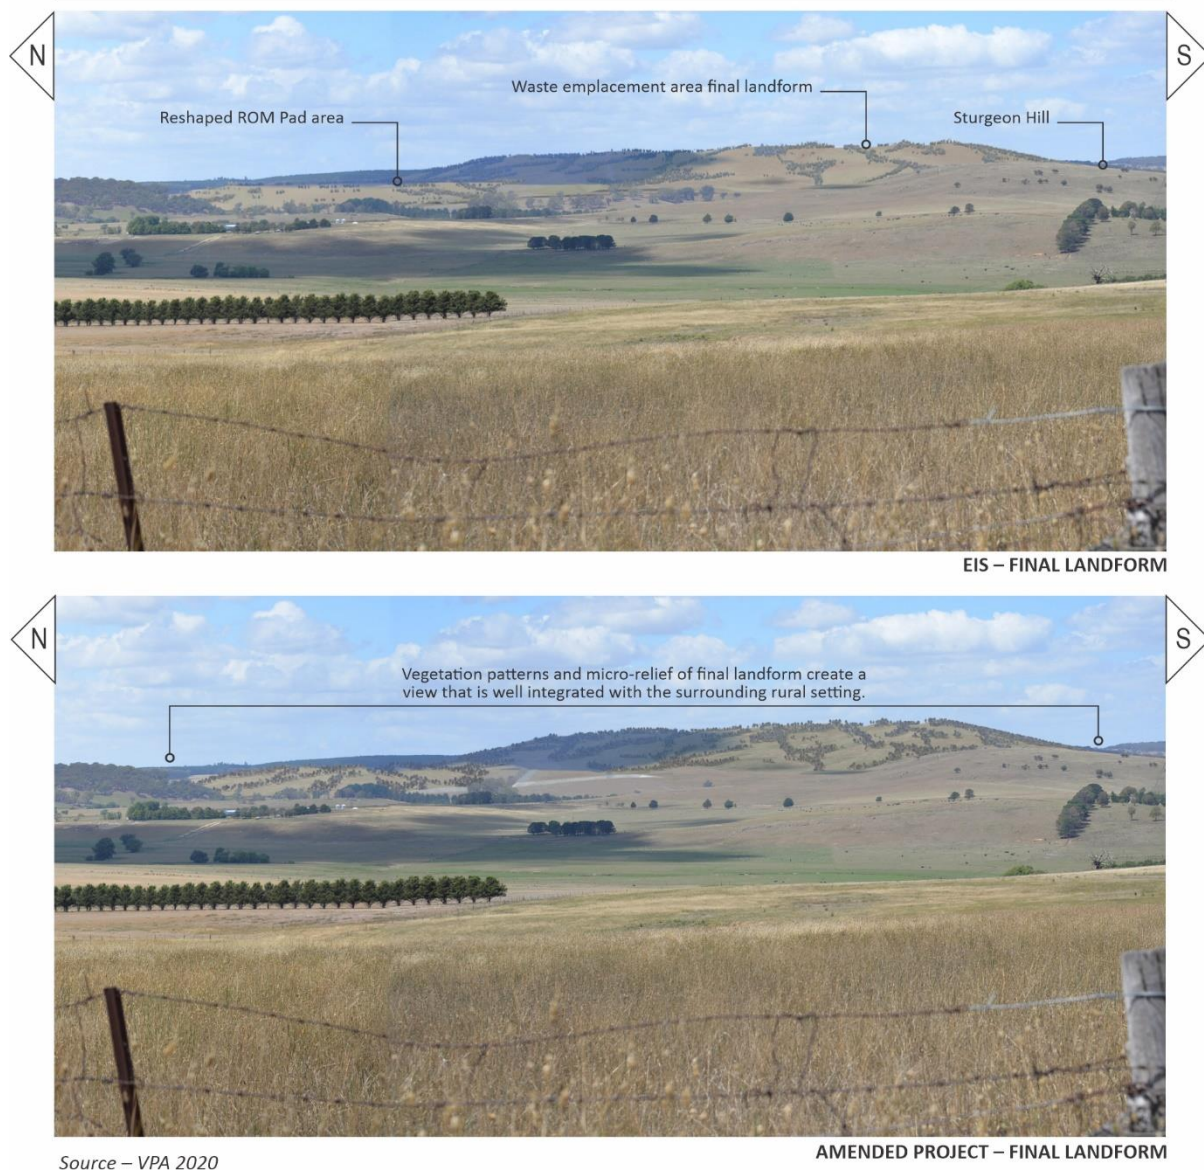
Figure 5.5 VP1 – Guyong Road – Final landform
Comparison between EIS and amended project

Final landform: Upper profile modulation has improved visual integration with surrounding landforms. Vegetation patterns and micro-relief of final landform create a view that is well integrated with the surrounding rural setting. Visual effects are Level 3 – Low.

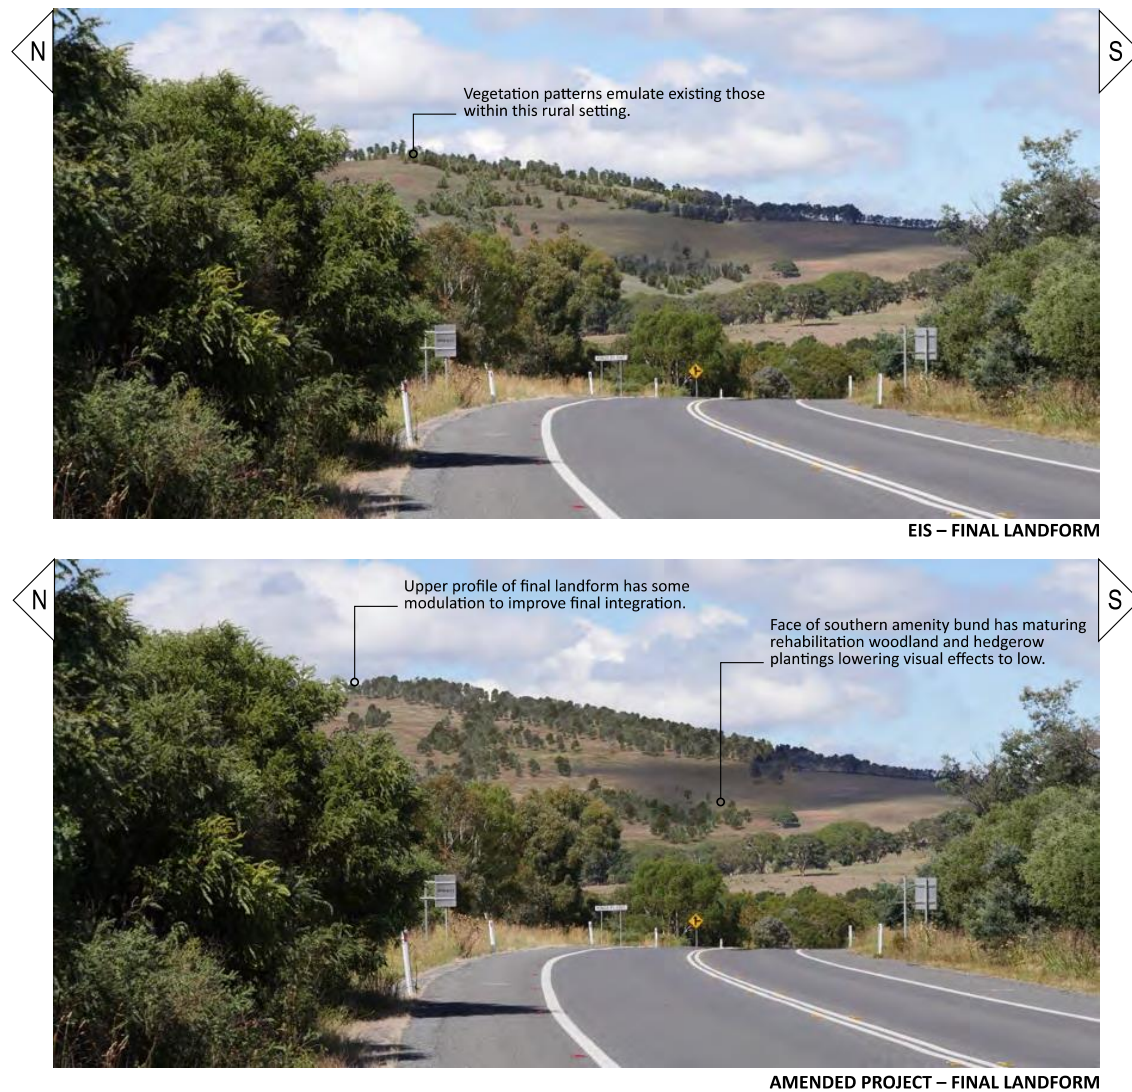
Figure 5.9 VP2 Mid Western Highway – Final landform
Comparison between EIS and amended project

Final landform: Final landform is higher than existing ridgeline, refer to Section 5.1 regarding landform height. Upper profile modulation has improved visual integration with surrounding landforms. Rehabilitation across southern face has lowered contrast and improved overall integration. Visual effects are Level 3.

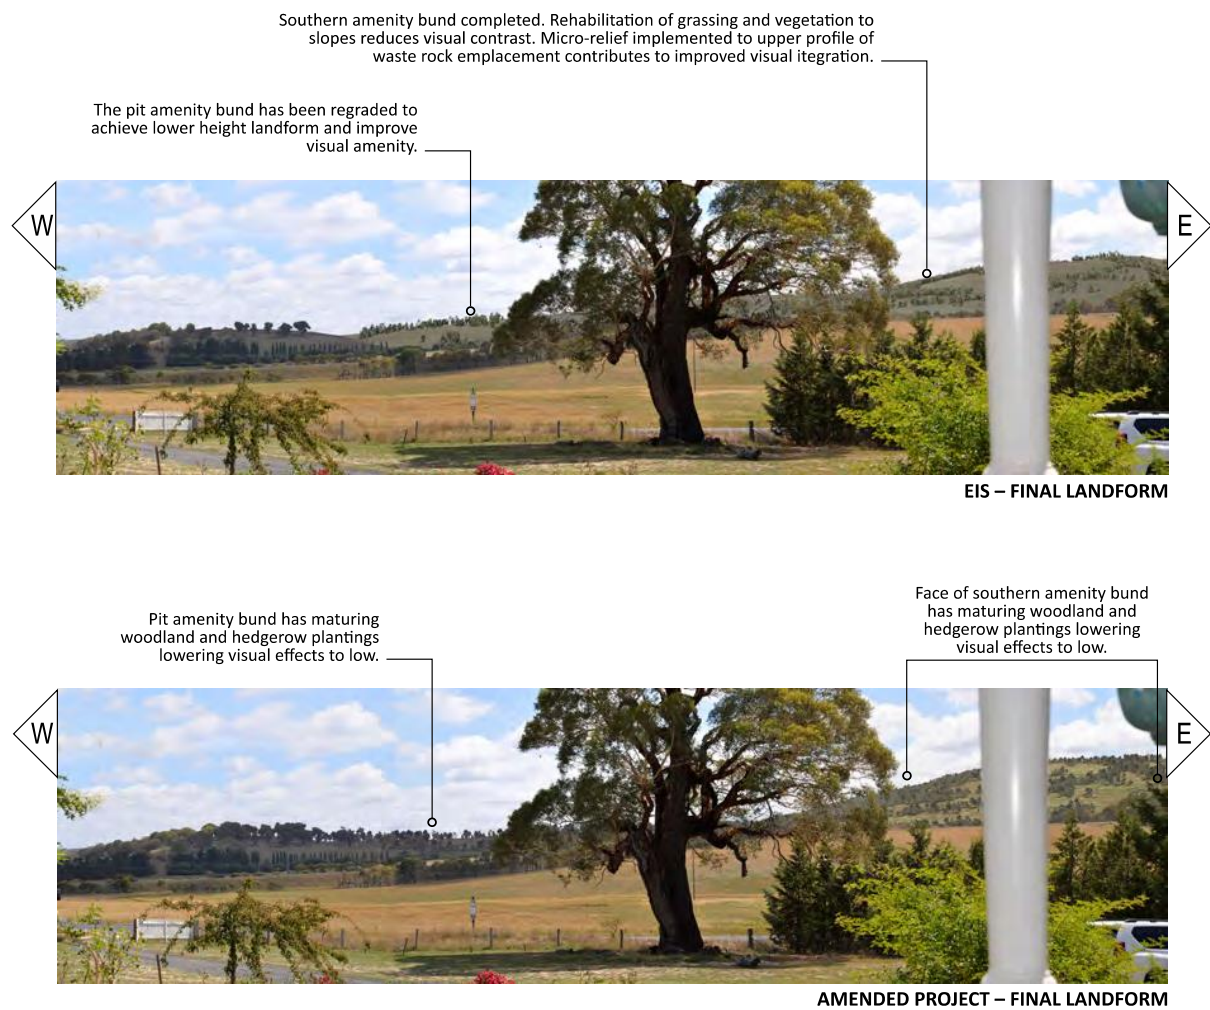
Figure 5.13 VP3 Kings Plains Residence – Final landform
Comparison between EIS and amended project

Final landform: Visual effects are Level 4 with established rehabilitation reducing contrast and improving visual integration with surrounding rural setting.

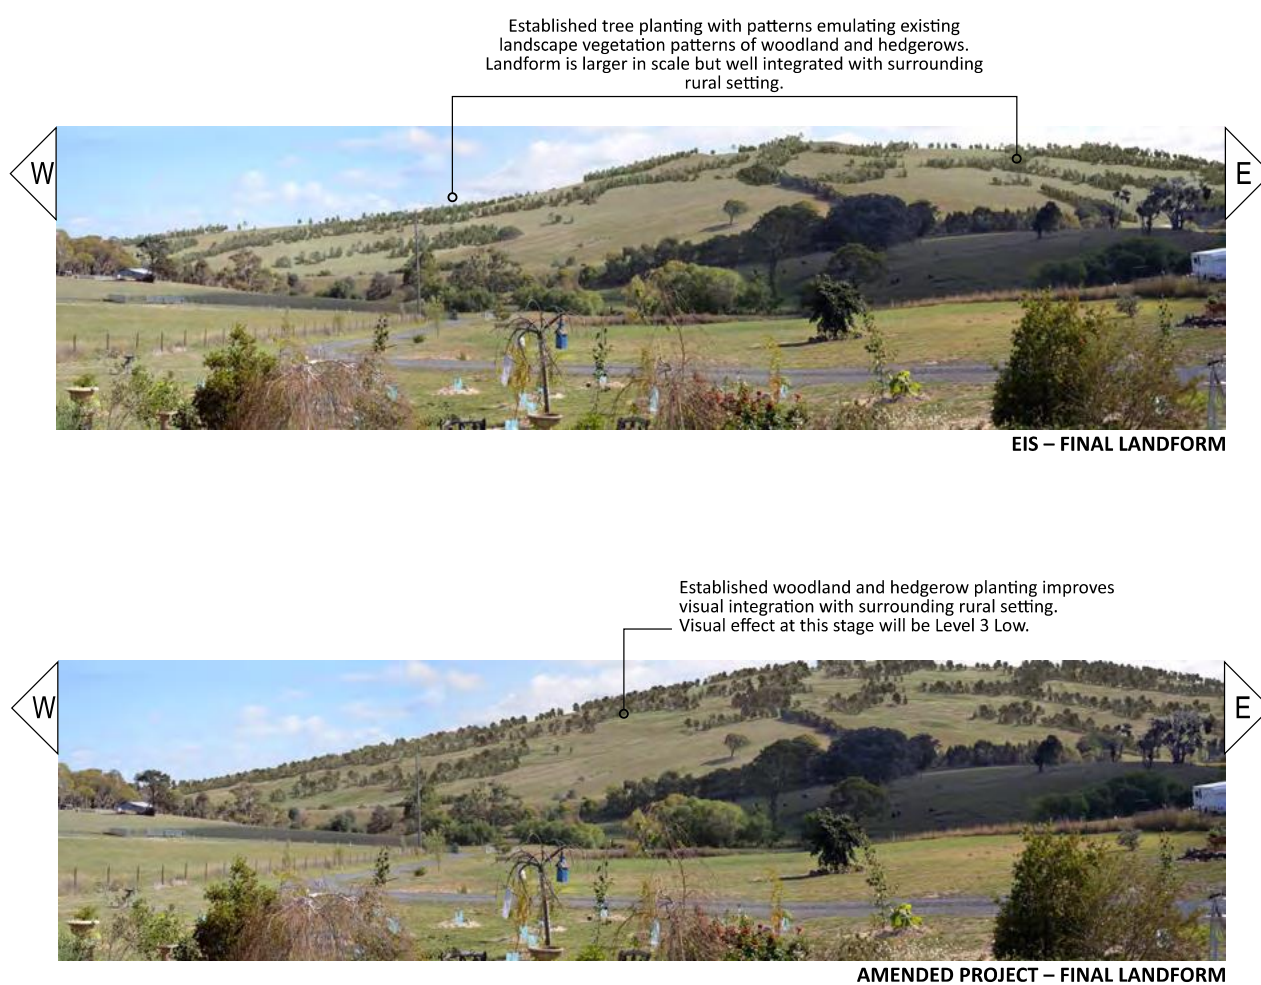
Figure 5.17 VP4 Kings Plains Residence – Final landform
Comparison between EIS and amended project

Visual effects are Level 4 with established rehabilitation reducing contrast and improving visual integration with surrounding rural setting.

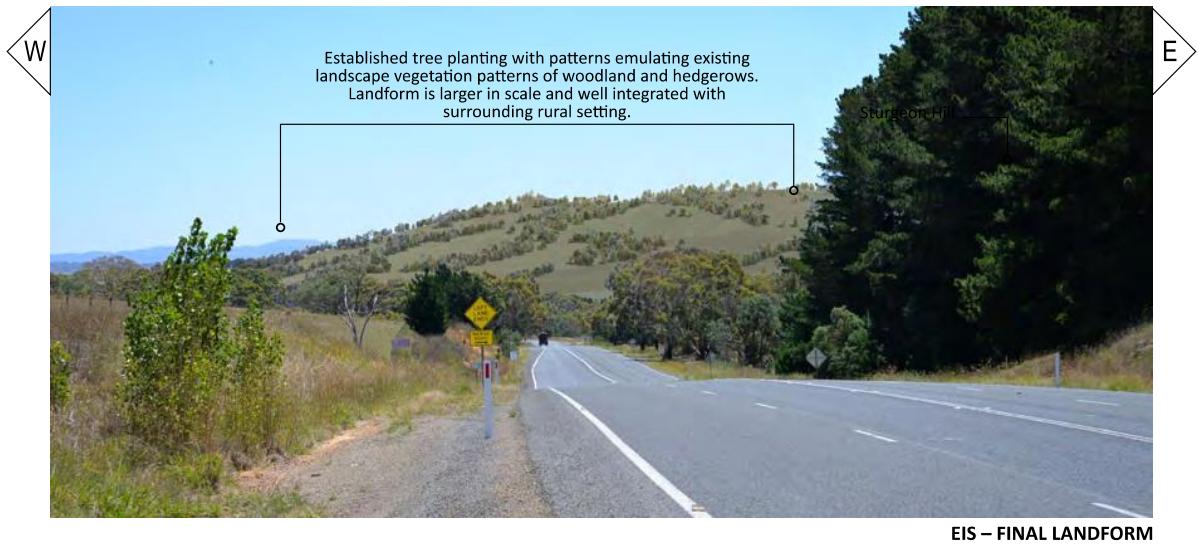
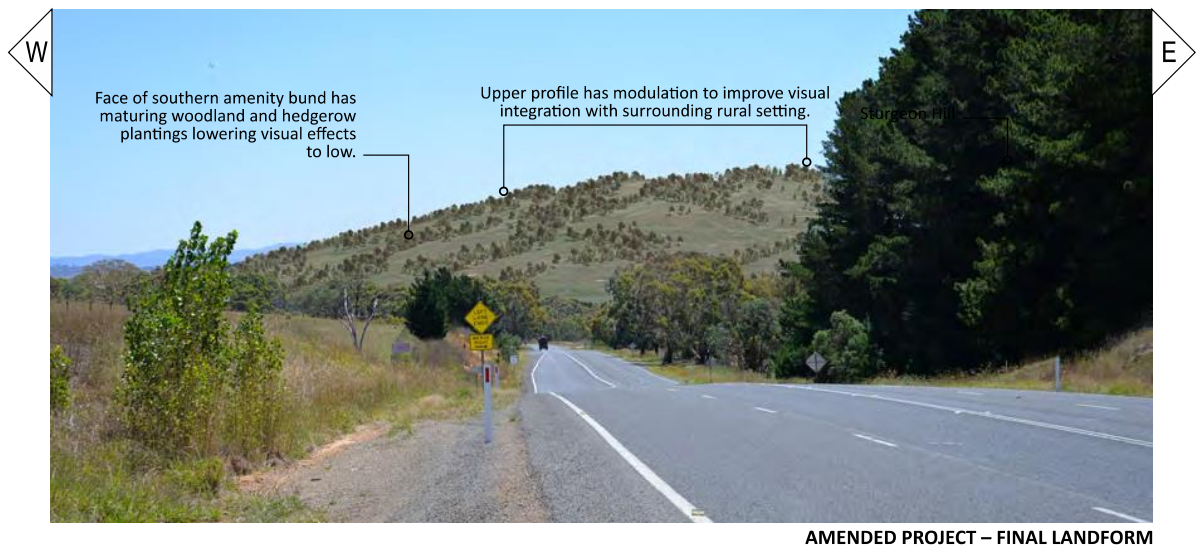
Figure 5.21 VP5 Mid Western Highway (East) – Final landform
Comparison between EIS and amended project

Visual effects are Level 4 with established rehabilitation reducing contrast and improving visual integration with surrounding rural setting. The upper profile is modulated consistent with the EIS outcome.

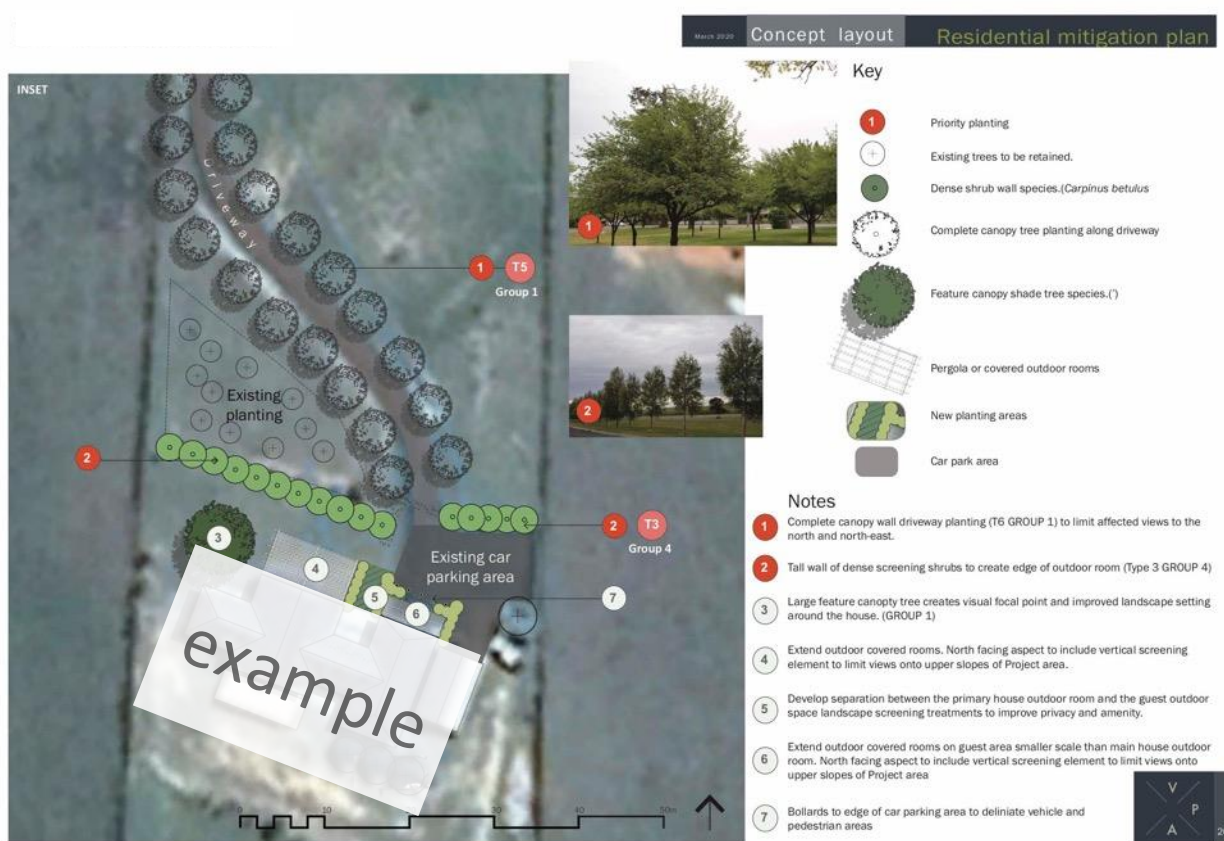
Figure 7.1 Residential mitigation concept plan example

The intention is for this representative residence to reflect effectiveness of a range of off-site residential visual mitigation measures.
