LONG-TERM ENVIRONMENTAL MANAGEMENT PLAN

Lots 14 and 15 Section L DP 8993
No. 7 James Street
Argenton

for
Alesco Senior College

Ref: 2020233-LEMP
17 June 2020

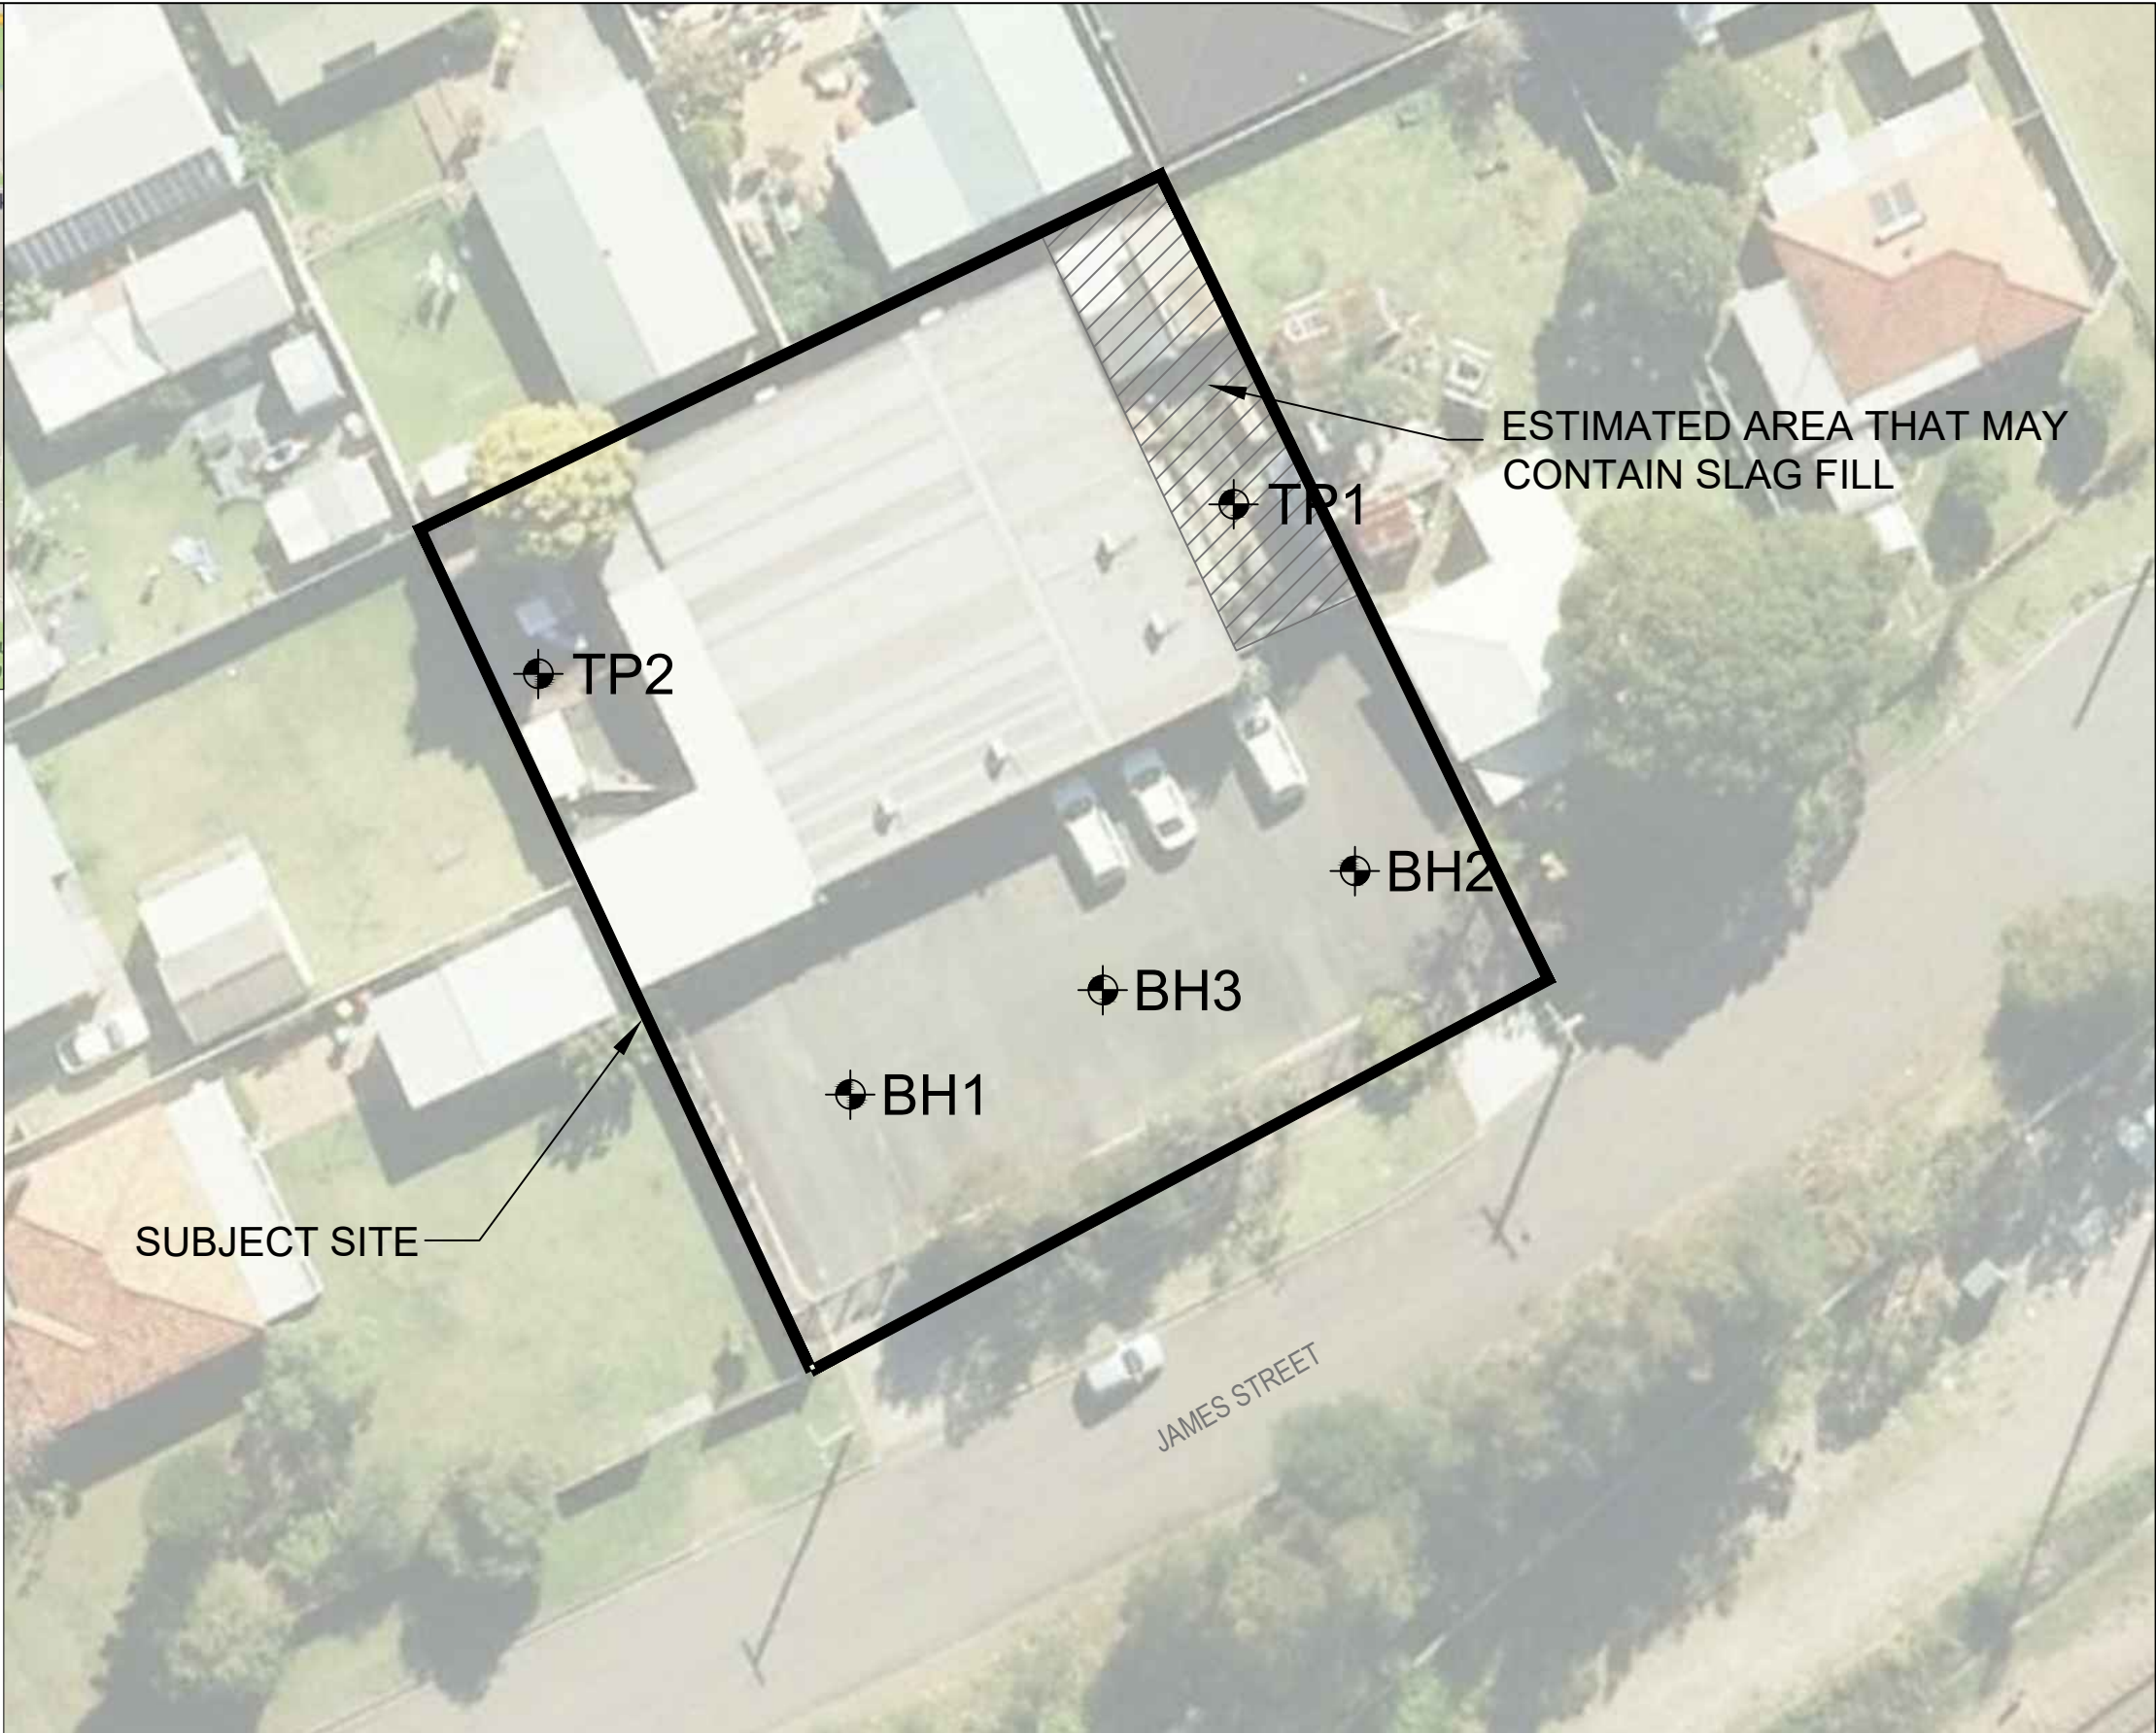
TITLE SITE PLAN LOTS 14 & 15 SECTION L DP 8993 No. 7 JAMES STREET ARGENTON	CLIENT ALESCO SENIOR COLLEGE	SCALE NOT TO SCALE
	DATE 19/09/2019	DRAWING No. 2019233-SIT-01
	DRAWN M.C	REVISION 0

LEGEND:
BH1/TP1 - APPROXIMATE BOREHOLE/TESTPIT LOCATION

1. Drawing 2020233-LEMP-SIT-01
2. General Notes
