22 May 2019 Ref: E30910KGlet4 (ASS)

Meriden School C/- Allen Jack and Cottier

### ACID SULFATE SOIL DESKTOP SCREENING PROPOSED LANDSCAPED PLAYGROUND – MERIDEN SCHOOL 4 VERNON STREET, STRATHFIELD, NSW 2135

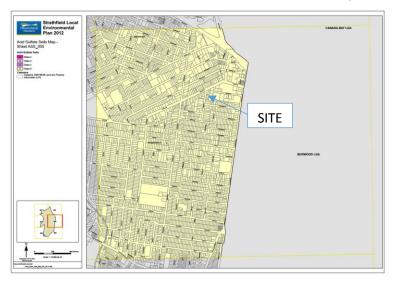
A review of the Strathfield Council LEP indicates that the site is located in a Class 5 risk Area (refer to appendices for further details on each risk class). An extract from the Plan is reproduced below.

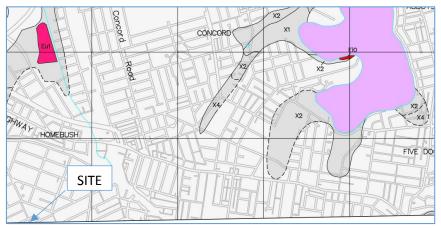
A review of the ASS risk maps prepared by Department of Land and Water Conservation (1997)<sup>4</sup> indicates that the site is located in an area classified as no known occurrence of acid sulfate soil. A section of the map is reproduced below.

Based on the risk maps there do not appear to be any risk areas within 500m of the site. There is a creek source (Powells Creek) approximately 460m to the north-east of the site.

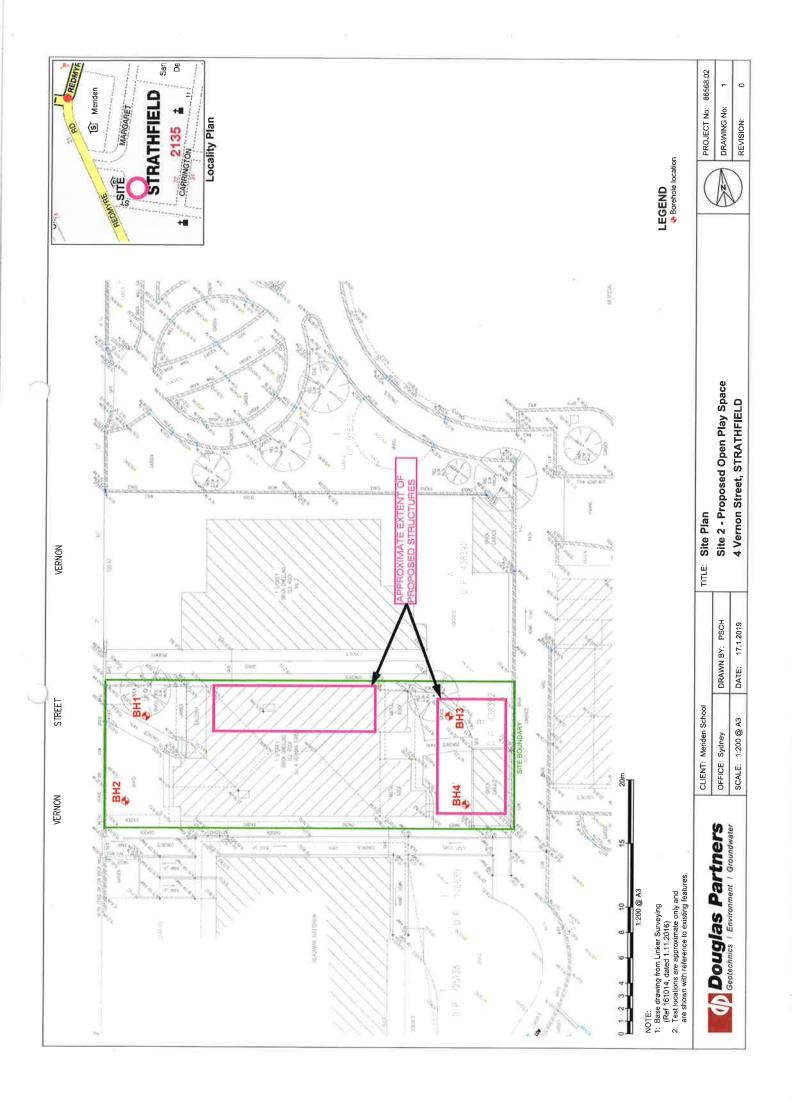
# Appendix A: Report Figures (Douglas Partners)

The site location and the investigation locations are shown on Drawing No. 1 extracted from a report provided by Douglas Partners (Douglas).

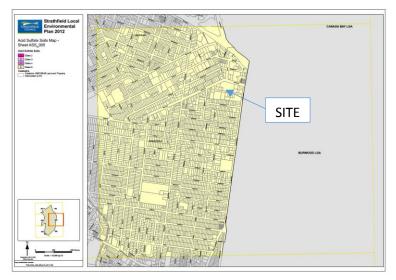
A review of the Strathfield Council LEP indicates that the site is located in a Class 5 risk Area (refer to appendices for further details on each risk class). An extract from the Plan is reproduced below.

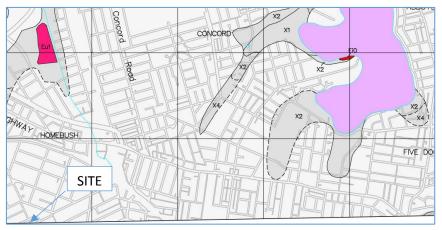
A review of the ASS risk maps prepared by Department of Land and Water Conservation (1997)<sup>4</sup> indicates that the site is located in an area classified as no known occurrence of acid sulfate soil. A section of the map is reproduced below.

Based on the risk maps there do not appear to be any risk areas within 500m of the site. There is a creek source (Powells Creek) approximately 550m to the north of the site.

The acid sulfate soil risk map does include a notation that river and creek sediments may contain acid sulfate soil. However EIS note that the sections of creek closest to the site are concrete lined. This area does not show up as Class 1, 2, 3, or 4 area on the Strathfield LEP 2012.
