# Groundwater Assessment

86529.00.R.009.Rev1

**Comments on Groundwater for Stage 2 SEARs  
Sydney Football Stadium Redevelopment  
Moore Park, NSW****1. Introduction**

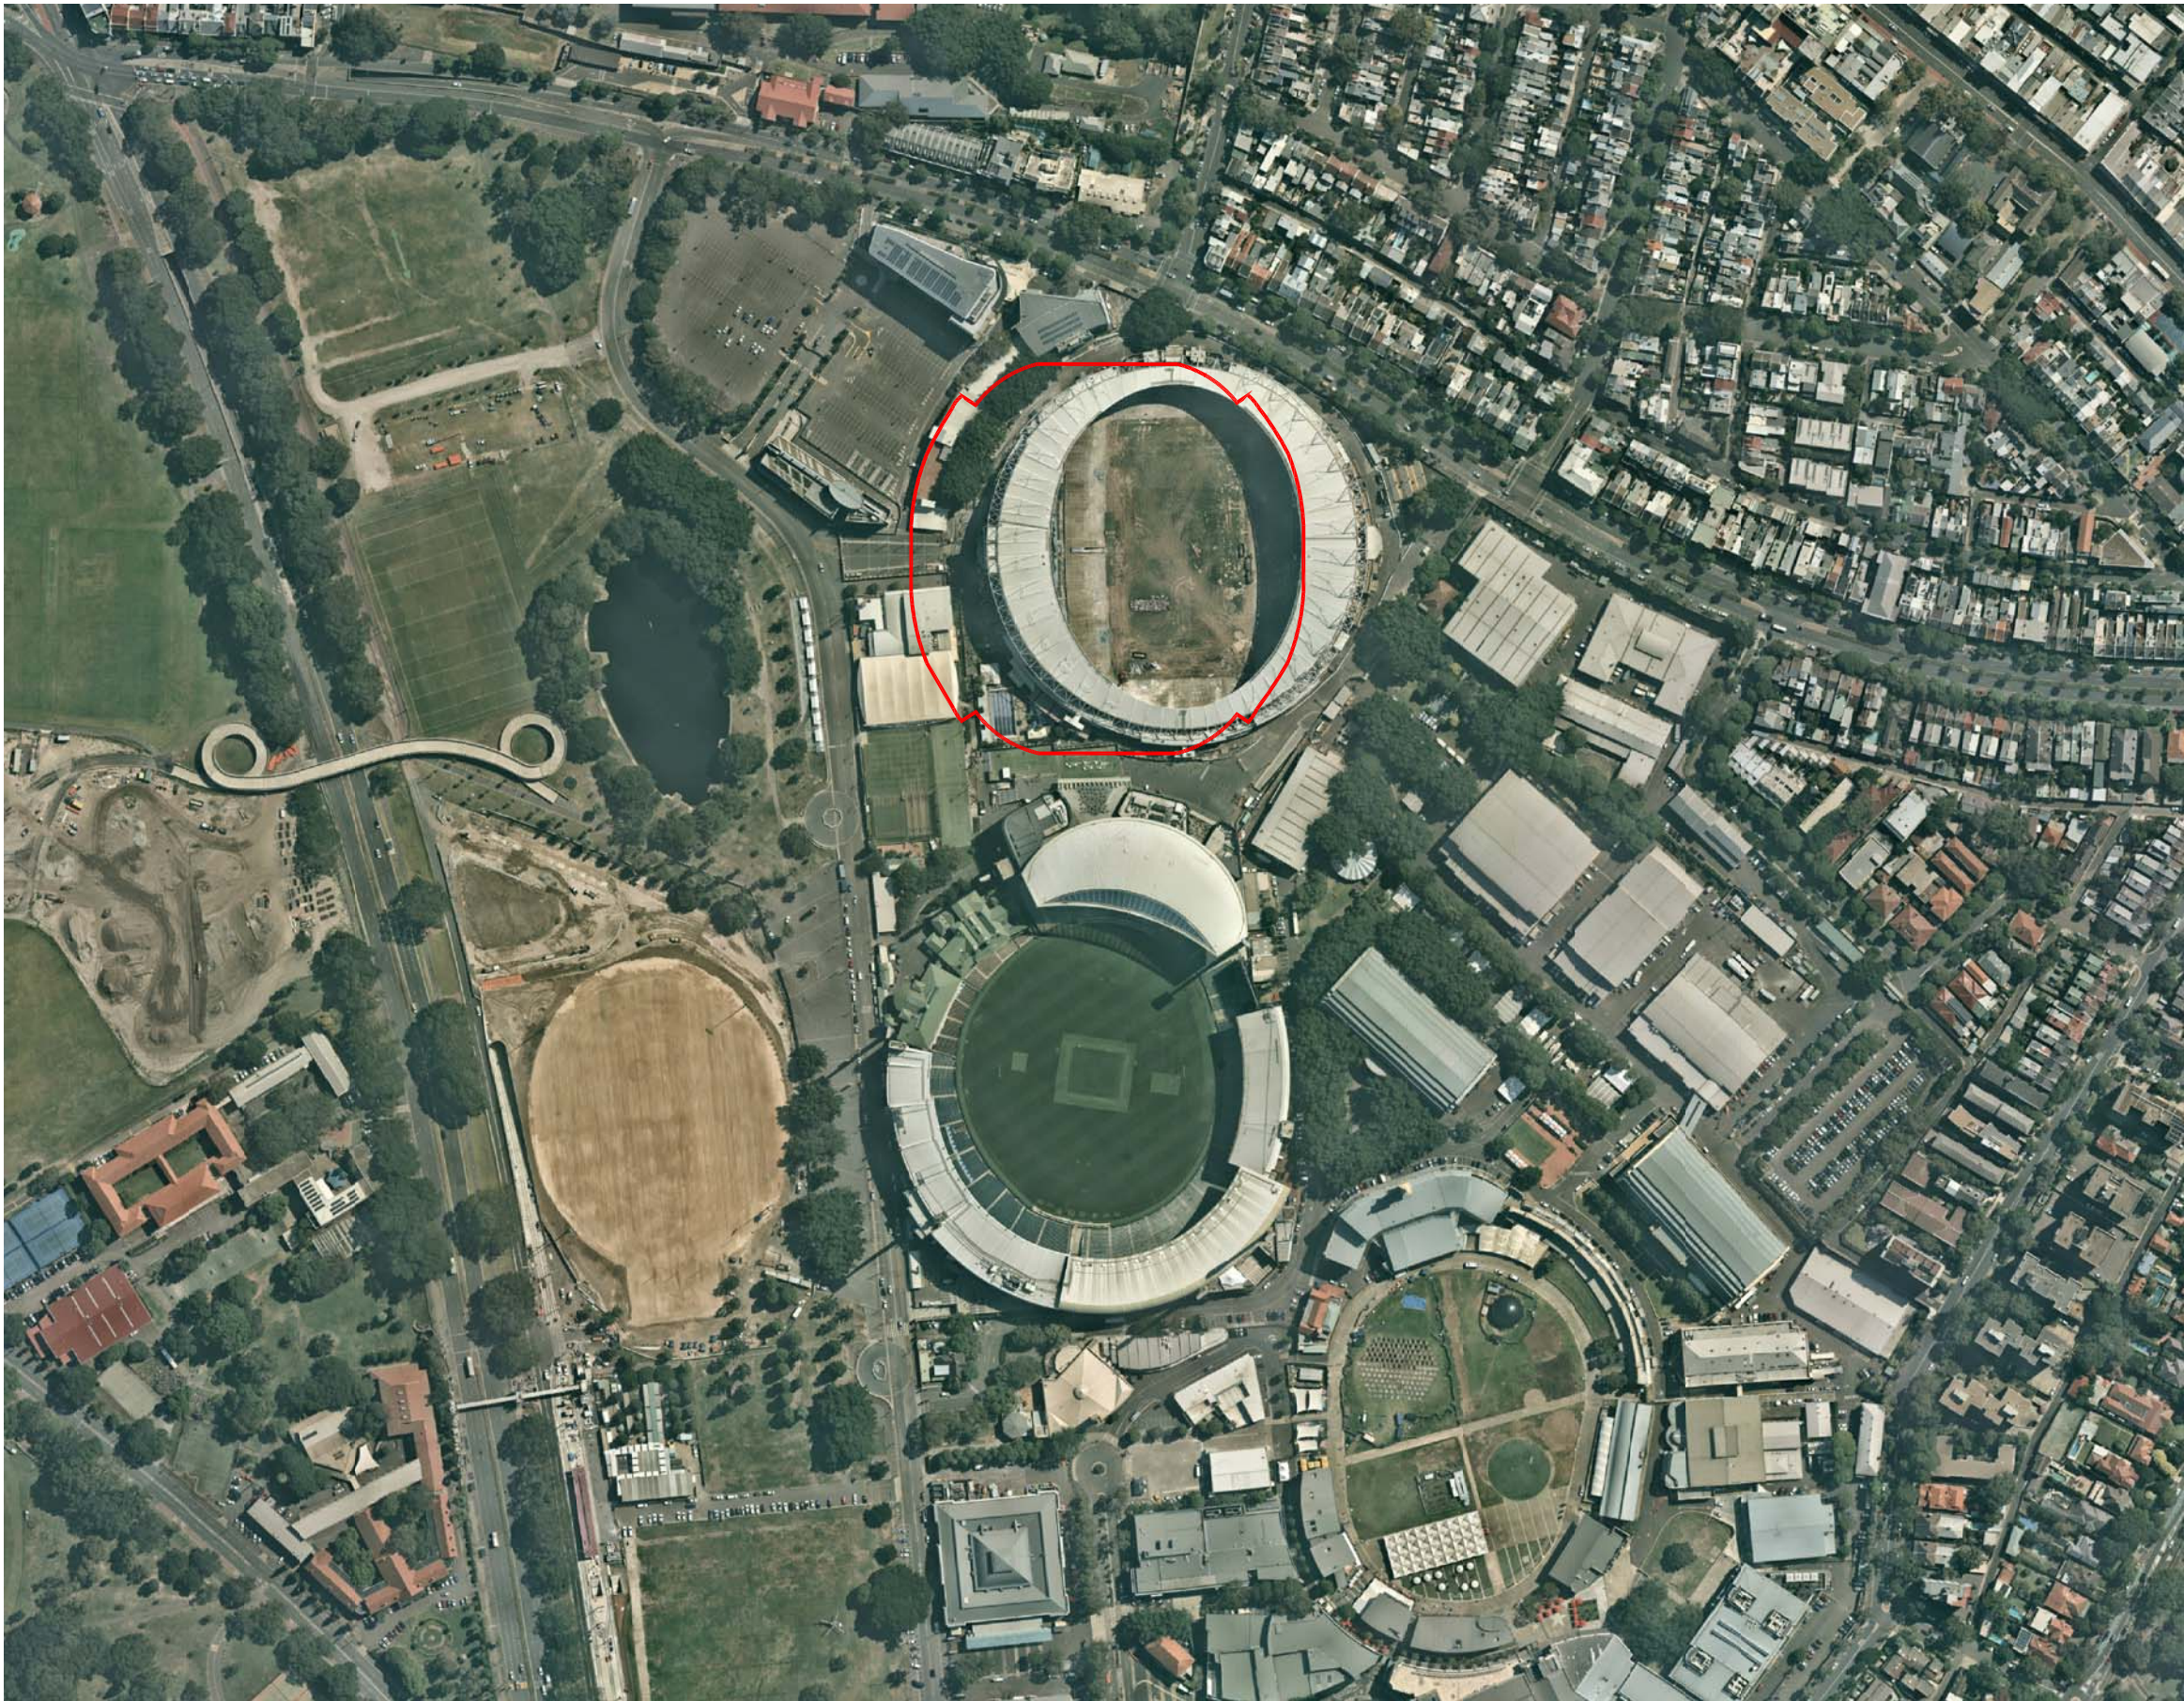
<b>Douglas Partners</b> <i>Geotechnics   Environment   Groundwater</i>	CLIENT: Lendlease Building Pty Ltd		TITLE: <b>Approximate Ground Floor Footprint Sydney Football Stadium Redevelopment MOORE PARK</b>	 	PROJECT No: 86529.00
	OFFICE: Sydney	DRAWN BY: PSCH			DRAWING No: G1
	SCALE: 1:4000 @ A3	DATE: 4.4.2019			REVISION: 0

The location of the site is shown on Drawing G1 in Attachment B.

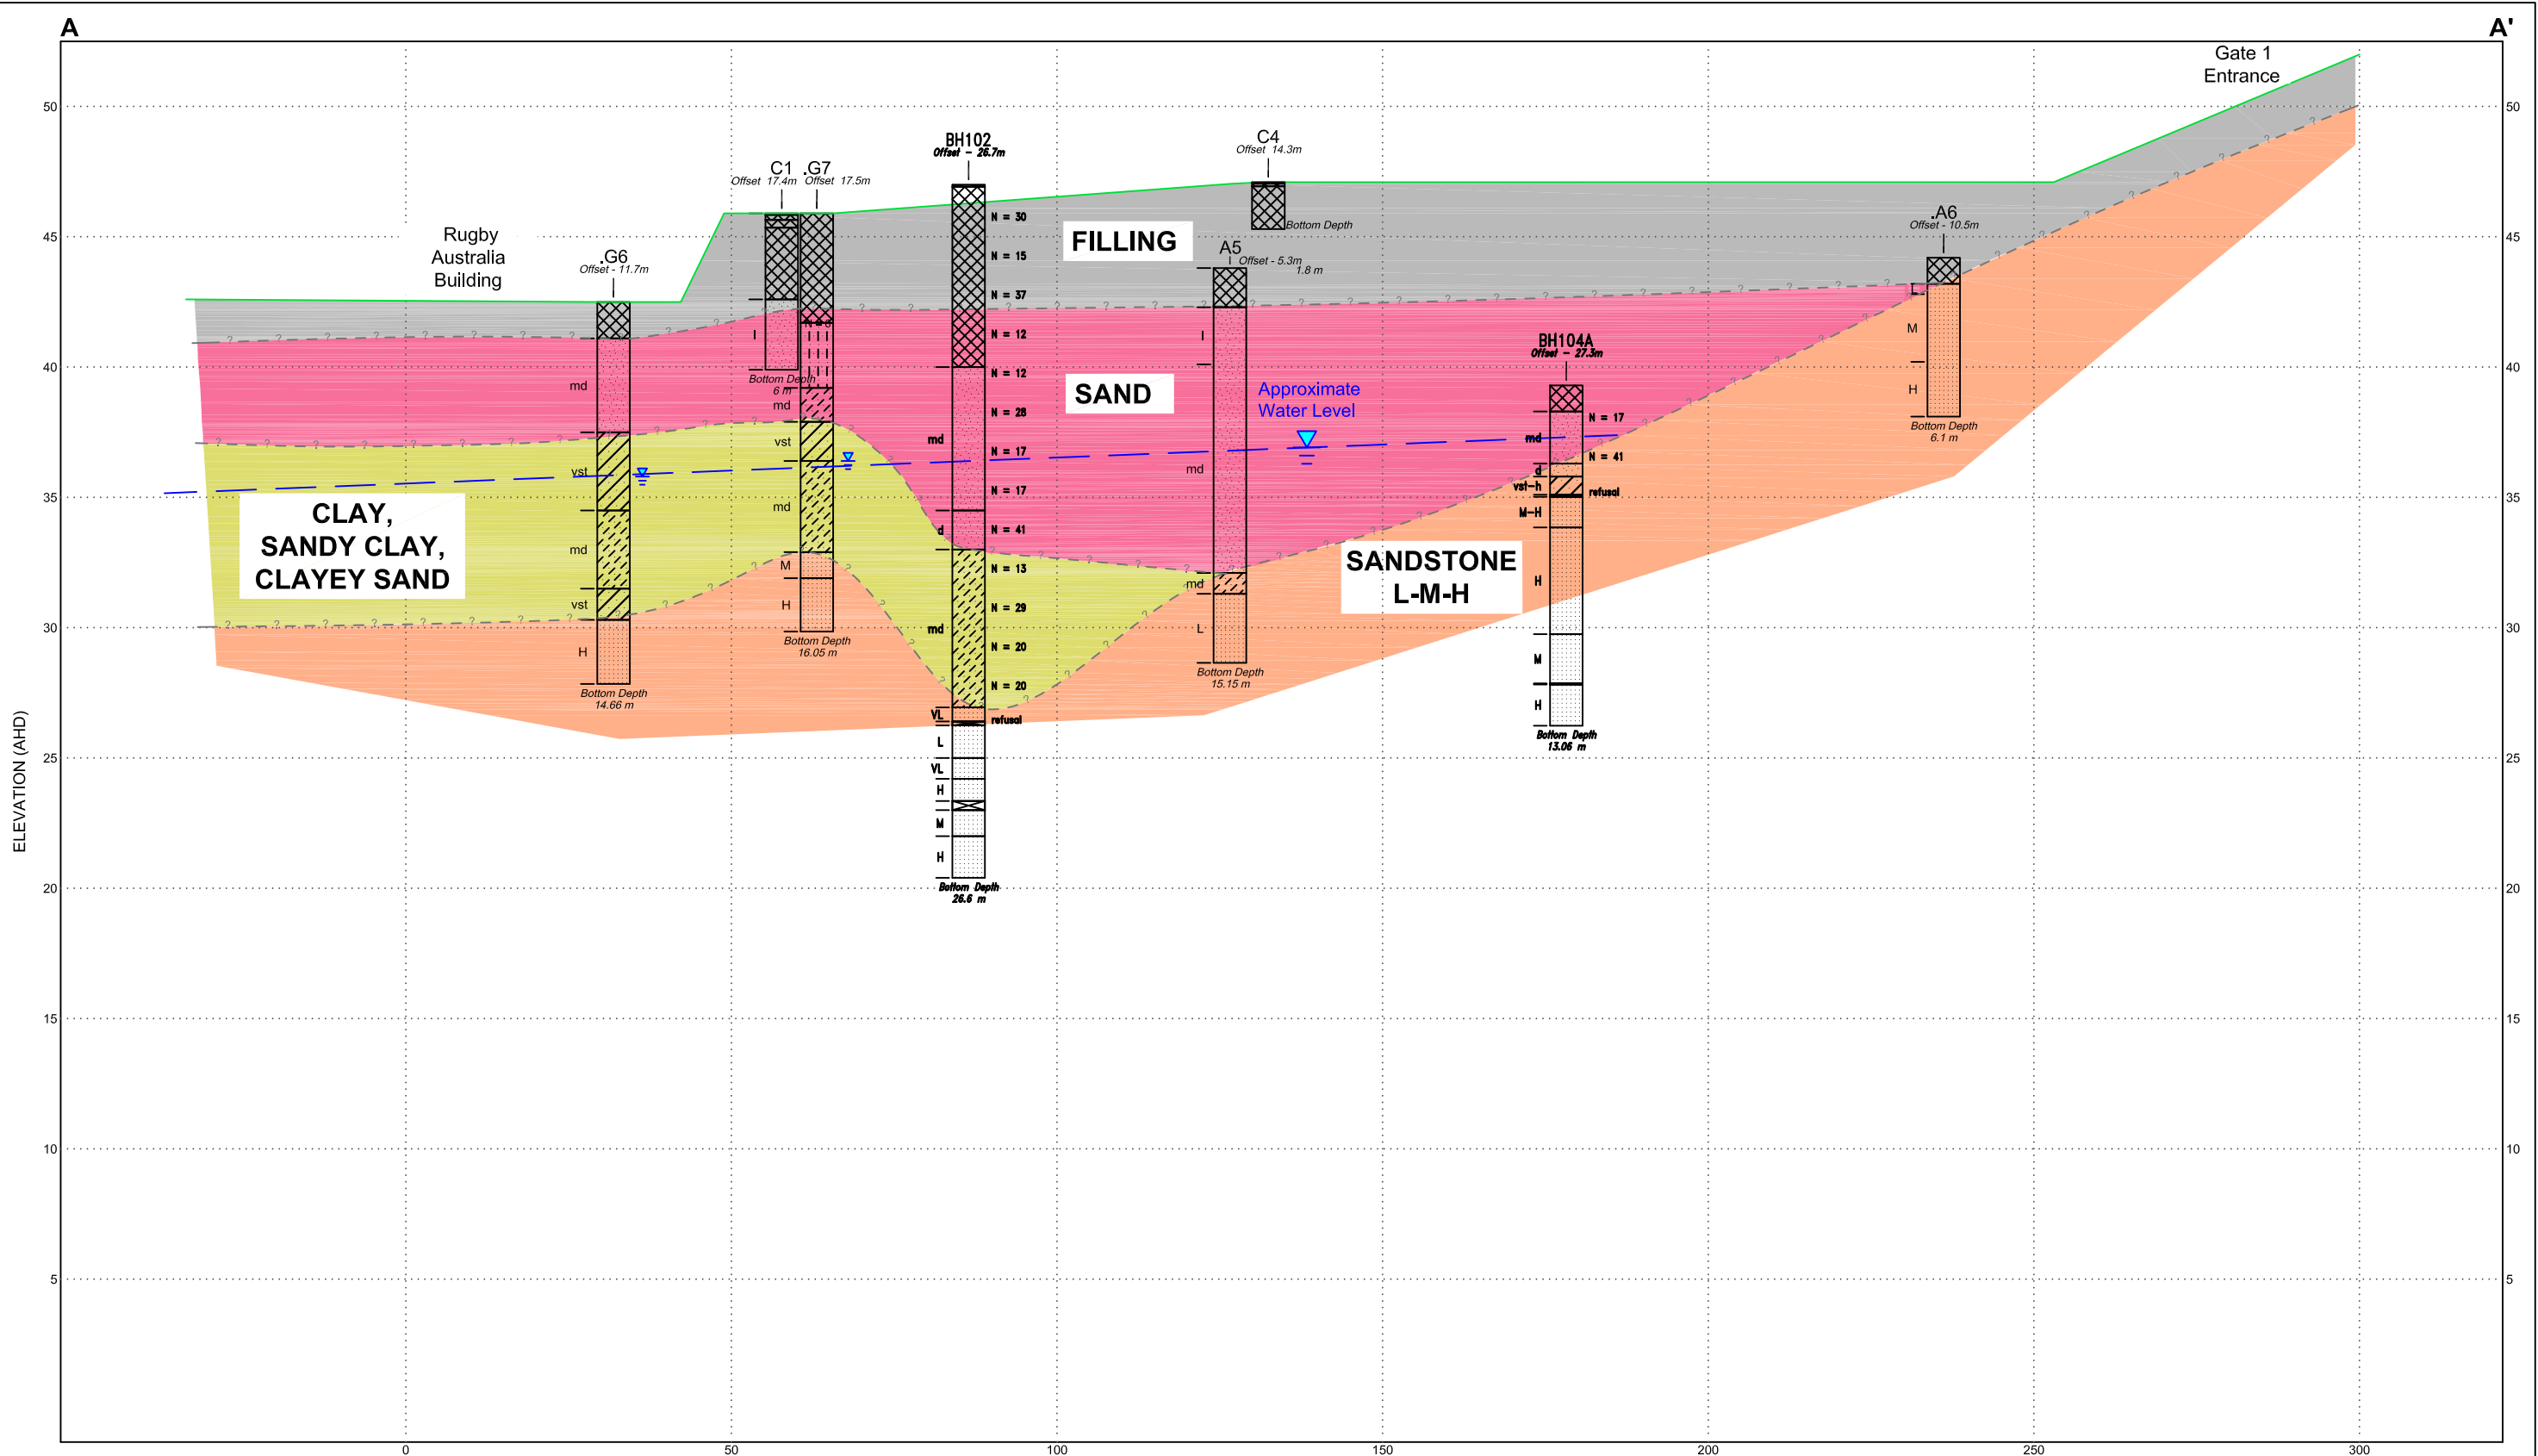
**Vertical Exaggeration = 4.0**

<b>Douglas Partners</b> Geotechnics   Environment   Groundwater	CLIENT: Lendlease Building Pty Ltd		TITLE: <b>Interpteted Geotechnical Cross Section A-A'</b> <b>Sydney Football Stadium Redevelopment</b> <b>MOORE PARK</b>	PROJECT No: 86529.00	
	OFFICE: Sydney	DRAWN BY: PSCH		DRAWING No: G103	
	SCALE: 1:1000 (H) 1:250 (V) @ A3	DATE: 4.4.2019		REVISION: 0
