CBD AND SOUTH EAST LIGHT RAIL PROJECT
ENVIRONMENTAL IMPACT STATEMENT

TECHNICAL PAPER 9: PRELIMINARY TREE ASSESSMENT

Preliminary Tree Assessment

CBD and South East Light Rail

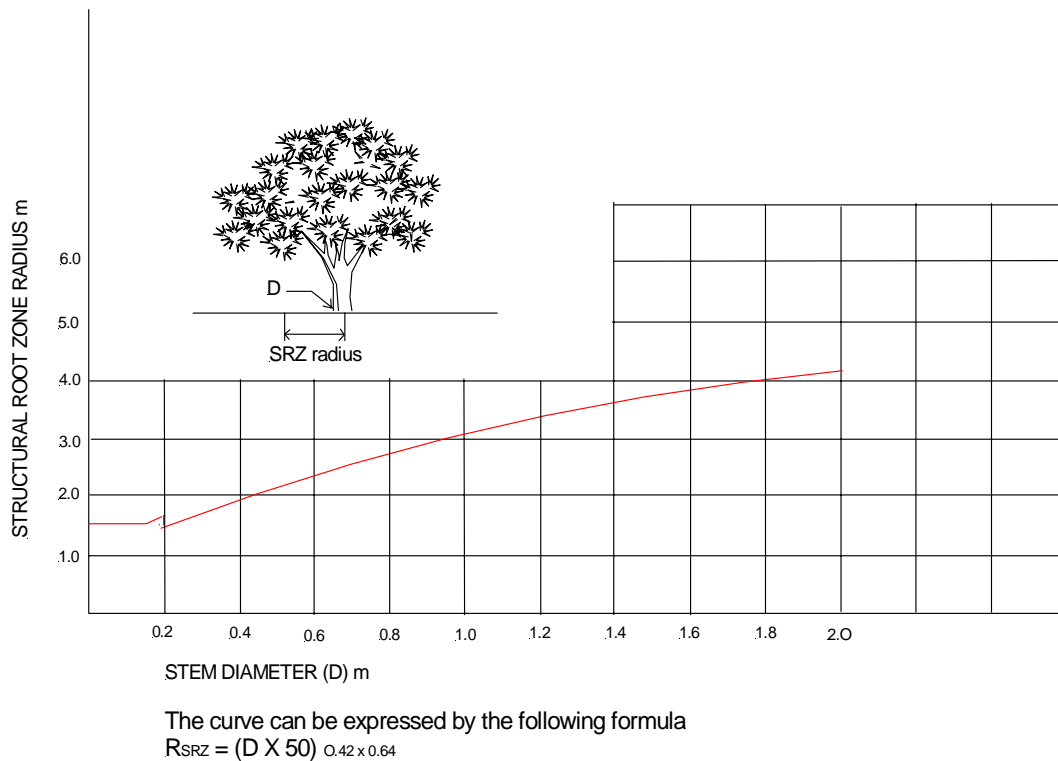
This zone considers a tree's structural stability only, **not** the root zone required for a tree's vigour and long term viability, which will usually be a much larger area.

The SRZ only needs to be calculated when major encroachment into a TPZ is likely to occur.

- 1 R_{SRZ} is the structural root zone radius
- 2 D is the stem diameter measured immediately above to root buttress
- 3 The SRZ for trees less than 0.15 m diameter is 1.5m
- 4 The SRZ formula and graph do not apply to palms, other monocots, cycads & tree ferns
- 5 This does not apply to trees with an asymmetrical root plate
