Rest of project area

Table 3-3 Summary of existing flooding and drainage conditions – rest of project area

Transport for NSW
Sydney Metro - Sydenham to Bankstown upgrade
Surface Water Assessment
**Summary of existing flooding
and drainage conditions**
Page 1 of 6

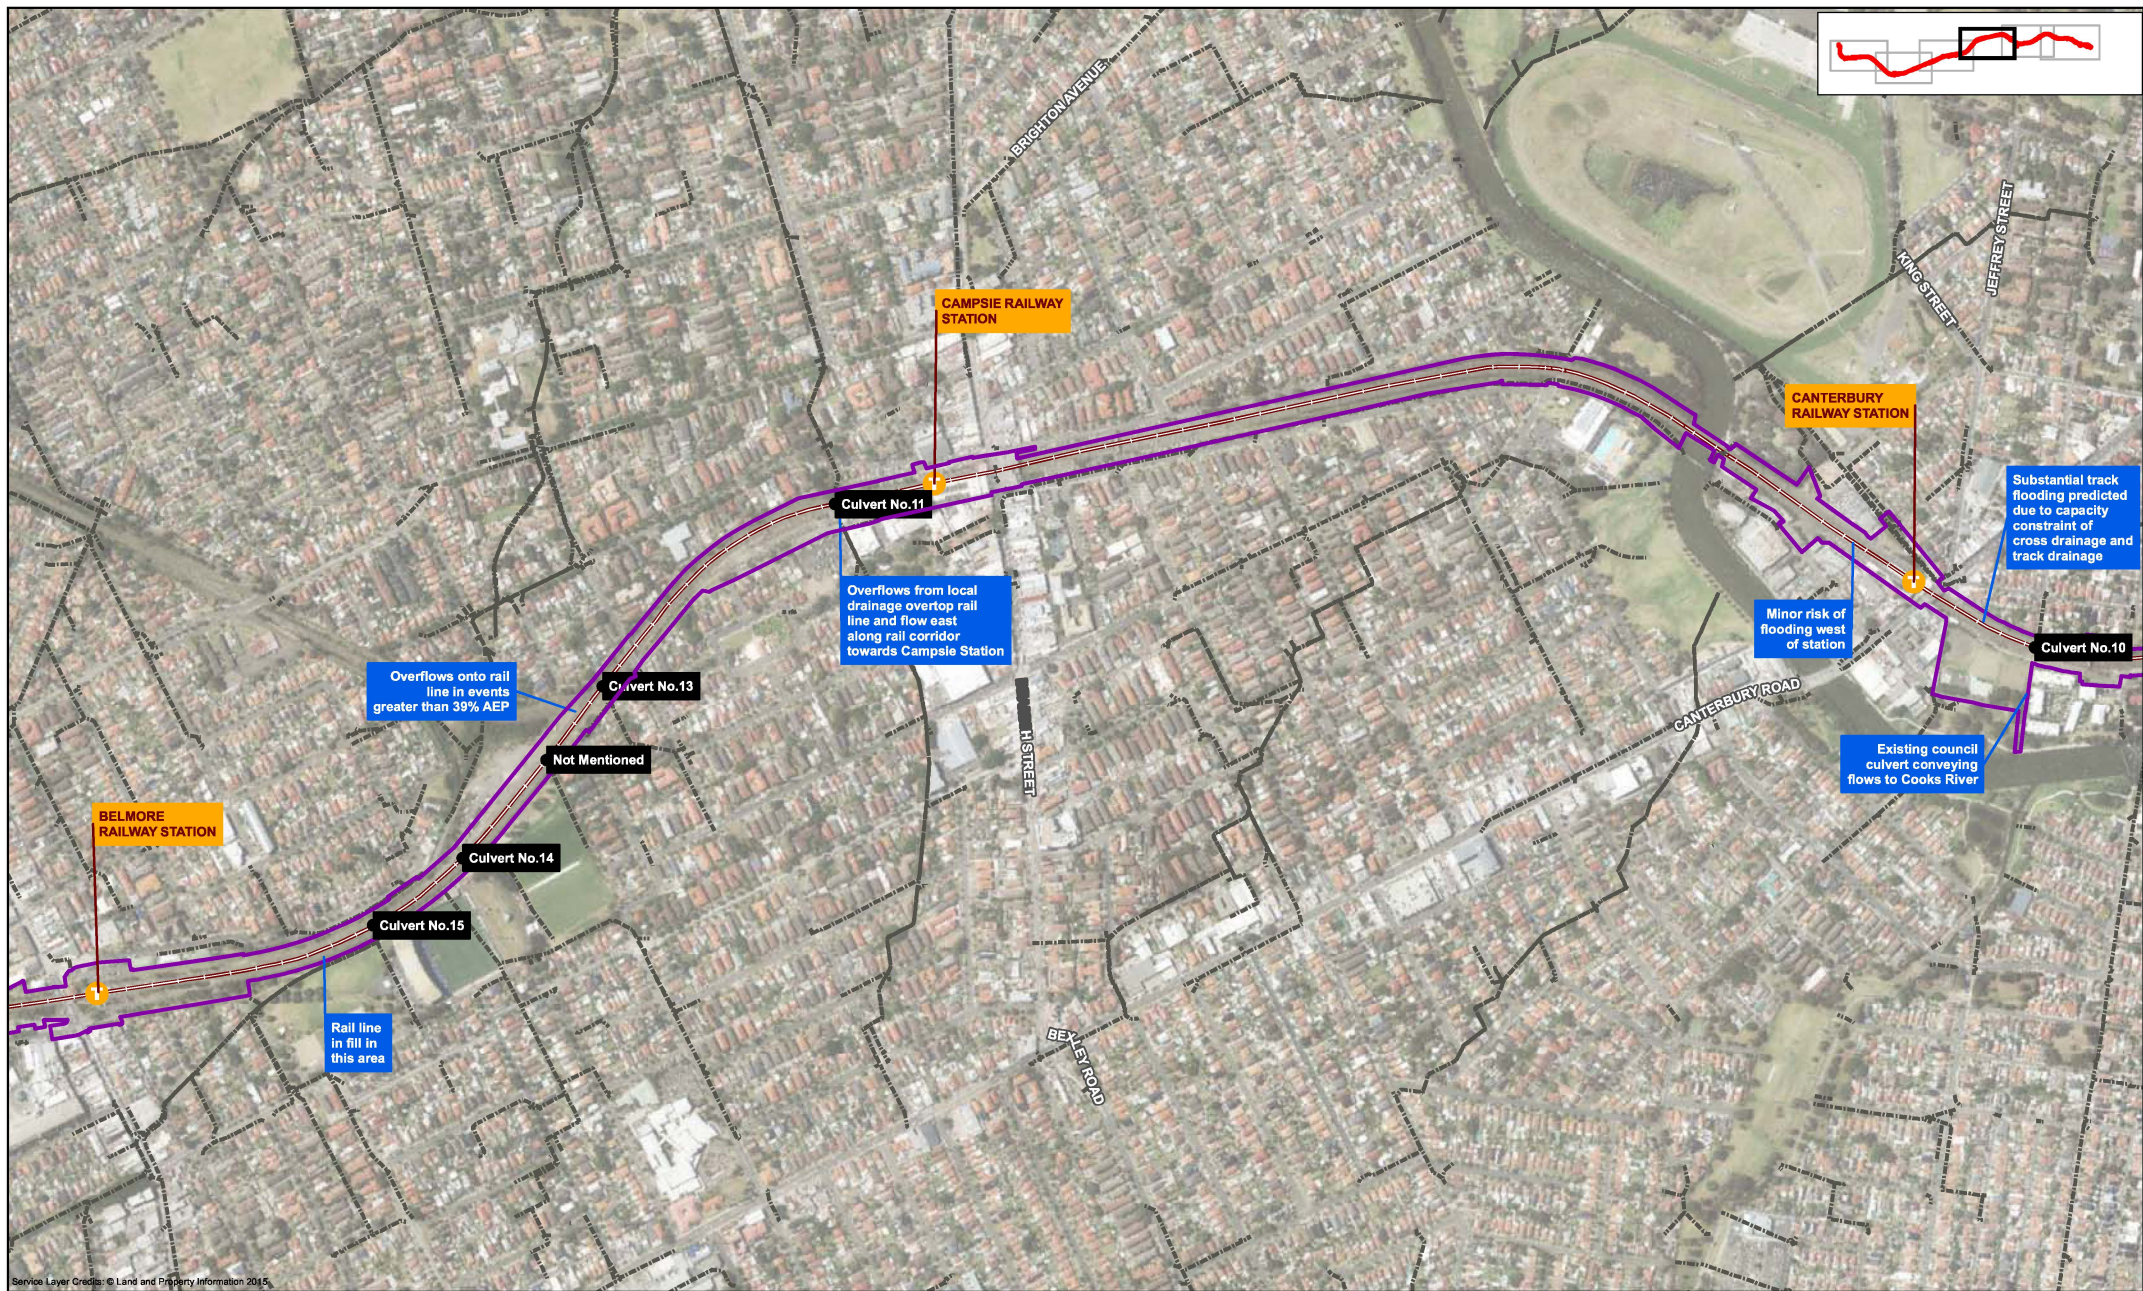
| Location | Summary of existing flooding and drainage issues | Figure reference |
|--|---|---|
| Campsie Station | <ul style="list-style-type: none"> • Surface water flows from south to north beneath rail corridor. • Overflows from local drainage enter the rail corridor and flow east towards Campsie Station in events greater than the 10 % AEP . • West of Campsie Station is a high flood hazard area. • Overflows from local drainage enter the rail corridor near Belmore triangle area in events greater than 39 % AEP. | Figure 3-11 |

Summary of existing flooding and drainage conditions
