Western Harbour Tunnel and Warringah Freeway Upgrade

Technical working paper: Contamination

January 2020

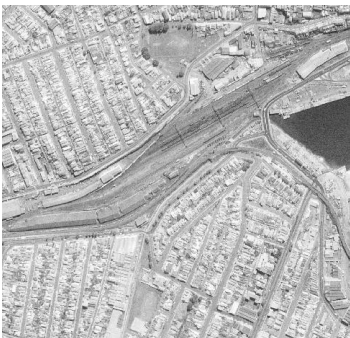
The majority of Rozelle Rail Yards (WHT1) appears to be railyards. Rozelle Rail Yards (WHT1) is occupied by a number of buildings (large warehouse and workshop type buildings) and rolling stock. The eastern portion of Rozelle Rail Yards (WHT1) (adjoining Rozelle Bay) appears to be used for industrial purposes.	Rozelle Rail Yards (WHT1) is surrounded by established residential (north and south), commercial/industrial land use (north-east and south-west) and railway (east and west). Large above-ground tanks are visible on a property located to the south-east of Rozelle Rail Yards (WHT1). Rozelle Bay is located to the east of Rozelle Rail Yards (WHT1). Earthworks are being carried out on Federal Park.
1983/84

Table A.1 Historical aerial photography review - Rozelle Rail Yard (WHT1) construction support site and Rozelle surface

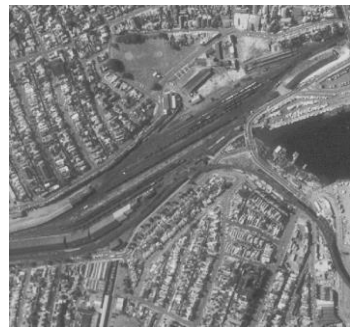
Rozelle Rail Yards (WHT1) is generally unchanged from the 1975 imagery, with the exception of wharf type structures constructed into Rozelle Bay.	Surrounding area is generally unchanged from the 1975 imagery with the exception of the demolition of the large above-ground storage tanks and associated buildings on the property located to the south-east of Rozelle Rail Yards (WHT1). Earthworks are being carried out on the current location of Jubilee Park.

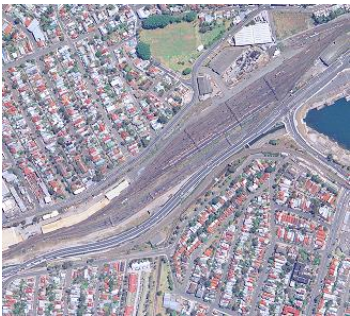
A number of buildings within Rozelle Rail Yards (WHT1) and the wharf structures in Rozelle Bay have been demolished. The north-western corner of Rozelle Bay has been infilled.	Surrounding area is generally unchanged from the 1983/84 imagery with the exception of the construction of the City West Link to the south of the site and construction of Federal and Bicentennial Parks.

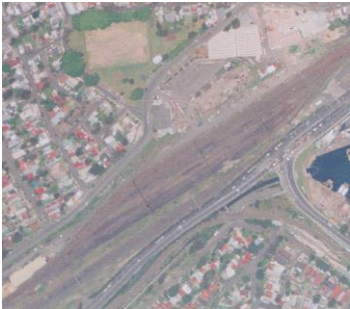
Rozelle Rail Yards (WHT1) is generally unchanged from the 1994 imagery with the exception of no rolling stock present on-site and wharf structures have been constructed into Rozelle Bay.	Surrounding area is generally unchanged from the 1994 imagery.
2002	No image available		
2005	No image available

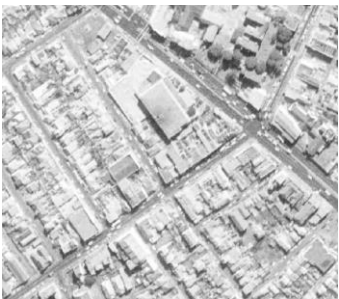
Victoria Road (WHT2) appears to be an area of mixed land use including a large building (likely leagues club) and retail type buildings fronting Darling Street. Possible service station site in the northern portion of Victoria Road (WHT2).	The surrounding area appears to be dominated by established residential with some minor commercial premises fronting main roads (Darling Street, Victoria Road). Larger type buildings (Rozelle Public School) are located to the east of Victoria Road (WHT2).
1983/84

Table A.2 Historical aerial photography review - Victoria Road (WHT2) construction support site

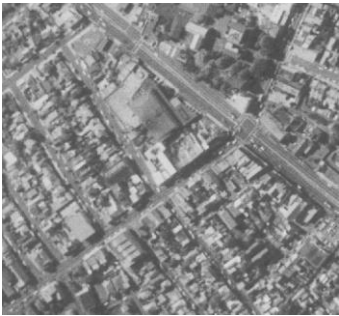
Victoria Road (WHT2) is generally unchanged from the 1975 imagery with the exception of some larger retail type buildings fronting Darling Street.	Surrounding area is generally unchanged from the 1975 imagery.
1986	No image available

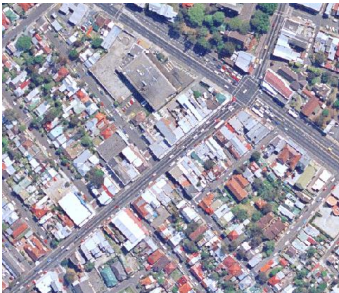
Victoria Road (WHT2) is generally unchanged from the 1983/84 imagery with the exception of additional structures and the possible service station located within the northern portion of Victoria Road (WHT2).	Surrounding area is generally unchanged from the 1983/84 imagery.
1998

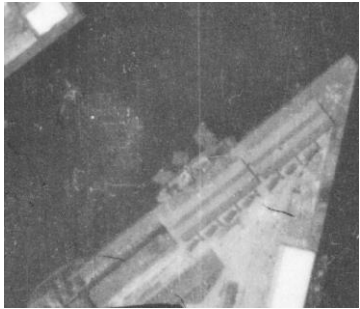
White Bay (WHT3) (South) appears to be a land-based industrial facility located next to White Bay. White Bay (South) (WHT3) is occupied by a number of buildings (large warehouse type buildings) and wharf structures. Possible stockpile observed (possibly coal for power station). The frontage of White Bay (South) (WHT3) with White Bay is very linear (possible reclamation).	White Bay (WHT3) (South) is surrounded by water (White and Johnstons Bays) to the north, east and south. Areas to the west of the site are not visible in the image.
1955	No image available		
1961	No image available		
1970	No image available

Table A.3 Historical aerial photography review - White Bay (South) (WHT3) construction support site

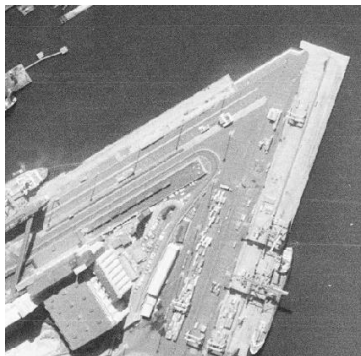
Buildings previously observed on White Bay (South) (WHT3) have been demolished, larger wharf structure and cranes (south-eastern portion of site) and grain silos constructed.	Areas to the west of White Bay (South) (WHT3) comprise a power station and other industrial facilities.
1983/84

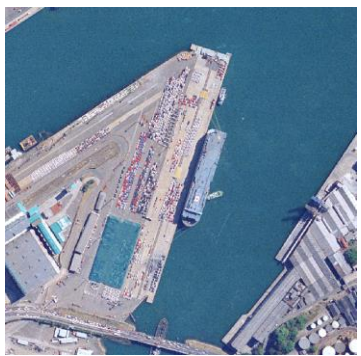
White Bay (South) (WHT3) is generally unchanged from the 1983/84 imagery with the exception of the site being used to store motor vehicles.	Surrounding area is generally unchanged from the 1975 imagery. Construction of the Anzac Bridge to the south of the site has started.
1998

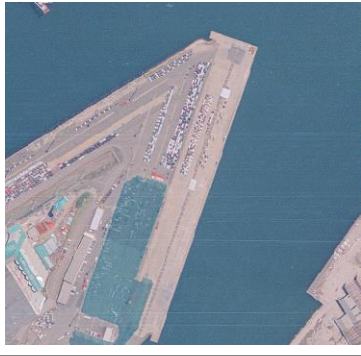
White Bay (South) (WHT3) is generally unchanged from the 1994 imagery.	Surrounding area is generally unchanged from the 1994 imagery. Glebe Island Bridge has been demolished. The Anzac Bridge has been constructed.

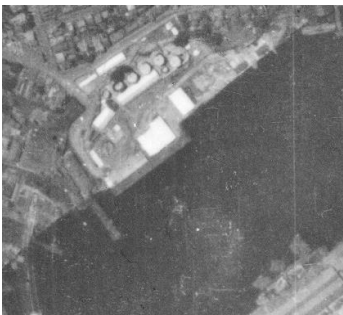
White Bay (WHT3) (North) appears to be a land-based industrial facility located next to Whites Bay. White Bay (WHT3) (North) is occupied by a number of buildings, a wharf structure and several above-ground storage tanks (possibly fuel storages). The frontage of White Bay (WHT3) (North) with White Bay is very linear (possible reclamation).	The surrounding area comprises established low density residential land use to the north of White Bay (WHT3) (North), industrial land use to the west, Whites Bay and Glebe Island to the south.
1955	No image available		
1961	No image available		
1970	No image available		
1975

Table A.4 Historical aerial photography review - White Bay (North) (WHT3) construction support site

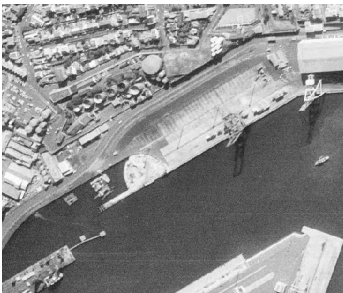
White Bay (WHT3) (North) is cleared of former buildings and now comprises wharf structure and crane. Wharf structure extends further into White Bay than that observed in the 1930 imagery (possible reclamation).	Surrounding area is generally unchanged from the 1930 imagery with the exception of a container terminal located to the east of White Bay (WHT3) (North).

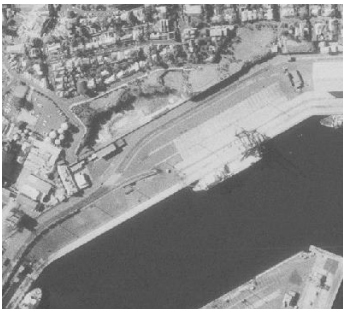
The wharf structure has been extended along the south-western portion of the site (possible reclamation).	Surrounding area is generally unchanged from the 1975 imagery. Above-ground storage tanks to the north of White Bay (WHT3) (North) have been removed.
1986	No image available		
1991	No image available

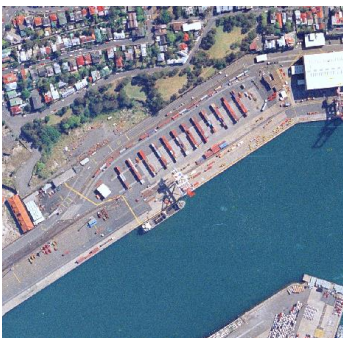
White Bay (WHT3) (North) is generally unchanged from the 1983/84 imagery with the exception of shipping containers present on White Bay.	Surrounding area is generally unchanged from the 1983/84 imagery.
1998

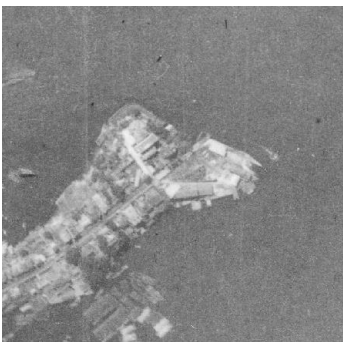
Yurulbin Point (WHT4) appears to be a land-based commercial/industrial facility located next to Snails Bay. Yurulbin Point is occupied by a number of buildings (including a larger warehouse/workshop building) and wharf structures.	Yurulbin Point (WHT4) is surrounded by water (Snails Bay and Port Jackson) to the east and south. Areas immediately to the north and south-west of Yurulbin Point appear to be used for similar activities to those on-site. Established residential areas are present further to the west of Yurulbin Point.

Table A.5 Historical aerial photography review – Yurulbin Point (WHT4) construction support site

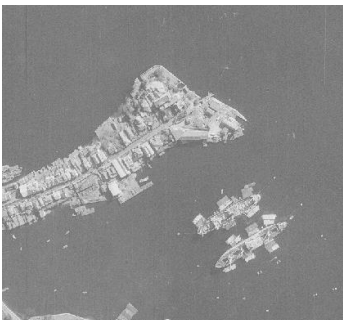
Yurulbin Point (WHT4) is generally unchanged from the 1930 imagery.	Surrounding area is generally unchanged from the 1930 imagery with the exception of a large residential development present to the north of Yurulbin Point (WHT4).
1961

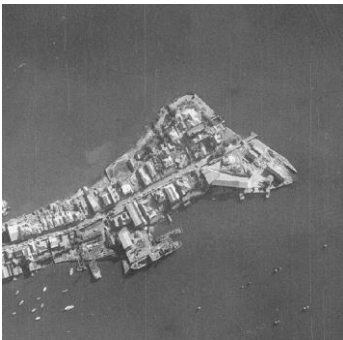
Yurulbin Point (WHT4) is generally unchanged from the 1955 imagery.	Surrounding area is generally unchanged from the 1955 imagery.
1970

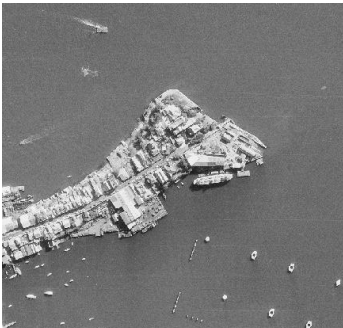
Yurulbin Point (WHT4) is generally unchanged from the 1961 imagery.	Surrounding area is generally unchanged from the 1961 imagery.
1975

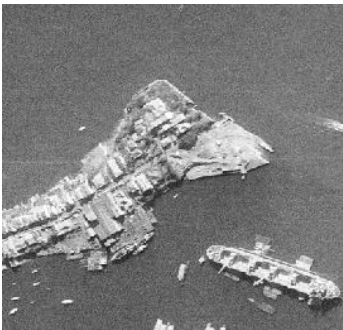
Buildings and structures formerly present on Yurulbin Point (WHT4) have been demolished and removed. Yurulbin Point is vacant.	Surrounding area is generally unchanged from the 1970 imagery.

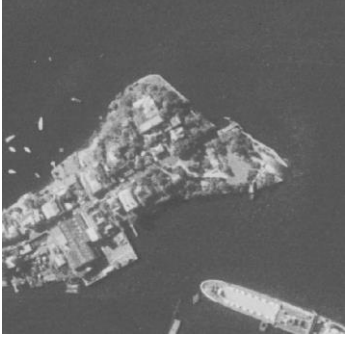
Yurulbin Point (WHT4) appears to be parkland (grass and trees present).	Surrounding area is generally unchanged from the 1975 imagery.
1986

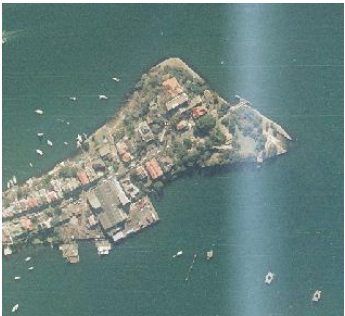
Yurulbin Point (WHT4) is generally unchanged from the 1983/84 imagery.	Surrounding area is generally unchanged from the 1983/84 imagery.
1991

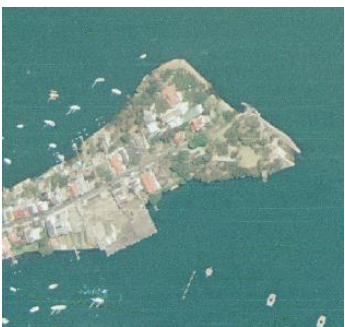
Yurulbin Point (WHT4) is generally unchanged from the 1986 imagery.	Surrounding area is generally unchanged from the 1986 imagery with the exception of the buildings associated with the industrial premises to the west of Yurulbin Point (WHT4) being demolished.
1994

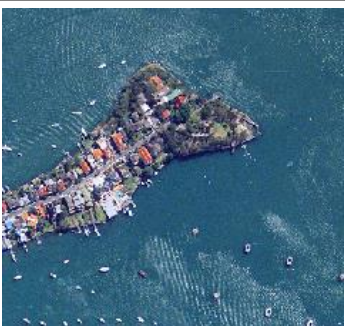
Yurulbin Point (WHT4) is generally unchanged from the 1991 imagery.	Surrounding area is generally unchanged from the 1991 imagery with the exception of the construction of residential buildings on the former industrial premises to the west of Yurulbin Point (WHT4).

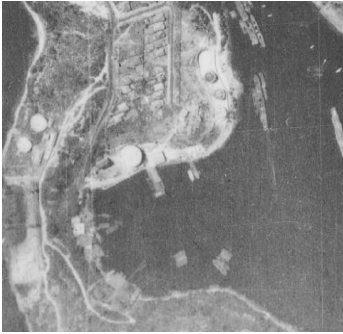
Table A.6 Historical aerial photography review – Berrys Bay (WHT7) construction support site

Berrys Bay (WHT7) appears to be a land-based commercial/industrial facility located next to Berrys Bay. Berrys Bay is occupied by a number of buildings and wharf structures. The northern portion of Berrys Bay contains a large above-ground storage tank (possible fuel storage).	Berrys Bay (WHT7) is surrounded by established low density residential areas, bushland, Berrys Bay and a number of industrial land uses including HMAS <i>Waterhen</i> to the north-east. There are a number of above-ground storage tanks (possible fuel storages) to the north-east and west of Berrys Bay (WHT7).

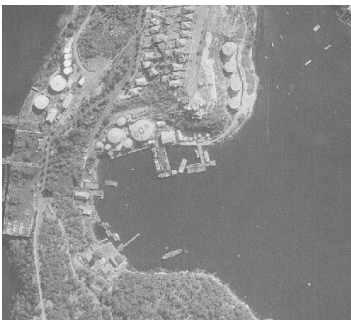
Additional commercial/industrial development has occurred on Berrys Bay (WHT7) including additional buildings, wharf structures and above-ground storage tanks.	Numerous above-ground storage tanks are present to the north-east and west of Berrys Bay (WHT7). More development appears to have occurred on the HMAS <i>Waterhen</i> site. The coal loader is present to the west of Berrys Bay.
1961

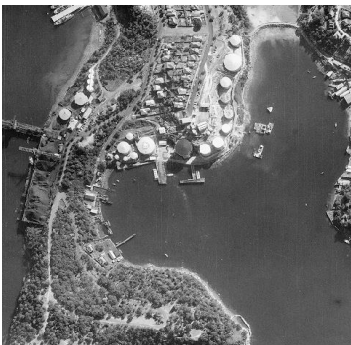
Additional above-ground storage tanks have been constructed within the northern portion of Berrys Bay (WHT7).	Additional above-ground storage tanks have been constructed to the north-east of Berrys Bay (WHT7). Area now occupied by Waverton Park (to the north-east of Berrys Bay) has been reclaimed.
1970

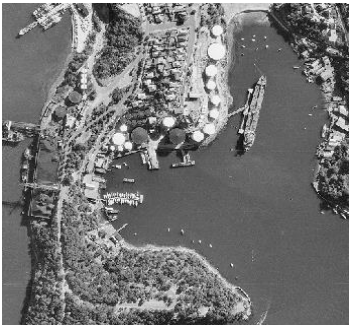
An additional above-ground storage tank has been constructed within the northern portion of Berrys Bay (WHT7).	Surrounding area is generally unchanged from the 1961 imagery.

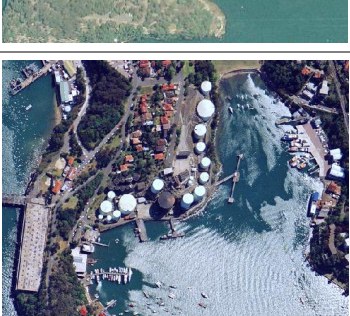
Berrys Bay (WHT7) is generally unchanged from the 1991 imagery.	Surrounding area is generally unchanged from the 1991 imagery with the exception of a new marina facility constructed to the east of Berrys Bay (WHT7) and removal of two above-ground storage tanks to the west of Berrys Bay. No coal present at the coal loader to the west of Berrys Bay.

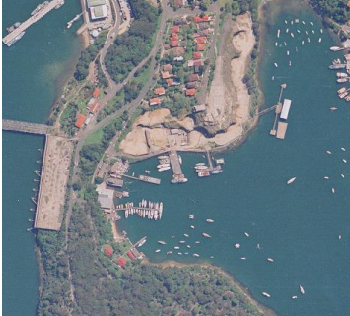
All above-ground storage tanks have been removed from Berrys Bay (WHT7).	Above-ground storage tanks to the north of Berrys Bay (WHT7) have been removed. New buildings and wharf structures constructed at HMAS <i>Waterhen</i> .
2002

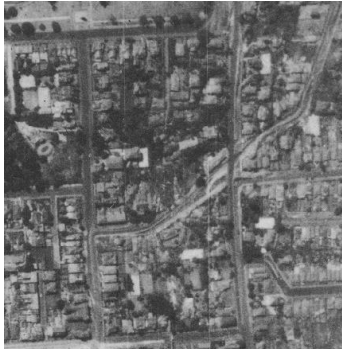
Table A.7 Historical aerial photography review – Berry Street north (WHT8) construction support site

Berry Street north (WHT8) is covered by residential dwellings. A road runs through the centre of Berry Street north (WHT8) (oriented generally north-east to west).	The surrounding area comprises established residential land use. Open space areas associated with St Leonards Park and North Sydney Oval are located to the north of Berry Street north (WHT8).

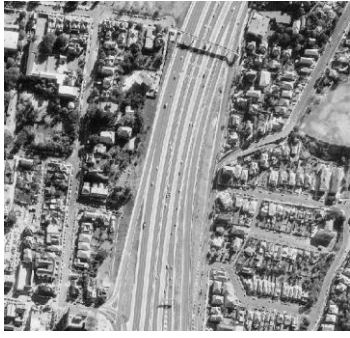
Berry Street north (WHT8) is now the verge next to the western side of the Warringah Freeway.	Areas to the east of Berry Street north (WHT8) (ie roads and residential premises) have been demolished for the Warringah Freeway. Residential premises to the west of Berry Street north (WHT8) have been demolished with high density residential apartments constructed.

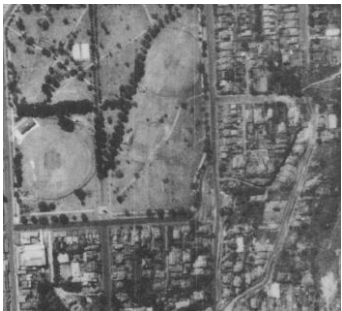
Table A.8 Historical aerial photography review – Ridge Street north (WHT9) construction support site

Ridge Street north (WHT9) is a vacant portion of open space within the south-eastern corner of St Leonards Park. No structures are visible on Ridge Street north (WHT9).	The surrounding area comprises established residential land use, open space areas associated with St Leonards Park and North Sydney Oval.

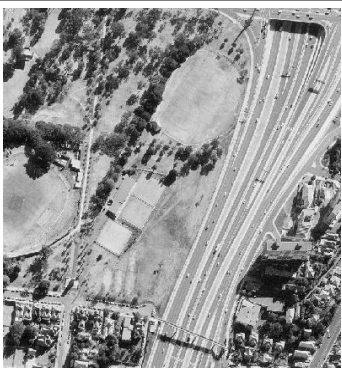
A portion of Ridge Street north (WHT9) (south-western corner) has been reclaimed for construction of the Warringah Freeway. Some ground disturbance is evident in the southern portion of St Leonards Park (WHT9).	Areas to the east of Ridge Street north (WHT9) (ie roads and residential premises) have been demolished for the Warringah Freeway.
1975

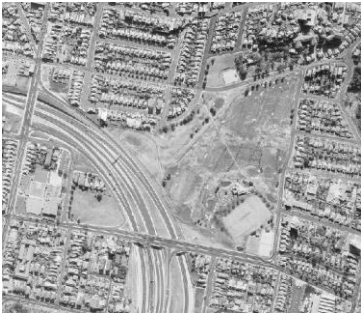
<p>The Warringah Freeway has been/is being constructed in areas to the south-west of Cammeray Golf Course (WFU8) and north-east of Rosalind Street east (WFU9). Buildings previously occupying Rosalind Street east (WFU9) have been demolished, Rosalind Street east (WFU9) is now open space.</p>	<p>Previous areas of open space and residential land use identified in the 1961 imagery have been demolished to facilitate the construction of the Warringah Freeway.</p>
1975

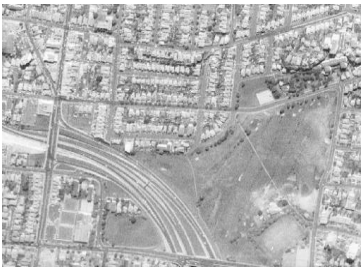
<p>Cammeray Golf Course (WFU8) and Rosalind Street east (WFU9) are generally unchanged from the 1970 imagery.</p>	<p>Surrounding area is generally unchanged from the 1970 imagery.</p>

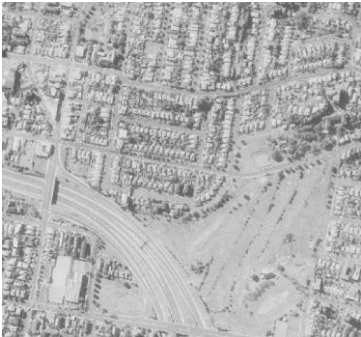
<p>Cammeray Golf Course (WFU8) and Rosalind Street east (WFU9) are generally unchanged from the 1975 imagery.</p>	<p>Surrounding area is generally unchanged from the 1975 imagery with the exception of some additional buildings constructed to the south of Rosalind Street east (WFU9).</p>

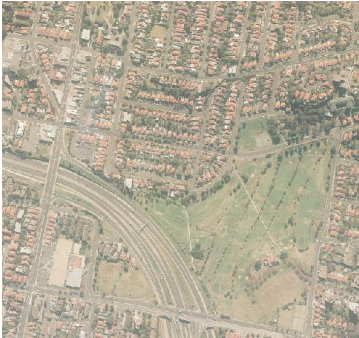
Cammeray Golf Course (WFU8) and Rosalind Street east (WFU9) are generally unchanged from the 1983/84 imagery.	Surrounding area is generally unchanged from the 1983/84 imagery with the exception of some additional buildings constructed to the south of Rosalind Street east (WFU9).
1991
