Project #: EART-05

Subject: Technical Review of Coal Ash Management in Environmental Impact Statement for Bayswater Power Station Upgrade SSD-9697--

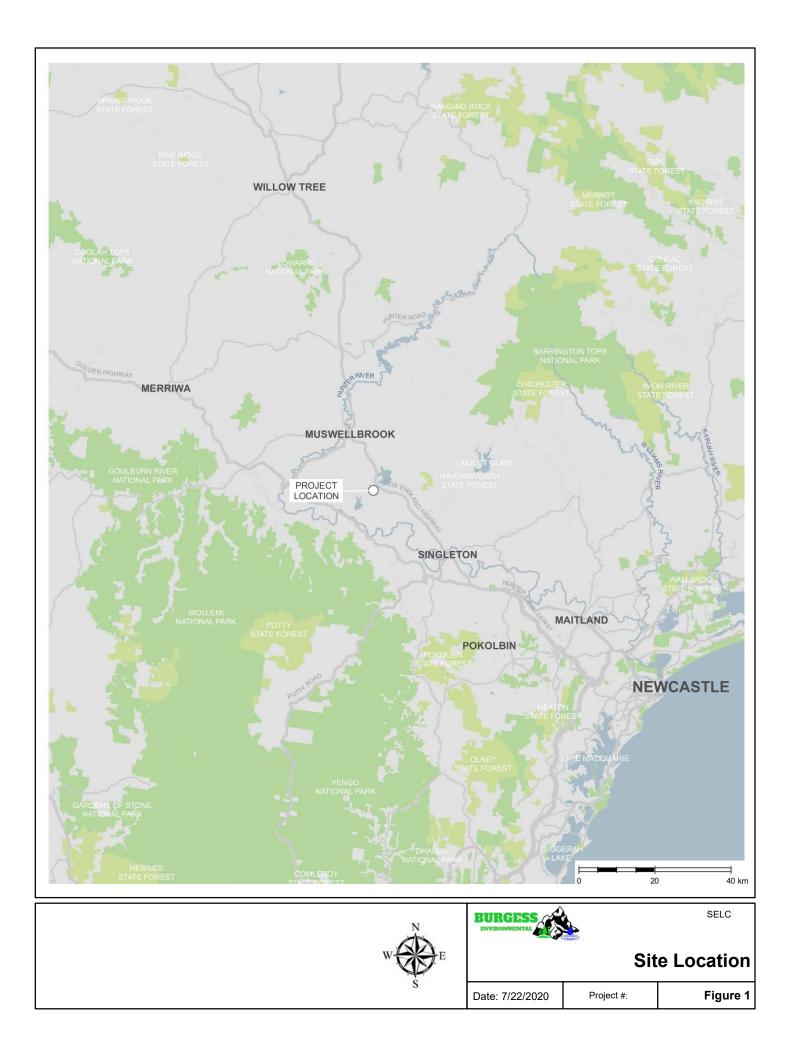
AGL Macquarie (AGL) owns and operates the Bayswater Power Station (Bayswater), which is located approximately 80 km northwest of Newcastle, NSW (Figure 1). AGL is proposing to undertake a range of upgrades to Bayswater aimed at improving the environmental performance of ash, salt and water management infrastructure and associated rehabilitation outcomes referred to as the Bayswater water and other associated operational works project (Project, Figure 2). Bayswater has a current generation capacity of 2,640 megawatts (MW) and approval for efficiency upgrades that would increase capacity to 2,740 MW. AGL retained Jacobs to complete an Environmental Impact Statement for the Project, which is currently in the period of public consultation.
