SAINT IGNATIUS' COLLEGE VISUAL ASSESSMENT REPORT

2-60 Riverview Street, Riverview

Title:	St Ignatius College Visual Impact Assessment
Prepared for:	St Ignatius College
Date:	21.05.2021
Status:	Final
Prepared by:	Hatch RobertsDay
Approved by:	Hatch RobertsDay

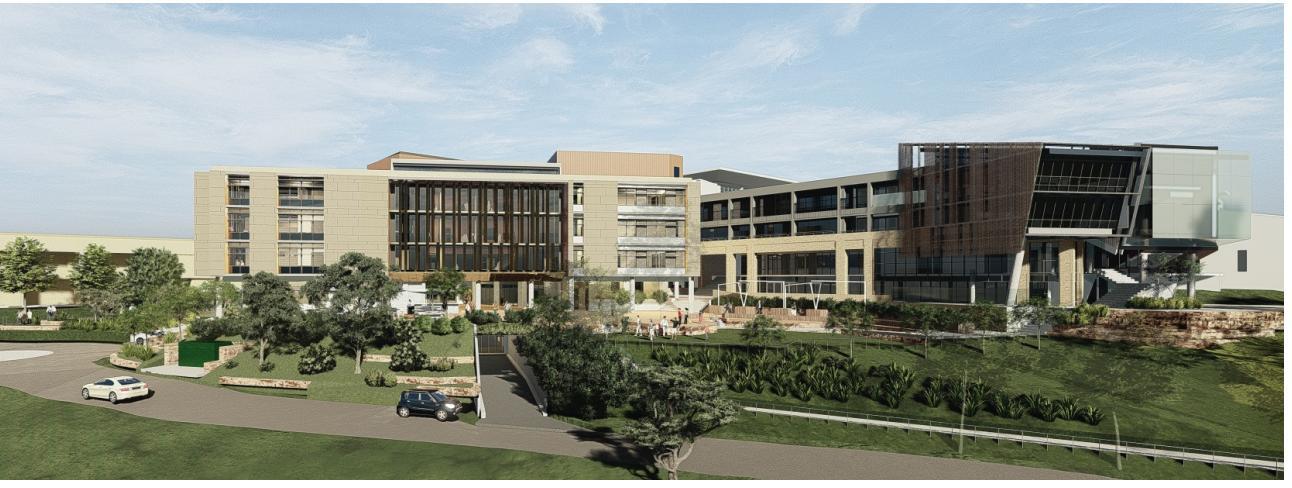
Proposal (Source: PMDL)

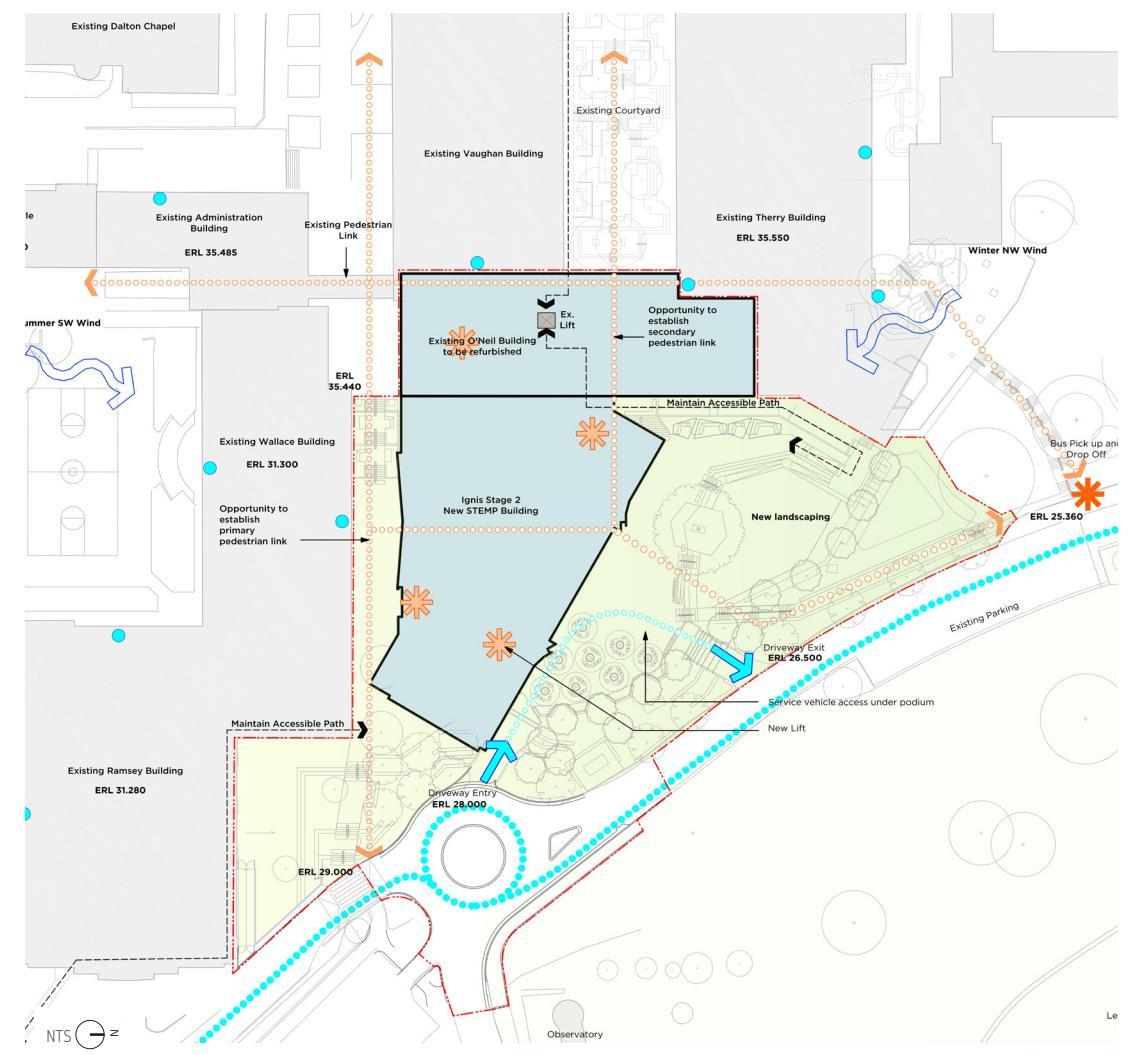
Overall Site Plan (Source: PMDL)

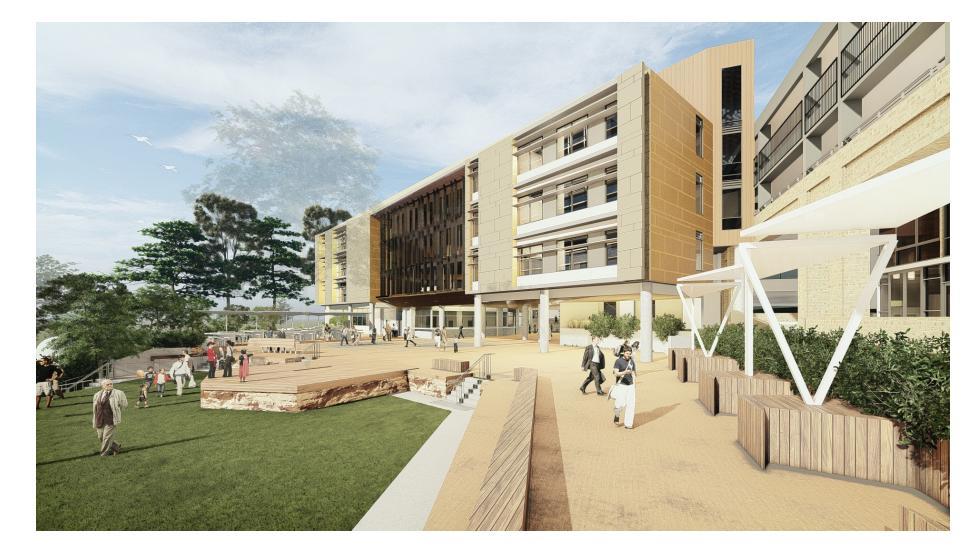
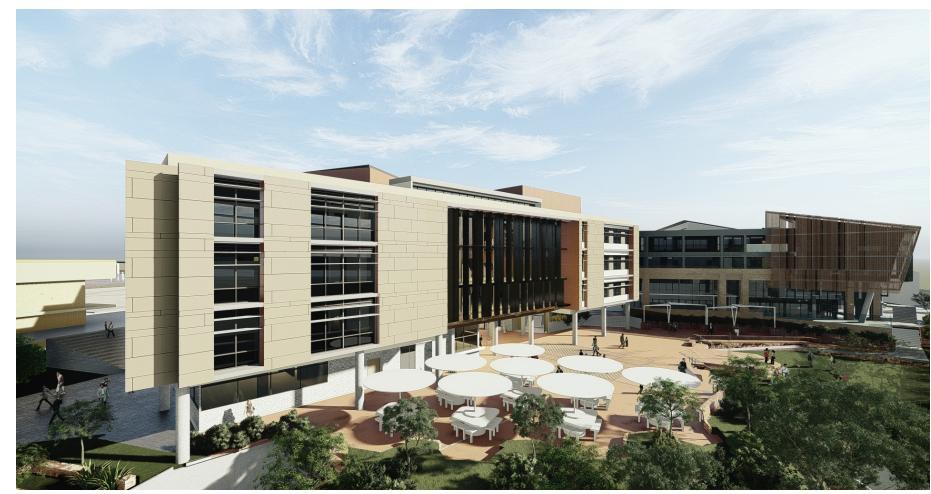
Elevations (Source: PMDL)

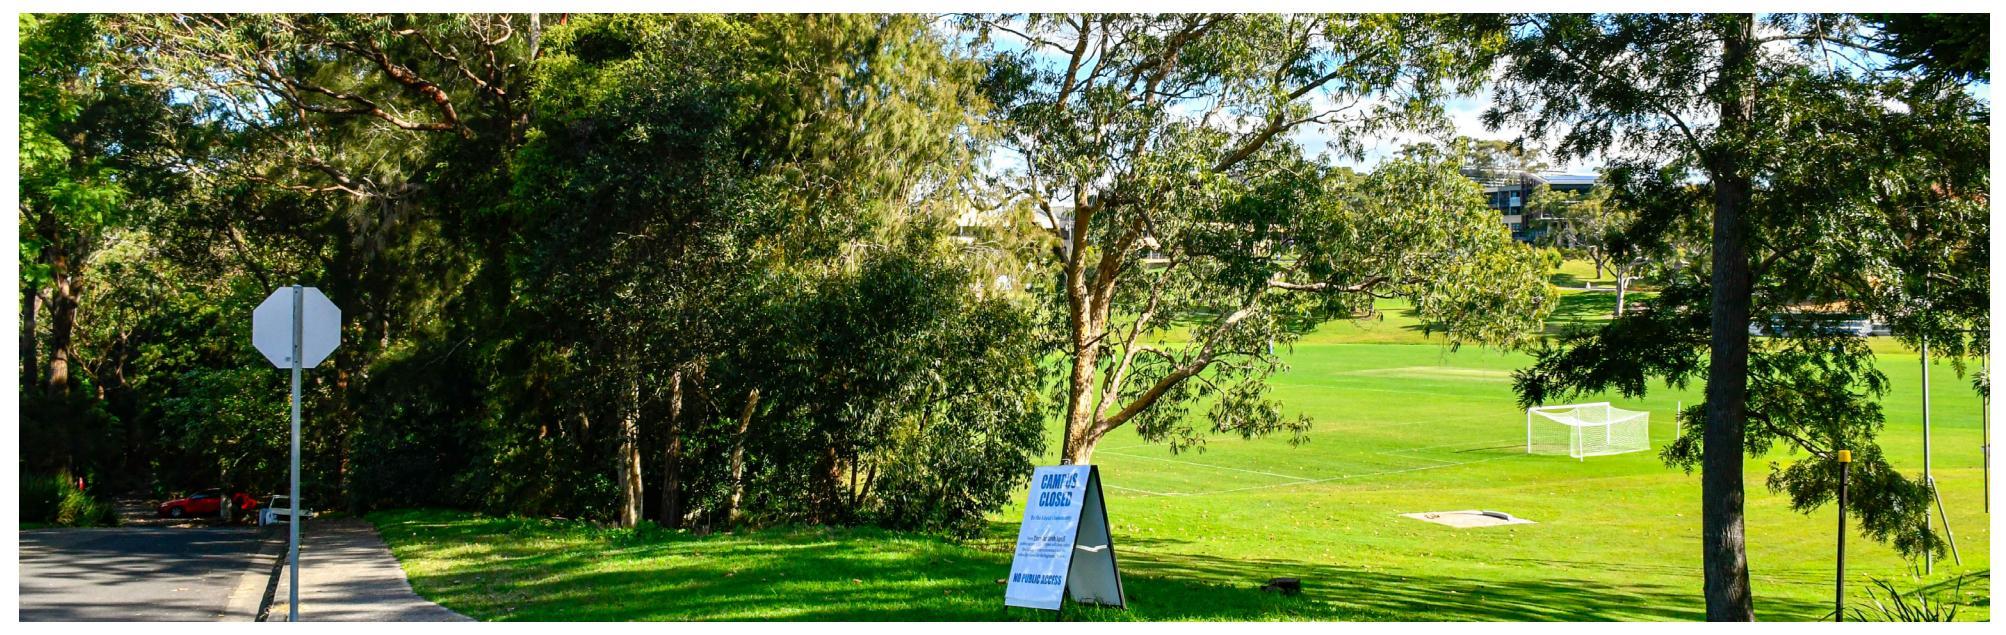
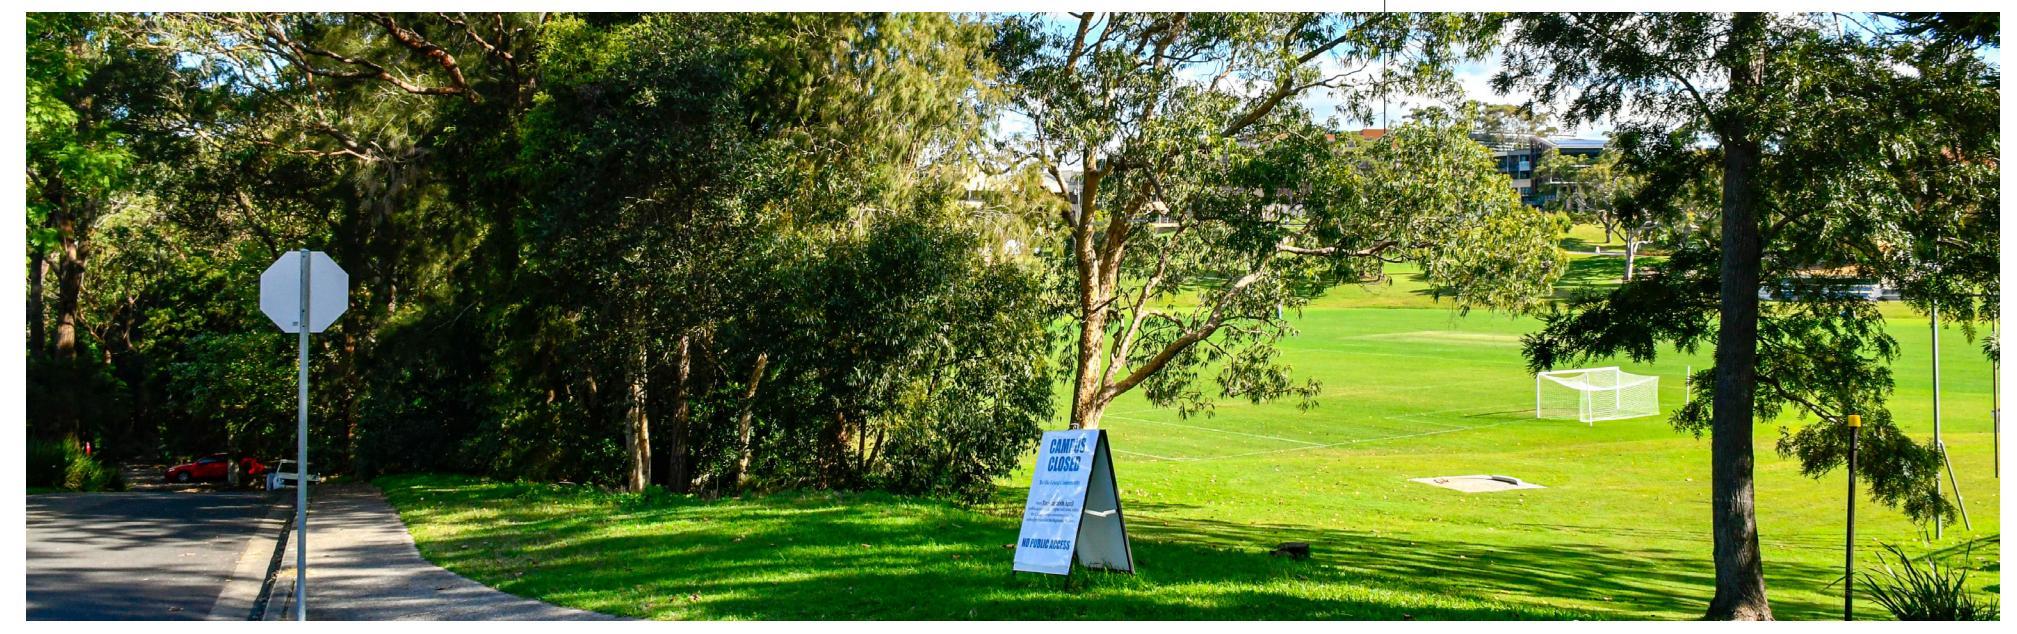
Viewpoint 1

The sensitivity of view from intersection of Miramont Ave & Tambourine Bay Rd has MODERATE sensitivity due to:

The magnitude of the proposal in this view is considered VERY LOW due to:

- Proposal is largely screened by existing vegetation, including large trees
- Proposal constitutes only a minor component of the view which might be missed by the casual receptor
- No effect on the overall quality of the scene

The visual impact for this view is assessed as LOW/NEGLIBLE, which is the combination of the sensitivity and magnitude of impact.

Existing

Proposed Building |

Proposed

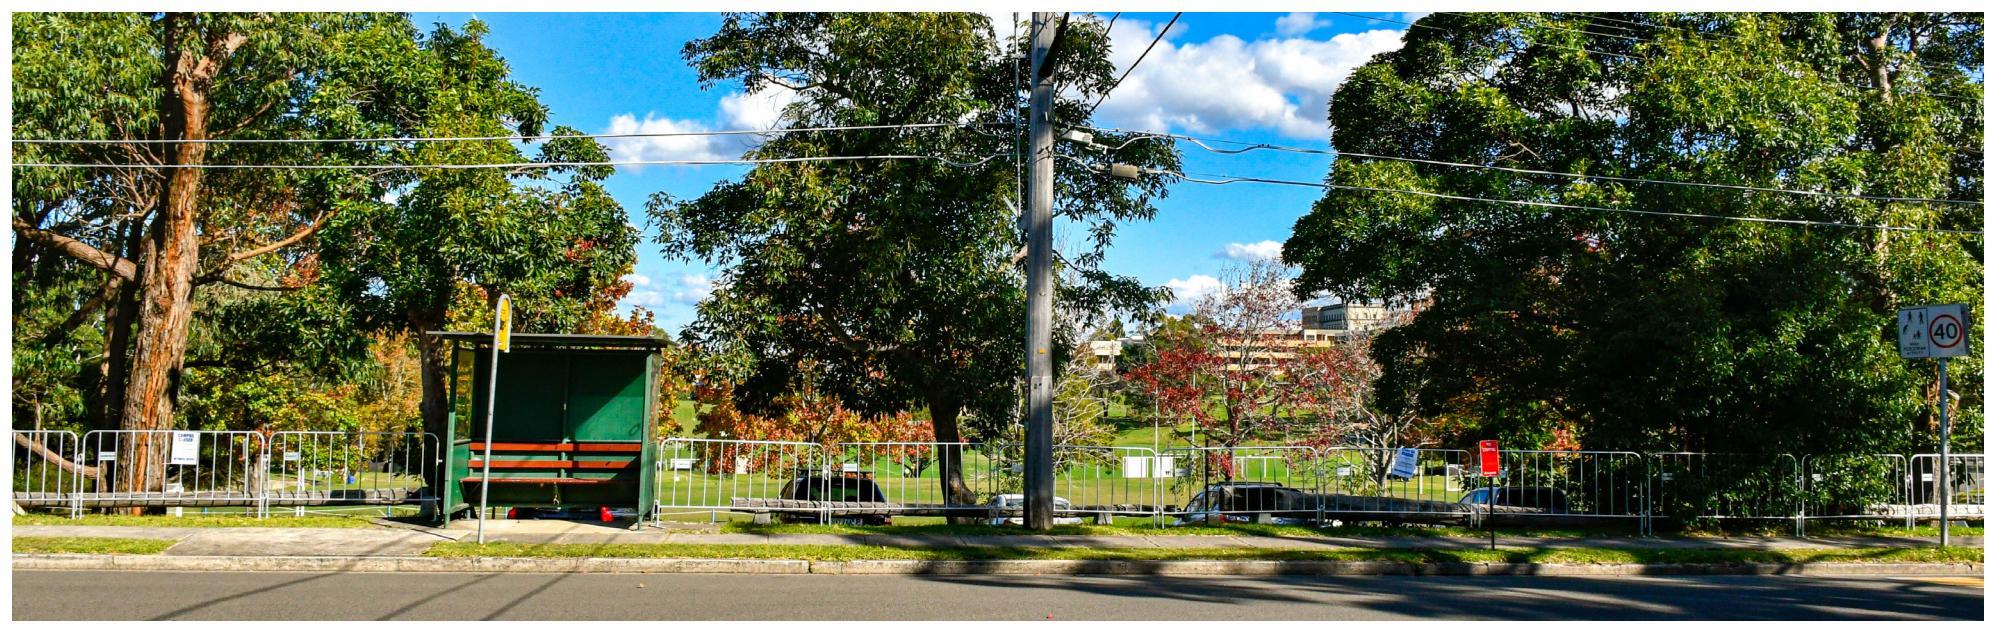
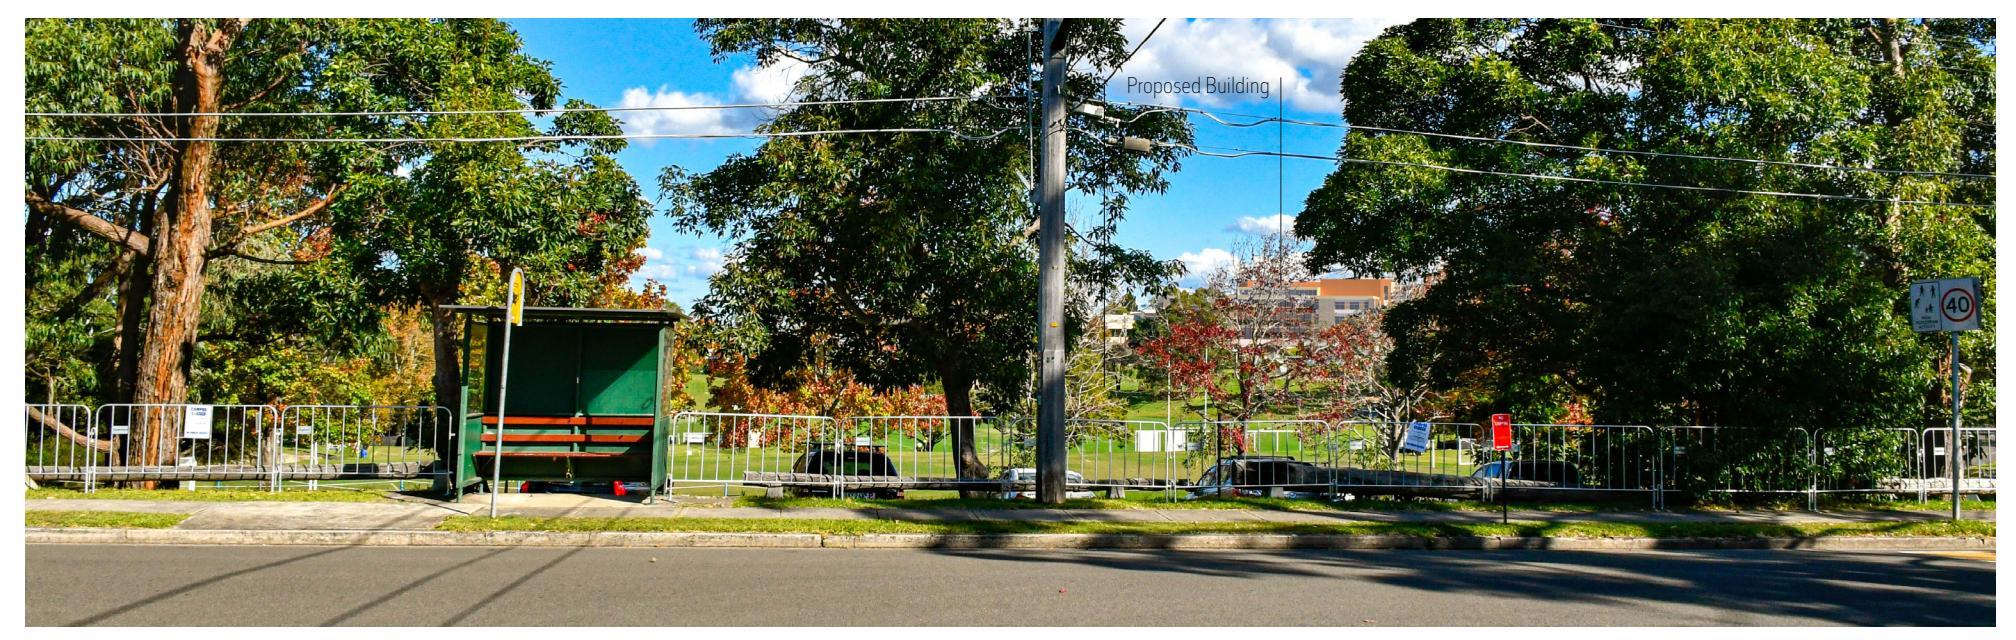
Viewpoint 2

The sensitivity of view from the intersection of Warilla PI & Riverview St has MODERATE sensitivity due to:

The magnitude of the proposal in this view is considered LOW, due to:

- Proposal is in the distance and largely screened by the existing structuresand vegetation
- There is a only a slight change in view

The visual impact for this view is assessed as LOW, which is the combination of the sensitivity and magnitude of impact.

Existing

Proposed

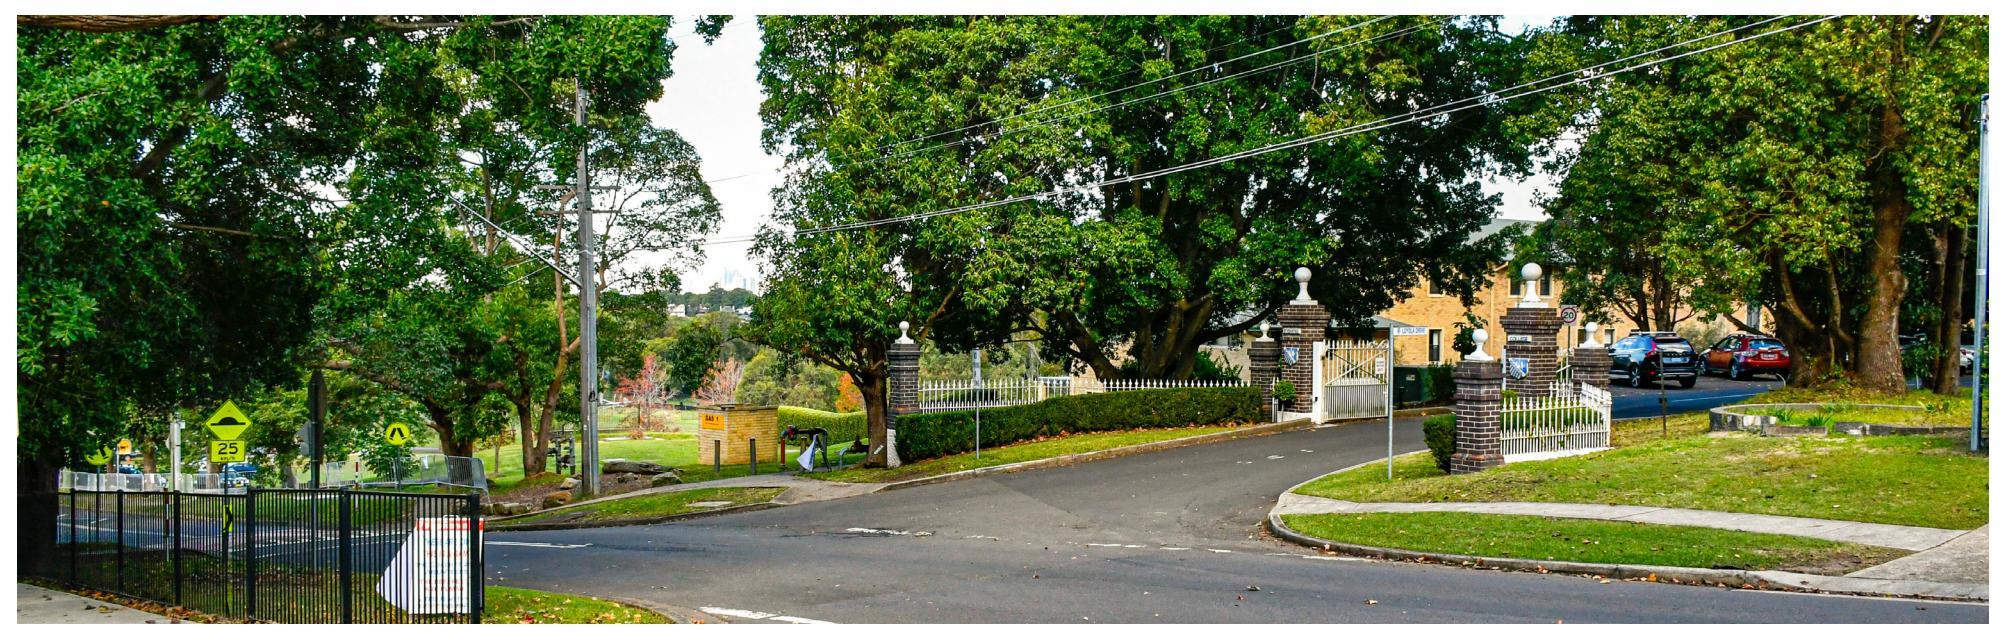
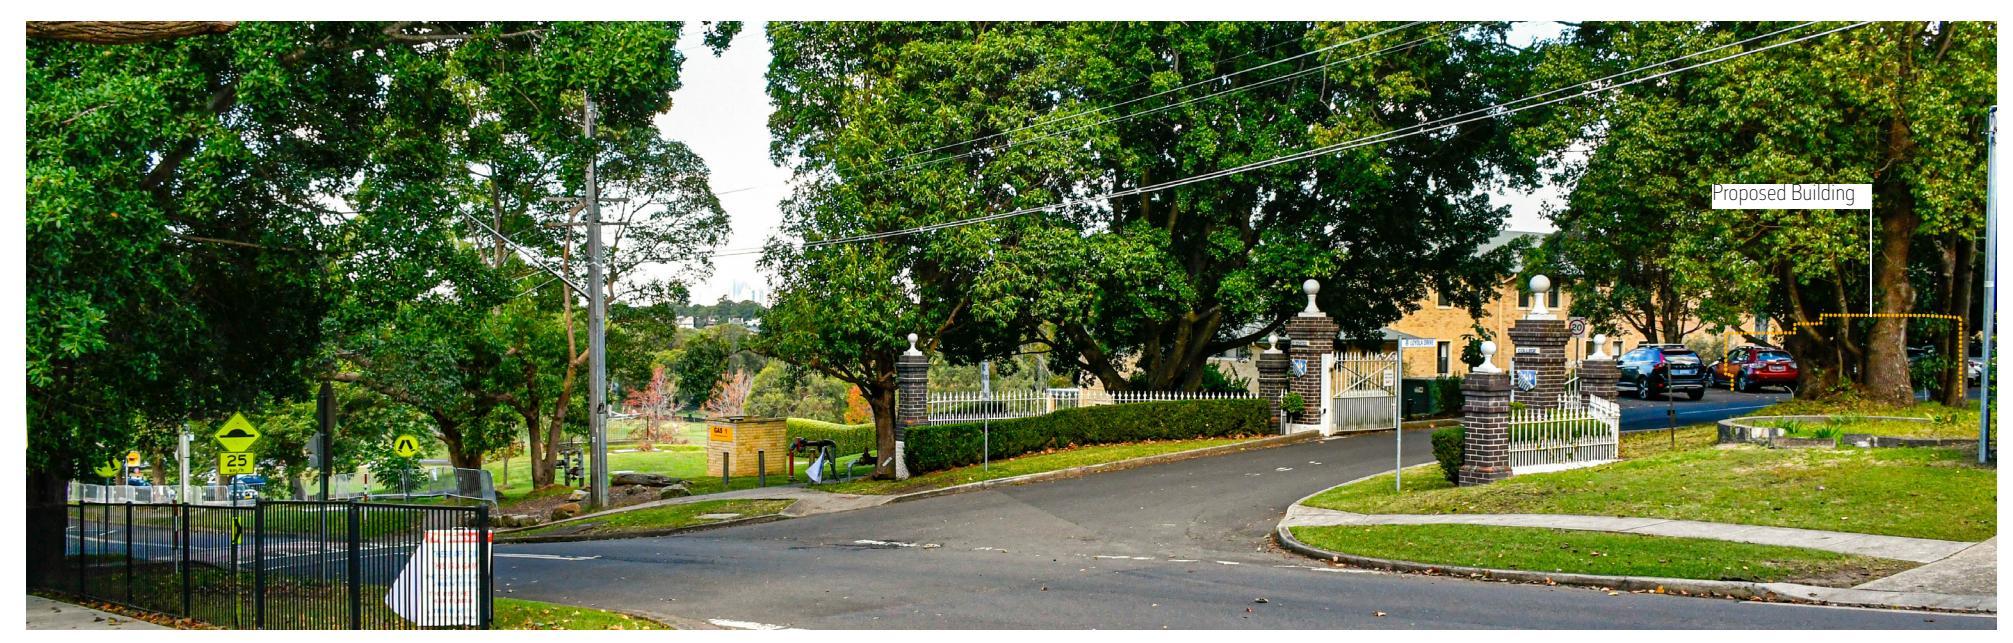
Viewpoint 3

The view from intersection of 6 Regis Dr & Riverview St considered to have LOW sensitivity due to:

The magnitude of the proposal in this view is considered NEGLIGIBLE, due to:

- Proposal is completely screened by existing vegetation and built form on the school campus
- There is no change in view

The visual impact for this view is assessed as NONE, which is the combination of the sensitivity and magnitude of impact.

Existing

Proposed

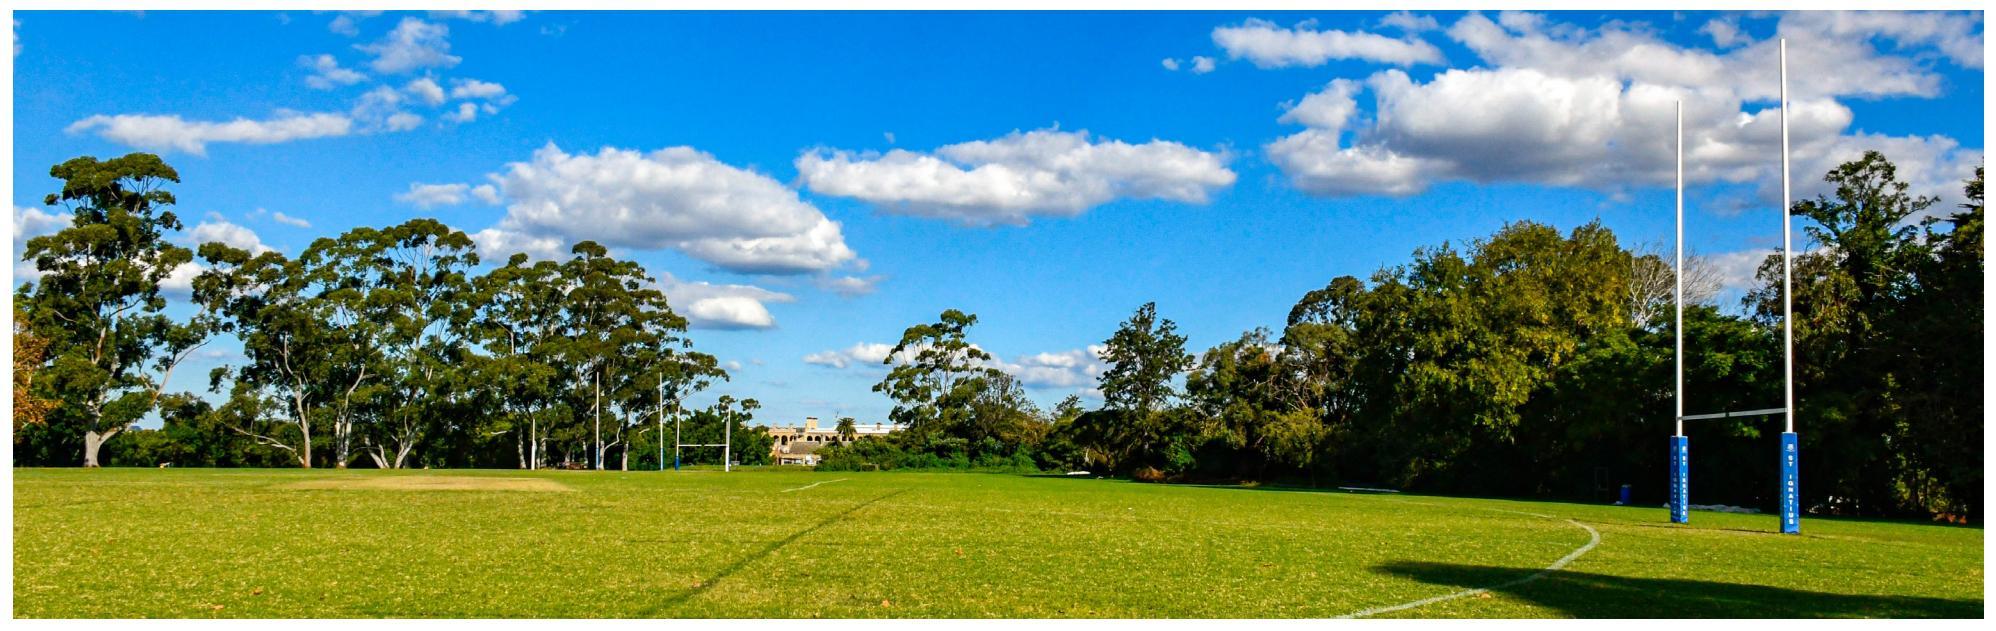
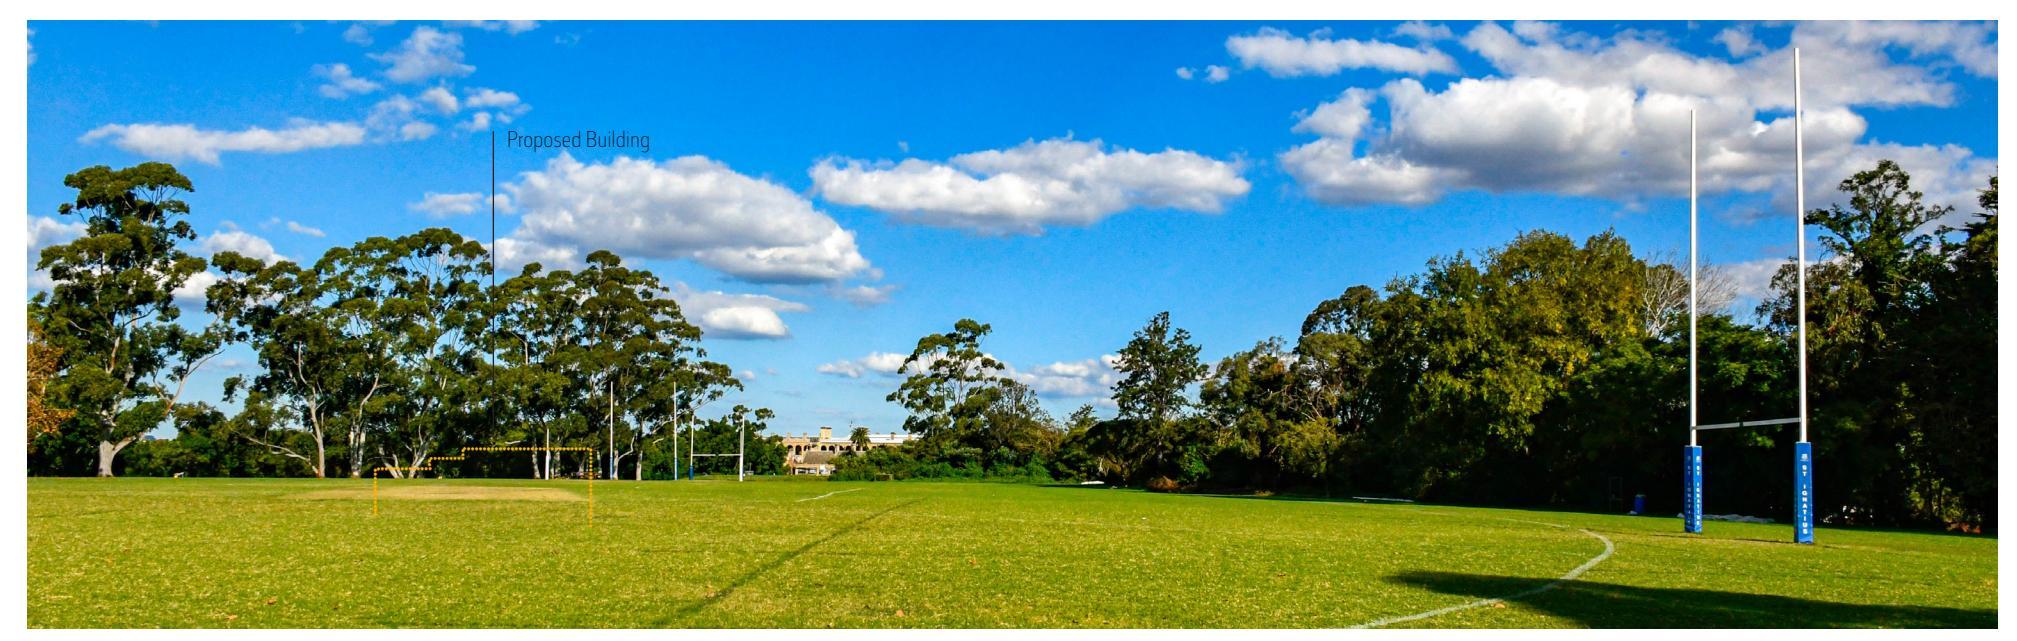
Viewpoint 4

The sensitivity of view from 64 Riverview St has LOW sensitivity due to:

The magnitude of the proposal in this view is considered NEGLIGIBLE, due to:

- Proposal is completely screened by existing vegetation on the school campus
- There is no change in view

The visual impact for this view is assessed as NONE, which is the combination of the sensitivity and magnitude of impact.

Existing

Proposed

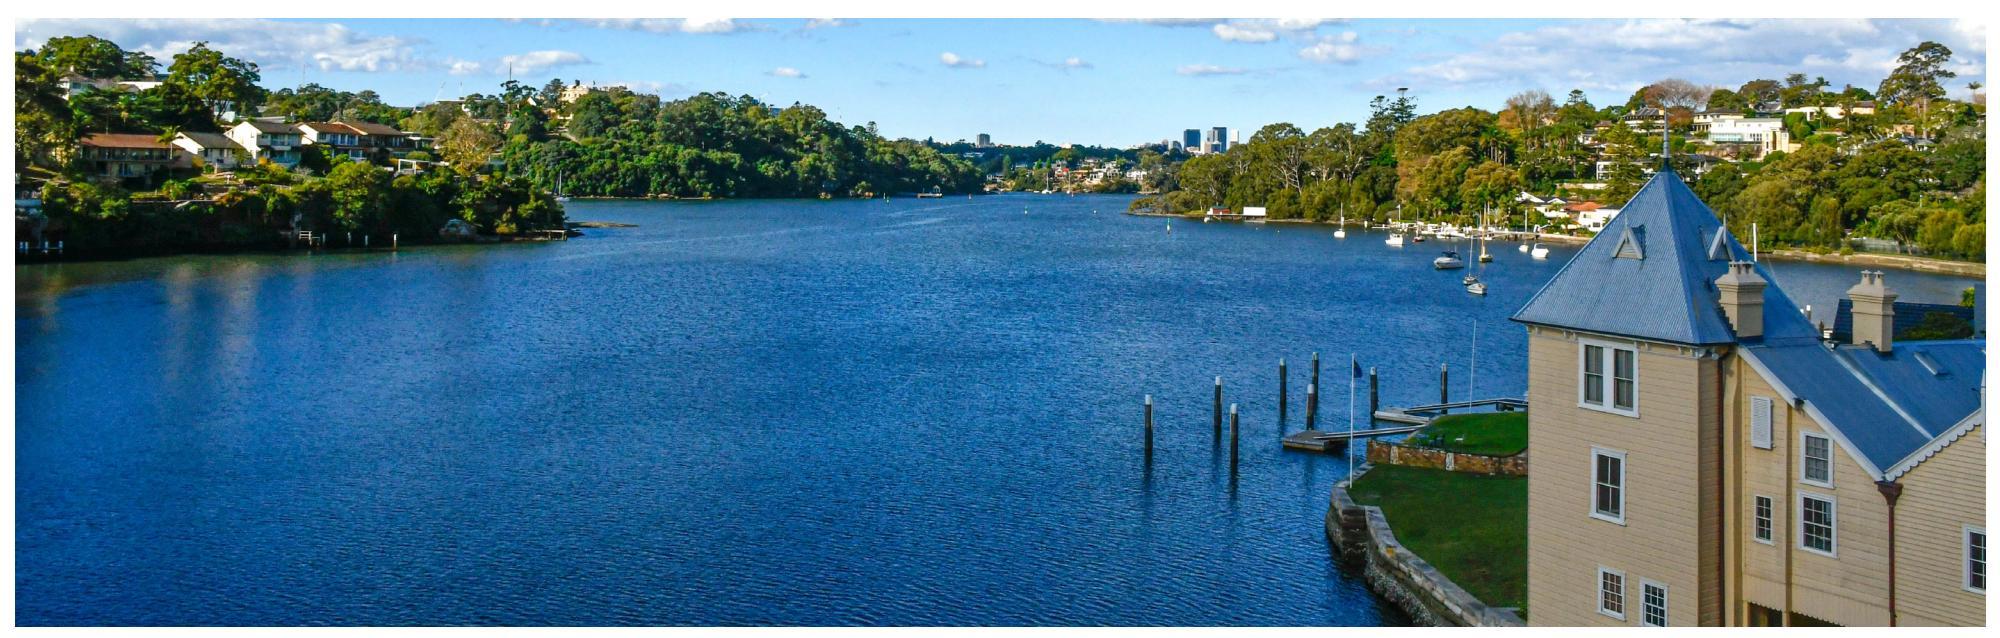
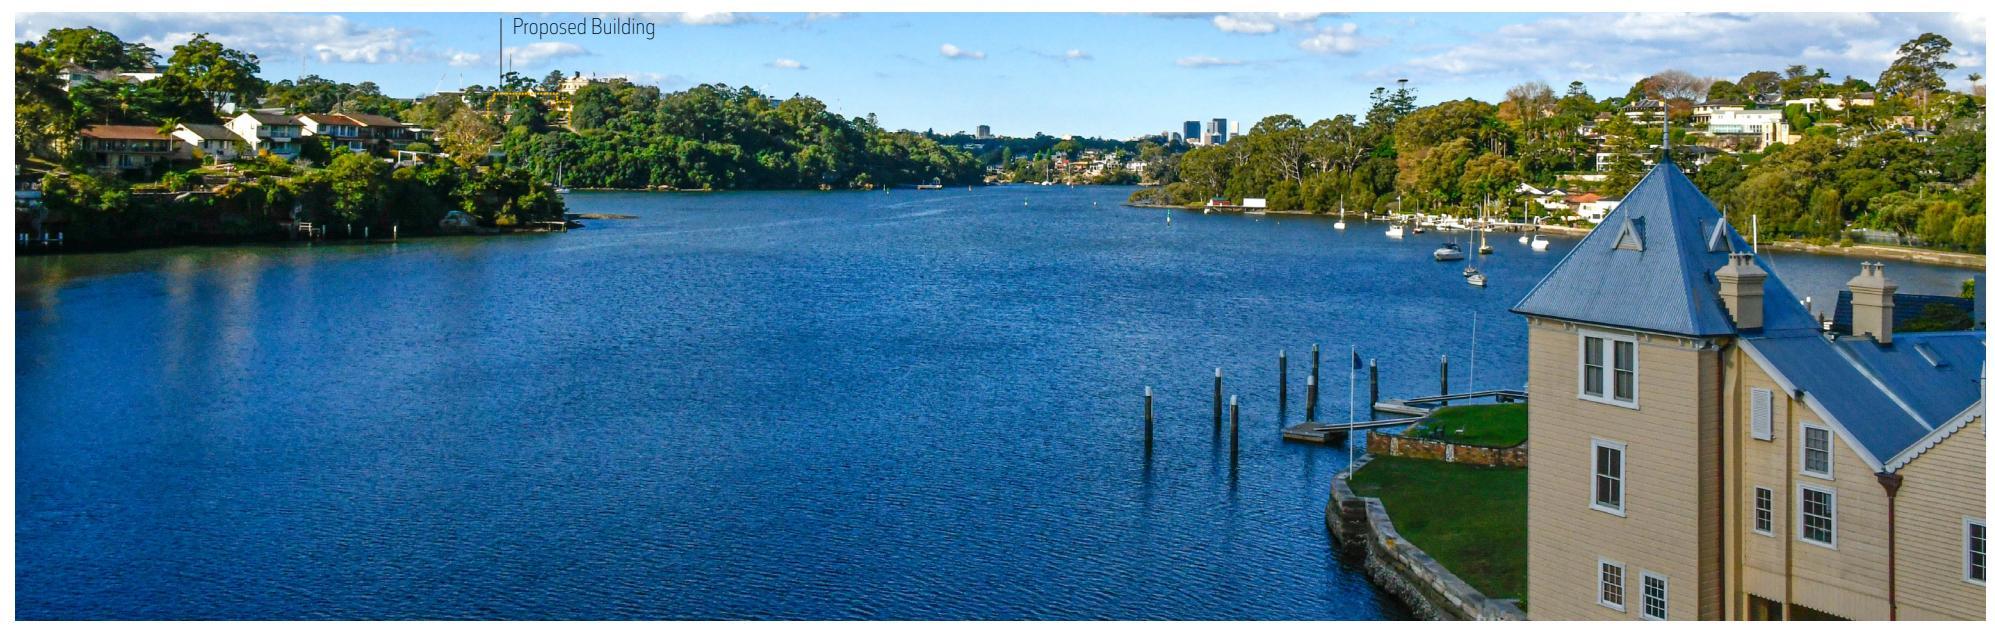
Viewpoint 5

The view from Sidewalk of Fig Tree Bridge is considered to have MODERATE sensitivity due to:

The magnitude of the proposal in this view is considered NEGLIGIBLE, due to:

- Proposal is in the distance and completely screened by the existing vegetation
- No change in the view

The visual impact for this view is assessed as NONE, which is the combination of the sensitivity and magnitude of impact.

Existing

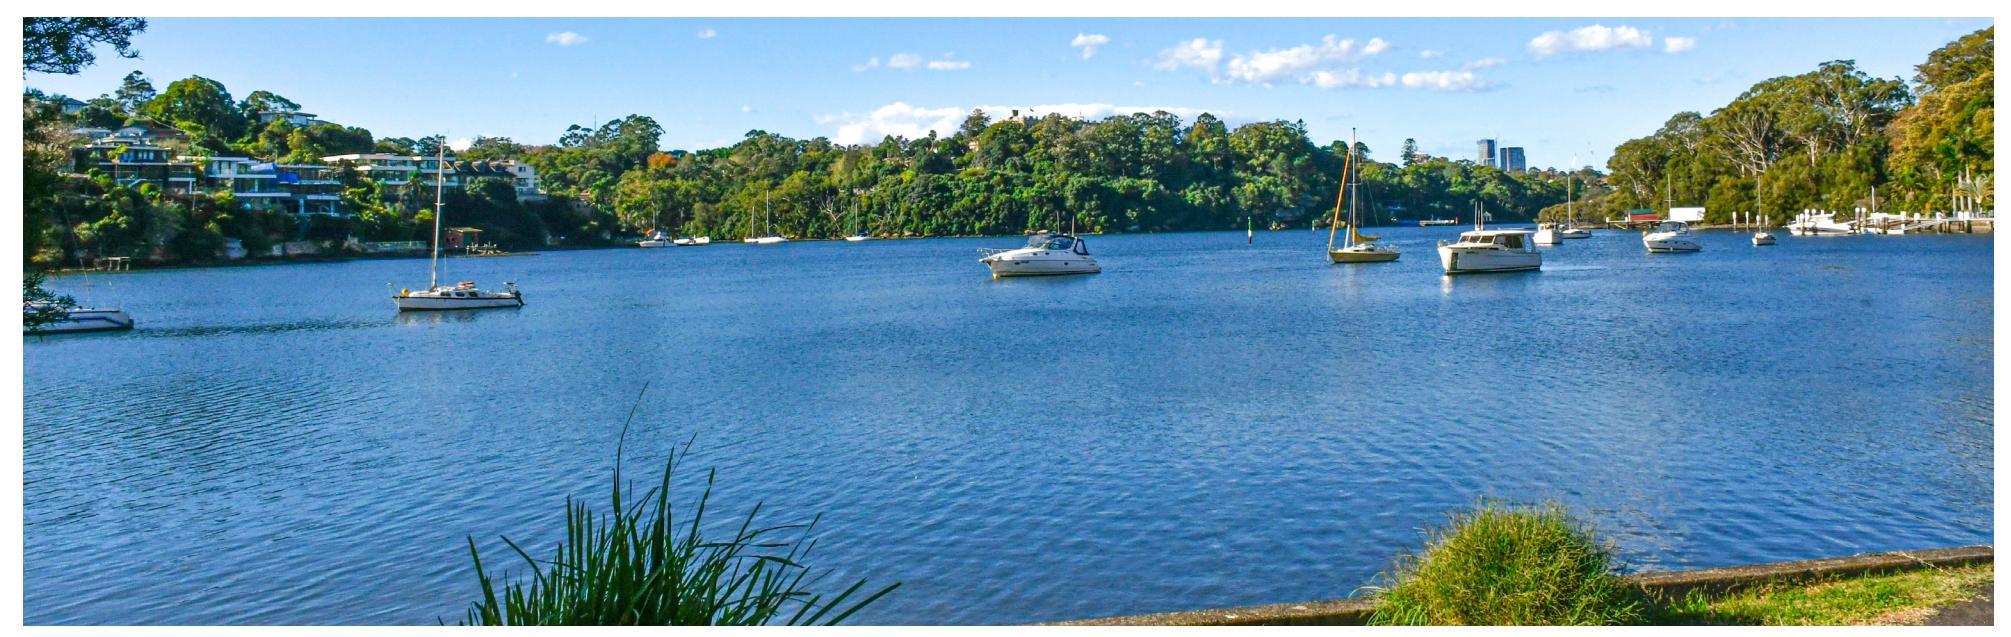
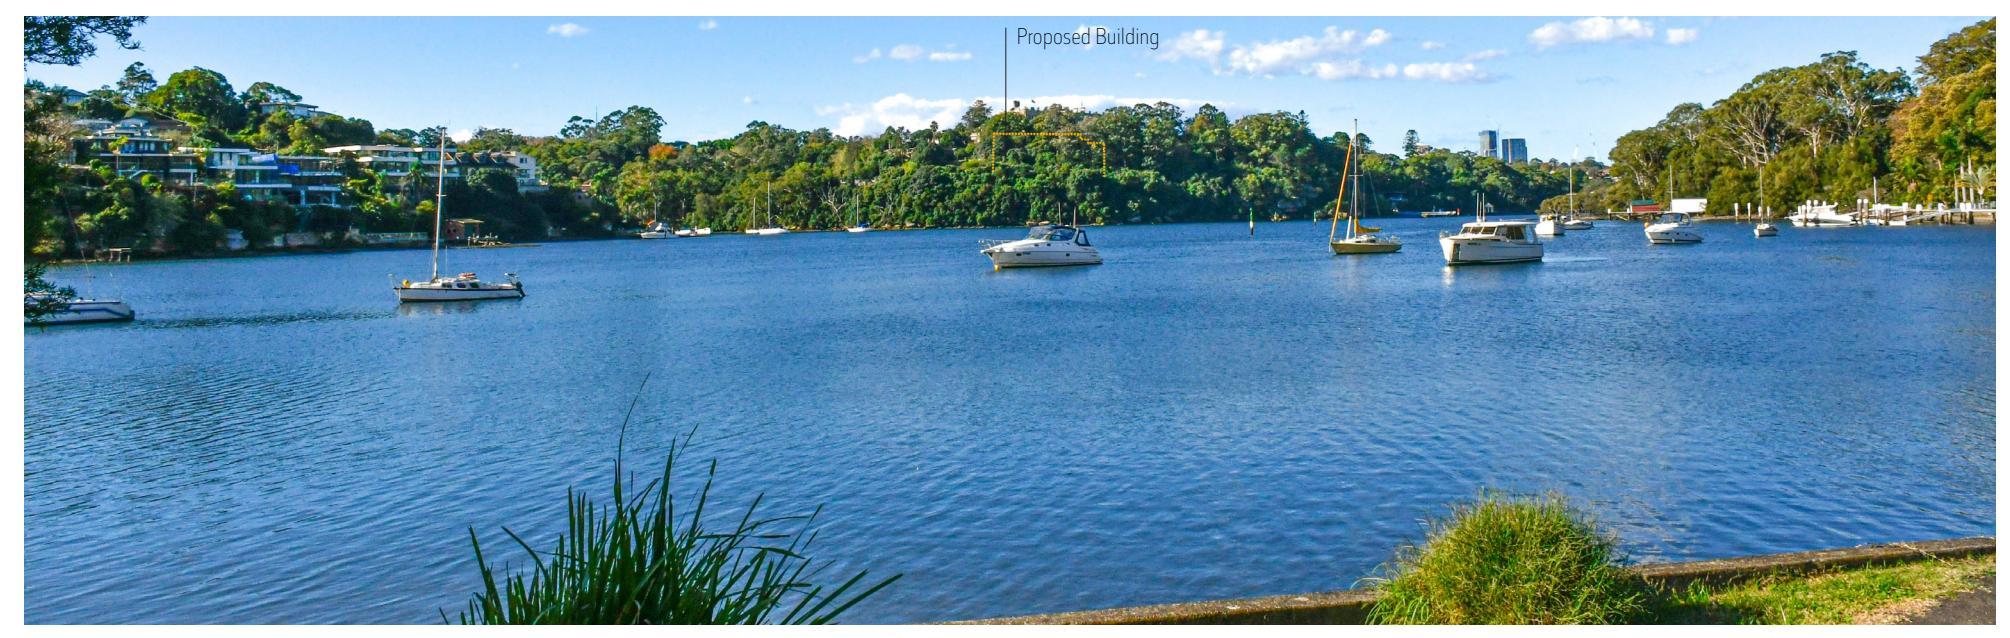
Viewpoint 6

The view from Lane Cove Valley Walk is considered to have HIGH sensitivity due to:

The magnitude of the proposal in this view is considered NEGLIGIBLE, due to:

- Proposal is in the distance and completely screened by the existing vegetation
- No change in the view

The visual impact for this view is assessed as NONE, which is the combination of the sensitivity and magnitude of impact.

Existing

Proposed

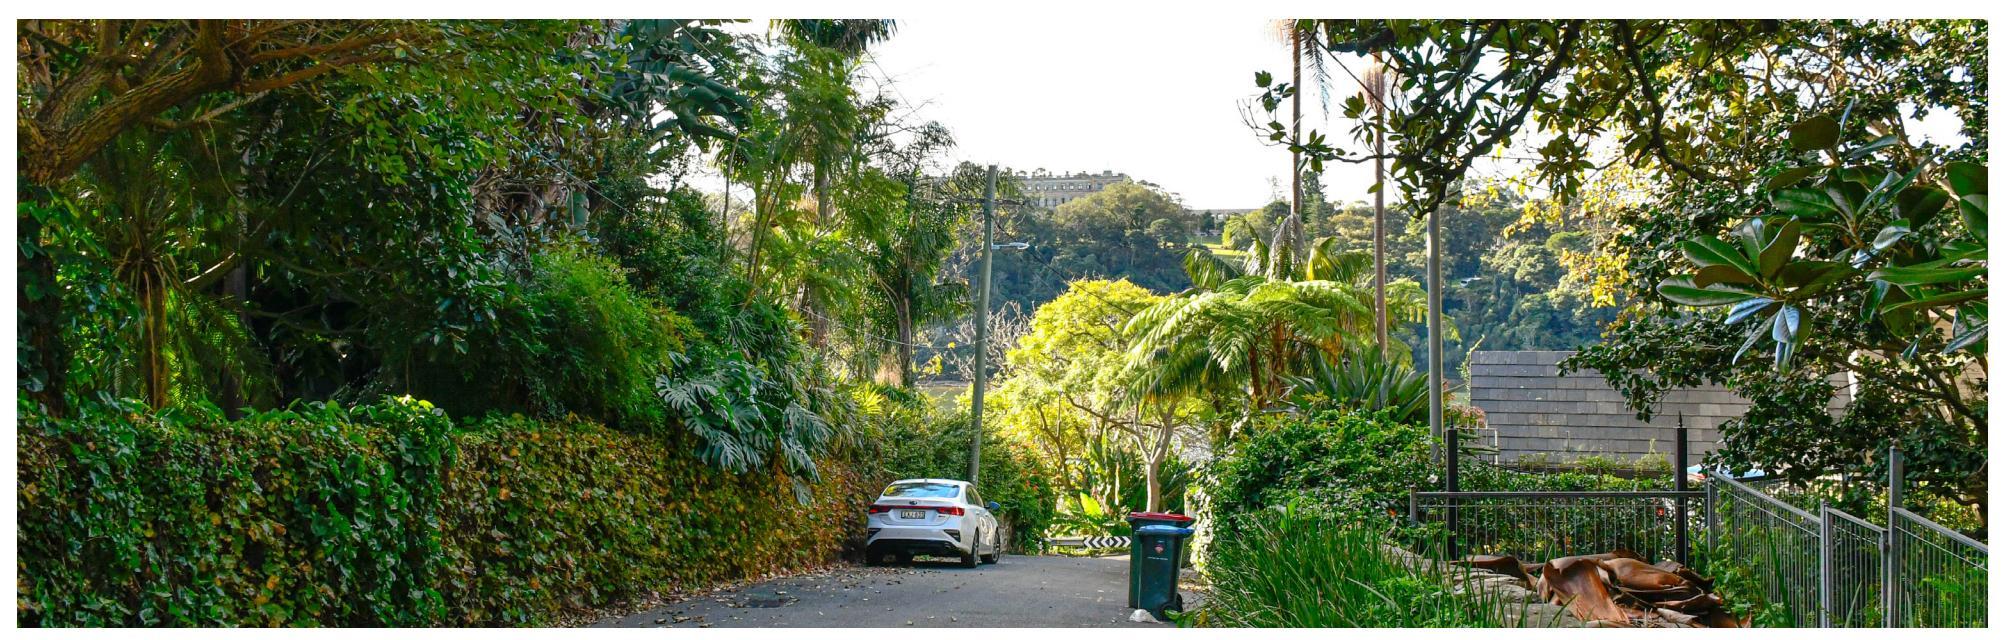
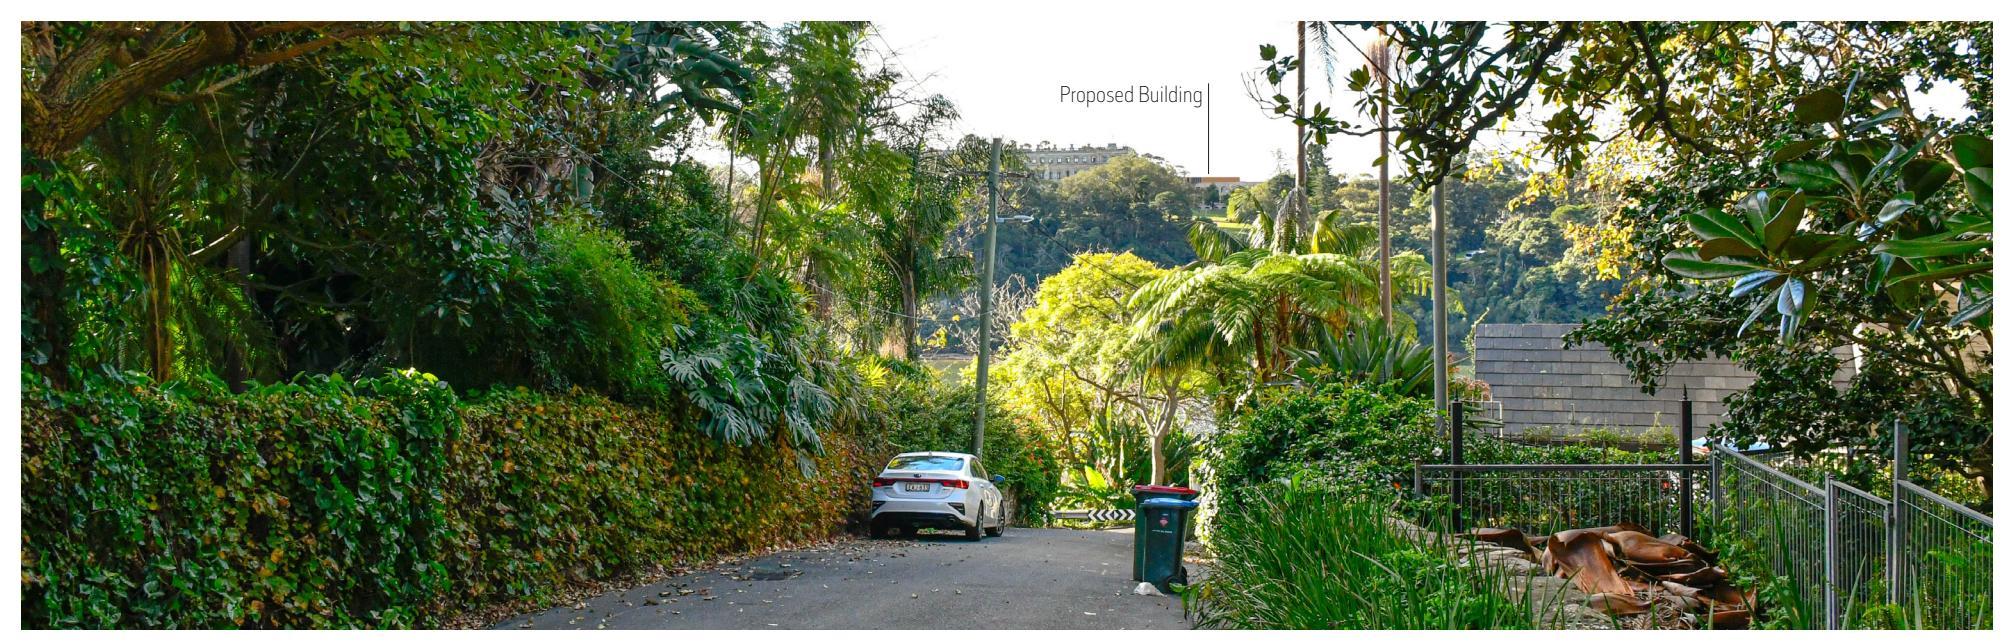
Viewpoint 7

The view from intersection of Mcbride Ave & Ady St is considered to have LOW sensitivity due to:

The magnitude of the proposal in this view is considered VERY LOW, due to:

- Proposal is completely screened by existing vegetation and mature trees
- The proposal is not visible and there is no change in view

The visual impact for this view is assessed as NEGLIGIBLE, which is the combination of the sensitivity and magnitude of impact.

Existing

Proposed
