SAINT IGNATIUS' COLLEGE VISUAL ASSESSMENT REPORT

2-60 Riverview Street, Riverview

Title:	St Ignatius College Visual Impact Assessment
Prepared for:	St Ignatius College
Date:	21.05.2021
Status:	Final
Prepared by:	Hatch RobertsDay
Approved by:	Hatch RobertsDay

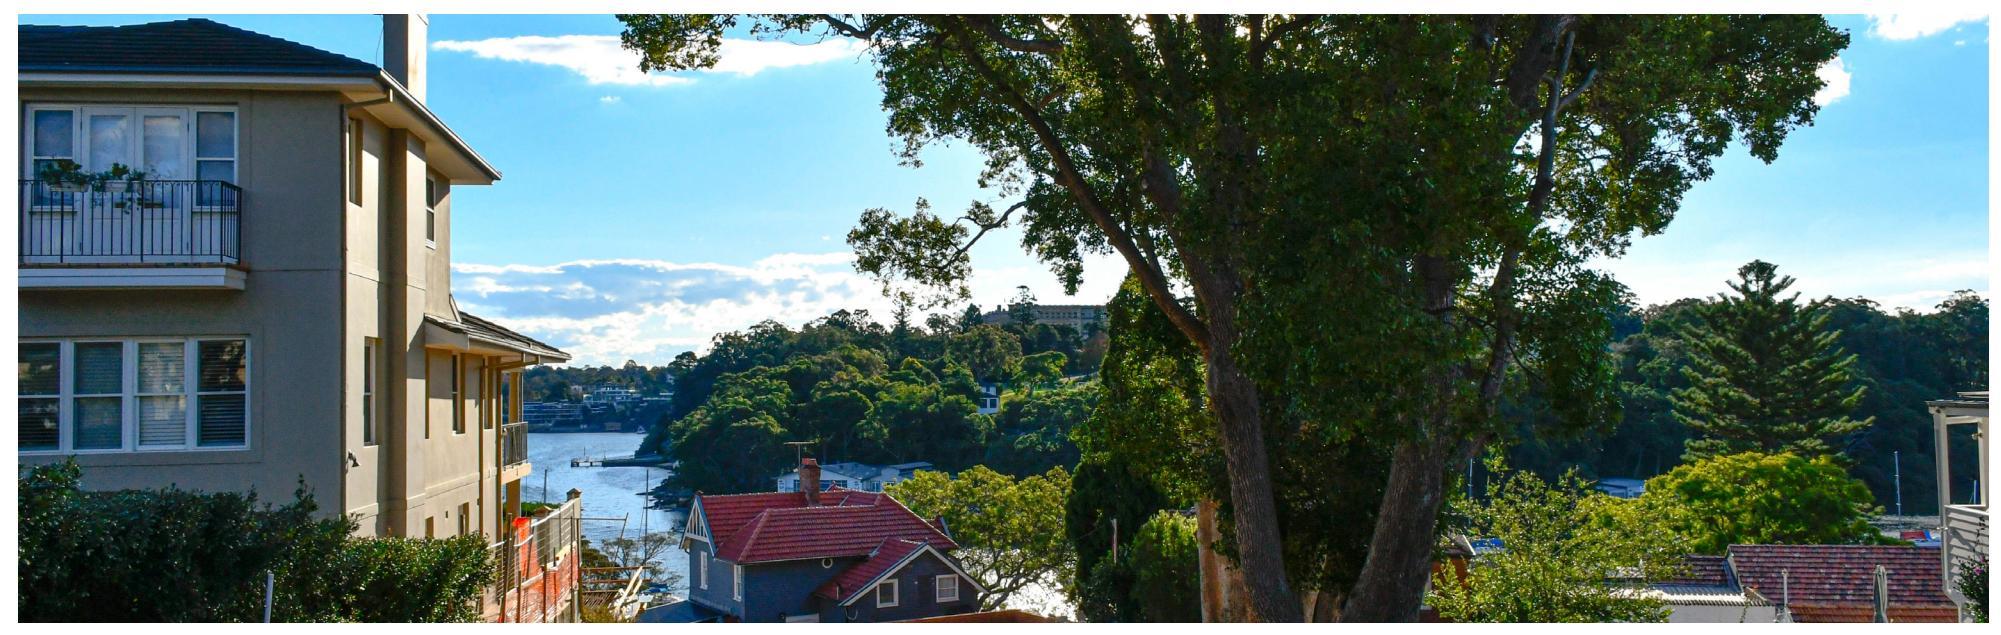
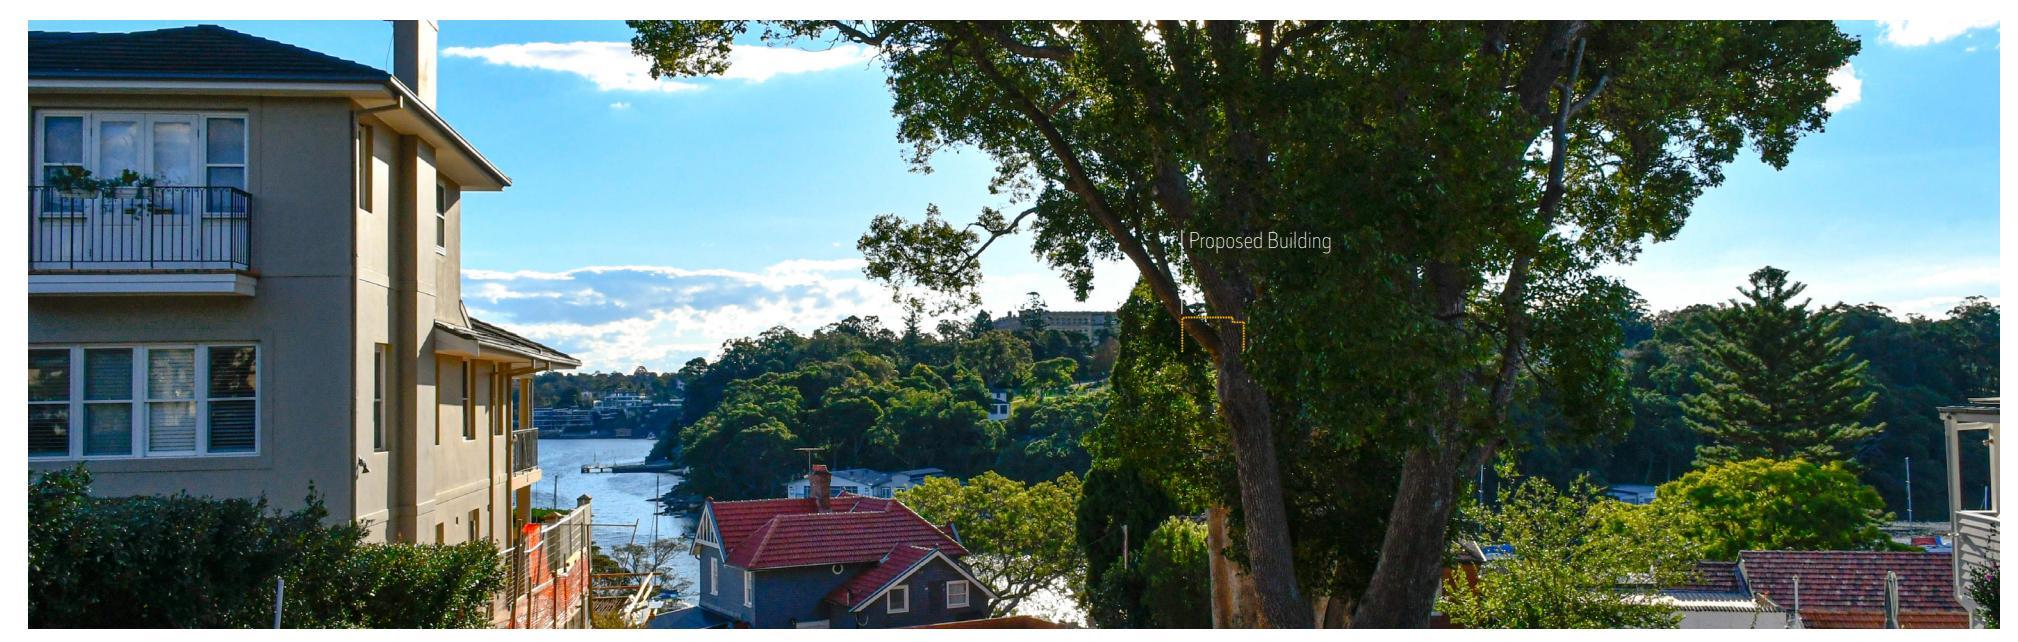
Viewpoint 8

The view from 21-23 Norfolk Rd is considered to have HIGH sensitivity due to:

The magnitude of the proposal in this view is considered NEGLIGIBLE, due to:

- Proposal is completely screened by existing vegetation and mature trees
- The proposal is not visible and there is no change in view

The visual impact for this view is assessed as NONE, which is the combination of the sensitivity and magnitude of impact.

Existing

Proposed
