Our Ref: 9692-LTR-1-1

RE: Meadowbank Education and Employment Precinct Schools Project (SSD 9343) Advice on Contaminated Land matters within the Environmental Impact Statement (EIS)

Locations of AF/FA Detections & Proposed Development				
Alliance Geotechnical ENGINEERING ENVIRONMENTAL TESTING Manage the earth, eliminate the risk	Client Name:	Wood Bagot	•	Figure Number:	1
	Project Name:	Meadowbank Education and Employment Precinct Schools (SSD 9343)	\bigwedge	Figure Date:	21 February 2020
	Project Location:	2 Rhodes Street Meadowbank		Report Number:	9692-LTR-1-1

SOIL CONTAMINATION **REMEDIATION PLAN**

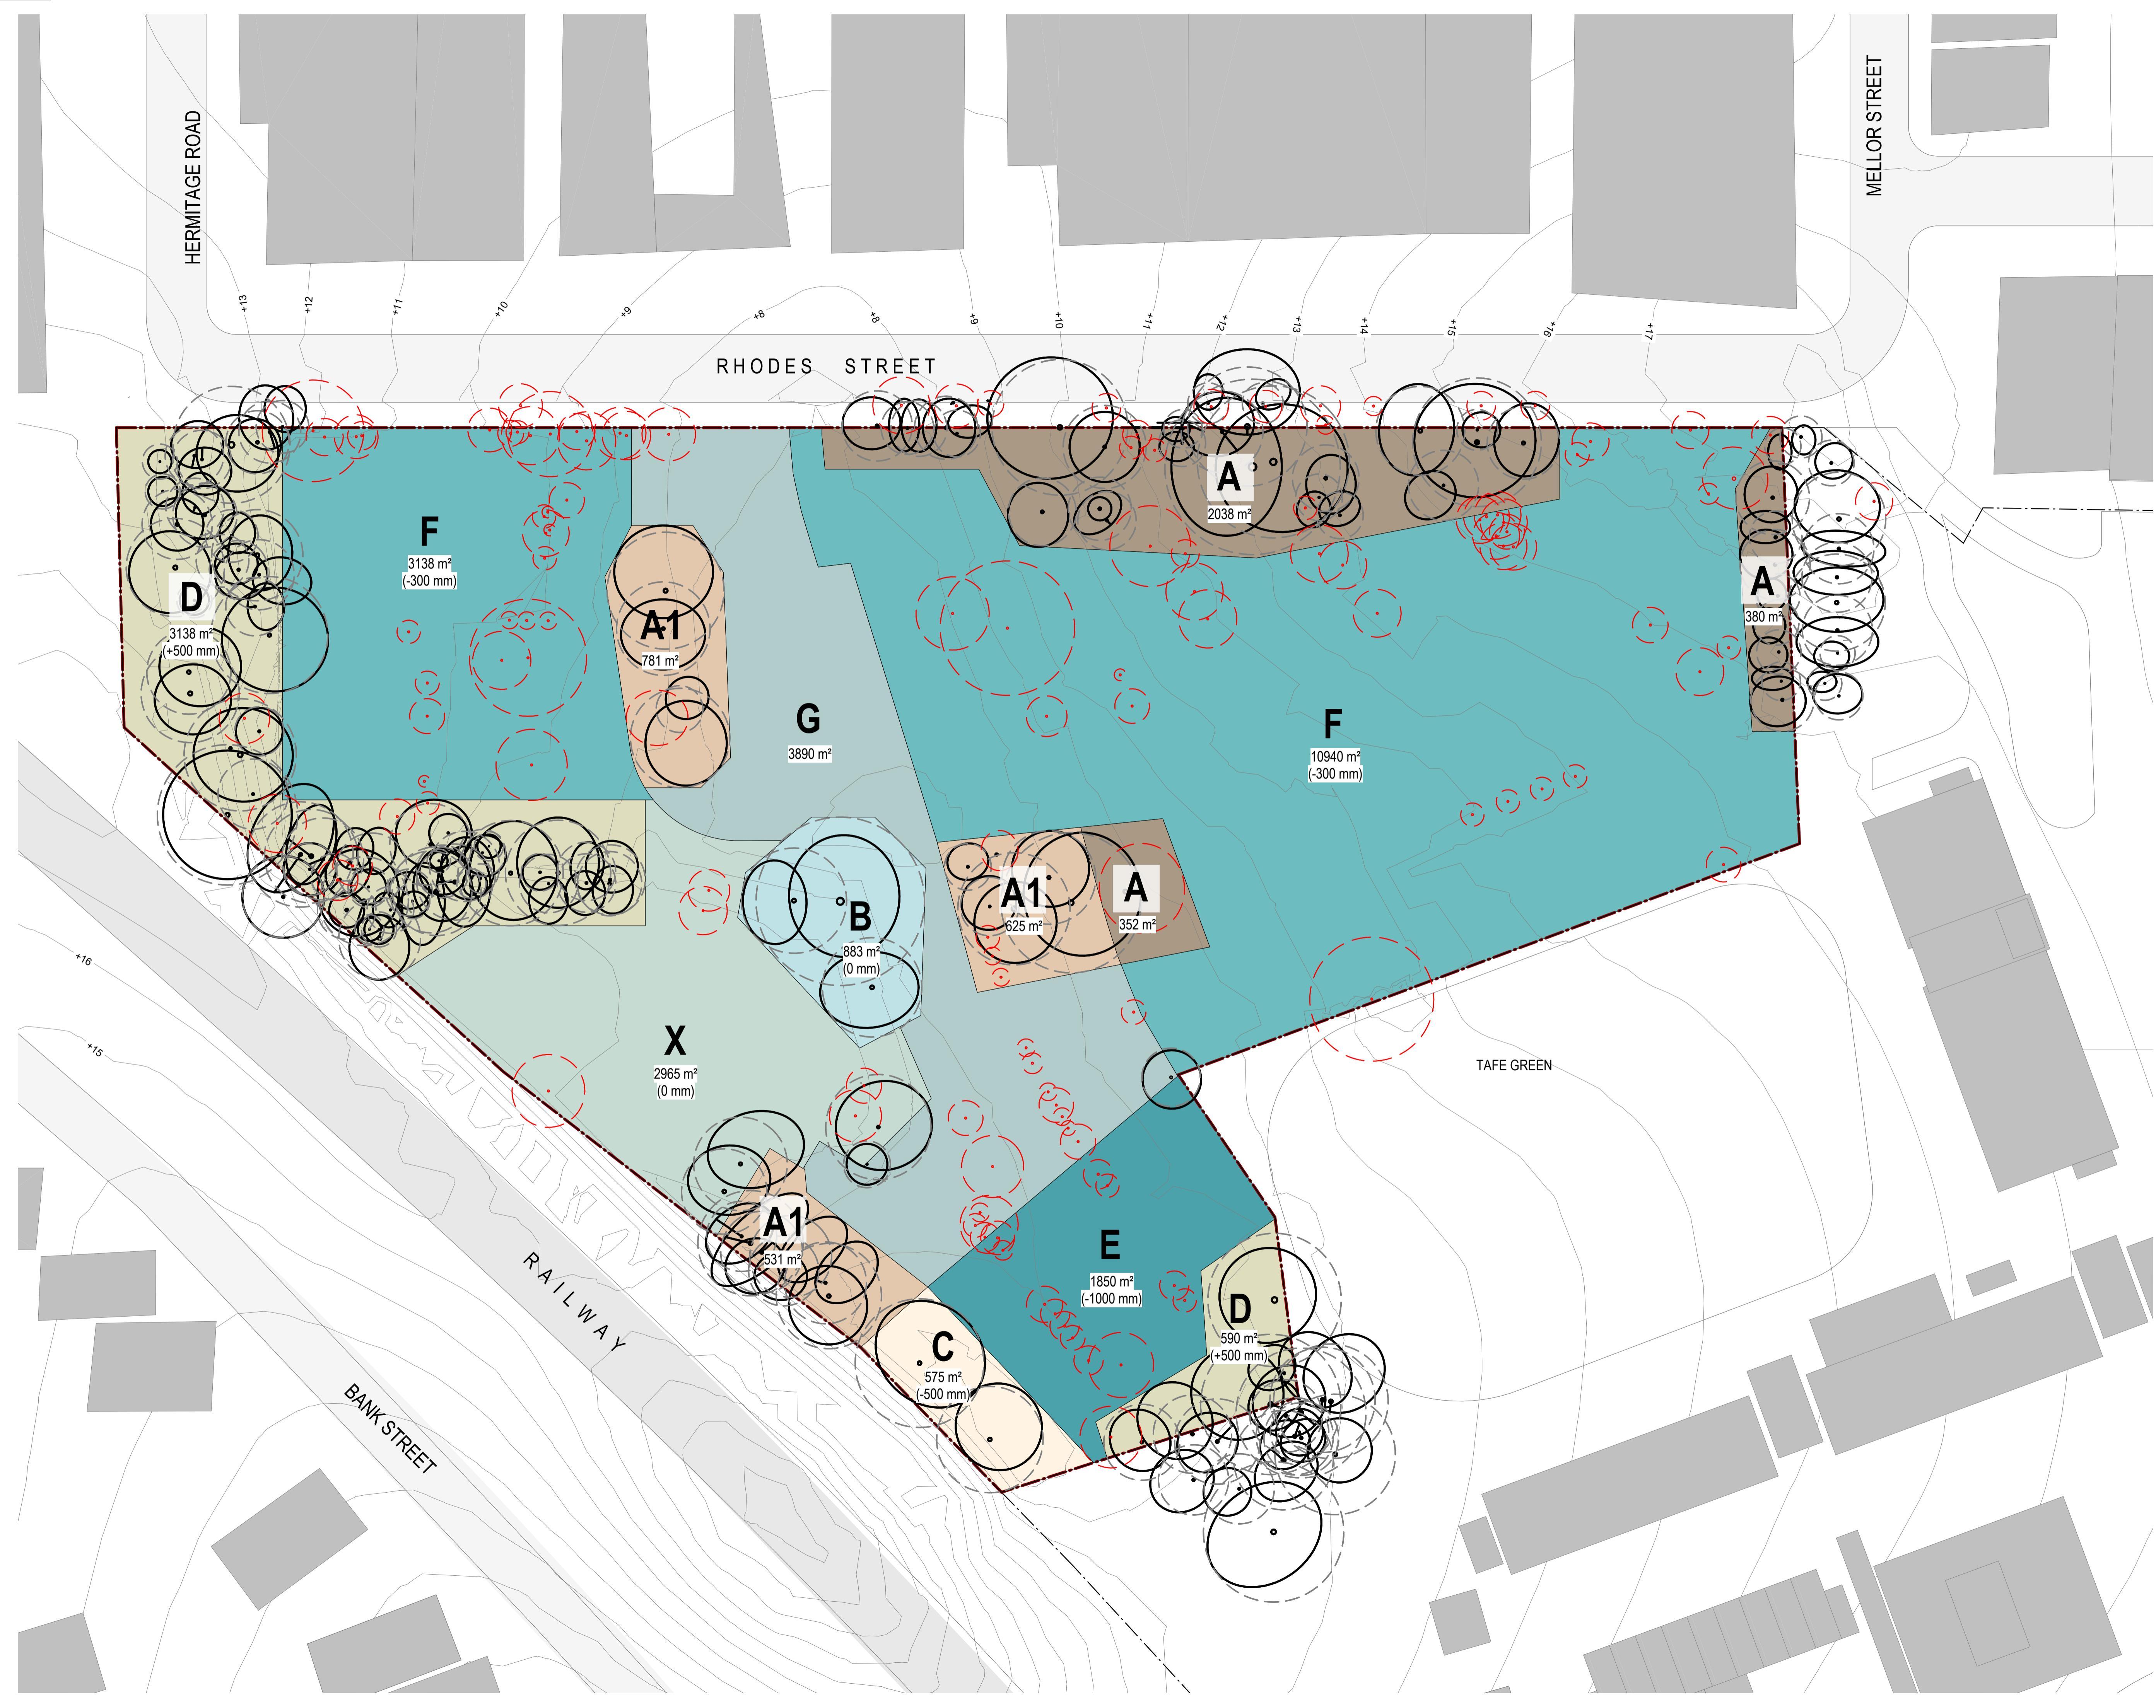
ATTACHMENT 2

The legend below is a summary of the types of remediation. Refer to Remedial Action plan, Civil Engineering Drawings and Arborist Report for details.

Α Remove by hand any visible rubble under tree canopy and do not disturb tree roots

A1 As 'A' but first remove hardstanding and confirm on site extent of contamination.

B Retain existing soil levels. Add geotextile membrane, crushed rock. Area to have raised timber deck prior to future occupation.

Remove hardstanding, excavate to 500mm depth below existing level. Add geotextile membrane, fill to existing levels with clean fill.

D As 'B'. Area to be built up with 500mm topsoil and native grasses. Area to be fenced off and made inaccessible prior to future occupation.

E Excavate to 1m depth below existing levels, add geotextile membrane, fill to existing levels with clean

F Remove up to 300mm of soil. Area to be occupied by building in future.

G Area of handstanding with expected low contamination. Hardstanding to be removed and confirm extent of contamination on site.

- Details of the site history, including an explanation as to the land use activity attributed to be the source of the asbestos contamination was made in the *Stage 1 Preliminary Site Investigation* (*Appendix O*), and determined to be due to historic uncontrolled filling and uncontrolled demolition onsite; and
- A site map, showing the locations of asbestos fines/ fibrous asbestos (AF/FA) in respect of future site development infrastructure has been prepared and is included in Attachment 1. Also included is Figure 4 (Site Contamination Remediation Plan) from the RAP (enclosed as Attachment 2) which demonstrates the remedial management measures for the area where asbestos fines/ fibrous
