Integra Underground

INT5047-5

INTEGRA UNDERGROUND: LONGWALL 15 BI-MONTHLY SUBSIDENCE REPORT FOR **FEBRUARY AND MARCH 2020**

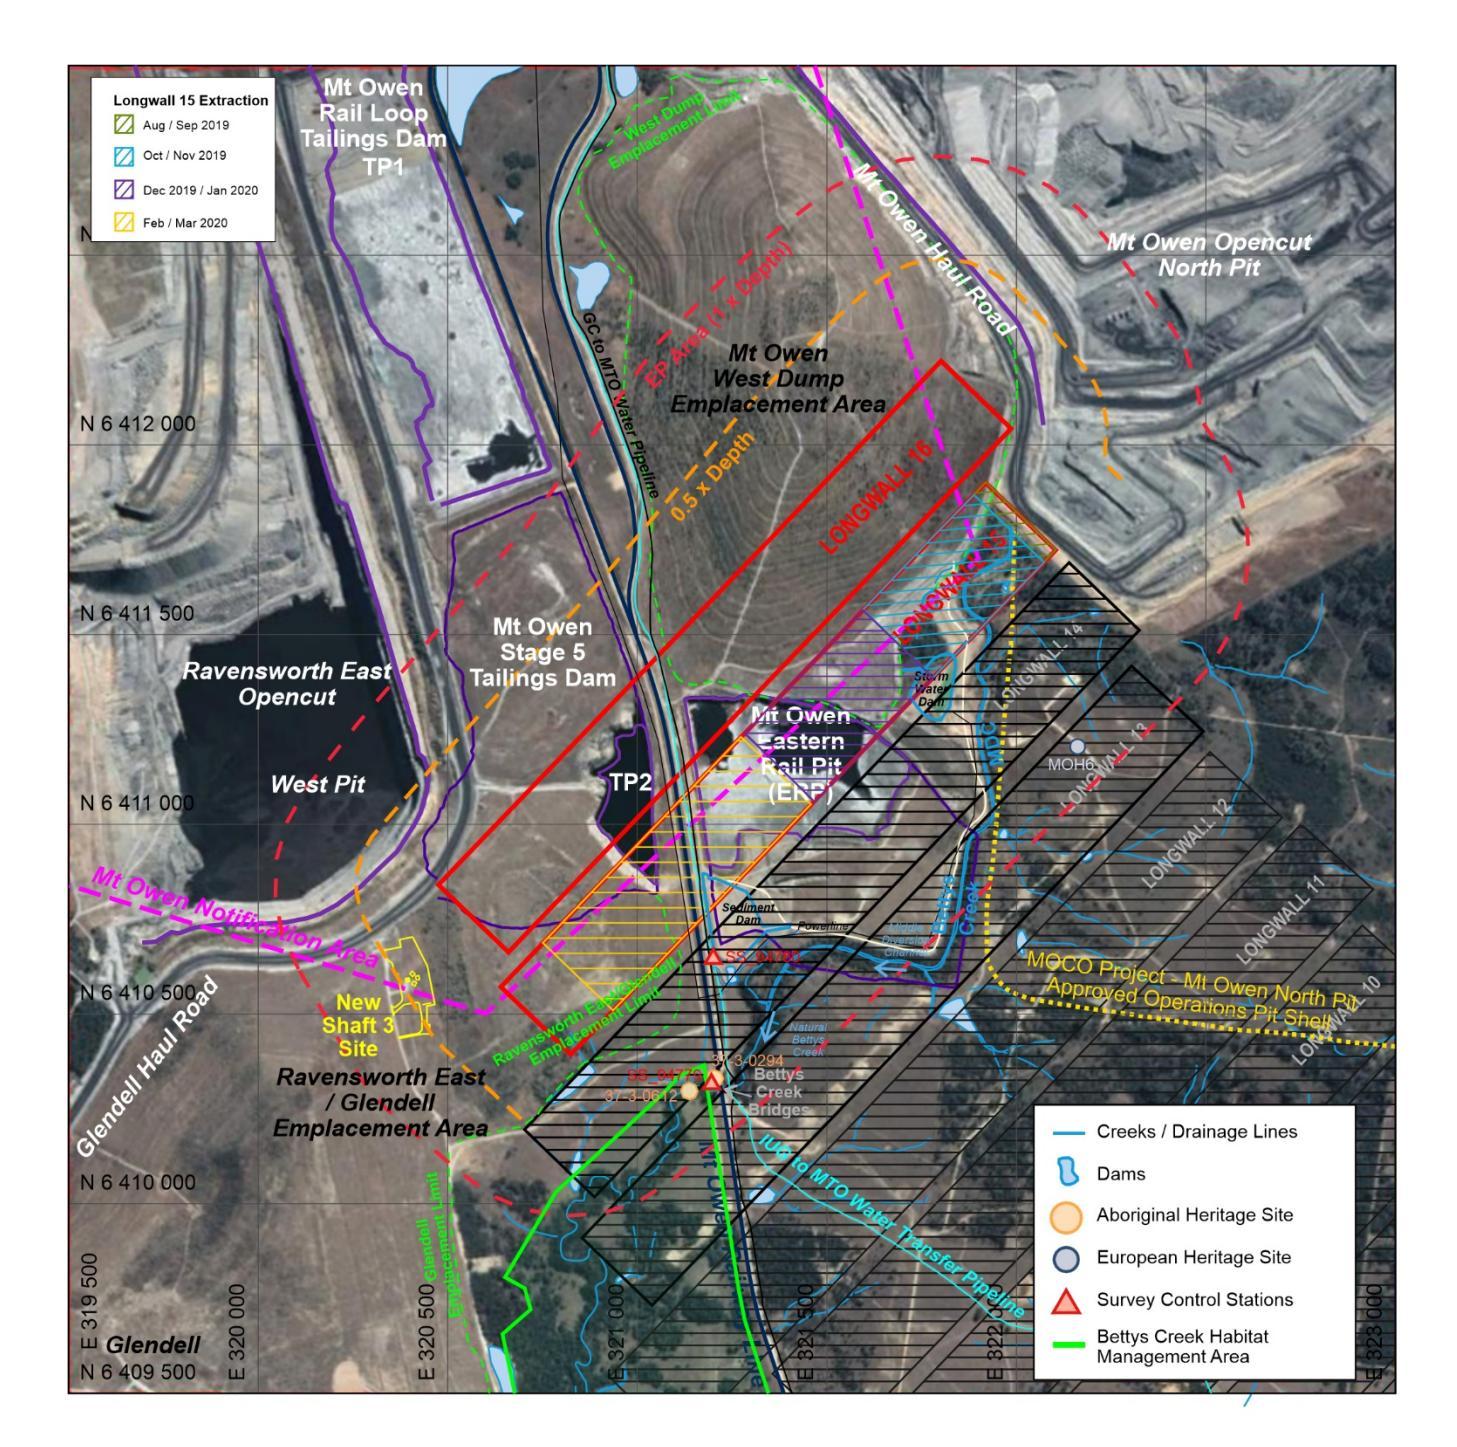
Figure 1: Locations of surface features and Bi-monthly mining areas.

Figure 1 shows the longwall mining areas, superimposed onto a Google Earth image of the surface from August 2018 (the Mt Owen - North Pit has not extended over the extracted longwall panels since this time). This figure is a copy of Figure 4 from SCT (2018) amended to show the completed mining in Longwall 14 and the mining in Longwall 15, during the bi-monthly reporting periods, up to the end of March 2020.

Longwall 15 commenced production on 19 September 2019 at CH1825m.

During the February and March 2020 reporting period, Longwall 15 mined from CH917m to approximately CH162m, a total of 755m. This distance represents a significant increase in longwall retreat rate compared to previous monitoring periods.

At the end of March 2020, the void length for Longwall 15, including the 9m installation roadway width, was approximately 1672m.

The void width for Longwall 15 is 257m.
