# Arboricultural Impact Assessment Report

Site Address:	Hornsby Ku-ring-gai Hospital 1 Derby Road HORNSBY NSW 2077
Prepared For:	Health Infrastructure C/- TSA Management Level 16, 207 Kent Street Sydney NSW
Prepared On:	14 <sup>th</sup> April 2011
Report Number:	L1001
Prepared By:	Louise Bennett Registered Consulting Arborist <sup>TM</sup> No: 00021 Diploma Horticulture (Arboriculture) -AQF Level 5 Certificate IV Training and Education Secretary Arboriculture Australia Member Footings and Foundation Society of Australia Member Housing Engineering Design & Research Association (HEDRA). Consulting Arborist for
	The Arborist Network 58 South Creek Road Shanes Park NSW 2747 Phone (+612) 9835 1234

Tree Report: Hornsby Ku-ring-gai Hospital 1 Derby Road, HORNSBY

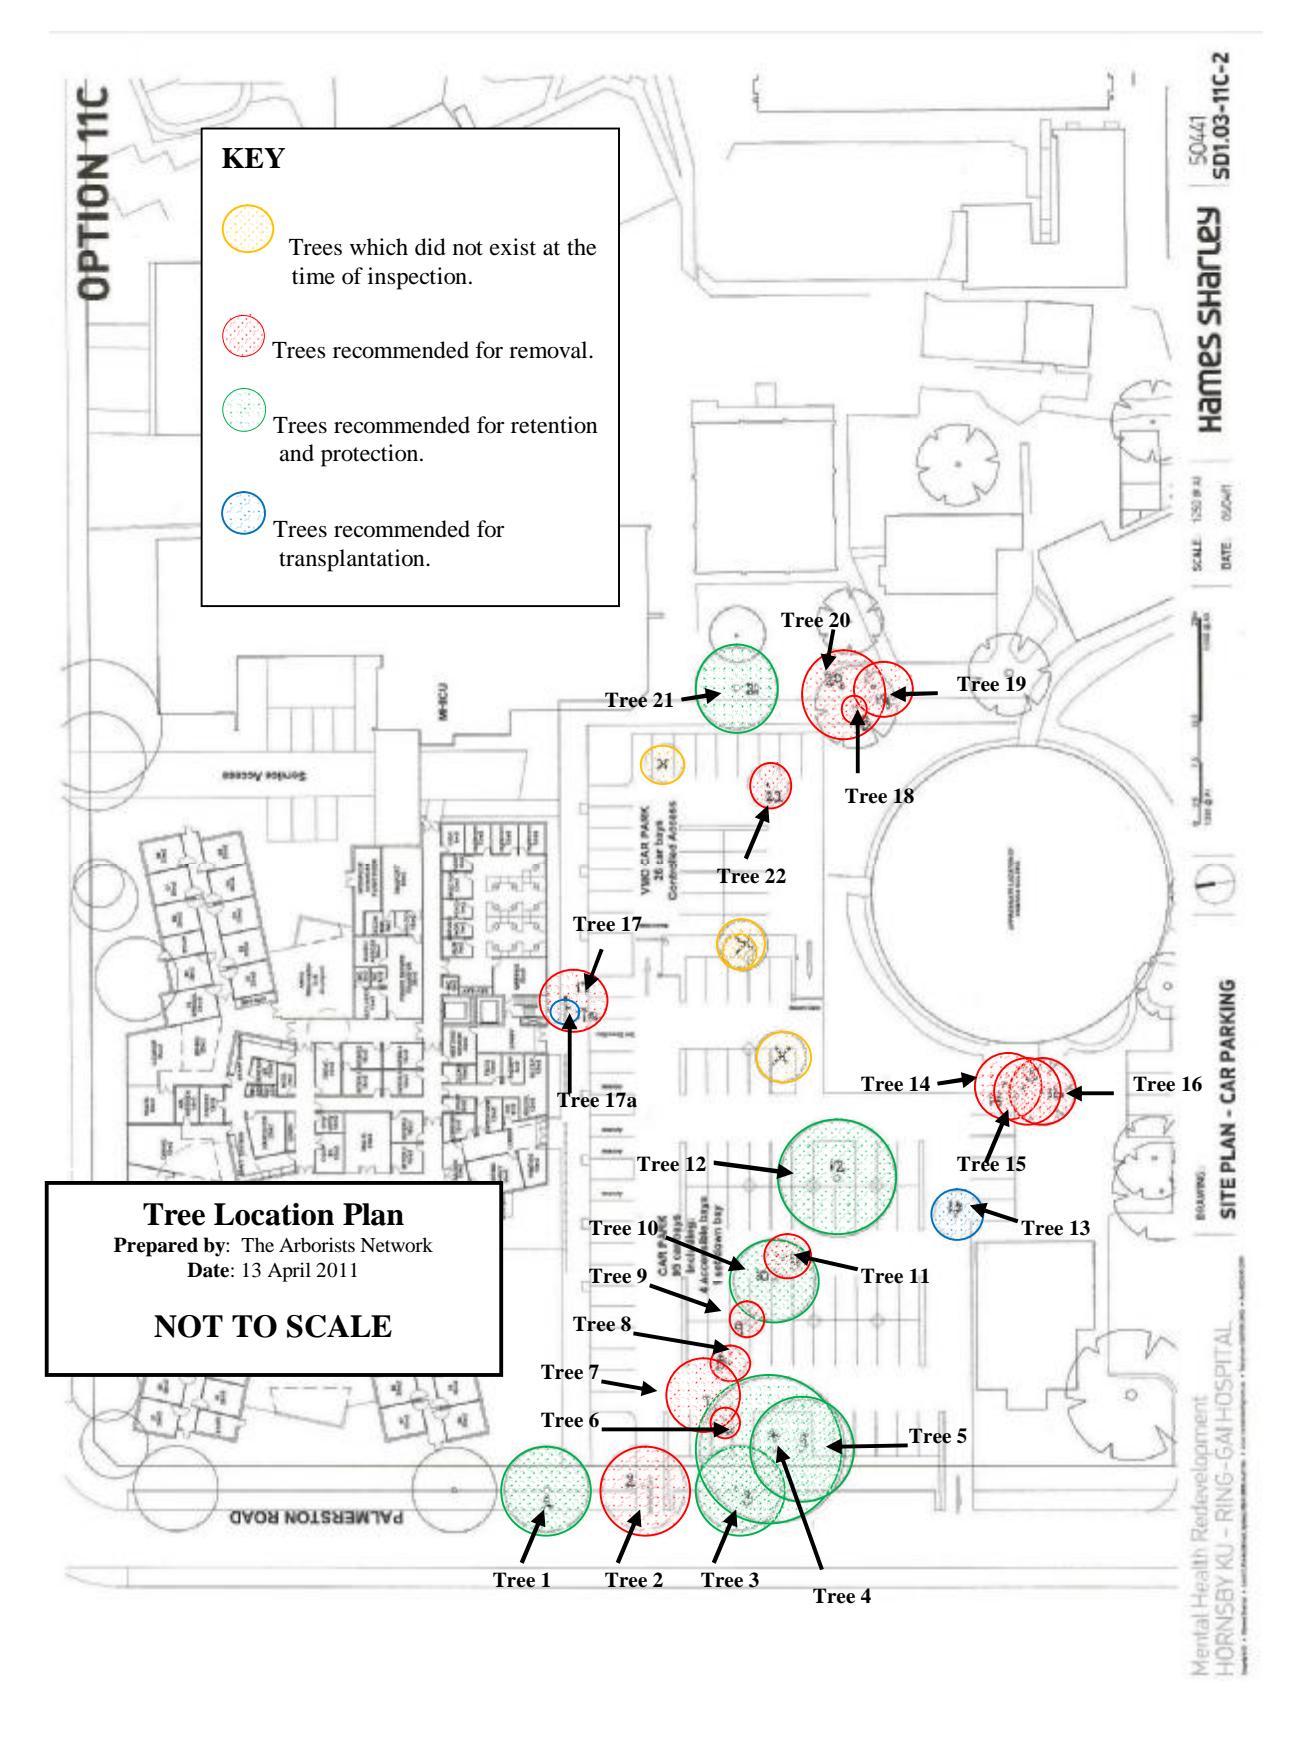
#### **Tree Location Plan**

The trees that were not located on the survey plans provided are shown with their approximate centres marked on the Tree Protection Plan (drawing) (See Appendix 2).

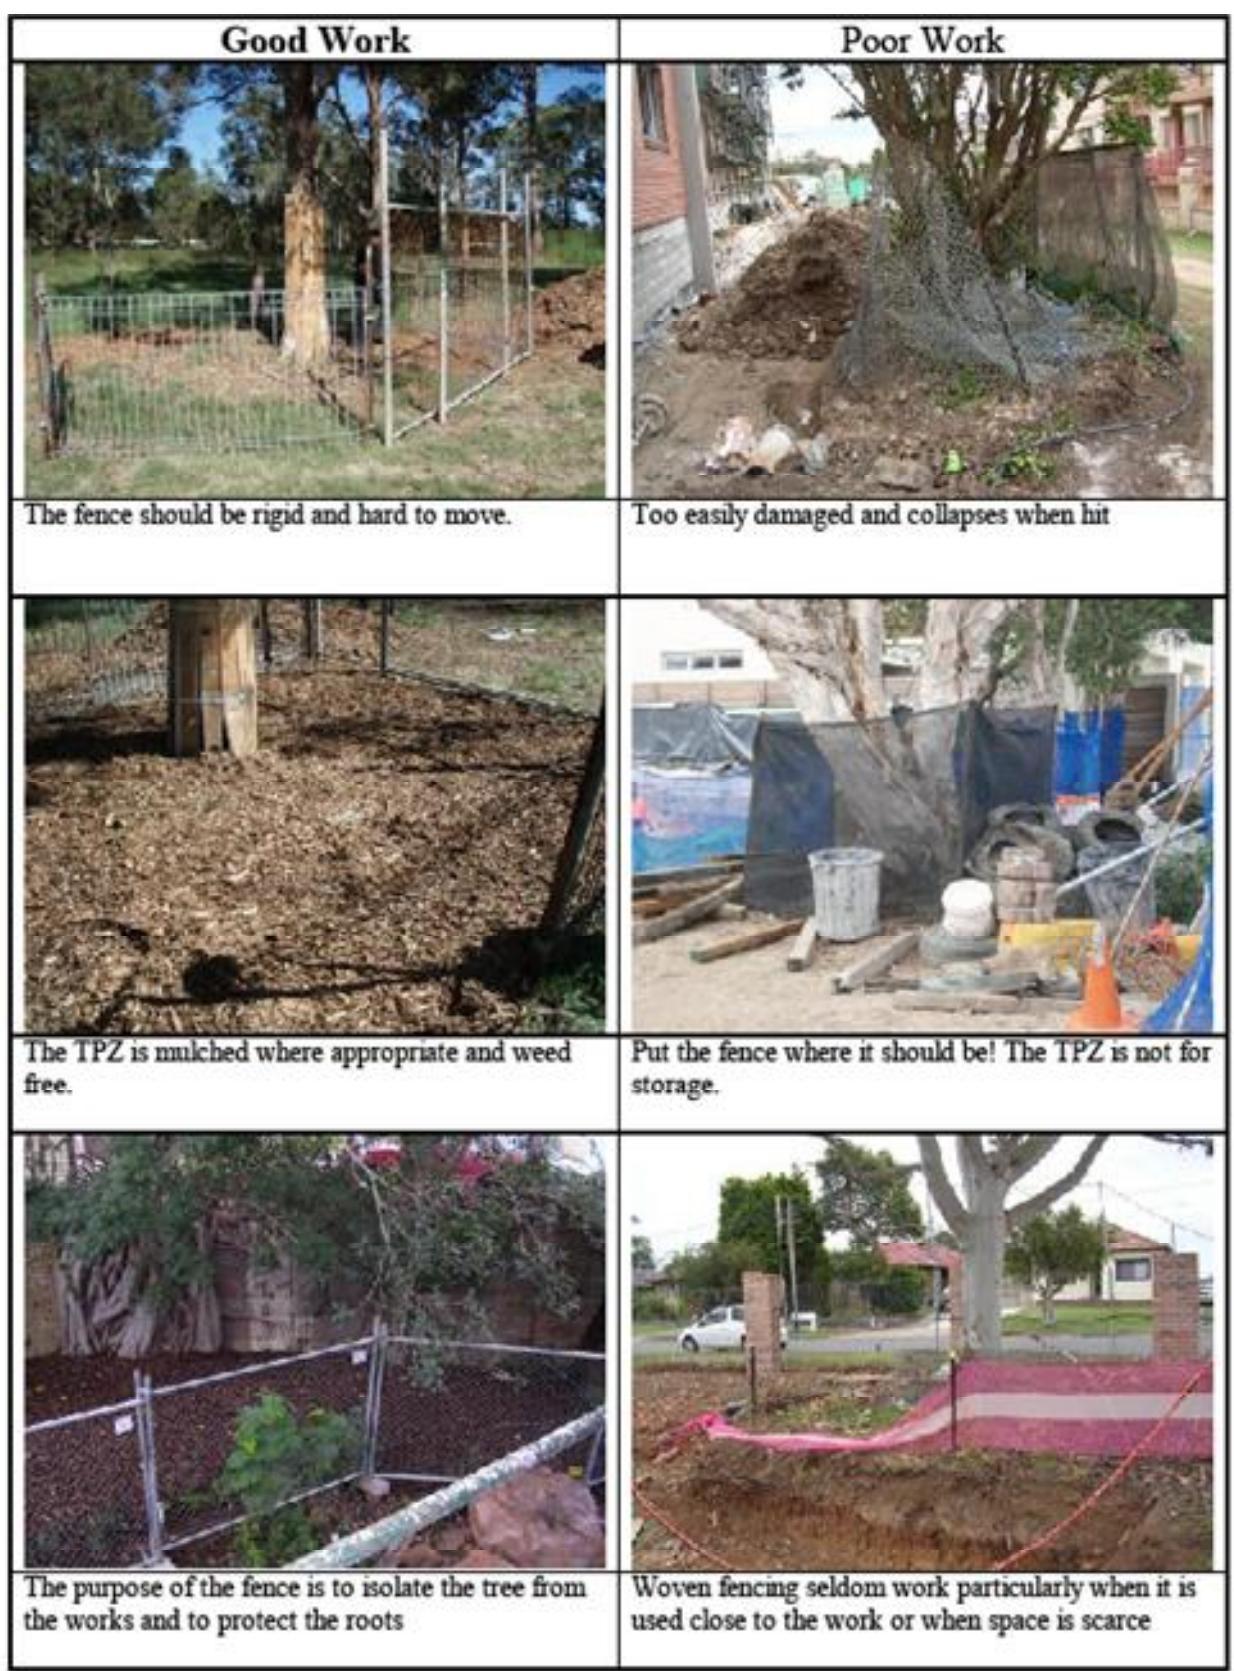
### **Establishing a Tree Protection Zone**

The most appropriate method of protecting a tree is to establish an exclusion zone using some form of rigid temporary fence (a Tree Protection Zone or TPZ). Whilst it may seem easier to use flexible fabric barrier fence these products tend to fail over time and is easily pushed out of the way or damaged. In comparison, damaging rigid fence requires more of a hit, can damage machinery and involves the cost of repair or replacement of the damaged fence.

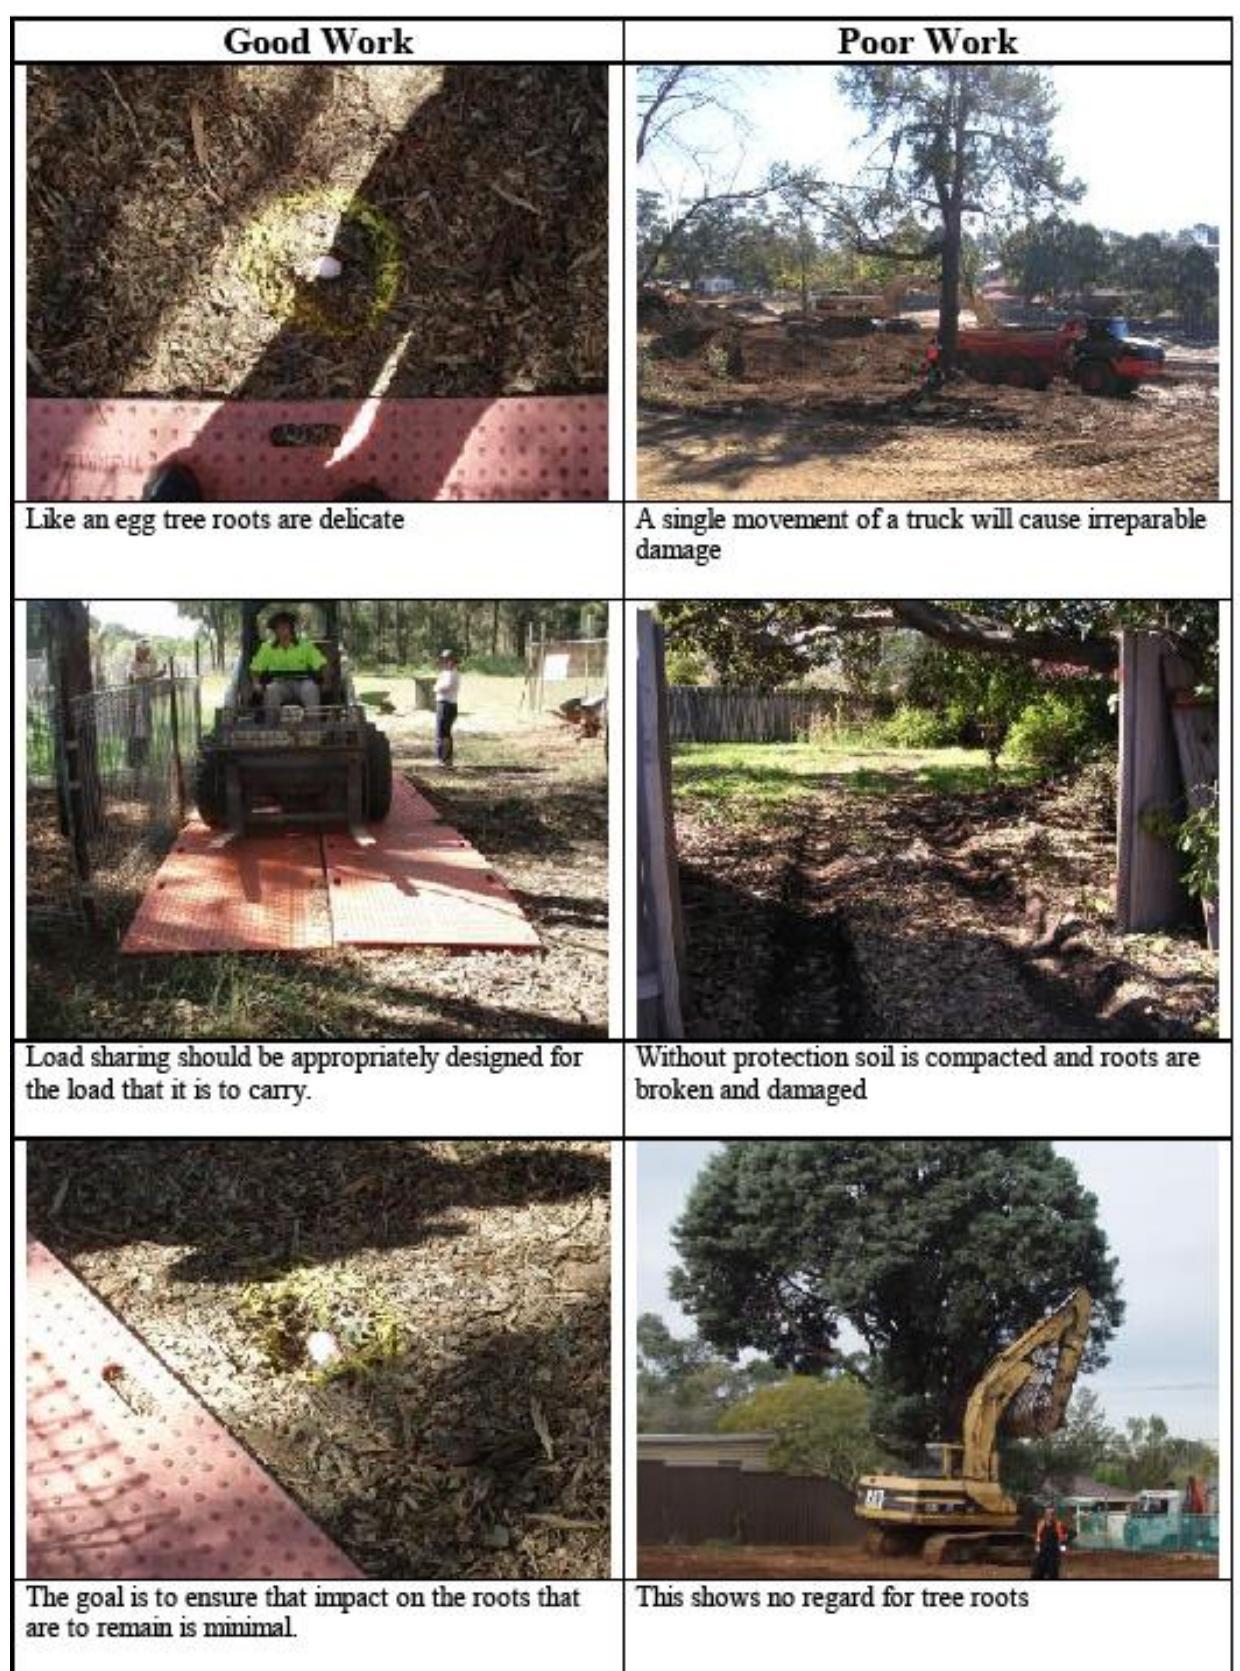
#### Load –Sharing Surfaces and root protection

Sometimes however, it may become necessary to work within or to gain access through a Tree Protection Zone. To do this we need to develop a method to stop soil compaction and prevent direct physical damage to roots. A simple action such as walking on the same spot half a dozen times or more can lead to soil compaction. Pushing a full wheelbarrow will cause compaction on the first instance. It does not take long for that damage to accumulate and harm the roots of a tree.

Fully load-bearing structures include finished structures such as the slab of a building, a driveway or a pathway. Obviously each of these has a limit to the weight that it can bear and if this is exceeded the structure and things beneath it can be damaged. Load bearing systems can also include scaffolding and temporary bridging structures.

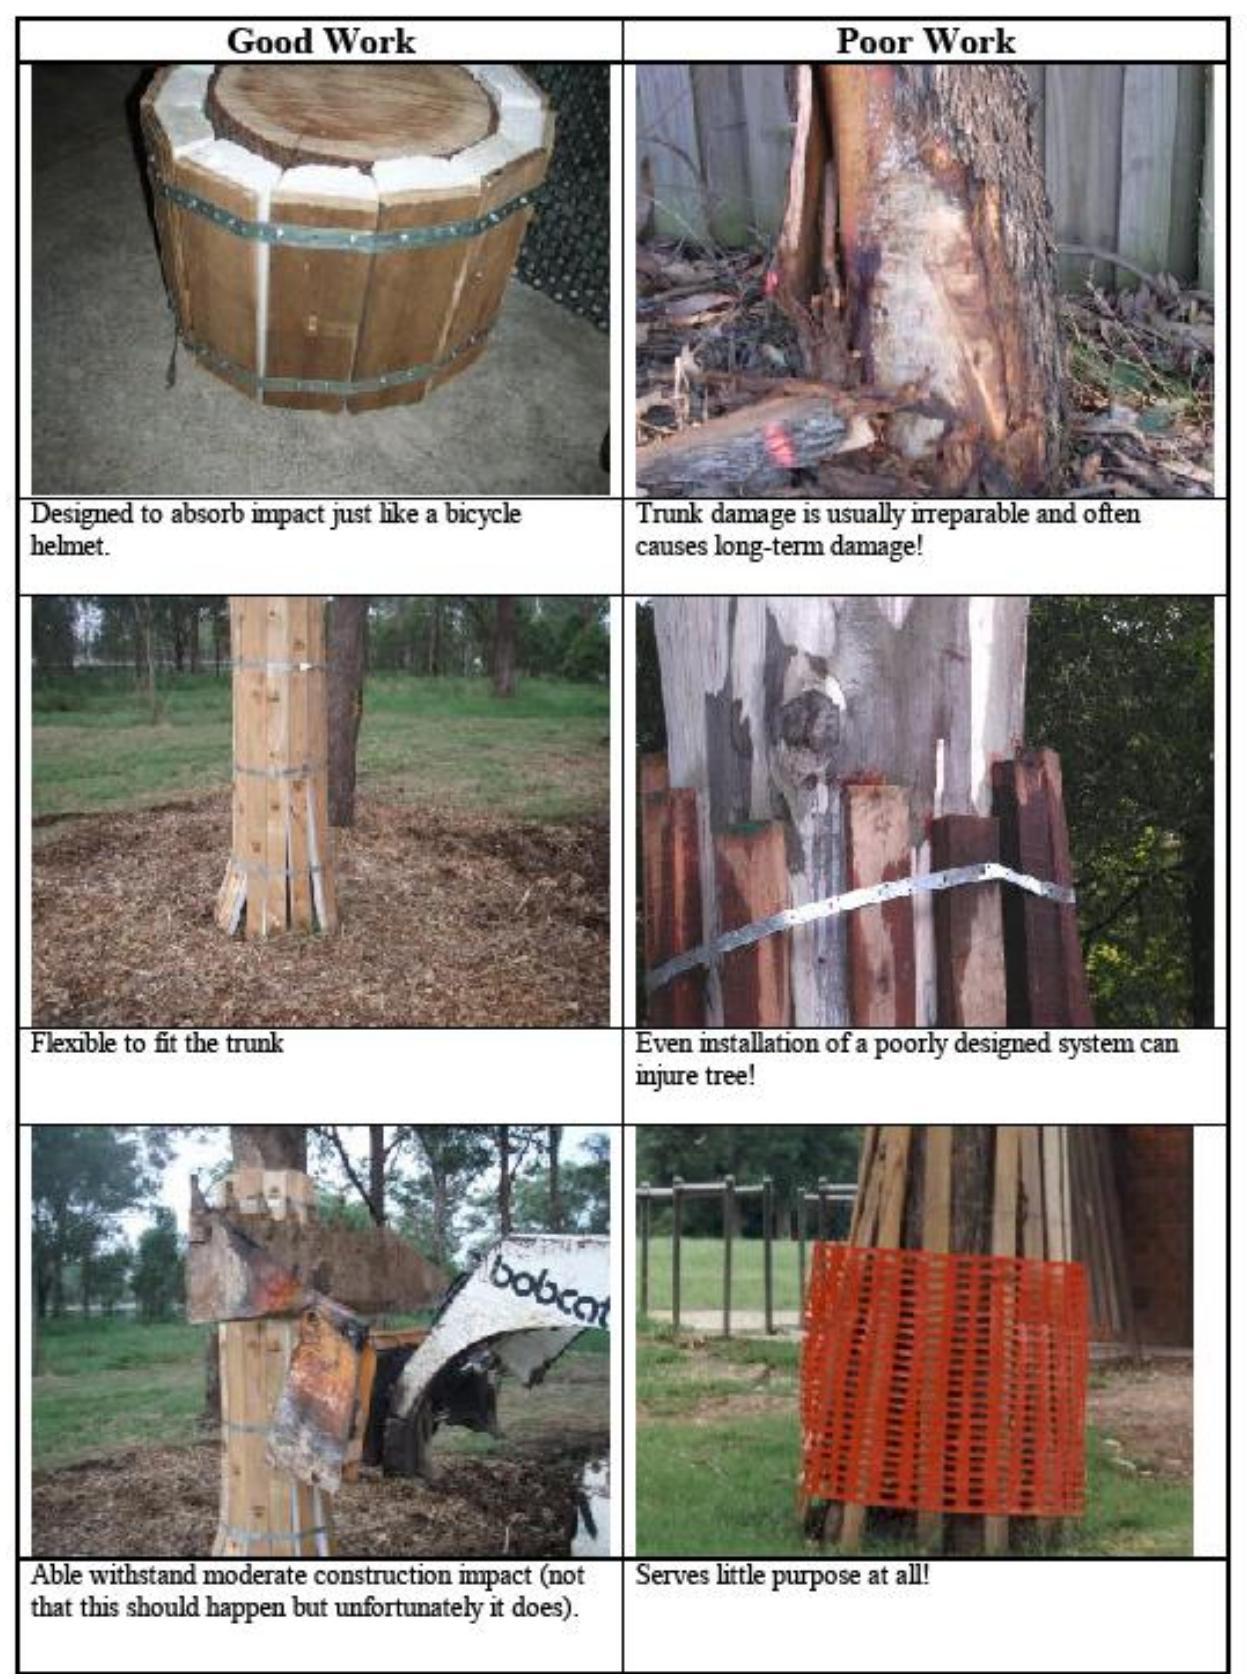
### Trunk protection using TrunkGuard

A more appropriate system needs a hard but flexible outer surface bonded to a soft impact absorbing material that has a low water holding capacity. This system is better at absorbing the energy of an impact ... just think about a bicycle helmet. Just as with a bicycle helmet, if impact damages a board, it needs replacing and at the same time, the trunk of the tree needs inspecting.
