Appendix B: Land Management Plan Longwalls 30 & LWW6-LWW8

Ulan Underground

Document Number:ULNCX-111515275-3363Status:ApprovedVersion:3.0Effective:29/01/2021Review:3 yearsOwner:Environment and Community Manager

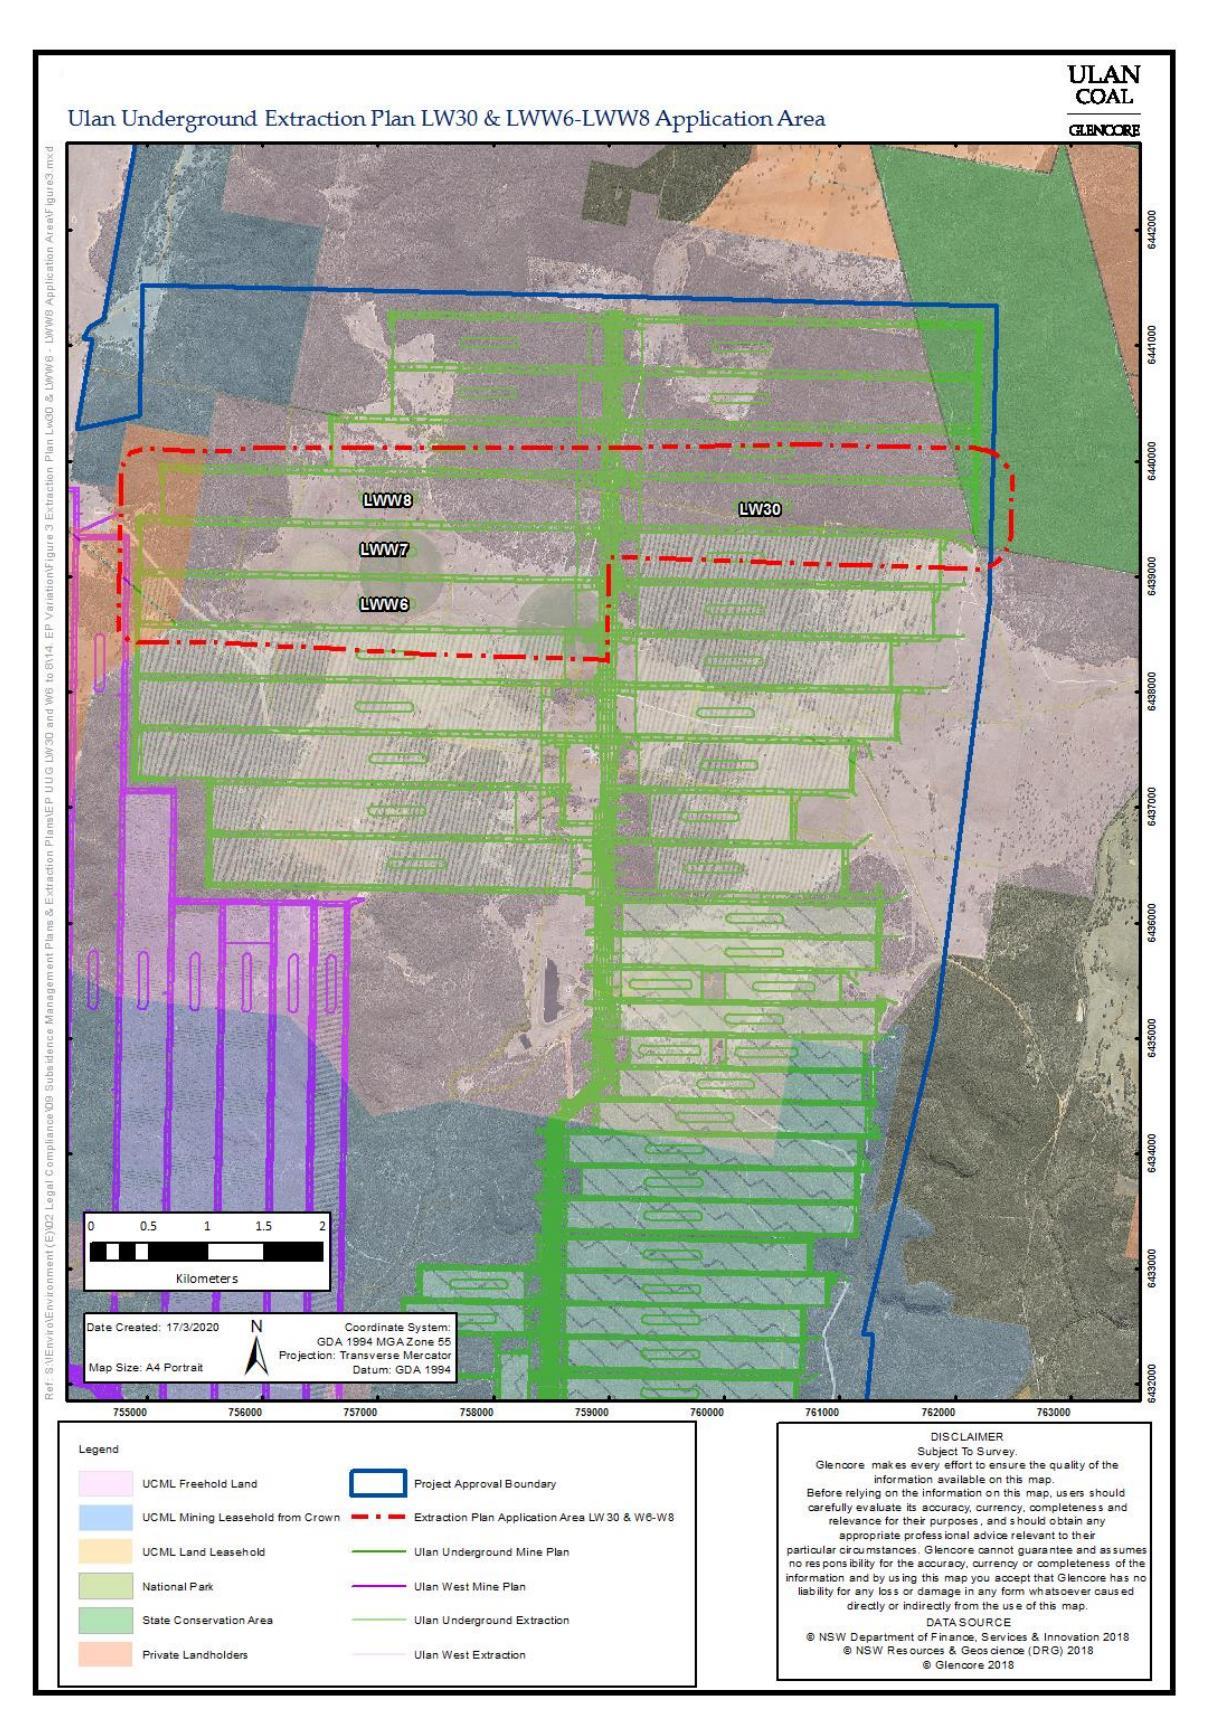
Figure 1 Extraction Plan LW30 & LWW6-LWW8 Application Area

Ulan Coal Mines Pty Limited (UCMPL) has Extraction Plan approval for longwall (LW) panels LW30 & LWW6, LWW7 and LWW8, herein referred to as the Application Area (**Figure 1**), for the Ulan Underground Mine (UUG).

This Plan applies to the general land surface and sandstone features potentially impacted as a result of mining within the Application Area (**Figure 1**). A description of the landform features specific to the Application Area are summarised in **Section 1.4** and are shown in **Figure 2**.

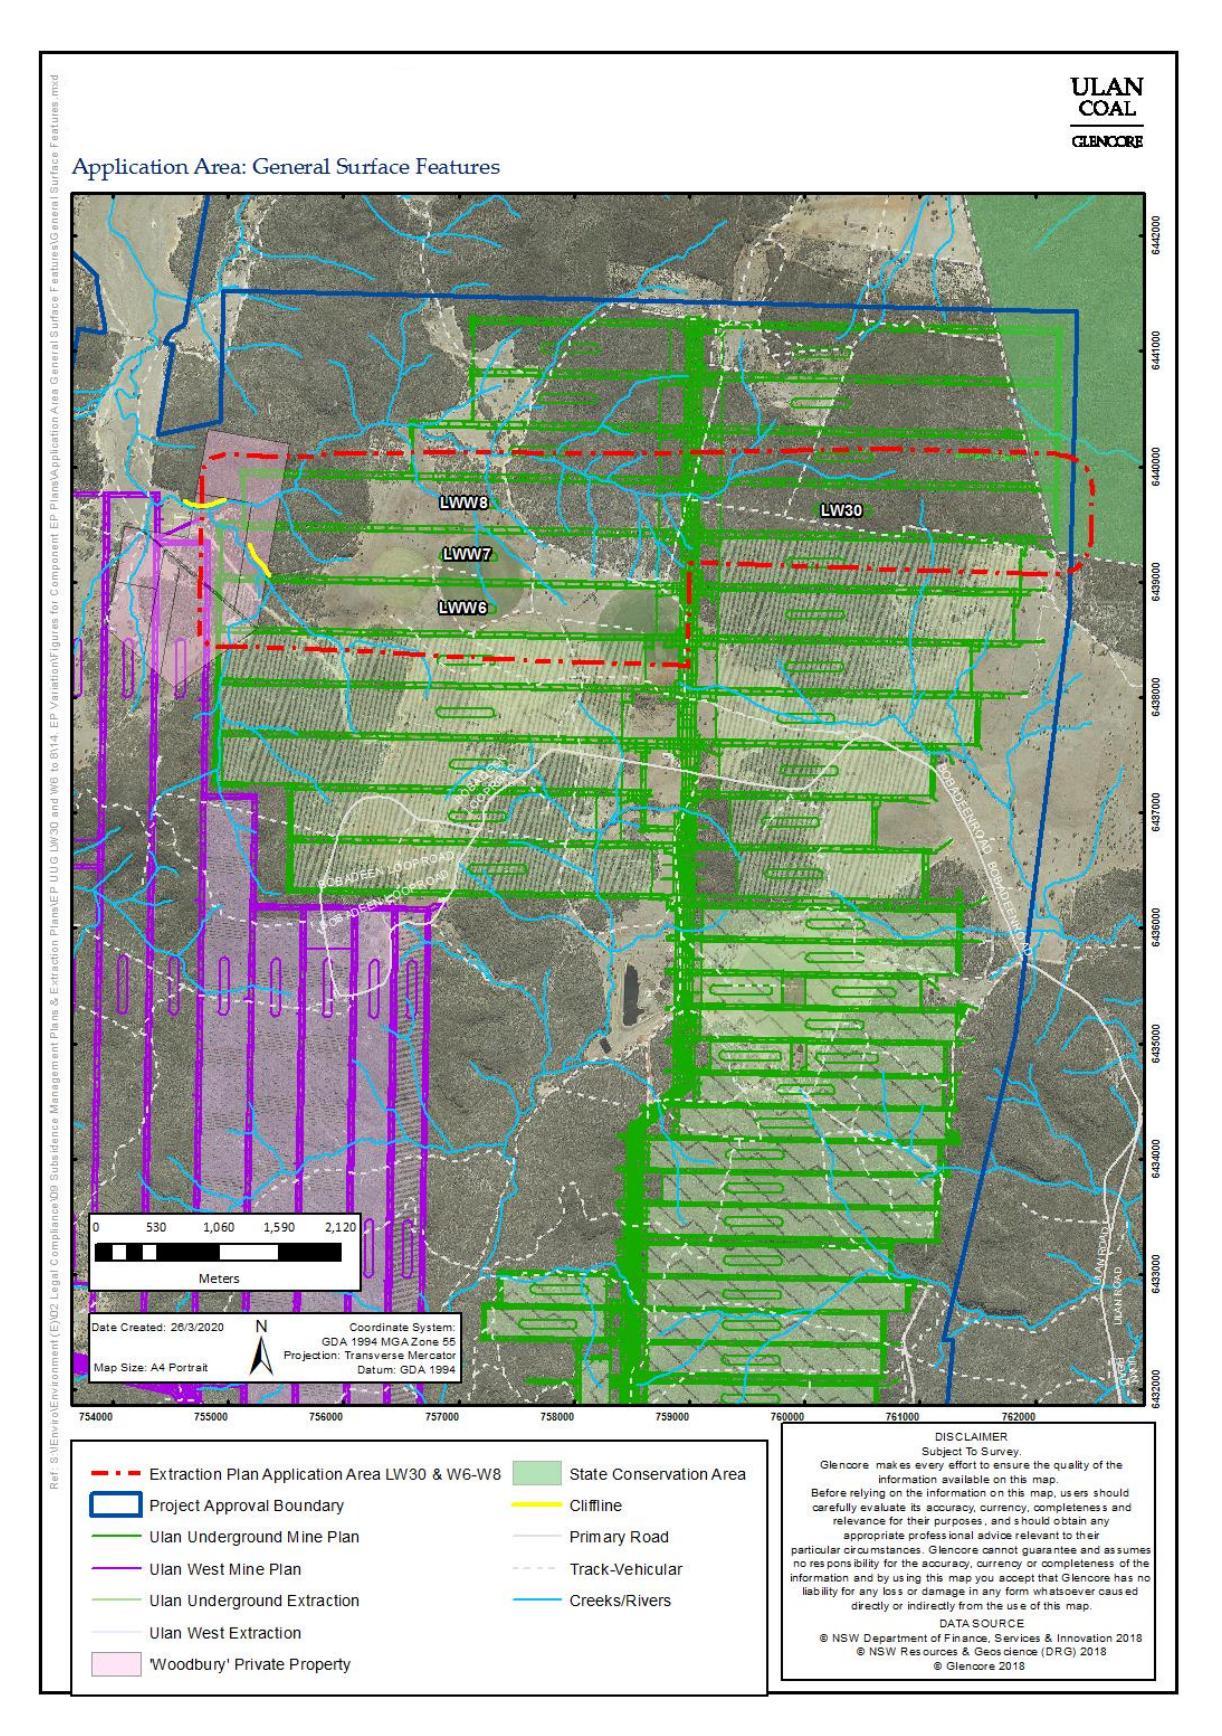
Figure 2 Landform Features within the Application Area

The major natural features within the Application Area include sandstone formations, a number of ephemeral watercourses, a spring fed dam and the DSCA. The spring is located within a dam located on privately owned land. All water courses within the Application Area are ephemeral in nature comprising of drainage lines and occasional pools that form after rain. Flow lines in the east of the Application Area report to Curra Creek and Bobadeen Creek in the Goulburn River catchment. Flow lines in the west report to Mona Creek in the Talbragar River catchment (**Figure 2**).

Approximately 2.8ha of the DSCA is located directly above the eastern portion of LW30. The revised Application Area that extends over the DSCA is predominately undeveloped bushland. There are no features of specific conservation values known to exist within the Application Area over DSCA. (**Figure 2**).

There are two cliff formations within the Application Area (**Figure 2**). The cliff line in the north-west corner of the Application Area across both UCMPL owned land and privately owned land and contains the Mona Creek Aboriginal rock shelter sites (Ulan ID#180 to 187) which are protected from subsidence impacts by an offset from mining. The cliff line over LWW7 is approximately 300m in length, is less than 20 meters high and has no recorded Aboriginal rock shelter sites. This cliff line extends from UCMPL owned land onto privately owned land.

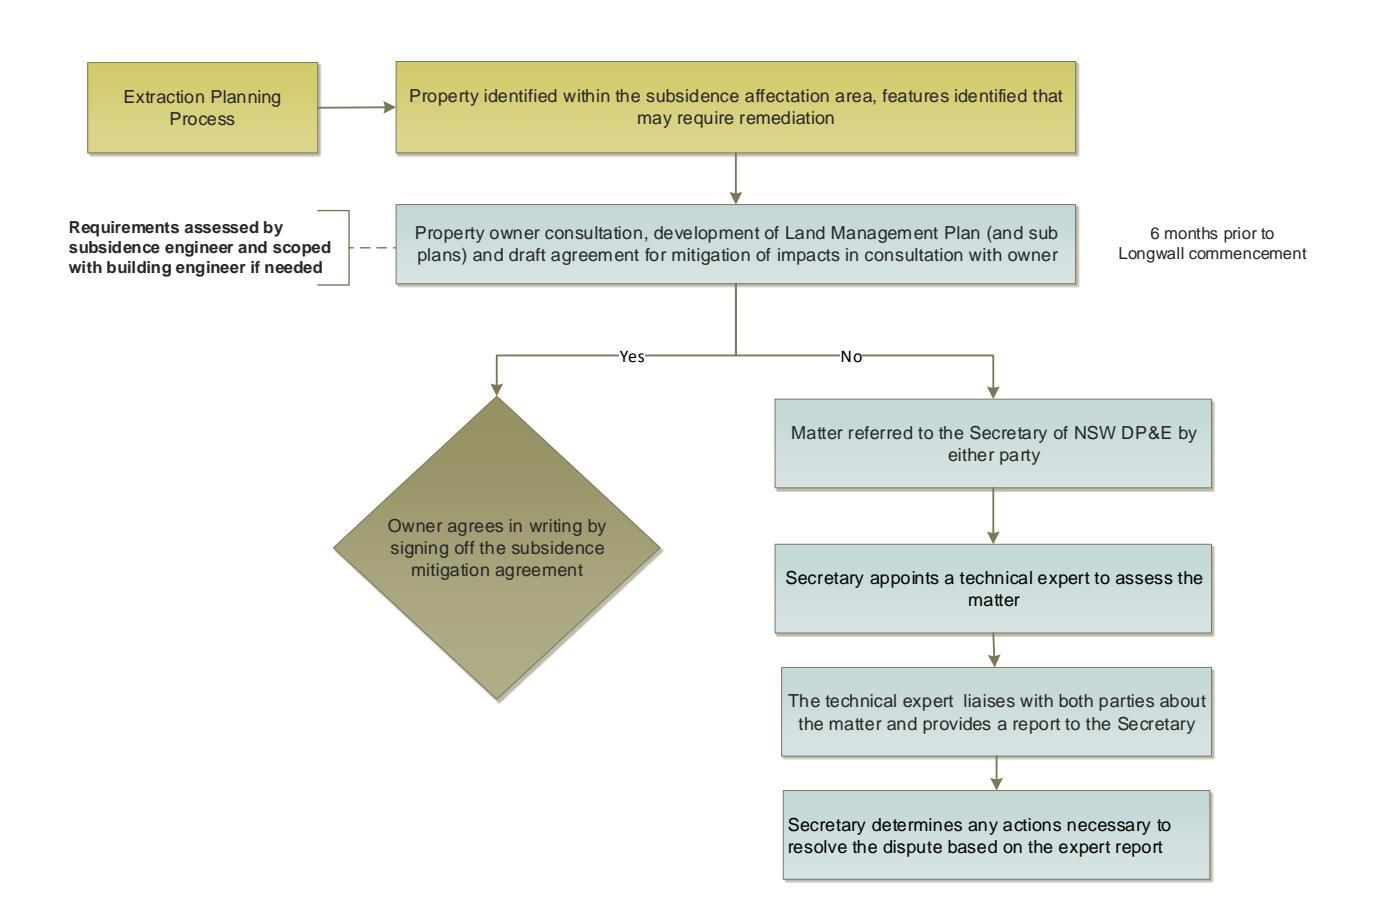
Figure 3 Landholder Dispute Resolution Process

Consultation with owners of land within the subsidence affectation area of LW30 & LWW6 - LWW8 has occurred since development of the Extraction Plan in 2016. Detailed consultation history is provided in the Private Property Subsidence Management Plans (PPSMP),⁹ which is a sub-plan to this plan. Through the PPSMP, UCMPL will seek to reach agreement with the landholder on the monitoring and mitigation that will be implemented. If agreement cannot be reached within a reasonable time prior to the longwall commencing, the following dispute resolution process may be followed (**Figure 3**).

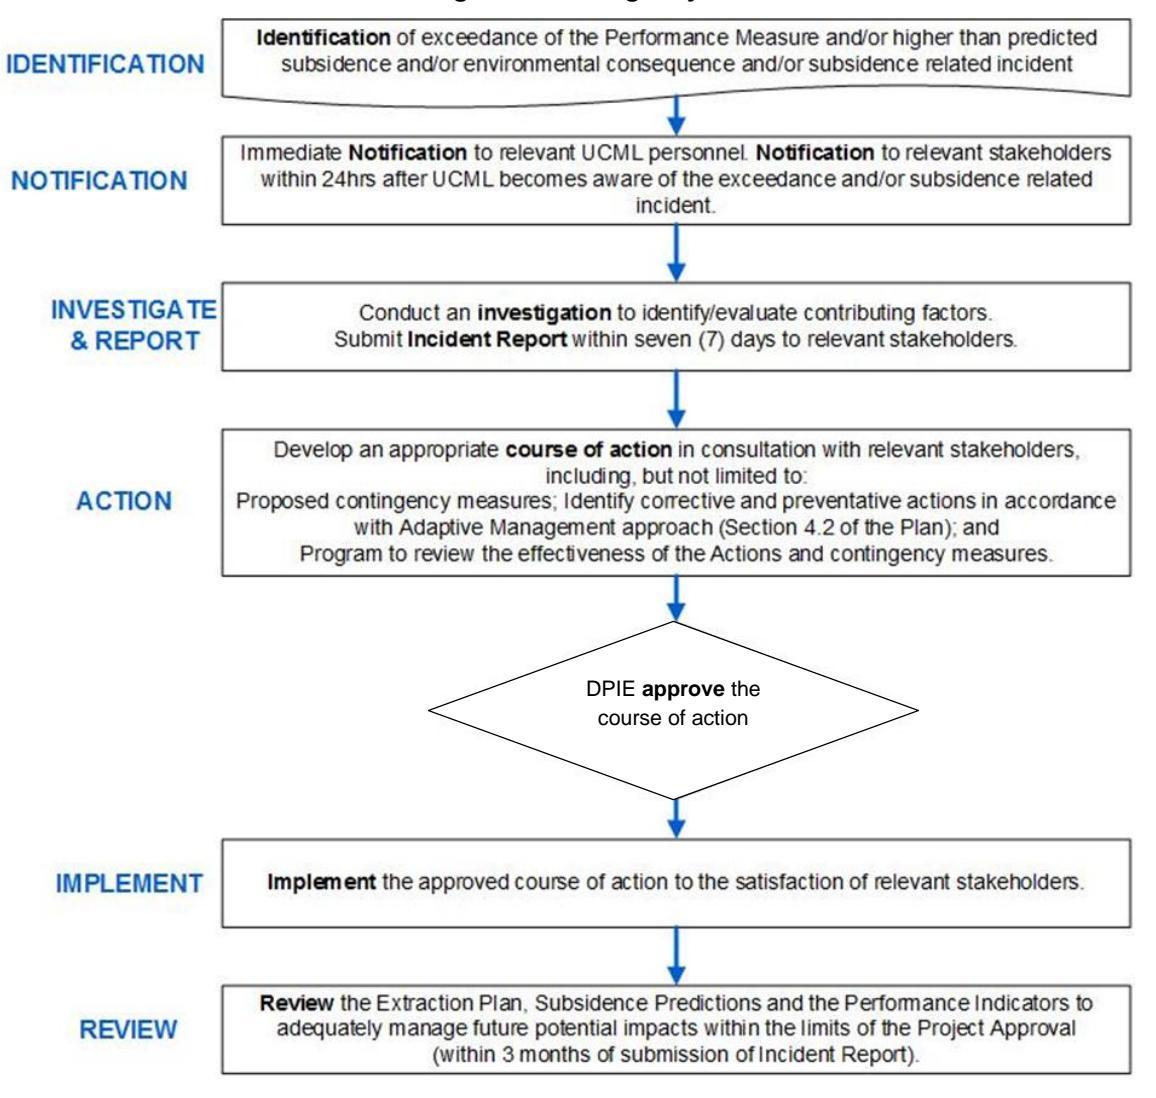
Figure 4 Contingency Plan

Figure 4 displays the Contingency Plan to be implemented in the event the land performance measures are exceeded, higher than predicted subsidence or environmental consequence has occurred or in the event of a subsidence related incident.
